Your Ref: M225492  
Our Ref : CS/MSG19004708/D

26 March 2019

**TECHNICAL INVESTIGATION REPORT OF FIRE INCIDENT INVOLVING THE  
INSURED VEHICLE SLC 1899J ON 09 MARCH 2019**

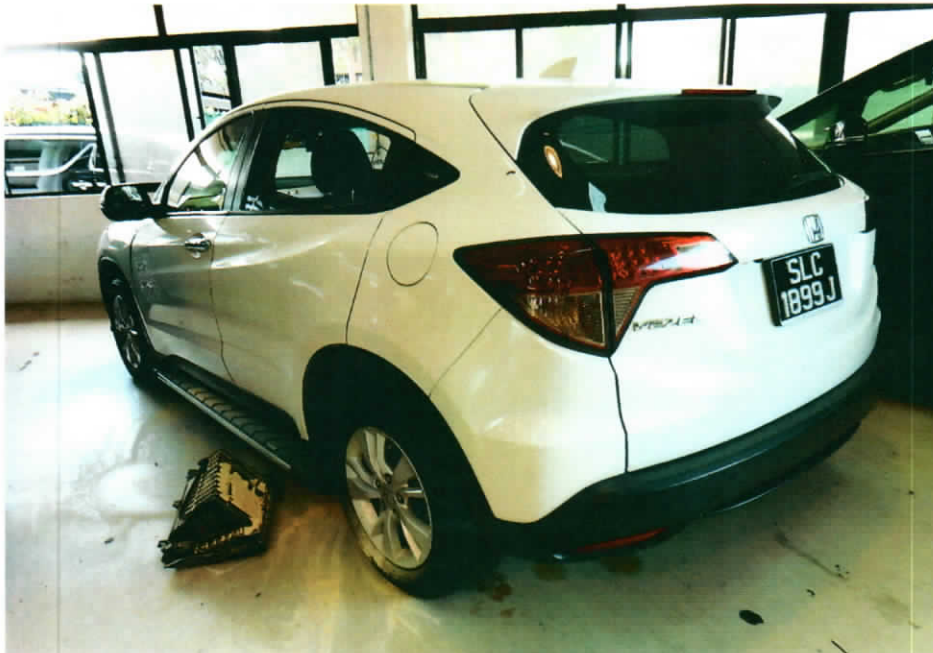
**Photo 1** shows a general view of the rear left body of the Insured Vehicle at the time of my inspection. The exterior body of the Insured Vehicle was observed to be in good general condition with no damage of fire/smoke nature found apart from a blackened front windscreen.

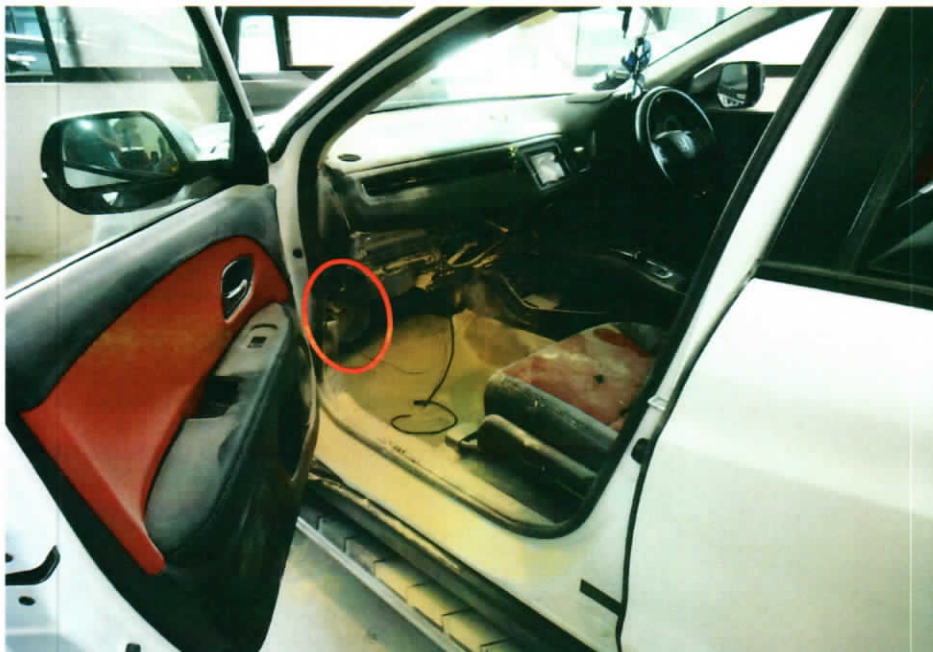
**Photo 2** shows a general view of the interior compartment of the Insured Vehicle at the time of inspection. I had observed slight fire/smoke damage that was confined to a single area of the Insured Vehicle. This was at the front left side of its interior compartment, near the glove compartment at the left side of the front dashboard (circled).

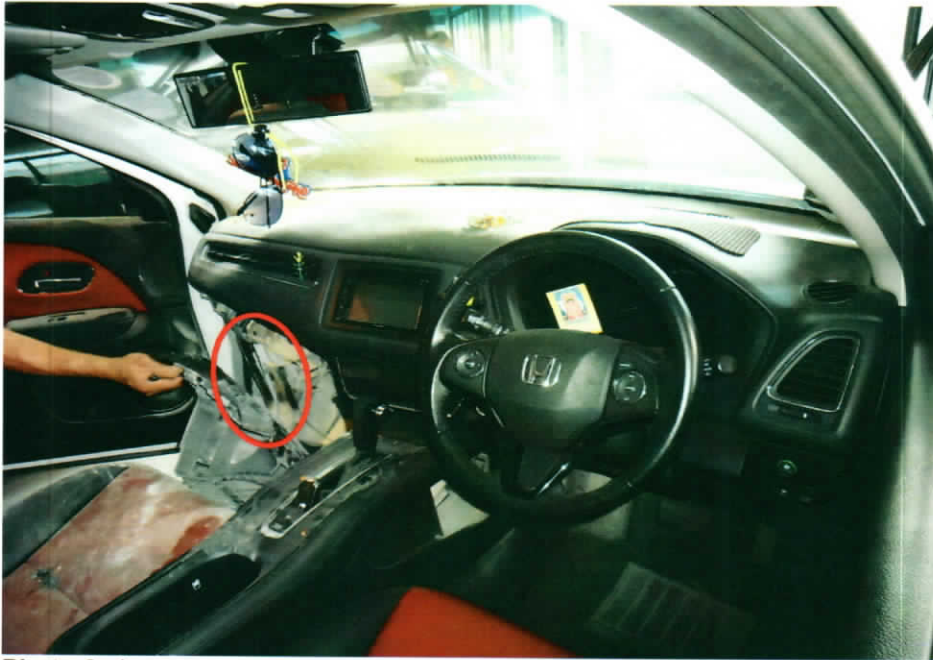
**Photo 3** shows a general view of the interior compartment of the Insured Vehicle at the time of inspection. I had observed slight fire/smoke damage that was confined to a single area of the Insured Vehicle. This was at the front left side of its interior compartment, near the glove compartment at the left side of the front dashboard (circled).

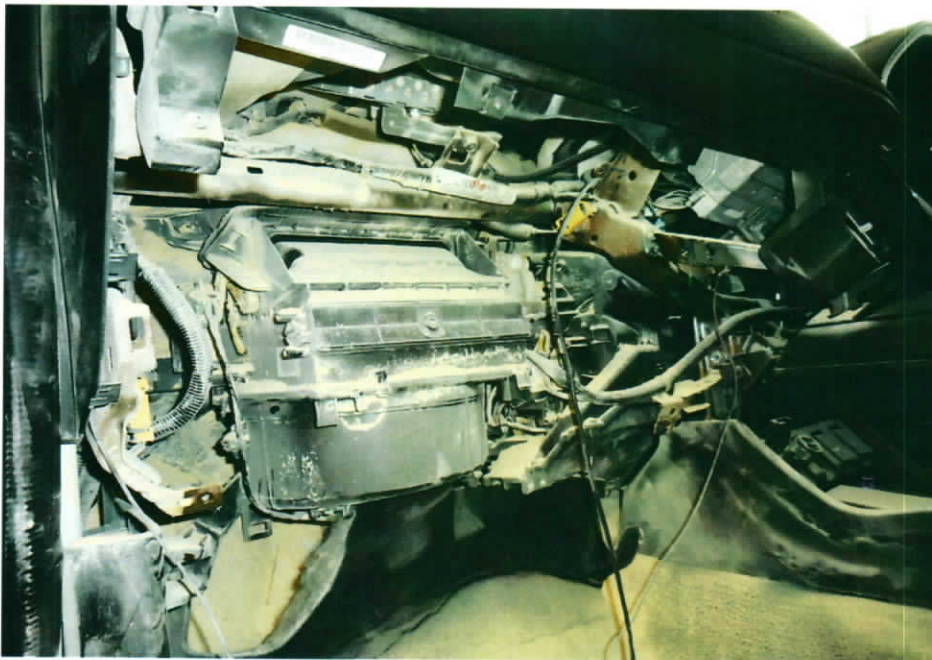
**Photo 4** shows a closer view of the left side of the front dashboard, which was where the slight fire/smoke damage was confined to. The front dashboard, upholstery and various plastic trims near the glove compartment at the left side of the front dashboard were slightly melted/burnt.

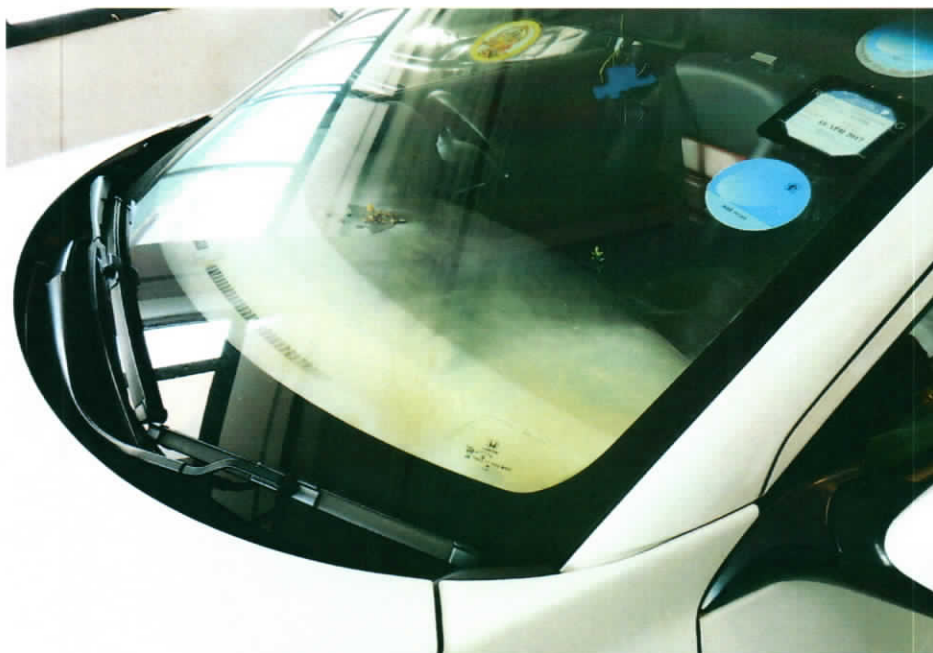
**Photo 5** shows the blackened front windscreen of the Insured Vehicle as a result of the incident. Apart from this blackened front windscreen, the exterior of the Insured Vehicle was unaffected by the fire.

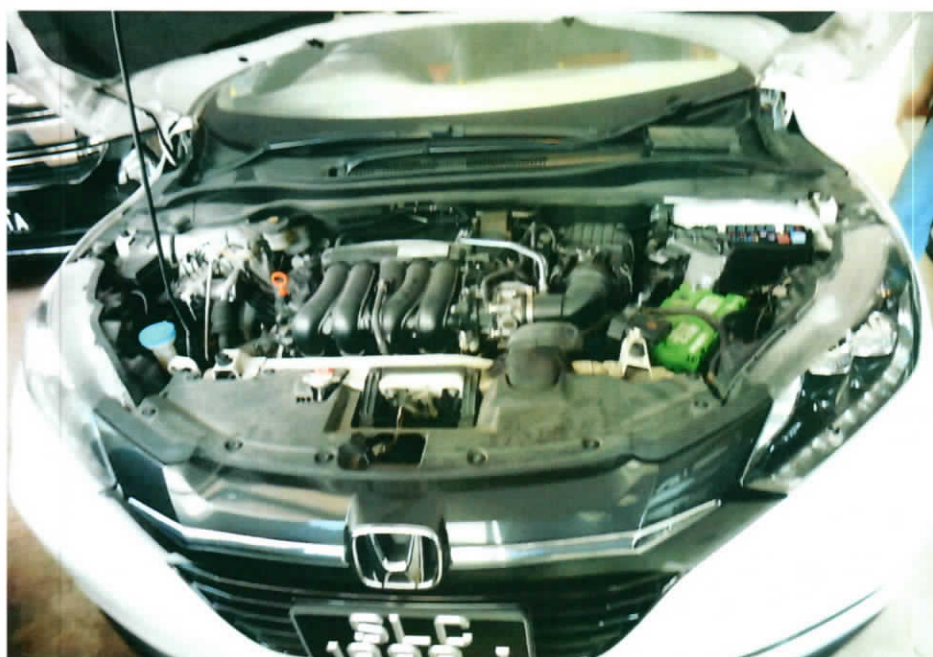
**Photo 6** shows a general view of the engine compartment of the Insured Vehicle, which was not affected by the incident.

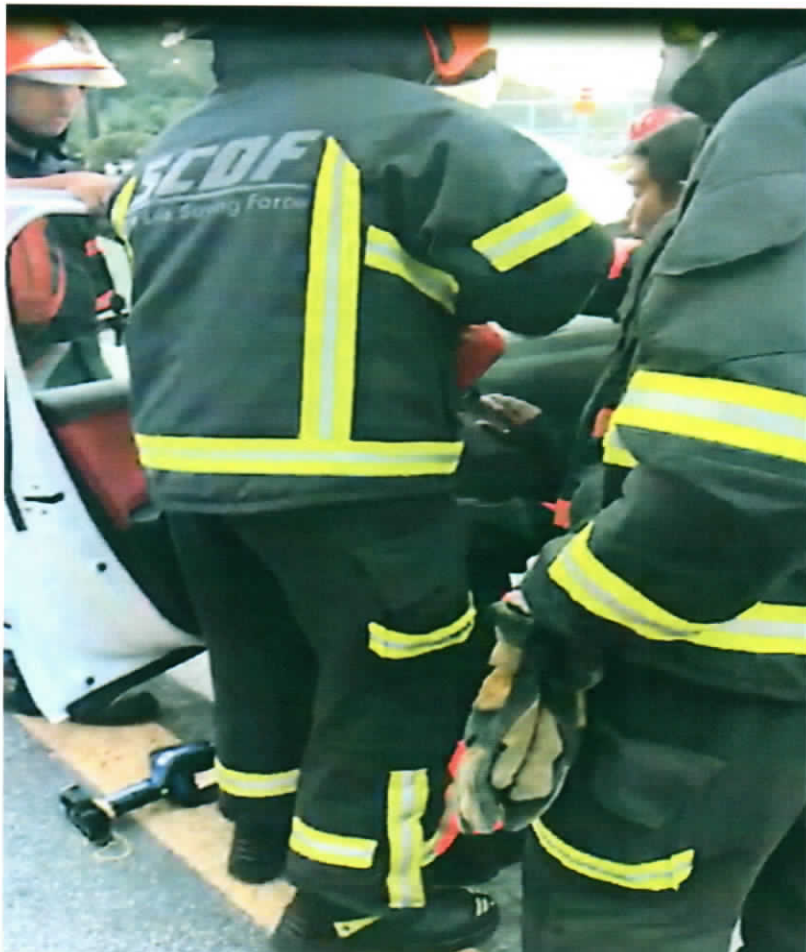
**Photo 8** shows screenshot taken from the video recording that was provided by Mr Sankar. Firefighting operation was focused within the interior compartment, at the front left side of the Insured Vehicle, where smoke was seen coming out.

15. For this case, the smoke incident to the Insured Vehicle can be determined to have originated at the front left side of its interior compartment, near the glove compartment at the left side of the front dashboard. This was established given that the damage relating to this incident was confined to the front left side, inside the interior compartment of the Insured Vehicle; and also given that the video recording taken at the incident scene had showed SCDF officers focusing their firefighting operation at this area of the Insured Vehicle.

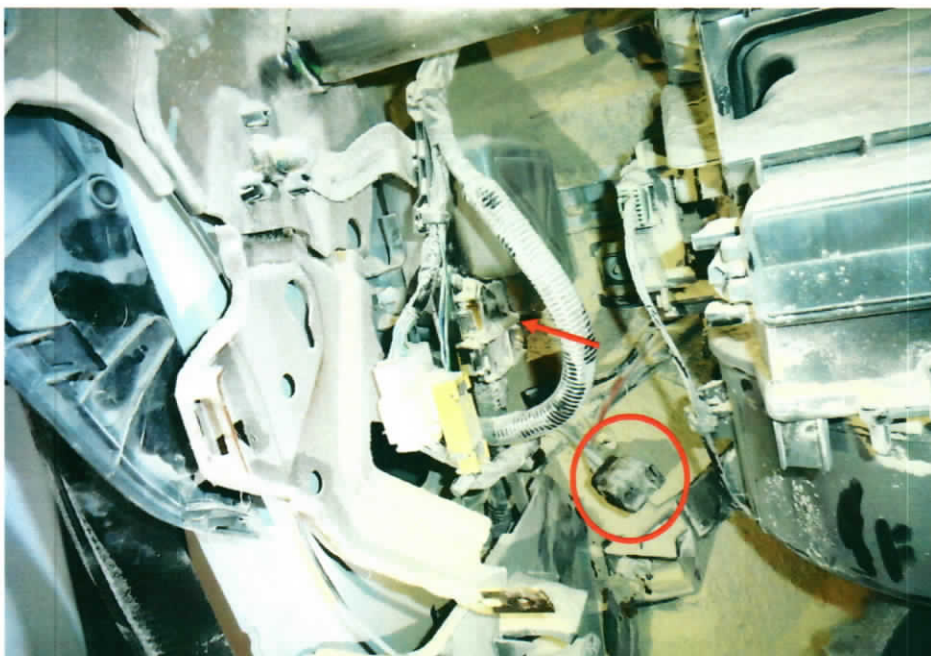
16. Examination of the area behind the front dashboard at the front left passenger side, which was where the smoke to the Insured Vehicle had originated, revealed a wire connector that was slightly burnt/melted. The wire connector was for a component that was partially burnt. This component was fixed onto the inner side of the Insured Vehicle's front left "A" pillar, towards the left and below the glove compartment. This physical evidence at the area where the smoke had originated would then appear to indicate that the cause of the smoke incident to the Insured Vehicle was due to electrical in nature that involved the partially burnt component. See photo 9 - 11 below.

**Photo 9** shows a general view of the area behind the front dashboard at the front left passenger side, which was where the smoke to the Insured Vehicle had originated. Upon examination of this area, it was observed that a wire connector (circled) was slightly burnt/melted. The wire connector was further observed to be for a component (arrowed) that was partially burnt.

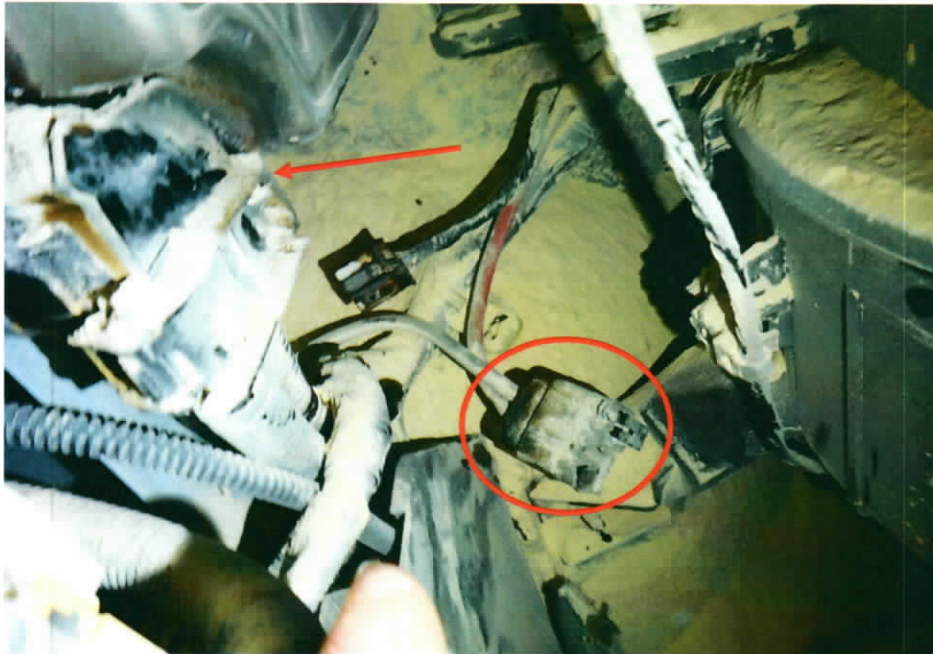
**Photo 10** shows a closer view of the wire connector (circled) that was found to be slightly burnt/melted. The wire connector was observed to be for a component (arrowed) that was also partially burnt.

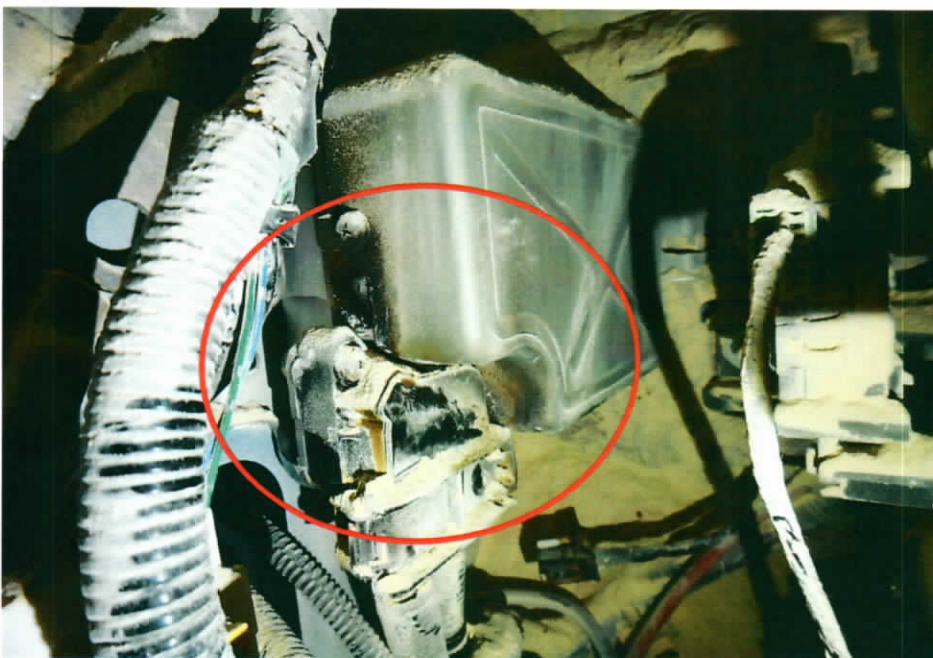
**Photo 11** shows a closer view of the partially burnt component (circled), which the slightly burnt/melted wire connector connects into. This physical evidence at the area where the smoke had originated would appear to indicate that the cause of the smoke incident to the Insured Vehicle was due to electrical in nature that involved the partially burnt component.

18. My further research and checks on this capacitor revealed that this capacitor is the exact same component fitted on the Insured Vehicle that was found to be partially burnt (refer to photograph 11 above). Basing on the information gathered pertaining to the capacitor; and given that no rectification to address the capacitor issue has been carried out to the Insured Vehicle, it can be determined that the smoke incident to the Insured Vehicle is related to the purpose of the manufacturer recall campaign that involved the Insured Vehicle. See search result below gathered from my further research and checks.

22. Having investigated and technically analysed the damages of burnt nature to the Insured Vehicle, I am of the view that the cause of the smoke incident to the Insured Vehicle was of electrical in nature. For this particular case, the smoke had originated at a component that was fixed onto the inner side of the Insured Vehicle's front left "A" pillar, towards the left and below the glove compartment. The component is an original fitted component.

23. My investigations also revealed that this smoke incident is related to a manufacturer recall campaign that involved the Insured Vehicle as the purpose of the recall was due to a fault in this component, which was referred to as a capacitor. Rectification to address the purpose of the recall campaign was not carried out to the Insured Vehicle prior to this incident.

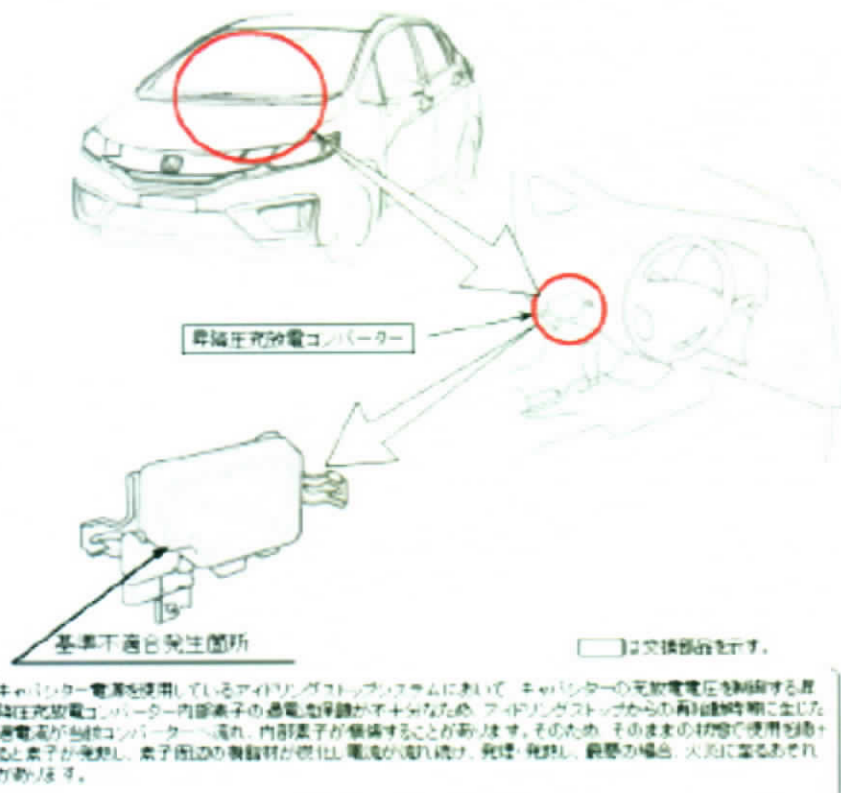
Screenshot shows the write up that I was able to gather pertaining to the manufacturer recall campaign of similar make and model vehicles as the Insured Vehicle.

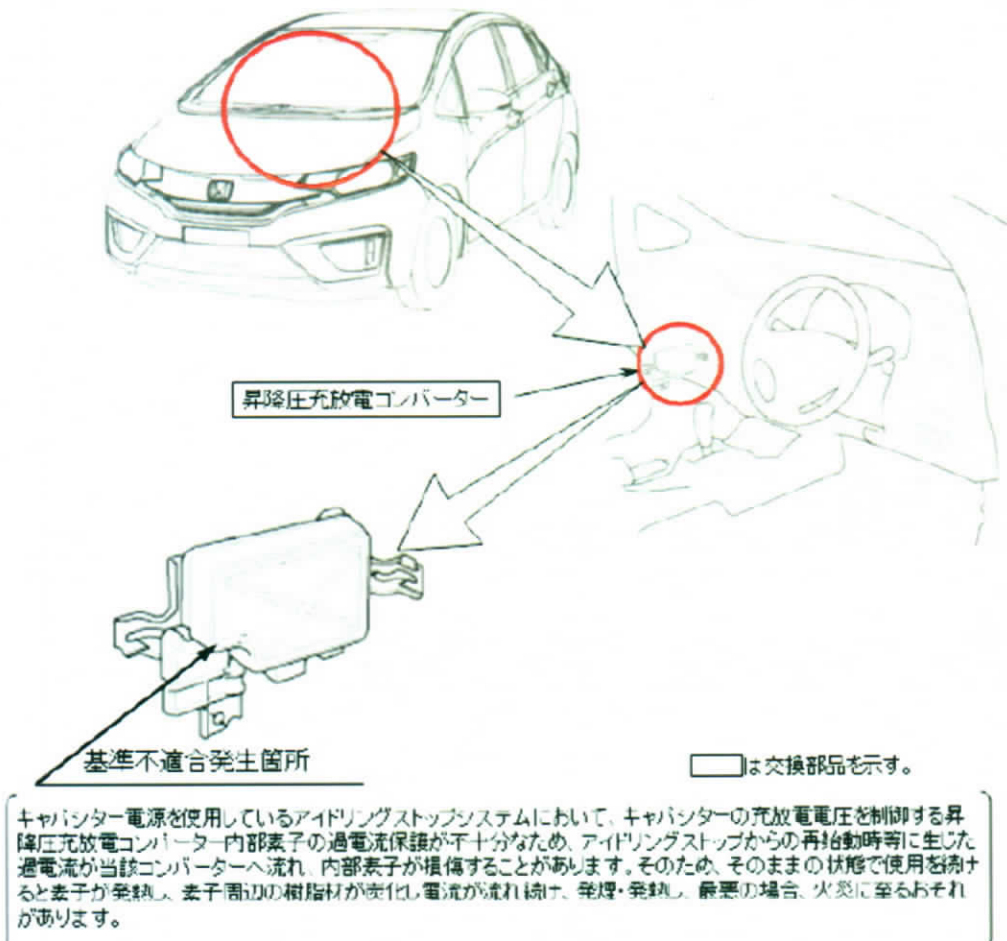
Screenshot shows a zoom in view of the schematic diagram pertaining to the manufacturer recall campaign of similar make and model vehicles as the Insured Vehicle. The component, circled in the schematic diagram, was of same shape as the partially burnt component that was observed on the Insured Vehicle. The location where this component was fitted was also at the same area where the smoke to the Insured Vehicle had originated.
