# ComfortDelGro Engineering Pte Ltd

Assessment number: GBB8662C / 08032019 / WW

Full Report

Manufacturer: FIAT  
Model: DOBLO VAN  
Sub Model: CARGO  
Model Sheet Number: 08 47 01  
Registration: GBB8662C  
VIN number: ZFA22300005698111  
Odometer:

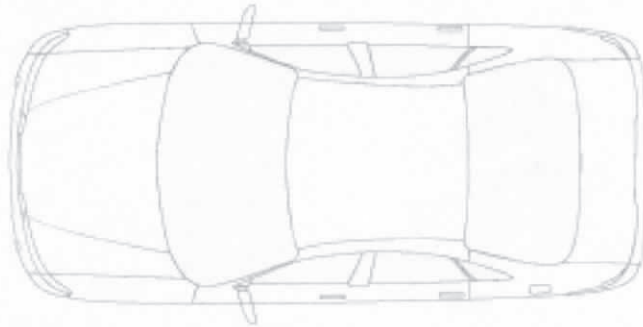
### Damage Areas

All ☐  
Underbody ☐

Code	Description	Time Base 10 WU/h	Price = 45.00 SGD/h	
			WU	Price SGD
7604A 02	VEHICLE PREPARATION TIME		2.0	9.00
7660C 04	R + R R/R SIDE BUMPER		2.0	9.00
5540A 44	R + R R/OUTER TAILLAMP		2.0	9.00
5540A 43	R + R R/TAILLAMP COVER		1.0	4.50
2592	R/R BUMPER CORNER REPAIR		20.0*	90.00
<b>Labour Cost</b>			<b>Hrs</b>	<b>WU</b>
<b>Panel / Mechanical Labour</b>			<b>2.70</b>	<b>27.0</b>
<b>Total of Labour</b>				<b>121.50</b>
