ComfortDelGro Engineering Pte Ltd

Assessment number: GBB8662C / 08032019 / WW

Full Report

Manufacturer:	FIAT
Model:	DOBLO VAN
Sub Model:	CARGO
Model Sheet Number:	08 47 01
Registration:	GBB8662C
VIN number:	ZFA22300005698111
Odometer:

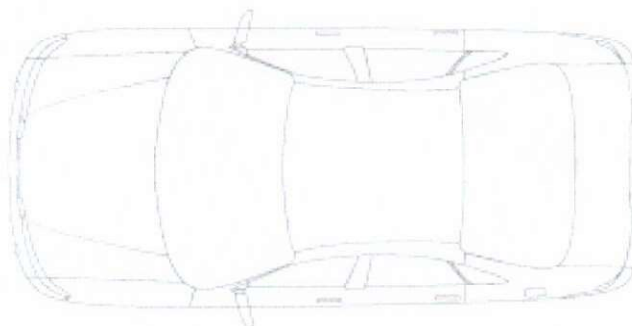
Damage Areas

Code	Description	Time Base 10 WU/h	Price = 45.00 SGD/h	
			WU	Price SGD
7604A 02	VEHICLE PREPARATION TIME		2.0	9.00
7660C 04	R + R R/R SIDE BUMPER		2.0	9.00
5540A 44	R + R R/OUTER TAILLAMP		2.0	9.00
5540A 43	R + R R/TAILLAMP COVER		1.0	4.50
2592	R/R BUMPER CORNER REPAIR		20.0*	90.00
Labour Cost			Hrs	WU
Panel / Mechanical Labour			2.70	27.0
Total of Labour				121.50
