Your Ref: 2473355709SG
Our Ref : CI/AIG19004979/D

**TECHNICAL INVESTIGATION REPORT OF FIRE INCIDENT INVOLVING THE
INSURED VEHICLE SLJ 3671Z ON 30 JANUARY 2019**

Vehicle Registration No.	: SLJ 3671Z
Make / Model	: Jaguar XJ 3.0L Diesel
Chassis No	: SAJAC2229ANV09855
Year of Registration	: 2010 (September)
Mileage	: N.A (wiring affected)

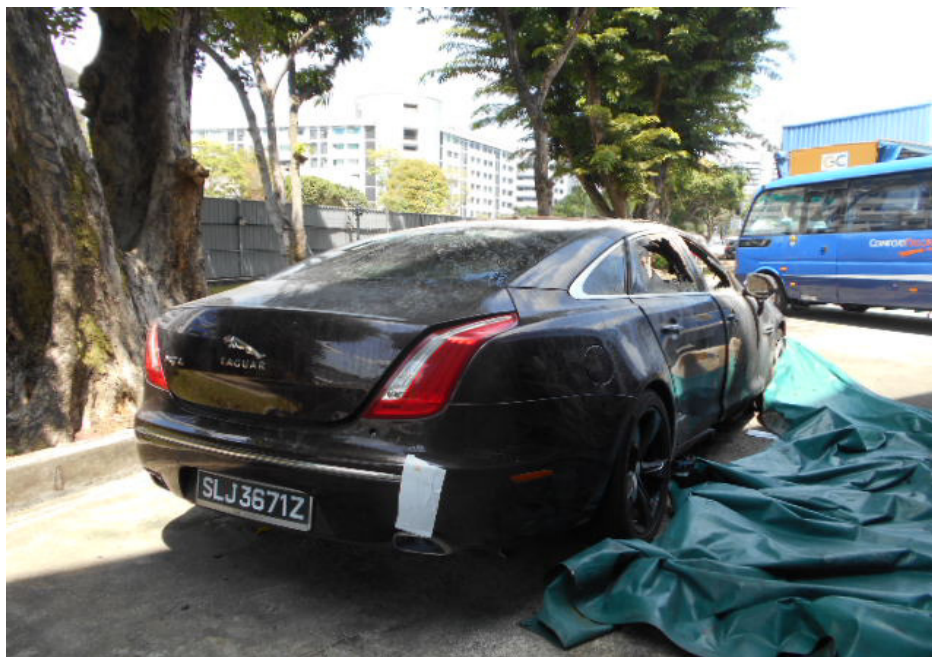
Photo 1 shows a general view of the rear portion of the Insured Vehicle at the time of my inspection. The Insured Vehicle was observed to have sustained severe fire damage at its centre portion. Its rear portion had sustained minor fire damage that was mainly due to heat from the fire.

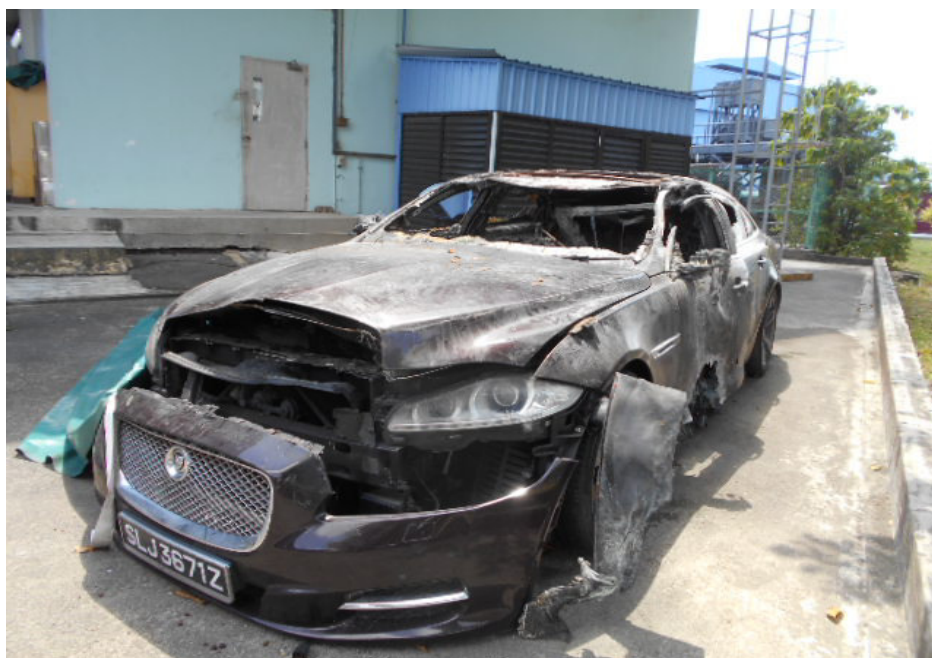
Photo 2 shows a general view of the front portion of the Insured Vehicle at the time of my inspection. The Insured Vehicle was observed to have sustained severe fire damage at its centre portion. Its front portion had sustained minor fire damage that was mainly due to heat from the fire.

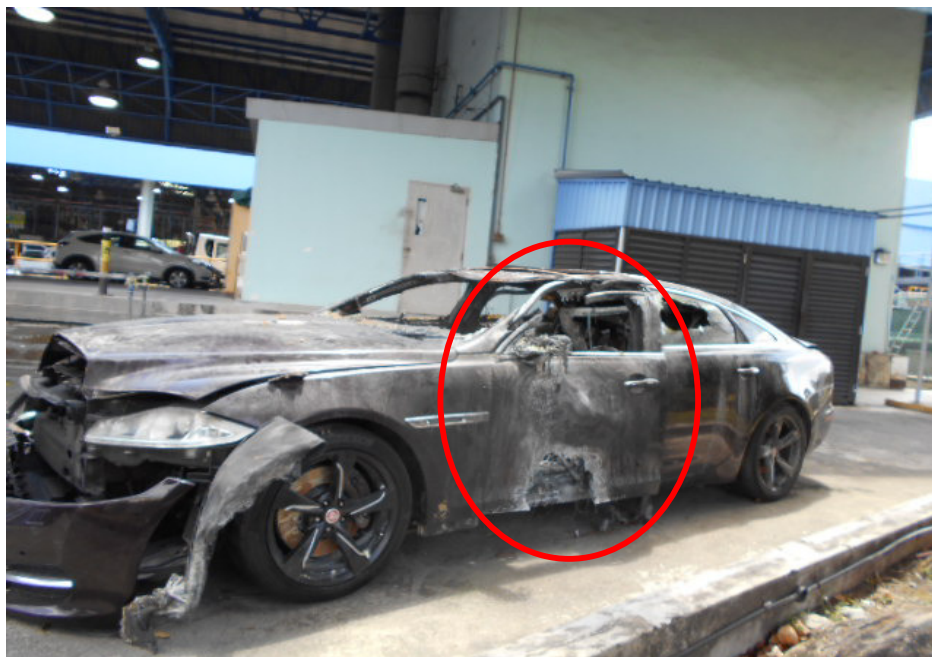
Photo 3 shows a general view of the left side of the Insured Vehicle at the time of my inspection. From the burn pattern, the fire appears to have been most intense at the centre portion (circled) of the Insured Vehicle. This follows the severe fire damage that was observed within the interior compartment of the Insured Vehicle.

17. For this case, the severity of the burn damage sustained to the centre portion of the Insured Vehicle as compared to its other areas indicates that the origin of fire was at the centre body of the Insured Vehicle, within its interior compartment.

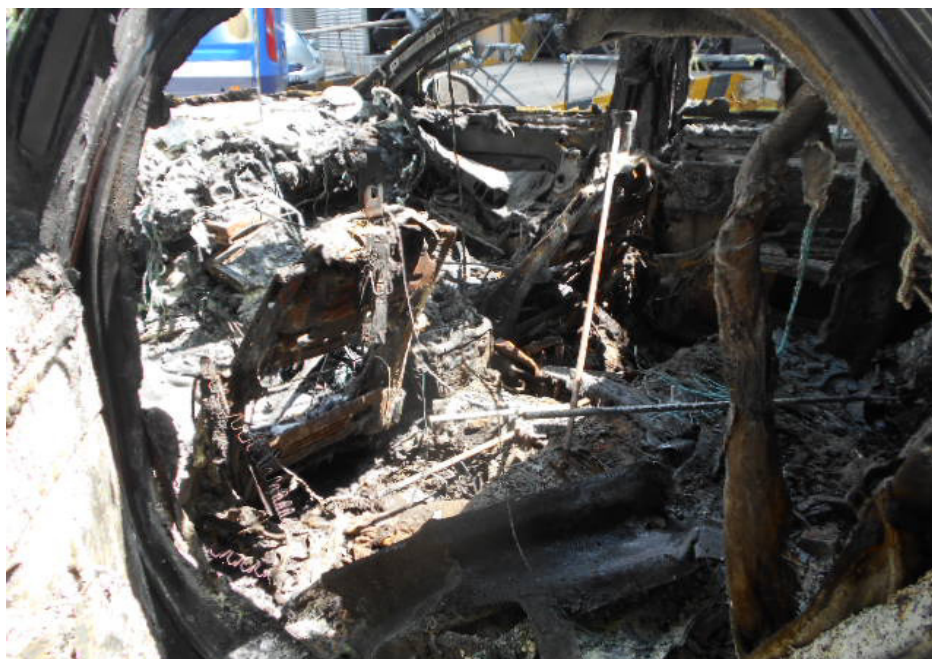
Photo 4 shows a general view of the interior compartment of the Insured Vehicle, which was affected the most by the fire. Almost all the parts within the interior compartment were severely burnt and/or melted.

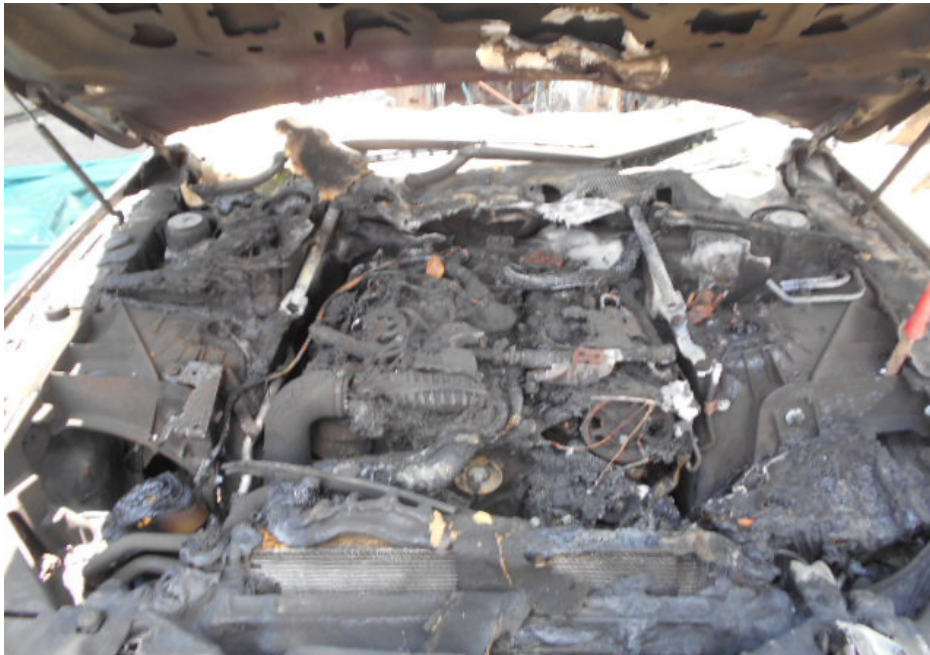
Photo 5 shows a general view of the engine compartment of the Insured Vehicle. Although the parts within the engine compartment were also affected by the fire, the extent of burn damage was less severe as compared to the parts within the interior compartment.

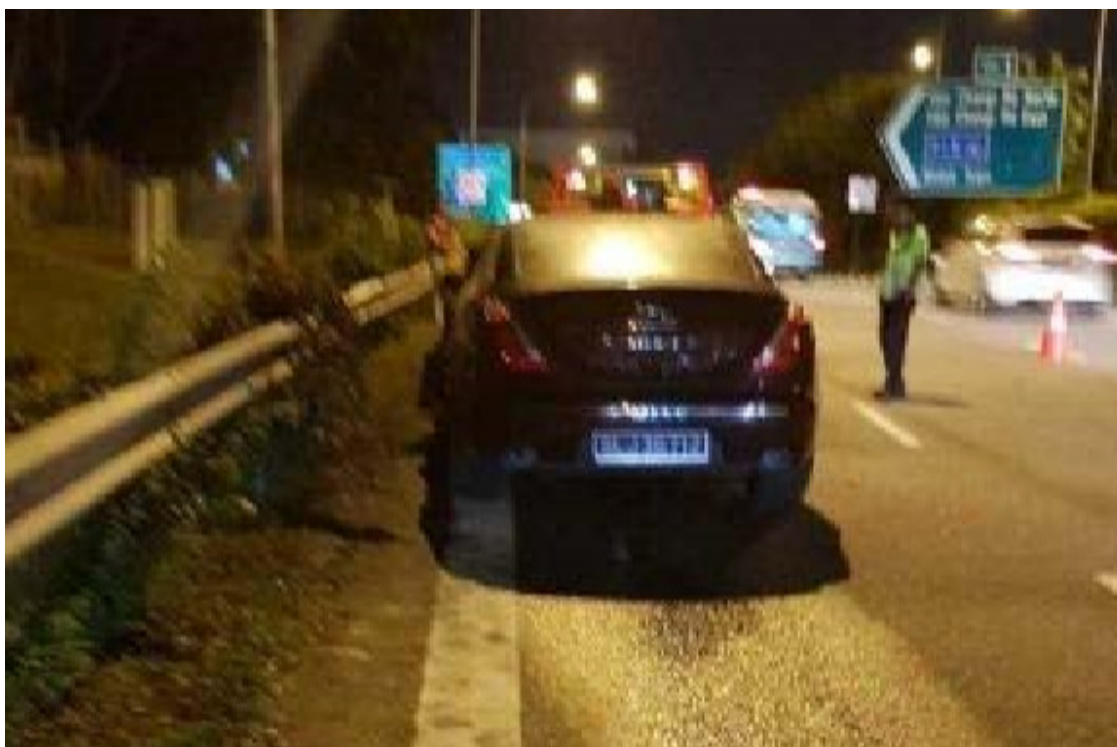
Photo 6 shows the Insured Vehicle at the incident scene after the fire was extinguished (photograph taken by Mr Tay at the incident scene).

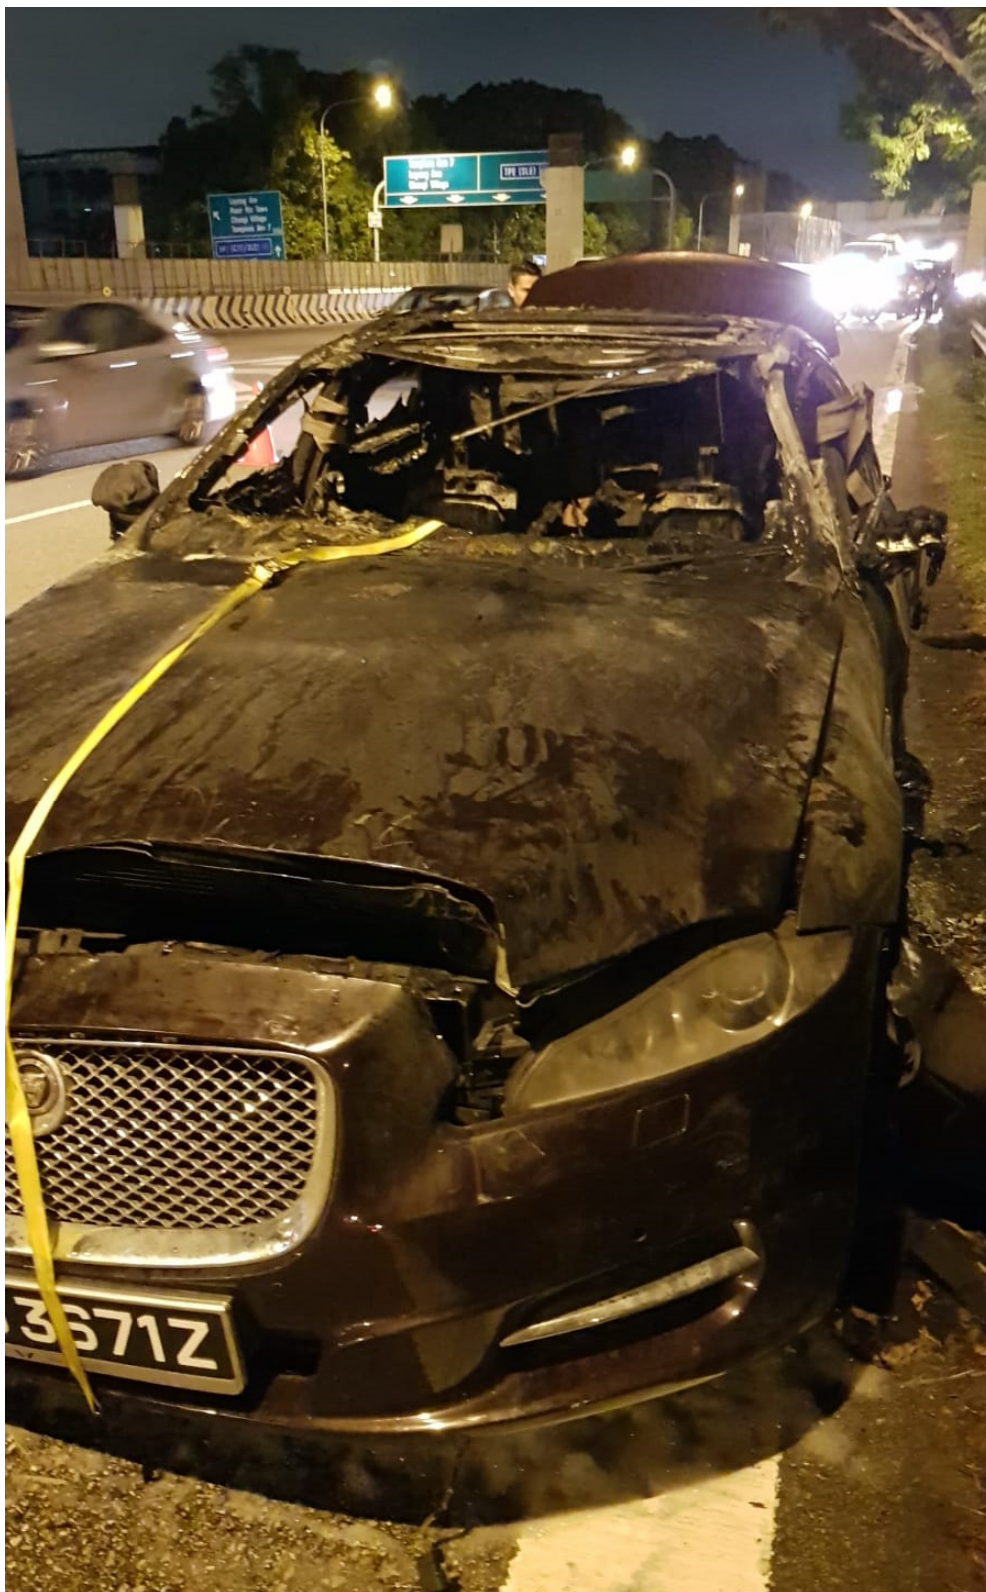
Photo 7 shows the Insured Vehicle at the incident scene after the fire was extinguished (photograph taken by Mr Tay at the incident scene).

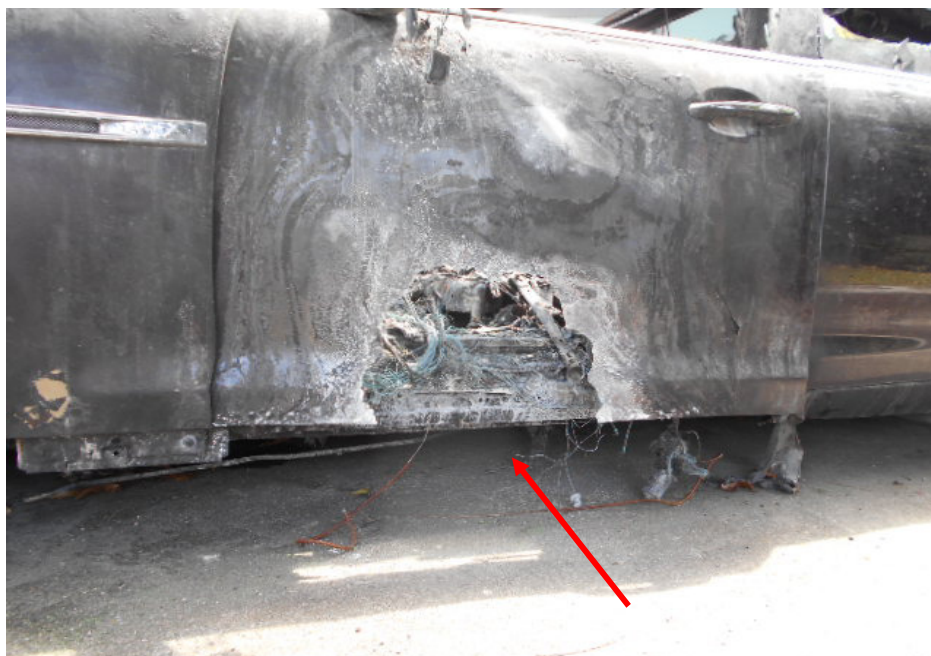
Photo 9 shows the left centre of the Insured Vehicle, at its left front door area. The DPF is located at the underside centre of the Insured Vehicle (arrowed).

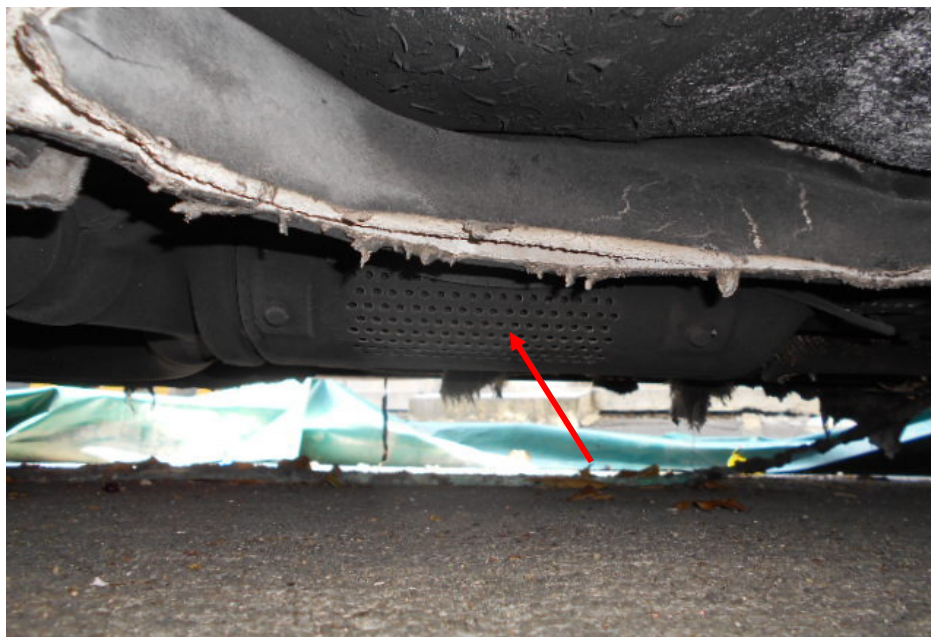
21. The DPF of the Insured Vehicle is located at the underside centre of the Insured Vehicle, below the centre console of the Insured Vehicle. Mr Tay’s wife had felt the area under the front left passenger seat was quite hot and Mr Tay himself had noticed smoke coming out from the rear of the Insured Vehicle and from the centre console/armrest area of the Insured Vehicle just before the fire. The evidence gathered would then appear to indicate that the fire to the Insured Vehicle was a result of heat radiating from a fire that had occurred within the DPF that was fitted at the underside centre of the Insured Vehicle. Mr Tay was in fact regenerating (cleaning) the DPF when the fire occurred thereafter. See photo 9 & 10 below showing the DPF of the Insured Vehicle.

Photo 10 shows the DPF (arrowed) of the Insured Vehicle. The DPF is located at the underside centre of the Insured Vehicle. From my observations, the DPF of the Insured Vehicle was blackened, indicating exposure to the fire/extreme heat.

24. Having investigated and technically analysed the damages of burnt nature to the Insured Vehicle, I am of the view that the cause of fire to the Insured Vehicle was due to fire that had occurred within the Diesel Particulate Filter (DPF) of the Insured Vehicle. For this particular case, heat from a fire that had occurred within the DPF had radiated to the surrounding components leading to fire within the interior compartment of the Insured Vehicle.

25. The diesel particles (soot, carbon etc) trapped by the filter element inside the DPF of the Insured Vehicle had self-ignited when the exhaust temperature within the DPF had increased as a result of clogging in the DPF.
