Your Ref : M564214
Our Ref : CS3/MSG18012821/N

14 December 2018

**AUTOMOBILE TECHNICAL INVESTIGATION REPORT OF ACCIDENT
INVOLVING SKA 1068M AND SKM 46U ON 7 JULY 2018**

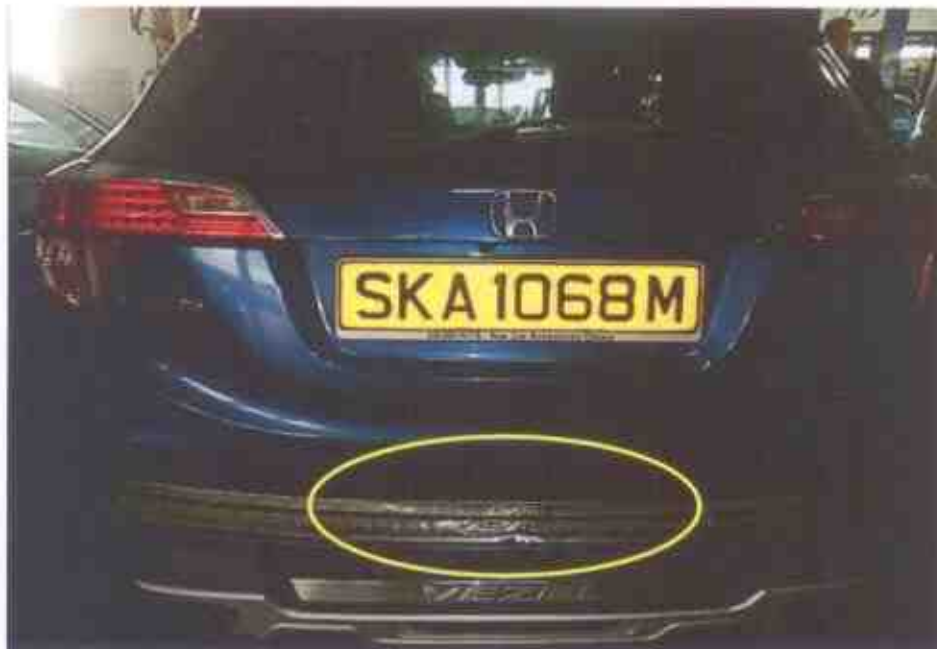
Photo 1 shows the general view of the rear of the Honda at the time of the Pre-Repair Survey conducted by LKK Auto Consultants Pte. Ltd. taken 5 months after the accident. The damage to the Honda was observed to be confined to its rear centre portion (circled).

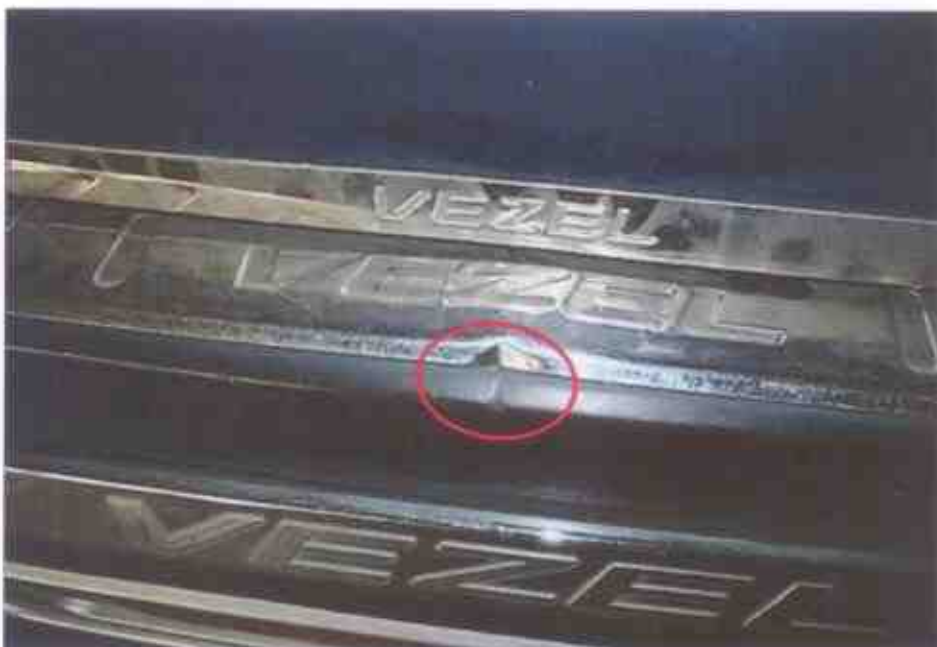
Photo 2 shows a close up view of the rear bumper of the Honda at the time of the Pre-Repair Survey conducted by LKK Auto Consultants Pte. Ltd. taken 5 months after the accident. We observed that the rear bumper scuff plate as well as the rear bumper were buckled at the centre portion (circled).

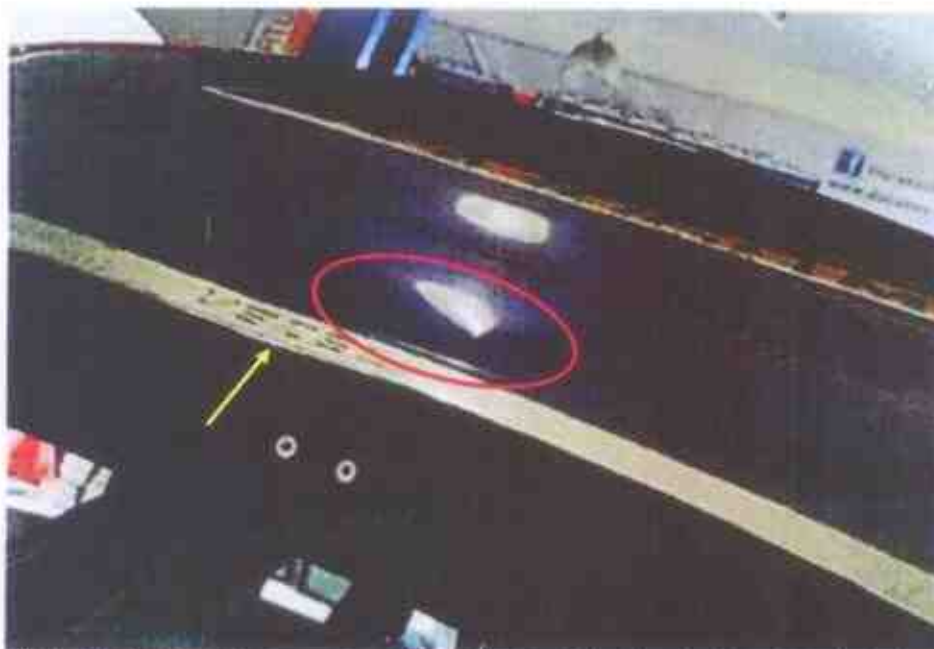
Photo 3 shows a close up view of the tailgate of the Honda. The tailgate bottom chrome moulding was buckled at the centre portion (arrowed). The boot lid was also dented at the lower centre portion (circled).

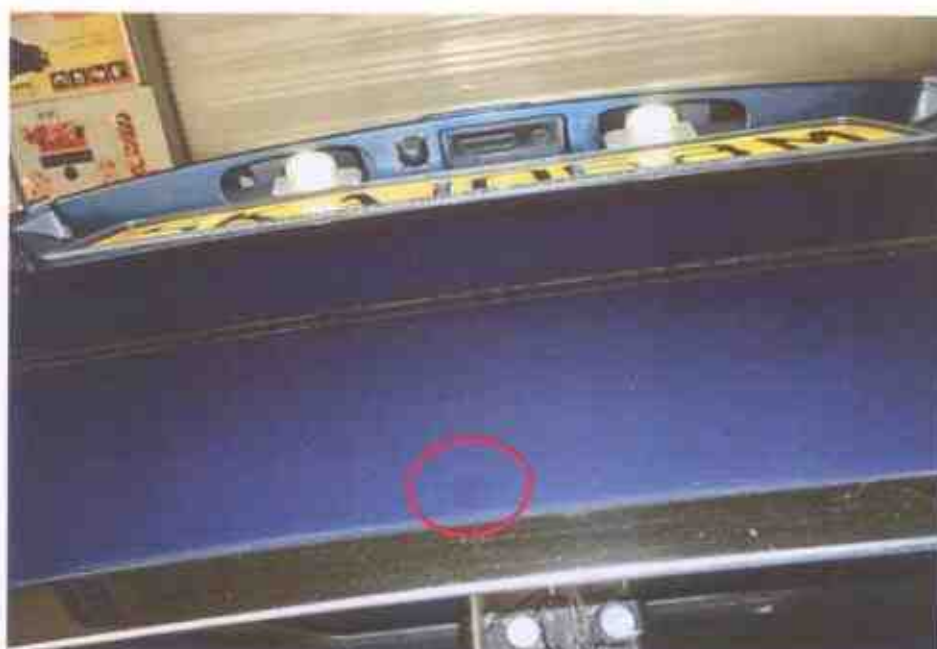
Photo 4 shows a close up view of the slight dent on the lower centre portion of the boot lid (circled).

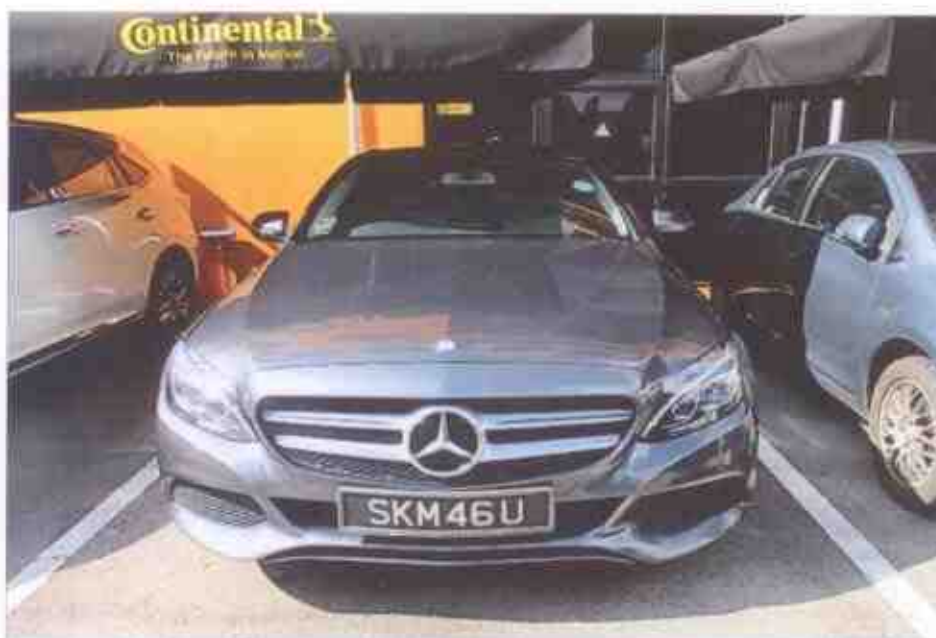
Photo 5 shows the general view of the front portion of the Mercedes upon our physical inspection.

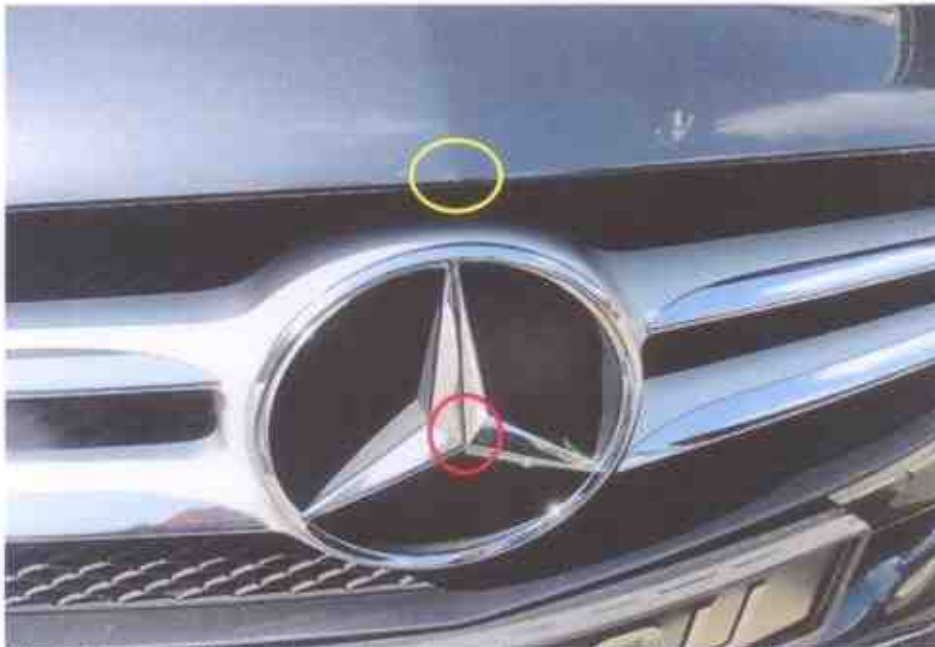
Photo 6 shows the white mark on the centre portion of the front bonnet (yellow circle). The front emblem was observed to be slightly dented at the centre portion (red circle).

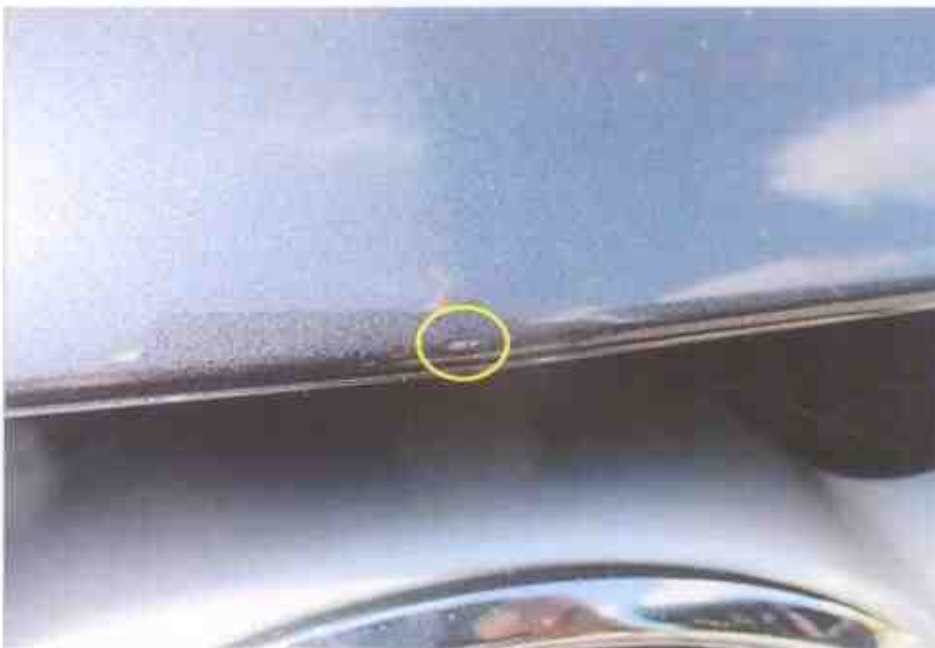
Photo 7 shows a close up view of the white mark on the centre portion of the Mercedes's front bonnet (circled).

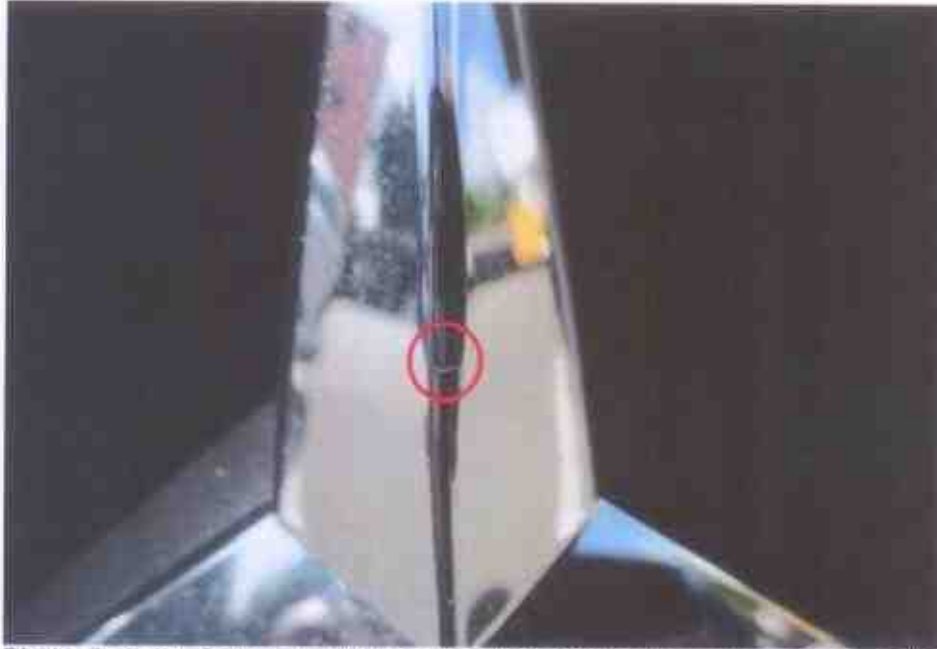
Photo 8 shows a close up view of the slight dent at the centre portion of the Mercedes's front emblem (circled).

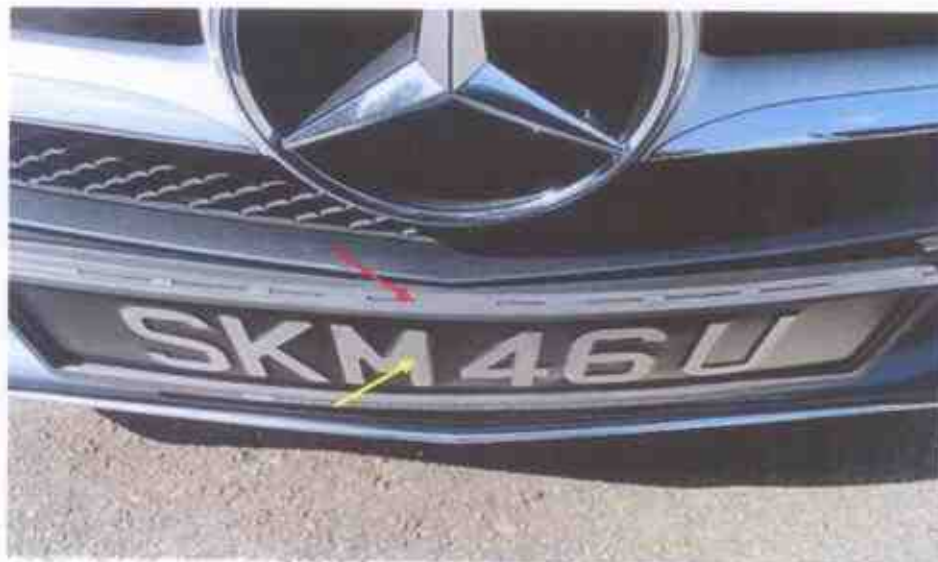
Photo 9 shows upon closer examination of the front number plate of the Mercedes, we observed cracks on the top centre portion of the front number plate frame (red arrow). There were also several black marks on the alpha- numeric letterings of the front number plate of the Mercedes (yellow arrow).

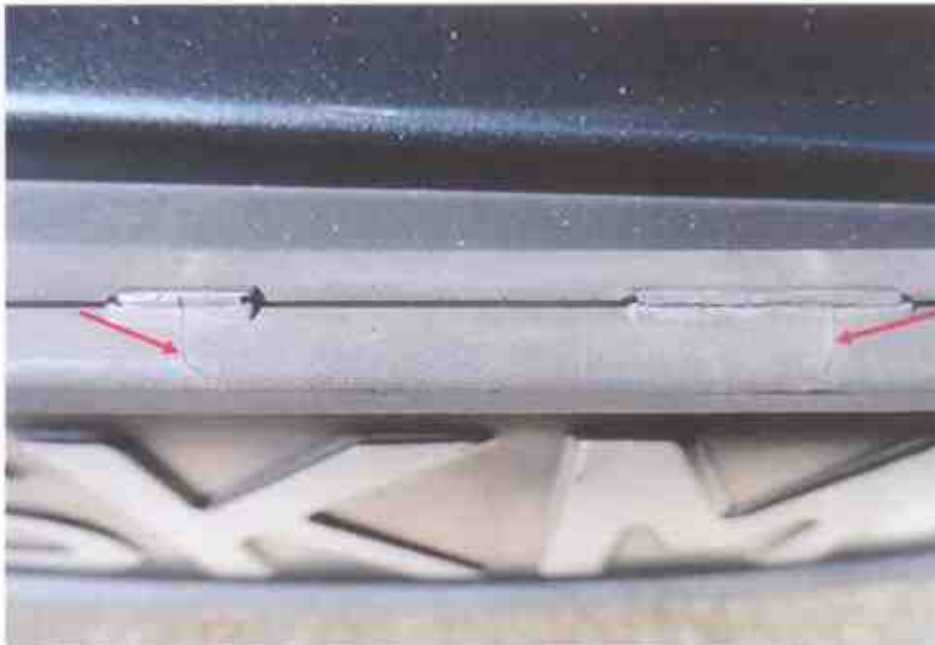
Photo 10 shows a close up view of the cracks on the top centre portion of the Mercedes's front number plate frame (red arrows).

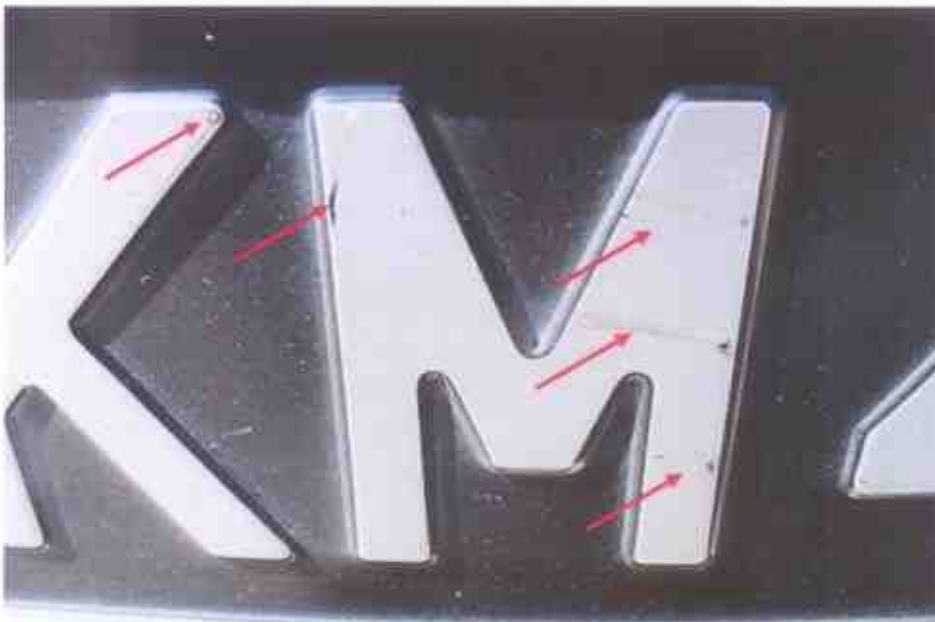
Photo 11 shows a close up view of the several black marks on the alpha-numeric letterings of the front number plate of the Mercedes (red arrows).

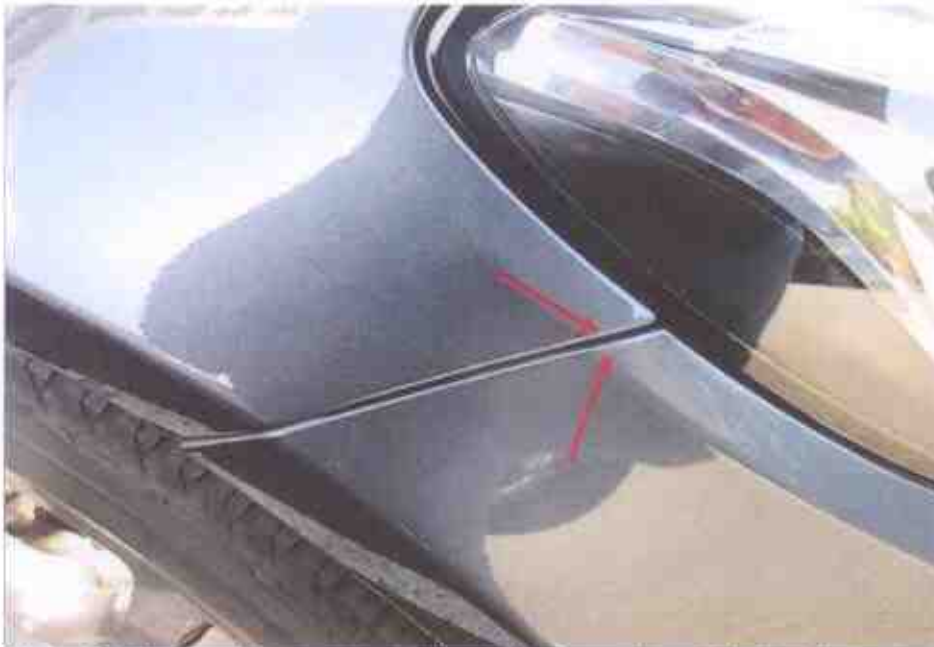
Photo 12 shows a close up view of the right corner edge of the front bumper of the Mercedes. We observed that there was no misalignment at the corner edges (red arrows).

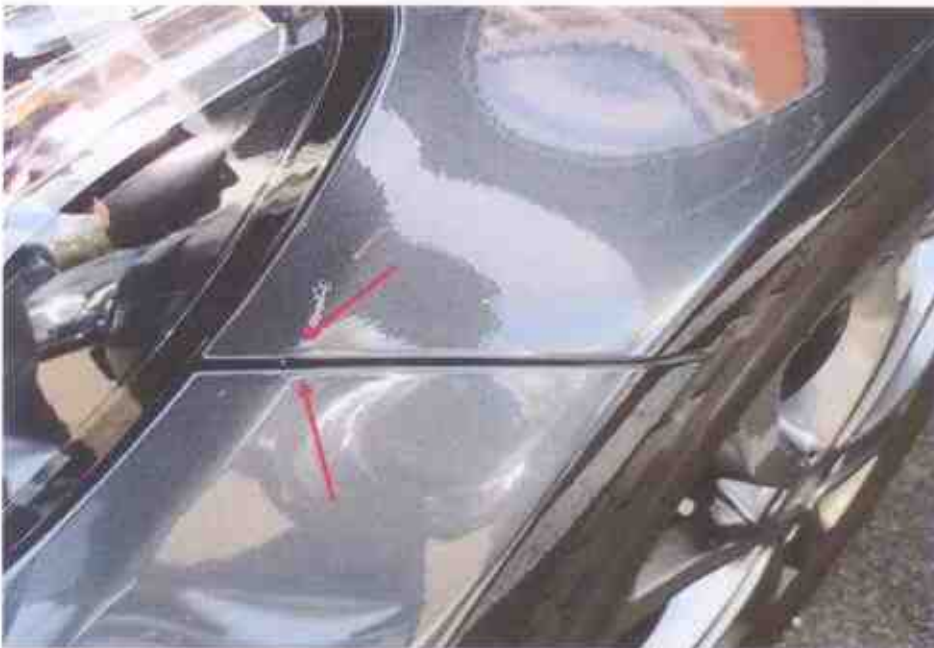
Photo 13 shows a close up view of the left corner edge of the front bumper of the Mercedes. We observed that there was no misalignment at the corner edges (red arrows).

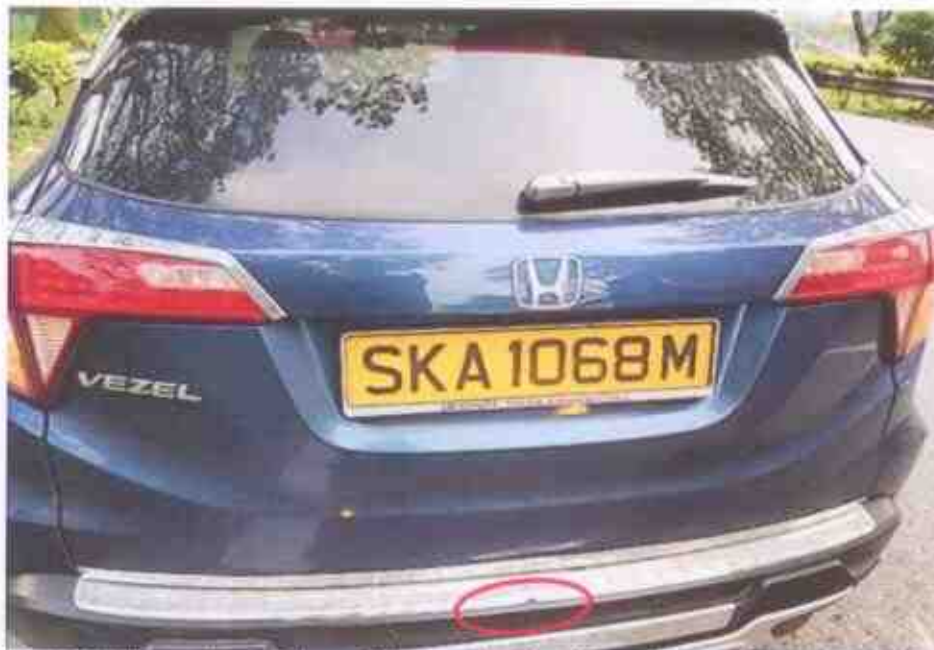
Photo 14 shows the position of the Honda after the accident. Closer examination of the accident photograph shows the damaged rear bumper scuff plate as well as the rear bumper of the Honda (circled).

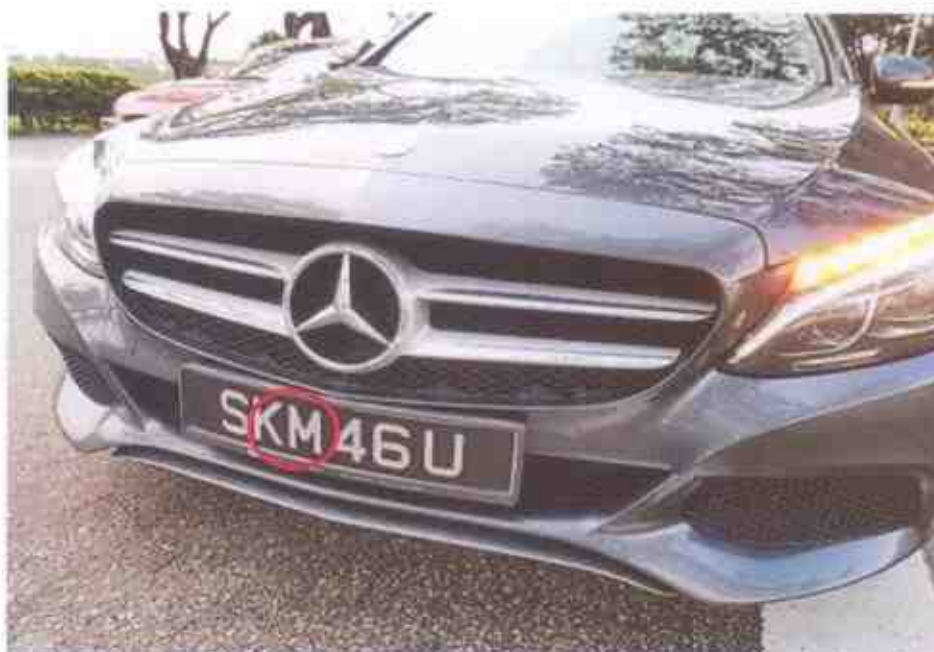
Photo 15 shows the position of the Mercedes after the accident. Upon closer examination of the accident photograph, we observed the same black marks on several alpha- numeric letterings of the front number plate of the Mercedes as per our physical inspection (circled).

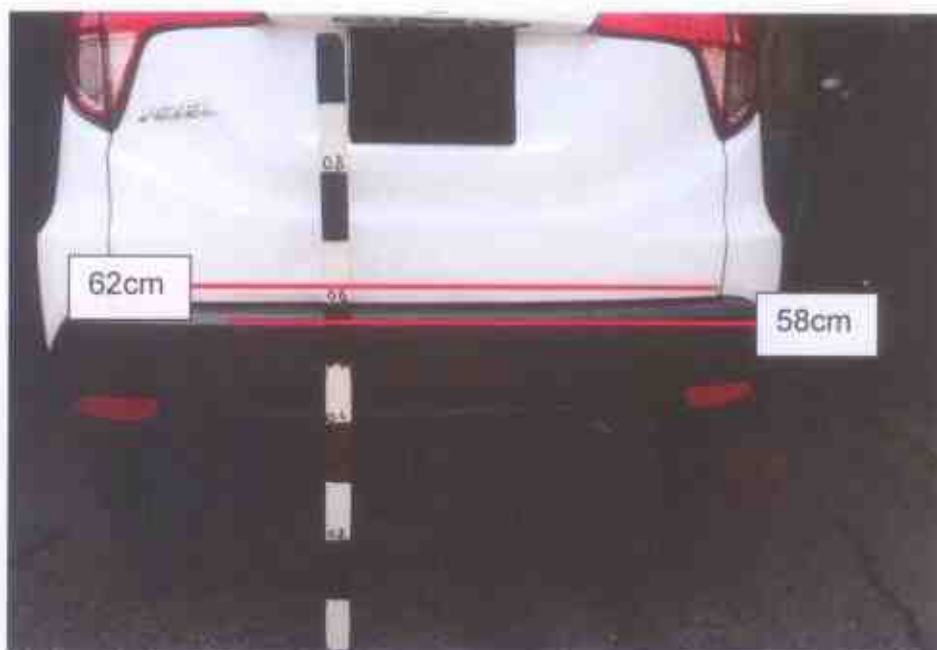
Photo 16 shows the height measurement being conducted on the rear portion of the Honda (using a similar make and model). The height above ground level of the top portion of the rear bumper where the damages were found was measured to be approximately 58cm. The height above ground level of the lower part of the boot lid where the dent was found was measured to be approximately 62cm.

- a) the height above ground level of the top portion of the Honda's rear bumper where the damages were found was measured to be approximately 58cm;
- b) the height above ground level of the lower part of the Honda's boot lid where the dent was found was measured to be approximately 62cm;
- c) the height range of the damages found on the Mercedes's front number plate and the front number plate frame was measured to be between 35cm and 42cm;
- d) the height above ground level of the Mercedes's front emblem where the dent was found was measured to be approximately 58cm;

- e) the height above ground level of the white mark on the front centre portion of the Mercedes's front bonnet was measured to be approximately 68cm;
- f) the height measurements appear to support the findings of possible contact between the rear bumper of the Honda and the front portion of the Mercedes. The damage observed on the rear bumper of the Honda was a result of this contact and corresponds to the damage observed on the front portion of the Mercedes.

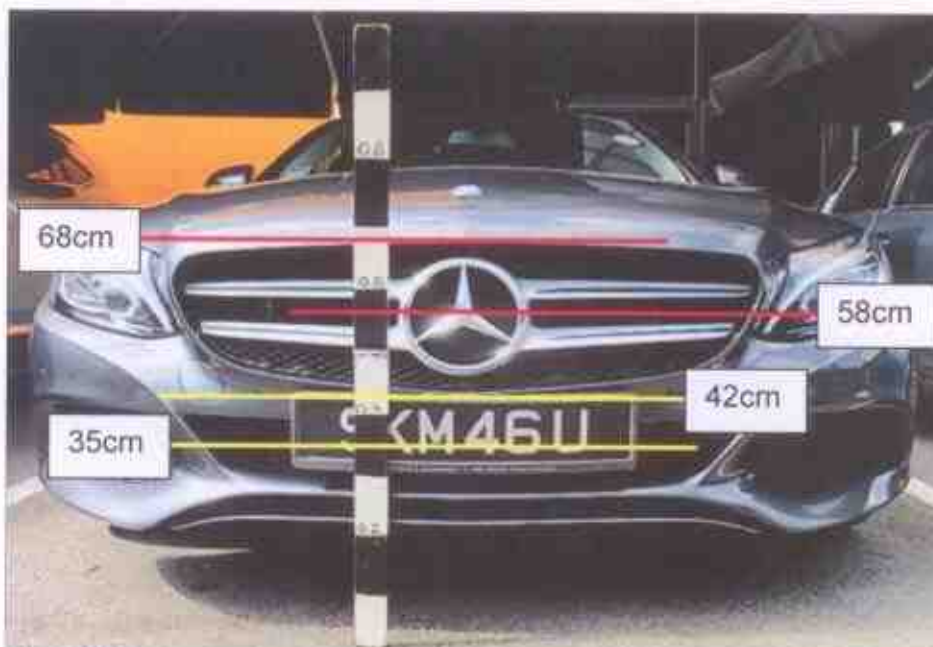
Photo 17 shows the height measurement being conducted on the front portion of the Mercedes. The height range of the damages found on the front number plate and the front number plate frame was measured to be between 35cm and 42cm. The height above ground level of the front emblem where the dent was found was measured to be approximately 58cm. The height above ground level of the white mark on the front centre portion of the Mercedes's front bonnet was measured to be approximately 68cm.
