Your Ref: 587268
Our Ref : CS/MSG19005267/N

29 March 2019

TECHNICAL INVESTIGATION REPORT OF FIRE INCIDENT INVOLVING THE INSURED VEHICLE SJS 4257G ON 26 FEBRUARY 2019

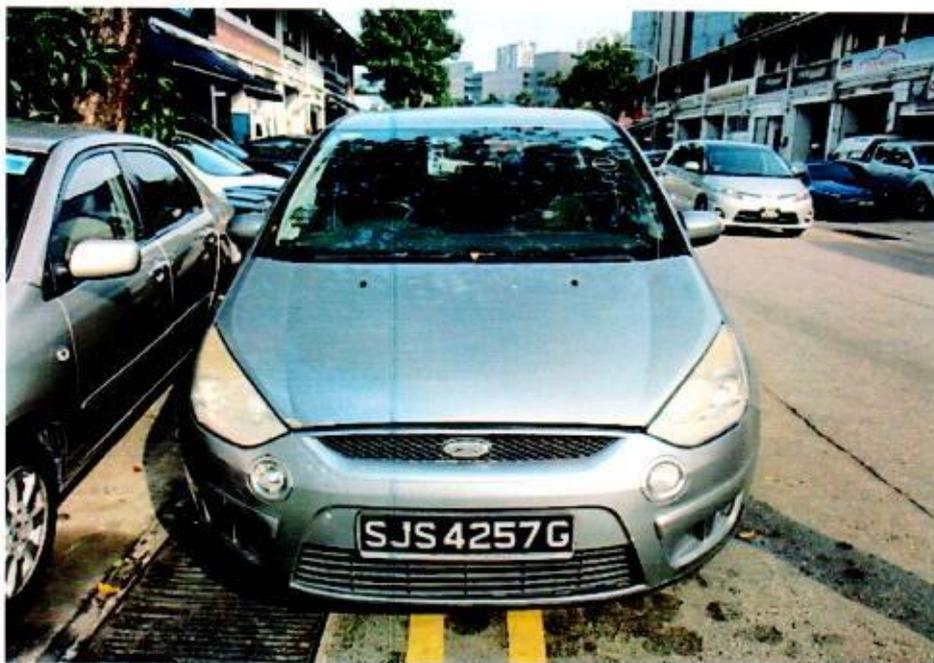
Photo 1 shows the general view of the front portion of the Insured Vehicle at the time of our inspection.

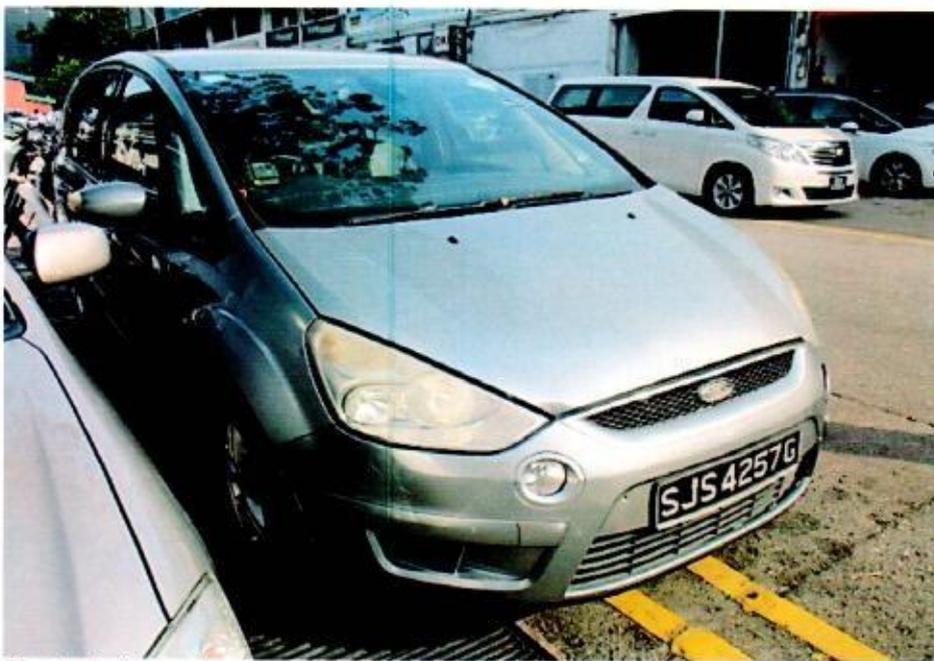
Photo 2 shows the general view of the right portion of the Insured Vehicle at the time of our inspection.

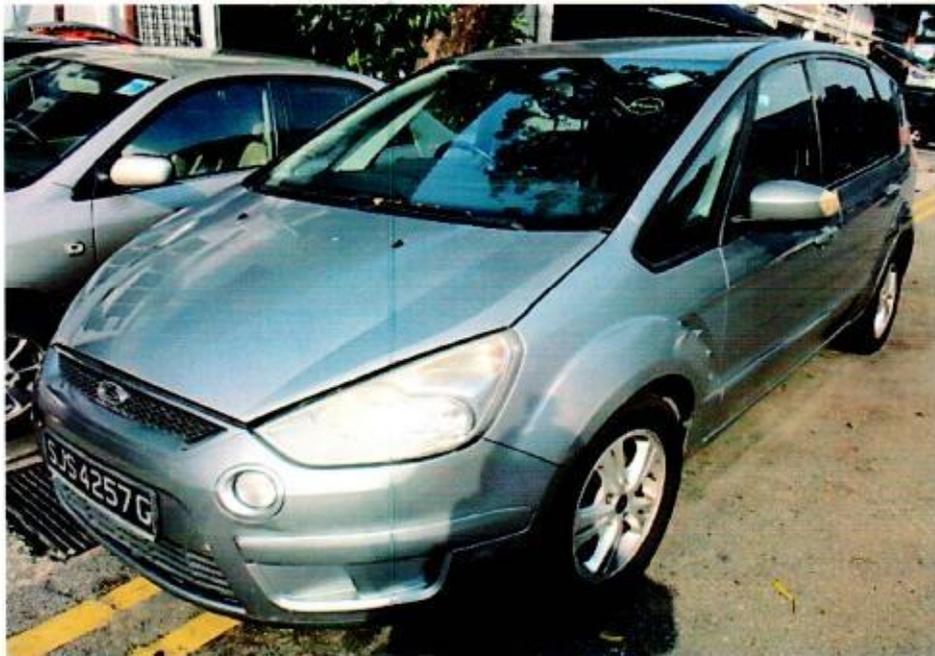
Photo 3 shows the general view of the left portion of the Insured Vehicle at the time of our inspection.

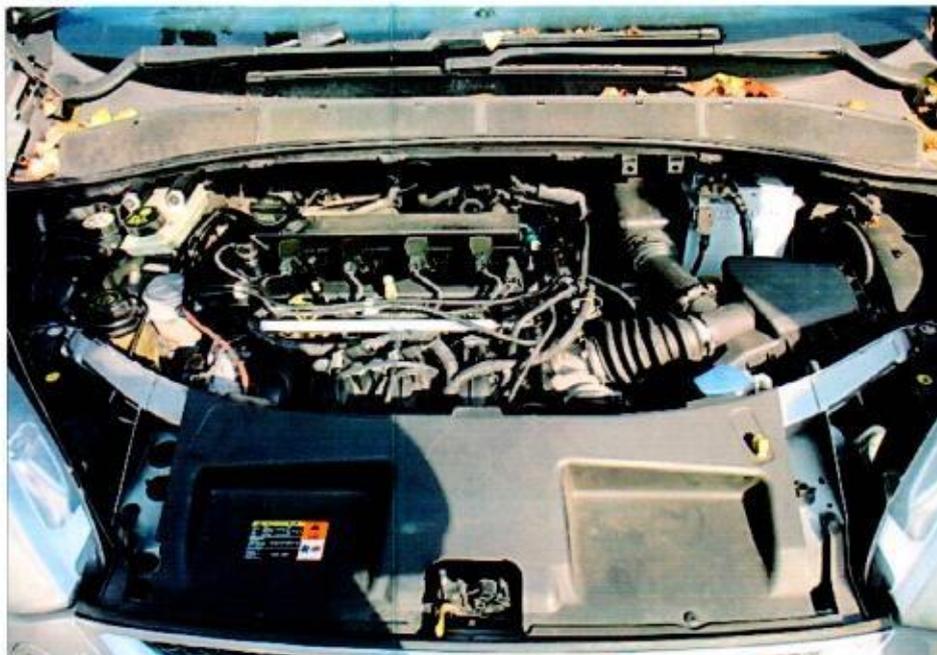
Photo 4 shows a general view of the engine compartment of the Insured Vehicle at the time of our inspection. There was no damage of fire nature to the engine compartment.

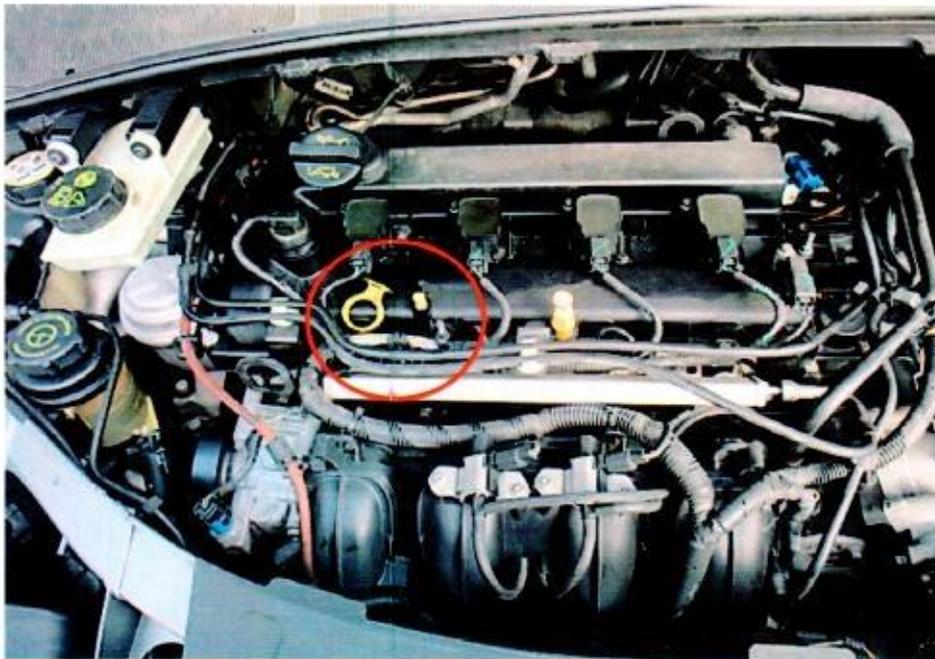
7. Upon closer examination of the engine compartment, we observed that the top portion of the engine oil dipstick had broken off. We had found worn tubings on some of the wirings. We did not find any burnt and/or melted wirings. There were also no burnt marks on any of the components in the engine compartment. Fluid stains were observed to have been formed around the top portion of the top camshaft cover of the engine. The presence of dust and/or dirt particles accumulated at the areas where the fluid stains had formed indicates that a fluid leak had occurred. There were also wet fluid stains around the front right corner of the top portion of the top camshaft cover of the engine. See photos 5 – 7 below.

Photo 5 shows a closer inspection of the engine compartment of the Insured Vehicle. We observed that the top portion of the engine oil dipstick had broken off. We had found worn tubings on some of the wirings (circled). We did not find any burnt and/or melted wirings. There were also no burnt marks on any of the components in the engine compartment.

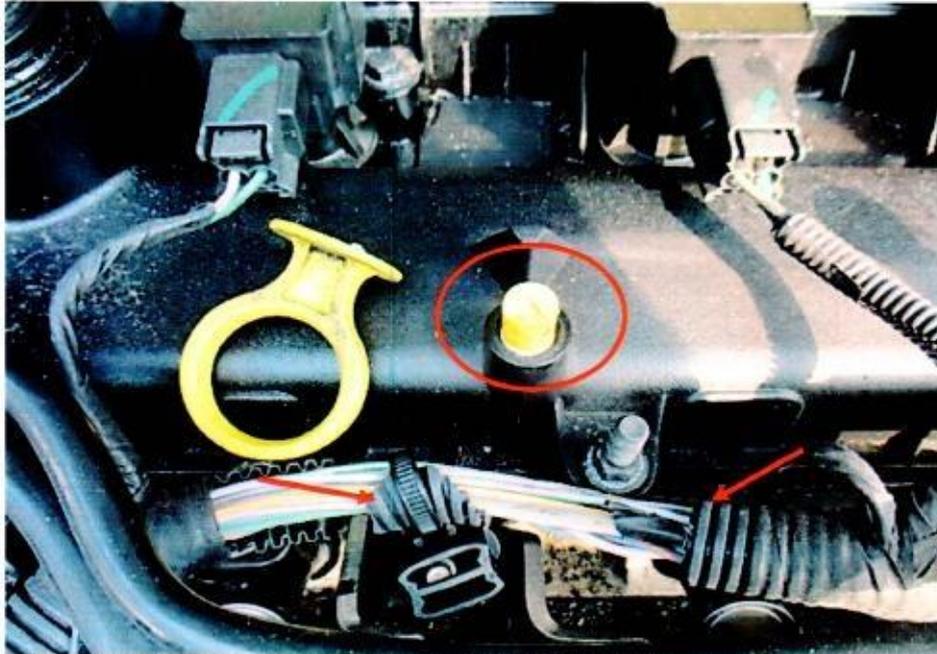
Photo 6 shows a closer view of the broken engine oil dipstick (circled) and worn tubings on some of the wirings (arrowed).

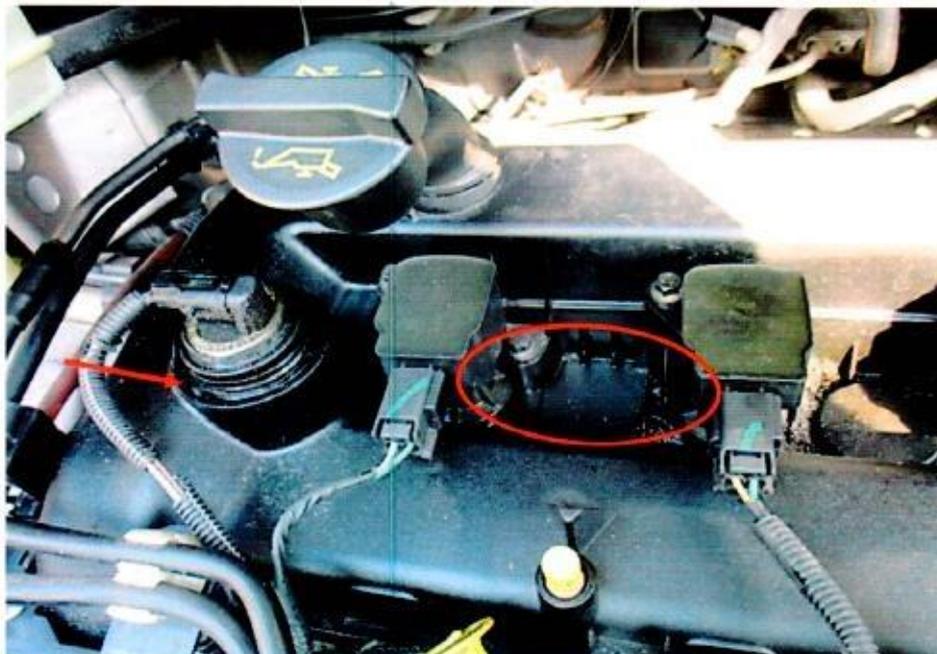
Photo 7 shows fluid stains were observed to have been formed around the top portion of the top camshaft cover of the engine (circled). The presence of dust and/or dirt particles accumulated at the areas where the fluid stains had formed indicates that a fluid leak had occurred. There were also wet fluid stains around the front right corner of the top portion of the top camshaft cover of the engine (arrowed).

21. Having investigated and technically analysed the damages to the Insured Vehicle, we are of the view that there was no fire to the Insured Vehicle.
22. The engine of the Insured Vehicle was unable to be started up upon our inspection. Our investigations revealed oil seepage from the top portion of the top cover of the engine. We did not find evidence of any burnt components in the engine compartment of the Insured Vehicle as a result of fire.
23. In view of our observations during the inspection we are further of the view that the incident falls under fair wear and tear circumstances and hence not covered under an own damage claim.

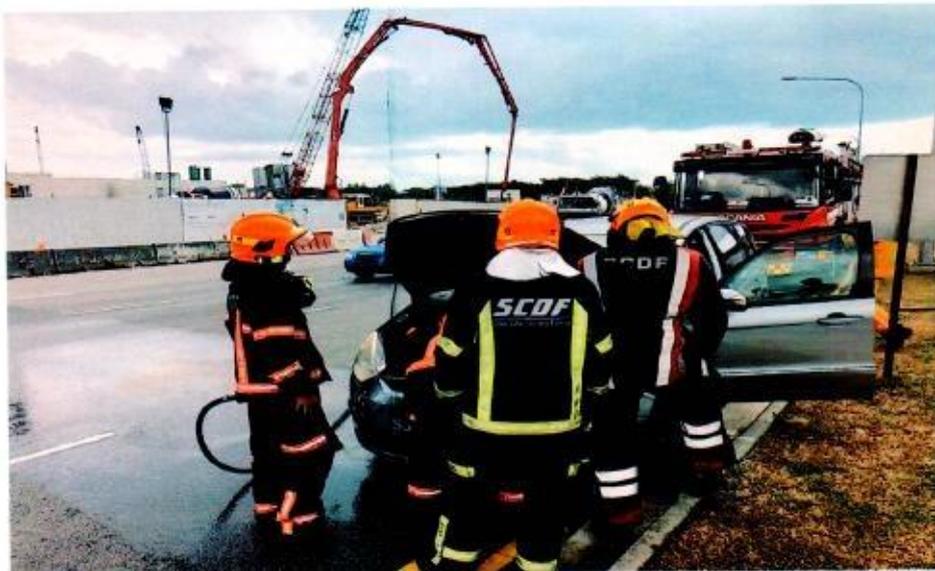
Photo 8 shows firefighters spraying water onto the engine bay of the Insured Vehicle. In general, the information that could be gathered from this photograph had corresponded to the events that were related to us by Ms Elisabeth, which is the SCDF were present at the incident location.
