**INITIAL INSPECTION REPORT OF VEHICLE NO. SBS 3976R**

| Affiliated to Federation Internationale Des Experts En Automobile | | | | |
|---|---|---|---|---|
| Insured Veh. | SHC 3906G | Veh. Inspected | SBS 3976R | |

## ADJUSTMENT ON REPAIR COST FOR VEHICLE NO. SBS 3976R

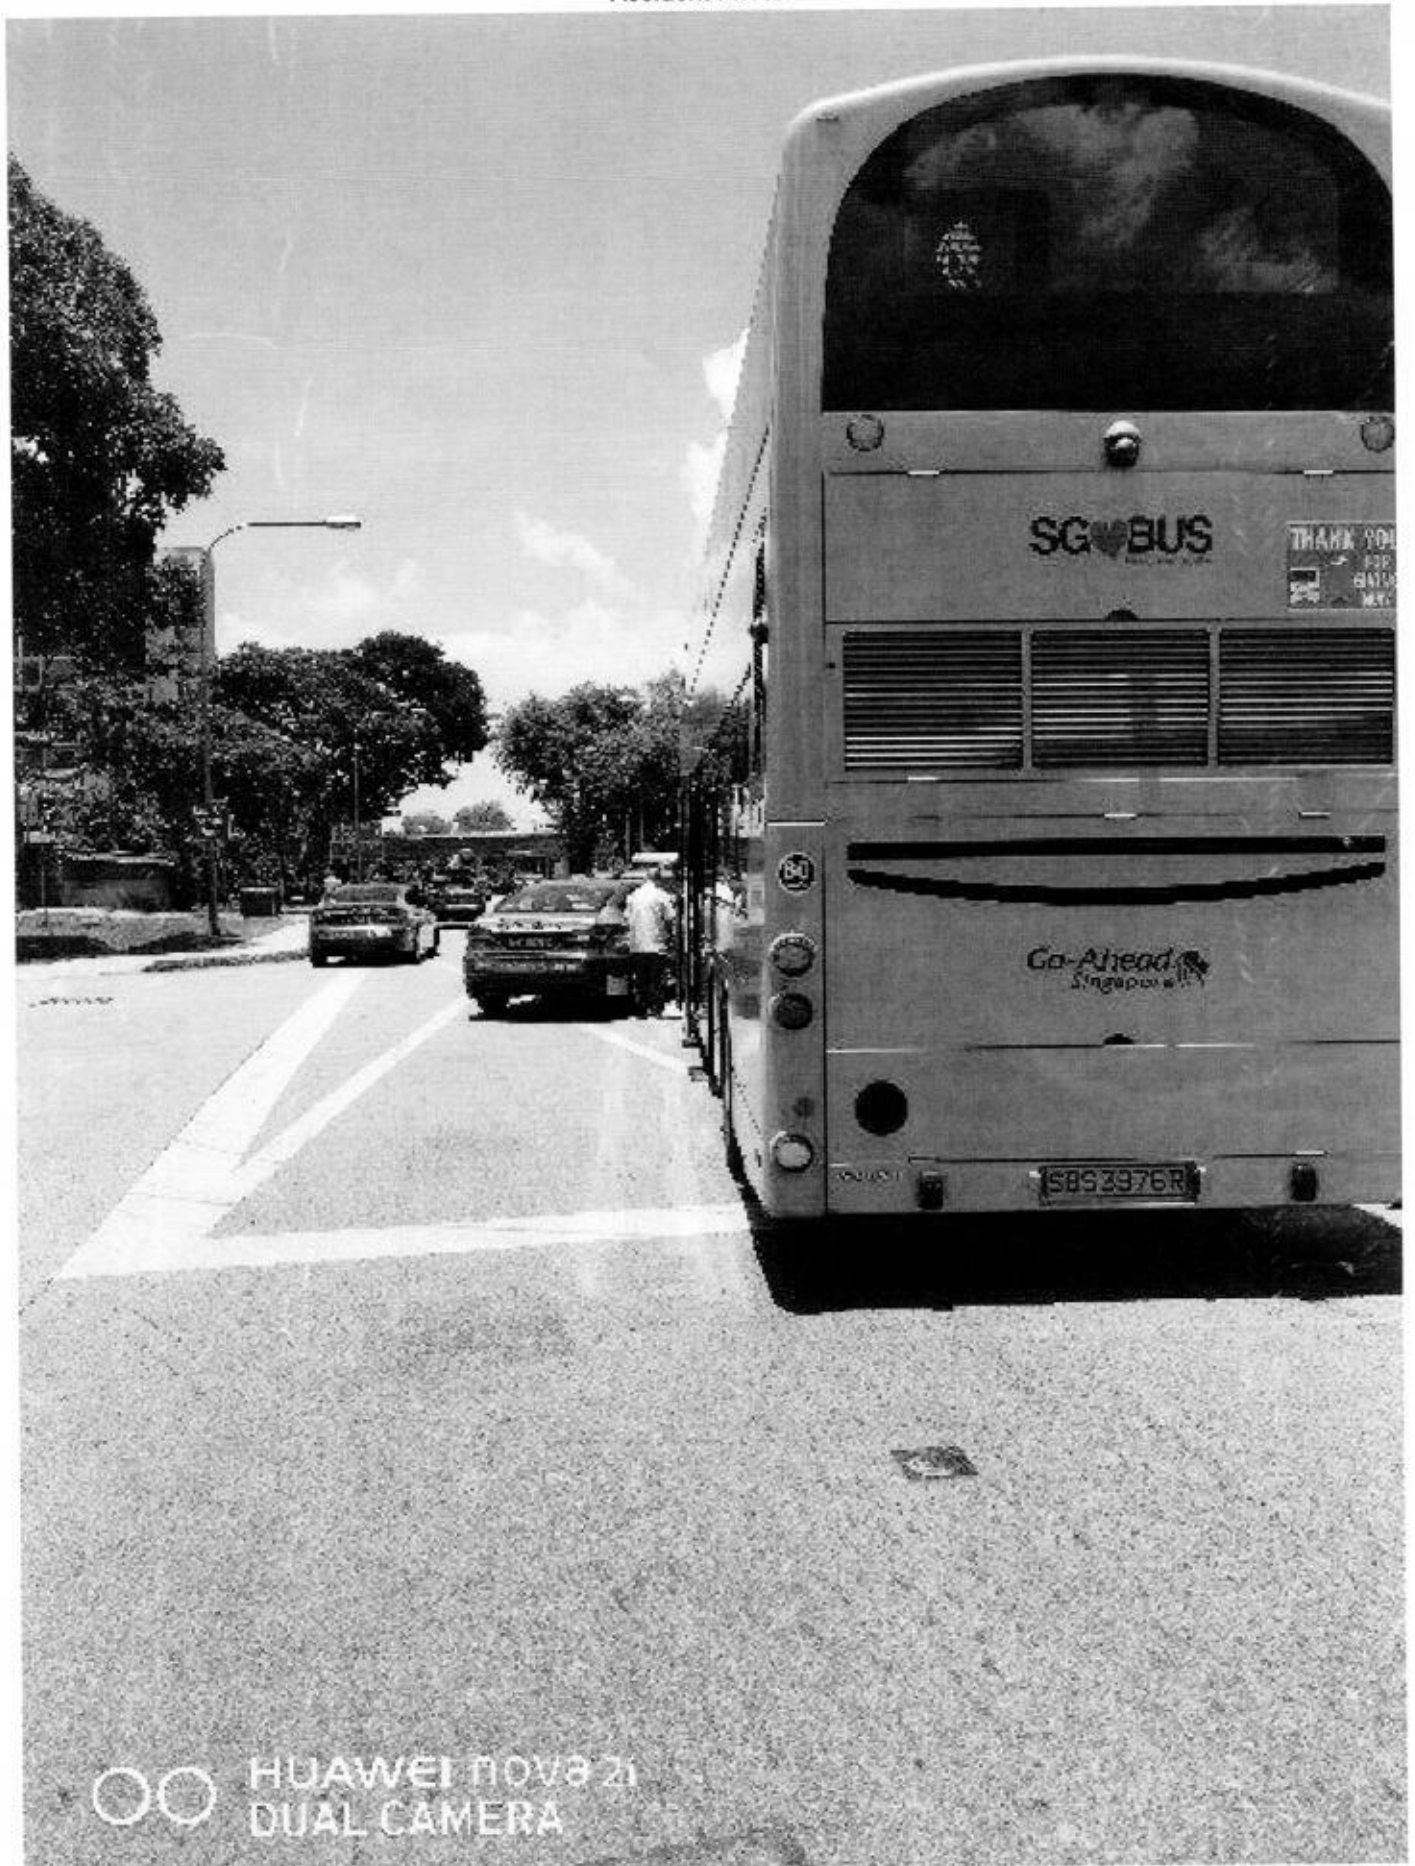
Accident Photo

| Affiliated to Federation Internationale Des Experts En Automobile | | | | |
|---|---|---|---|---|
| THE VEHICLE SUSTAINED DAMAGES AT THE FRONT N/S PORTION.<br>DAMAGES SEE DETAILS. | | | | |
