Your Ref: 1201900007404  
Our Ref :CS/FWD19005359/D

01 April 2019

**TECHNICAL INVESTIGATION REPORT OF FIRE INCIDENT INVOLVING THE  
INSURED VEHICLE SJM 8954H ON 20 MARCH 2019**

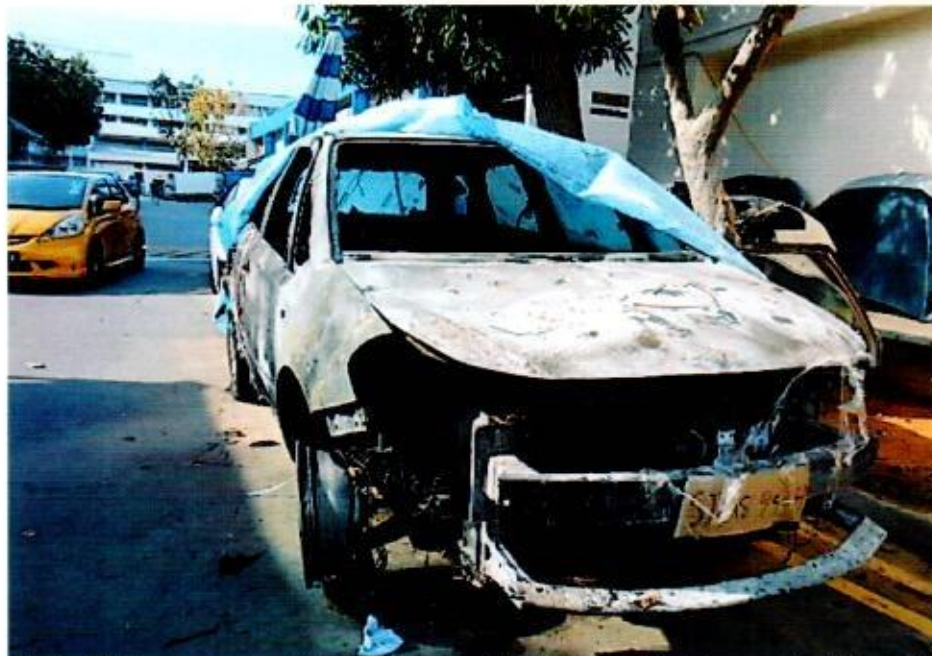
**Photo 1** shows a general view of the front right body of the Insured Vehicle at the time of inspection. The Insured Vehicle was observed to have sustained extensive fire damage all around. The body panels at the frontal portion and the undercarriage components at the front underside were all found to have been burnt to char.

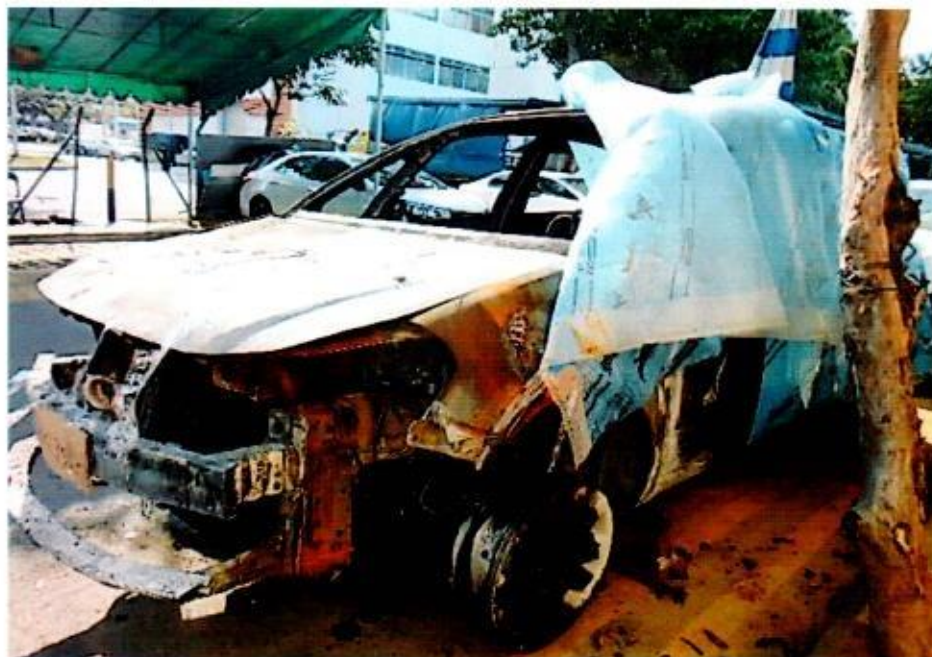
**Photo 2** shows a general view of the front left body of the Insured Vehicle at the time of inspection. The Insured Vehicle was observed to have sustained extensive fire damage all around. The body panels at the frontal portion and the undercarriage components at the front underside were all burnt to char.

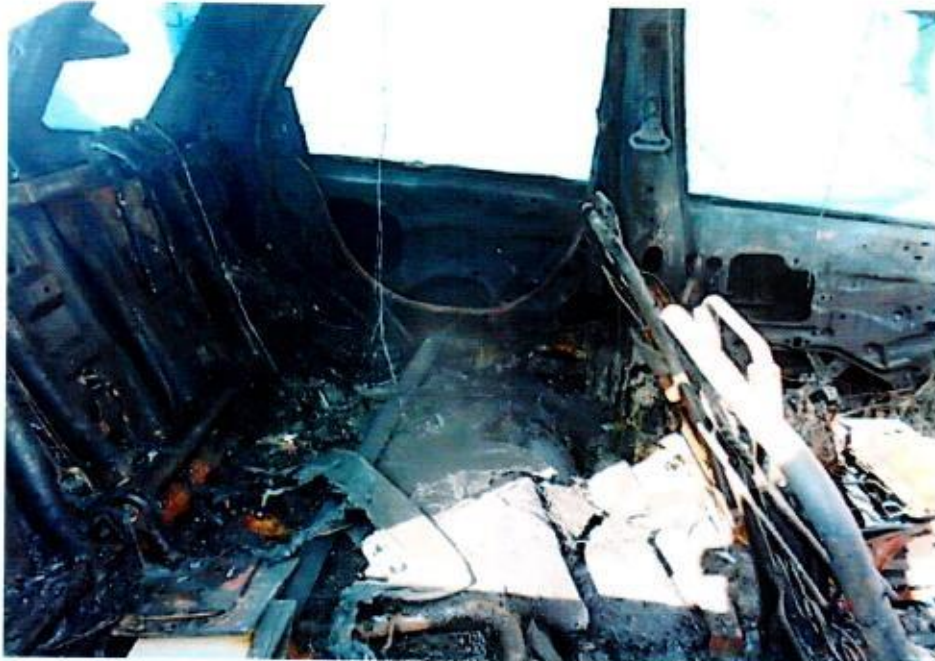
**Photo 3** shows the interior compartment of the Insured Vehicle. All the parts inside the interior compartment were found to be extensively burnt. Its front seats, rear seats, roof upholstery, carpet and various trims were all burnt and/or melted as a result of the fire.

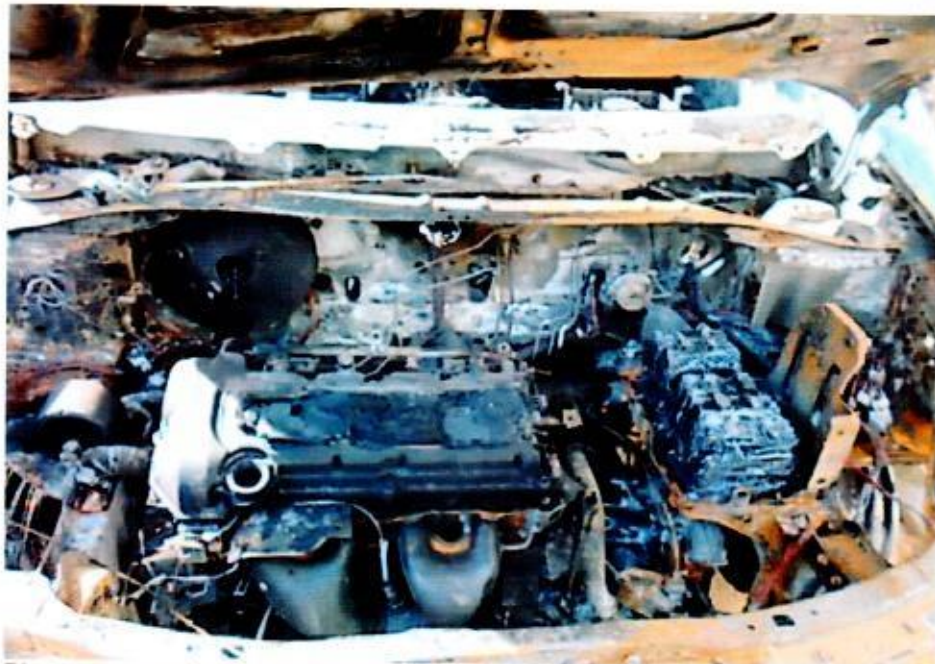
**Photo 4** shows the engine compartment of the Insured Vehicle. The various parts and components within the engine compartment of the Insured Vehicle were all extensively affected by the fire. This had included the engine and transmission of the Insured Vehicle.

20. For this case, the wirings within the engine compartment of the Insured Vehicle were all completely burned to its bare copper state. Because of this, I was not able to determine the electrical fault had occurred along which wiring(s) within the engine compartment.

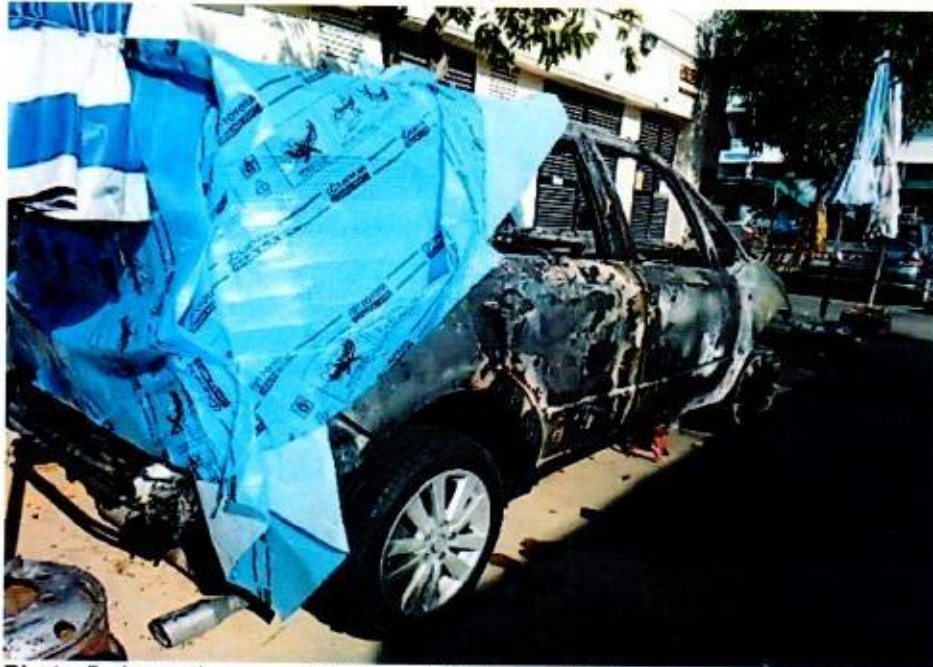
**Photo 5** shows the rear right body of the Insured Vehicle. Comparing the overall extent of fire damage like the rear tyres vs the front tyres, rear exhaust pipe unaffected etc, it would appear that the frontal portion of the Insured Vehicle was more affected as compared to its rear portion.

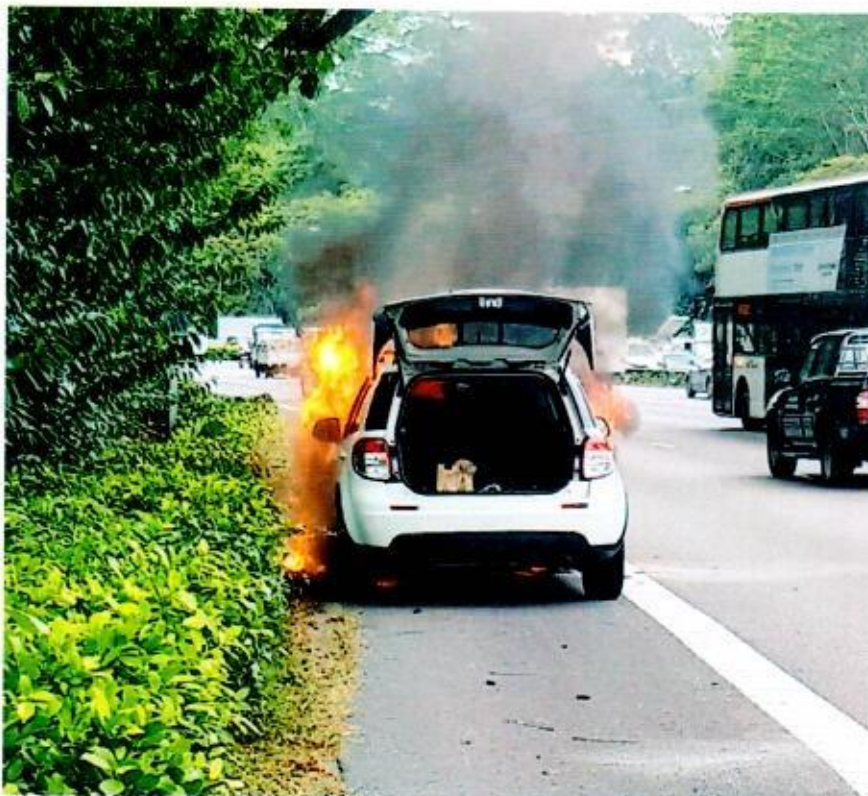
**Photo 6** shows the Insured Vehicle at the incident scene. From the photographs provided by Mr Wang, the Insured Vehicle could be seen parked along the road shoulder with the fire at its frontal portion, outside of its interior compartment. The flames thereafter spread to its interior compartment before spreading to its rear portion and eventually covering the entire Insured Vehicle. Base on the sequence of events seen from the photographs provided by Mr Wang, it can be established that the fire to the Insured Vehicle had originated at its frontal portion.

16. Since the fire can be established to have first appeared at the frontal portion of the Insured Vehicle, outside of its interior compartment; and given that Mr Wang had seen smoke coming out from the gaps surrounding the front bonnet, the origin of fire would have then been from within the engine compartment of the Insured Vehicle and had ignited whilst the Insured Vehicle was being driven/engine in operation. Common causes of fire arising from a vehicle that is being driven and/or with its engine in operation include engine overheating, leakage of fluid onto hot surfaces or electrical nature.

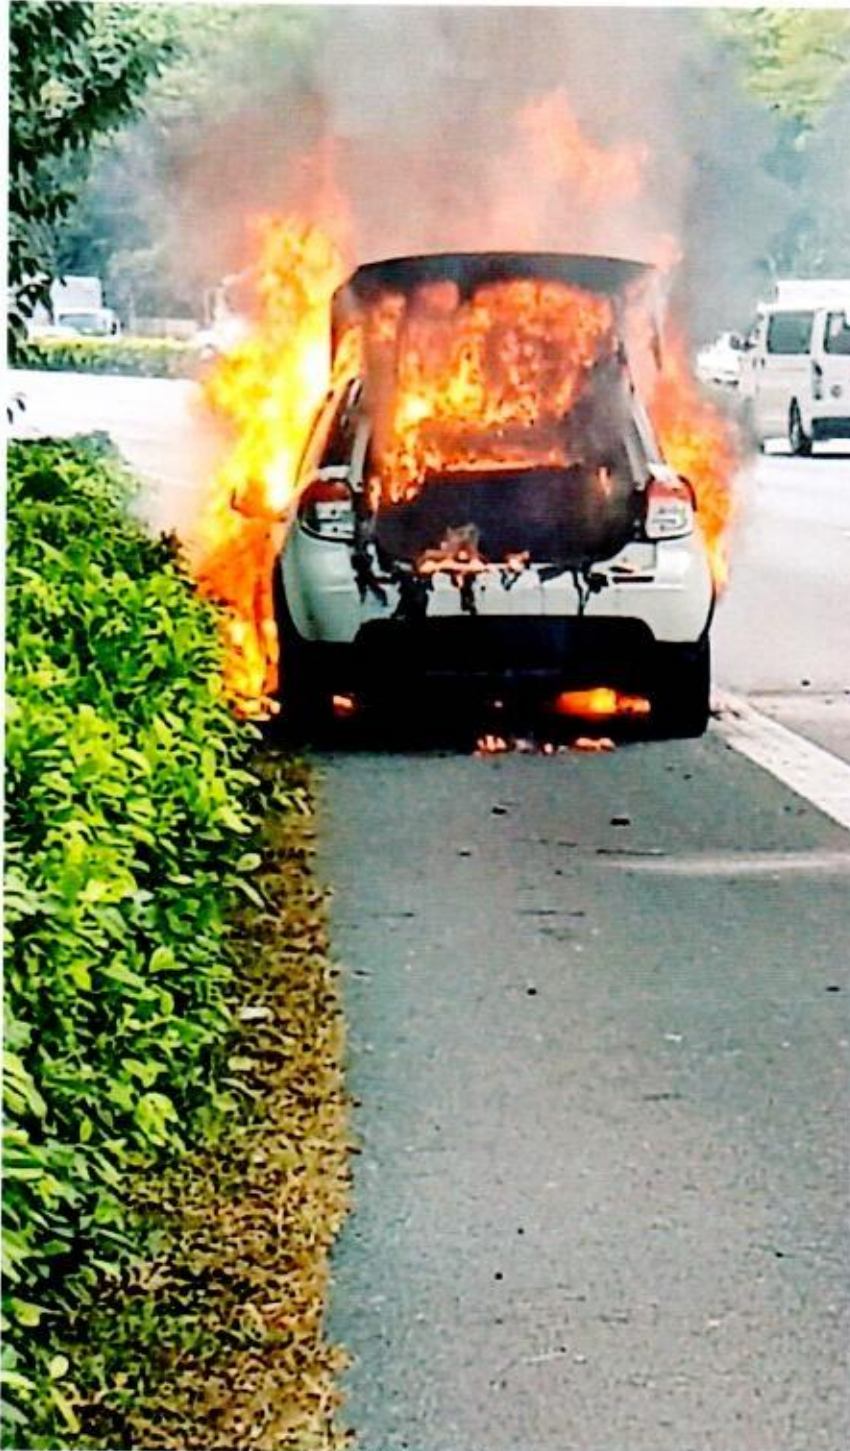
Photo 7 shows the Insured Vehicle with the fire having spread to its interior compartment (photograph taken by Mr Wang). Base on the sequence of events seen from the photographs provided by Mr Wang, it can be established that the fire to the Insured Vehicle had originated at its frontal portion, outside of its interior compartment.

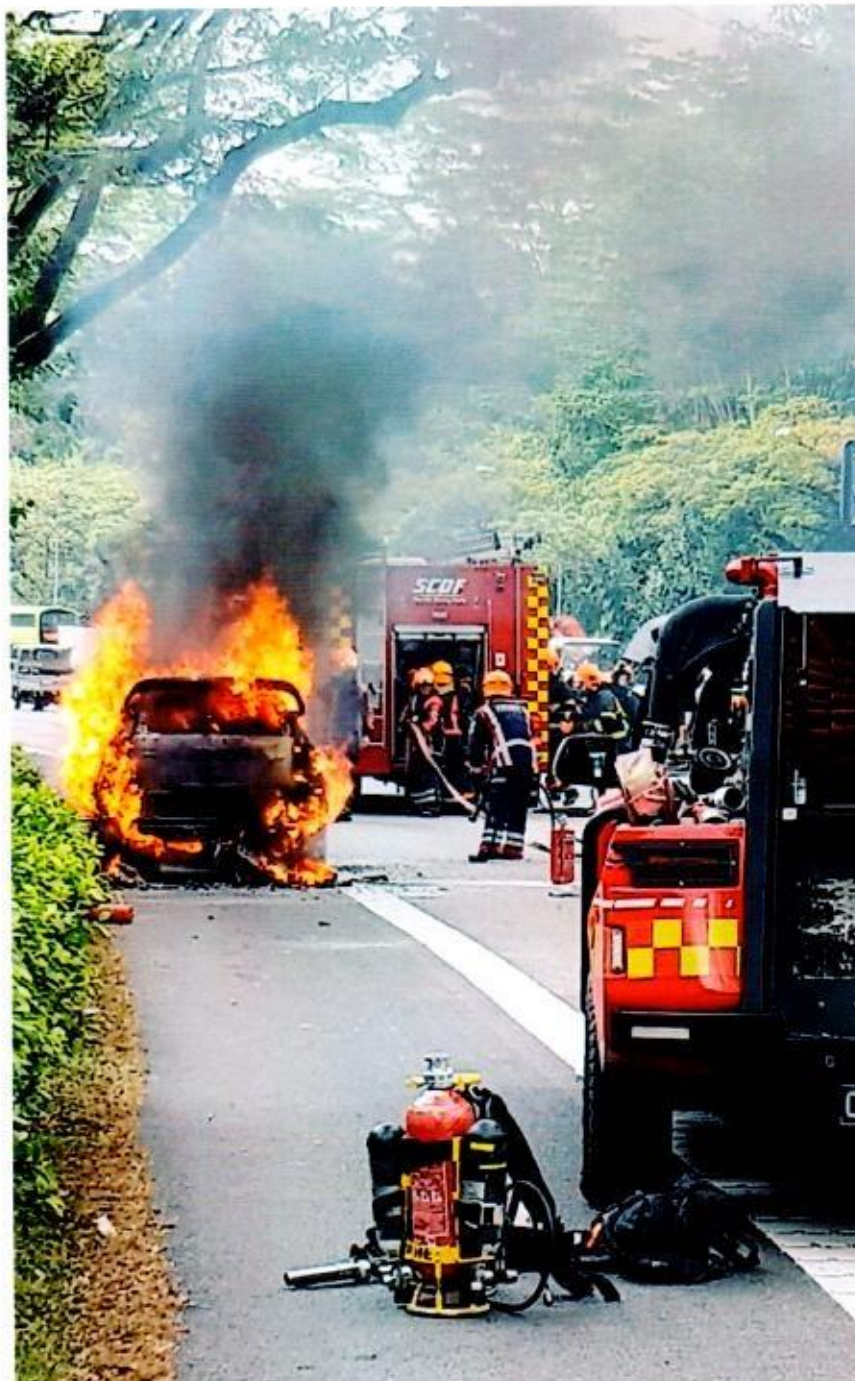
**Photo 8** shows the Insured Vehicle completely covered by fire at the incident scene (photograph taken by Mr Wang). Upon examination of the photographs provided, it was noted that flames had first engulfed the frontal portion of the Insured Vehicle, outside of its interior compartment before spreading to its rear portion. Base on the sequence of events seen from the photographs provided by Mr Wang and shown in photograph 6 to 8 above, it can be established that the fire to the Insured Vehicle had originated at its frontal portion, outside of its interior compartment.
