Your Ref: 1201900007404  
Our Ref :CS/FWD19005359/D

**TECHNICAL INVESTIGATION REPORT OF FIRE INCIDENT INVOLVING THE INSURED VEHICLE SJM 8954H ON 20 MARCH 2019**

Vehicle Registration No.	: SJM 8954H
Make / Model	: Suzuki SX4 1.6HB AT
Chassis No	: JSAGYA21S00203790
Year of Registration	: 2009 (January)
Mileage	: N.A (wiring affected)

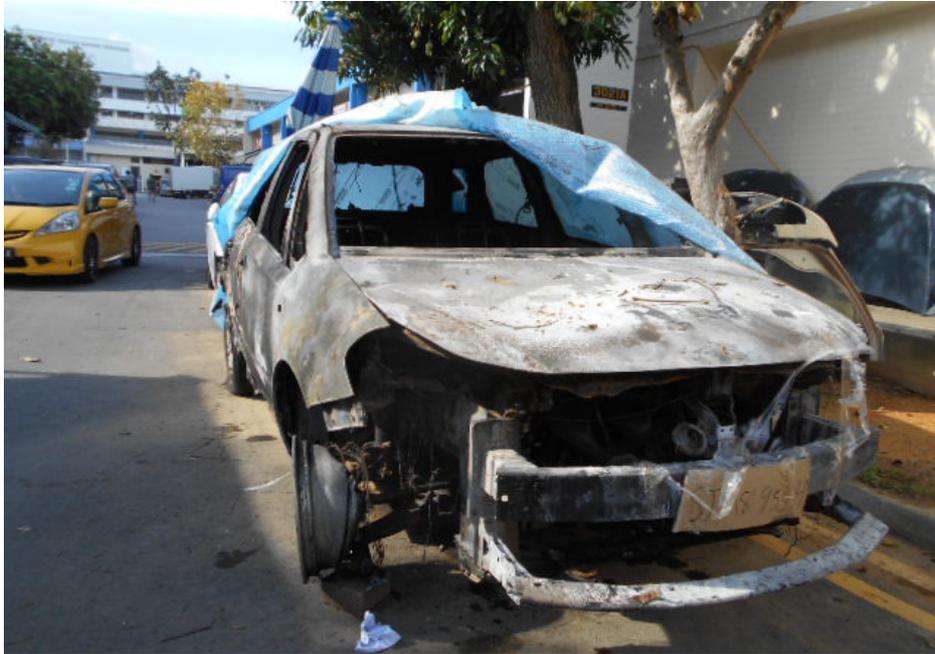
**Photo 1** shows a general view of the front right body of the Insured Vehicle at the time of inspection. The Insured Vehicle was observed to have sustained extensive fire damage all around. The body panels at the frontal portion and the undercarriage components at the front underside were all found to have been burnt to char.

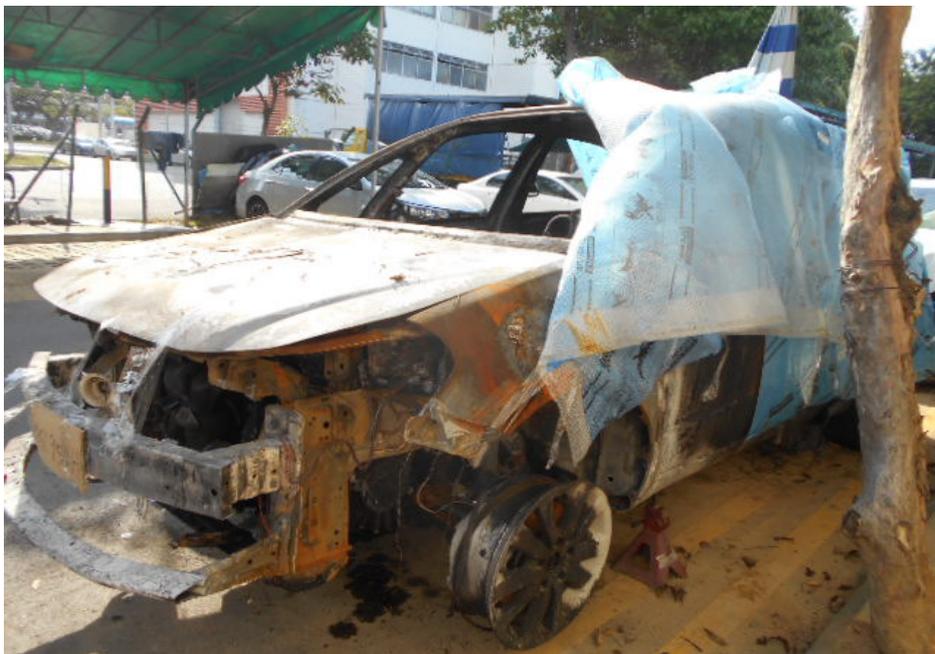
**Photo 2** shows a general view of the front left body of the Insured Vehicle at the time of inspection. The Insured Vehicle was observed to have sustained extensive fire damage all around. The body panels at the frontal portion and the undercarriage components at the front underside were all burnt to char.

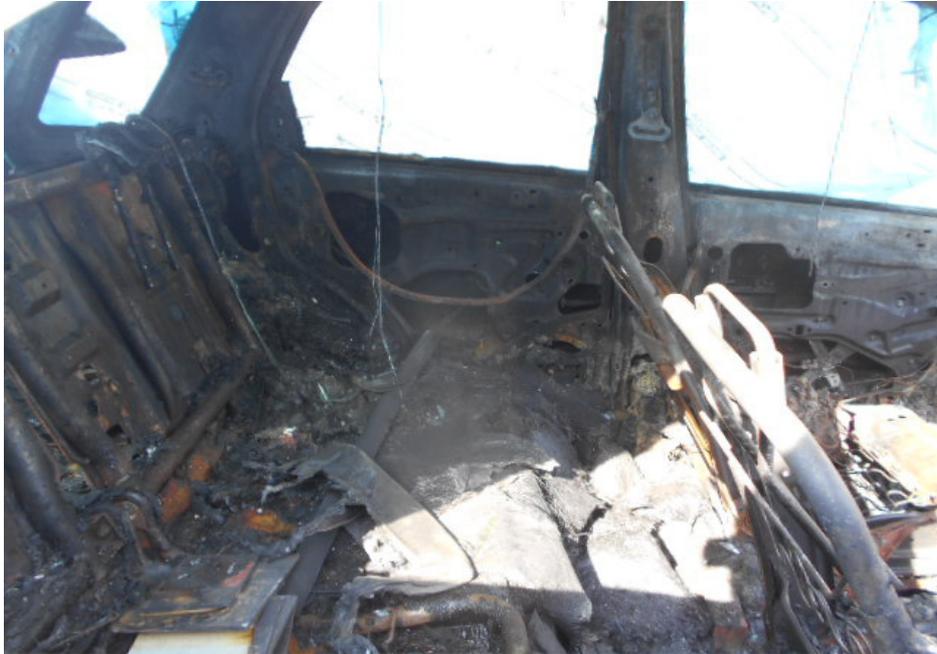
**Photo 3** shows the interior compartment of the Insured Vehicle. All the parts inside the interior compartment were found to be extensively burnt. Its front seats, rear seats, roof upholstery, carpet and various trims were all burnt and/or melted as a result of the fire.

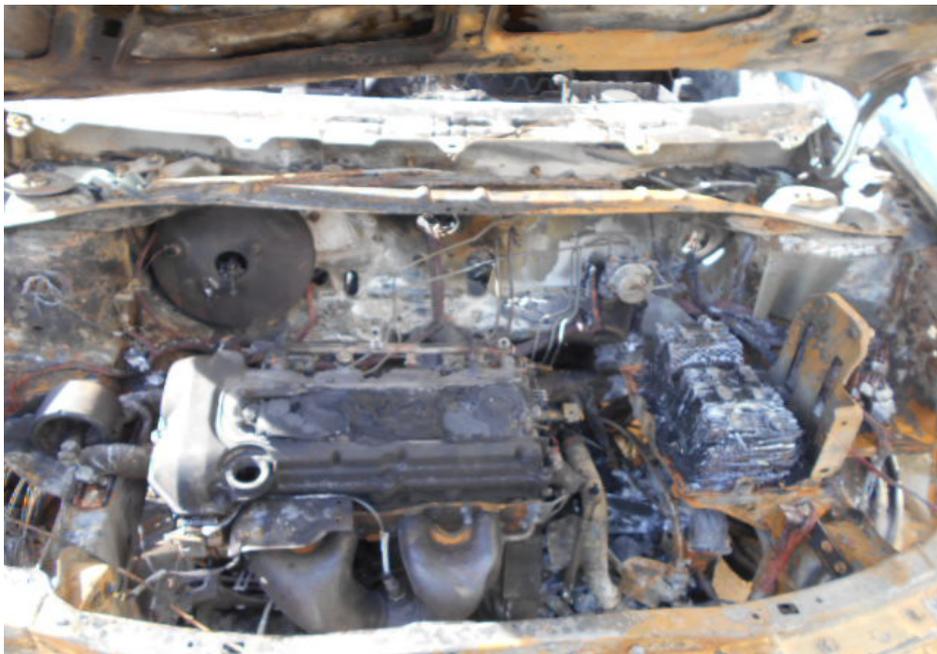
**Photo 4** shows the engine compartment of the Insured Vehicle. The various parts and components within the engine compartment of the Insured Vehicle were all extensively affected by the fire. This had included the engine and transmission of the Insured Vehicle.

20. For this case, the wirings within the engine compartment of the Insured Vehicle were all completely burned to its bare copper state. Because of this, I was not able to determine the electrical fault had occurred along which wiring(s) within the engine compartment.

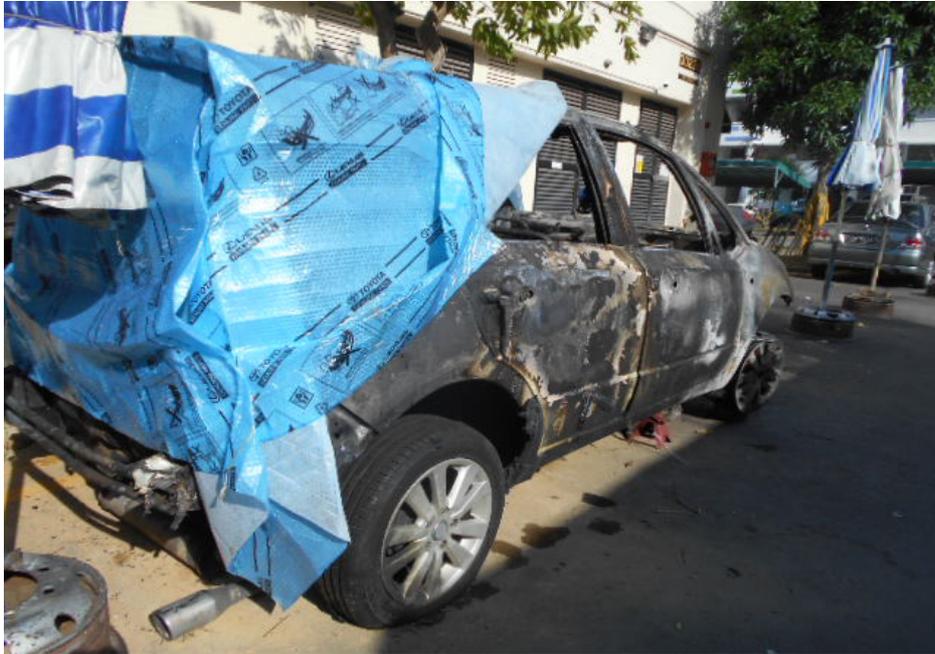
**Photo 5** shows the rear right body of the Insured Vehicle. Comparing the overall extent of fire damage like the rear tyres vs the front tyres, rear exhaust pipe unaffected etc, it would appear that the frontal portion of the Insured Vehicle was more affected as compared to its rear portion.

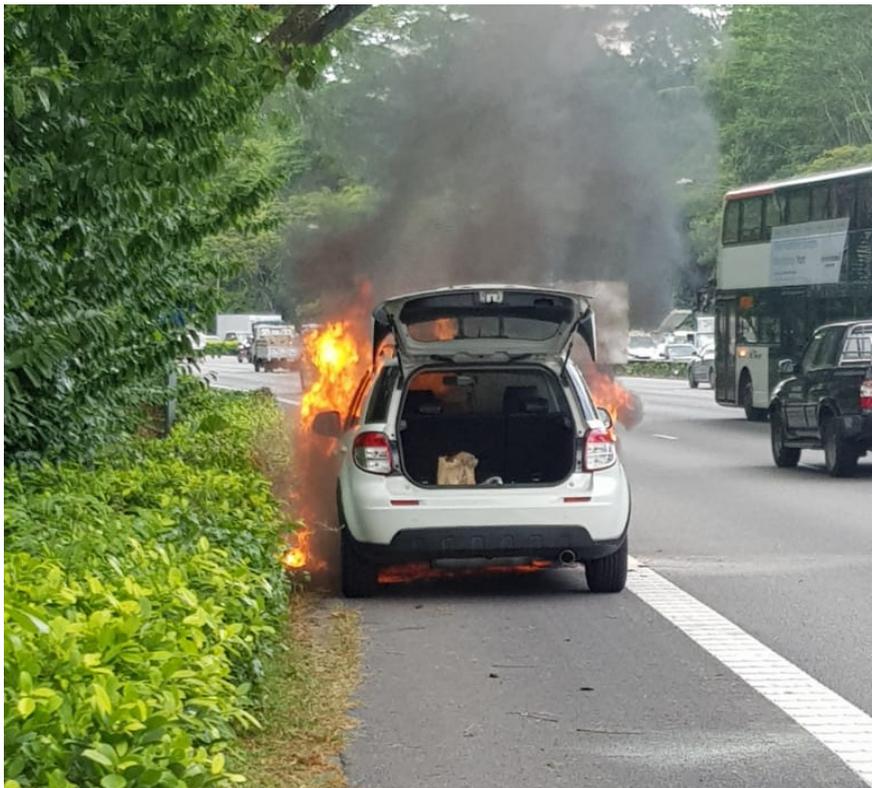
**Photo 6** shows the Insured Vehicle at the incident scene. From the photographs provided by Mr Wang, the Insured Vehicle could be seen parked along the road shoulder with the fire at its frontal portion, outside of its interior compartment. The flames thereafter spread to its interior compartment before spreading to its rear portion and eventually covering the entire Insured Vehicle. Base on the sequence of events seen from the photographs provided by Mr Wang, it can be established that the fire to the Insured Vehicle had originated at its frontal portion.

16. Since the fire can be established to have first appeared at the frontal portion of the Insured Vehicle, outside of its interior compartment; and given that Mr Wang had seen smoke coming out from the gaps surrounding the front bonnet, the origin of fire would have then been from within the engine compartment of the Insured Vehicle and had ignited whilst the Insured Vehicle was being driven/engine in operation. Common causes of fire arising from a vehicle that is being driven and/or with its engine in operation include engine overheating, leakage of fluid onto hot surfaces or electrical nature.

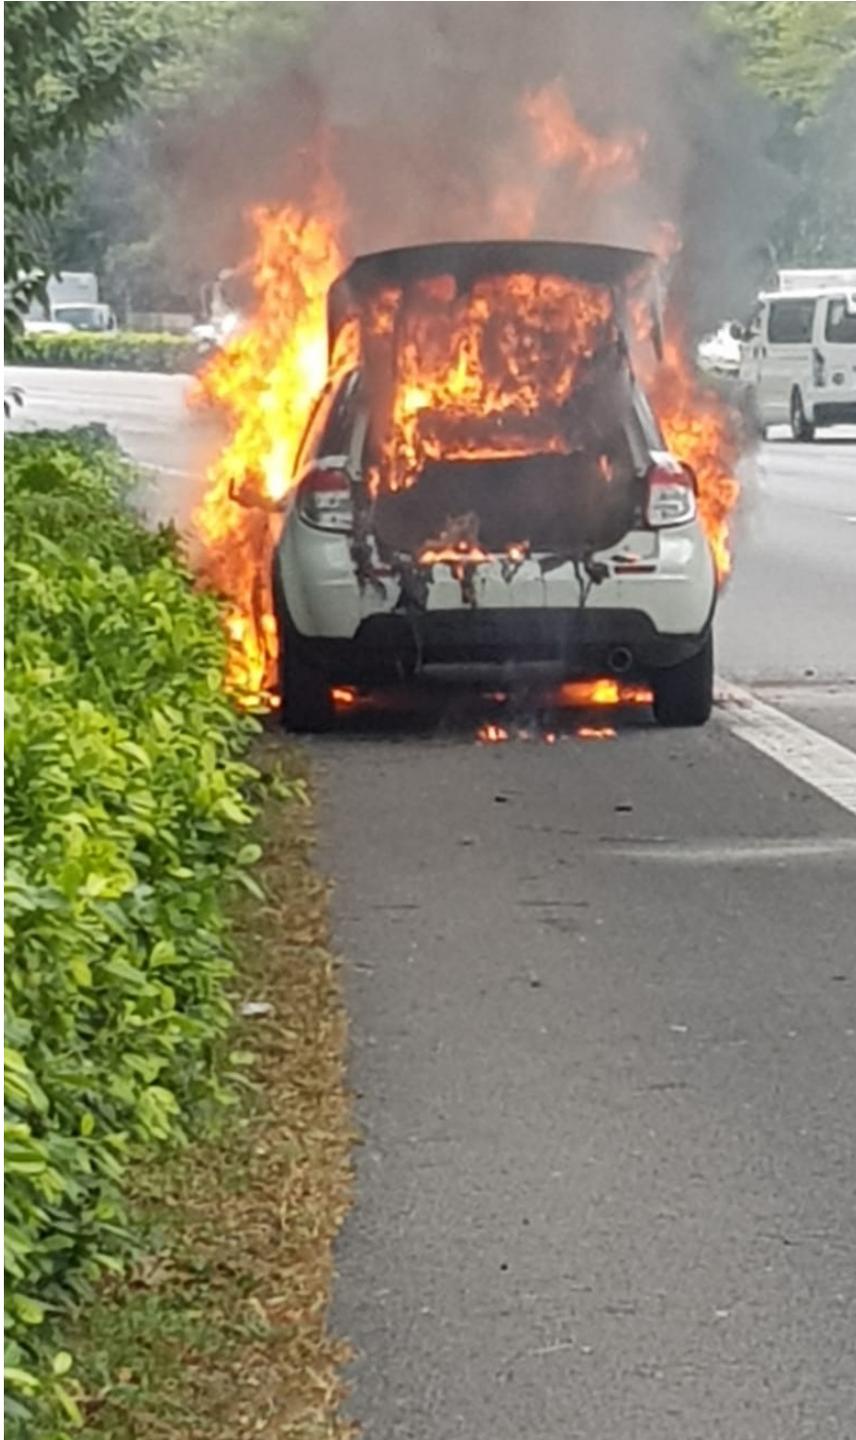
**Photo 7** shows the Insured Vehicle with the fire having spread to its interior compartment (photograph taken by Mr Wang). Base on the sequence of events seen from the photographs provided by Mr Wang, it can be established that the fire to the Insured Vehicle had originated at its frontal portion, outside of its interior compartment.

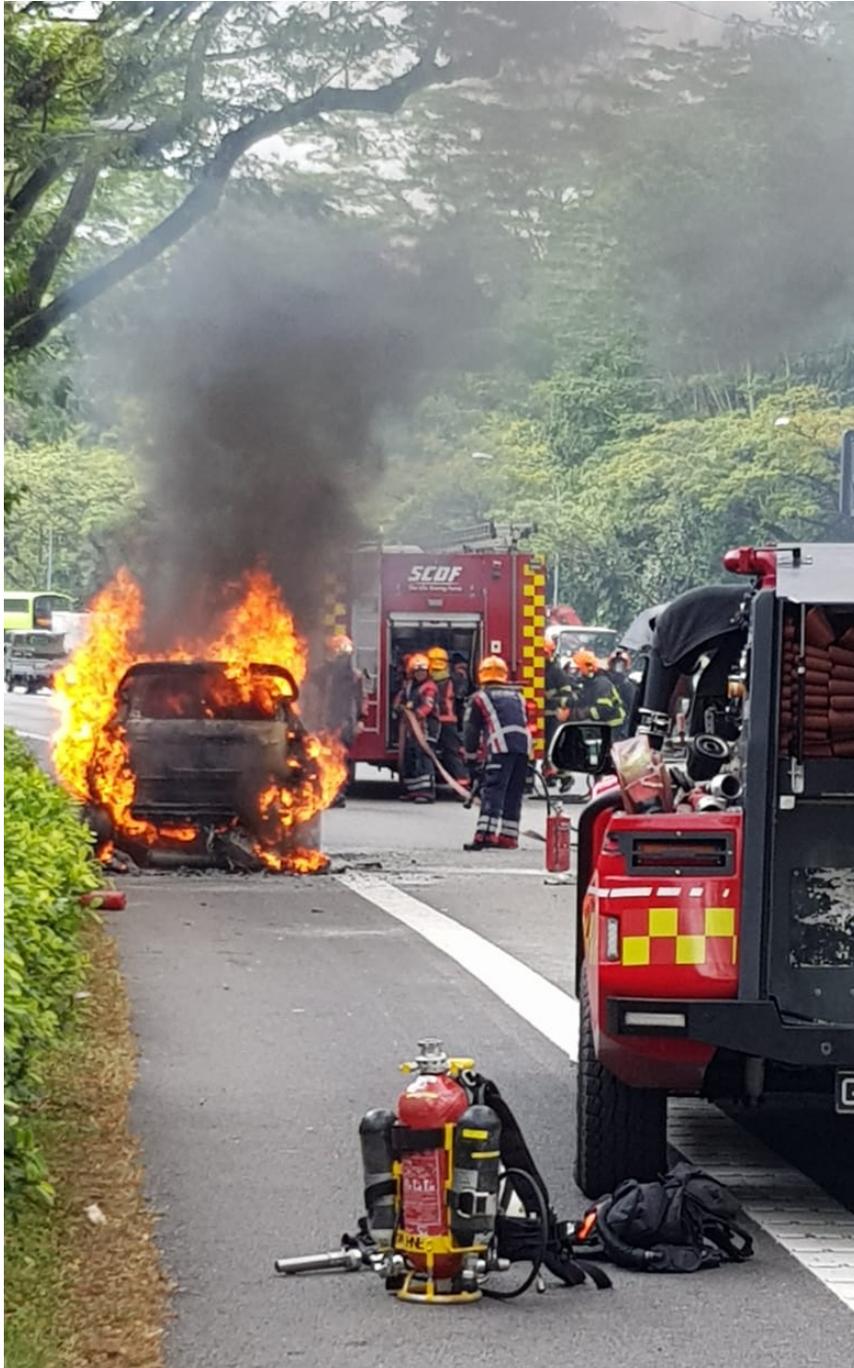
**Photo 8** shows the Insured Vehicle completely covered by fire at the incident scene (photograph taken by Mr Wang). Upon examination of the photographs provided, it was noted that flames had first engulfed the frontal portion of the Insured Vehicle, outside of its interior compartment before spreading to its rear portion. Base on the sequence of events seen from the photographs provided by Mr Wang and shown in photograph 6 to 8 above, it can be established that the fire to the Insured Vehicle had originated at its frontal portion, outside of its interior compartment.
