Your Ref: S9M01/10
Our Ref : CS/ASM19005417/D

04 April 2019

**TECHNICAL INVESTIGATION REPORT OF FIRE INCIDENT INVOLVING THE
INSURED VEHICLE SGG 1769P ON 25 MARCH 2019**

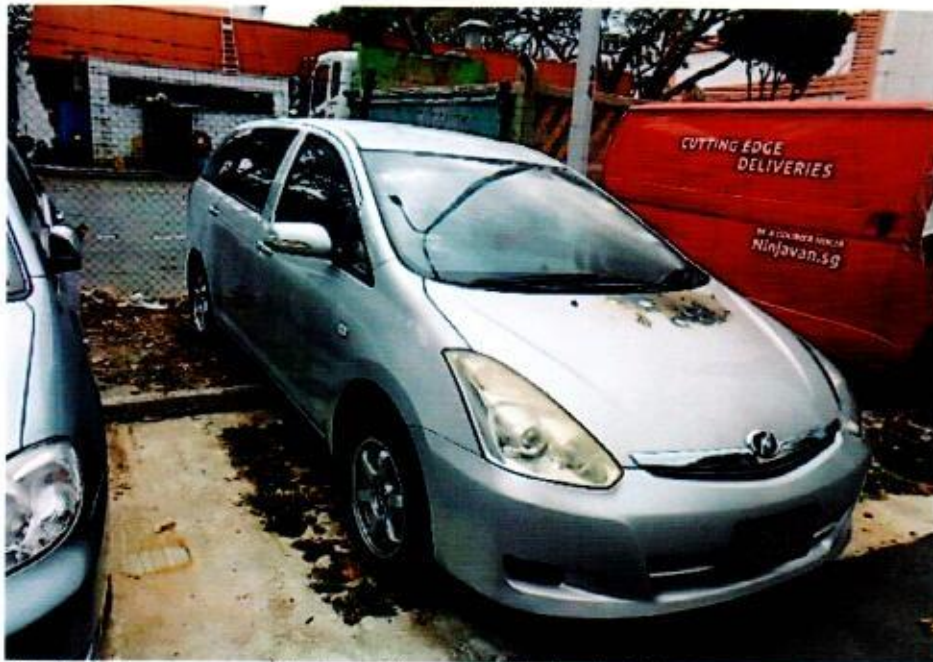
Photo 1 shows a general view of the front right body of the Insured Vehicle at the time of my inspection. The fire damage was confined to the engine compartment of the Insured Vehicle. The interior compartment and the rear portion of the Insured Vehicle were unaffected.

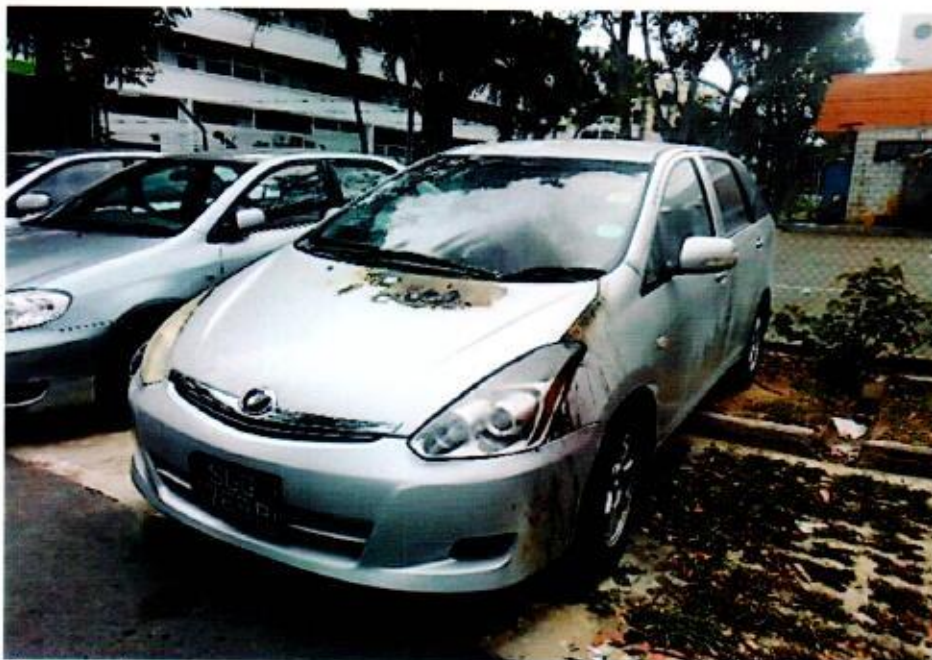
Photo 2 shows a general view of the front left body of the Insured Vehicle at the time of my inspection. The fire damage was confined to the engine compartment of the Insured Vehicle. Exterioirly, only the front bonnet, front left fender and front windscreen were affected by the incident.

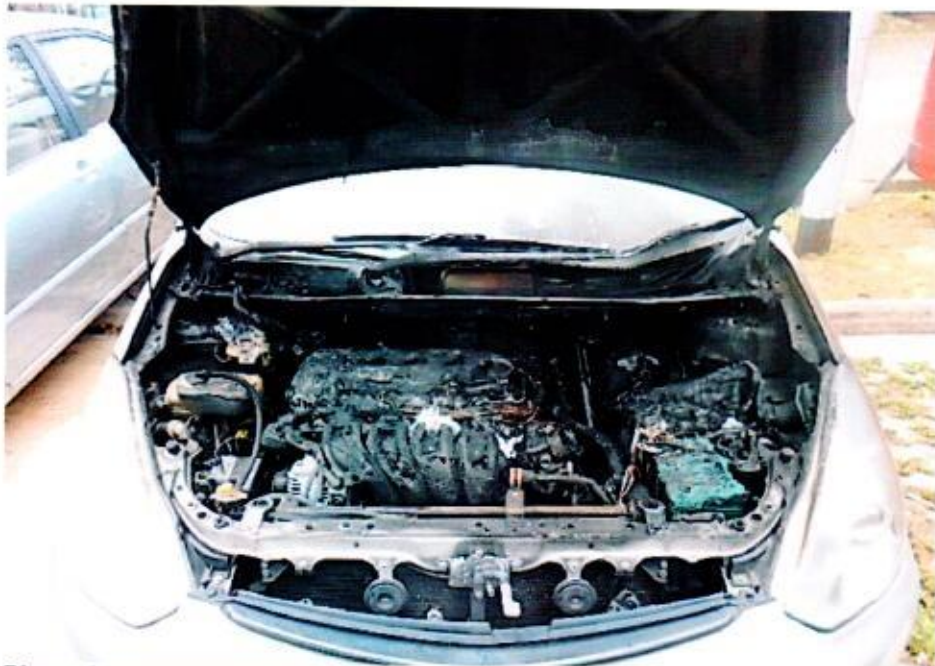
Photo 3 shows a general view of the Insured Vehicle's engine compartment at the time of my inspection. Most of the parts and components within the engine compartment were burnt and/or melted. This had included various rubber hoses, wiper panel, battery, air intake duct, fuse box, brake fluid reservoir, cooling fan, radiator, intake manifold and alternator amongst others.

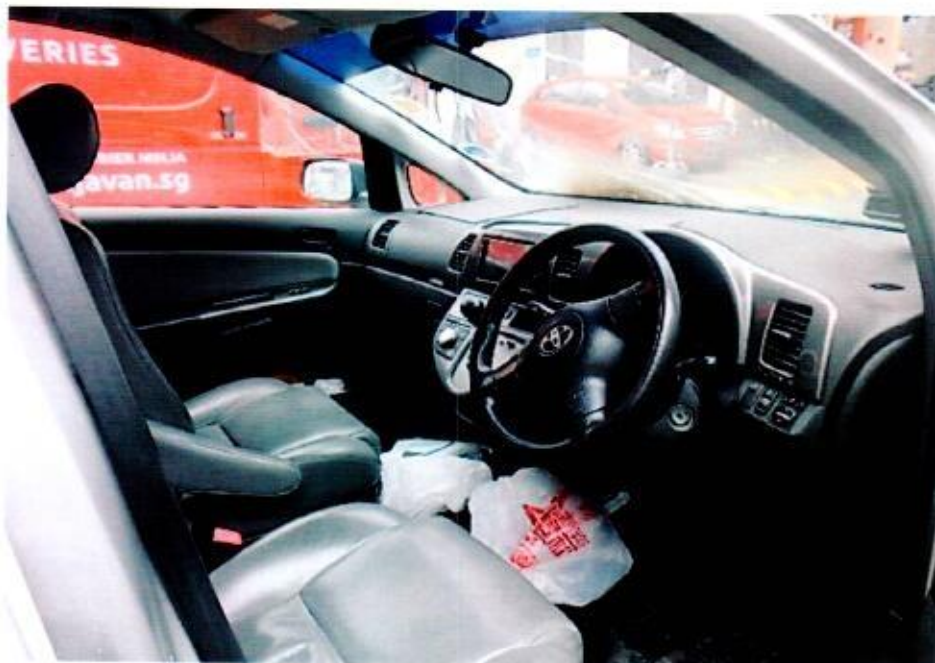
Photo 4 shows the interior compartment of the Insured Vehicle, which was unaffected by the incident.

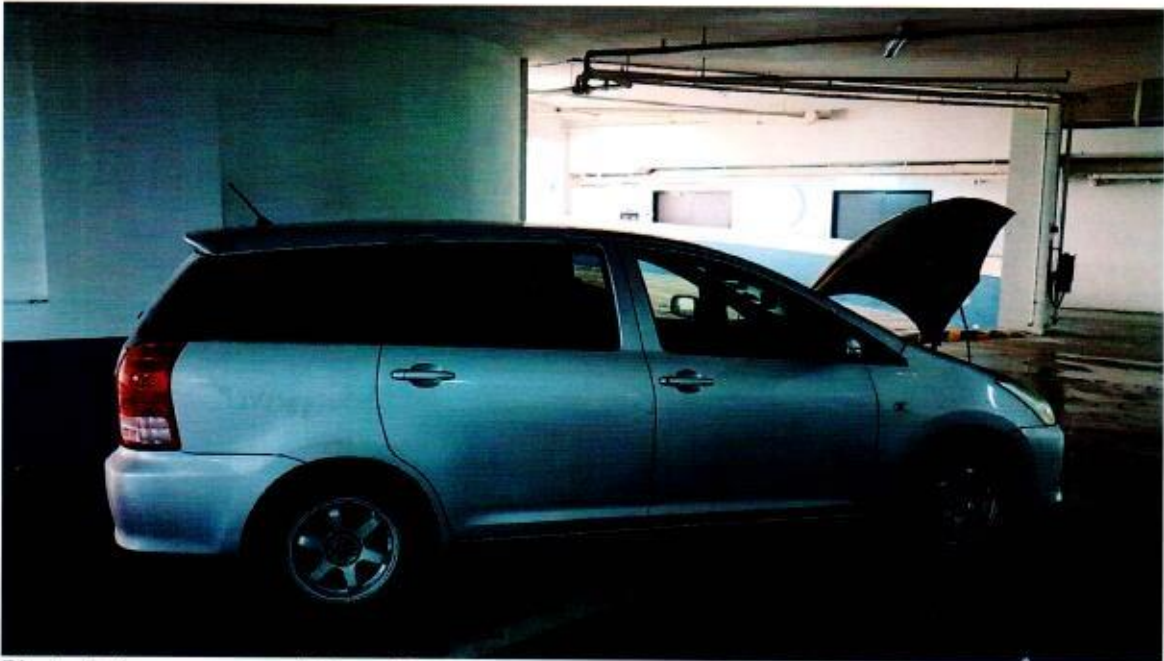
15. The photographs taken by Mr Tan had showed the Insured Vehicle stopped on a sheltered driveway, a short distance before an upslope ramp, with the fire already extinguished. Generally, I note that the damage of fire nature to the Insured Vehicle, as seen from the photographs provided, was similar to what I had observed during my inspection of the Insured Vehicle.

Photo 5 shows a general view of the Insured Vehicle at the incident with fire already extinguished. The Insured Vehicle could be seen stopped on a sheltered driveway, a short distance before an upslope ramp. In general, the observations gathered from my review of the photographs provided by Mr Tan at the incident scene had corresponded to the description of events that he had related to me during our conversation on 03 April 2019.

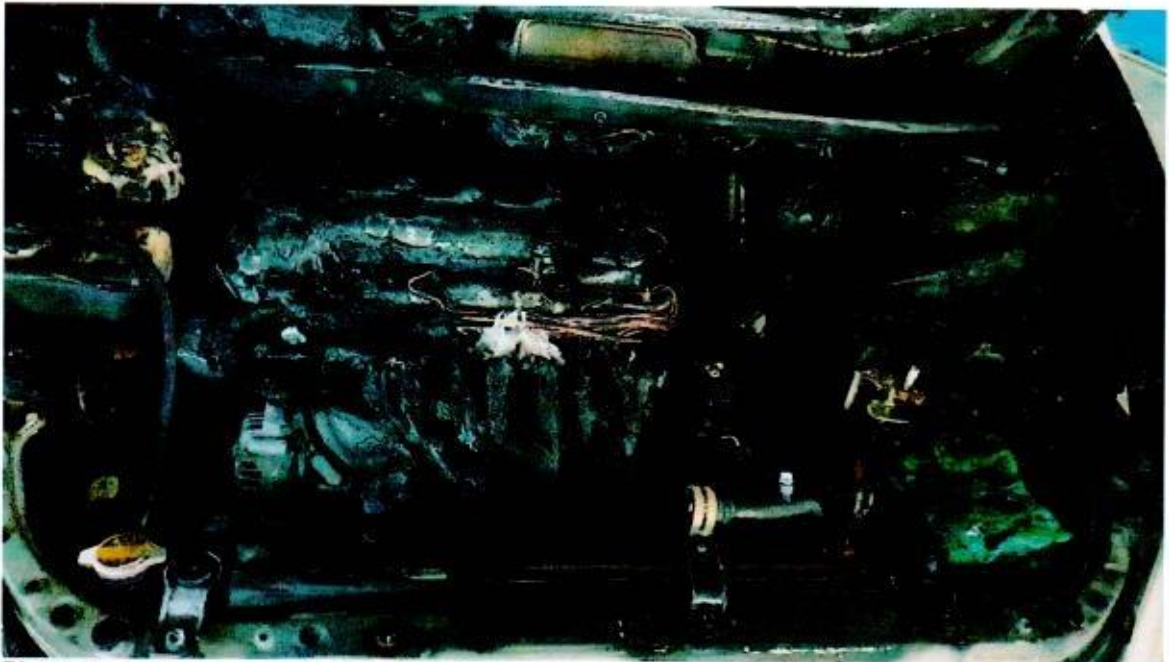
Photo 6 shows a general view of the Insured Vehicle's engine compartment. The damage of fire nature to the Insured Vehicle, as seen from the photographs provided, was similar to what I had observed during my inspection of the Insured Vehicle.

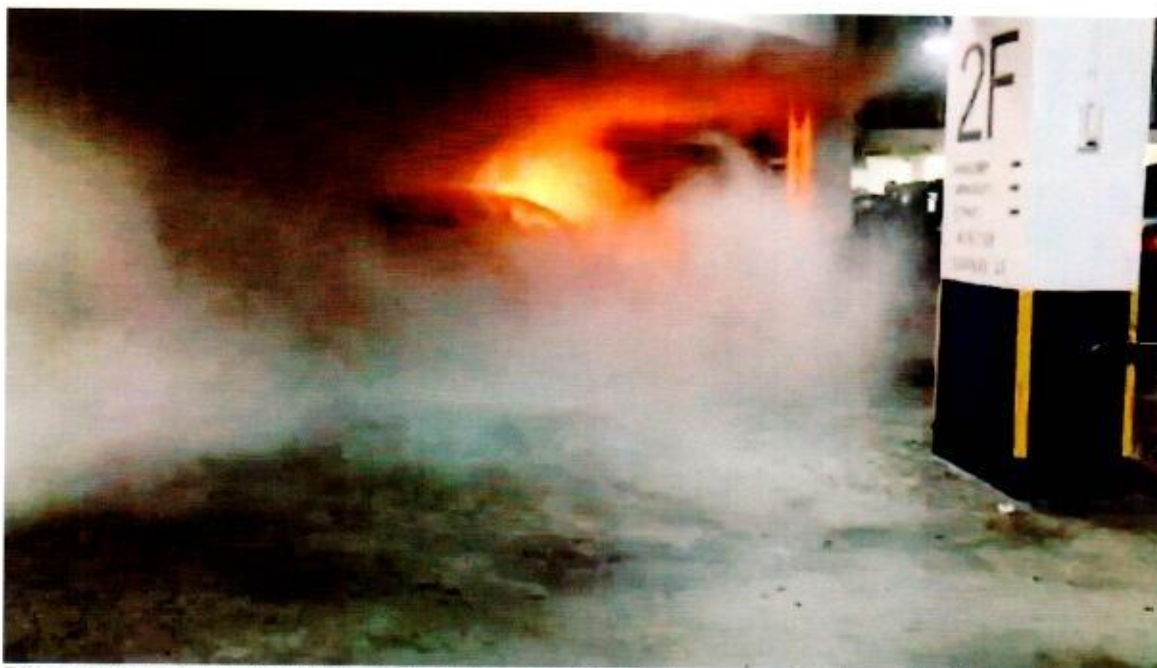
16. My review of the video recording taken at the incident scene showed the Insured Vehicle with dense smoke covering the Insured Vehicle and its immediate surrounding. This was before the fire was extinguished. Flames could be seen at the frontal body of the Insured Vehicle, slightly towards the left from the centre.

Photo 7 shows a screenshot from the video recording that was provided to me by Mr Tan. My review of the video recording taken at the incident scene showed the Insured Vehicle with dense smoke covering the Insured Vehicle and its immediate surrounding. Flames could be seen at the frontal body of the Insured Vehicle, slightly towards the left from the centre.

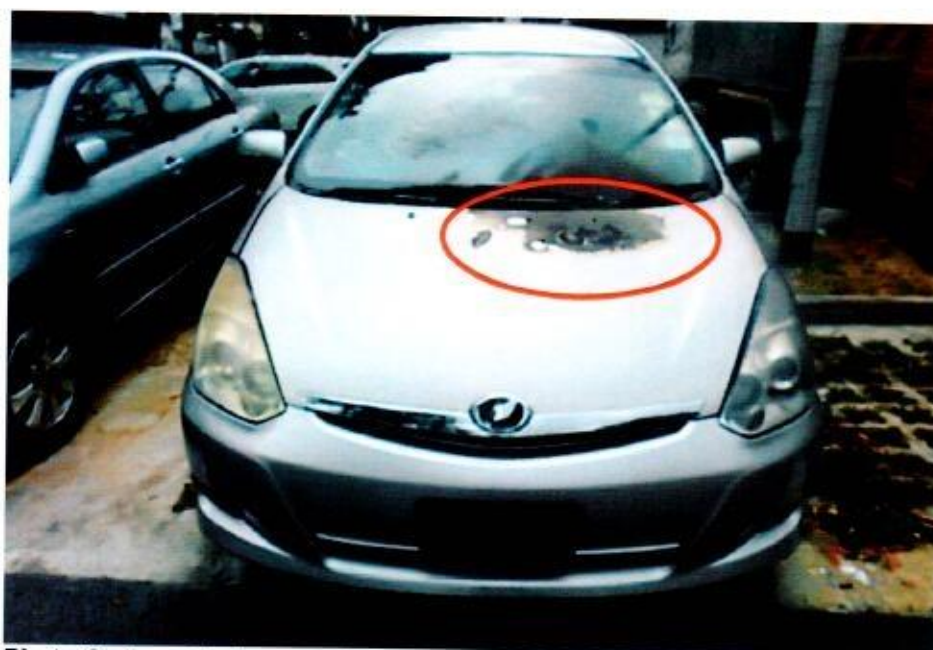
19. Firstly, the fire can be established to have originated within the engine compartment of the Insured Vehicle, given the single area of fire damage that the Insured Vehicle had sustained (interior compartment and rear portion unaffected). The burn mark found at a single area at the top side of its front bonnet further indicates that the fire had originated somewhere around the rear centre of the engine compartment.

Photo 8 shows the burn mark (circled) that was formed at a single area on the top side of the Insured Vehicle's front bonnet. Given this single burn mark on the front bonnet and the physical evidence that only the parts and components within the engine compartment were burnt and/or melted, the fire can be established to have originated within the engine compartment of the Insured Vehicle, somewhere around the rear centre of the engine compartment.

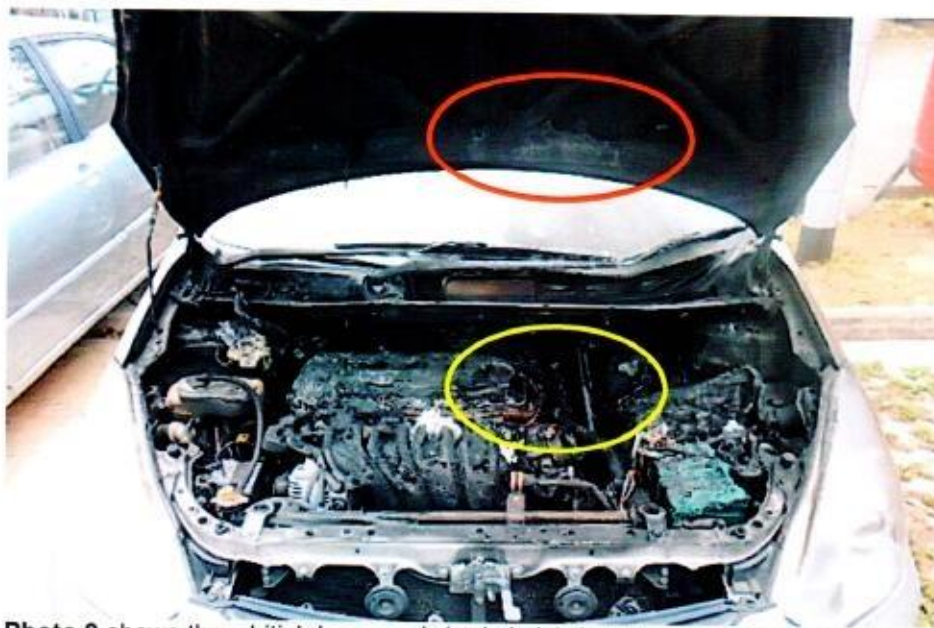
20. Following the characteristic of heat rising upwards, high heat intensity burn marks (whitish burn marks) were correspondingly found on the underside of the Insured Vehicle's front bonnet, directly below the area where the burn mark was formed on the top side of the front bonnet. These whitish burn marks are a result of exposure to prolong heat intensity. Rust would normally start to develop around these areas soon after a fire as prolonged exposure to high heat intensity usually causes steel/metal material body parts to be exposed to natural environmental condition. See photo 8 & 9 below.

Photo 9 shows the whitish burn mark (red circle) that was found on the underside of the Insured Vehicle's front bonnet, directly under the area where the single burn mark was formed on the top side of the front bonnet. Such whitish burn marks are a result of exposure to prolonged heat intensity. Following the characteristic of heat rising upwards, the fire to the Insured Vehicle can be established to have originated around the rear centre of the engine compartment (yellow circle).

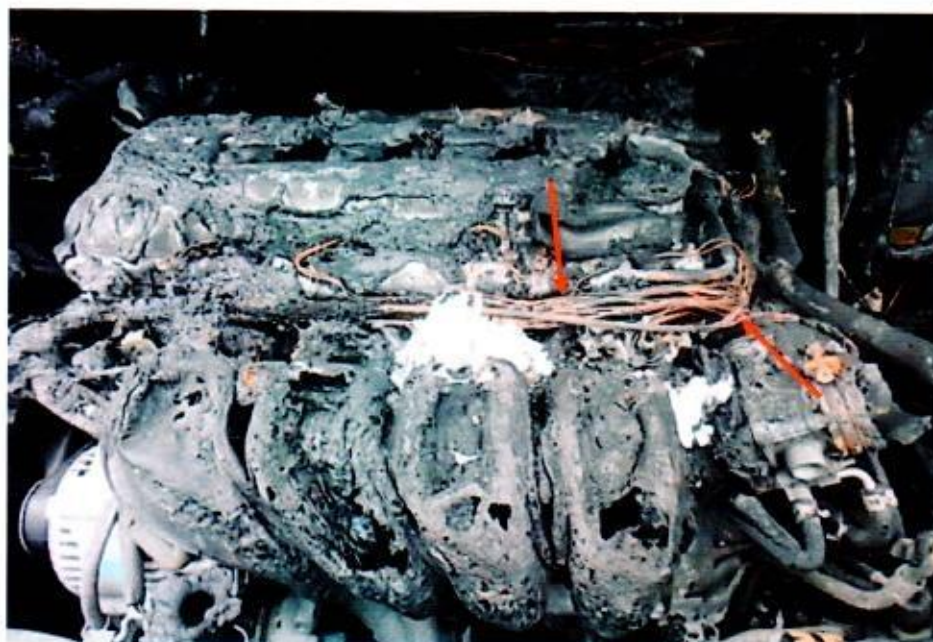
21. My examination of the rear centre area of the engine compartment during my inspection of the Insured Vehicle revealed several stretches of wirings that were completely burned to its bare copper state. These wirings were original wire harnesses of the Insured Vehicle and were all located at/or around the immediate vicinity of the rear centre area. The bright reddish colour of the copper wires suggest that the wirings were exposed to high heat. Such condition normally indicates internal heating of copper wires which is a sign of an electrical short circuit occurring. This would then appear to suggest that the cause of fire to the Insured Vehicle was due to electrical in nature. See photo 10 – 12 below.

22. To further explain briefly, heat from engine operation could cause the rubber insulation of the wires and/or wiring harness within the engine compartment to lose its flexibility and become hardened after a prolonged period of time. The hardened rubber insulation may then become brittle and break off bits by bits, exposing live wires that may come into contact with each other and/or the metal body of the vehicle, creating sparks that could ignite a fire. Unlike countries with different seasons, the hot local climate increases the heat within the engine compartment of locally used vehicles, and this could accelerate the hardening of rubber insulations, and any other rubber material parts within the engine compartment.

Photo 10 shows the centre area of the Insured Vehicle's engine compartment. Several stretches of wirings (arrowed) at/or around the immediate vicinity of the rear centre area were found to be burnt to its bare copper state. The bright reddish colour of the copper wires suggest that the wirings were exposed to high heat. Such condition normally indicates internal heating of copper wires which is a sign of an electrical short circuit occurring.

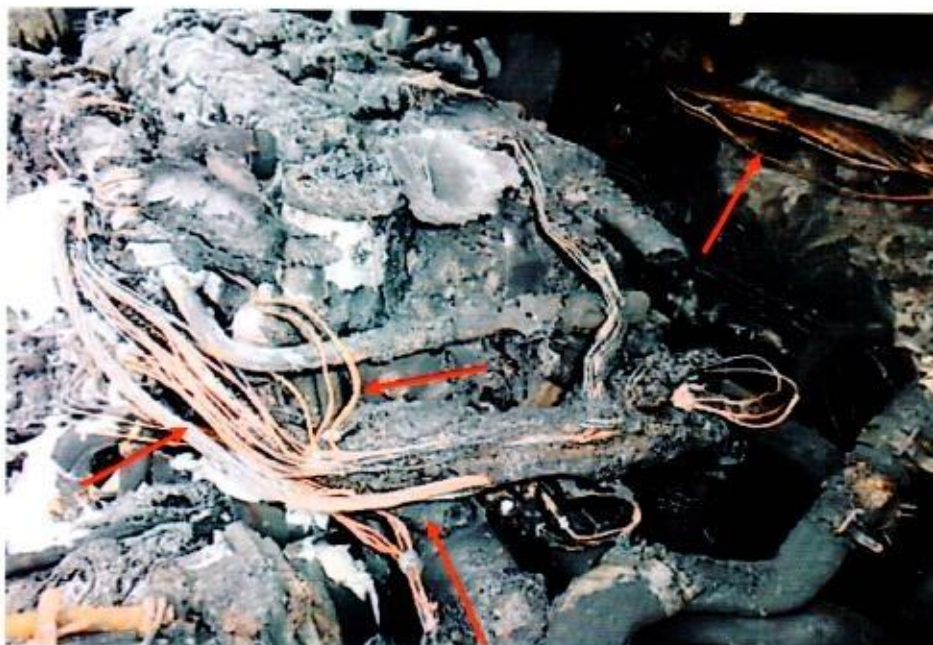
Photo 11 shows the wirings at the rear centre area of the Insured Vehicle's engine compartment. Several stretches of wirings (arrowed) at/or around the immediate vicinity of the rear centre area were found to be burnt to its bare copper state. Such condition normally indicates internal heating of copper wires which is a sign of an electrical short circuit occurring. These wirings were all original wiring harnesses of the Insured Vehicle.

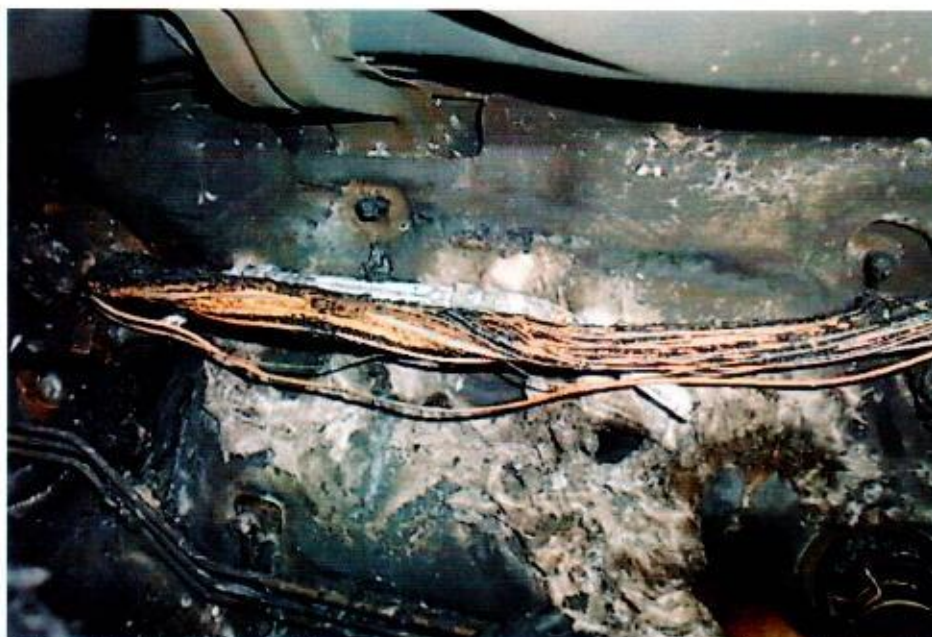
Photo 12 shows the wirings at the rear centre area of the Insured Vehicle's engine compartment, which was where the fire to the Insured Vehicle had originated. Several stretches of wirings at/or around the immediate vicinity of the rear centre area were found to be burnt to its bare copper state, an indication of an electrical short circuit occurring. These wirings were all original wiring harnesses of the Insured Vehicle.

24. Having investigated and technically analysed the damages of burnt nature to the Insured Vehicle, I am of the view that the cause of fire to the Insured Vehicle was of electrical in nature. For this particular case, the fire had originated along the wirings inside the engine compartment, at/or around the immediate vicinity of the rear centre of the engine compartment. The wirings were all original factory fitted wirings.
