Veh No: **SHC 8689A** at Regd: **2016 Jan**  
 Type: M/Car / M/Cycle / Bus / Van / Lorry / Truck / Prime Mover /  
 Truck / Trailer or \_\_\_\_\_  
 Make: **Hyundai I40** C/S: **1685**  
 Colour: **Blue** A/C: Insured / Std / Nil / NA  
 Sp Reading: **417403** T/Radio: Insured / Std / Nil / NA  
 Engine No: **D4FDFU580586**  
 Chassis: **KMHLB41UMGU083134**  
 Gen. Cond: Good / Fair / Poor / Burnt  
 Steering: Insured / Jammed / Leaked / Burnt or \_\_\_\_\_  
 Brake: Insured / Jammed / Leaked / Burnt or \_\_\_\_\_  
 Mod: Nil S/Rim / STD A/Rim or \_\_\_\_\_  
 Tyre Size: F: **205/60 R16**  
 R: **— " —**  
 BS / DUN / EXHOVA / GY / FS / LIZA / MIC / OHTSU / PIR / SUMI /  
 TOYO / YOKO or **Wastlake**  
 Front: \_\_\_\_\_ Rear: \_\_\_\_\_  
 R/Bal: **5** mm R/Bal: **5** mm  
 L/Bal: **5** mm L/Bal: **5** mm  
 D.O.A: **24/03/2019** D.O.I: **26/03/2019**  
 Survey held at: **Chunni AMC**  
 Des. of Damages: Frt / Rear / O/S / W/S / U/C / Rooftop or \_\_\_\_\_

Auto  
Consultants  
Pte Ltd

**INITIAL INSPECTION REPORT OF VEHICLE NO SHC 8689A**

## ADJUSTMENT ON REPAIR COST FOR VEHICLE NO. SHC 8689A

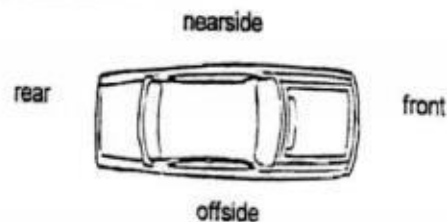
The vehicle sustained damages at the n/s front portion, n/s rear portion and n/s body

Damages Consistent
