Your Ref: SJE 34H
Our Ref : CI/TP19006069/D

AUTOMOBILE INSPECTION REPORT OF MOTOR CAR SJE 34H

Vehicle Registration No.	: SJE 34H
Make / Model	: Nissan Skyline 2.5A
Chassis No	: ER34018139
Year of Registration	: 1999 (January)
Mileage	: 115,822km

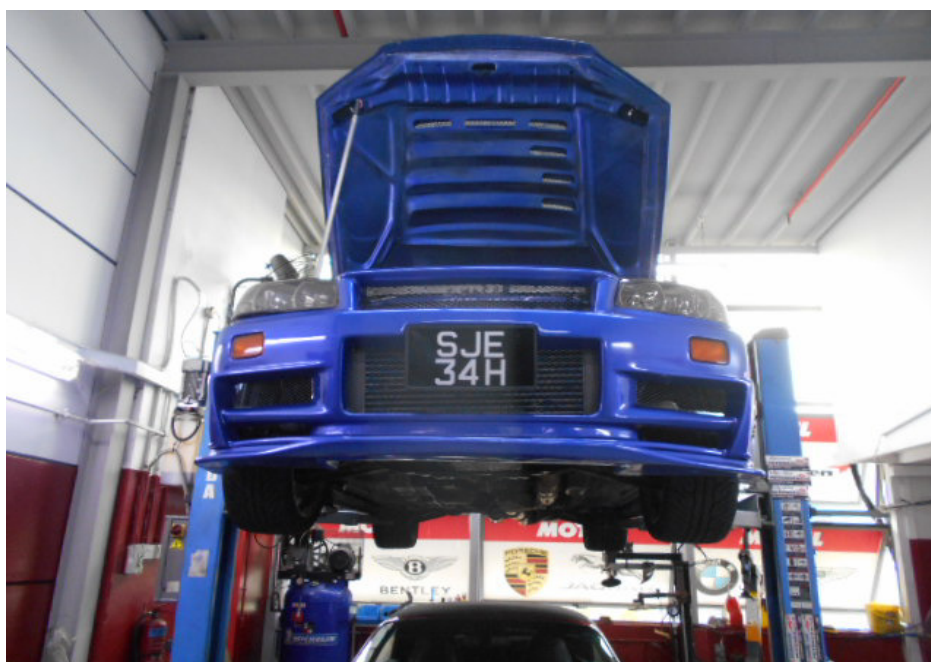
Photo 1 shows the Motor Car hoisted for checks on its undercarriage.

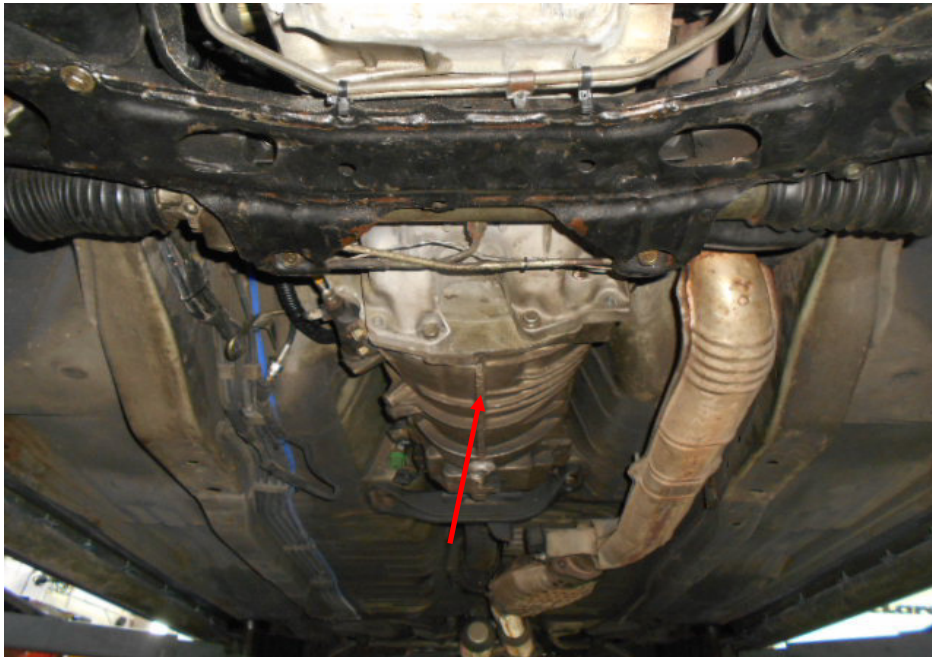
Photo 2 shows a general view of the transmission assembly (arrowed) that was fitted on the Motor Car. The front (input) side of the transmission is bolted to the crankshaft side of the engine block while the rear (output) side of the transmission was connected to the propeller shaft, which links to the rear axle of the Motor Car.

10. In general, the transmission assembly of the Motor Car was found to be secured properly. It was not mounted onto the chassis body or any integral body part of the Motor Car. The structural integrity of the Motor Car is not compromised by the fitment of this particular transmission assembly. Overall, the operating condition of the Motor Car's transmission system was satisfactory throughout the Motor Car's test drive.

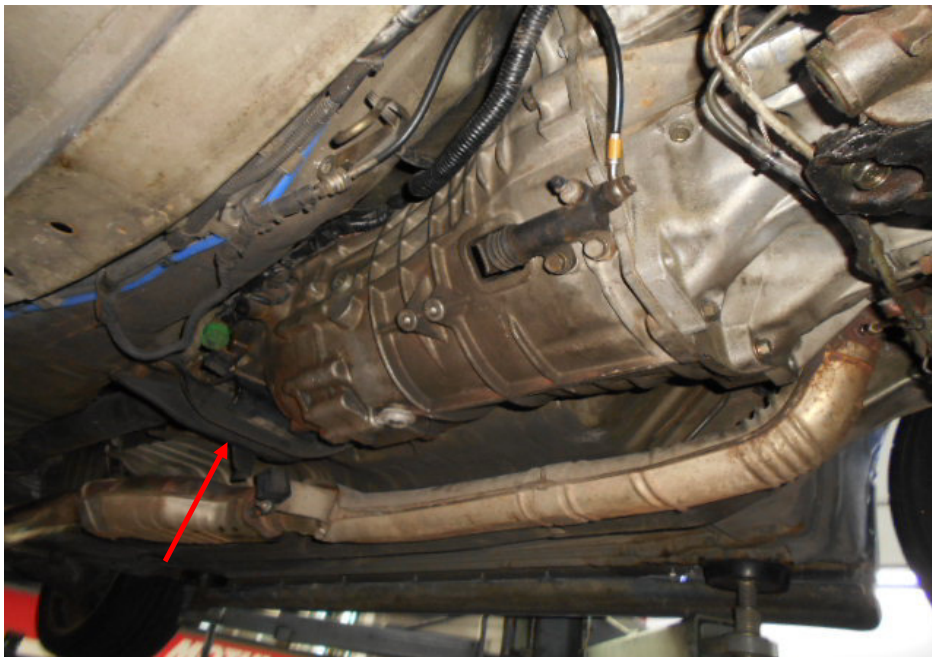
Photo 3 shows a general view of the bracket (arrowed) mounted to the underside of the floor board of the Motor Car, via bolts and nuts. The bracket supports the rear (output) side of the transmission.

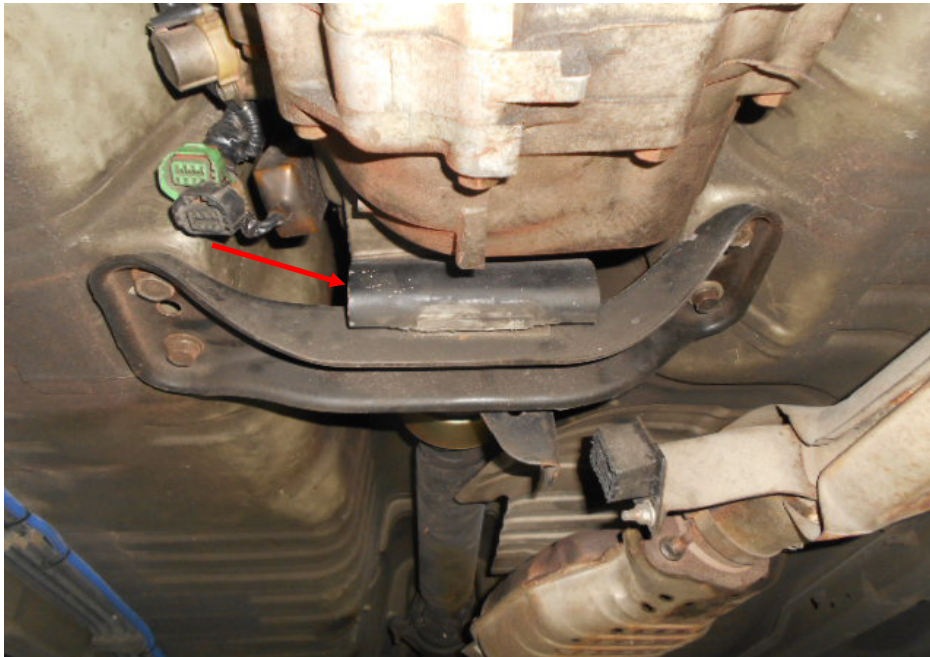
Photo 4 shows a closer view of the bracket mounted to the underside of the Motor Car's floor board, via bolts and nuts. The bracket supports the rear (output) side of the transmission. Rubber bushings (arrowed) absorbs any vibrations arising from the rotation of the transmission gears, minimising any stress to the bracket.

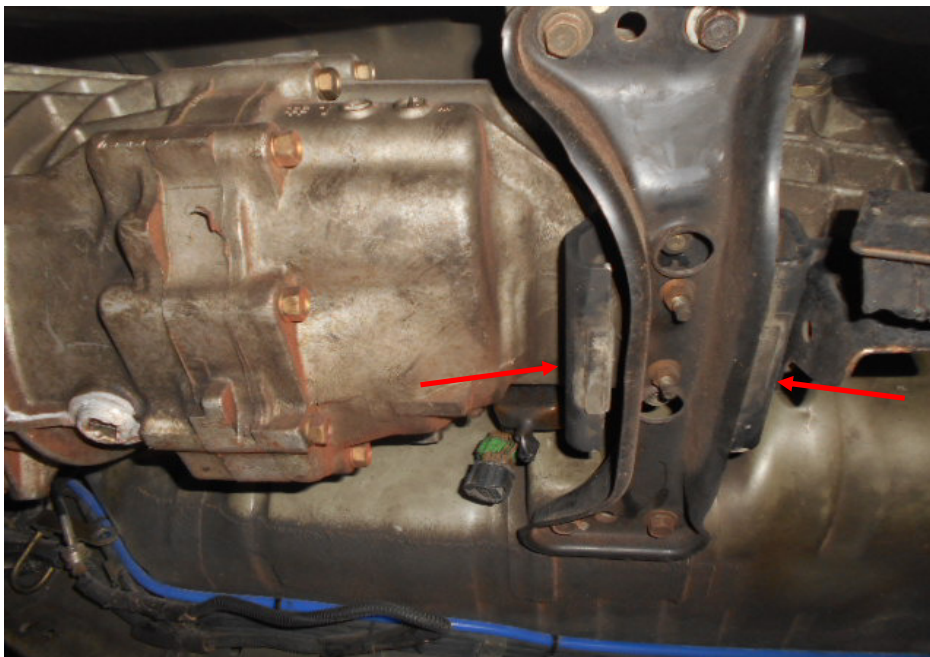
Photo 5 shows the rubber bushing (arrowed), sitting between the transmission and the bracket. The rubber bushing absorbs any vibrations arising from the rotation of the transmission gears, minimising any stress to the bracket.

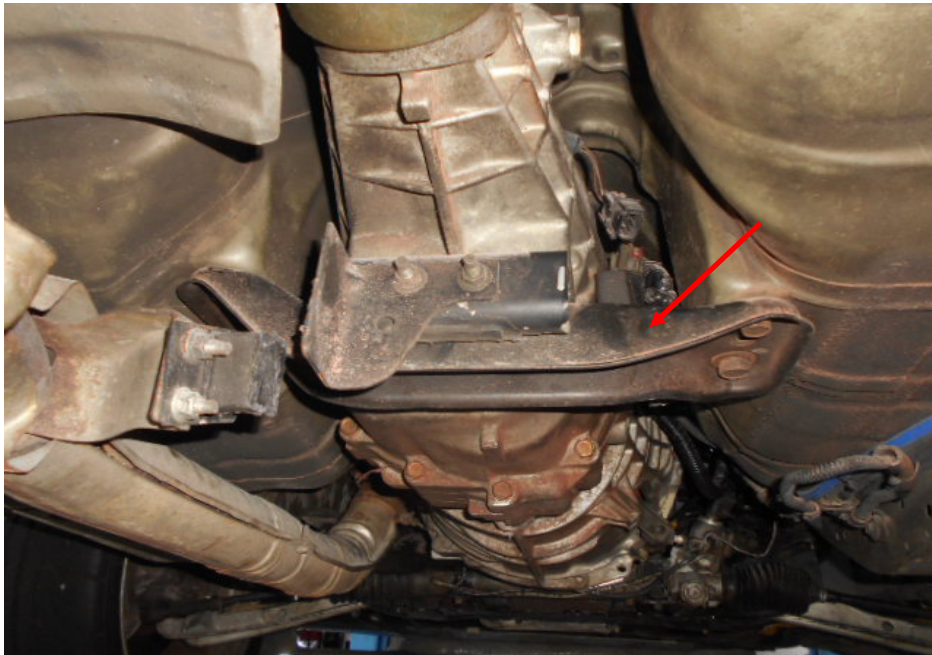
Photo 6 shows a general view of the transmission assembly that was fitted on the Motor Car, as viewed from the rear to front. The transmission assembly is supported by a bracket (arrowed) that is mounted on the underside of the floor board of the Motor Car, via bolts and nuts.

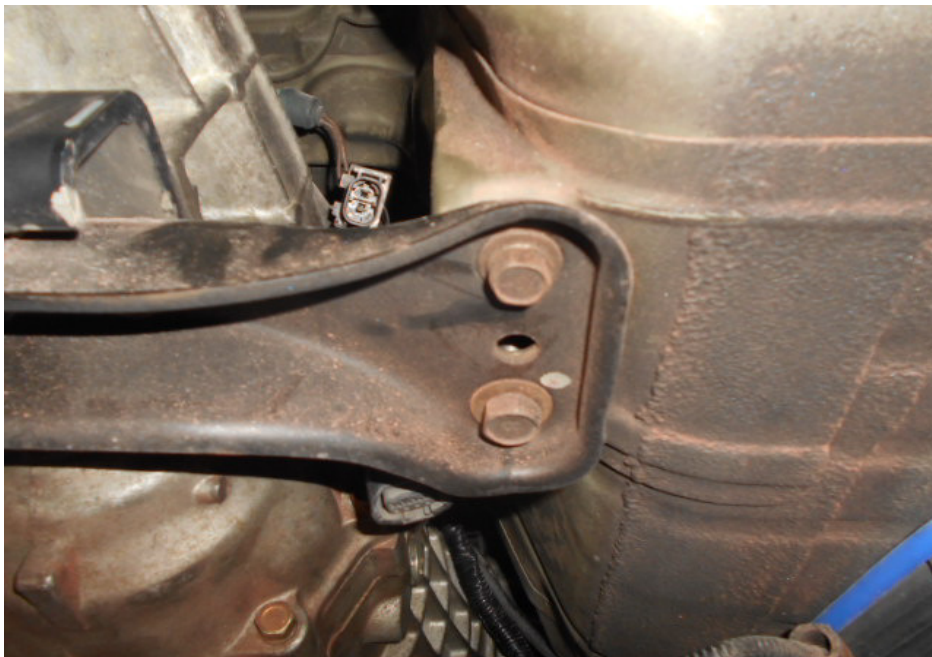
Photo 7 shows the bracket mounted on the underside of the Motor Car's floor board, via bolts and nuts.

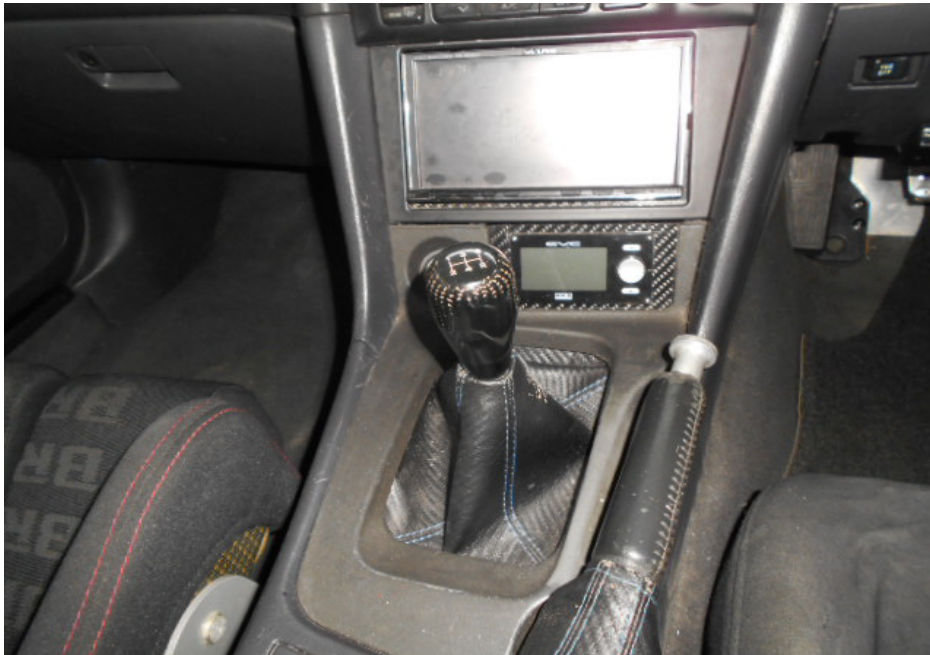
Photo 8 shows the manual gear shifter for manually selecting the transmission gear to be engaged.

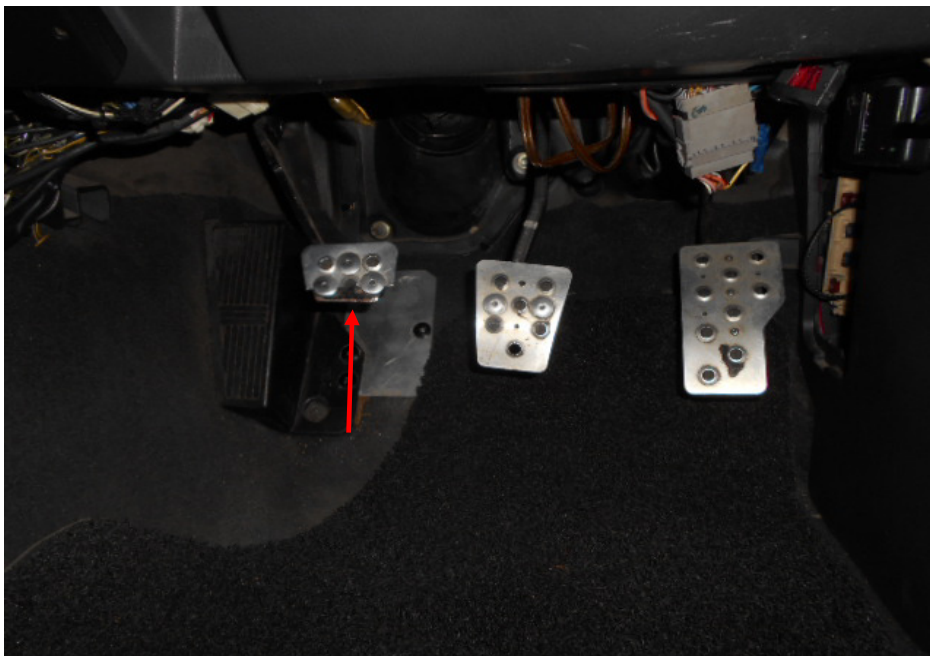
Photo 9 shows the clutch pedal (arrowed) for engaging and disengaging the transmission gears.
