Preliminary Advice

Insured Vehicle No	: SGR1894C	Accident Date	: 05/04/2019
TP Vehicle No	: SKK8318T	Assignment Date	: 09/04/2019
Make	: BMW 528i	Est. Duration of Repair	: 5.00
Date of Inspection	: 09/04/2019		
Inspection At	: CHEW GOON MOTOR (AMK) BLK 10 ANG MO KIO INDUSTRIAL PARK 2A, #01-15/16 & 17, AMK AUTOPOINT SINGAPORE 568047

VEHICLE DAMAGE INSPECTION REPORT

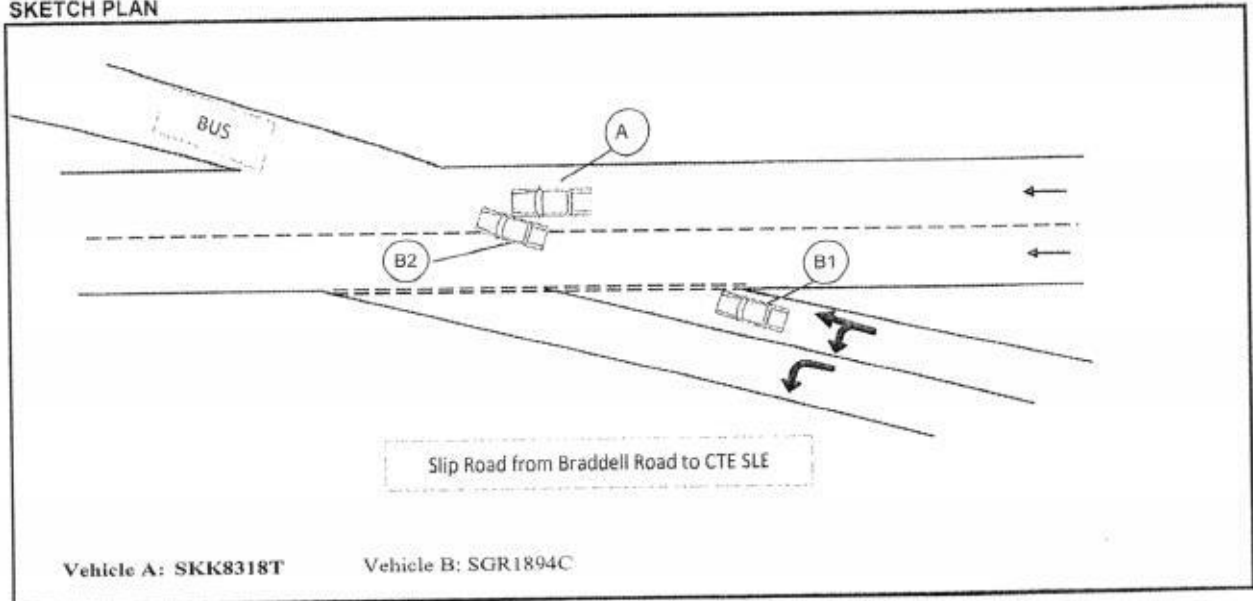
SKETCH PLAN

I was travelling along the slip road along lane 1. Suddenly, vehicle B dashed out from the side road. This resulted in the left front area of my vehicle A to hit into the right front fender and right front door area of vehicle B.
