Your Ref: S9M01JHS
Our Ref :CS/ASM19006306/D

14 April 2019

**TECHNICAL INVESTIGATION REPORT OF FIRE INCIDENT INVOLVING THE
INSURED VEHICLE SFT 26A ON 06 APRIL 2019**

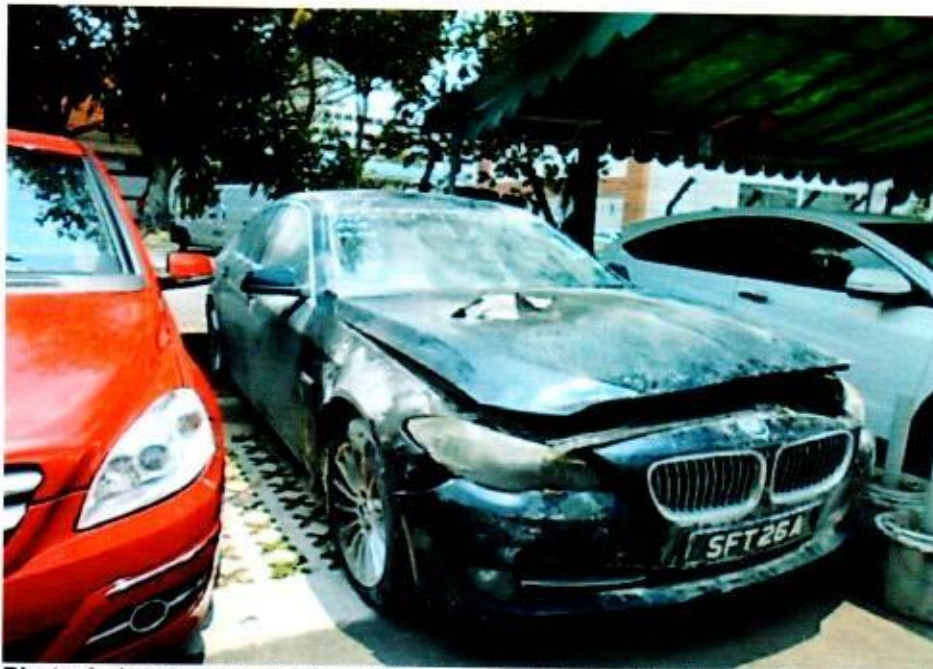
Photo 1 shows a general view of the front right body of the Insured Vehicle at the time of my inspection. The fire damage to the Insured Vehicle was confined to its frontal right body. Its front bumper, front bonnet, front right headlamp and front right fender were amongst the exterior body parts that were found to have been affected as a result of the fire.

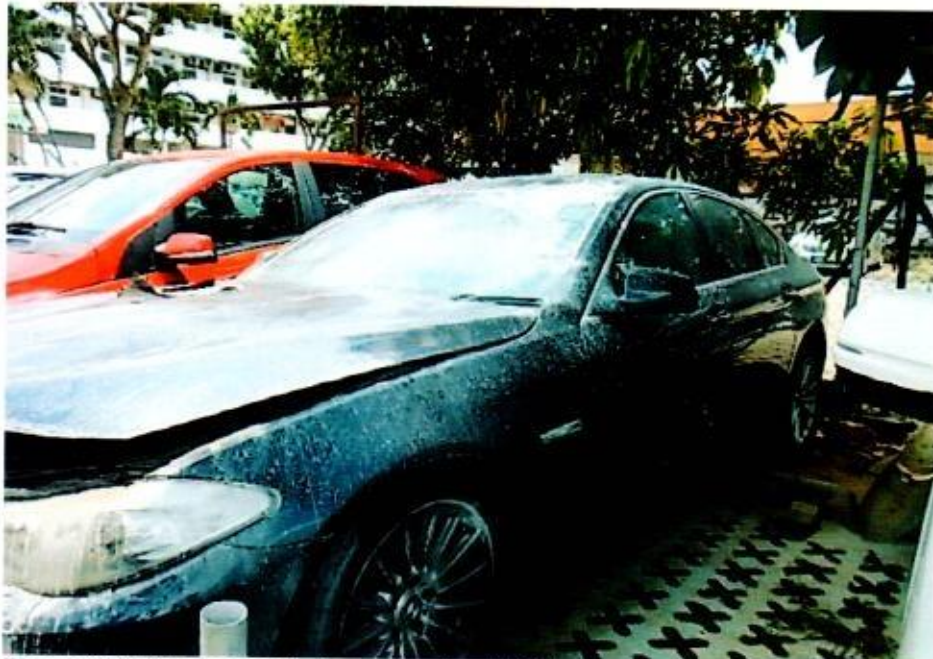
Photo 2 shows a general view of the front left body of the Insured Vehicle at the time of my inspection. The left side and rear body of the Insured Vehicle was observed to be relatively unaffected by the incident.

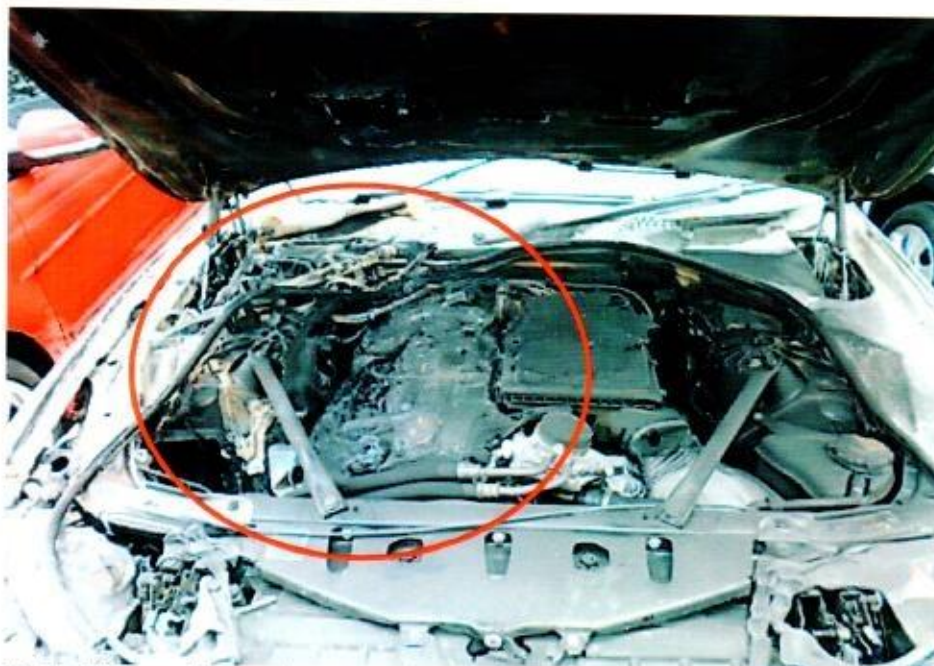
Photo 3 shows the engine compartment of the Insured Vehicle at the time of my inspection. The fire damage was observed to have been more severe at the right side of the engine compartment (circled). The parts that were found to have been burnt and/or melted include the air intake manifold, engine top cover, air filter housing, various hoses and pipes amongst others.

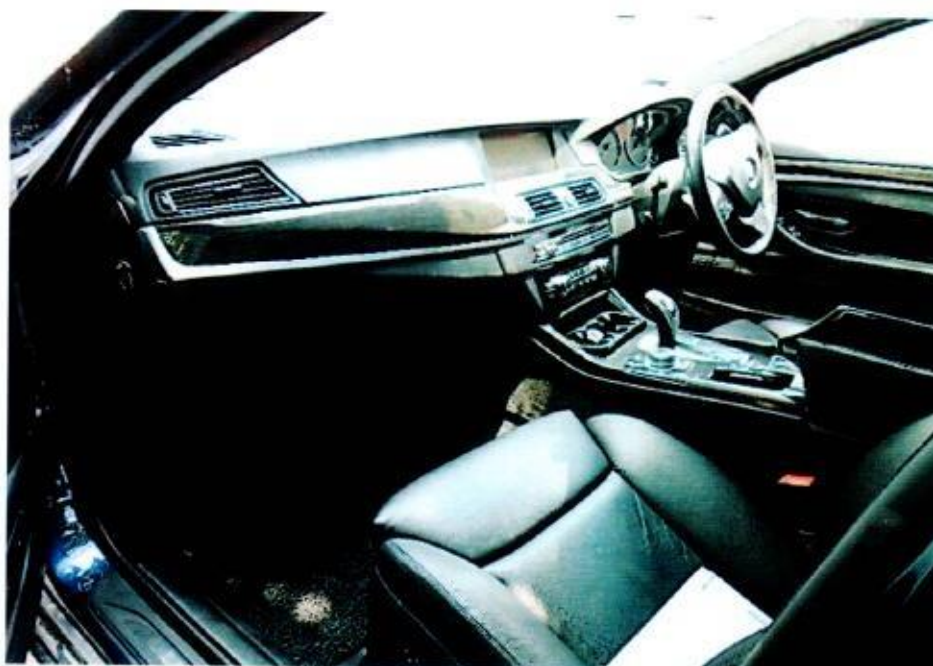
Photo 4 shows the interior compartment of the Insured Vehicle, which was not affected by the fire incident.

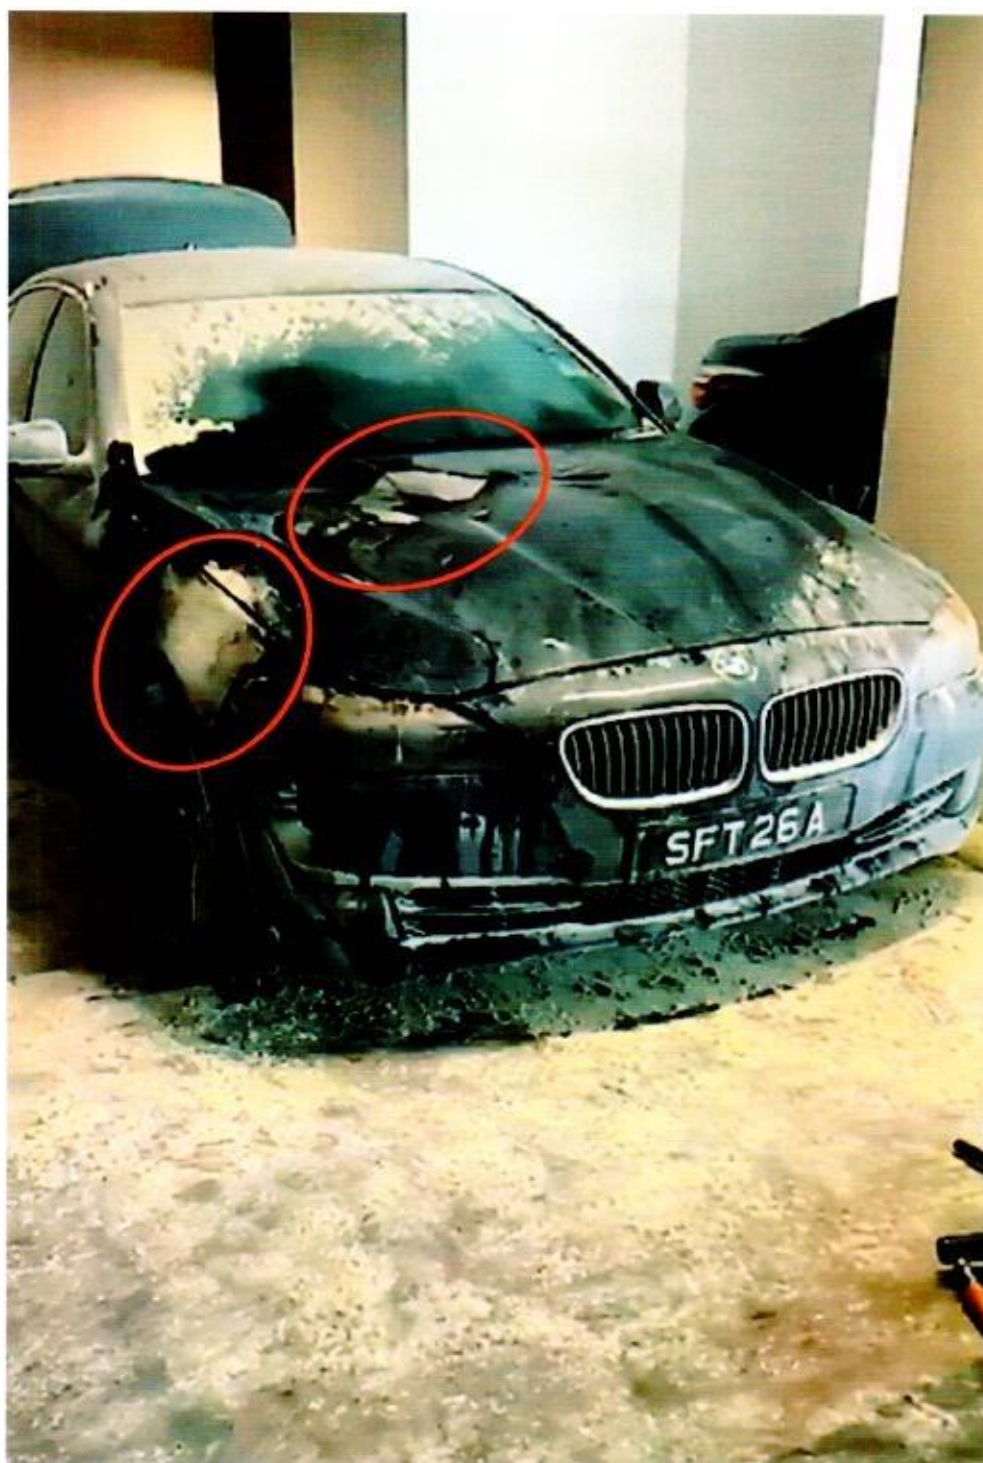
Photo 5 shows a screenshot taken from the video recording that was provided by Mr Ang. The damage of burnt nature to the Insured Vehicle immediately after the fire was put out had corresponded to the damage as seen by me during my inspection of the Insured Vehicle ie the frontal right body (circled) of the Insured Vehicle was exteriorly affected. Also, apart for the powder residue left behind by fire extinguishers, there appears to be no unusual foreign material(s) and/or object(s) found on the ground in the immediate area of where the Insured Vehicle was parked.

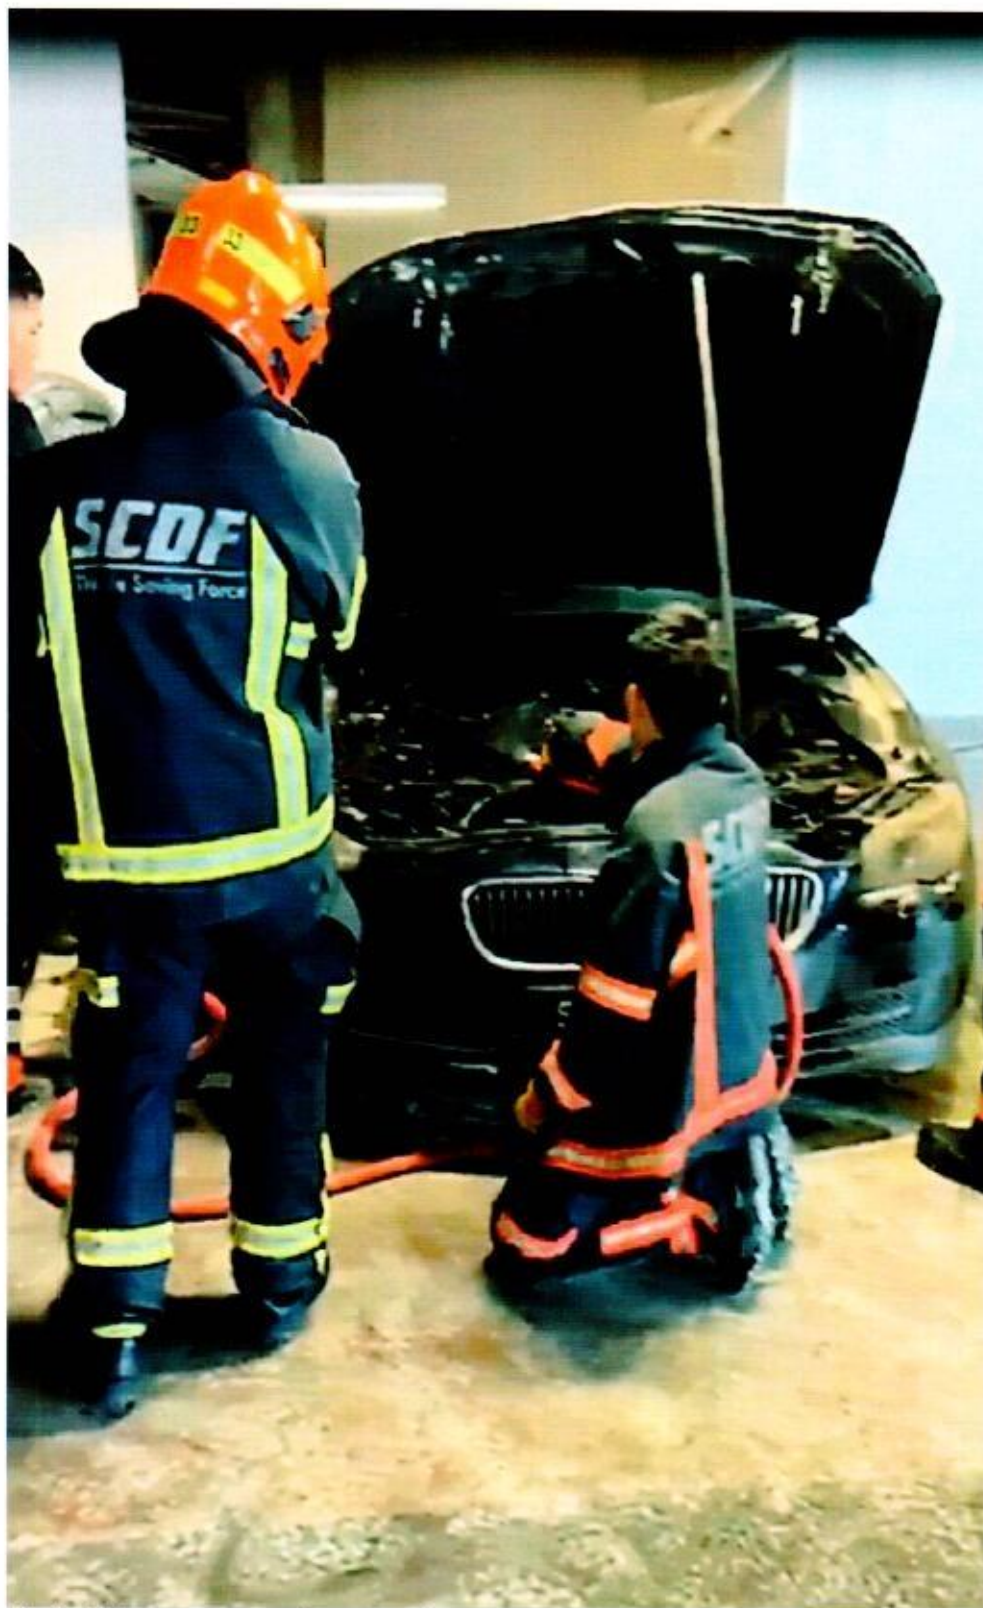
Photo 6 shows a screenshot taken from the video recording that was provided by Mr Ang, with SCDF officers examining the engine compartment of the Insured Vehicle.

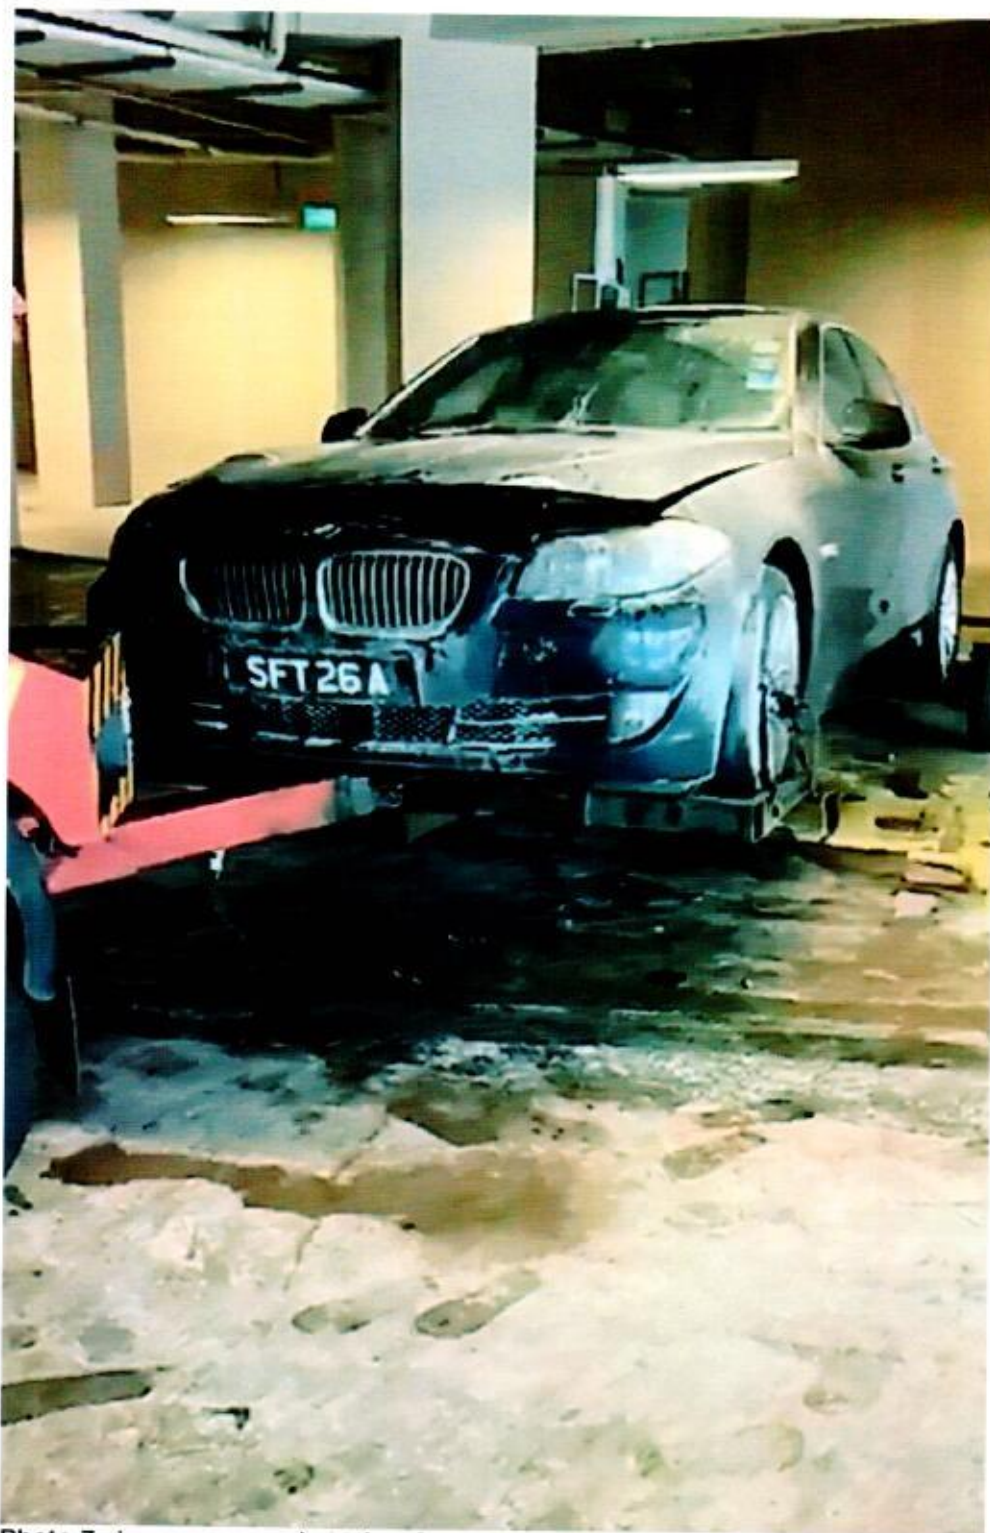
Photo 7 shows a screenshot taken from the video recording that was provided by Mr Ang, with the Insured Vehicle being towed area from the incident scene. In general, the observations gathered from my review of the video recordings that were taken by Mr Ang at the incident scene had corresponded to the description of events that he had related to me during our conversation on 11 April 2019.

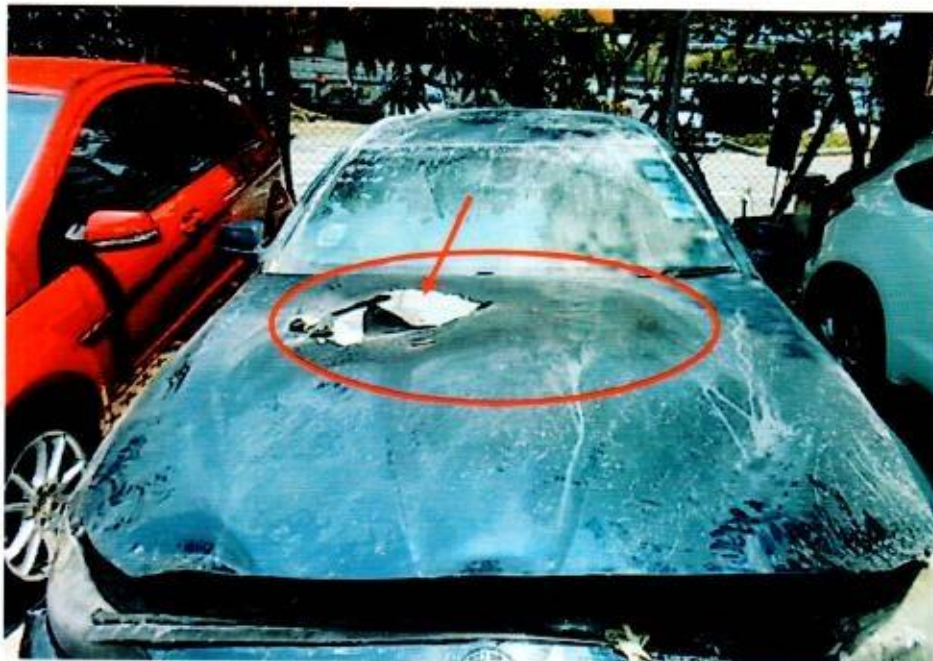
18. For this case, the origin of fire to the Insured Vehicle can be established basing on the burn pattern of the Insured Vehicle that was seen from the video recordings and at the time of my inspection. The paint around the rear centre area of the Insured Vehicle's front bonnet was found to be blackened. What is referred to as high heat intensity burned marks (whitish burn marks) were observed to have been formed at the rear right area of the front bonnet, within the blackened paint area. These whitish burn marks are a result of exposure to prolong heat intensity. Rust would normally start to develop around these areas soon after a fire as prolonged exposure to high heat intensity usually causes steel/metal material body parts to be exposed to natural environmental condition.

Photo 8 shows the whitish burn marks (arrowed) that were found on the rear right area of the Insured Vehicle's front bonnet, within an area (circled) of the front bonnet that was found with paint blackened. Such whitish burn marks are a result of exposure to prolong heat intensity. Following the characteristic of heat rising upwards, the fire to the Insured Vehicle can then be determined to have originated around the rear right area of the engine compartment.

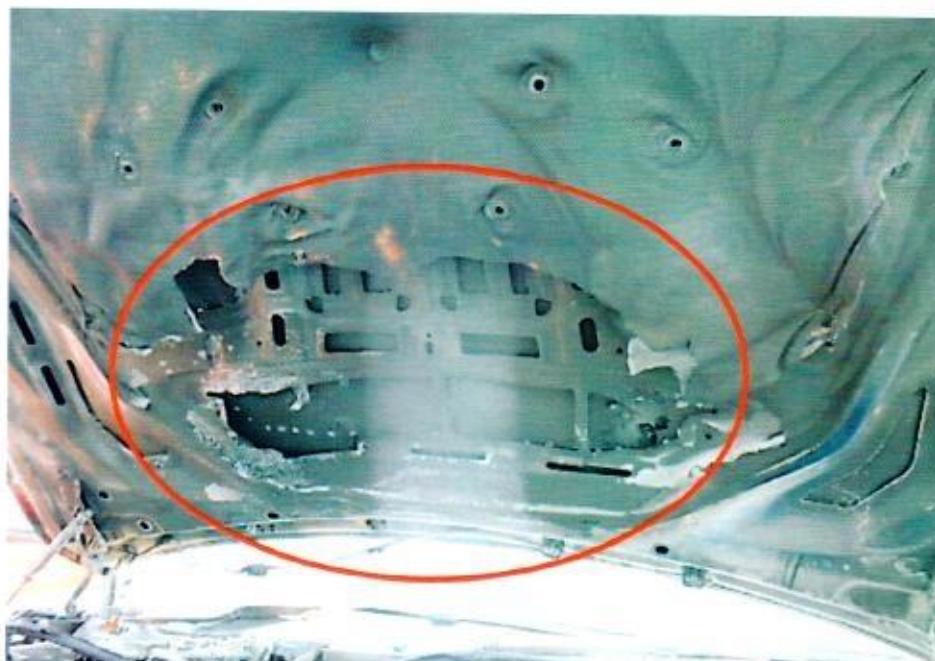
19. Correspondingly, the front bonnet insulator at the underside of the front bonnet at the rear centre area was found to have been melted whereas other areas of the front bonnet insulator were still intact. Following the characteristic of heat rising upwards, the burn pattern of the front bonnet, in particular the high heat intensity burned marks, would then indicate that the origin of fire was around the rear right area of the Insured Vehicle's engine compartment. This also follows the observation that the extent of fire damage was more severe at the right side of the engine compartment. See photo 8 - 10 below.

Photo 9 shows the underside of the Insured Vehicle's front bonnet. The front bonnet insulator at the rear centre area was melted whereas other areas was observed to be intact. The melted area of the front bonnet insulator was directly below the area where the paint at the top side of the front bonnet was blackened.

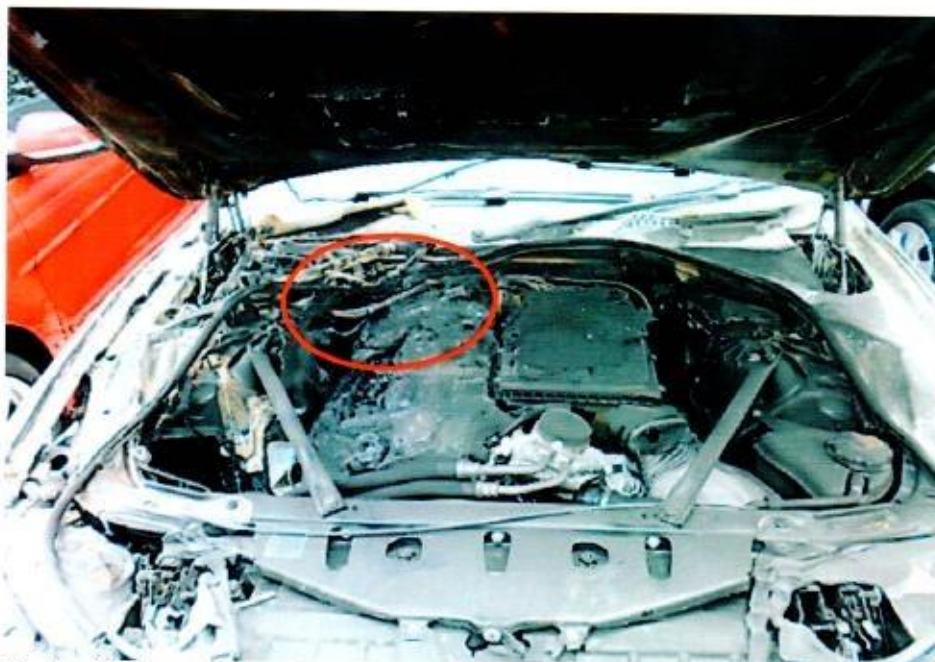
Photo 10 shows the engine compartment of the Insured Vehicle. Following the burn pattern, in particular the location where the high heat intensity burned marks were found on the front bonnet, and the characteristic of heat rising upwards, the fire to the Insured Vehicle had originated around the rear right side (circled) of the engine compartment. Correspondingly, the extent of fire damage was more severe at the right side of the engine compartment.

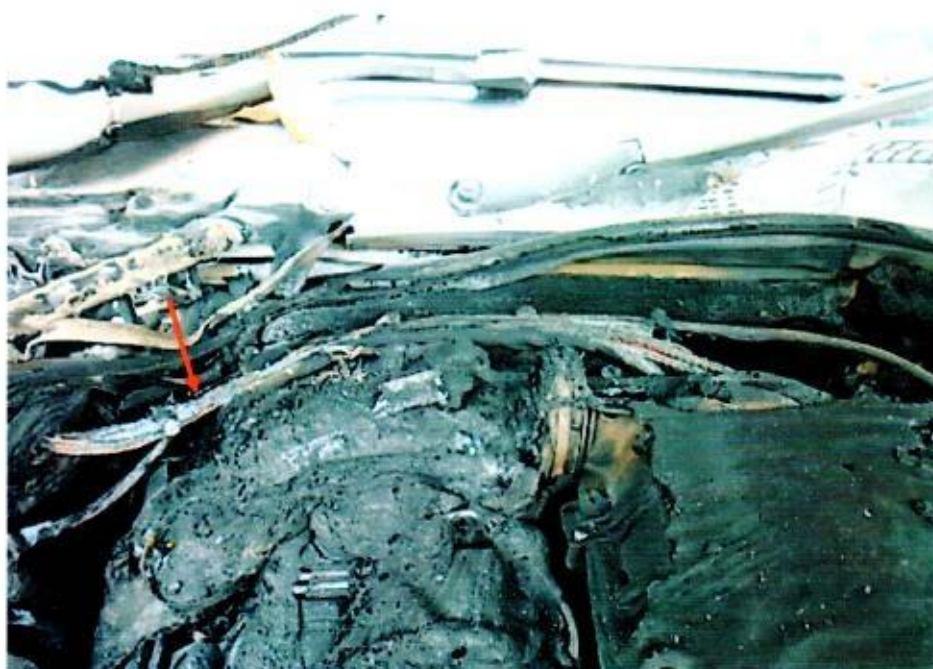
23. In fact, my examination of the rear right area of the engine compartment, during my inspection of the Insured Vehicle, revealed greenish residue on several stretches of original factory fitted wirings. The presence of greenish residue indicates internal heating of copper wires, a sign of an electrical short circuit occurring. The greenish residue is normally left behind from oxidation as a result of chemical reaction involving the copper wires. This physical evidence would then appear to suggest that the cause of fire to the Insured Vehicle was due to electrical in nature. See photo 11 & 12 below.

Photo 11 shows the stretch of wirings at the rear right area of the Insured Vehicle's engine compartment, which was where the fire had originated. Greenish residue was found along a stretch of original factory fitted wirings. The presence of such greenish residue suggests occurrence of an electrical short circuit.

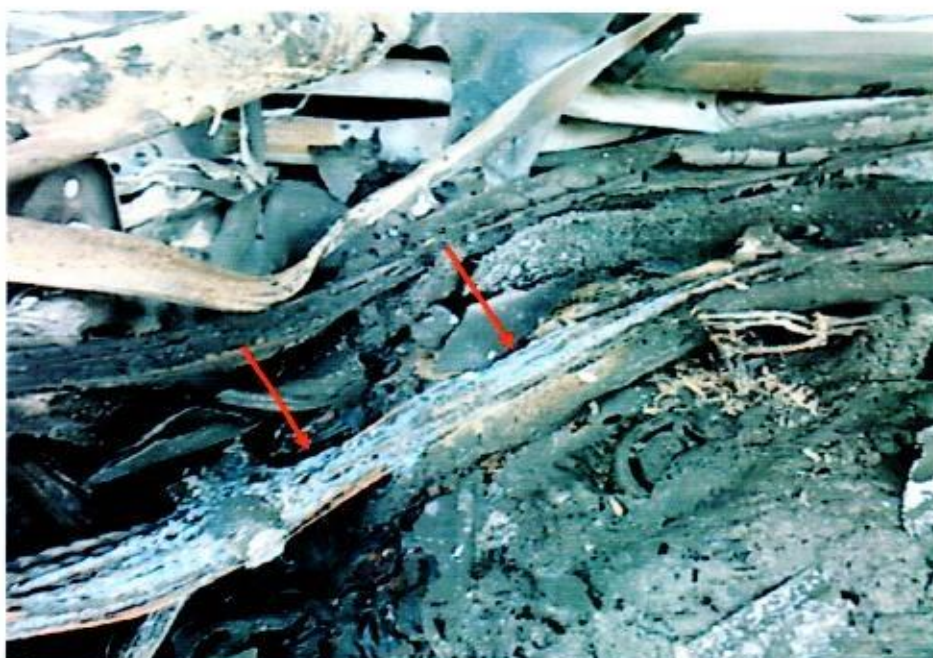
Photo 12 shows a closer view of the greenish residue (arrowed) that were found on the original factory fitted wirings at the rear right area of the Insured Vehicle's engine compartment. The presence of greenish residue suggests occurrence of an electrical short circuit. This physical evidence would then appear to suggest that the cause of fire to the Insured Vehicle was due to electrical in nature.

25. Having investigated and technically analysed the damages of burnt nature to the Insured Vehicle, I am of the view that the cause of fire to the Insured Vehicle was of electrical in nature. For this particular case, the fire had originated along the wirings inside the engine compartment, at the rear right area of the engine compartment. The wirings were original factory fitted wirings.
