Your Ref: S9M01JHS
Our Ref :CS/ASM19006306/D

14 April 2019

**TECHNICAL INVESTIGATION REPORT OF FIRE INCIDENT INVOLVING THE
INSURED VEHICLE SFT 26A ON 06 APRIL 2019**

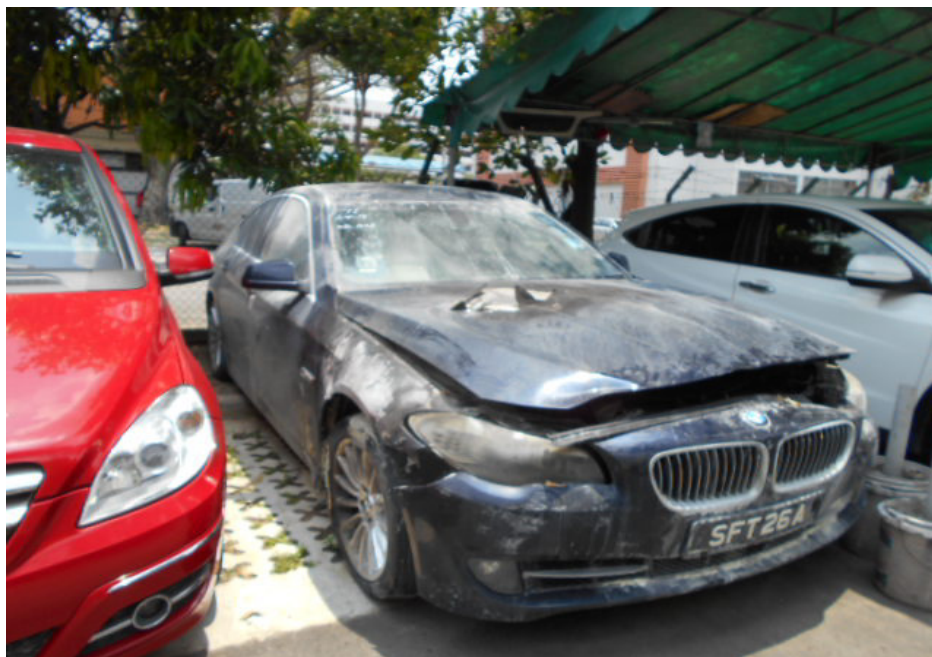
Photo 1 shows a general view of the front right body of the Insured Vehicle at the time of my inspection. The fire damage to the Insured Vehicle was confined to its frontal right body. Its front bumper, front bonnet, front right headlamp and front right fender were amongst the exterior body parts that were found to have been affected as a result of the fire.

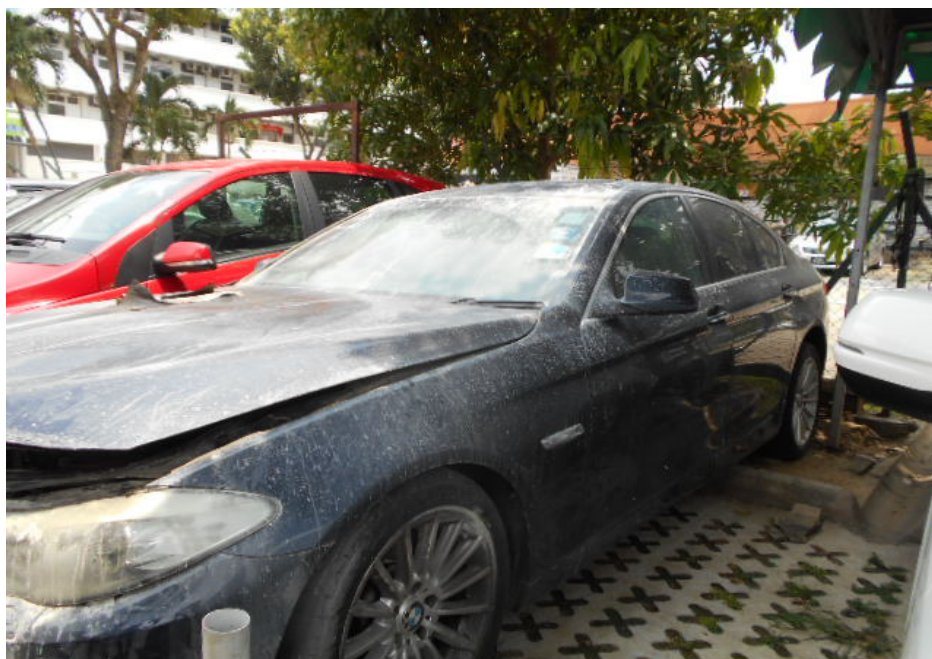
Photo 2 shows a general view of the front left body of the Insured Vehicle at the time of my inspection. The left side and rear body of the Insured Vehicle was observed to be relatively unaffected by the incident.

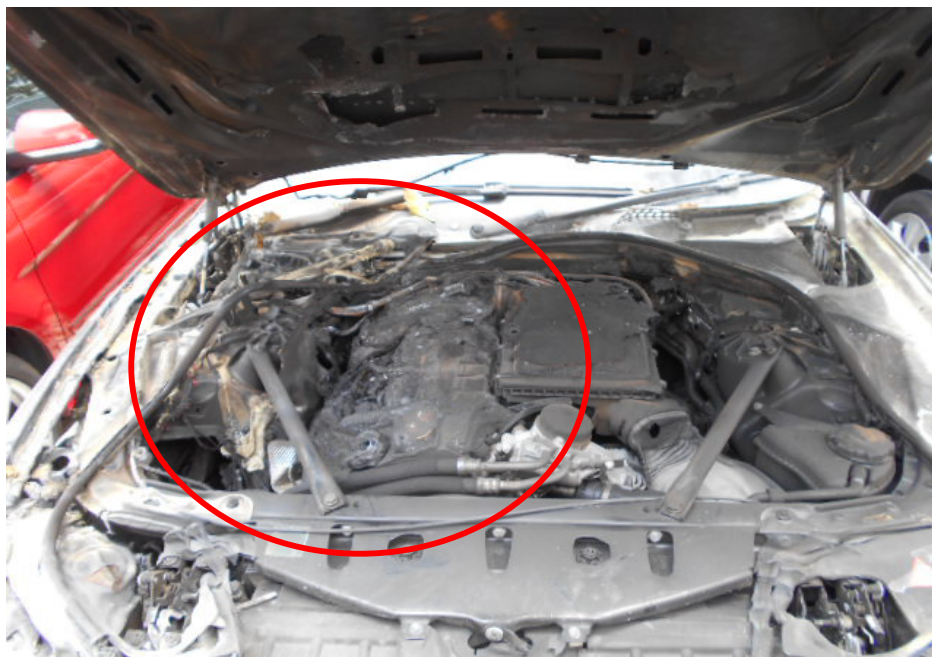
Photo 3 shows the engine compartment of the Insured Vehicle at the time of my inspection. The fire damage was observed to have been more severe at the right side of the engine compartment (circled). The parts that were found to have been burnt and/or melted include the air intake manifold, engine top cover, air filter housing, various hoses and pipes amongst others.

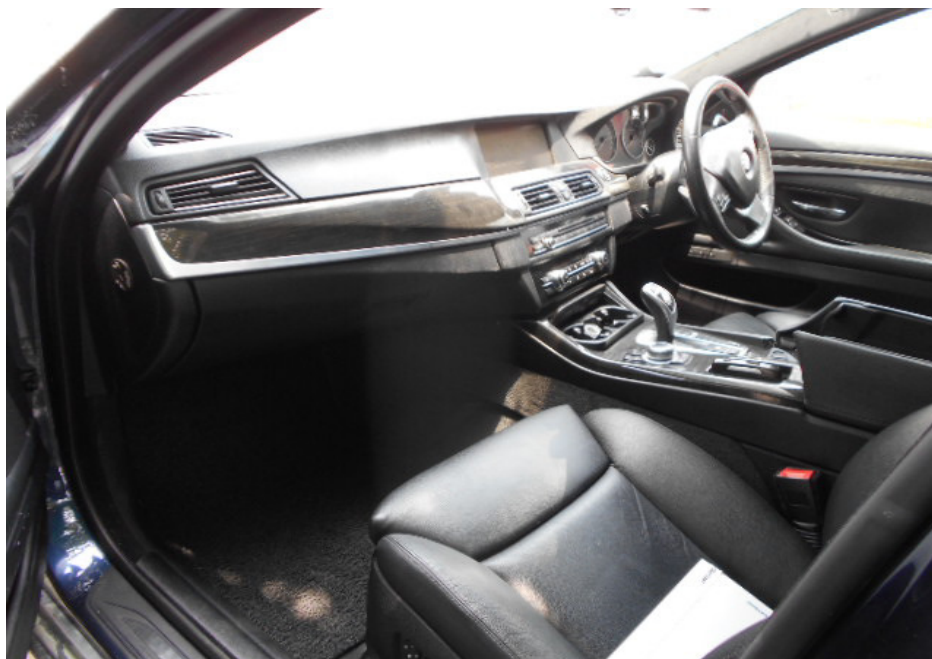
Photo 4 shows the interior compartment of the Insured Vehicle, which was not affected by the fire incident.

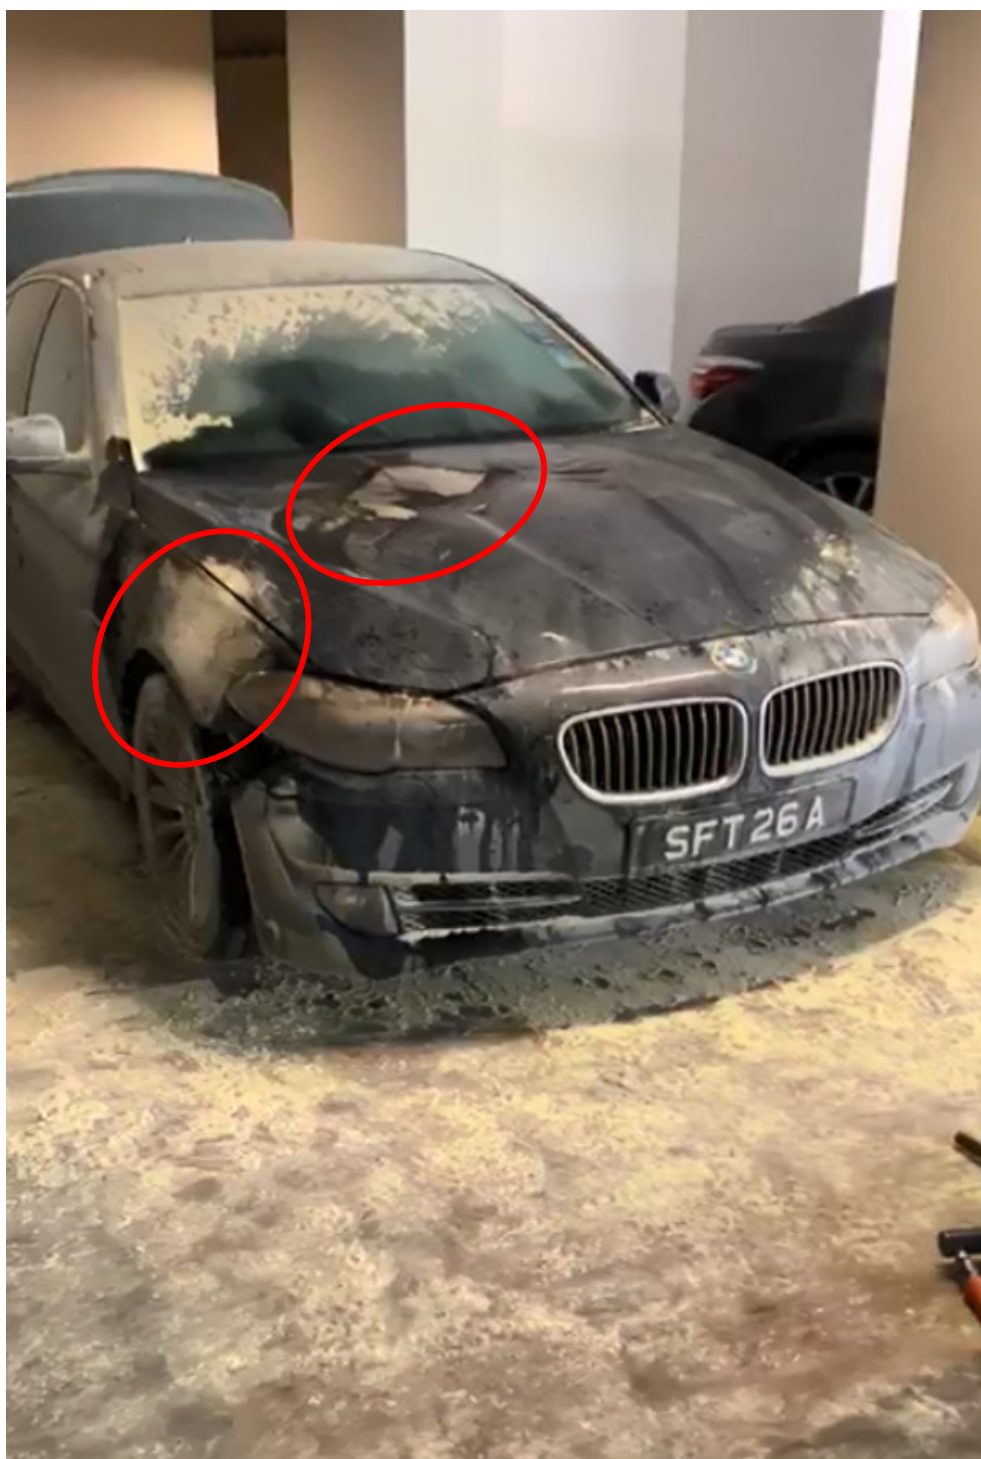
Photo 5 shows a screenshot taken from the video recording that was provided by Mr Ang. The damage of burnt nature to the Insured Vehicle immediately after the fire was put out had corresponded to the damage as seen by me during my inspection of the Insured Vehicle ie the frontal right body (circled) of the Insured Vehicle was exteriorly affected. Also, apart for the powder residue left behind by fire extinguishers, there appears to be no unusual foreign material(s) and/or object(s) found on the ground in the immediate area of where the Insured Vehicle was parked.

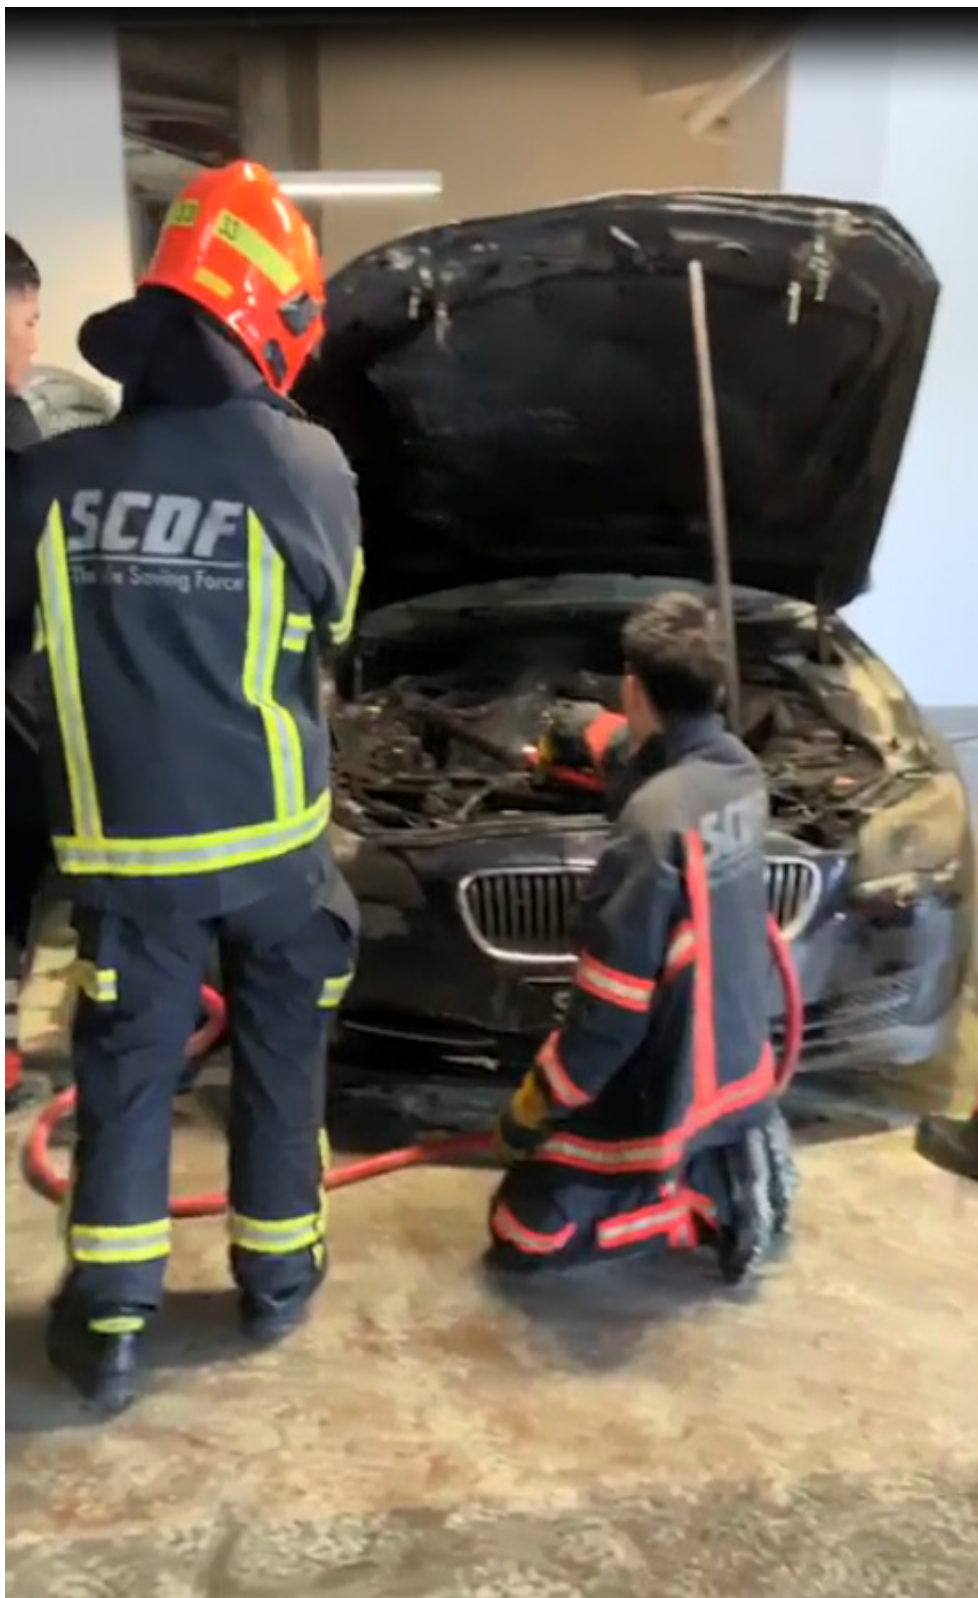
Photo 6 shows a screenshot taken from the video recording that was provided by Mr Ang, with SCDF officers examining the engine compartment of the Insured Vehicle.

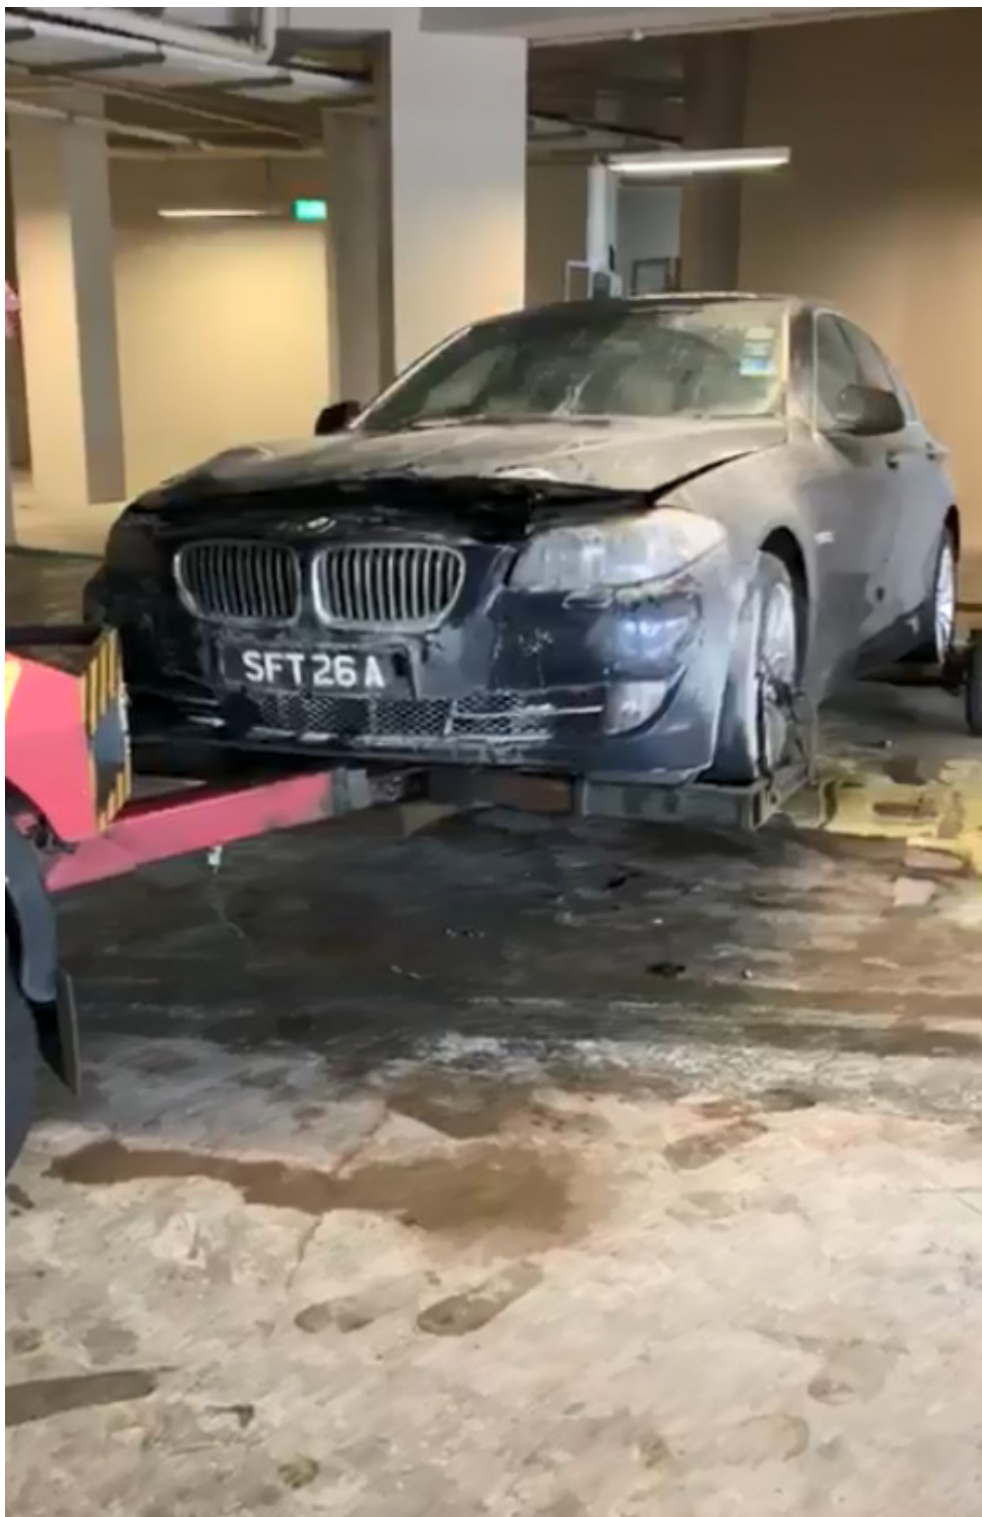
Photo 7 shows a screenshot taken from the video recording that was provided by Mr Ang, with the Insured Vehicle being towed area from the incident scene. In general, the observations gathered from my review of the video recordings that were taken by Mr Ang at the incident scene had corresponded to the description of events that he had related to me during our conversation on 11 April 2019.

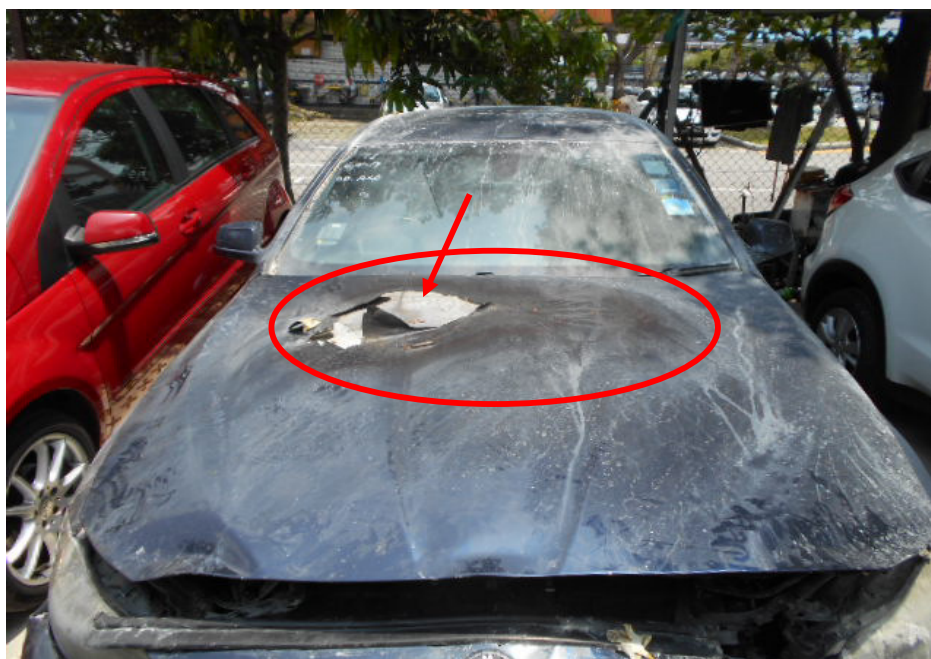
18. For this case, the origin of fire to the Insured Vehicle can be established basing on the burn pattern of the Insured Vehicle that was seen from the video recordings and at the time of my inspection. The paint around the rear centre area of the Insured Vehicle's front bonnet was found to be blackened. What is referred to as high heat intensity burned marks (whitish burn marks) were observed to have been formed at the rear right area of the front bonnet, within the blackened paint area. These whitish burn marks are a result of exposure to prolong heat intensity. Rust would normally start to develop around these areas soon after a fire as prolonged exposure to high heat intensity usually causes steel/metal material body parts to be exposed to natural environmental condition.

Photo 8 shows the whitish burn marks (arrowed) that were found on the rear right area of the Insured Vehicle's front bonnet, within an area (circled) of the front bonnet that was found with paint blackened. Such whitish burn marks are a result of exposure to prolong heat intensity. Following the characteristic of heat rising upwards, the fire to the Insured Vehicle can then be determined to have originated around the rear right area of the engine compartment.

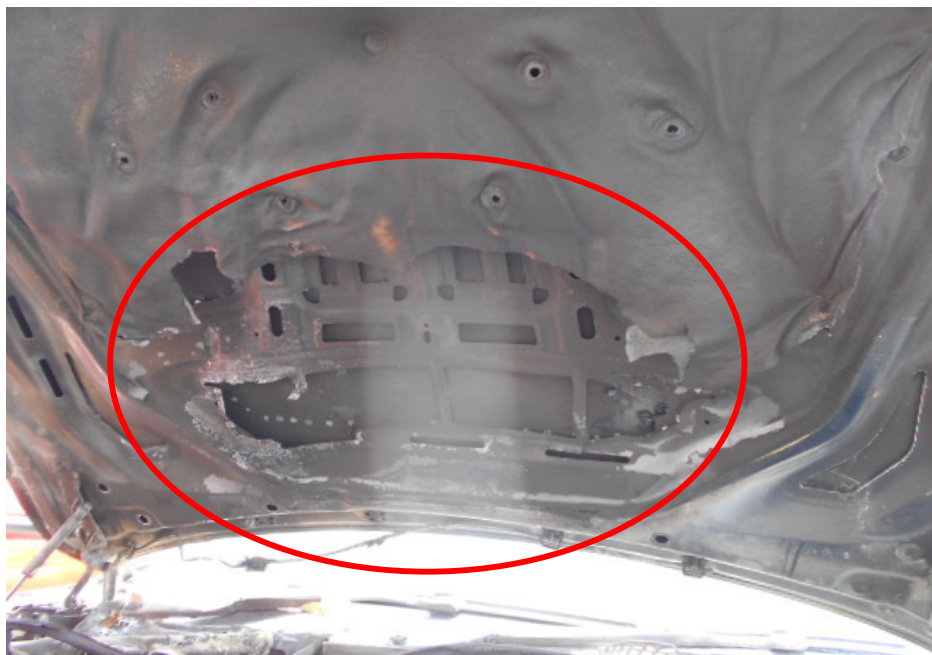
19. Correspondingly, the front bonnet insulator at the underside of the front bonnet at the rear centre area was found to have been melted whereas other areas of the front bonnet insulator were still intact. Following the characteristic of heat rising upwards, the burn pattern of the front bonnet, in particular the high heat intensity burned marks, would than indicate that the origin of fire was around the rear right area of the Insured Vehicle's engine compartment. This also follows the observation that the extent of fire damage was more severe at the right side of the engine compartment. See photo 8 - 10 below.

Photo 9 shows the underside of the Insured Vehicle's front bonnet. The front bonnet insulator at the rear centre area was melted whereas other areas was observed to be intact. The melted area of the front bonnet insulator was directly below the area where the paint at the top side of the front bonnet was blackened.

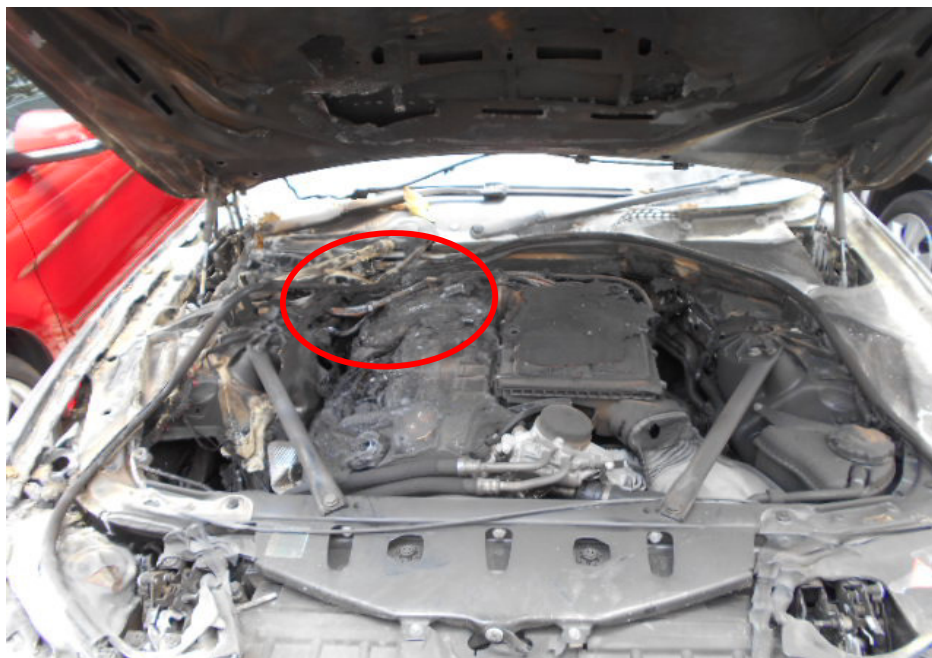
Photo 10 shows the engine compartment of the Insured Vehicle. Following the burn pattern, in particular the location where the high heat intensity burned marks were found on the front bonnet, and the characteristic of heat rising upwards, the fire to the Insured Vehicle had originated around the rear right side (circled) of the engine compartment. Correspondingly, the extent of fire damage was more severe at the right side of the engine compartment.

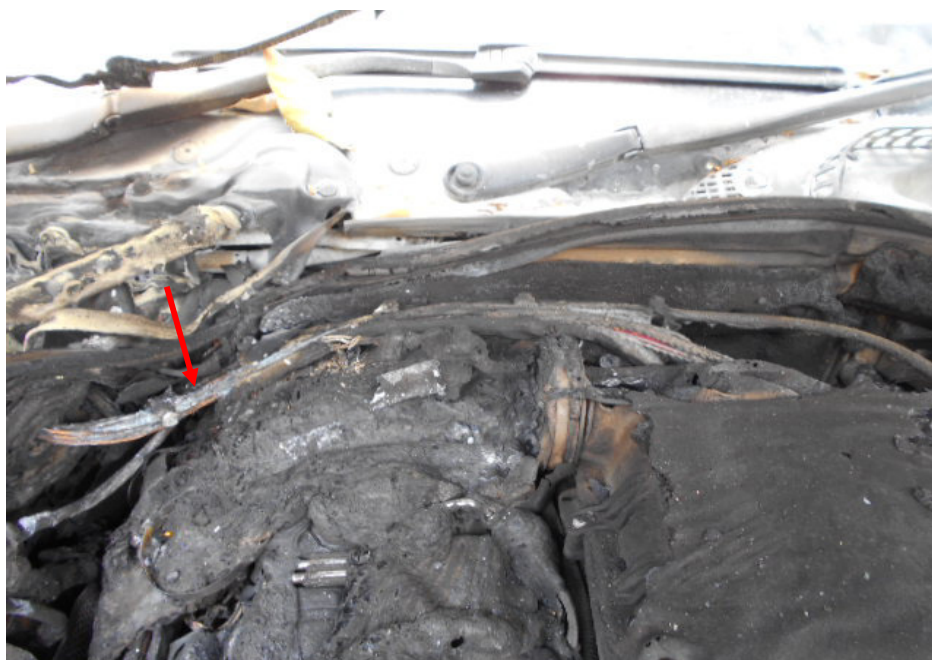
23. In fact, my examination of the rear right area of the engine compartment, during my inspection of the Insured Vehicle, revealed greenish residue on several stretches of original factory fitted wirings. The presence of greenish residue indicates internal heating of copper wires, a sign of an electrical short circuit occurring. The greenish residue is normally left behind from oxidation as a result of chemical reaction involving the copper wires. This physical evidence would then appear to suggest that the cause of fire to the Insured Vehicle was due to electrical in nature. See photo 11 & 12 below.

Photo 11 shows the stretch of wirings at the rear right area of the Insured Vehicle's engine compartment, which was where the fire had originated. Greenish residue was found along a stretch of original factory fitted wirings. The presence of such greenish residue suggests occurrence of an electrical short circuit.

25. Having investigated and technically analysed the damages of burnt nature to the Insured Vehicle, I am of the view that the cause of fire to the Insured Vehicle was of electrical in nature. For this particular case, the fire had originated along the wirings inside the engine compartment, at the rear right area of the engine compartment. The wirings were original factory fitted wirings.

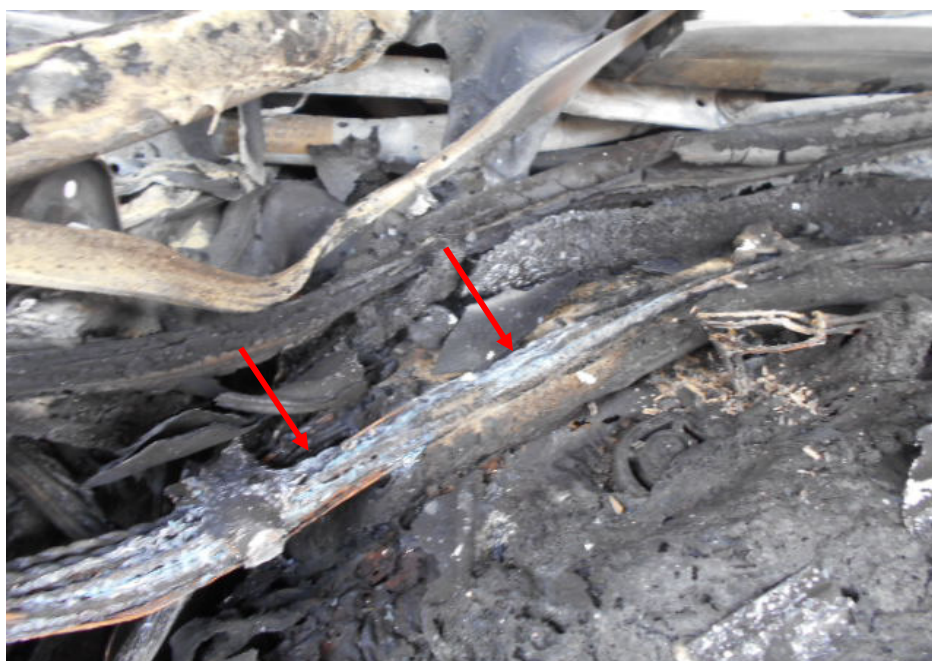
Photo 12 shows a closer view of the greenish residue (arrowed) that were found on the original factory fitted wirings at the rear right area of the Insured Vehicle's engine compartment. The presence of greenish residue suggests occurrence of an electrical short circuit. This physical evidence would then appear to suggest that the cause of fire to the Insured Vehicle was due to electrical in nature.
