Your Ref: DMPC1900096H  
Our Ref : CS/ICS19006376/D

14 April 2019

**TECHNICAL INVESTIGATION REPORT OF FIRE INCIDENT INVOLVING THE  
INSURED VEHICLE SLD 5378P ON 06 APRIL 2019**

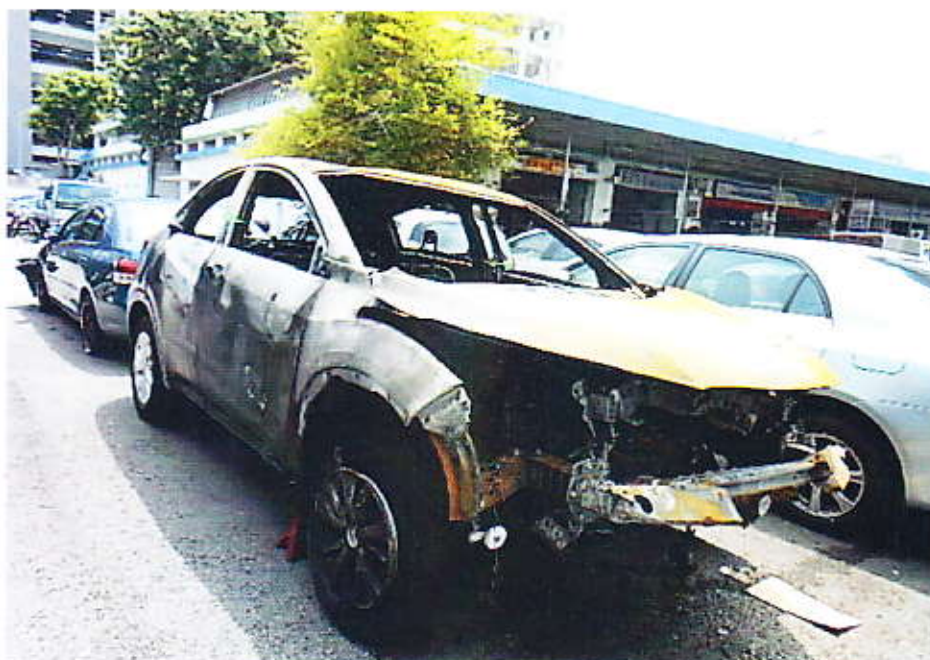
**Photo 1** shows a general view of the front right body of the Insured Vehicle at the time of inspection. The Insured Vehicle was observed to have sustained extensive fire damage. The body panels at the front body and the undercarriage components at the front underside were all found to have been burnt to char.

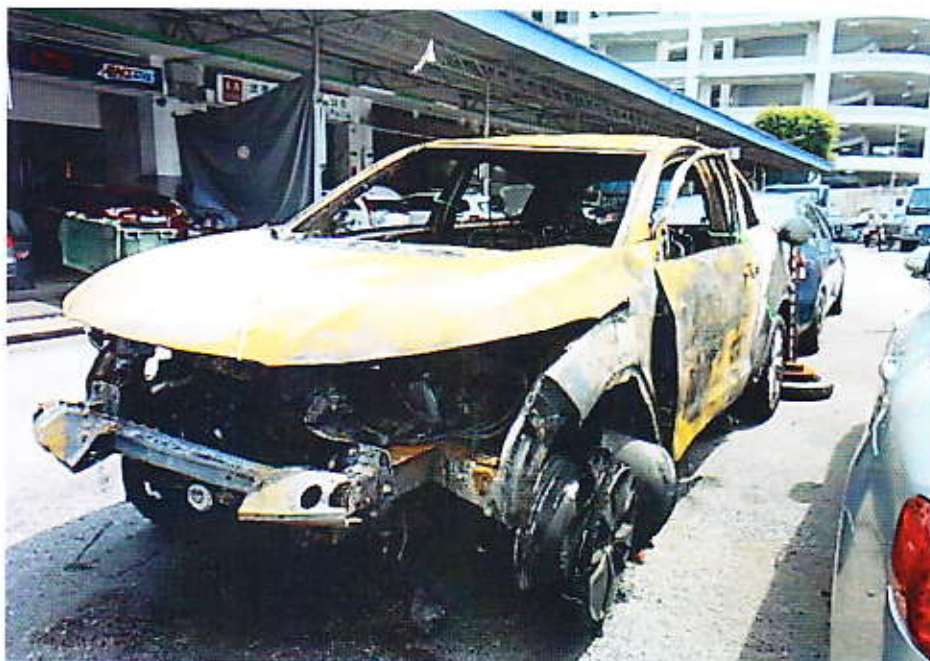
**Photo 2** shows a general view of the front left body of the Insured Vehicle at the time of inspection. The Insured Vehicle was observed to have sustained extensive fire damage. The body panels at the front body like the front bonnet, front fenders, front door amongst others were all burnt to bare metal state.

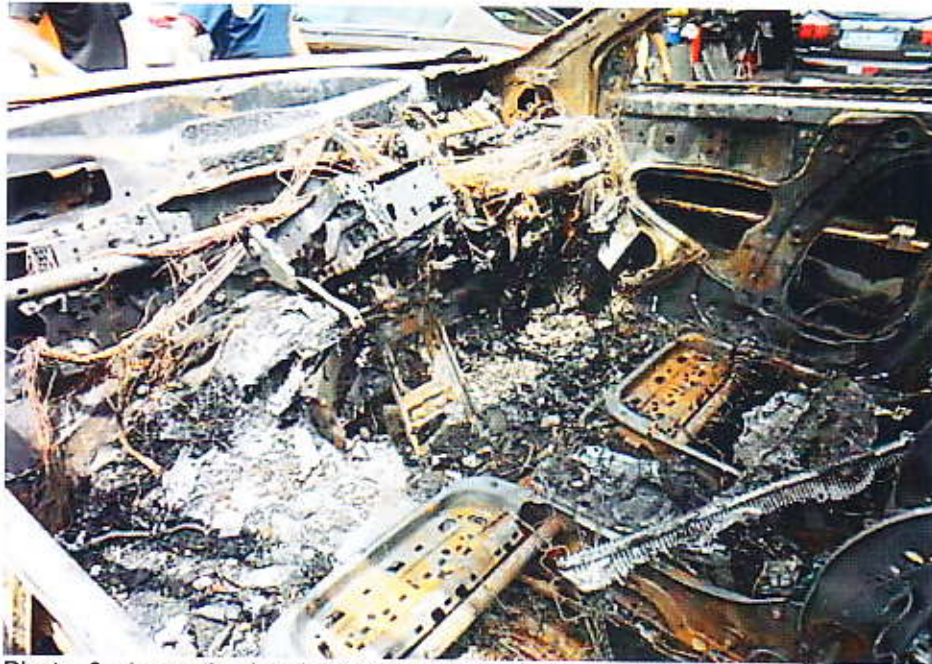
**Photo 3** shows the interior compartment of the Insured Vehicle. All the parts inside the interior compartment were found to be extensively burnt. Its front seats, rear seats, roof upholstery, carpet and various trims were all burnt and/or melted, leaving charred skeletal remains.

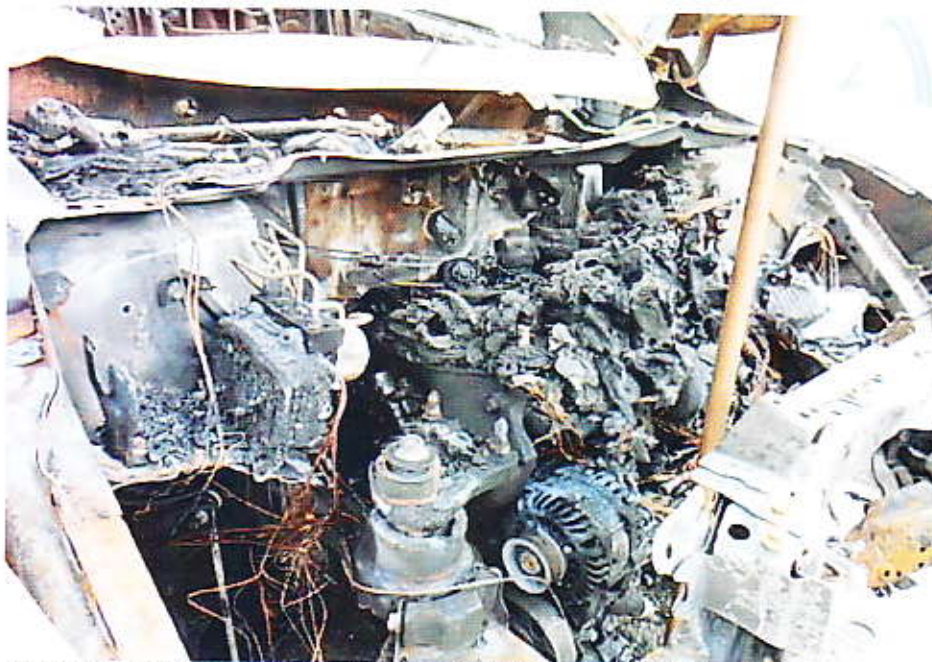
**Photo 4** shows the engine compartment of the Insured Vehicle. The various parts and components within the engine compartment of the Insured Vehicle were all extensively affected by the fire. This had included the engine and transmission of the Insured Vehicle.

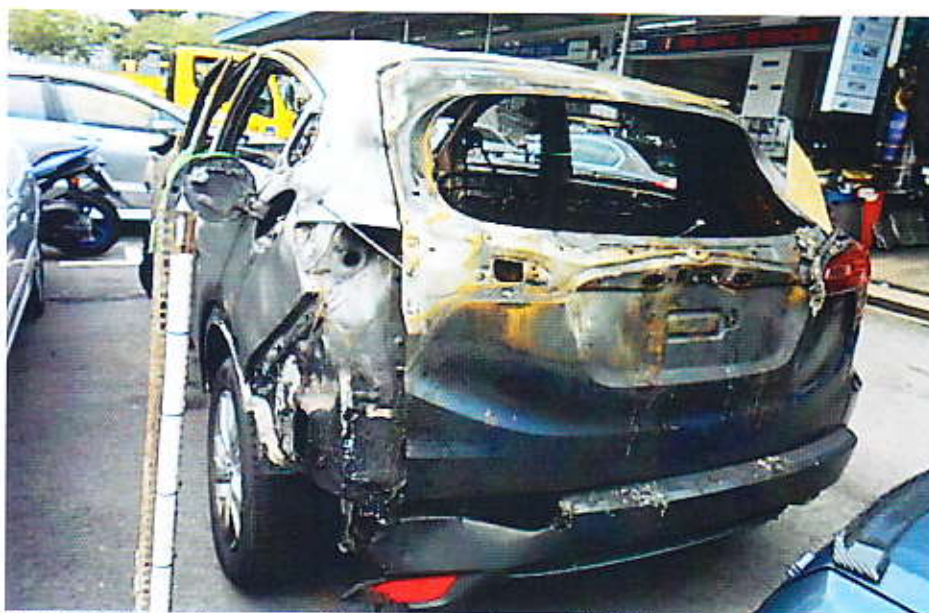
**Photo 5** shows the rear left body of the Insured Vehicle. Comparing the overall extent of fire damage like the rear tyres vs the front tyres, condition of rear body panels vs front body panels etc, it would appear that the front body of the Insured Vehicle was more severely affected than its rear portion.

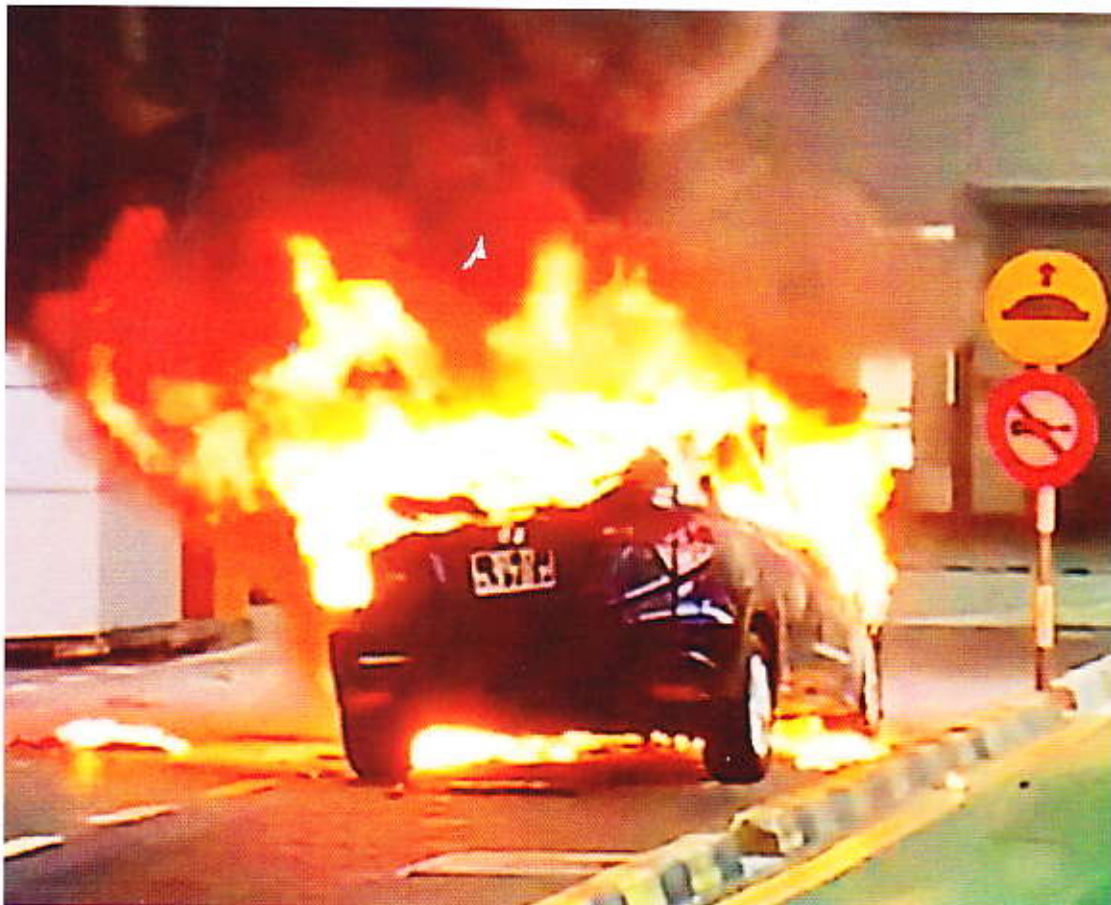
Photo 7 shows screenshot taken from the video recording that was provided by Mr Jumat. The Insured Vehicle could be seen with flames engulfing its front body and interior compartment.

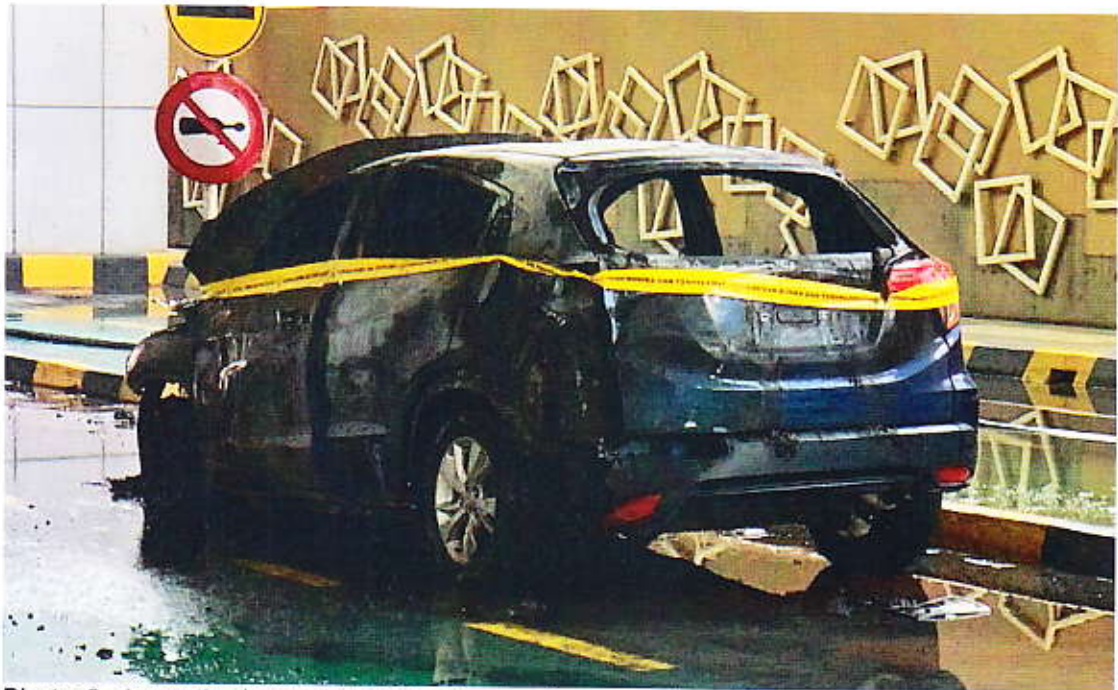
Photo 8 shows the Insured Vehicle after the fire was extinguished. Generally, the information that I was able to gather from the video recording and photographs provided by Mr Jumat had corresponded to the information that he had related to me during our telephone conversation on 11 April 2019.

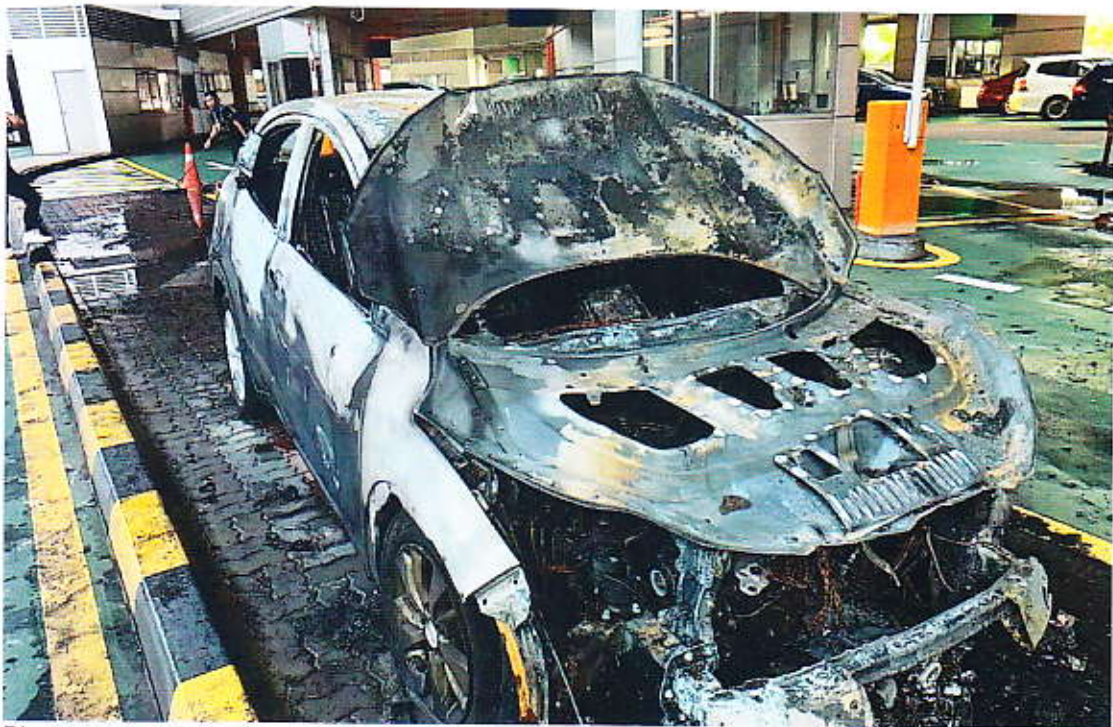
Photo 9 shows the Insured Vehicle after the fire was extinguished. The extent of fire damage was similar to what I observed when I inspected the Insured Vehicle. The background seen from the photographs had also corresponded to the incident occurring at Malaysia custom.

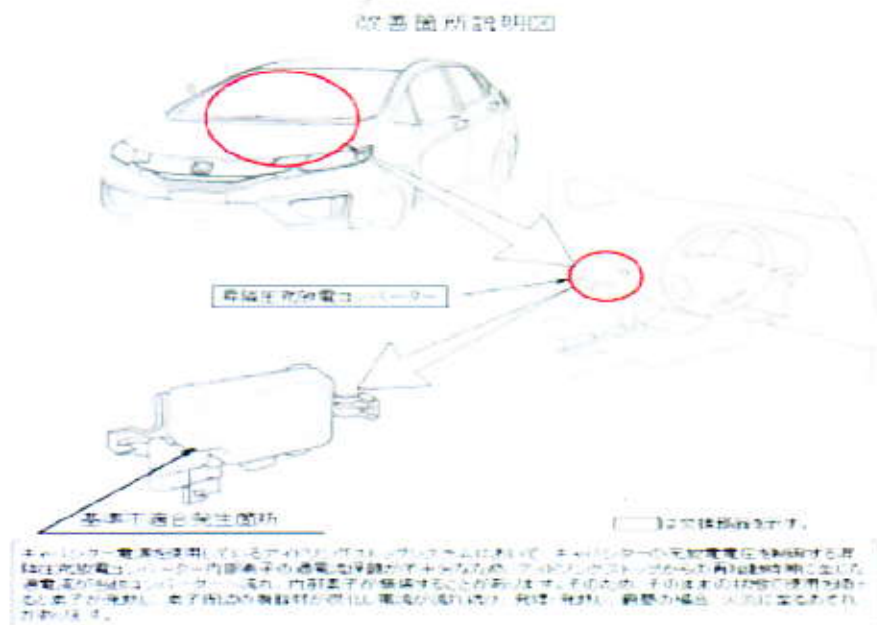
**Screenshot** shows the write up that I was able to gather pertaining to the manufacturer recall campaign of similar make and model vehicles as the Insured Vehicle.

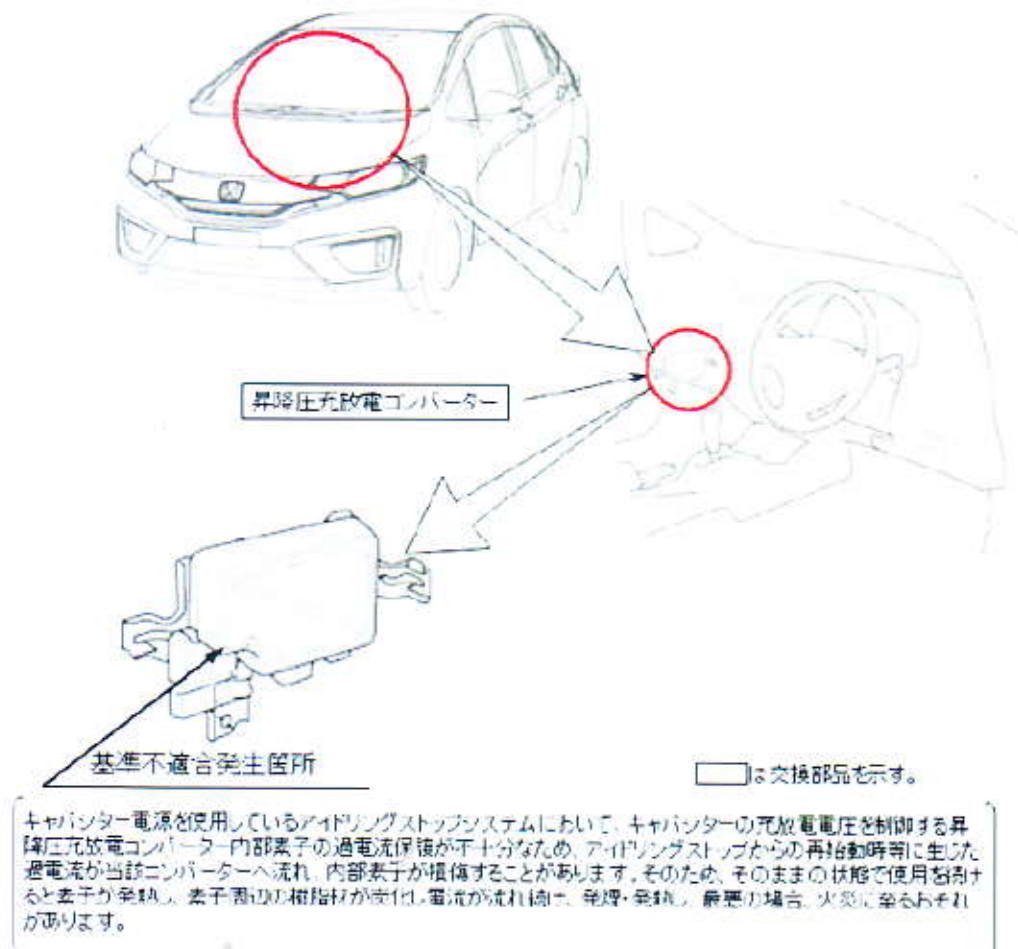
18. My further research and checks on the capacitor that was mentioned in the recall details of the LTA search result revealed that this capacitor is a component that is fitted onto the inner side of the Insured Vehicle's front left "A" pillar, towards the left and below the glove compartment of the Insured Vehicle. I note that this location is at or near the location where Mr Jumat had saw flames. Basing on the information gathered pertaining to the capacitor; and given that no rectification to address the capacitor issue was carried out to the Insured Vehicle, it can be determined that the fire to the Insured Vehicle is related to the purpose of the manufacturer recall campaign that involved the Insured Vehicle. See search result below gathered from my further research and checks.

Screenshot shows a zoom in view of the schematic diagram pertaining to the manufacturer recall campaign of similar make and model vehicles as the Insured Vehicle. The component, circled in the schematic diagram, is the capacitor that was mentioned in the recall details of the LTA search result. The location where this component was fitted was also at or near the location where Mr Jumat had saw flames.
