Your Ref: DMPC1900096H
Our Ref : CS/ICS19006376/D

14 April 2019

**TECHNICAL INVESTIGATION REPORT OF FIRE INCIDENT INVOLVING THE
INSURED VEHICLE SLD 5378P ON 06 APRIL 2019**

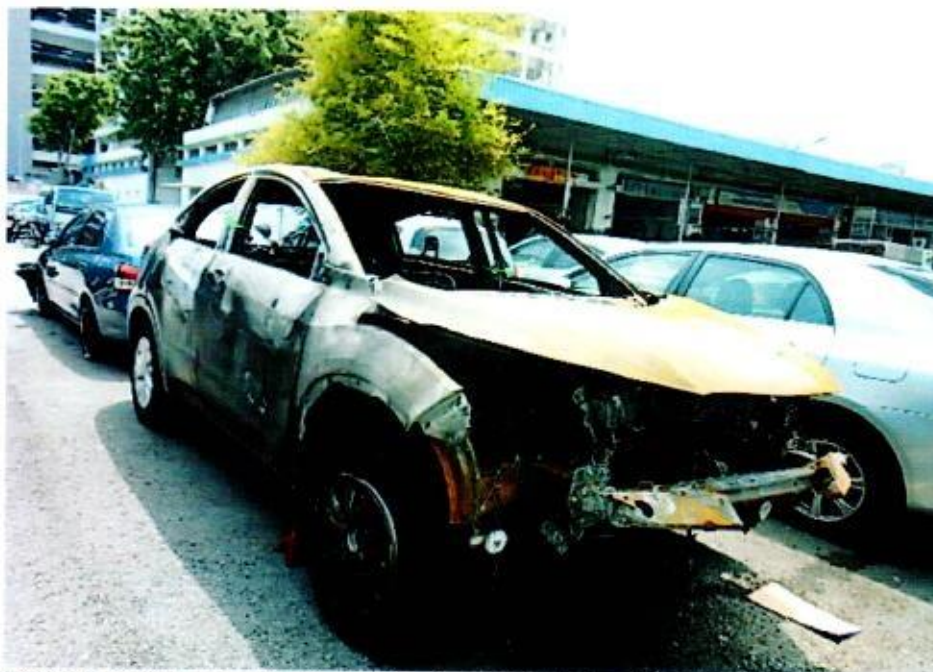
Photo 1 shows a general view of the front right body of the Insured Vehicle at the time of inspection. The Insured Vehicle was observed to have sustained extensive fire damage. The body panels at the front body and the undercarriage components at the front underside were all found to have been burnt to char.

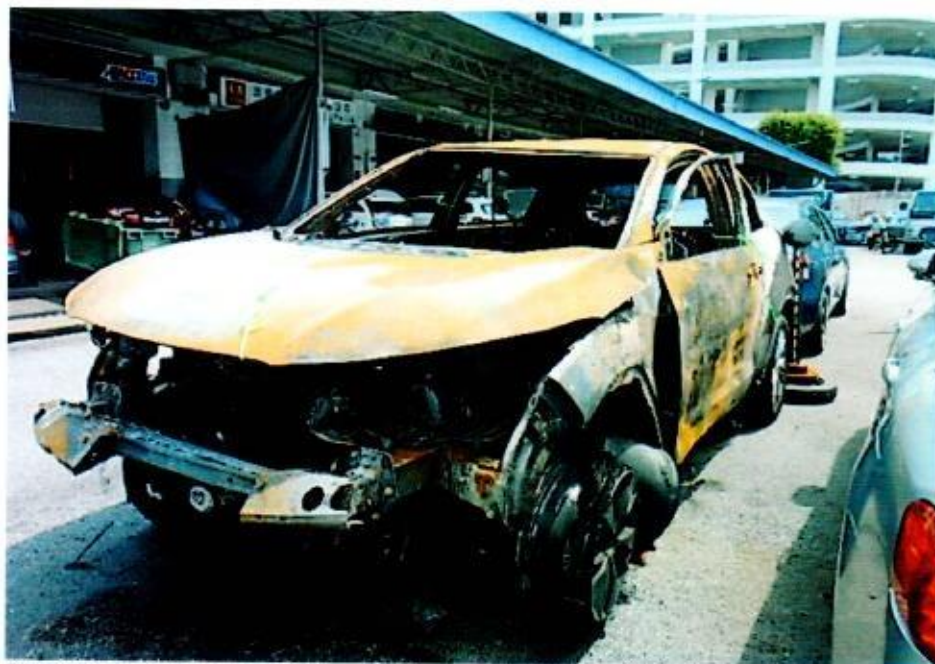
Photo 2 shows a general view of the front left body of the Insured Vehicle at the time of inspection. The Insured Vehicle was observed to have sustained extensive fire damage. The body panels at the front body like the front bonnet, front fenders, front door amongst others were all burnt to bare metal state.

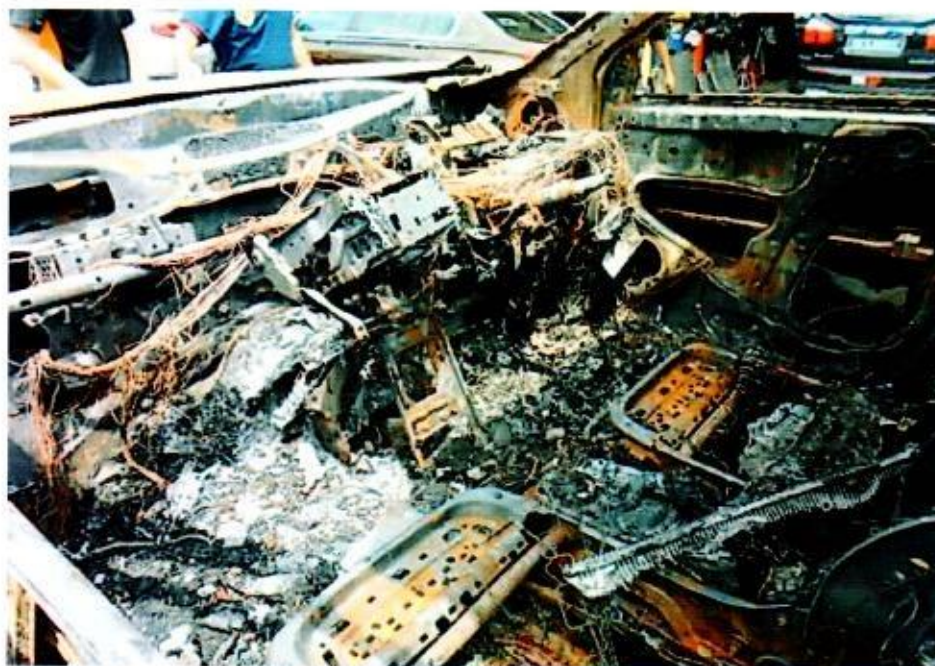
Photo 3 shows the interior compartment of the Insured Vehicle. All the parts inside the interior compartment were found to be extensively burnt. Its front seats, rear seats, roof upholstery, carpet and various trims were all burnt and/or melted, leaving charred skeletal remains.

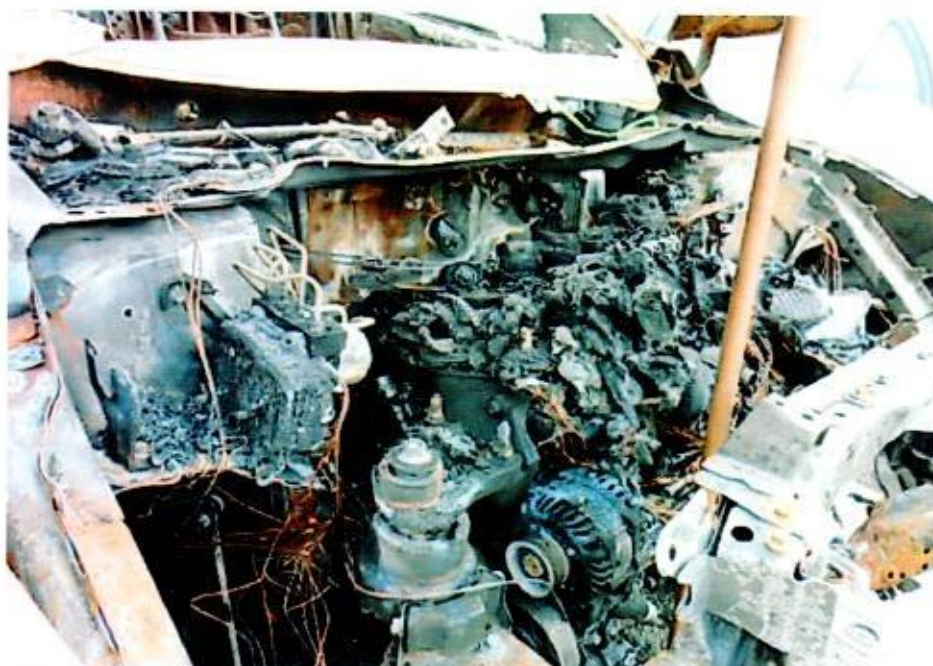
Photo 4 shows the engine compartment of the Insured Vehicle. The various parts and components within the engine compartment of the Insured Vehicle were all extensively affected by the fire. This had included the engine and transmission of the Insured Vehicle.

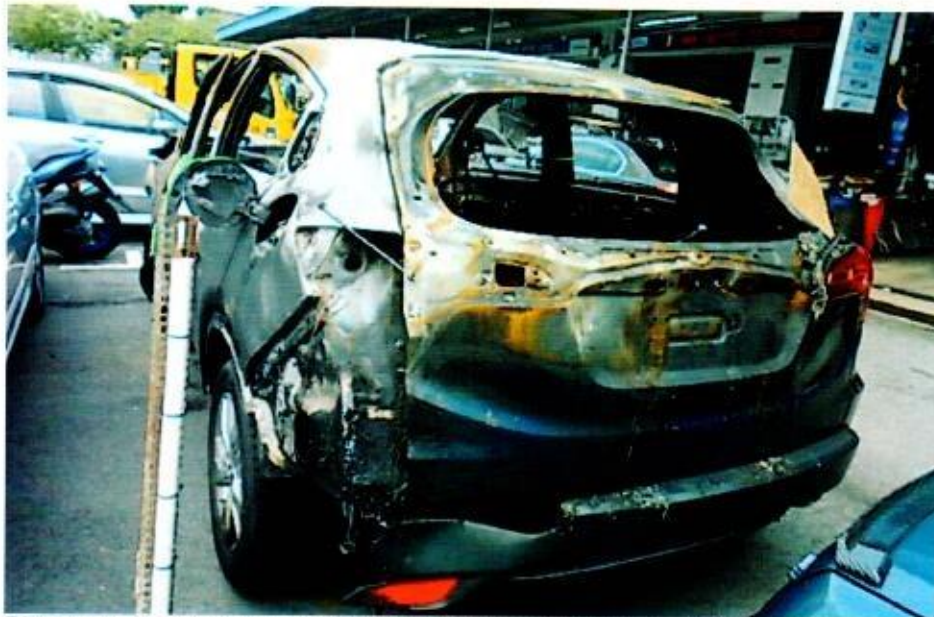
Photo 5 shows the rear left body of the Insured Vehicle. Comparing the overall extent of fire damage like the rear tyres vs the front tyres, condition of rear body panels vs front body panels etc, it would appear that the front body of the Insured Vehicle was more severely affected than its rear portion.

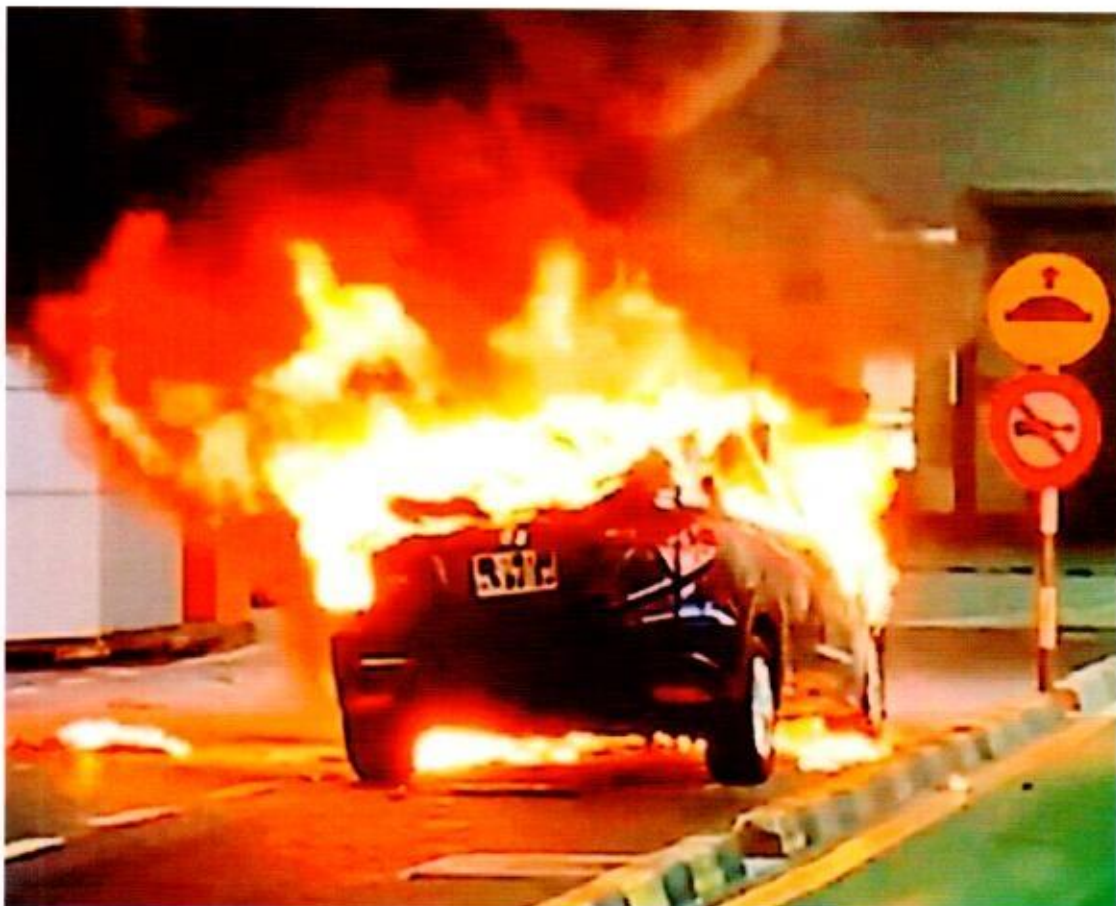
Photo 7 shows screenshot taken from the video recording that was provided by Mr Jumat. The Insured Vehicle could be seen with flames engulfing its front body and interior compartment.

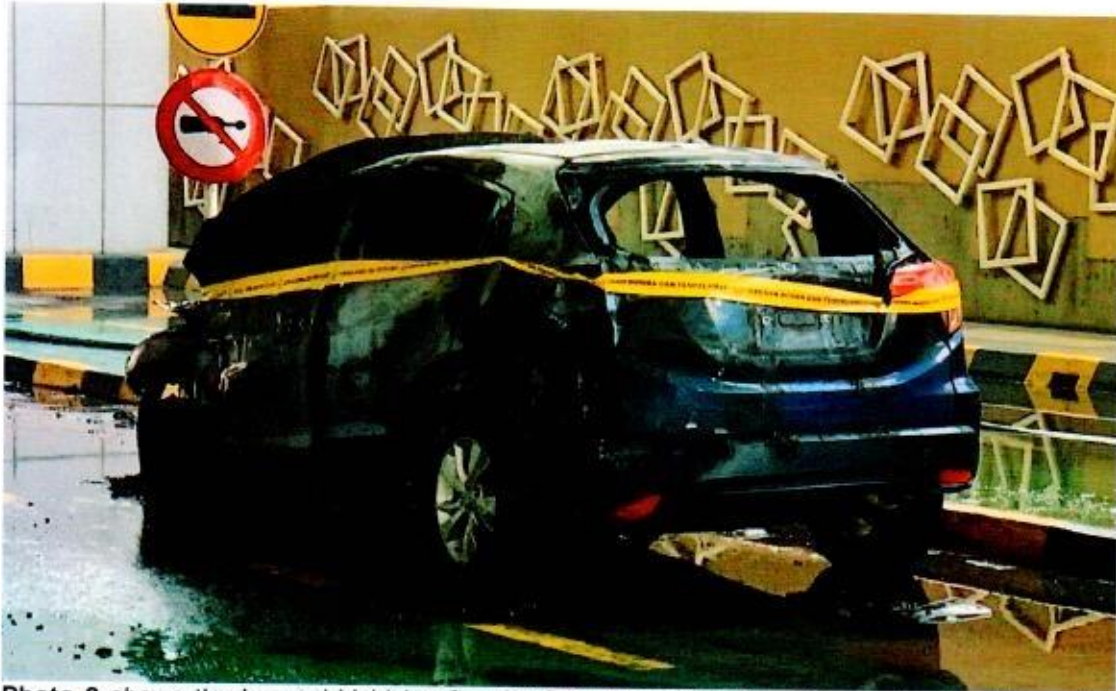
Photo 8 shows the Insured Vehicle after the fire was extinguished. Generally, the information that I was able to gather from the video recording and photographs provided by Mr Jumat had corresponded to the information that he had related to me during our telephone conversation on 11 April 2019.

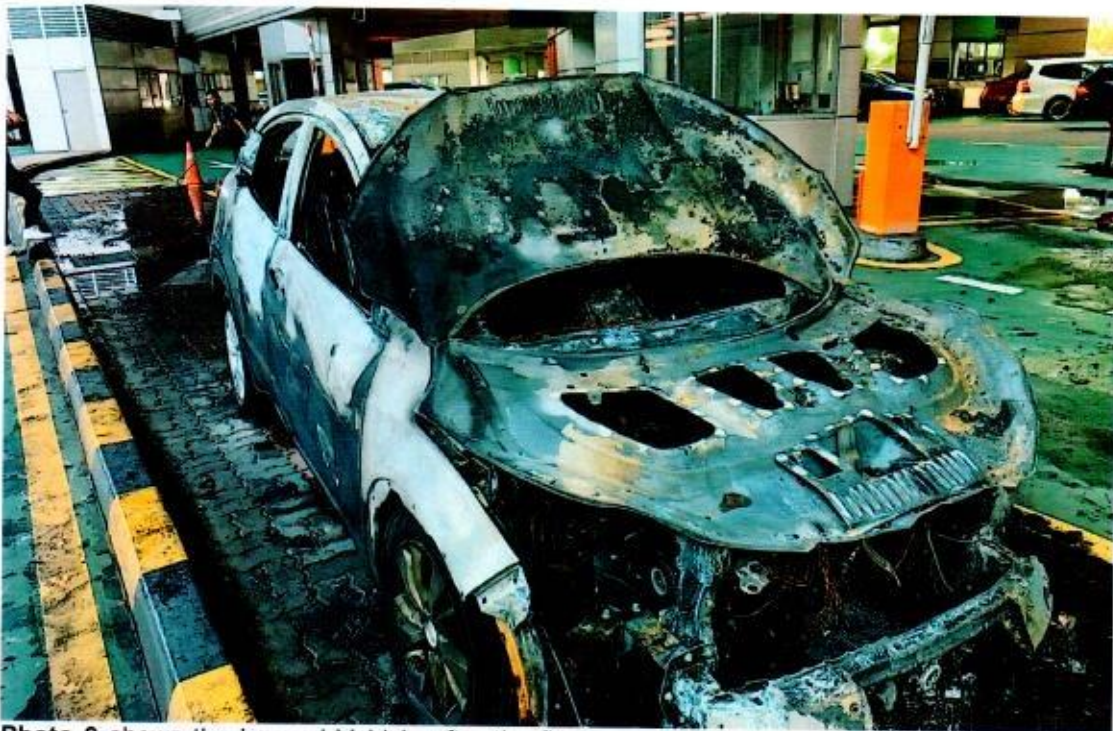
Photo 9 shows the Insured Vehicle after the fire was extinguished. The extent of fire damage was similar to what I observed when I inspected the Insured Vehicle. The background seen from the photographs had also corresponded to the incident occurring at Malaysia custom.

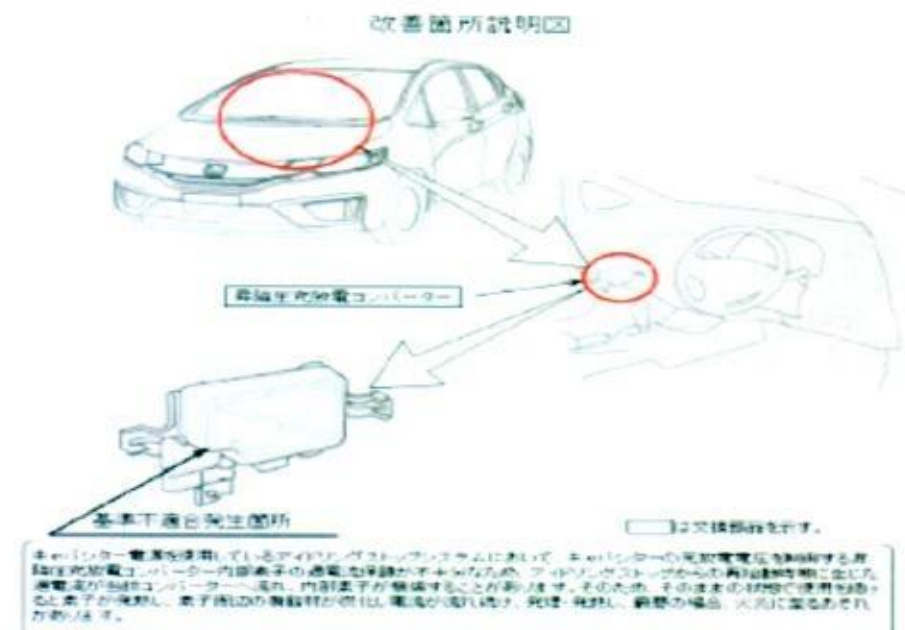
Honda recalled 160,000 Fit subcompact and Vezel sport-utility vehicles in Japan because of defective power steering and a part that controls the electric current in the vehicles. The recall does not affect any Honda models sold abroad.

There have been no injuries related to the problems. Six fires were reported related to the faulty part that controls electricity for capacitors, and two minor accidents were reported to the defect in the steering, according to Honda Motor Co.

Screenshot shows the write up that I was able to gather pertaining to the manufacturer recall campaign of similar make and model vehicles as the Insured Vehicle.

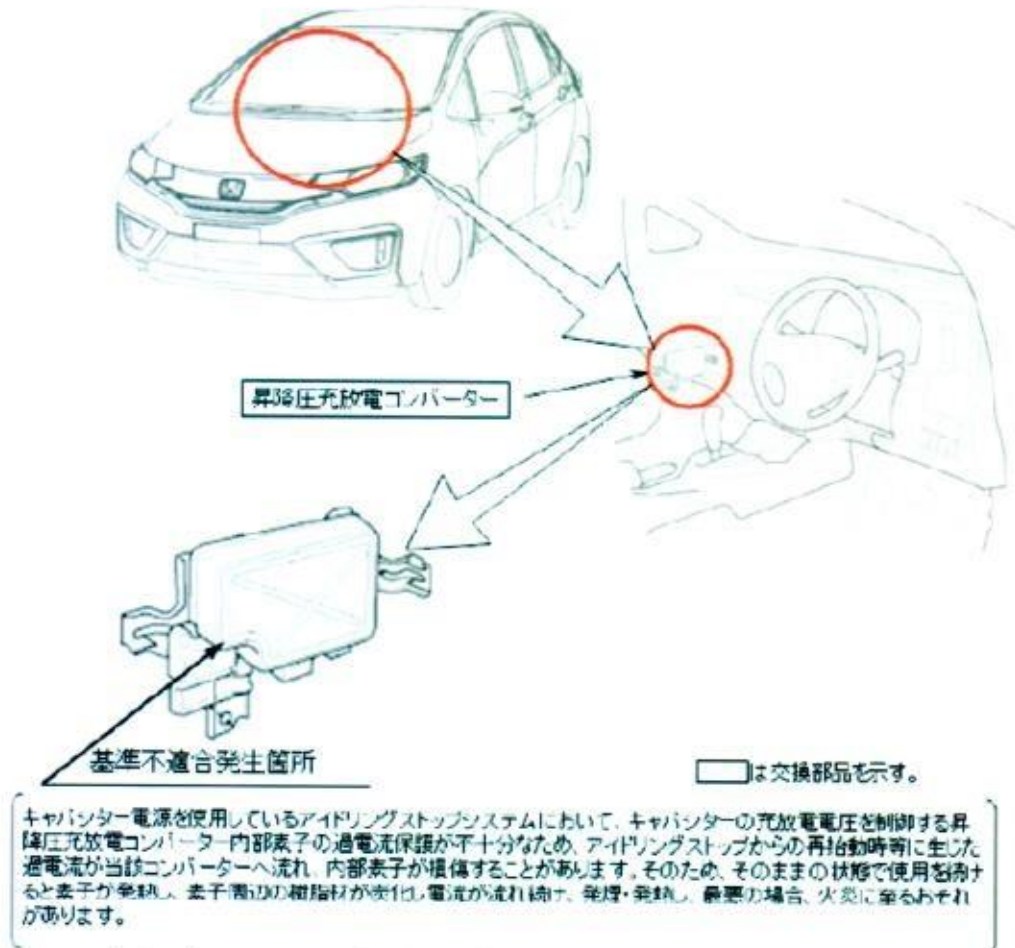
改善箇所説明図

18. My further research and checks on the capacitor that was mentioned in the recall details of the LTA search result revealed that this capacitor is a component that is fitted onto the inner side of the Insured Vehicle's front left "A" pillar, towards the left and below the glove compartment of the Insured Vehicle. I note that this location is at or near the location where Mr Jumat had saw flames. Basing on the information gathered pertaining to the capacitor; and given that no rectification to address the capacitor issue was carried out to the Insured Vehicle, it can be determined that the fire to the Insured Vehicle is related to the purpose of the manufacturer recall campaign that involved the Insured Vehicle. See search result below gathered from my further research and checks.

Screenshot shows a zoom in view of the schematic diagram pertaining to the manufacturer recall campaign of similar make and model vehicles as the Insured Vehicle. The component, circled in the schematic diagram, is the capacitor that was mentioned in the recall details of the LTA search result. The location where this component was fitted was also at or near the location where Mr Jumat had saw flames.

Affected vehicles are equipped with a power capacitor that enables engine start/stop during idling. Due to insufficient overcurrent protection in the bi-directional buck-boost convertor (BBC) that controls voltage charge/discharge in the power capacitor, the BBC could become damaged during overcurrent occurrences. If vehicle operation continues after the buck-boost convertor (BBC) is damaged, heat generated in the BBC could result in smoke and in the worst case scenarios, a fire may occur.
