Your Ref: DMPC1900096H  
Our Ref : CS/ICS19006376/D

14 April 2019

**TECHNICAL INVESTIGATION REPORT OF FIRE INCIDENT INVOLVING THE  
INSURED VEHICLE SLD 5378P ON 06 APRIL 2019**

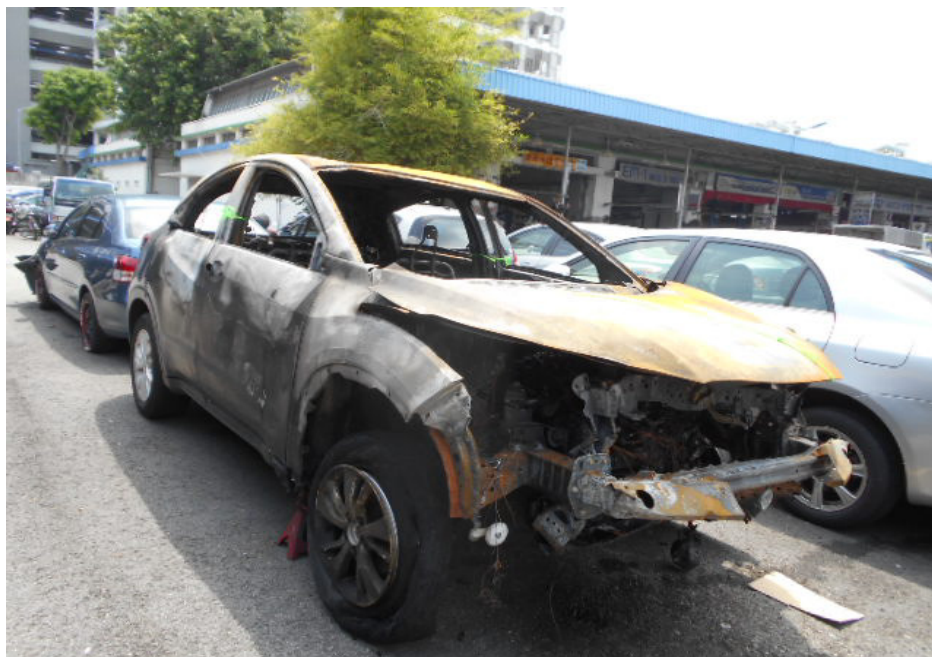
**Photo 1** shows a general view of the front right body of the Insured Vehicle at the time of inspection. The Insured Vehicle was observed to have sustained extensive fire damage. The body panels at the front body and the undercarriage components at the front underside were all found to have been burnt to char.

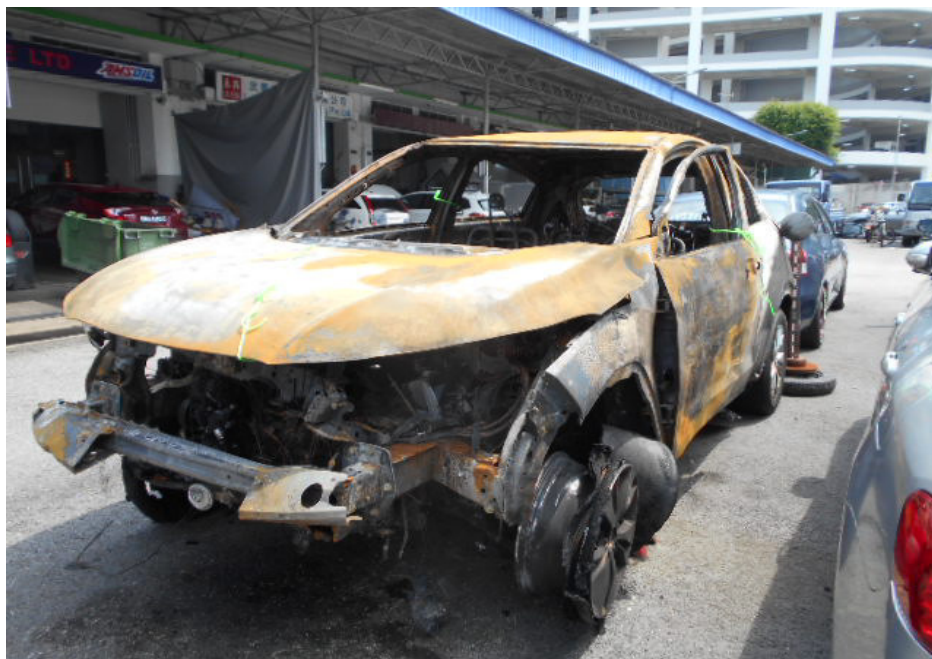
**Photo 2** shows a general view of the front left body of the Insured Vehicle at the time of inspection. The Insured Vehicle was observed to have sustained extensive fire damage. The body panels at the front body like the front bonnet, front fenders, front door amongst others were all burnt to bare metal state.

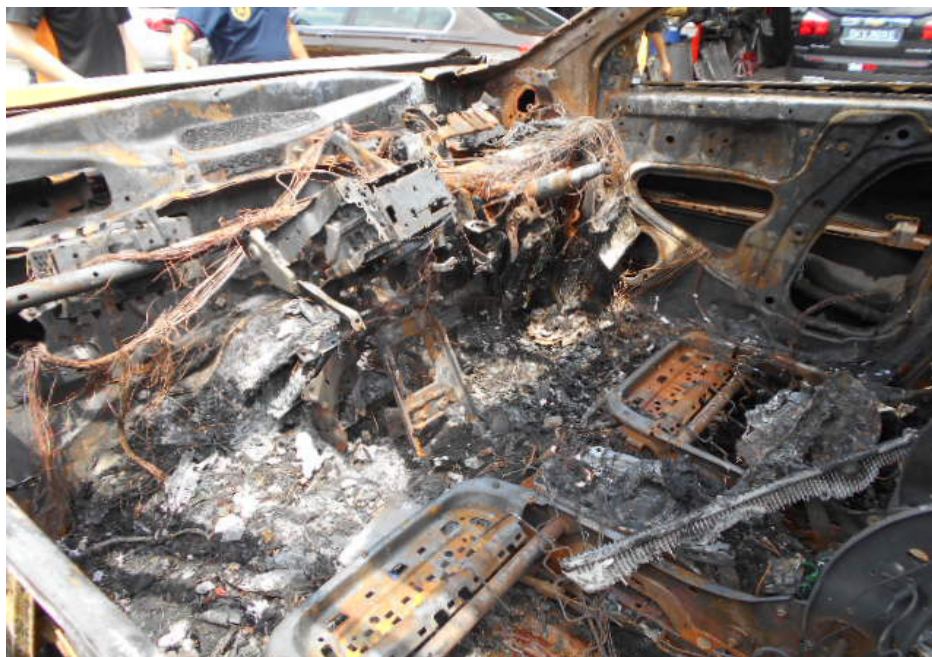
**Photo 3** shows the interior compartment of the Insured Vehicle. All the parts inside the interior compartment were found to be extensively burnt. Its front seats, rear seats, roof upholstery, carpet and various trims were all burnt and/or melted, leaving charred skeletal remains.

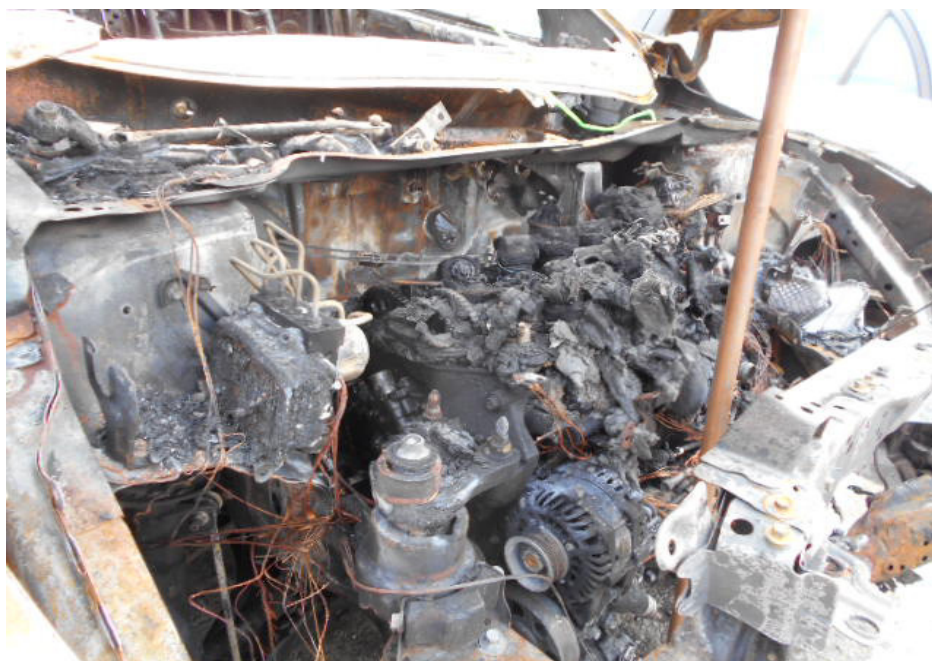
**Photo 4** shows the engine compartment of the Insured Vehicle. The various parts and components within the engine compartment of the Insured Vehicle were all extensively affected by the fire. This had included the engine and transmission of the Insured Vehicle.

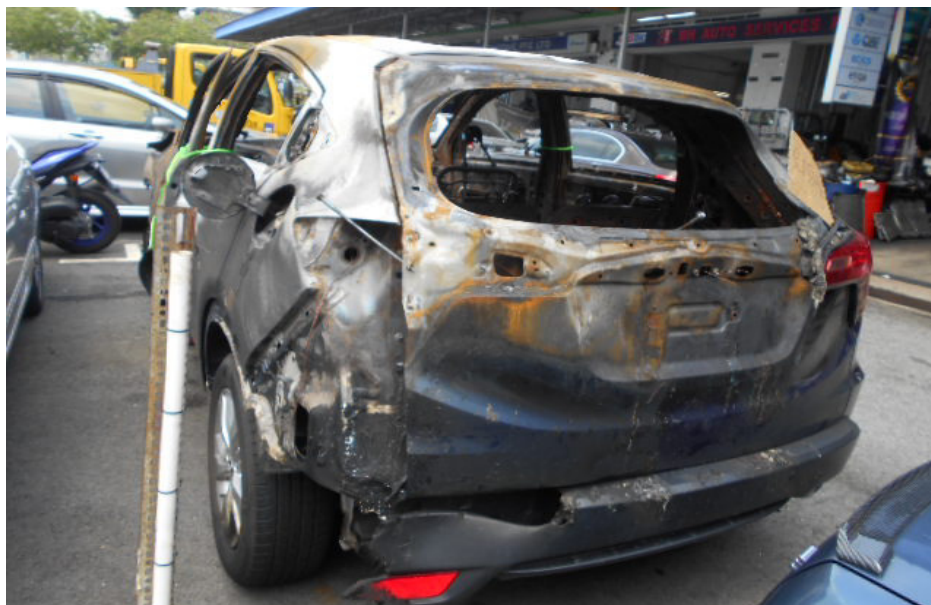
**Photo 5** shows the rear left body of the Insured Vehicle. Comparing the overall extent of fire damage like the rear tyres vs the front tyres, condition of rear body panels vs front body panels etc, it would appear that the front body of the Insured Vehicle was more severely affected than its rear portion.

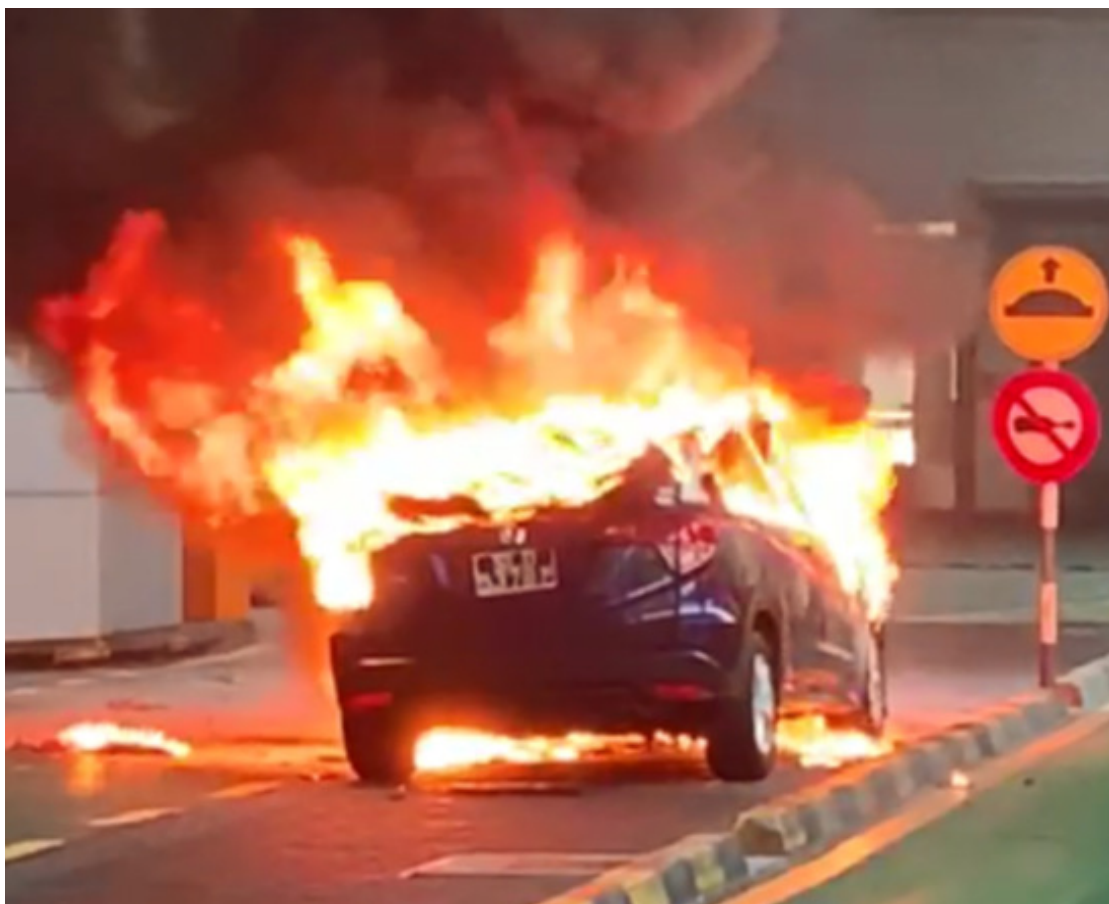
**Photo 7** shows screenshot taken from the video recording that was provided by Mr Jumat. The Insured Vehicle could be seen with flames engulfing its front body and interior compartment.

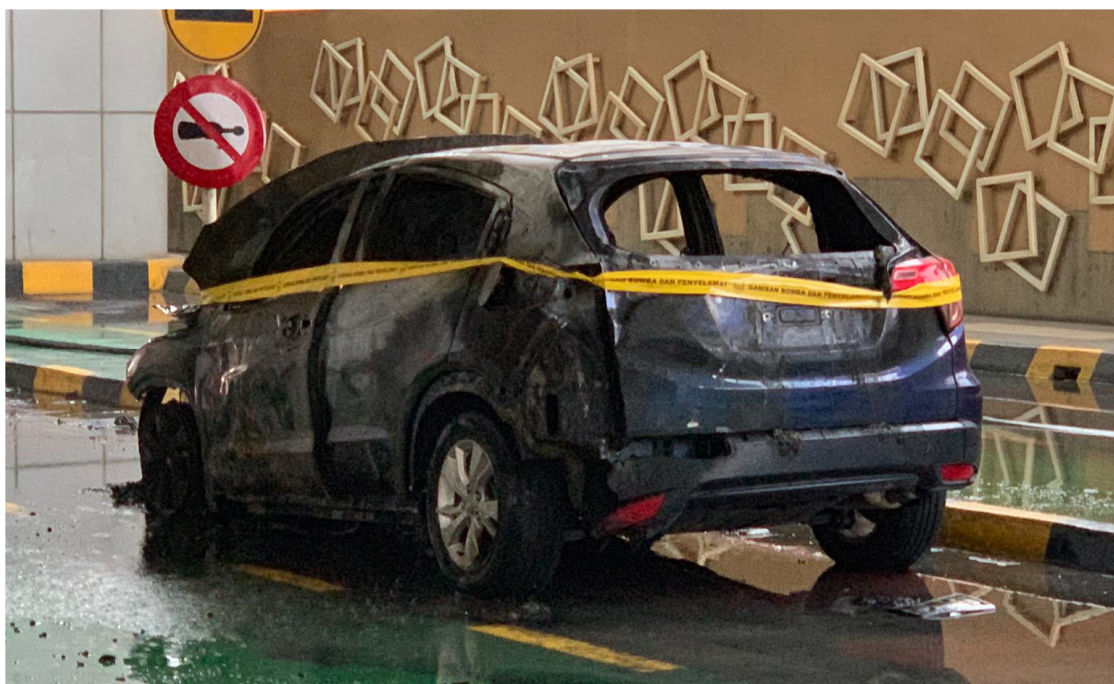
**Photo 8** shows the Insured Vehicle after the fire was extinguished. Generally, the information that I was able to gather from the video recording and photographs provided by Mr Jumat had corresponded to the information that he had related to me during our telephone conversation on 11 April 2019.

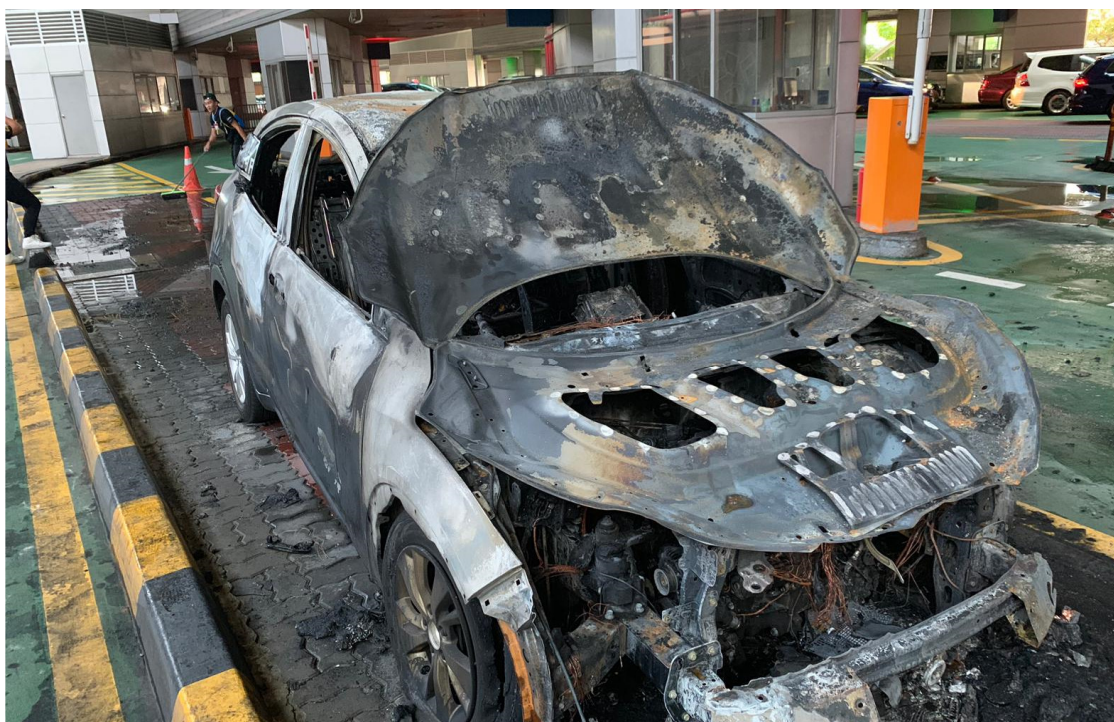
**Photo 9** shows the Insured Vehicle after the fire was extinguished. The extent of fire damage was similar to what I observed when I inspected the Insured Vehicle. The background seen from the photographs had also corresponded to the incident occurring at Malaysia custom.

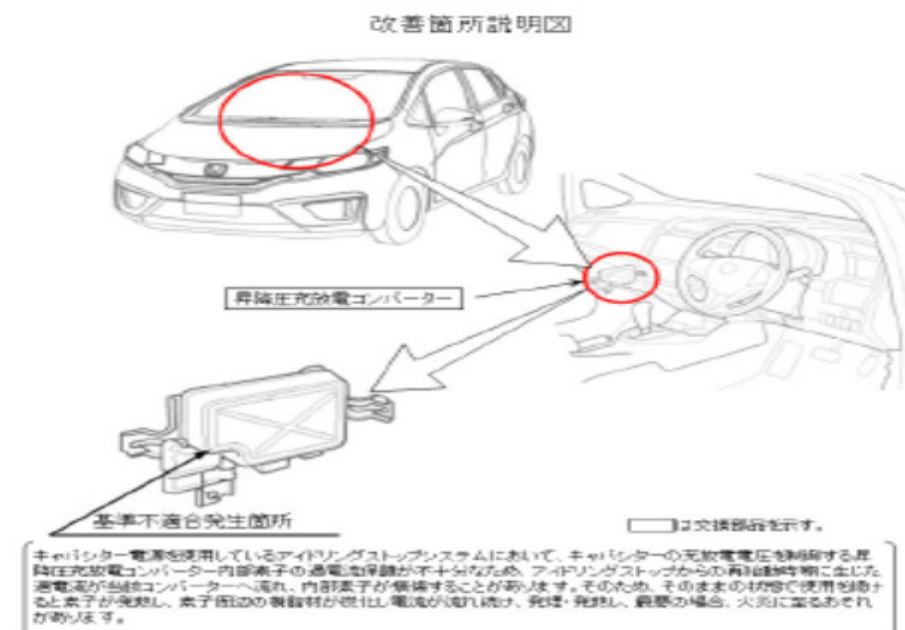
Screenshot shows the write up that I was able to gather pertaining to the manufacturer recall campaign of similar make and model vehicles as the Insured Vehicle.

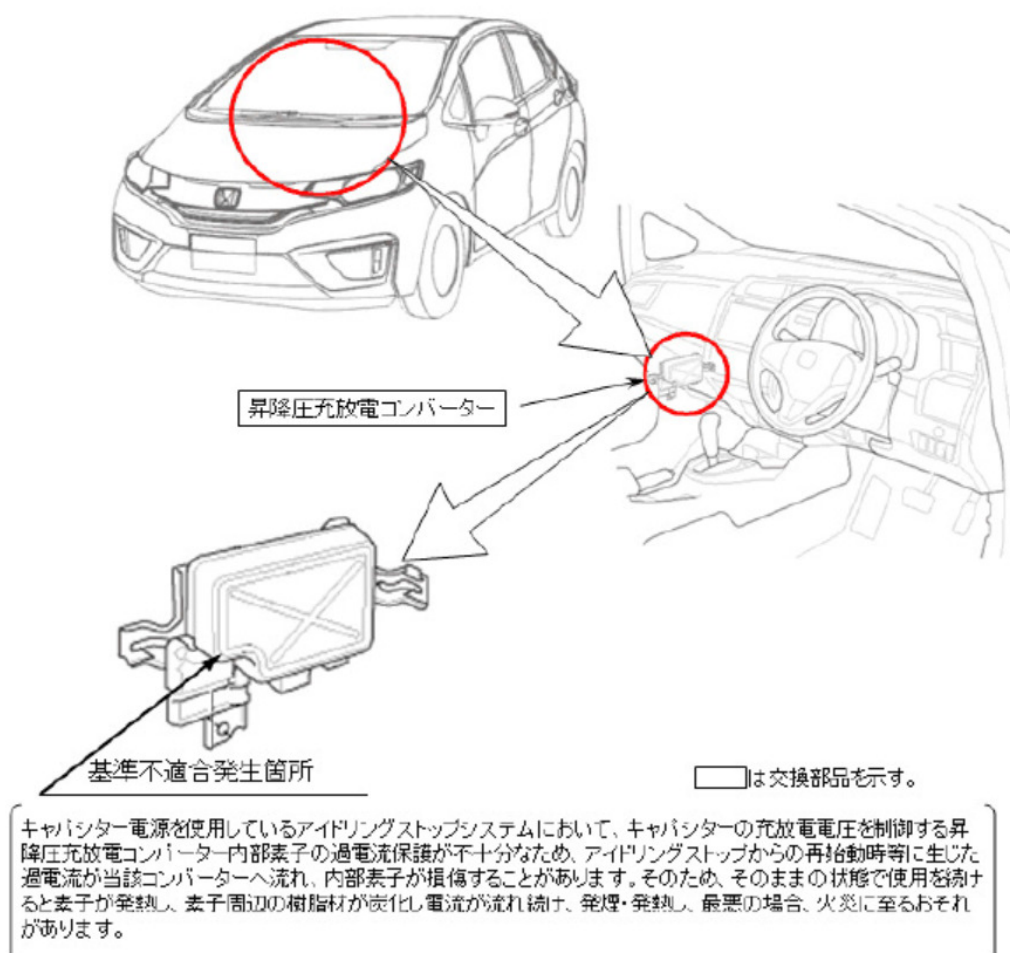
16. For this case, Mr Jumat first saw smoke coming out from the gaps surrounding the dashboard and thereafter flames at the glove compartment area, under the dashboard. Taking Mr Jumat's observations into consideration, the fire to the Insured Vehicle had originated around the left side of the dashboard, at or near the glove compartment area; with the cause of fire related to a defective originally fitted component. The following paragraphs discusses this aspect.

18. My further research and checks on the capacitor that was mentioned in the recall details of the LTA search result revealed that this capacitor is a component that is fitted onto the inner side of the Insured Vehicle's front left "A" pillar, towards the left and below the glove compartment of the Insured Vehicle. I note that this location is at or near the location where Mr Jumat had saw flames. Basing on the information gathered pertaining to the capacitor; and given that no rectification to address the capacitor issue was carried out to the Insured Vehicle, it can be determined that the fire to the Insured Vehicle is related to the purpose of the manufacturer recall campaign that involved the Insured Vehicle. See search result below gathered from my further research and checks.

**Screenshot** shows a zoom in view of the schematic diagram pertaining to the manufacturer recall campaign of similar make and model vehicles as the Insured Vehicle. The component, circled in the schematic diagram, is the capacitor that was mentioned in the recall details of the LTA search result. The location where this component was fitted was also at or near the location where Mr Jumat had saw flames.
