Your Ref: 590109
Our Ref :CS/MSG19006439/Z

M/s MSIG Insurance (Singapore) Pte Ltd
16 Raffles Quay #24-01, Hong Leong Building,
Singapore 048581
(Motor Claims Department)

**TECHNICAL INVESTIGATION REPORT OF FIRE INCIDENT INVOLVING THE
INSURED VEHICLE SKR 7813A ON 04th APRIL 2019**

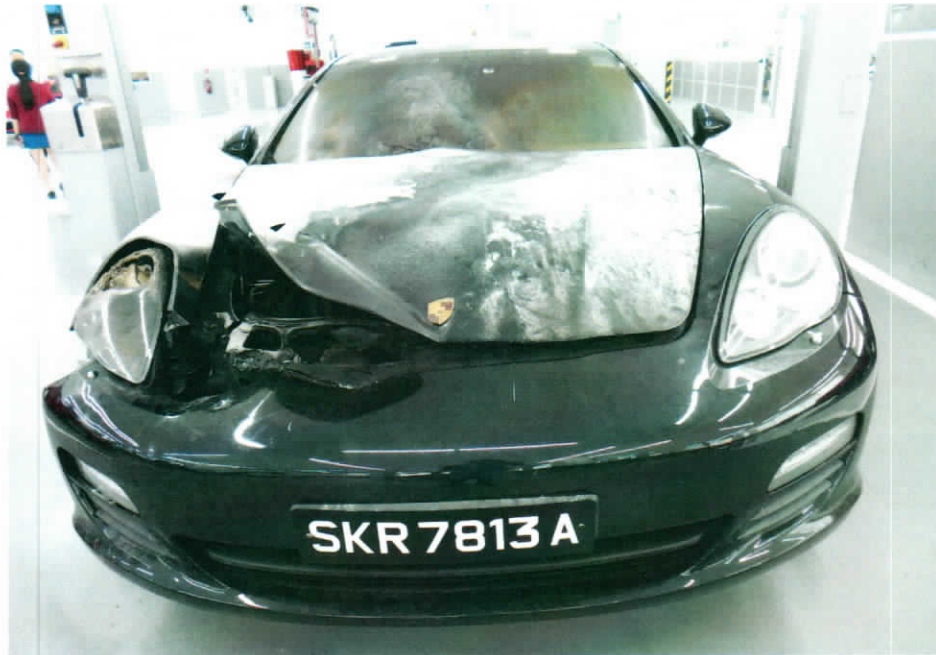
Photo 1 shows the general view of the Insured Vehicle at the time of our inspection. The fire damage to the Insured Vehicle was confined to its front bonnet and most engine parts were amongst the body parts that were found to have been affected as a result of the fire.

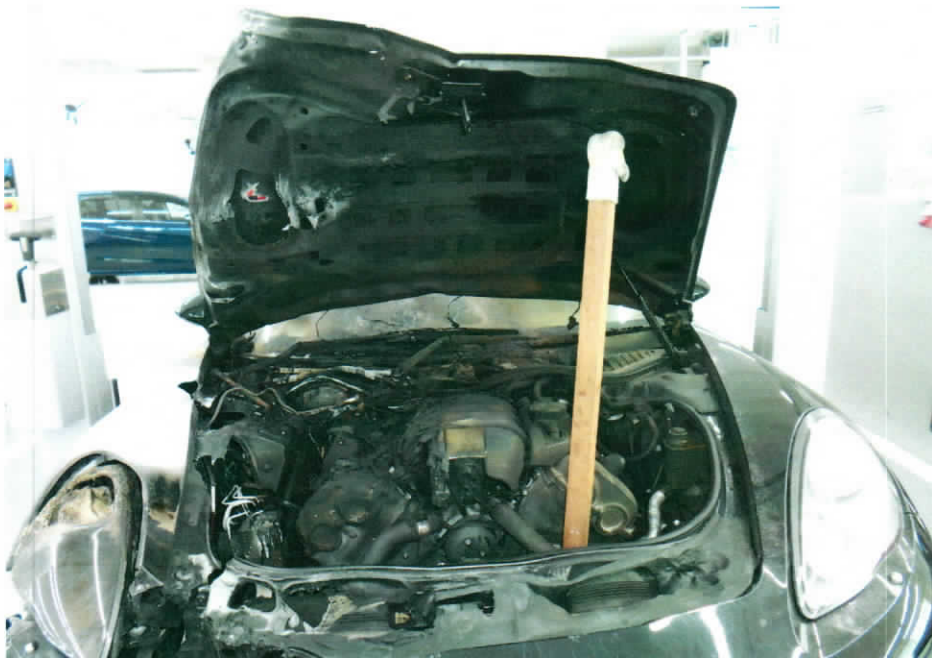
Photo 2 shows the general view of the front engine portion of the Insured Vehicle at the time of our inspection. The fire damage to the Insured Vehicle was confined to its front bonnet and most engine parts were amongst the body parts that were found to have been affected as a result of the fire.

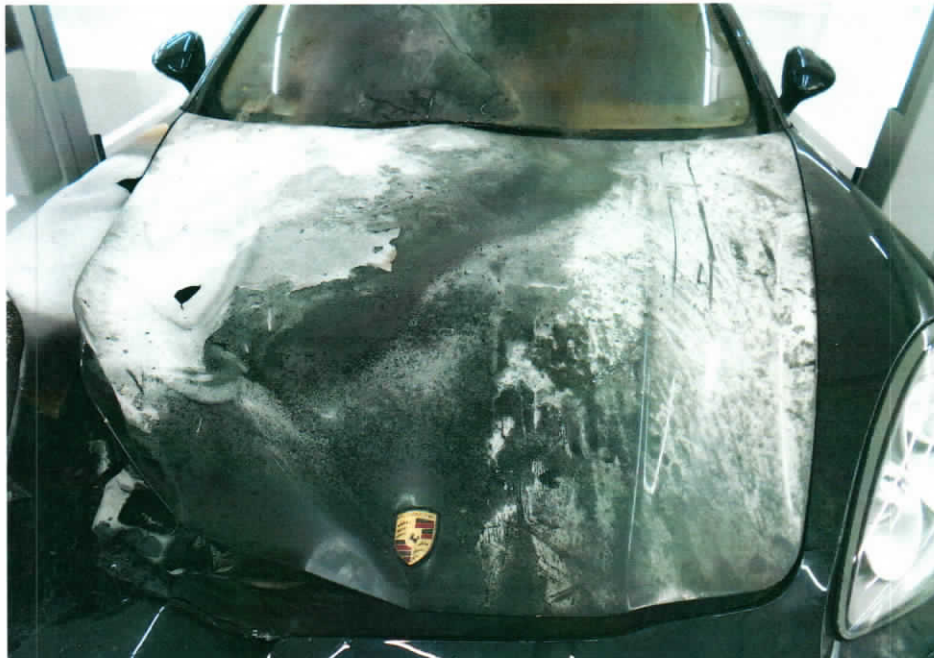
Photo 3 shows the topside bonnet of the Insured Vehicle at the time of our inspection. It was observed to sustain with burnt marks.

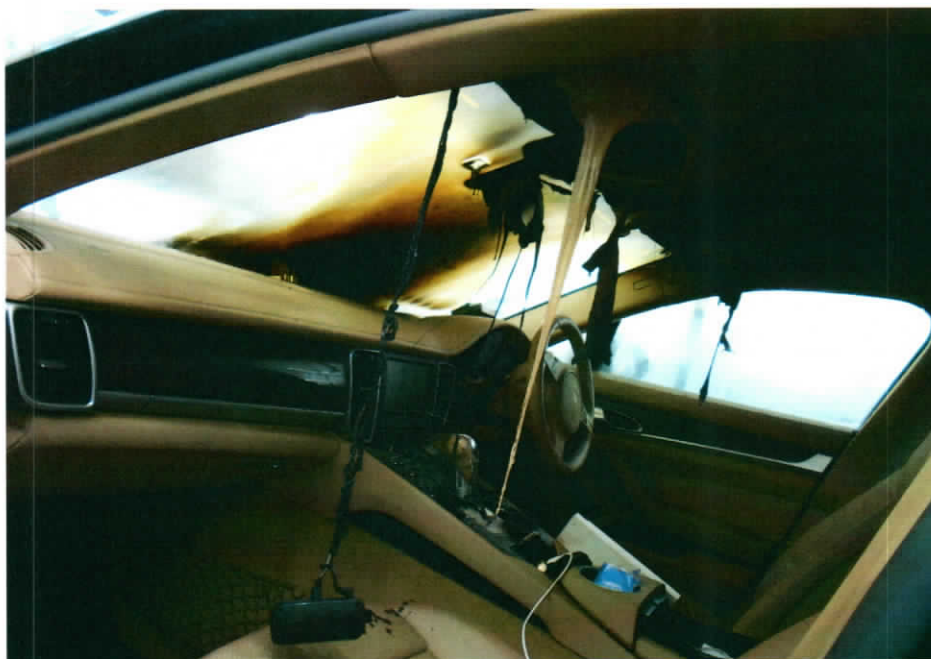
Photo 4 shows the interior compartment of the Insured Vehicle, which was observed to be affected by the fire incident. Burnt video camera was also noted to be dangling at time of our visit to the workshop.

7. At the time of inspection of the Insured Vehicle, we found an additional video camera recorder fitted on the front windshield. We did not find any other additionally fitted electronic and/or electrical component(s) on the Insured Vehicle. There also appears to be no modification(s) fitted on the Insured Vehicle.

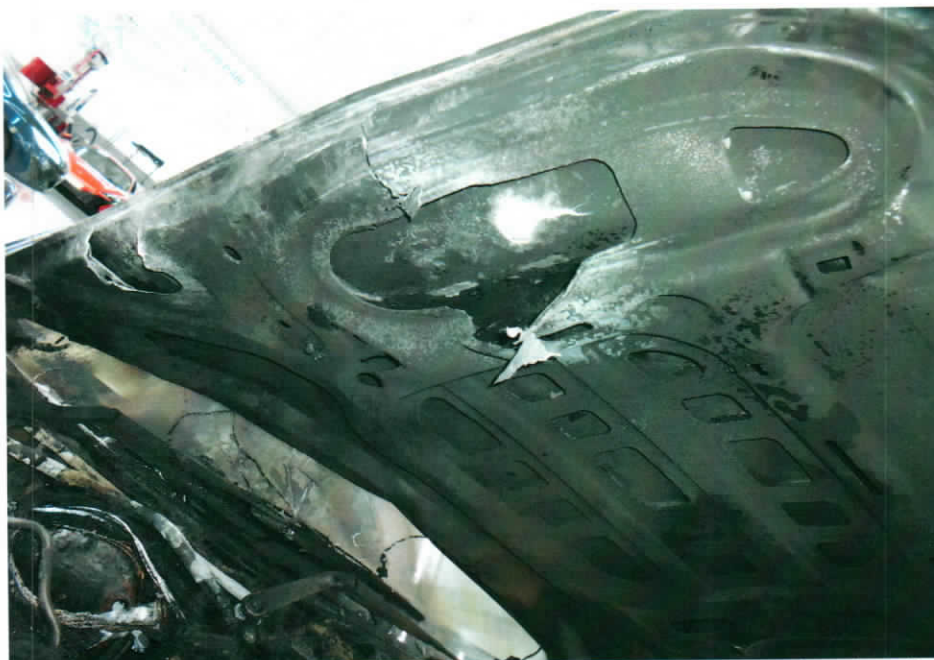
8. For this particular case, the fire appears to have originated within the engine compartment of the Insured Vehicle, somewhere around the front right of the engine compartment. This can be determined from the burn pattern and the high heat intensity burn marks (whitish burn marks) found on the front bonnet of the Insured Vehicle, at both its top and under side.
9. These (whitish) burn marks are a result of exposure to prolong heat intensity. Rust would normally start to develop around these areas soon after a fire as prolonged exposure to high heat intensity usually causes steel/metal material body parts to be exposed to natural environmental condition. See photo 5 & 6 below.

Photo 5 shows the burn pattern and whitish burn marks that were found on the underside of the front bonnet of the Insured Vehicle. Such whitish burn marks are a result of exposure to prolong heat intensity, which may indicate where the fire had started. Rust would also begin to develop on these areas soon after the fire.

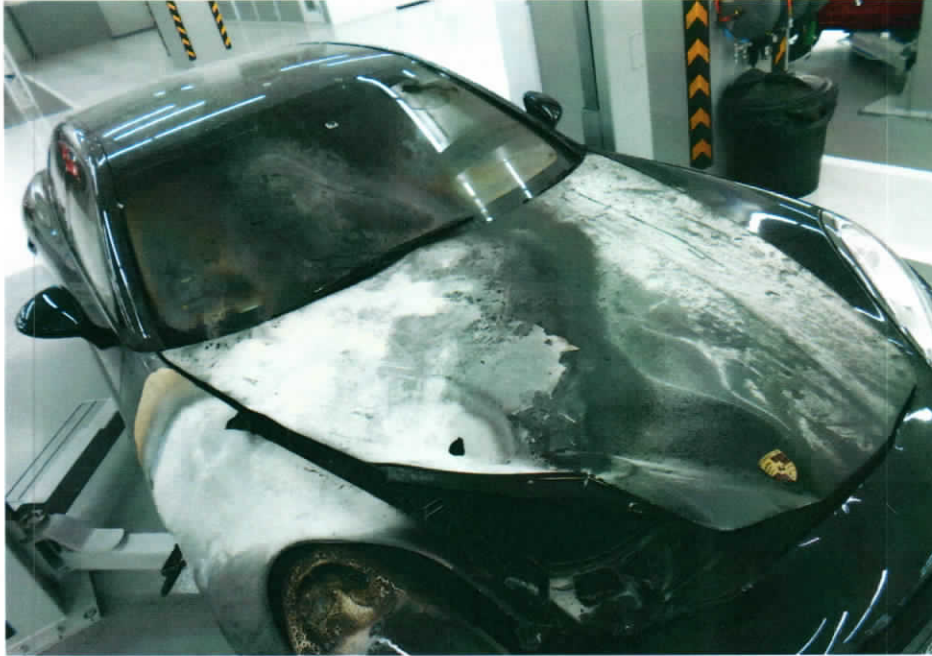
Photo 6 shows the burn pattern and whitish burn marks that were found on the topside of the front bonnet of the Insured Vehicle. Such whitish burn marks are a result of exposure to prolong heat intensity, which may indicate where the fire had started. Rust would also begin to develop on these areas soon after the fire.

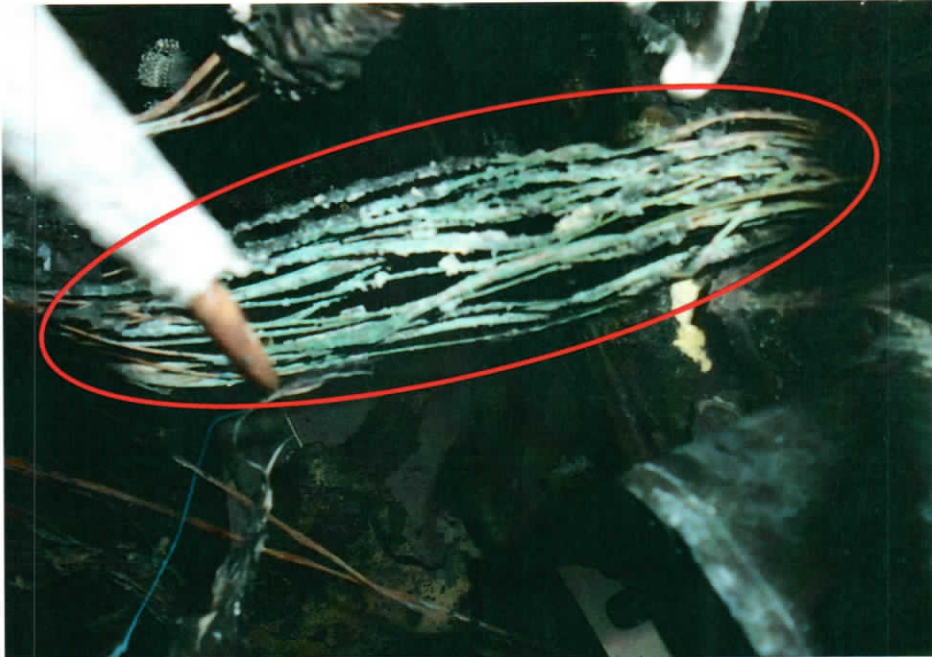
10. Upon closer examination of the area around the front right of the engine compartment, which was in the immediate vicinity of where the fire to the Insured Vehicle had likely started, we had found several stretches of wiring burnt internally. There were traces of greenish residue as evidence to show that such condition normally indicate internal heating of copper wires which is a sign of an electrical short circuit occurring. This would then appear to suggest that the cause of fire to the Insured Vehicle could have possibly been due to electrical in nature. See photo 7 & 8 below.

Photo 7 shows a closer view of the ABS motor pump wirings around the front right of the engine compartment, which was in the immediate vicinity where the fire to the Insured Vehicle had likely started.

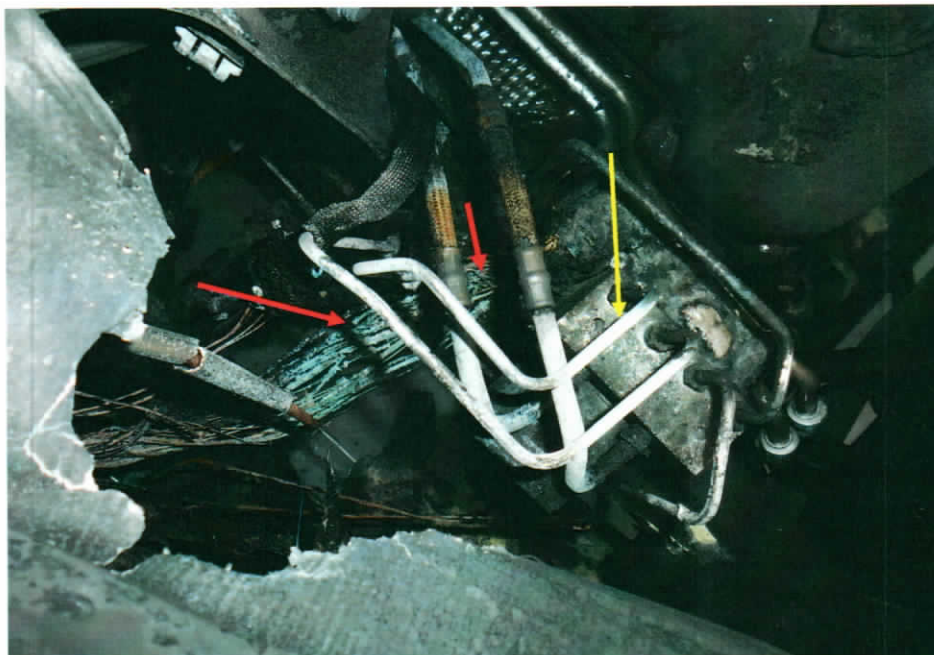
Photo 8 shows a semi close-up view of the ABS motor pump wirings (red arrow) which were found to have been burnt internally to its bare copper state, suggesting occurrence of an electrical short circuit. These wirings were observed to be greenish believe to be the focal point of the fire ignition.

31. Having investigated and technically analysed the damages of burnt nature to the Insured Vehicle, We are of the view that the cause of fire to the Insured Vehicle was of electrical in nature. For this particular case, the fire had originated along the wiring inside the engine compartment, somewhere around the ABS motor pump section of the engine. The wirings were likely to be from the original manufacturer's installation wire harness.

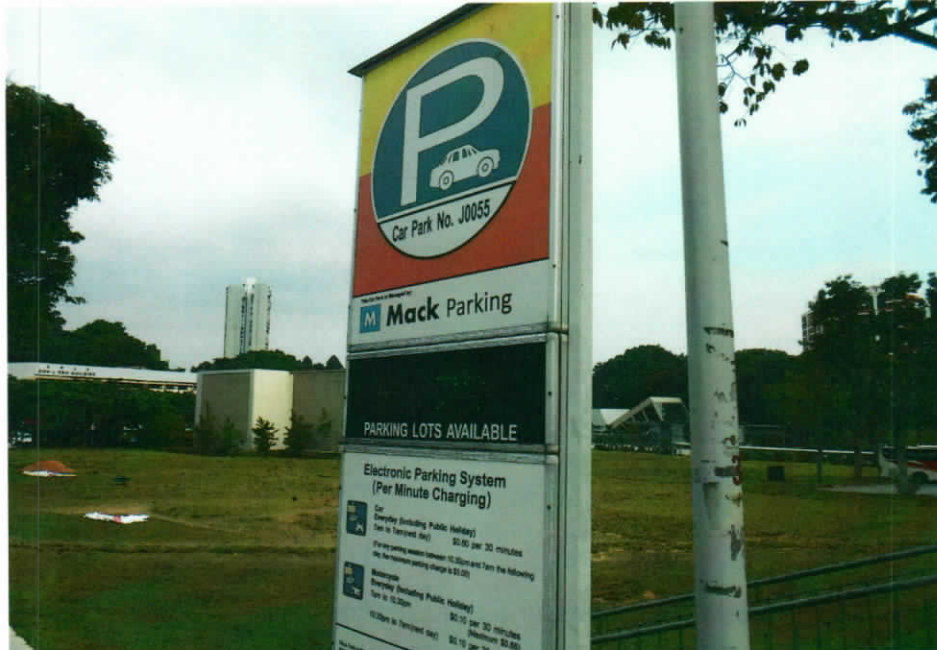
Photo 9 shows the general view of open space Car park sign board No. J0055 where the fire incident took place.

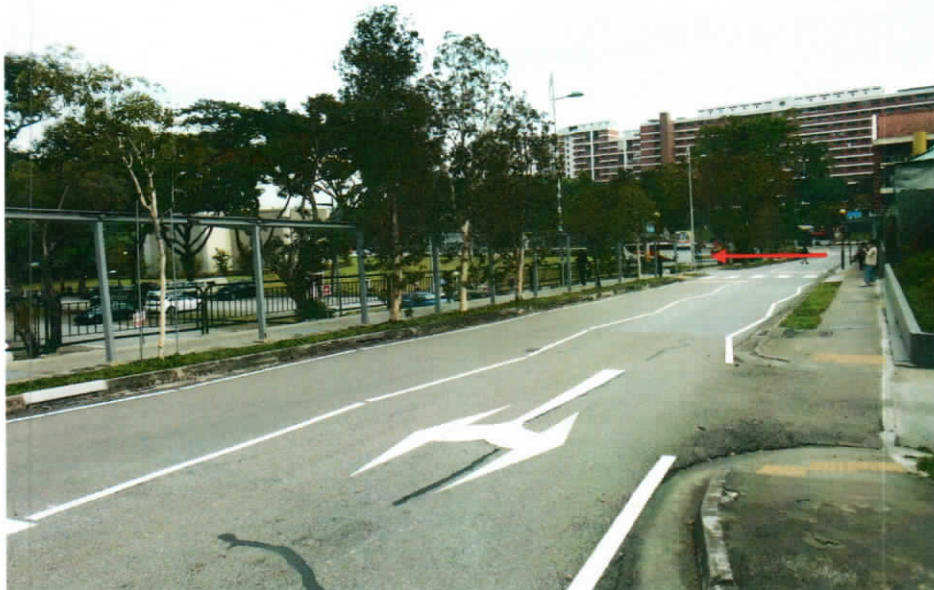
Photo 10 shows the general view of the open space car park entrance along Chun Tin Road.

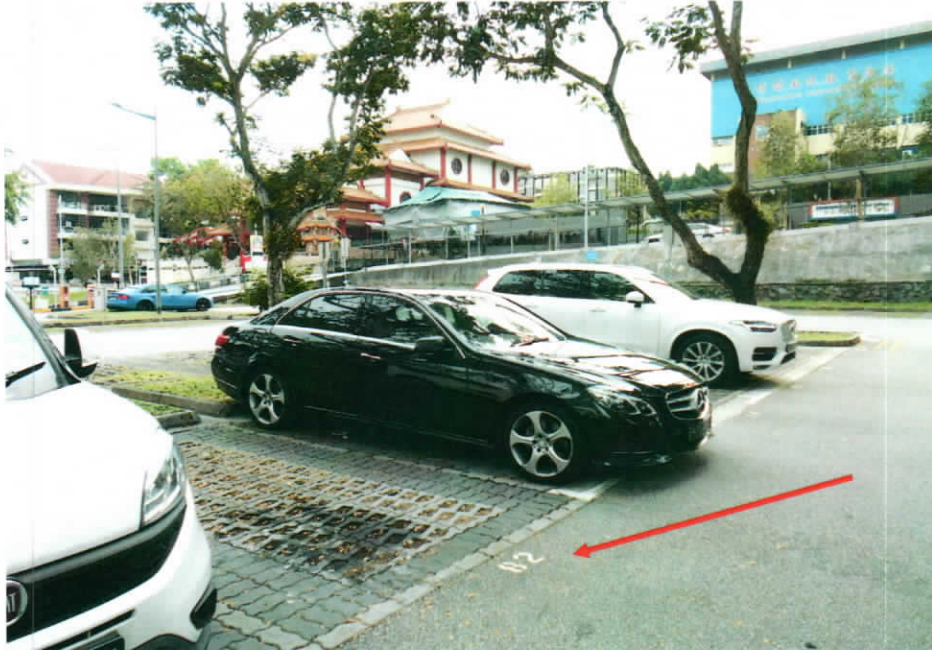
Photo 11 shows the general view of the car park lot where the fire incident took place. Arrow shows where the Insured Vehicle last position before it caught fire.

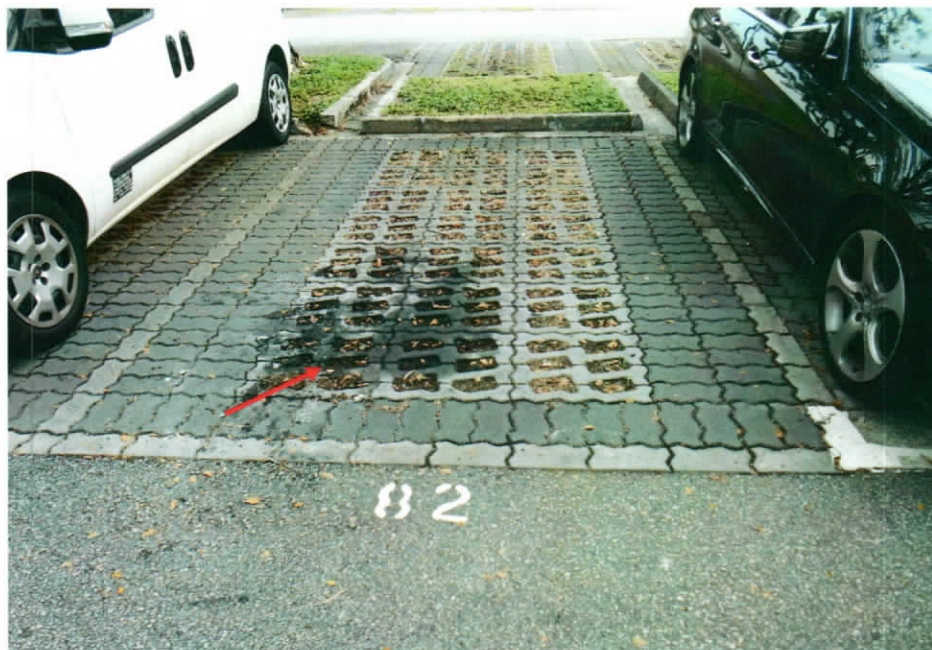
Photo 12 shows the closer view of the car park lot where it had caught fire. Burnt debris remains believe from the Insured Vehicle was observed on the car park lot ground.

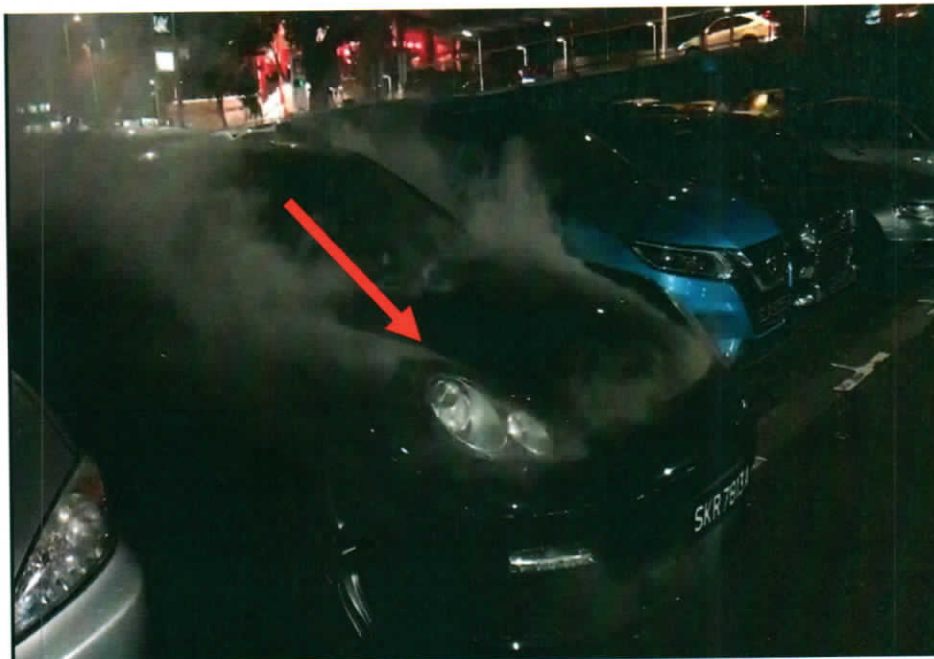
Photo 13 shows the Insured Vehicle at the fire incident scene. There appears to be no abnormal foreign material(s) and/or object(s) found on the ground in the immediate area where the Insured Vehicle was located. In general, the information that could be gathered from these photographs had corresponded to the events that were related to us by Mr Adam.

28. The possibility of the fire being due to external factor (foreign material(s) stuck on hot surfaces, arson and sabotage amongst others) would also seem unlikely given that our examination of the available incident scene photographs did not reveal any unusual material(s)/object(s) found on the ground near where the Insured Vehicle was parked.
