Subject: RE: Fw: Re: Alert - Adj Mandate Maintained - SLT8155L - Claim Handler: Gan,

This mail is associated with:
*SLT8155L (2160517999SG)
OD
Apr 9 2019 9:10AM
[LEE ZHEN JIAN]
Premium Automobiles Pte Ltd

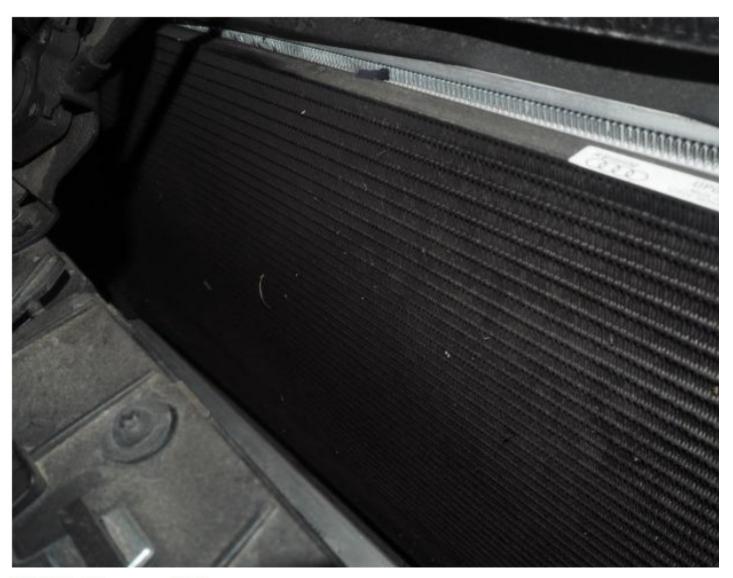
36/60: General View

Where is the damage? No damage photos to take out.

The condenser Photo please refer to the no. 36, 37, 39.
