PRE-REPAIR SURVEY REPORT

NTUC Income Insurance Co-operative Ltd

Assign Date:	05/10/2017	Survey Date:	05/10/2017	Our Ref:	AVS2017-12734/WH
Accident Date:	30/09/2017	TP Policy No:	TBA	Your Ref:	MT/0963605-002
Place of Survey:	Eng Soon Painting Services 3998 Woodlands Rd, Yew Tee Ind Est Singapore 678035	Claim Type:	Third Party

Veh. No:	FBE6658M	Make/Model:	Yamaha T135
Colour:	Yellow	Engine No:	5YP302747
Engine Capacity:	135cc	Chassis No:	5YP302747
Odometer:	71554	Reg. Date:	2010

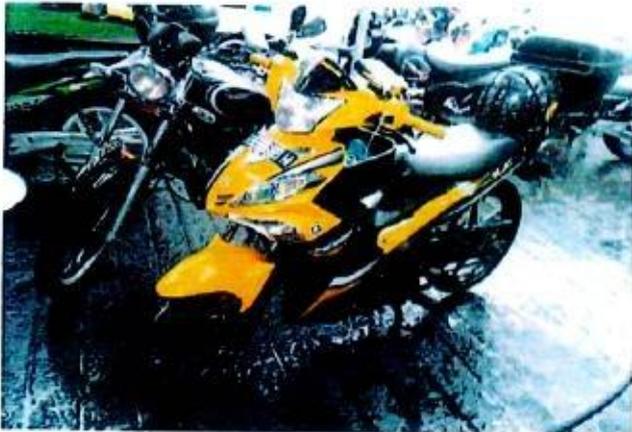
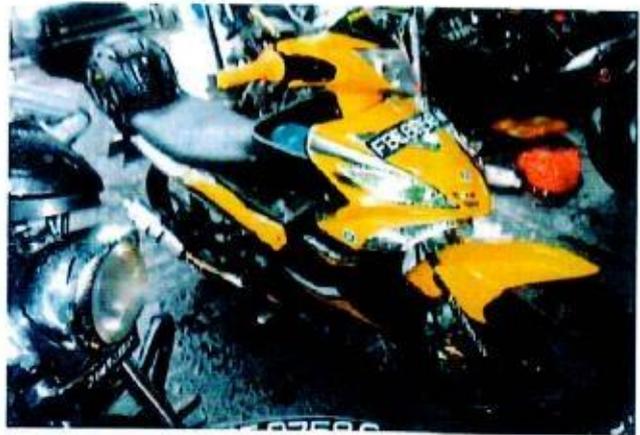
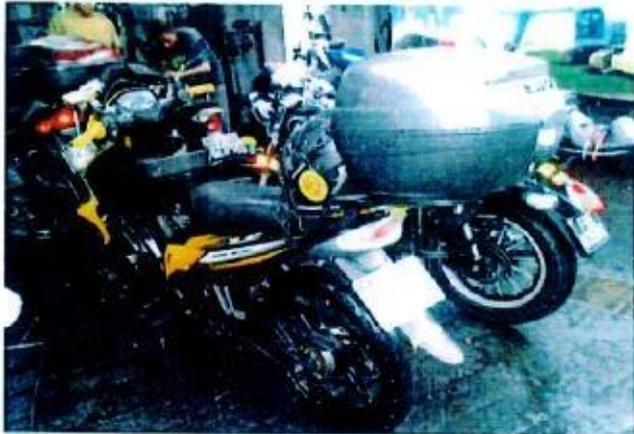
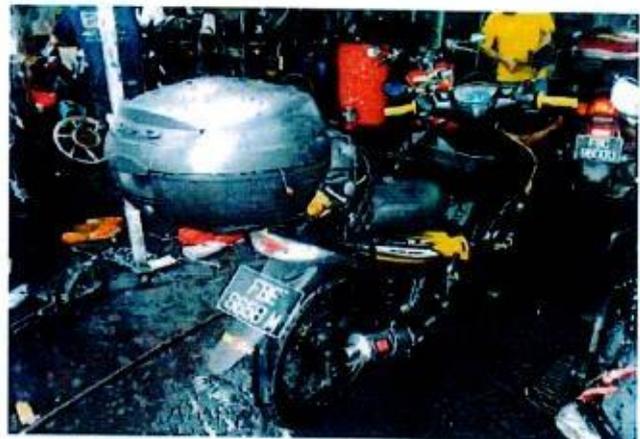
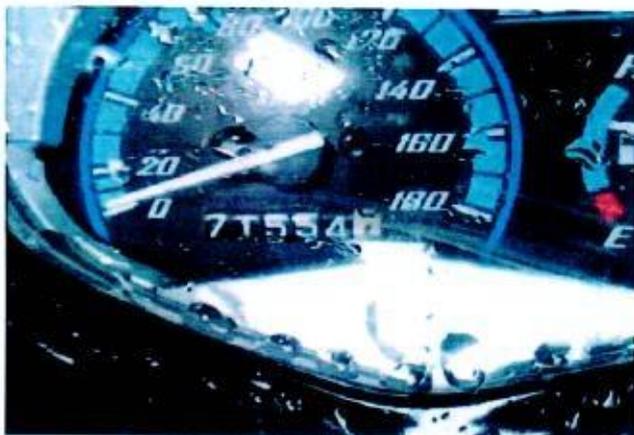
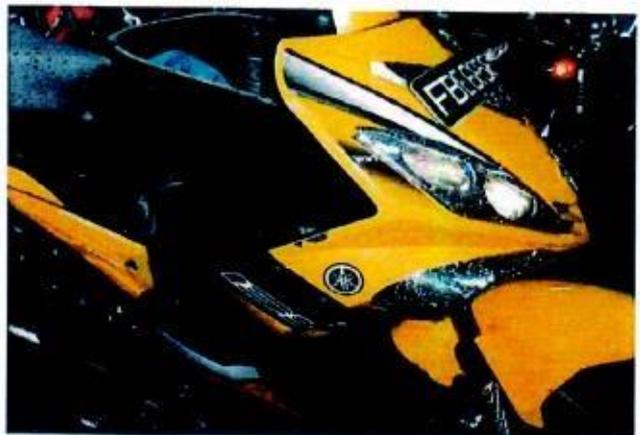
Pre-repair survey - 05/10/2017

The vehicle sustained damage on the left portion.

The rear box, exhaust pipe, front fairing, handle bar, clutch lever, brake lever and front mudguard were among the items affected.

Our recommended amount for the cost of contract lumpsum repair is S\$1,800.00 with approximately four (4) working days to complete. However, no finalisation was agreed with the repairer.
