NS/INC19006722/ Klv0352

Insured Veh.	SGR 5464J	Veh. Inspected	SH 7087L
Policy No.	5081725096-02	Coverage (\$)	0.00
Claim No.	MT/1040396-002	Excess (\$)	0.00
Assign From		Assign Date	15/04/2019

THE VEHICLE SUSTAINED DAMAGES AT THE REAR PORTION. DAMAGES SEE DETAILS.
--

ADJUSTMENT ON REPAIR COST FOR VEHICLE NO. SH 7087L

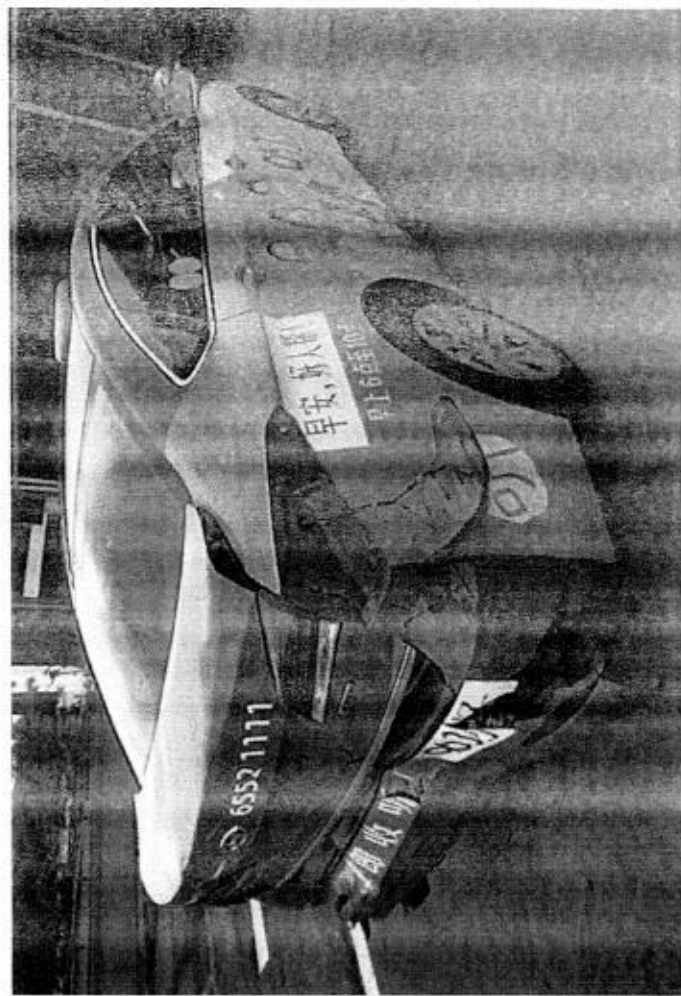
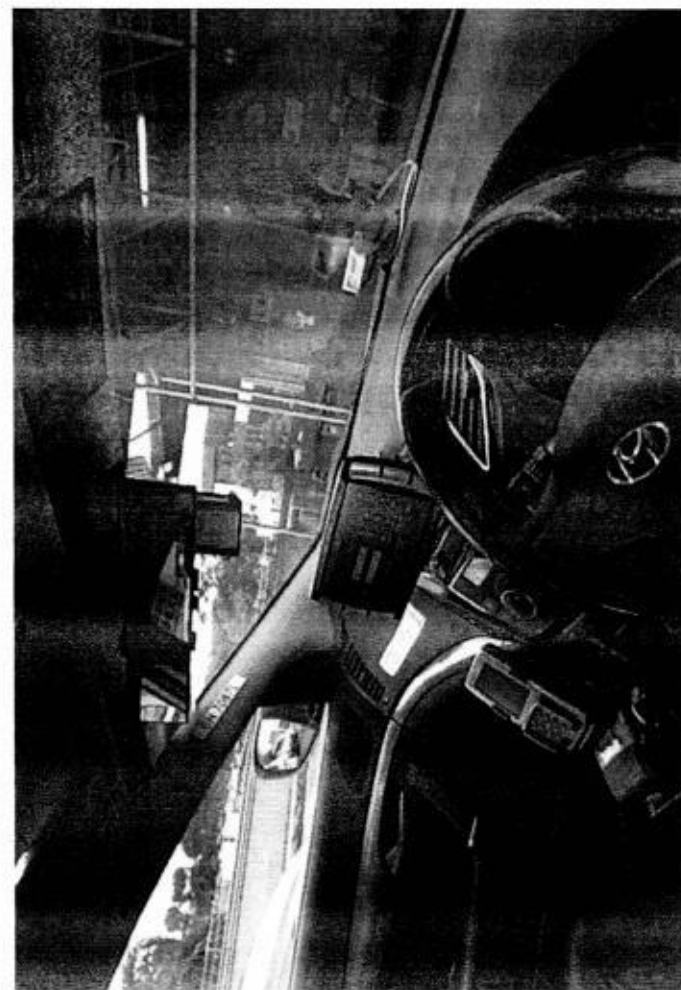
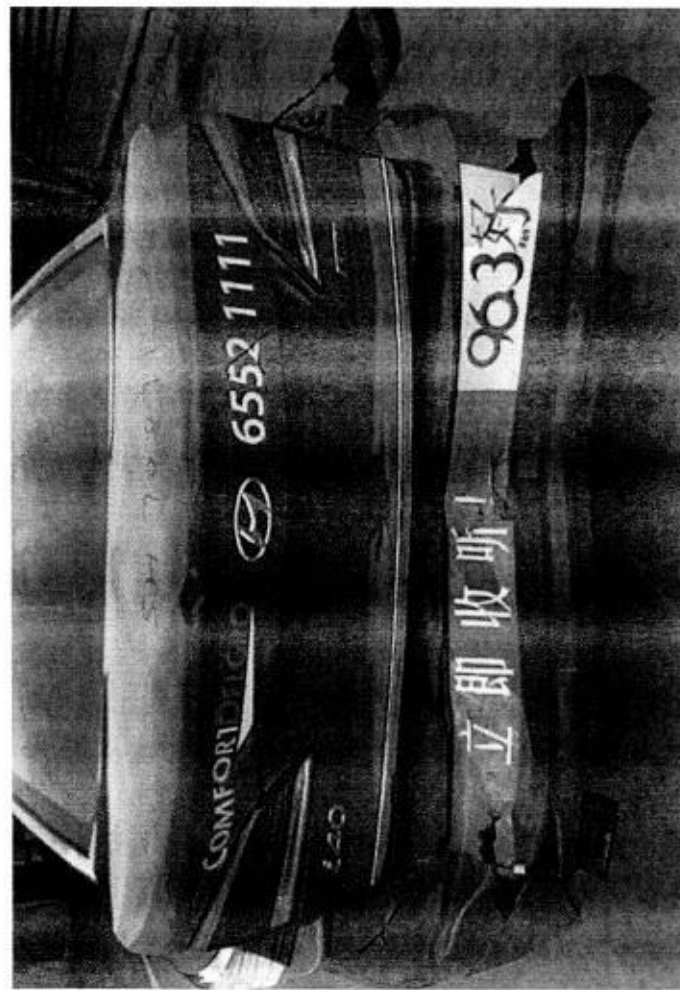
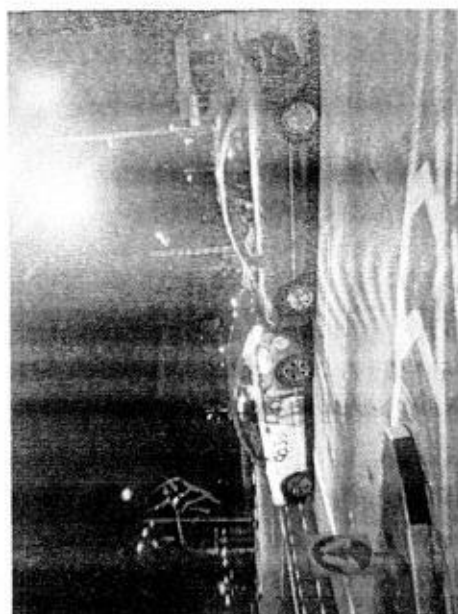
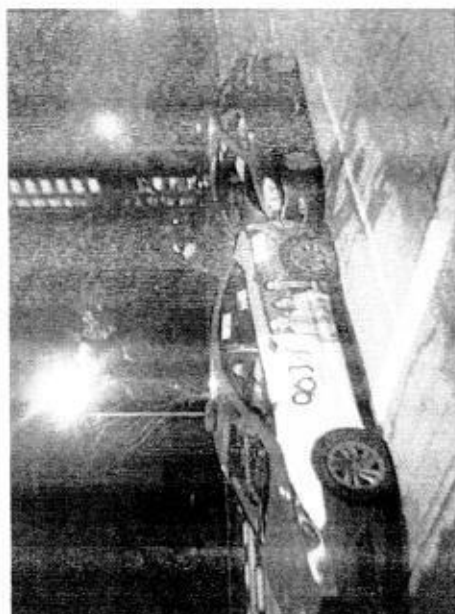
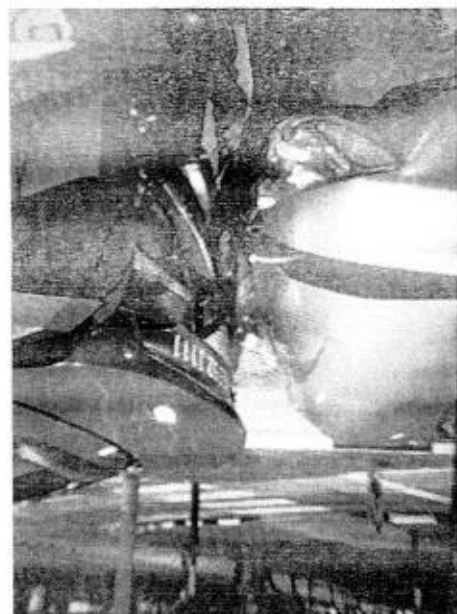
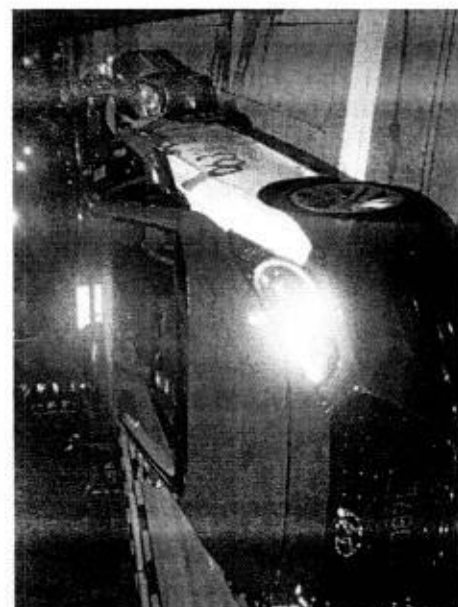
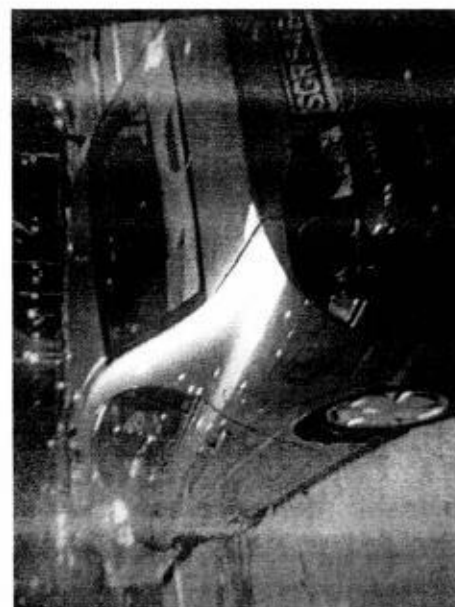
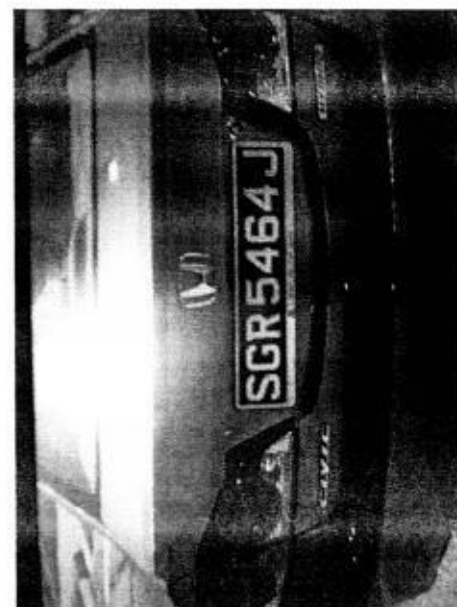
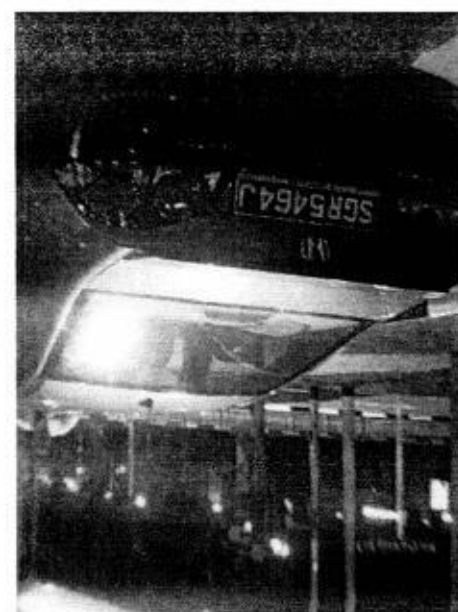
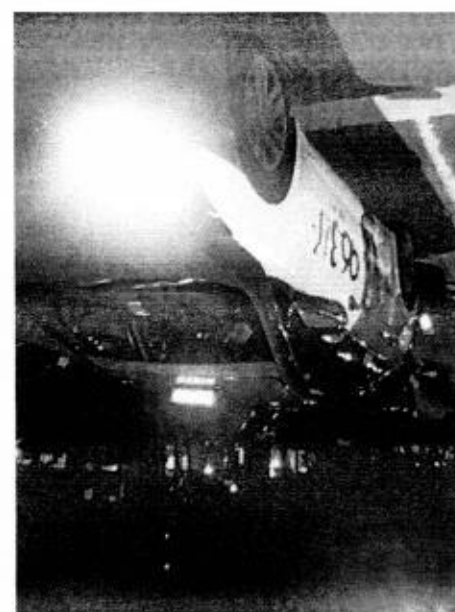
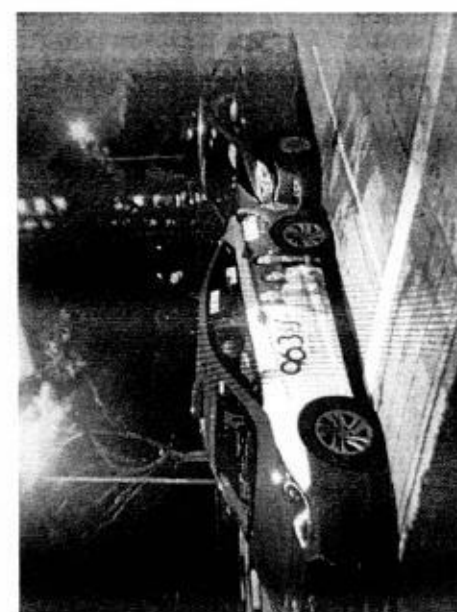
The UIC / Chassis frame / Body Structure affected due to collision.

RECOMMENDED COST OF LUMP SUM REPAIRS (TO ITS PRE-ACCIDENT CONDITION) (CONFIRMED)			7,700.00
--	--	--	----------
