Your Ref : 590729/IT
Our Ref : CS/MSG19006816/D

11 June 2019

**AUTOMOBILE TECHNICAL INVESTIGATION REPORT OF INCIDENT
INVOLVING SMJ 3582K AND SHB 8319Z ON 13 APRIL 2019**

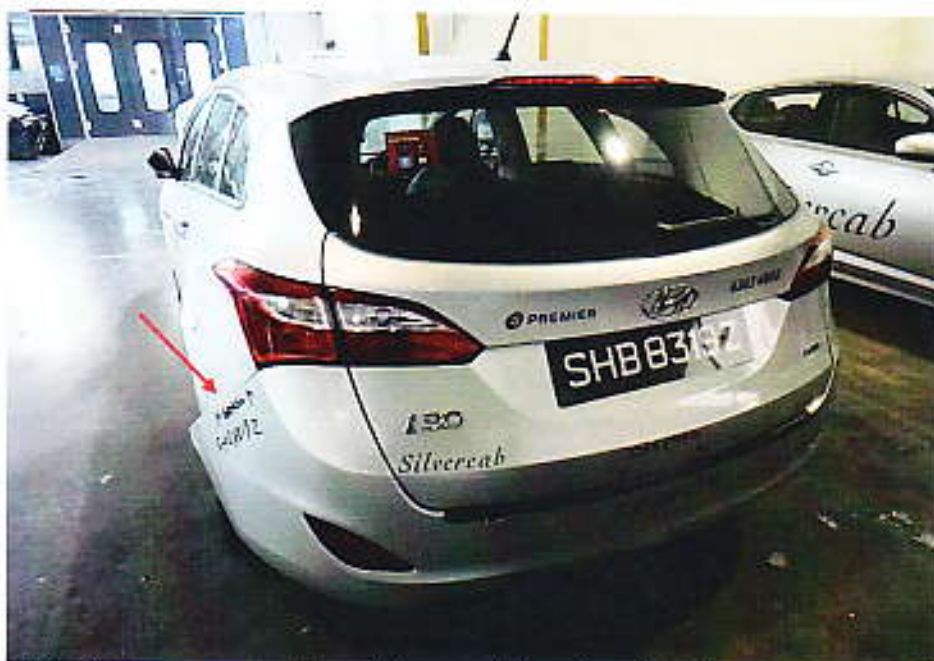
Photo 1 shows a general view of the rear left portion of the Third Party Vehicle at the time of inspection by LKK Auto Consultants Pte Ltd. The left side of the rear bumper (arrowed) was detached from its holding bracket.

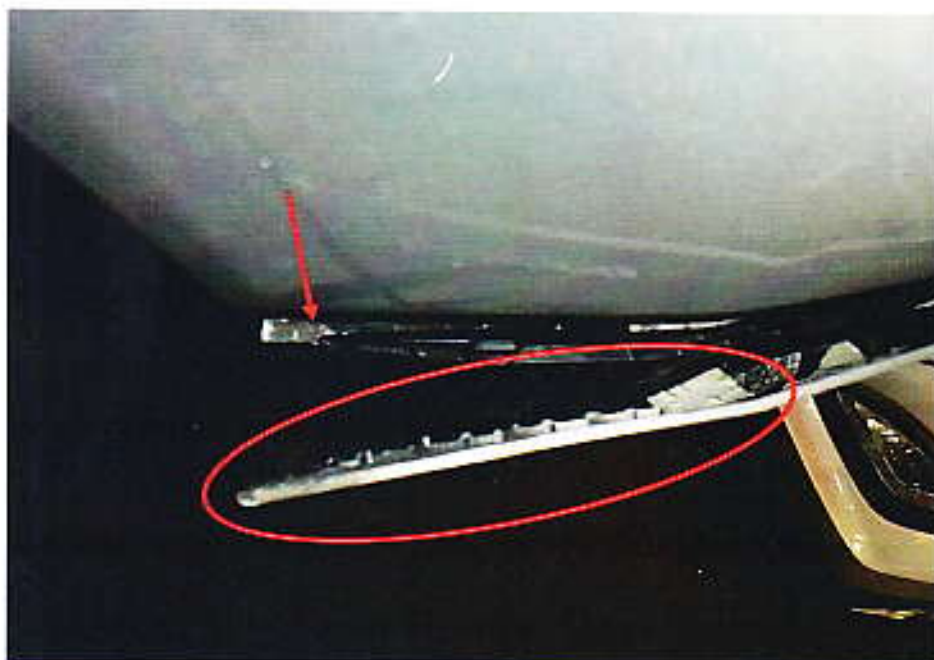
Photo 2 shows the mounting area at the left side of the rear bumper broken (circled and arrowed)

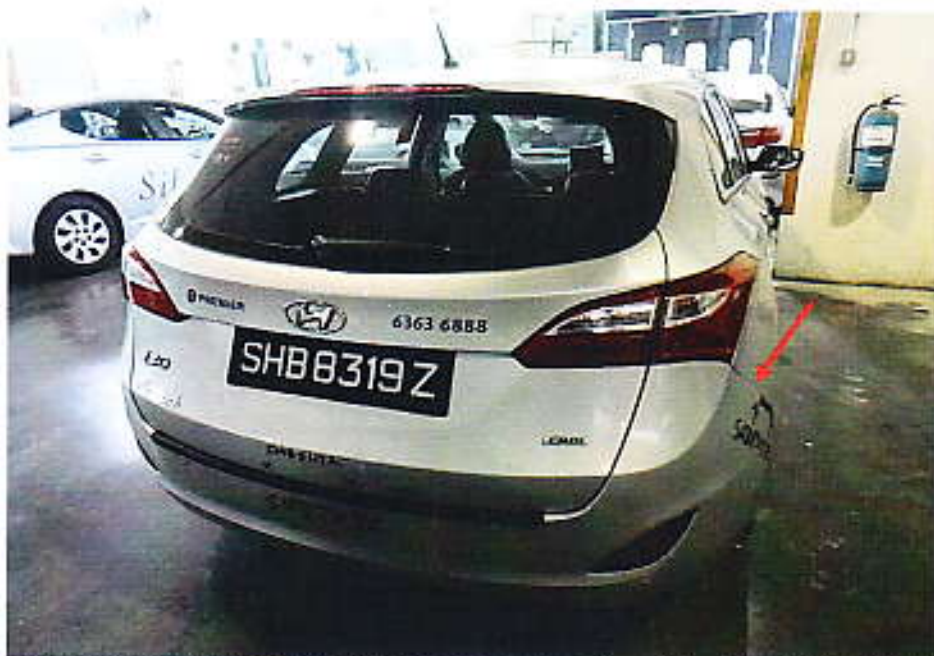
Photo 3 shows a general view of the rear right portion of the Third Party Vehicle at the time of inspection by LKK Auto Consultants Pte Ltd. The right side of the rear bumper (arrowed) was detached from its holding bracket.

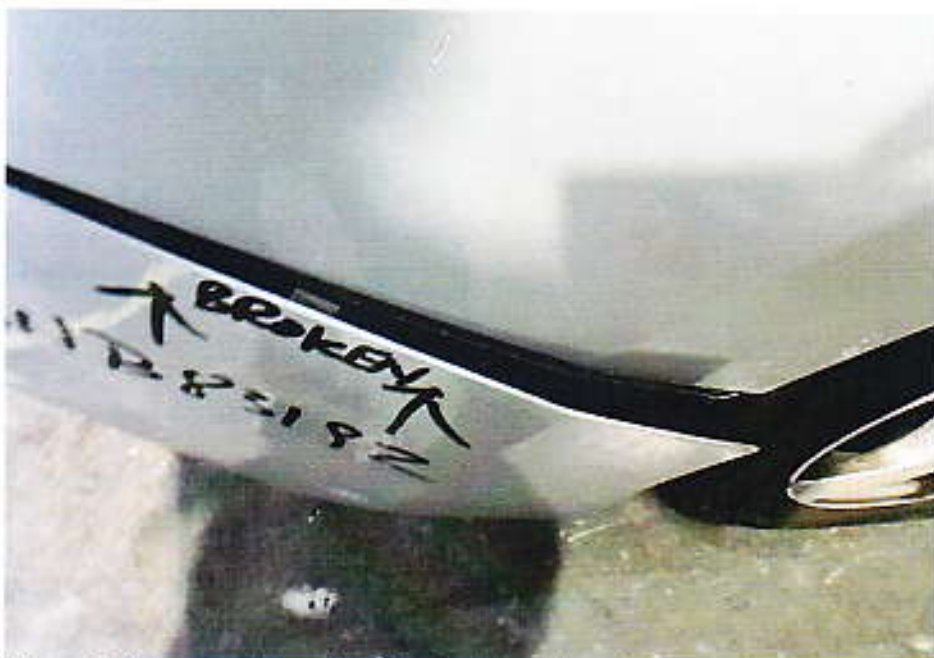
Photo 4 shows a closer view of the right side of Third Party Vehicle's rear bumper, which was detached from its holding bracket.

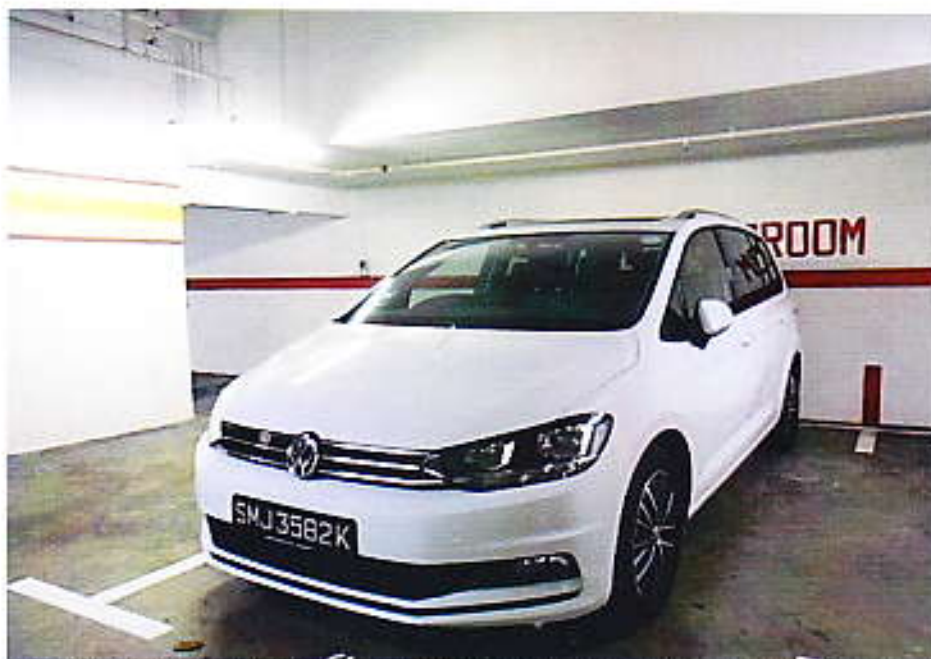
Photo 7 shows a general view of the front left portion of the Insured Vehicle at the time of my inspection. The mileage of the Insured Vehicle at the time of my inspection was recorded to be 1,663km.

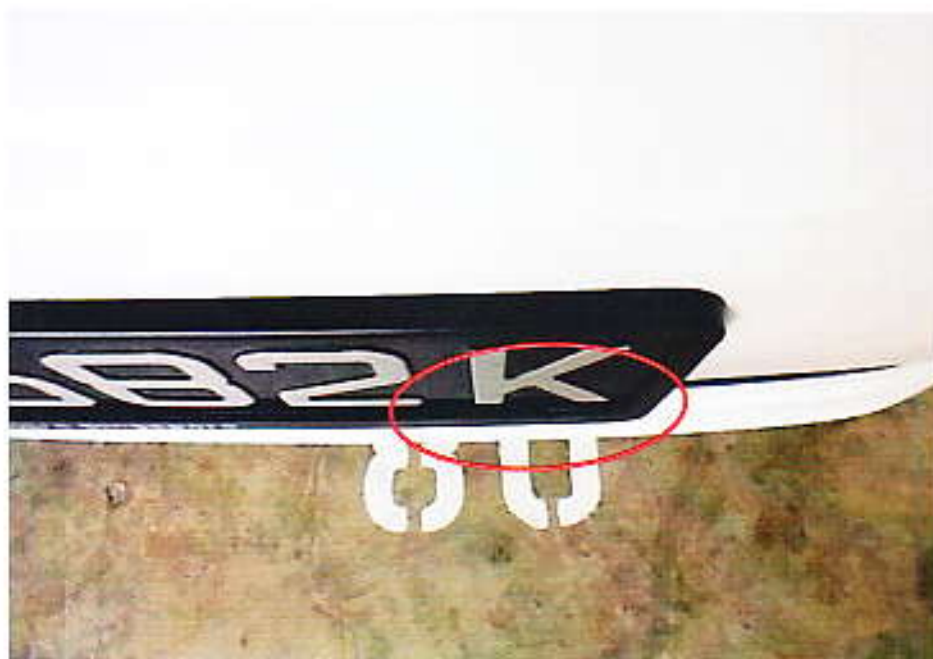
Photo 8 shows the front number plate and front number plate casing of the Insured Vehicle slightly bent inwards at a single area (circled). This was at the left bottom corner area.

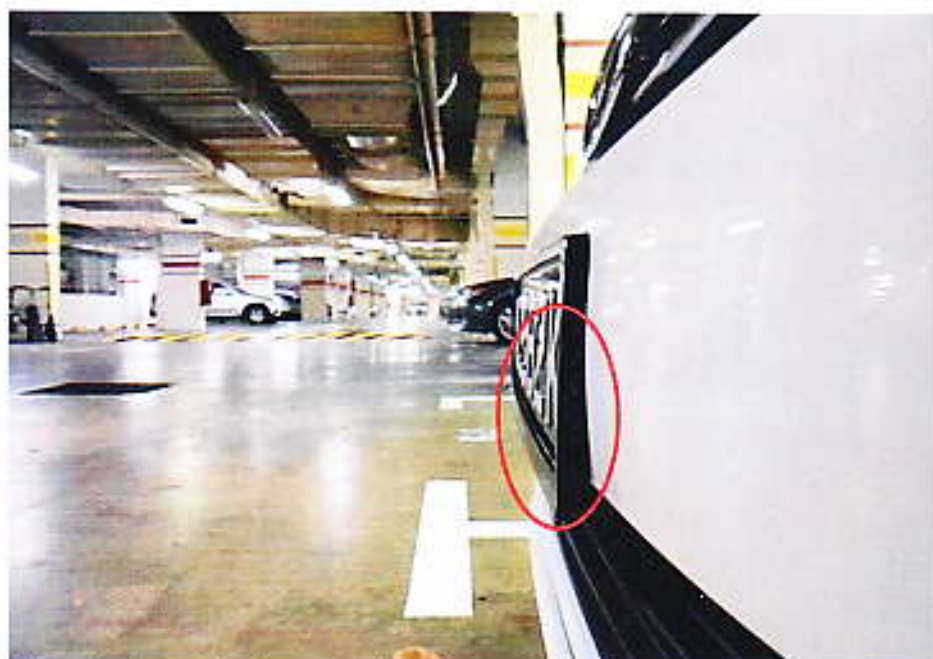
Photo 9 shows the front number plate and front number plate casing of the Insured Vehicle slightly bent inwards at a single area (circled). This was at the left bottom corner area. Apart from this, I did not observe any other visible damage to the frontal portion of the Insured Vehicle at the time of my inspection.

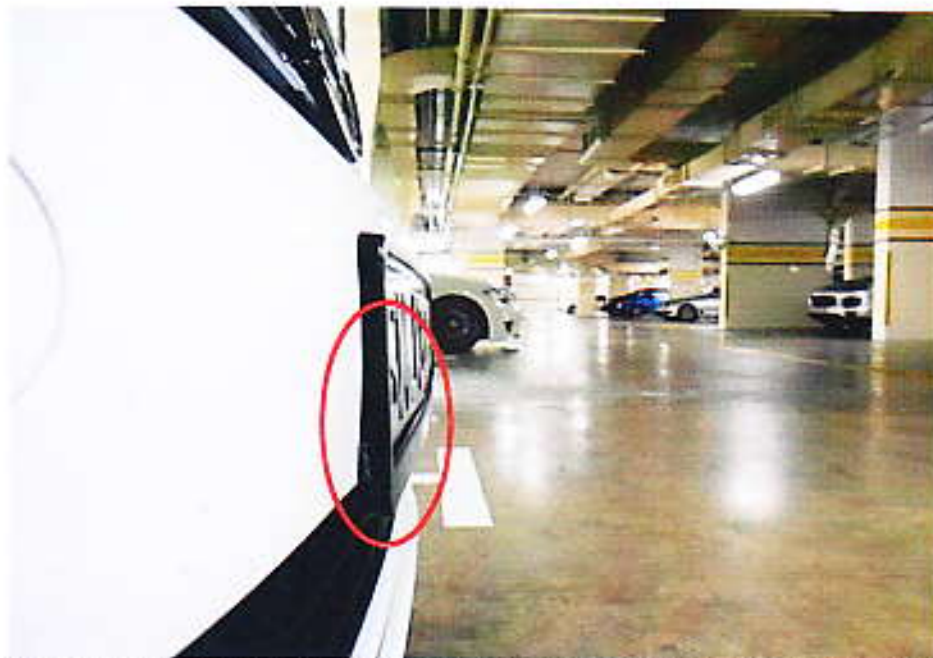
Photo 10 shows the front number plate and front number plate casing of the Insured Vehicle, at the right bottom corner area (circled) for comparison purposes with the left bottom area that was shown in photograph 9 above. The right side of the front number plate and front number plate casing is in an original curve shape whereas the same area at the left side was bent in comparison.

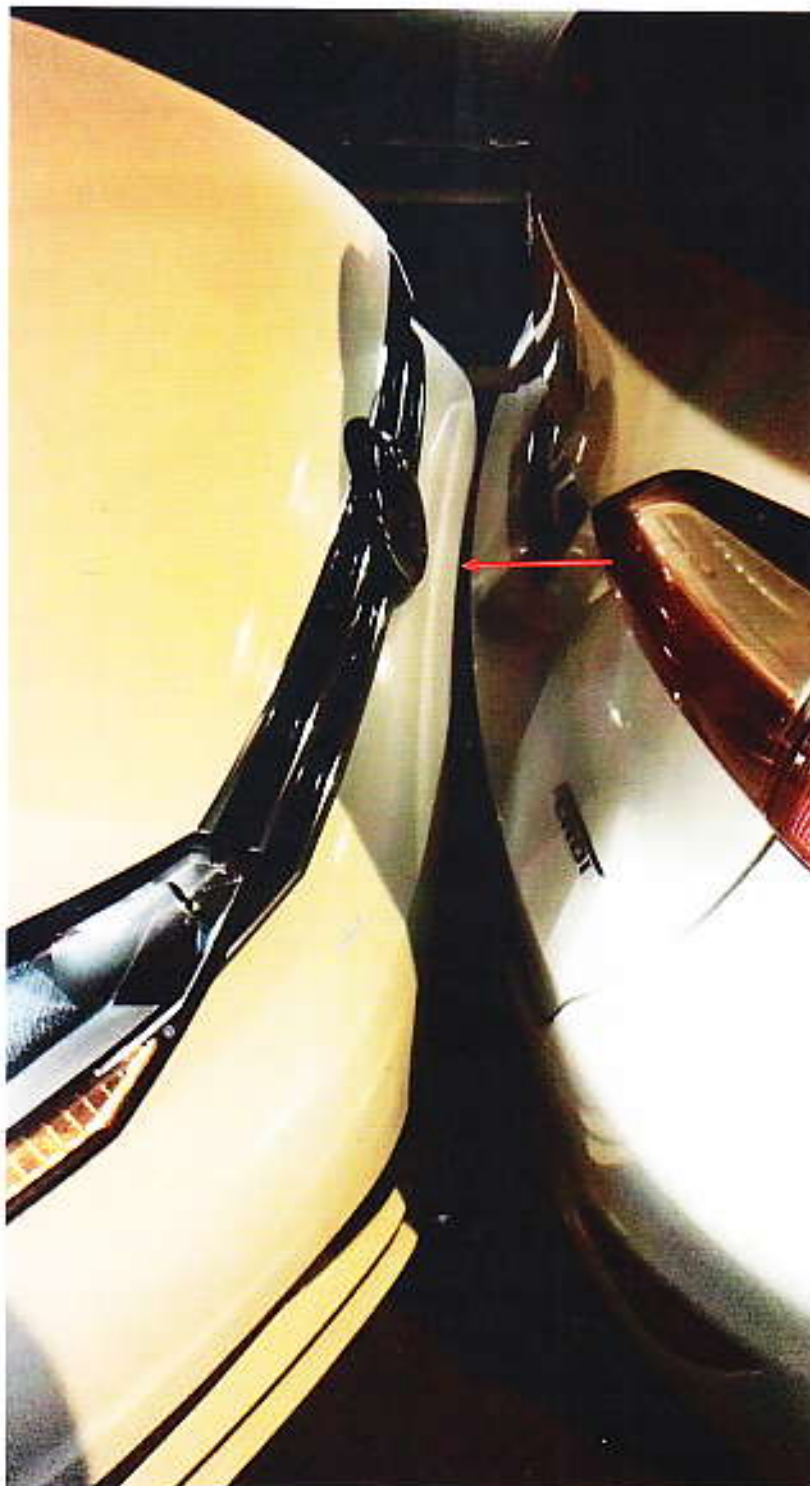
12. The 02 photographs that were taken at the incident scene by the driver of the Third Party Vehicle had showed the frontal portion of the Insured Vehicle in contact with the rear portion of the Third Party Vehicle. From the photographs, it was also seen that the Insured Vehicle was directly behind the Third Party Vehicle, in a relatively straight line.
13. The contact between the Insured Vehicle and the Third Party Vehicle can clearly be established by the compressed surface area of the front bumper, directly below the radiator grille. The compression was caused by a load/force acting directly onto the frontal portion of the Insured Vehicle, pushing the front bumper inwards. See photo 11 below.

Photo 11 shows the Insured Vehicle and the Third Party Vehicle at the incident scene. The inward compression (arrowed) of the Insured Vehicle's front bumper, at the surface area directly below the radiator grille indicates that there was contact between the frontal portion of the Insured Vehicle and the rear portion of the Third Party Vehicle.

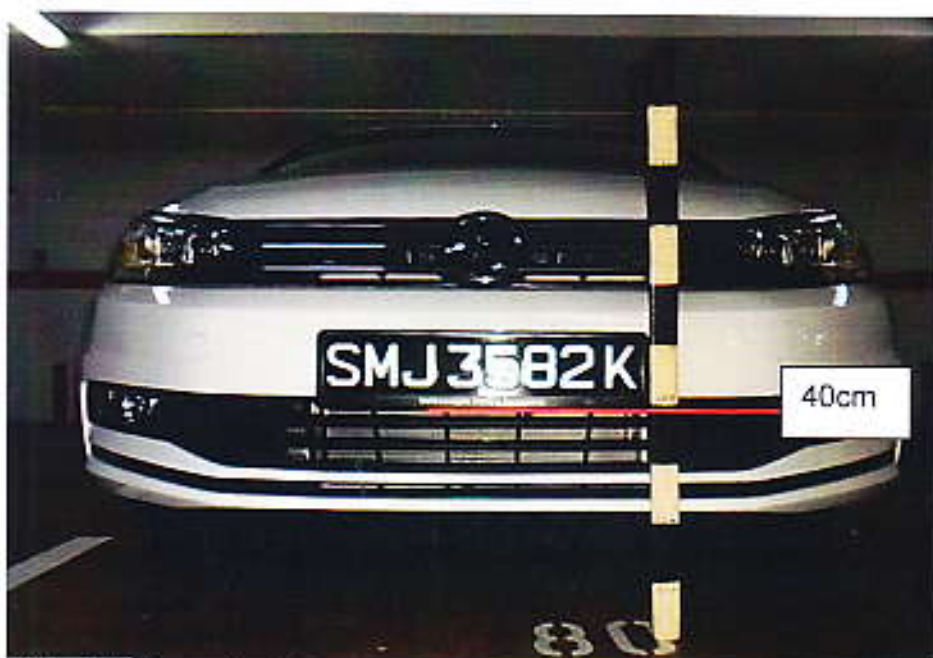
15. I now set out below the findings gathered following the height measurements that were conducted: -
 - a) the height above ground level of the lowest point of damage found on the Insured Vehicle (lower end of the Insured Vehicle's slightly bent front number plate and front number plate casing) was measured to be approximately 40cm above ground level;

Photo 12 shows the height measurement that was conducted on the frontal portion of the Insured Vehicle. The lower end of the Insured Vehicle's slightly bent front number plate and front number plate casing was approximately 40cm above ground level. This was also the lowest point of damage found on the Insured Vehicle.

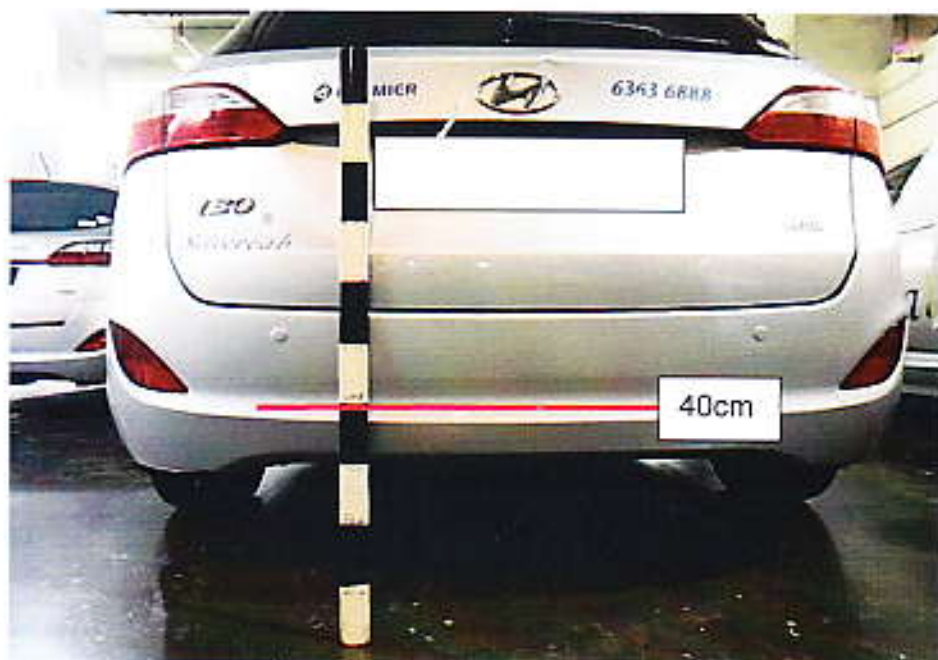
- b) comparing this height with the rear portion of a similar make and model vehicle as the Third Party Vehicle, I note that 40cm above ground level was at the rear bumper, slightly above the curve shape of the rear bumper;

Photo 13 shows the height measurement that was conducted on the rear portion of a similar make and model vehicle as the Third Party Vehicle. 40cm above ground level, was at the area slightly above the curve shape of the rear bumper. The bottom of the vertical indentation of the Third Party Vehicle's rear bumper, shown in photograph 5 above, was also slightly above the curve shape of the rear bumper.
