Your Ref: Mercedes Benz SLC 180  
(chassis number WDD1724312F146090)  
Our Ref : CI/TP19006964/D

**INSPECTION REPORT OF AN UNREGISTERD MERCEDES BENZ SLC 180  
MOTOR CAR WITH CHASSIS NUMBER WDD1724312F146090**

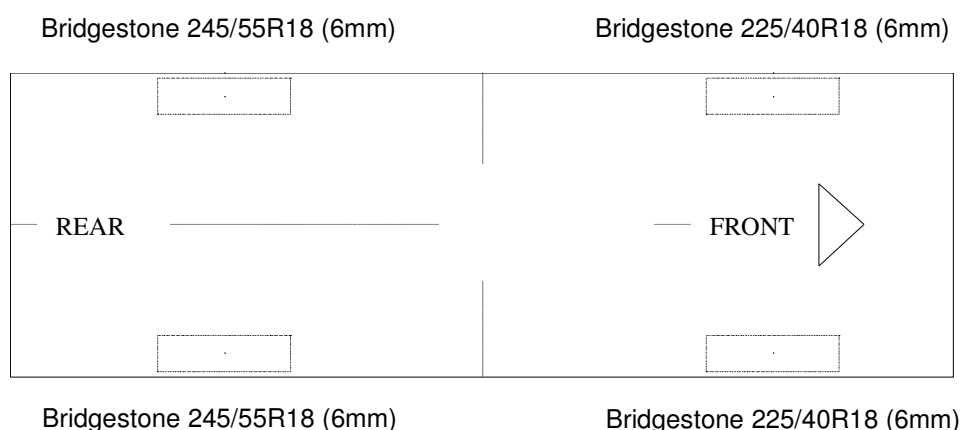
6. It was fitted with 18inch sport wheel rims that were wrapped with tyres that were observed to be of serviceable condition. The tyres were also sufficiently inflated for vehicular operation. The tyre brand, tyre size and approximate remaining tread depth of the 4 tyres of the Motor Car were recorded as follows: -

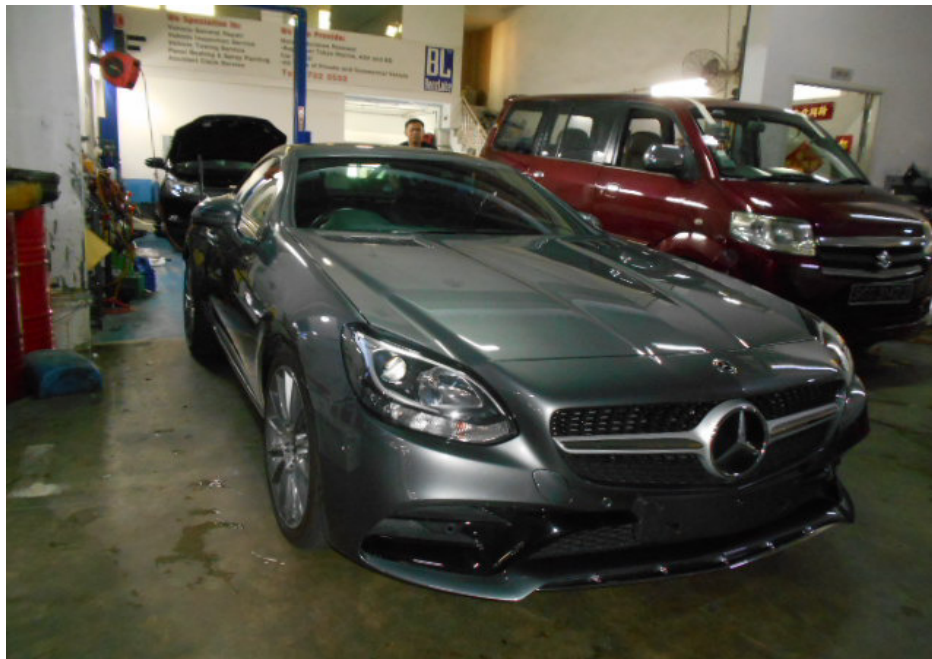
5. The Motor Car was observed to be in a relatively good general condition with no loose exterior fittings observed.

**Photo 1** shows a general view of the front right body of the Motor Car at the time of my inspection. The Motor Car was observed to be in relatively good general condition with no loose exterior fittings observed.

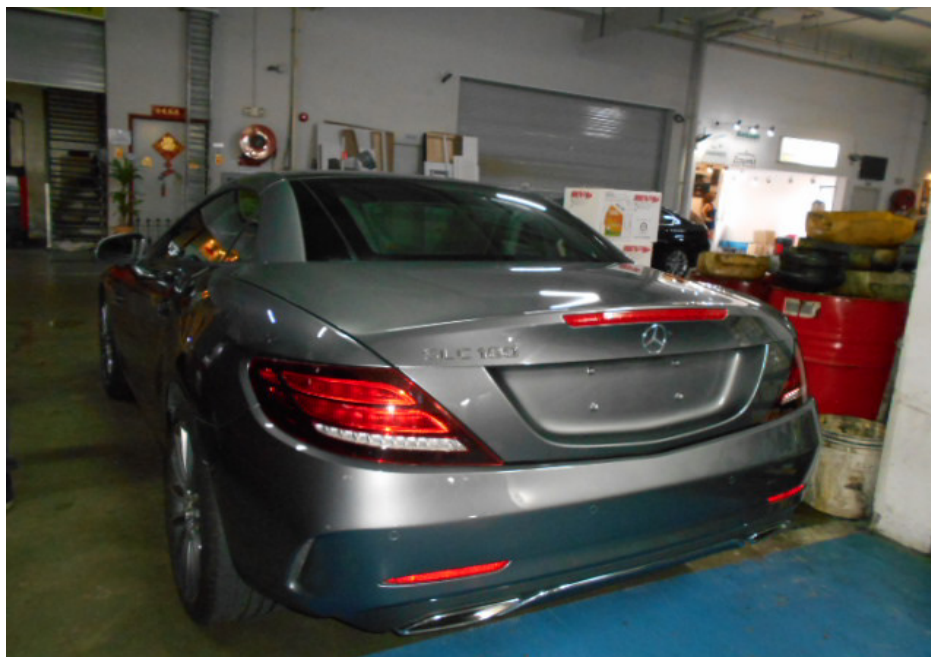
**Photo 2** shows a general view of the rear left body of the Motor Car at the time of my inspection. The Motor Car was observed to be in relatively good general condition with no loose exterior fittings observed.

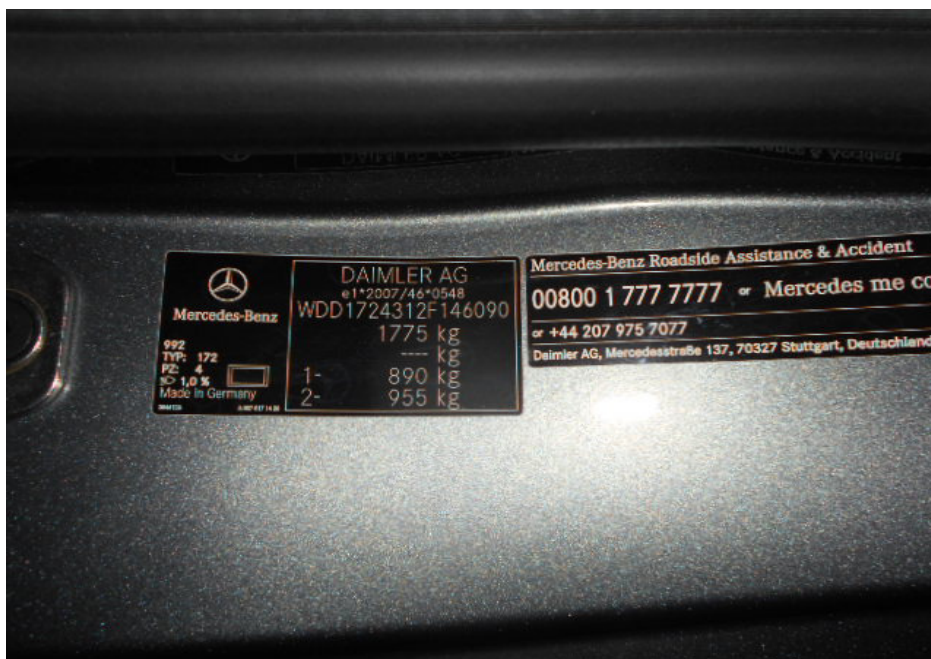
**Photo 3** shows the chassis number of the Motor Car. The chassis number recorded was WDD1724312F146090.

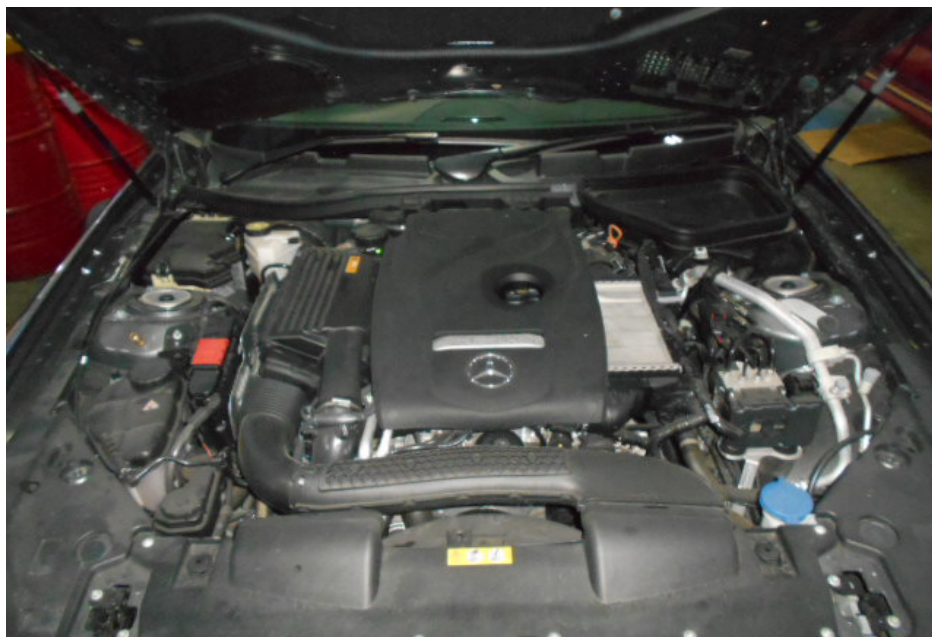
12. My examination of the engine compartment of the Motor Car revealed that the various parts and components inside the engine compartment were all intact and properly fitted. The engine oil, brake fluid and engine coolant were all found to be of sufficient level for operating purposes. Visually, there was also no contamination found to these fluids.
13. My checks on the underside of the Motor Car revealed no sign(s) or indication(s) of fluid leakage and/or fluid stain(s). The engine block and automatic transmission assembly were both secured properly. They were not mounted onto the chassis body or any integral body part of the Motor Car. All undercarriage components of the Motor Car were also observed to be intact and secured in an appropriate manner.

**Photo 4** shows a general view of the engine compartment of the Motor Car at the time of my inspection. The various parts and components inside the engine compartment were all observed to be intact and properly fitted. There was also no sign(s) or indication(s) of fluid leak and/or fluid stain found inside the engine compartment. The engine oil, brake fluid and engine coolant were all found to be of sufficient level for operating purposes. Visually, there was also no contamination found to these fluids.

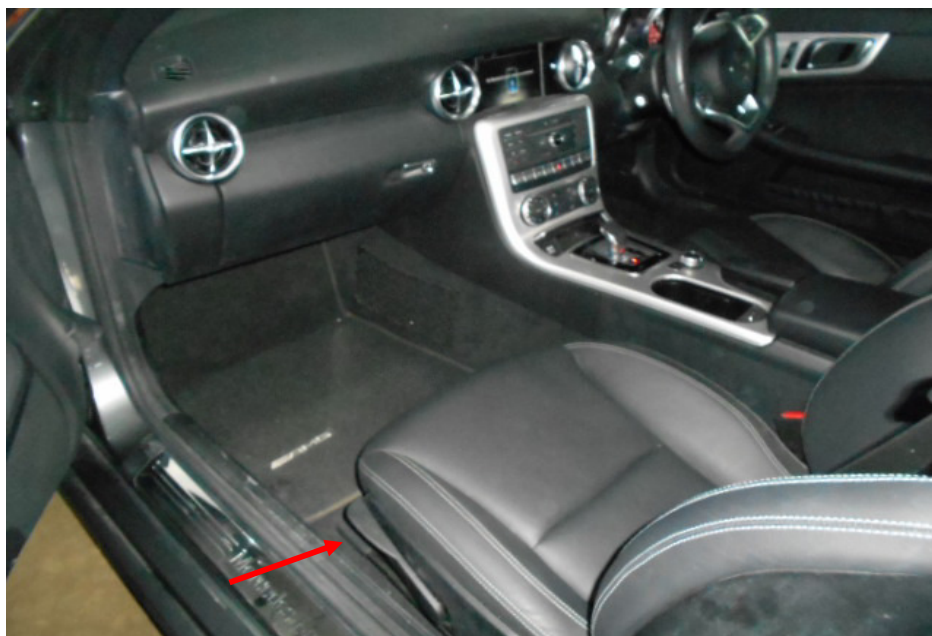
10. The seats of the Motor Car were found to be secured to the floor board of the Motor Car via seat rails bolted onto the floor board. Retractable seat belt reels and pre-tensioners were fitted on all seats of the Motor Car. The seat belt reels were able to be fastened securely to the respective pre-tensioner that is fixed to the side of all the seats.

**Photo 5** shows the front left seat of the Motor Car. The Motor Car is a 2-seater type of Motor Car. The 2 seats were secured via seat rails (arrowed) to the floor board. The seats were also fitted with a retractable seat belt reel and pretensioner. The seat belts were tested and able to be fastened to the pretensioners that were fitted on the side of each individual seat.

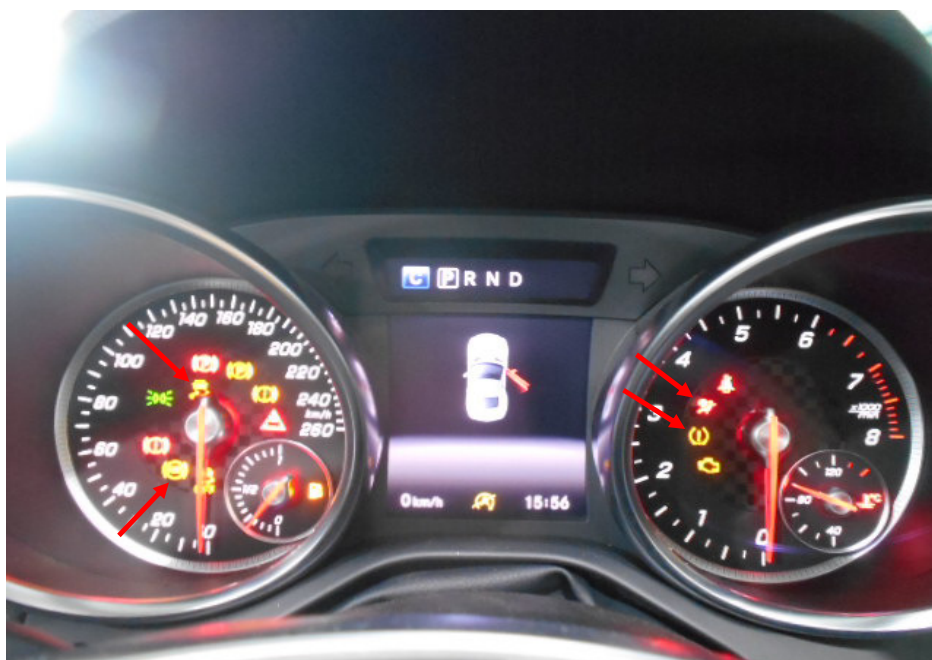
11. The Motor Car's automatic self-test of the functionality of its various electronic safety features like the Anti-Brake Lock System (ABS), Supplemental Restraint System (SRS), Tyre Pressure Monitor (TPM) and Traction Control System (TCS) during cranking of the engine had indicated that these electronic systems were in working condition. This was determined from the respective warning lights disappearing from the instrument panel after the self-test.

**Photo 6** shows the warning lights for the various electronic safety features appearing on the instrument panel of the Motor Car during its self-test when the engine is cranked, in particular the ABS, SRS, TPM and TCS lights (arrowed).

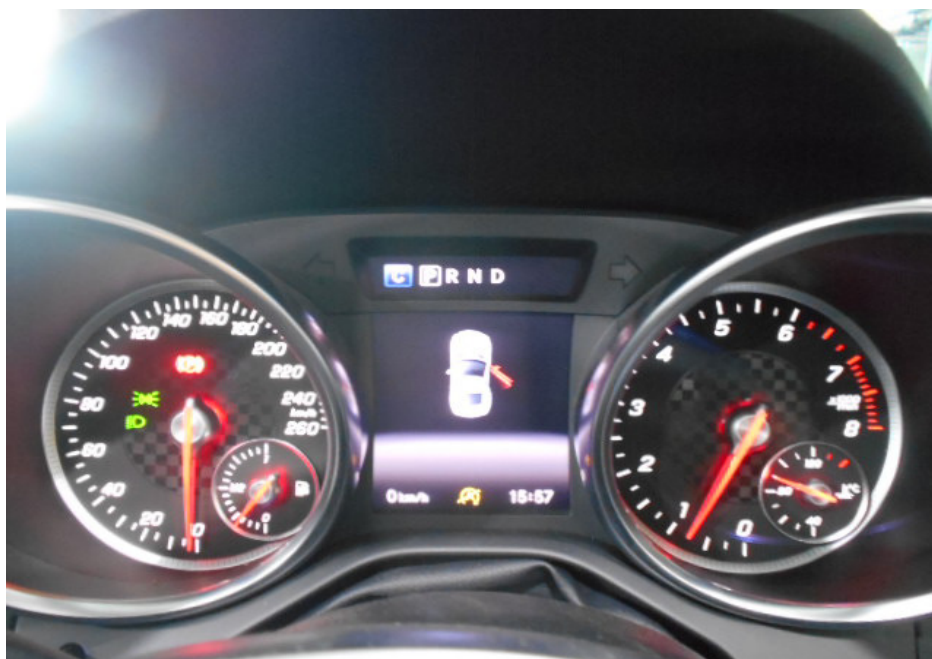
**Photo 7** shows the respective warning lights no longer illuminated, indicating that there is no fault detected to the ABS, SRS, TPM and TCS systems of the Motor Car during the self-test. These electronic systems were hence in working condition at the time of my inspection.

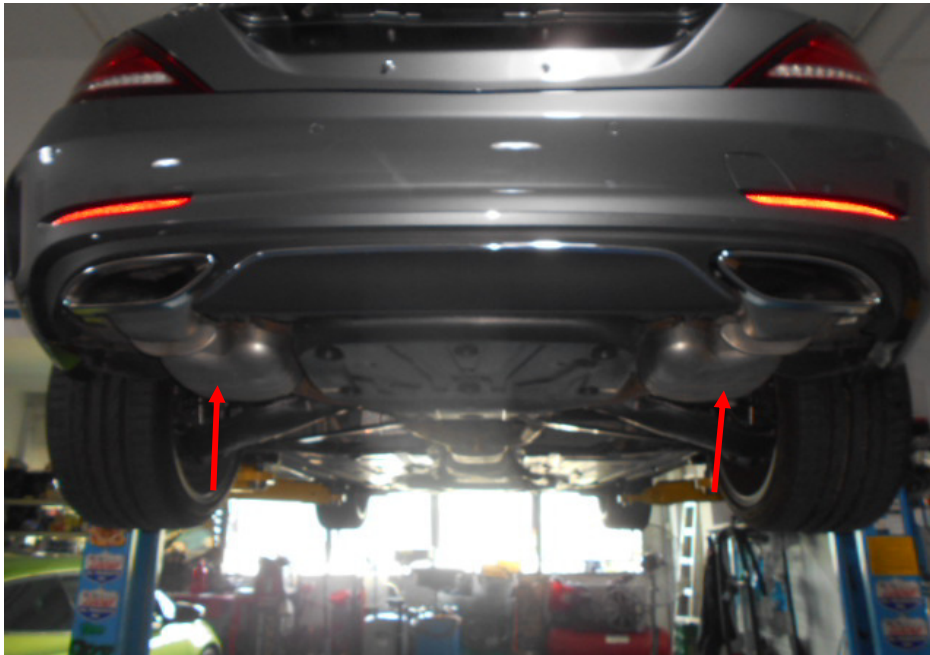
**Photo 8** shows the Motor Car hoisted up for checks on its undercarriage. There was no sign(s) or indication(s) of fluid leakage and/or fluid stain(s) found on the underside of the Motor Car. The undercarriage components were all observed to be intact and secured in an appropriate manner. My examination of the Motor Car's exhaust system revealed no sign(s) or indication(s) of any cut or weld marks along its exhaust pipes and on its rear mufflers (arrowed).

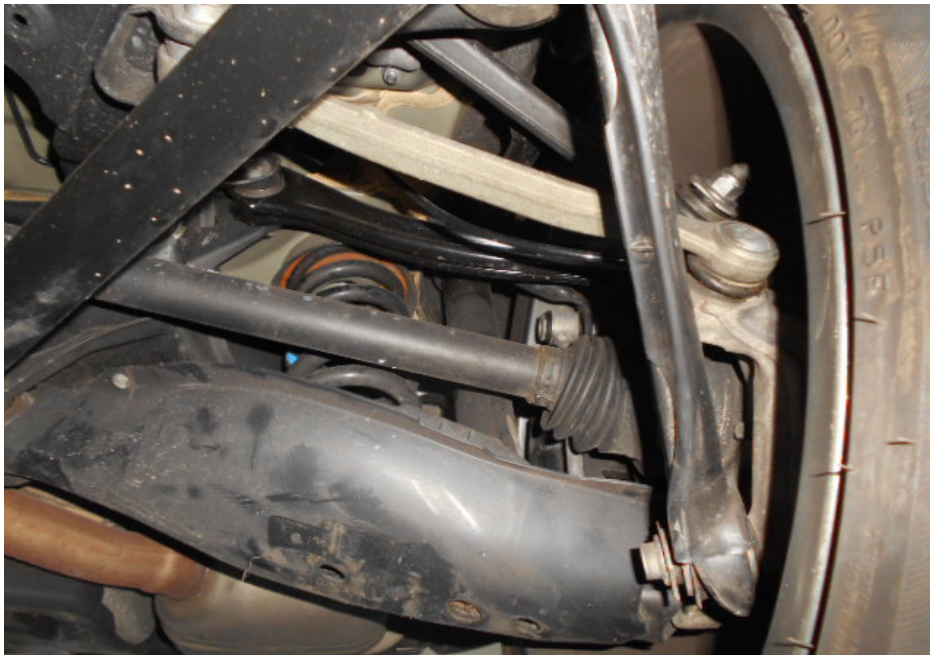
**Photo 9** shows a general view of the control arms and linkages at the rear left wheel of the Motor Car. I did not observe any fluid leak and/or fluid stain on the underside of the Motor Car. All of the Motor Car's undercarriage components were observed to be intact and secured in an appropriate manner.

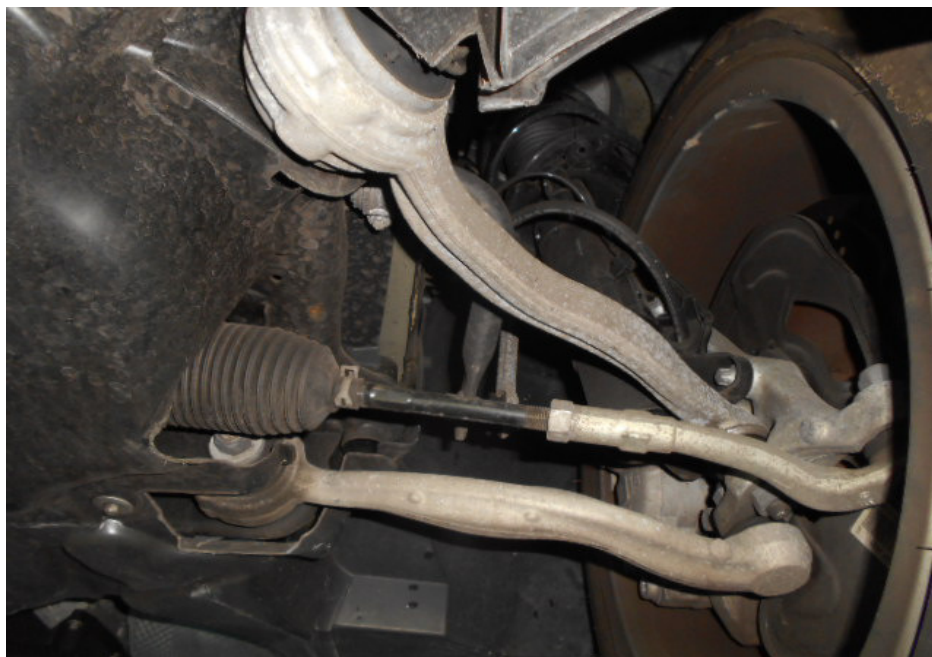
**Photo 10** shows the various undercarriage components at the front left wheel of the Motor Car. The mechanical components, control arms and linkages were all found to be intact and secured in an appropriate manner.

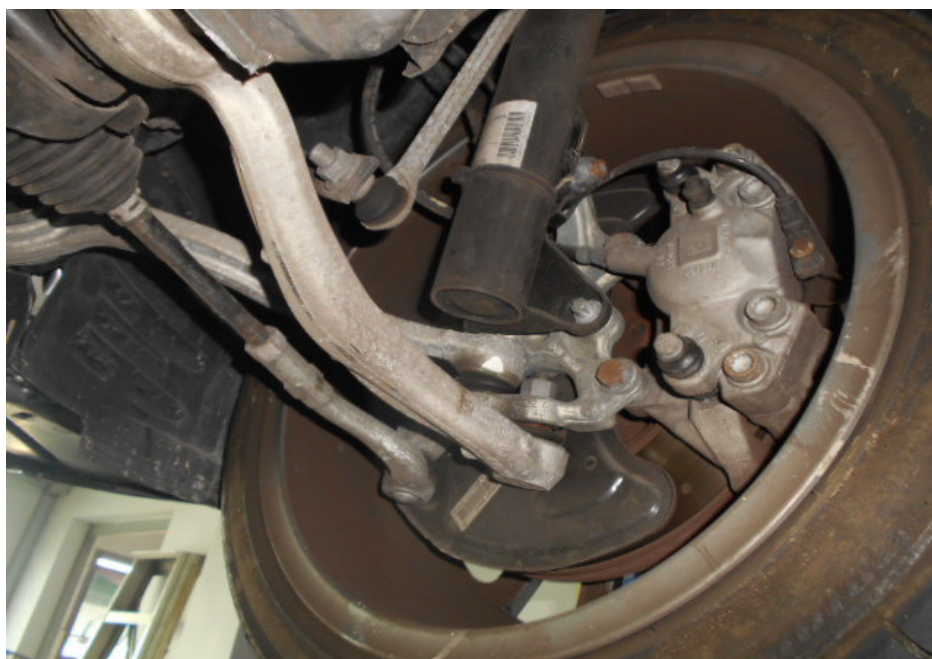
**Photo 11** shows the various undercarriage components at the front right wheel of the Motor Car. The mechanical components, control arms and linkages were all found to be intact and secured in an appropriate manner. I did not observe any fluid leak and/or fluid stain on the underside of the Motor Car.

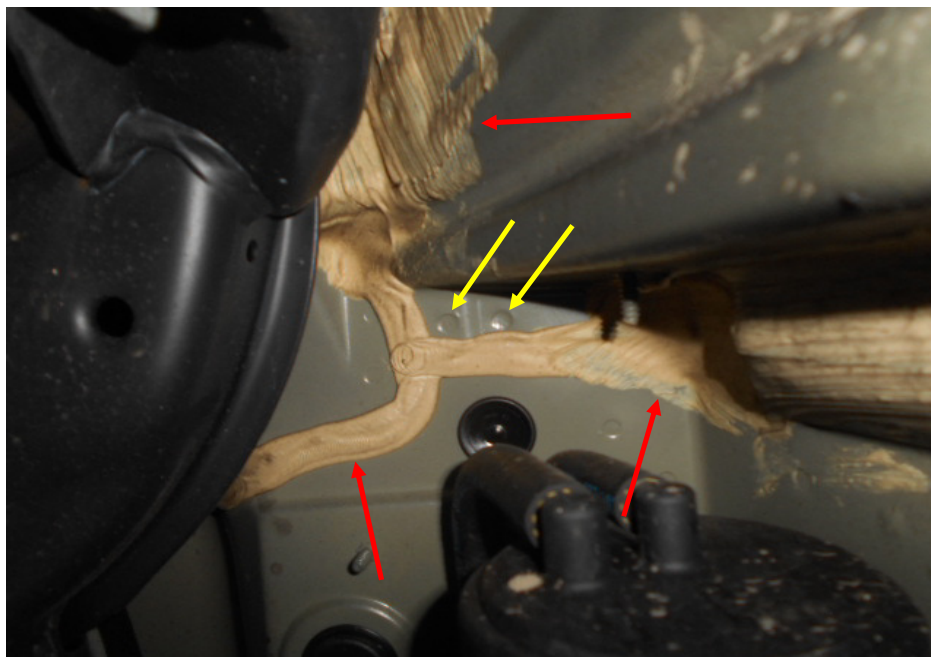
9. Visually, I did not find any weld marks, other than the original spot weld marks, on the chassis body of the Motor Car. The original factory sealant at the joints along the chassis body was also untouched, again indicating that no replacement of the chassis body was carried out; and that the chassis body was originally fitted.

**Photo 12** shows the structural body at the rear right underside of the Motor Car. Visually, I did not find any weld marks other than original spot weld marks (yellow arrow) on the chassis body of the Motor Car. The original factory sealant (red arrow) at the joints along the chassis body was also untouched, indicating no work was done on the chassis body of the Motor Car and that the chassis body was originally fitted.

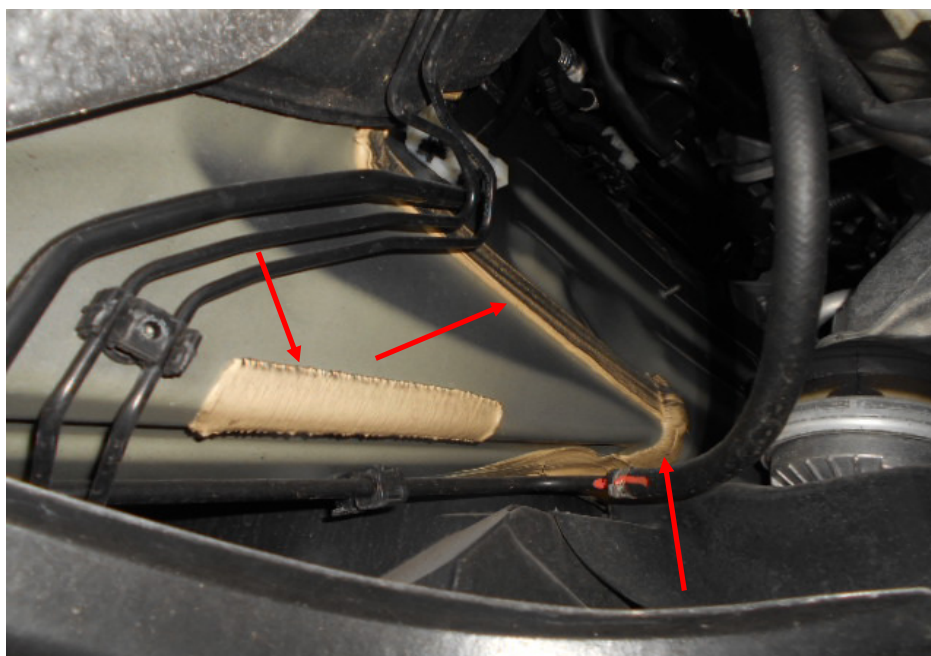
**Photo 13** shows the structural body at the centre left underside of the Motor Car. The original factory sealant at the joints (arrowed) along the chassis body was untouched, indicating no work was done on the chassis body of the Motor Car and that the chassis body was originally fitted.

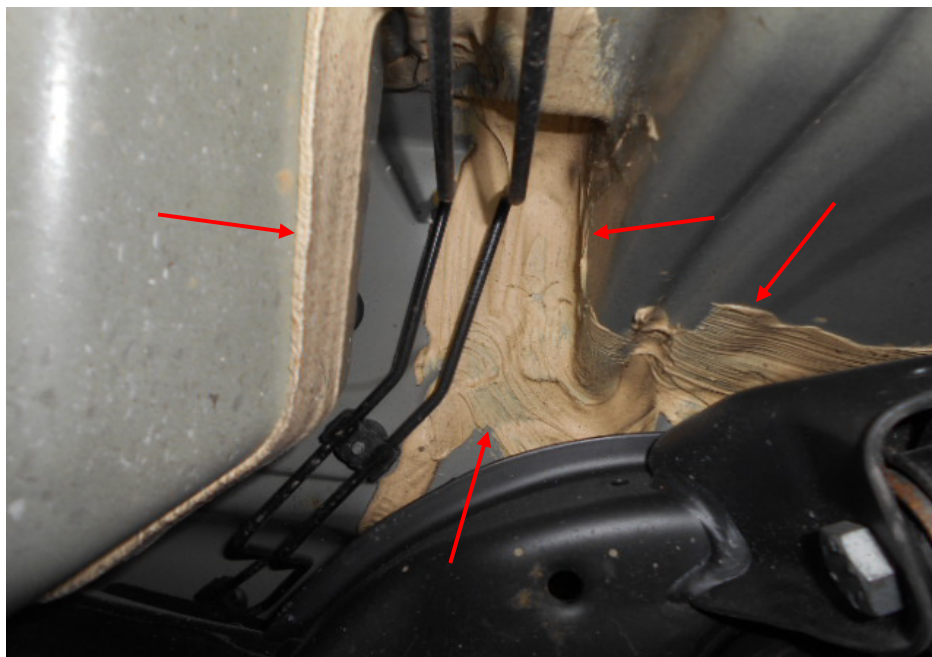
**Photo 14** shows the structural body at the rear left underside of the Motor Car. The original factory sealant at the joints (arrowed) along the chassis body was untouched, indicating no work was done on the chassis body of the Motor Car and that the chassis body was originally fitted.

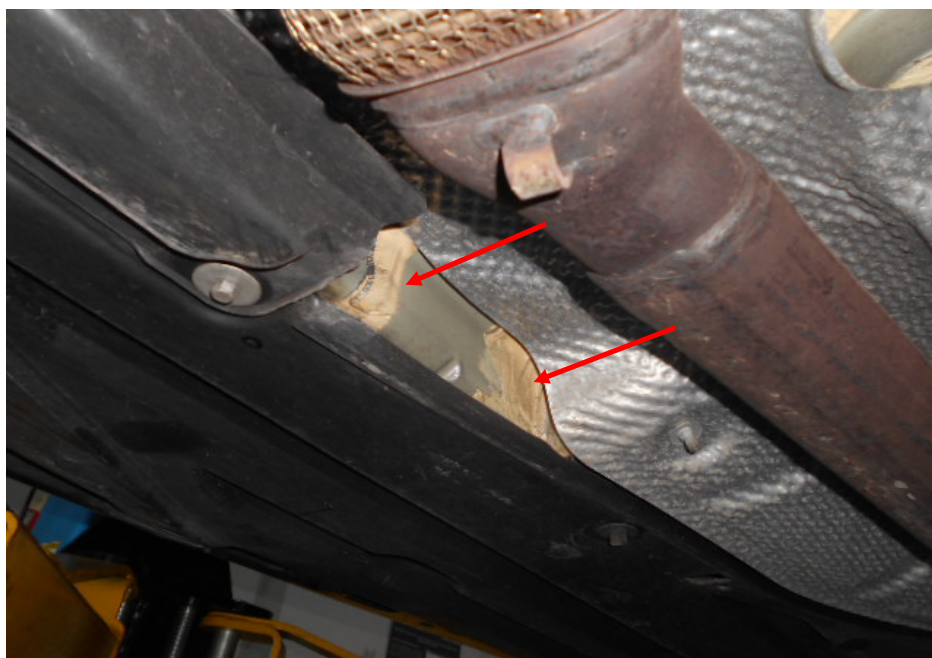
**Photo 15** shows the structural body at the centre right underside of the Motor Car. The original factory sealant at the joints (arrowed) along the chassis body was untouched, indicating no work was done on the chassis body of the Motor Car and that the chassis body was originally fitted.

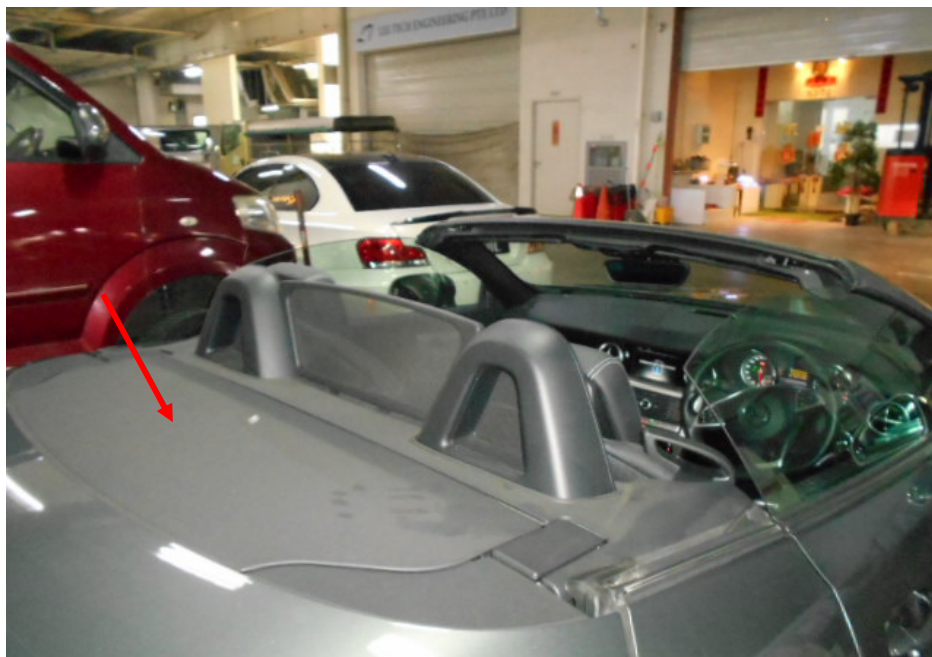
16. The Motor Car's hard top (convertible) was also tested and it was observed that, as a safety feature, the hard top could open and close only when the Motor Car was in a stationary position. When opened, the hard top is completely folded into the rear boot compartment with no parts protruding out of the Motor Car's body. The hard top was also found adequately secured to the "A" Pillar after closing.

**Photo 16** shows the Motor Car's hard top (convertible) opened during my testing. It was observed that as a safety feature, the hard top could open and close only when the Motor Car was in a stationary position. When opened, the hard top is completely folded into the rear boot compartment (arrowed) with no parts protruding out of the Motor Car's body. The hard top was also found adequately secured to the "A" Pillar after closing.
