Your Ref: M1902714  
Our Ref :CS/TMI19007038/D

29 April 2019

**Tokio Marine Insurance Singapore Ltd**

**TECHNICAL INVESTIGATION REPORT OF FIRE INCIDENT INVOLVING THE  
INSURED VEHICLE SKC 8078C ON 16 APRIL 2019**

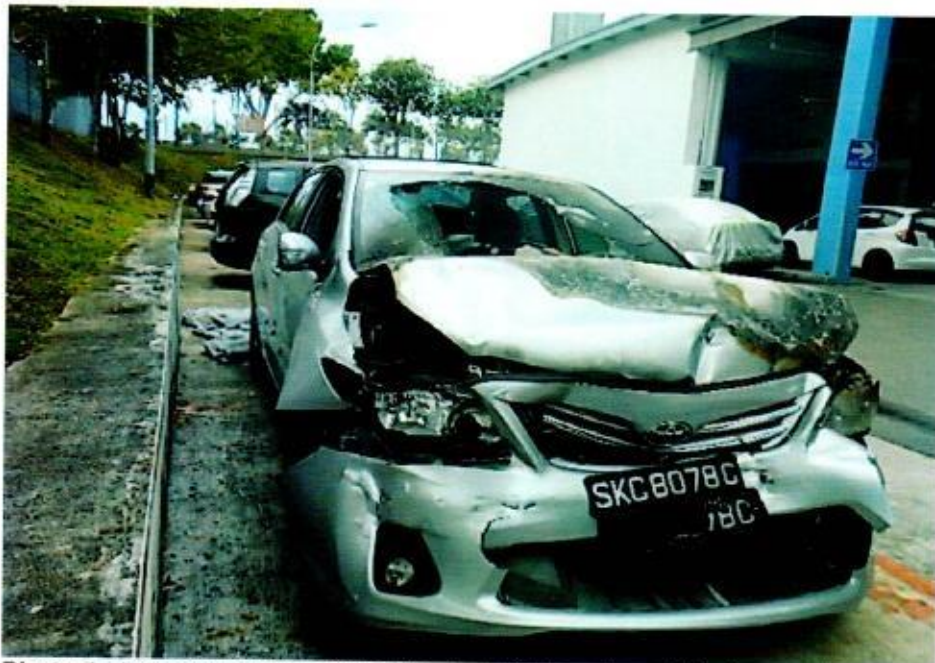
Photo 1 shows a general view of the front right portion of the Insured Vehicle at the time of my inspection. The fire damage to the Insured Vehicle was confined to its frontal portion. Its front bonnet and front windscreen were amongst the body parts that were found to have been affected as a result of the fire. Apart for the fire damage, the Insured Vehicle was also observed to have sustained impact damage at its frontal portion. Its front bumper, front fenders, front grille and front bonnet were all observed to have been damaged. The impact damage pattern suggests that the direction of impact was from the front to rear of the Insured Vehicle.

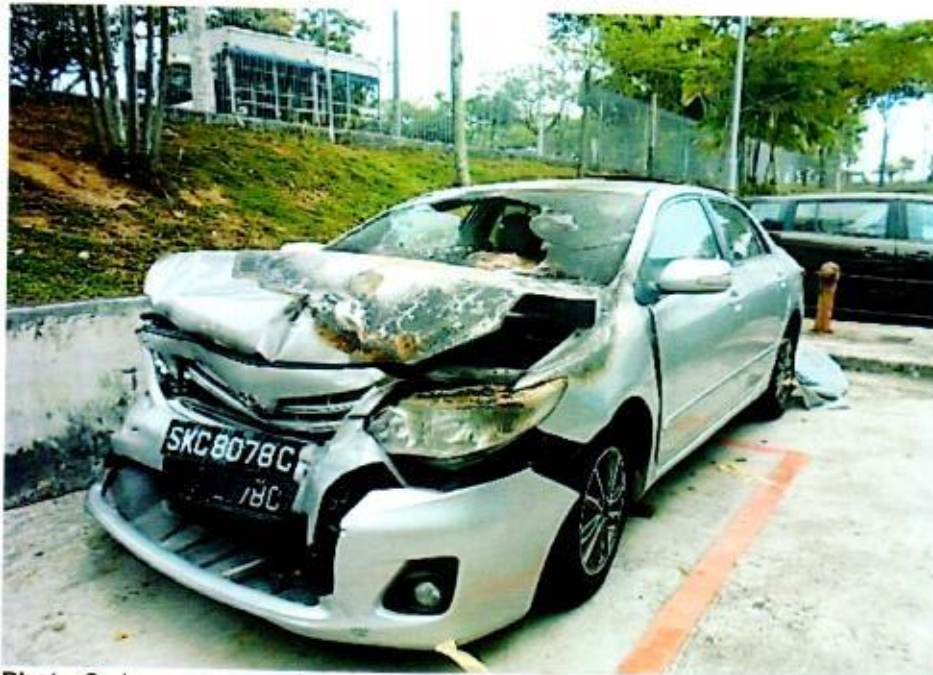
**Photo 2** shows a general view of the front left portion of the Insured Vehicle at the time of my inspection. The fire damage to the Insured Vehicle was confined to its front portion. Its front bonnet, front left headlamp and front left fender were amongst the body parts that were found to have been affected as a result of the fire. Apart for the fire damage, the Insured Vehicle was also observed to have sustained impact damage at its frontal portion.

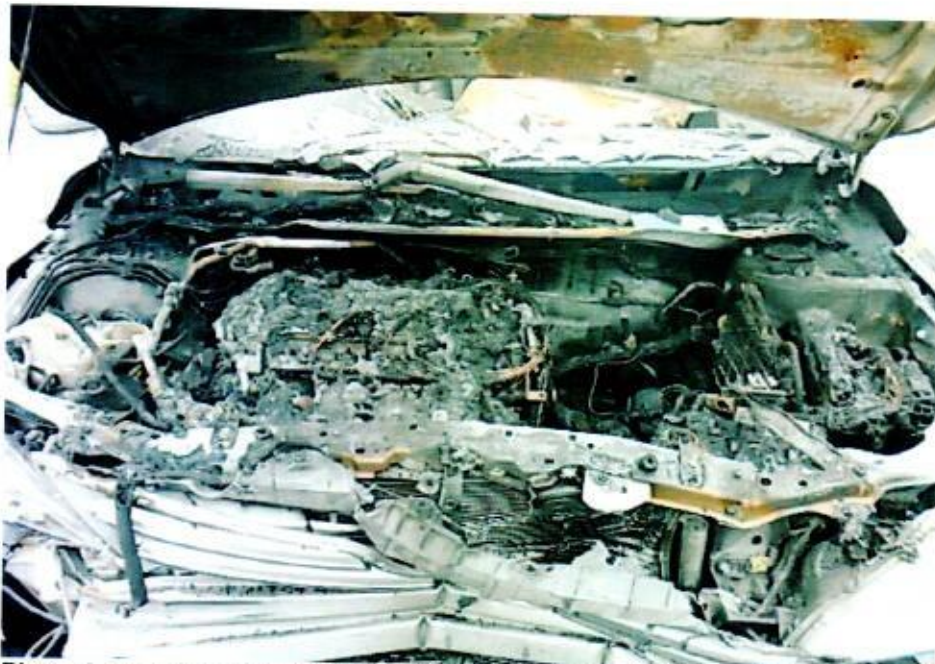
**Photo 3** shows the engine compartment of the Insured Vehicle at the time of my inspection. The engine compartment of the Insured Vehicle was observed to be severely burnt. Most of the parts inside the engine compartment were found to be burnt and/or melted as a result of the fire.

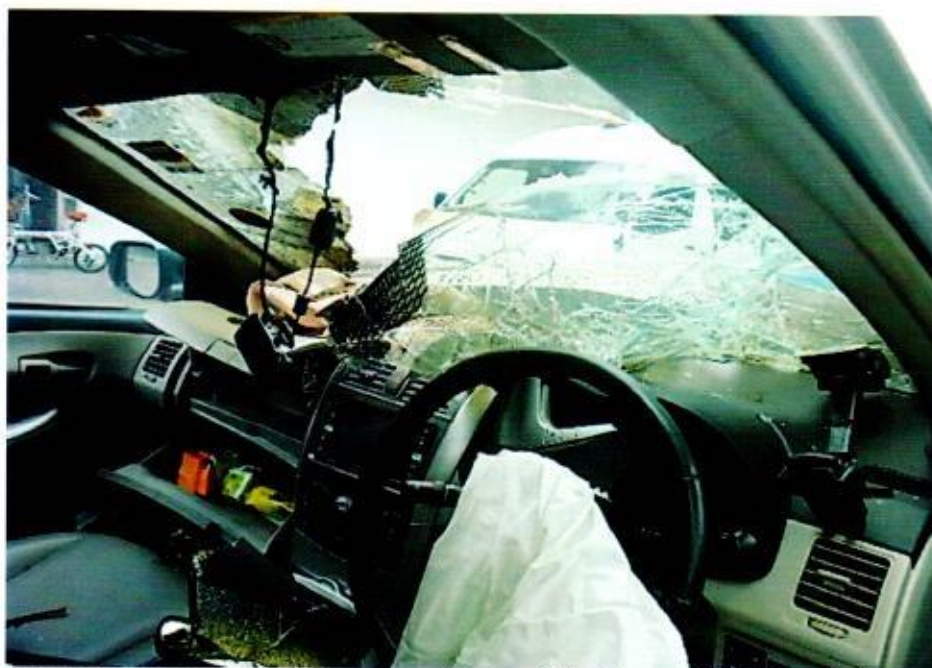
**Photo 4** shows the interior compartment of the Insured Vehicle, which was observed to be partially burnt at the front area. The front dashboard and roof upholstery were amongst the parts that were found to have been burnt and/or melted as a result of the fire.

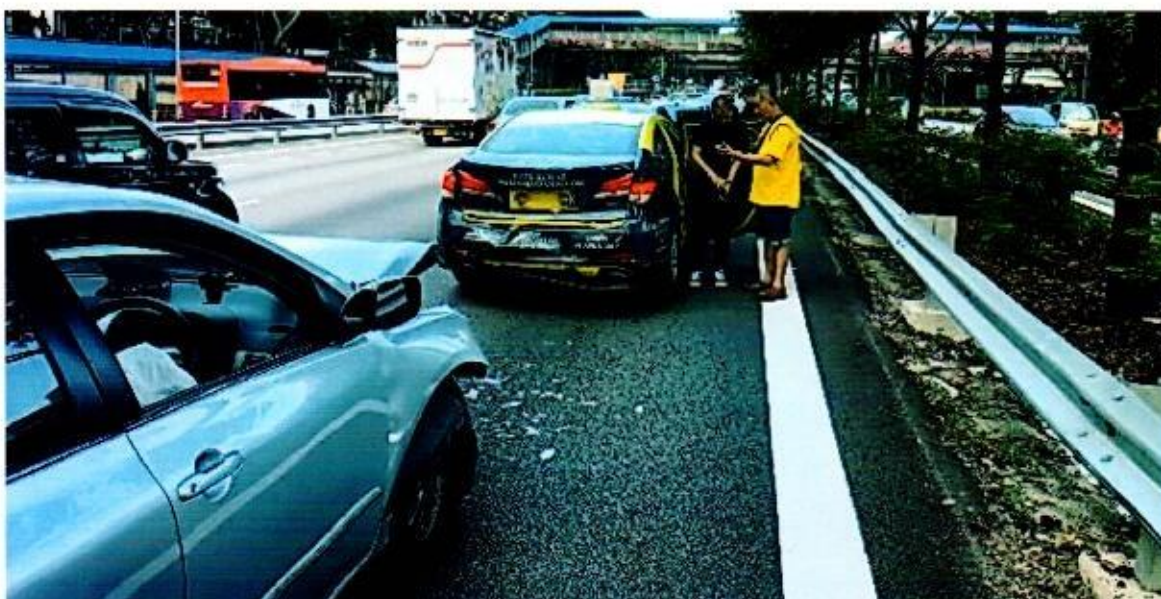
**Photo 6** shows the accident scene at PIE towards Changi Airport. From the photographs provided by Mr Lim, a Citycab motor taxi was directly in front of the Insured Vehicle.

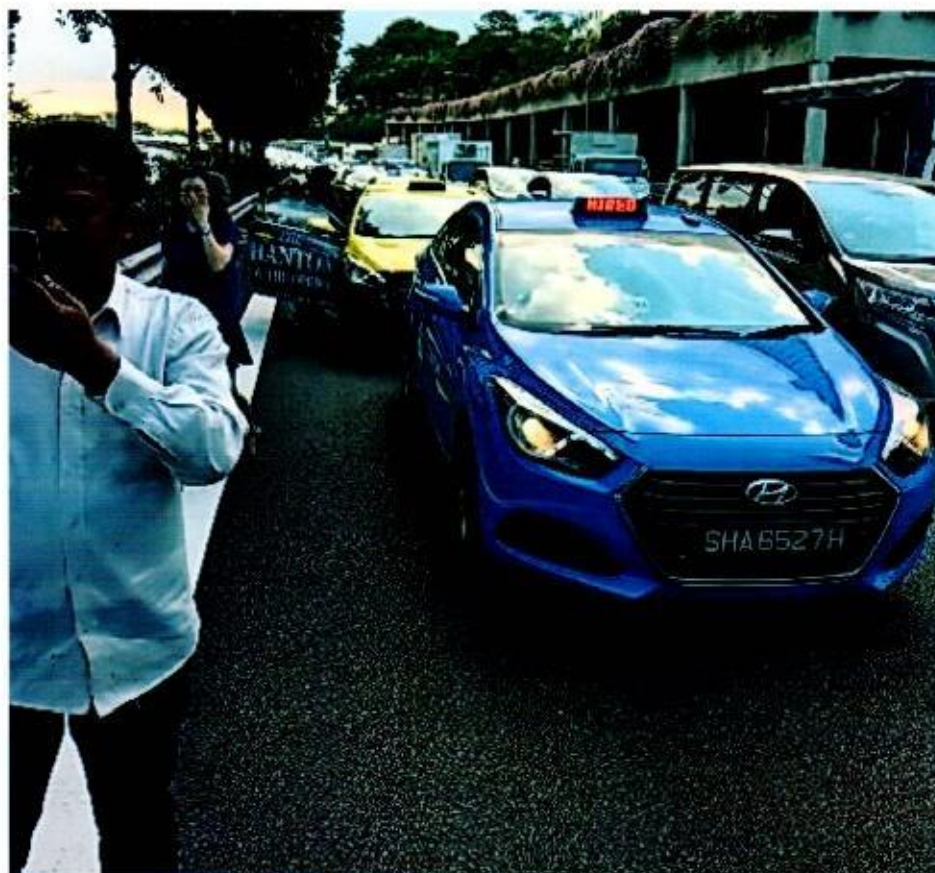
**Photo 7** shows the accident scene at PIE towards Changi Airport. From the photographs provided by Mr Lim, a Comfort motor taxi was directly in front of the Citycab motor taxi.

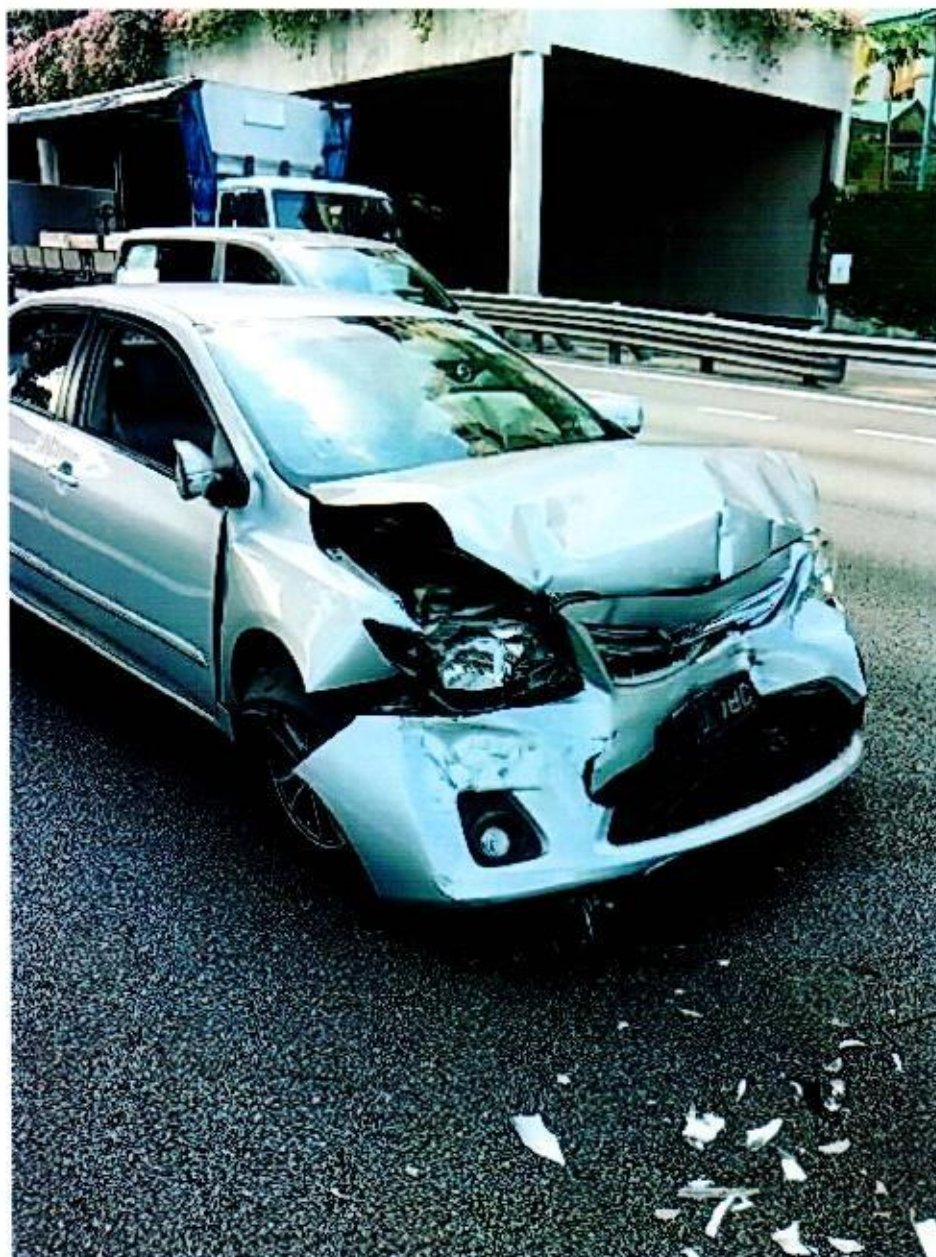
**Photo 8** shows a general view of the Insured Vehicle at the accident scene along PIE towards Changi Airport. From my review of the photographs provided by Mr Lim, I note that the Insured Vehicle had sustained impact damage at its frontal portion. There was no damage of fire nature seen on the Insured Vehicle at the accident scene. There was also no leaked fluid seen on the road surface where the Insured Vehicle had come to a stop.

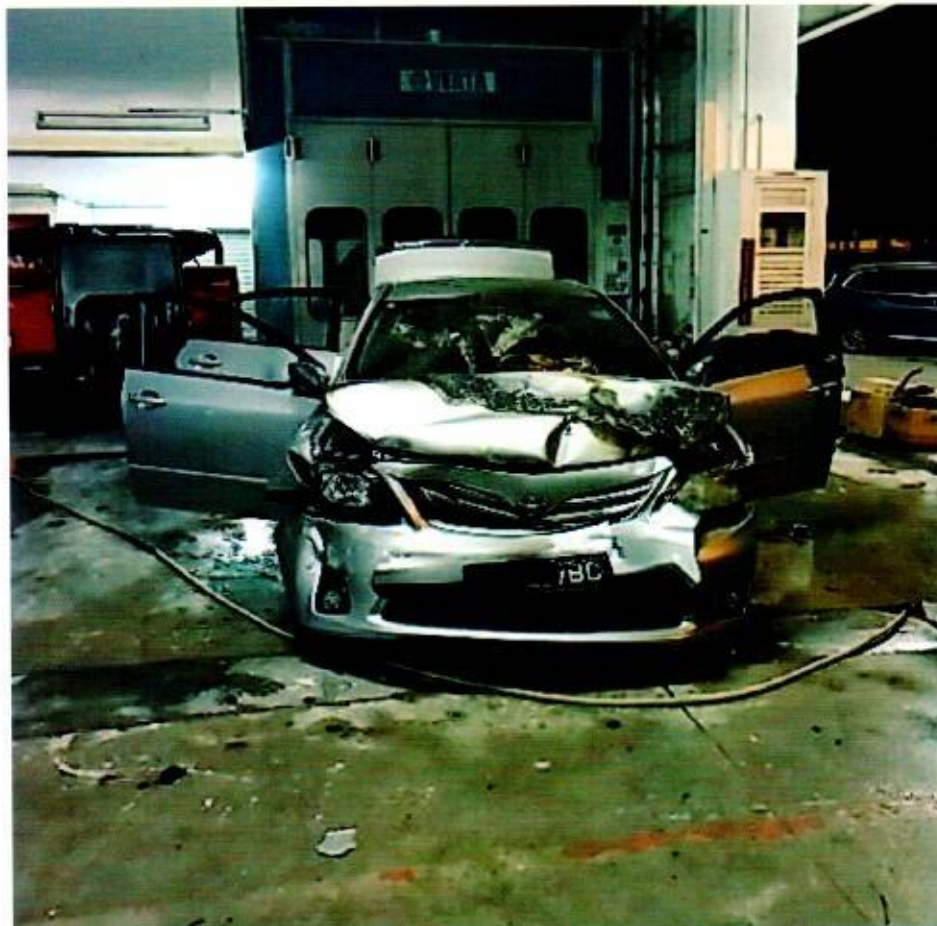
18. Upon reviewing the photographs showing the Insured Vehicle at the premise of M/s Chin Meng Motors after the fire was extinguished, I note that the Insured Vehicle was parked at the porch area directly in front of the shutter door leading to the workshop of M/s Chin Meng Motors. Upon close examination of the photographs, there appears to be no unusual foreign material(s) and/or object(s) found on the ground in the immediate area of where the Insured Vehicle was parked.
19. Generally, the impact damage seen on the Insured Vehicle after the fire was similar to the damage that was seen on the Insured Vehicle whilst it was at the accident scene along PIE. The overall damage (fire nature and impact nature) was similar to the damage observed when I had inspected the Insured Vehicle. See photo 9 below.

**Photo 9** shows a general view of the Insured Vehicle at the premise of M/s Chin Meng Motors. This was after the fire was extinguished. Upon close examination of the photographs, there appears to be no unusual foreign material(s) and/or object(s) found on the ground in the immediate area of where the Insured Vehicle was parked.

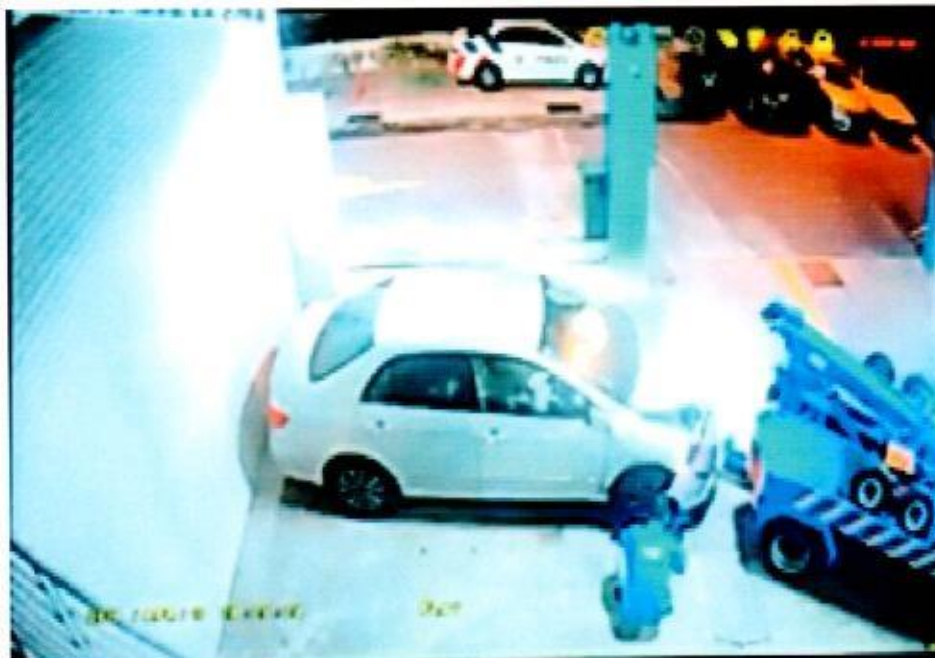
**Screenshot 1** shows the Insured Vehicle having just arrived at the premise of M/s Chin Meng Motors. The tow truck driver could be seen preparing to remove the tow fork from the front wheels of the Insured Vehicle. The shutter doors of M/s Chin Meng Motors were observed to be closed at that time.

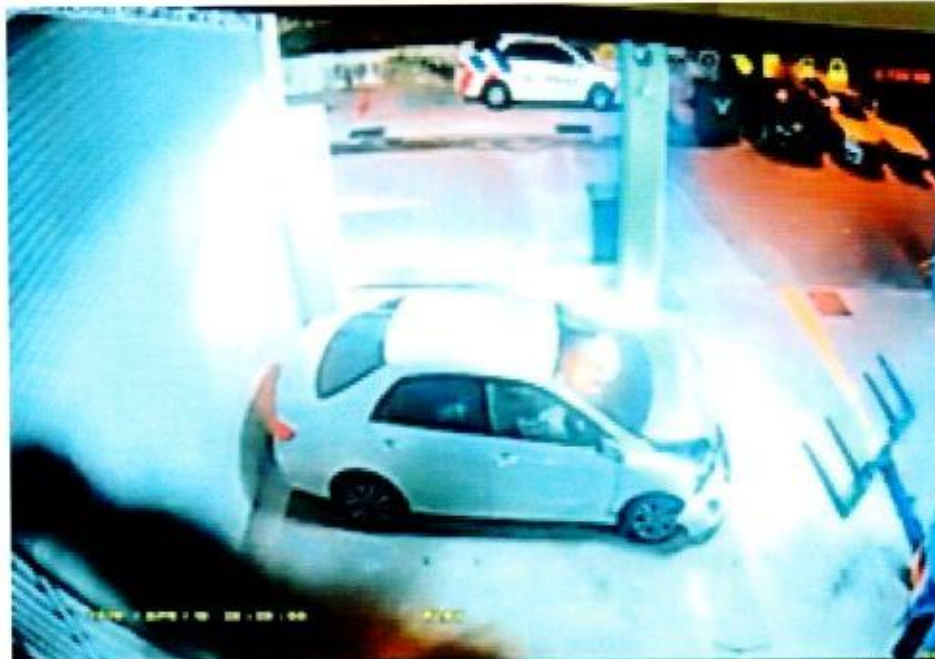
**Screenshot 2** shows the tow truck about to leave the Insured Vehicle. This was approximately 2045hrs thereabouts. The Insured Vehicle was observed to be intact with nothing amiss.

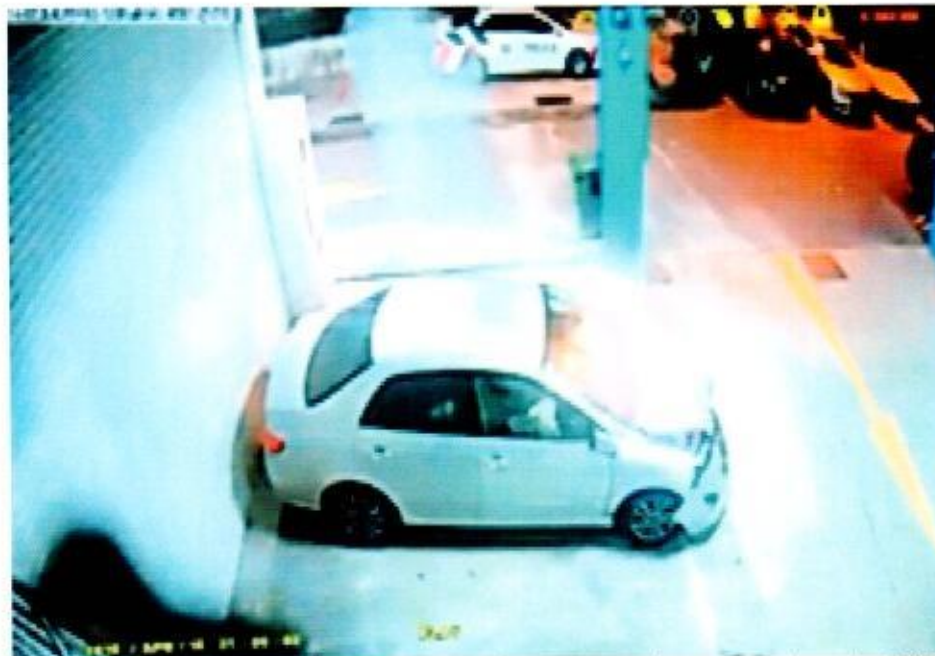
21. At about an hour later, smoke was seen coming out from the engine compartment, from the gaps created by the buckling of the Insured Vehicle's front bonnet that was a result of the accident. A short while later, flames appeared at the engine compartment area and moved onto the front bonnet of the Insured Vehicle. The flames were eventually put out by some members of public using water. Notably, between the time when the tow truck left the premise of M/s Chin Meng Motors till the time when smoke was first seen coming from the Insured Vehicle, there was no abnormal event ie no one walked by or walked near to the Insured Vehicle. The Insured Vehicle was basically untouched during this period. See screenshot 1 – 4 below taken from the video recordings that I had reviewed.

**Screenshot 3** shows smoke emitting from the engine compartment of the Insured Vehicle (note the blur at the bottom part of the front windscreen as compared to the same area in screenshot 2 above). This was about an hour after the tow truck had left. There was no abnormal event seen from the video recording leading up to the time when smoke was first seen.

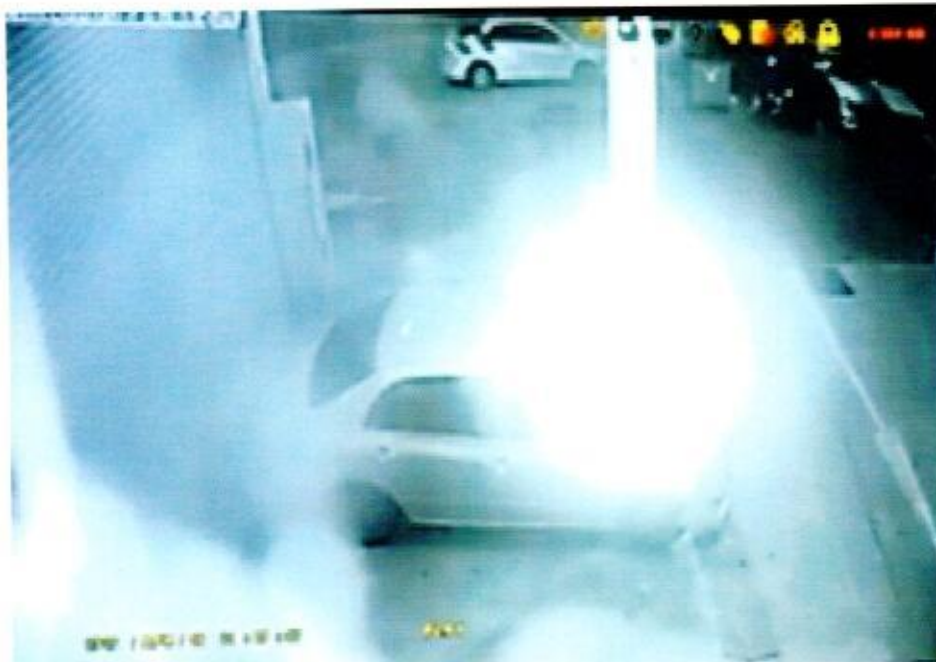
**Screenshot 4** shows fire at the frontal portion of the Insured Vehicle. The flames were initially seen coming from the engine compartment of the Insured Vehicle before moving onto its front bonnet. The fire was eventually put out by some members of public using water.

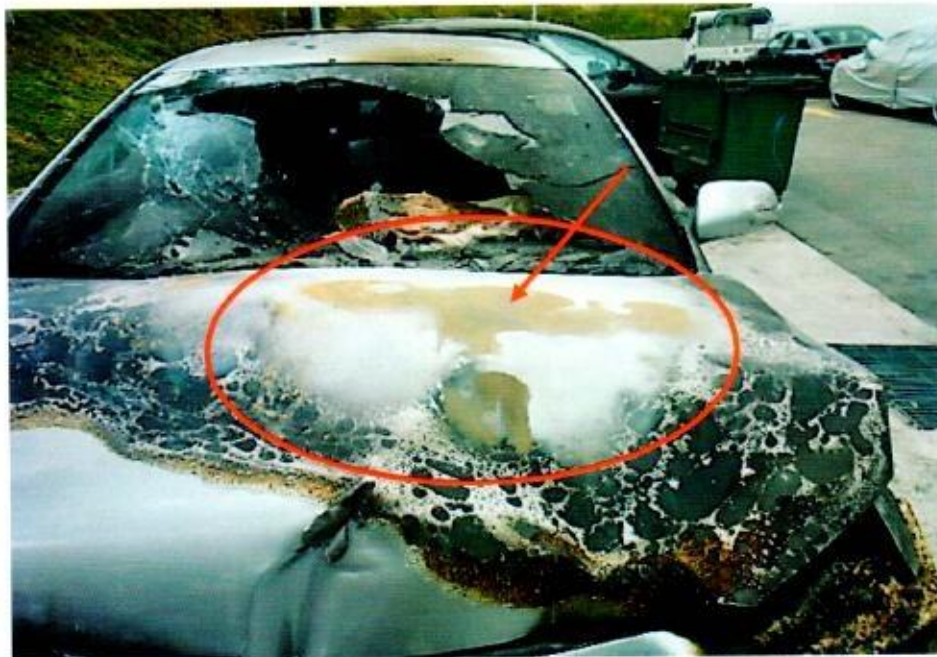
24. High heat intensity burned marks (whitish burn marks) were found at the centre left area of the front bonnet. These whitish burn marks are a result of exposure to prolong heat intensity. Rust would normally start to develop around these areas soon after a fire as prolonged exposure to high heat intensity usually causes steel/metal material body parts to be exposed to natural environmental condition. Note that rust had indeed formed at the centre left area of the Insured Vehicle's front bonnet.

**Photo 10** shows the whitish burn marks (circled) that were found on the centre left area of the Insured Vehicle's front bonnet. Such whitish burn marks are a result of exposure to prolonged heat intensity. Rust (arrowed) would normally start to develop around these areas soon after a fire as prolonged exposure to high heat intensity usually causes steel/metal material body parts to be exposed to natural environmental condition. Following the characteristic of heat rising upwards, the fire to the Insured Vehicle can then be determined to have originated around the centre left area of the engine compartment.

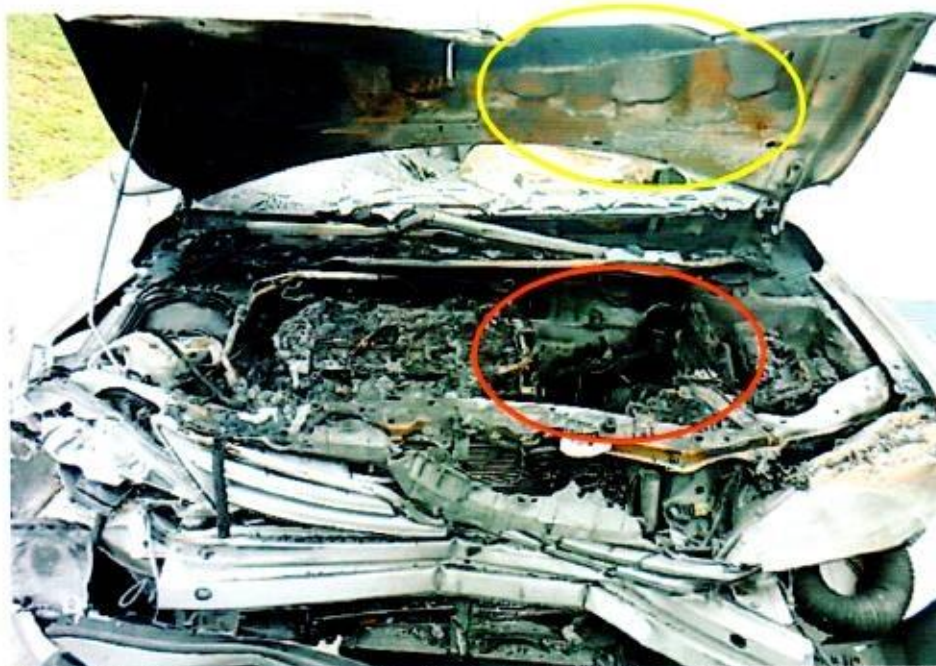
25. Correspondingly, the underside of the front bonnet at the centre left area was also found with similar high heat intensity burn marks (whitish burn marks). Rust had also started to develop at this area. Following the characteristic of heat rising upwards, the burn pattern of the front bonnet would then indicate that the origin of fire was at the centre left area of the Insured Vehicle's engine compartment.

**Photo 11** shows a general view of where the fire to the Insured Vehicle had originated, which was around the centre left area of the engine compartment (red circle). This was established basing on the burn pattern (whitish burn marks and rust) that was found on the top side and the underside (yellow arrow) of the Insured Vehicle's front bonnet.

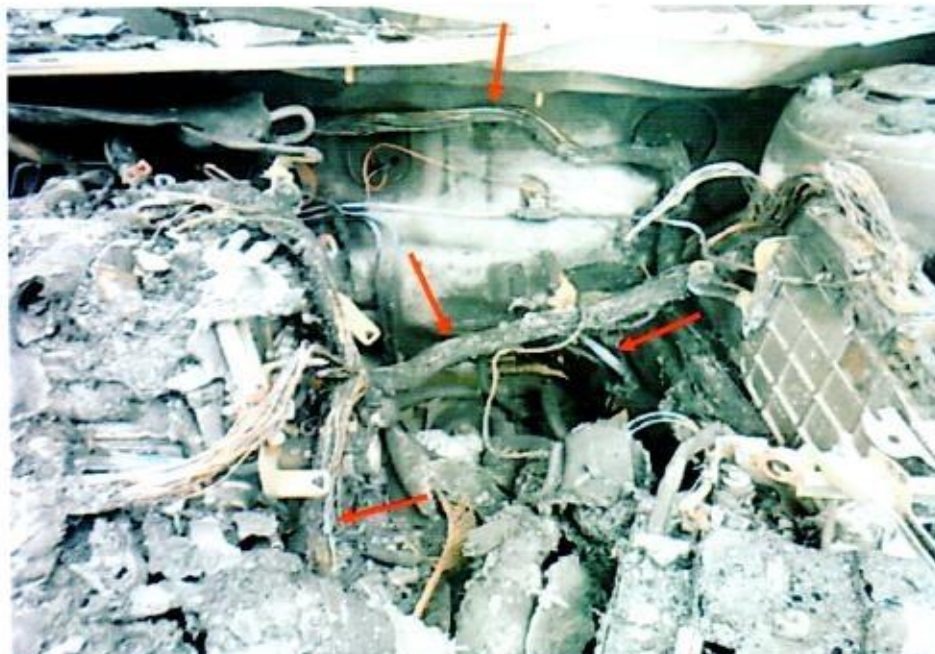
26. My examination of the centre left area of the engine compartment, during my inspection of the Insured Vehicle, revealed greenish residue on several stretches of original factory fitted wirings. The presence of greenish residue indicates internal heating of copper wires, a sign of an electrical short circuit occurring. The greenish residue is normally left behind from oxidation as a result of chemical reaction involving the copper wires. This physical evidence indicates that the cause of fire to the Insured Vehicle was due to electrical in nature. See photo 10 - 14 below.

**Photo 12** shows the wirings around the centre left area of the engine compartment, which was where the fire to the Insured Vehicle had originated. Greenish residue was found on several stretches of wirings (arrowed). These wirings were originally fitted wirings. The presence of such greenish residue suggests occurrence of an electrical short circuit.

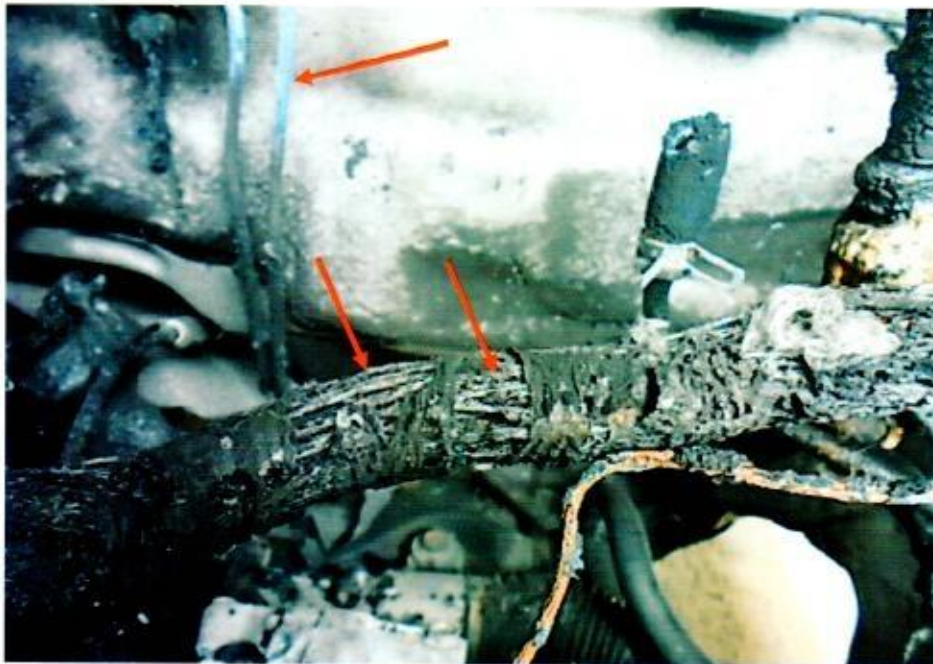
**Photo 13** shows a closer view of the wirings around the centre left area of the engine compartment. Greenish residue was found on the wirings (red arrow). The presence of such greenish residue suggests occurrence of an electrical short circuit. These wirings are original factory fitted wirings.

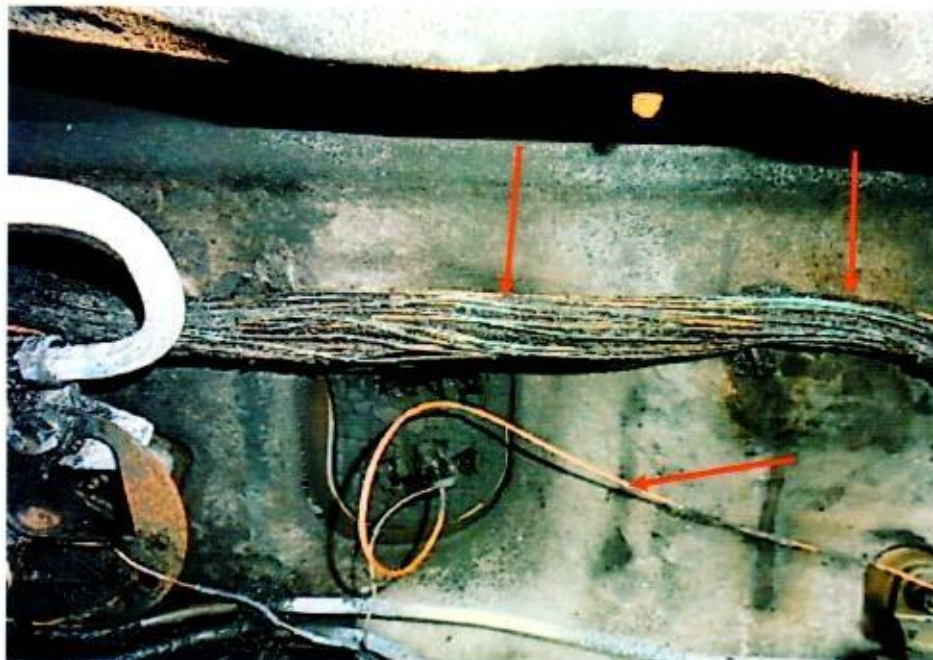
**Photo 14** shows another stretch of original factory fitted wirings that were found with greenish residue. The presence of greenish residue indicates internal heating of copper wires, a sign of an electrical short circuit occurring. The greenish residue is normally left behind from oxidation as a result of chemical reaction involving the copper wires.

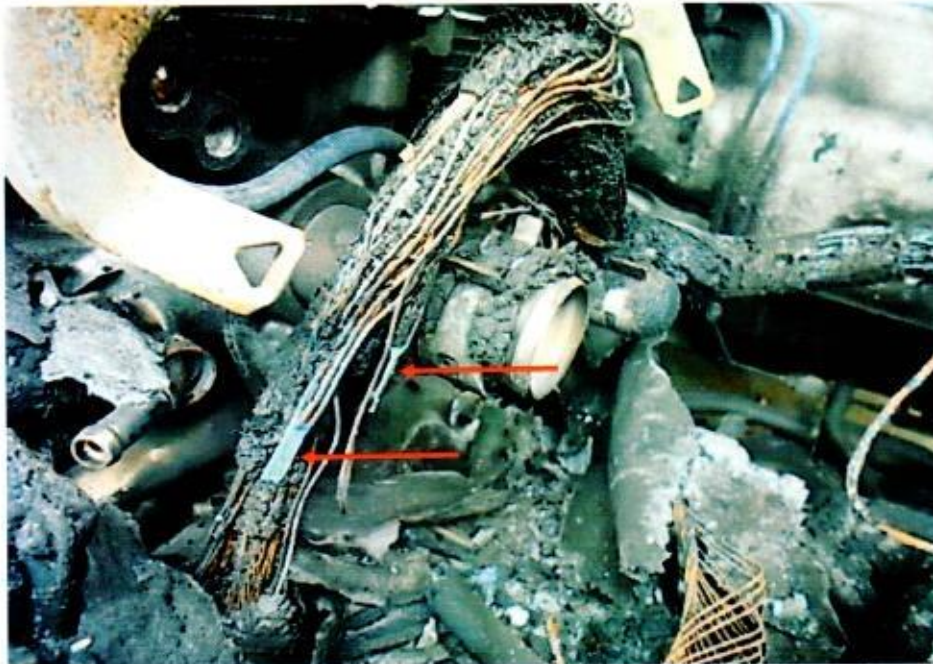
Photo 15 shows another stretch of wirings with greenish residue (arrowed) at the centre left area of the Insured Vehicle's engine compartment. The physical condition of the wirings as seen during my inspection of the Insured Vehicle supports the cause of fire being due to electrical in nature.

27. For this case, the Insured Vehicle was involved in an accident prior to the fire. The impact force arising from the collision had resulted in several body parts at the frontal portion to be pushed/shifted inwards. One of these parts was the battery. This could have caused slight instability to the current/voltage within the electrical system of the Insured Vehicle, ultimately leading to the fire a few hours after the accident.
