Your Ref: M1902714
Our Ref :CS/TMI19007038/D

29 April 2019

TECHNICAL INVESTIGATION REPORT OF FIRE INCIDENT INVOLVING THE INSURED VEHICLE SKC 8078C ON 16 APRIL 2019

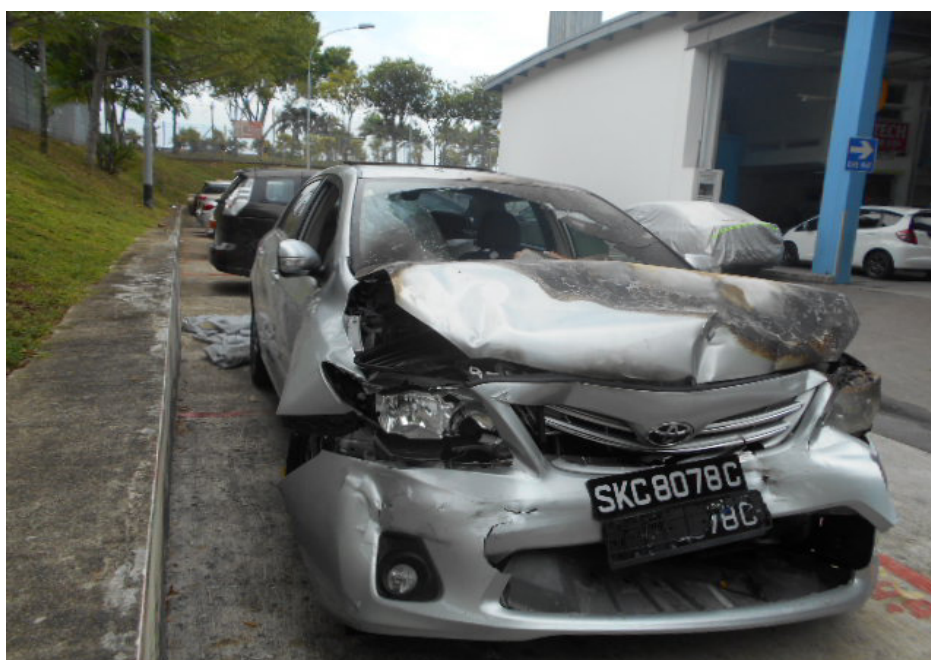
Photo 1 shows a general view of the front right portion of the Insured Vehicle at the time of my inspection. The fire damage to the Insured Vehicle was confined to its frontal portion. Its front bonnet and front windscreen were amongst the body parts that were found to have been affected as a result of the fire. Apart for the fire damage, the Insured Vehicle was also observed to have sustained impact damage at its frontal portion. Its front bumper, front fenders, front grille and front bonnet were all observed to have been damaged. The impact damage pattern suggests that the direction of impact was from the front to rear of the Insured Vehicle.

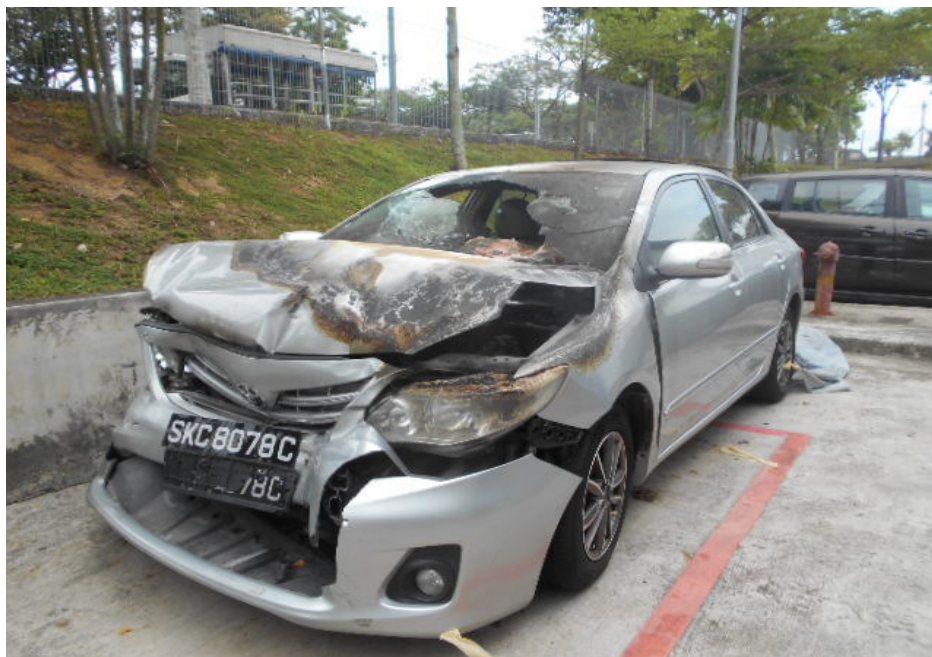
Photo 2 shows a general view of the front left portion of the Insured Vehicle at the time of my inspection. The fire damage to the Insured Vehicle was confined to its front portion. Its front bonnet, front left headlamp and front left fender were amongst the body parts that were found to have been affected as a result of the fire. Apart from the fire damage, the Insured Vehicle was also observed to have sustained impact damage at its frontal portion.

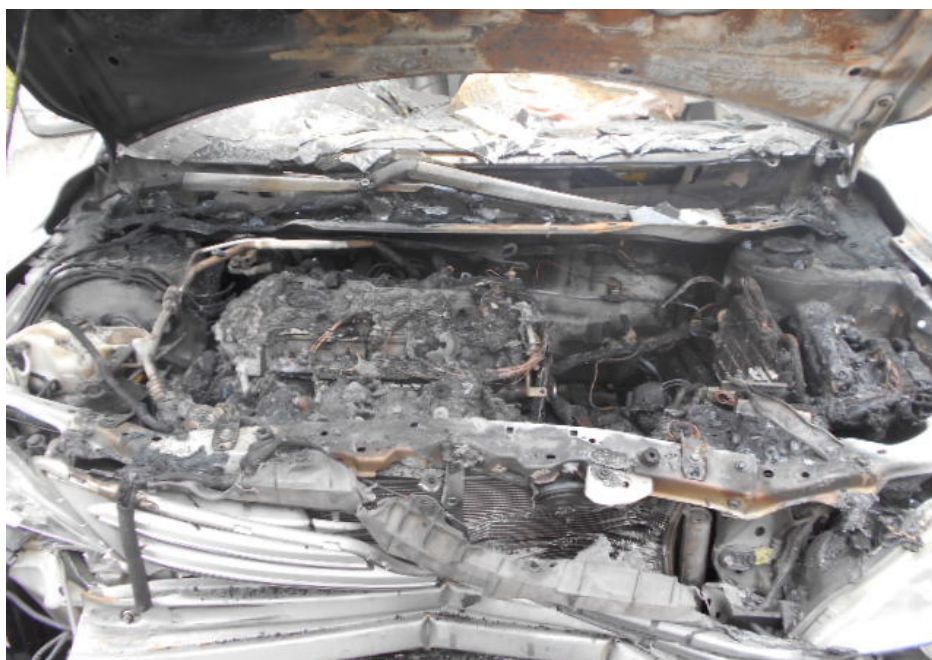
Photo 3 shows the engine compartment of the Insured Vehicle at the time of my inspection. The engine compartment of the Insured Vehicle was observed to be severely burnt. Most of the parts inside the engine compartment were found to be burnt and/or melted as a result of the fire.

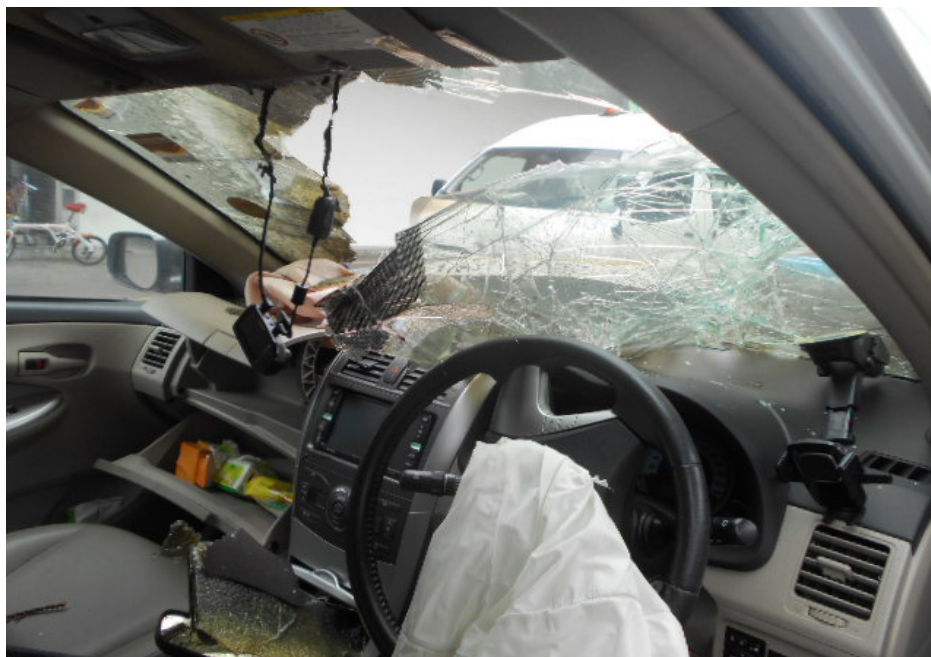
Photo 4 shows the interior compartment of the Insured Vehicle, which was observed to be partially burnt at the front area. The front dashboard and roof upholstery were amongst the parts that were found to have been burnt and/or melted as a result of the fire.

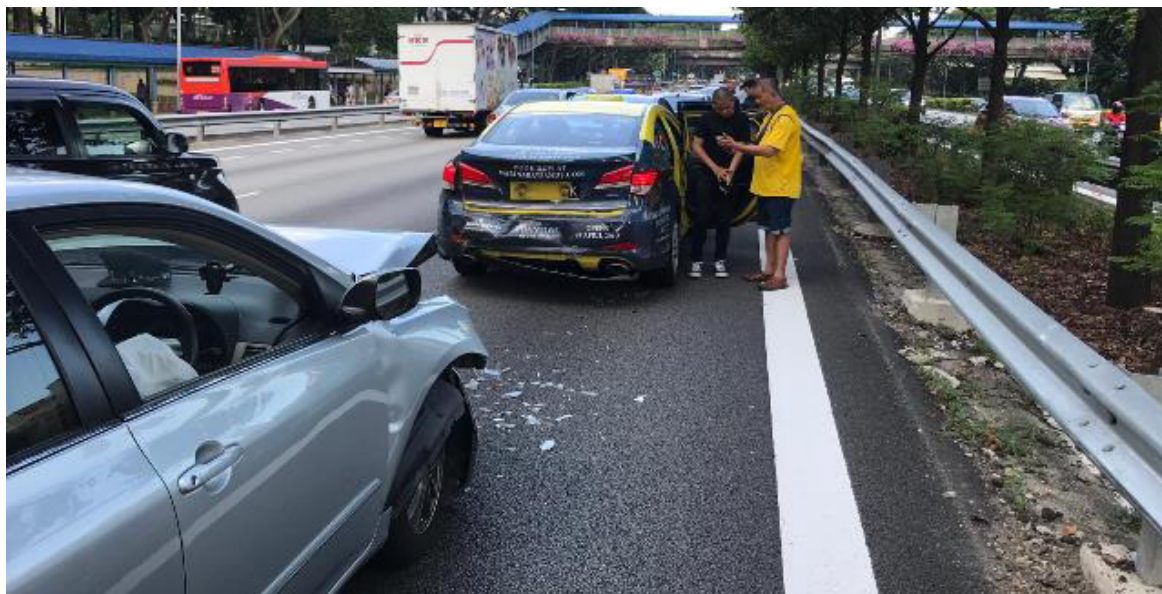
Photo 6 shows the accident scene at PIE towards Changi Airport. From the photographs provided by Mr Lim, a Citycab motor taxi was directly in front of the Insured Vehicle.

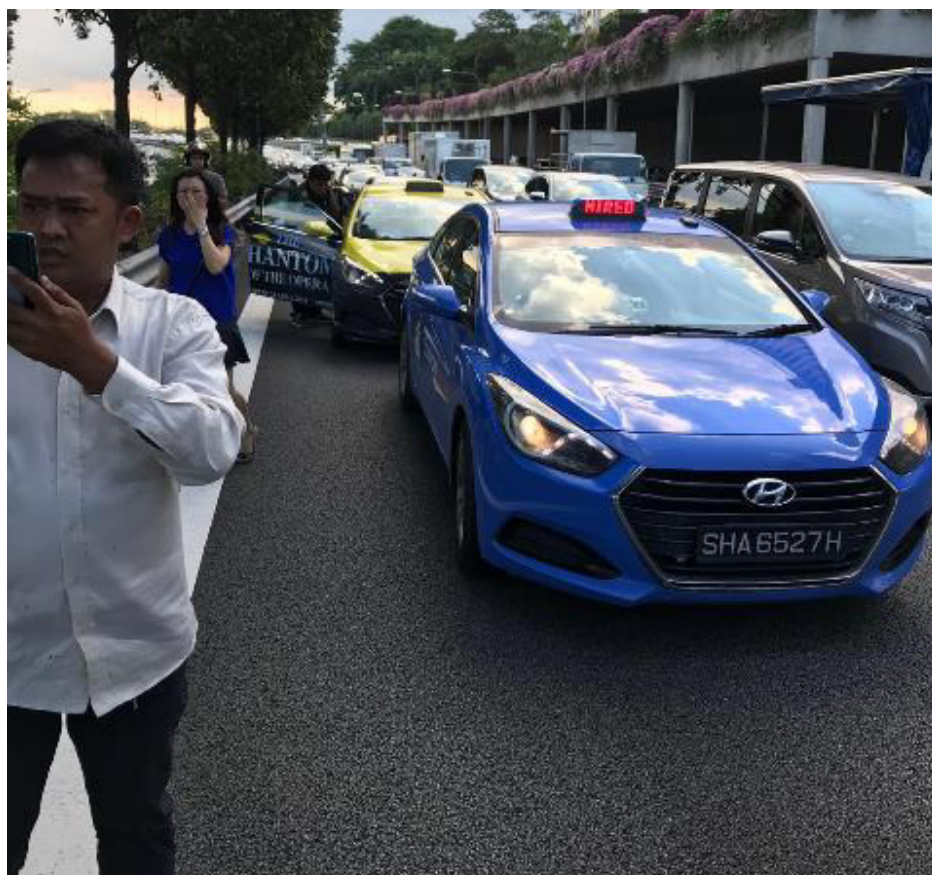
Photo 7 shows the accident scene at PIE towards Changi Airport. From the photographs provided by Mr Lim, a Comfort motor taxi was directly in front of the Citycab motor taxi.

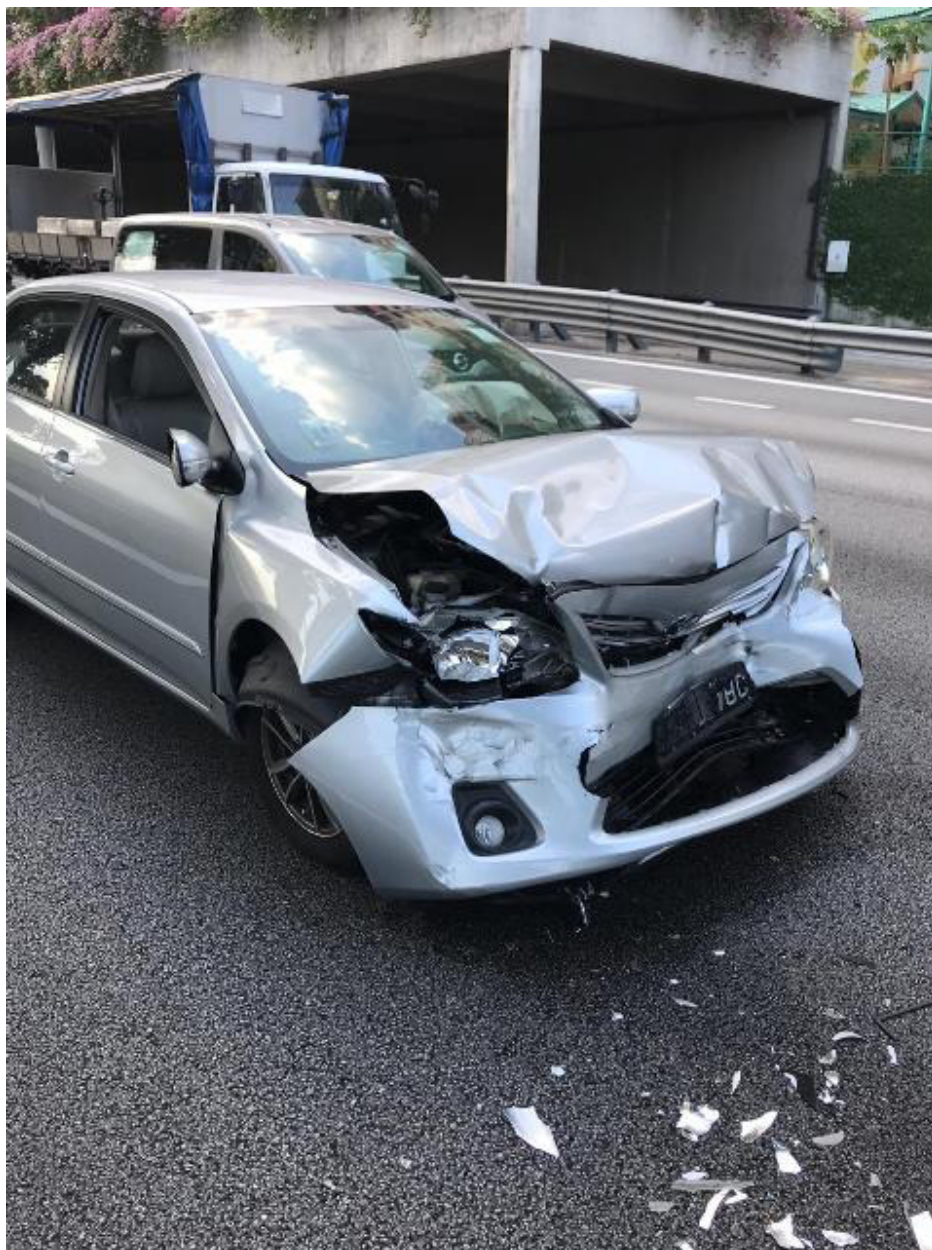
Photo 8 shows a general view of the Insured Vehicle at the accident scene along PIE towards Changi Airport. From my review of the photographs provided by Mr Lim, I note that the Insured Vehicle had sustained impact damage at its frontal portion. There was no damage of fire nature seen on the Insured Vehicle at the accident scene. There was also no leaked fluid seen on the road surface where the Insured Vehicle had come to a stop.

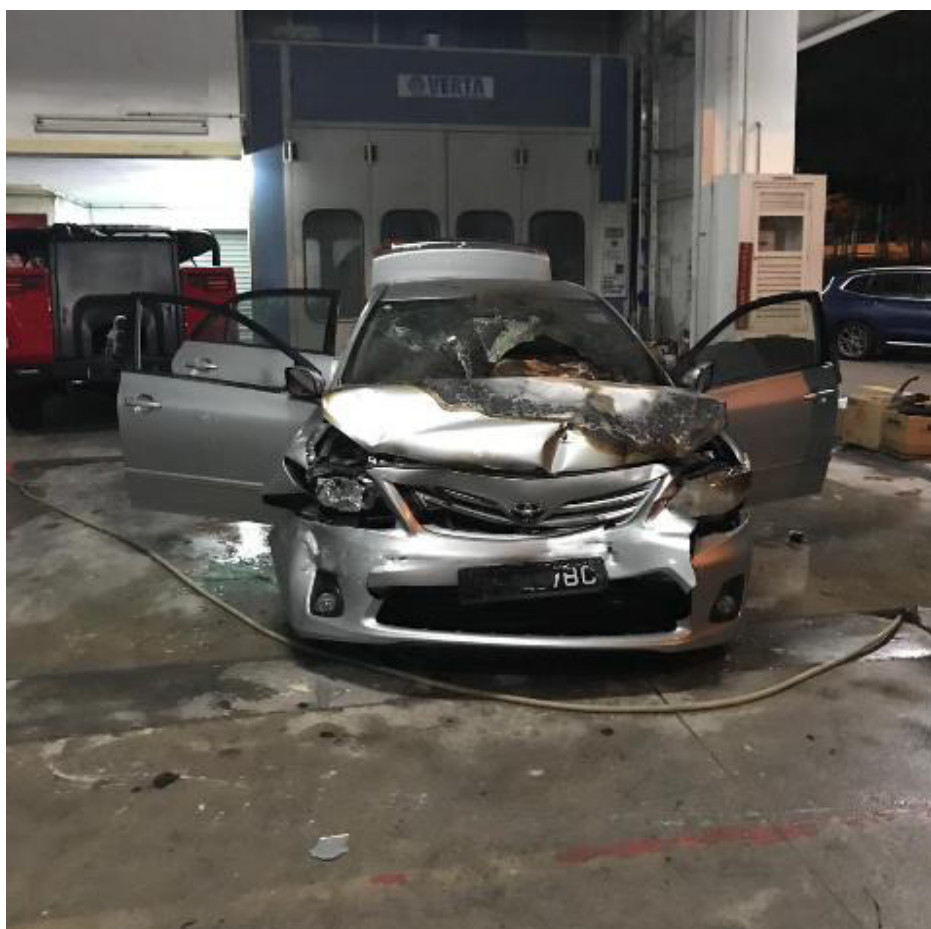
Photo 9 shows a general view of the Insured Vehicle at the premise of M/s Chin Meng Motors. This was after the fire was extinguished. Upon close examination of the photographs, there appears to be no unusual foreign material(s) and/or object(s) found on the ground in the immediate area of where the Insured Vehicle was parked.

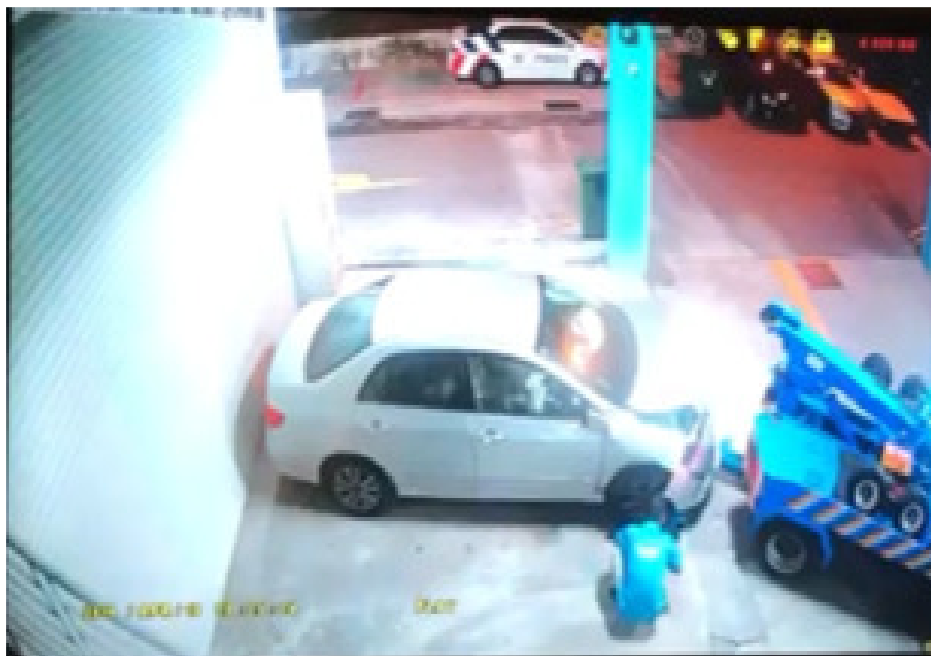
Screenshot 1 shows the Insured Vehicle having just arrived at the premise of M/s Chin Meng Motors. The tow truck driver could be seen preparing to remove the tow fork from the front wheels of the Insured Vehicle. The shutter doors of M/s Chin Meng Motors were observed to be closed at that time.

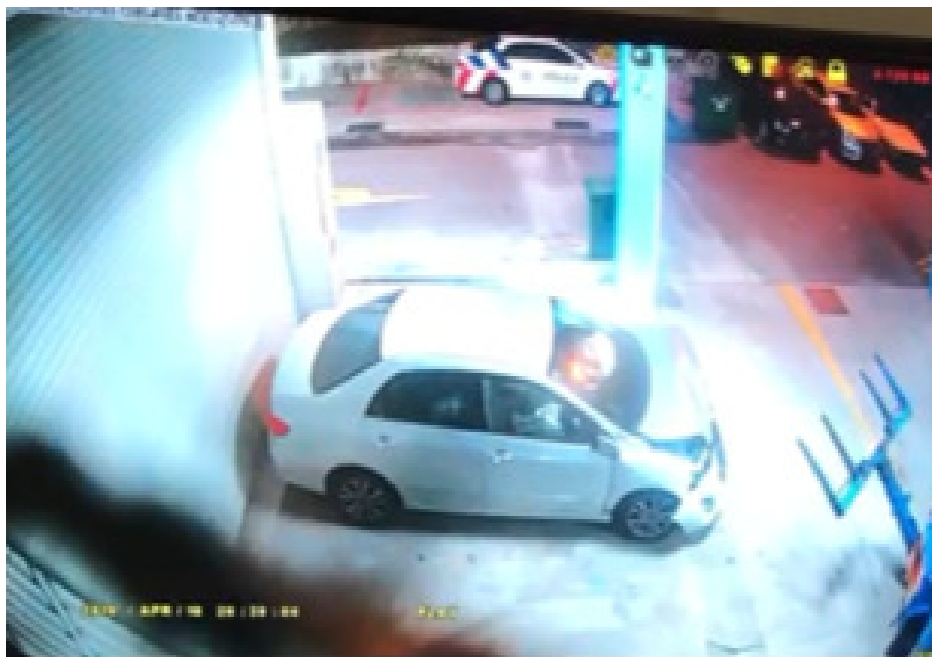
Screenshot 2 shows the tow truck about to leave the Insured Vehicle. This was approximately 2045hrs thereabouts. The Insured Vehicle was observed to be intact with nothing amiss.

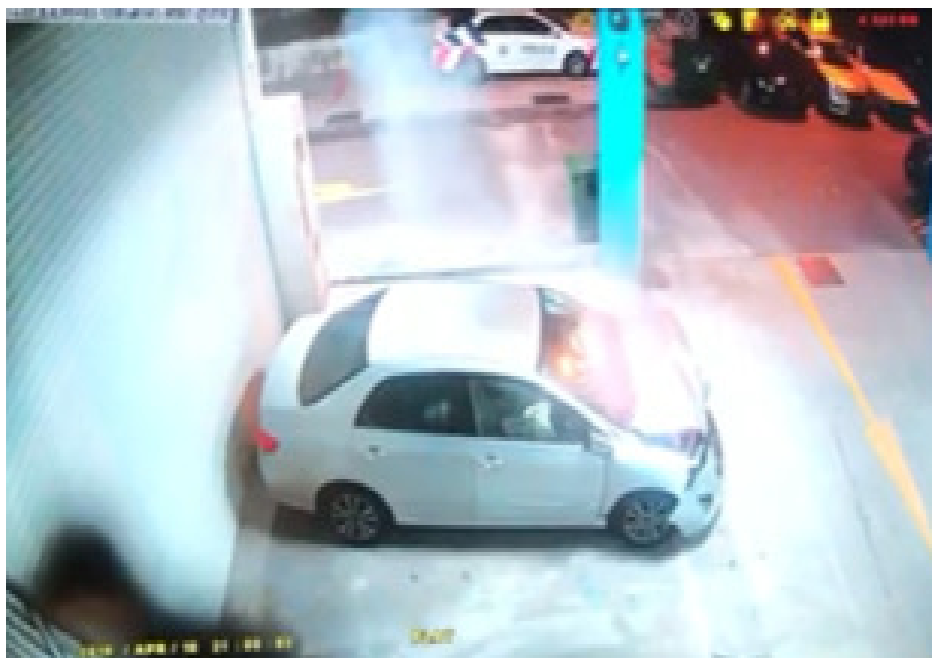
Screenshot 3 shows smoke emitting from the engine compartment of the Insured Vehicle (note the blur at the bottom part of the front windscreen as compared to the same area in screenshot 2 above). This was about an hour after the tow truck had left. There was no abnormal event seen from the video recording leading up to the time when smoke was first seen.

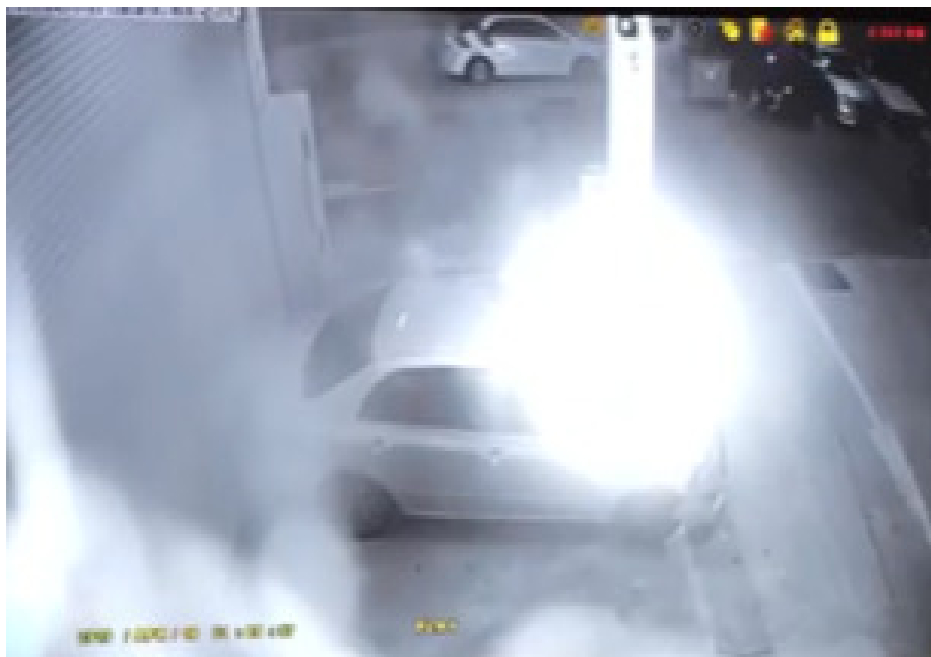
Screenshot 4 shows fire at the frontal portion of the Insured Vehicle. The flames were initially seen coming from the engine compartment of the Insured Vehicle before moving onto its front bonnet. The fire was eventually put out by some members of public using water.

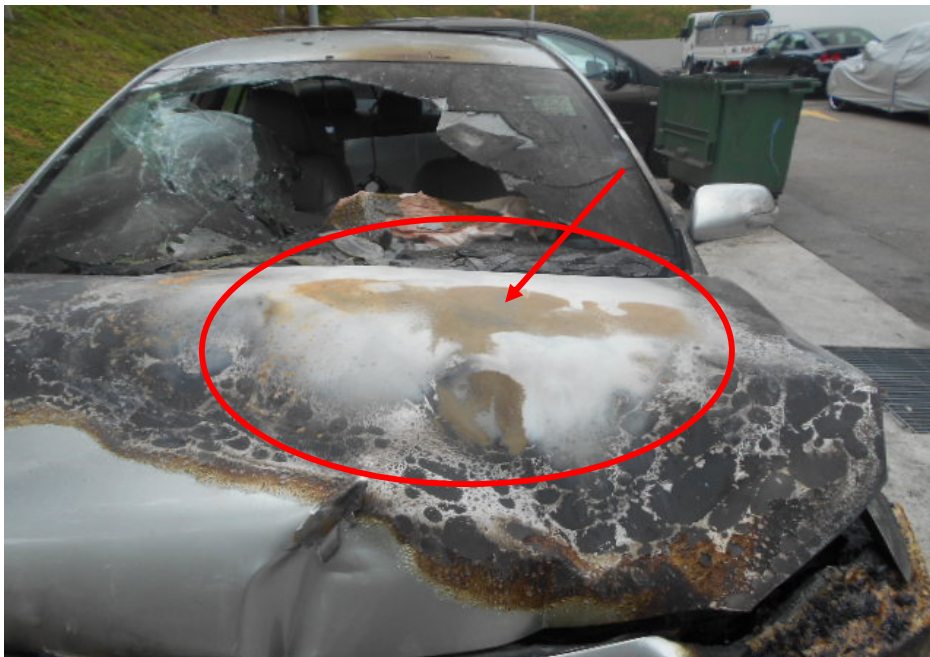
24. High heat intensity burned marks (whitish burn marks) were found at the centre left area of the front bonnet. These whitish burn marks are a result of exposure to prolong heat intensity. Rust would normally start to develop around these areas soon after a fire as prolonged exposure to high heat intensity usually causes steel/metal material body parts to be exposed to natural environmental condition. Note that rust had indeed formed at the centre left area of the Insured Vehicle's front bonnet.

Photo 10 shows the whitish burn marks (circled) that were found on the centre left area of the Insured Vehicle's front bonnet. Such whitish burn marks are a result of exposure to prolonged heat intensity. Rust (arrowed) would normally start to develop around these areas soon after a fire as prolonged exposure to high heat intensity usually causes steel/metal material body parts to be exposed to natural environmental condition. Following the characteristic of heat rising upwards, the fire to the Insured Vehicle can then be determined to have originated around the centre left area of the engine compartment.

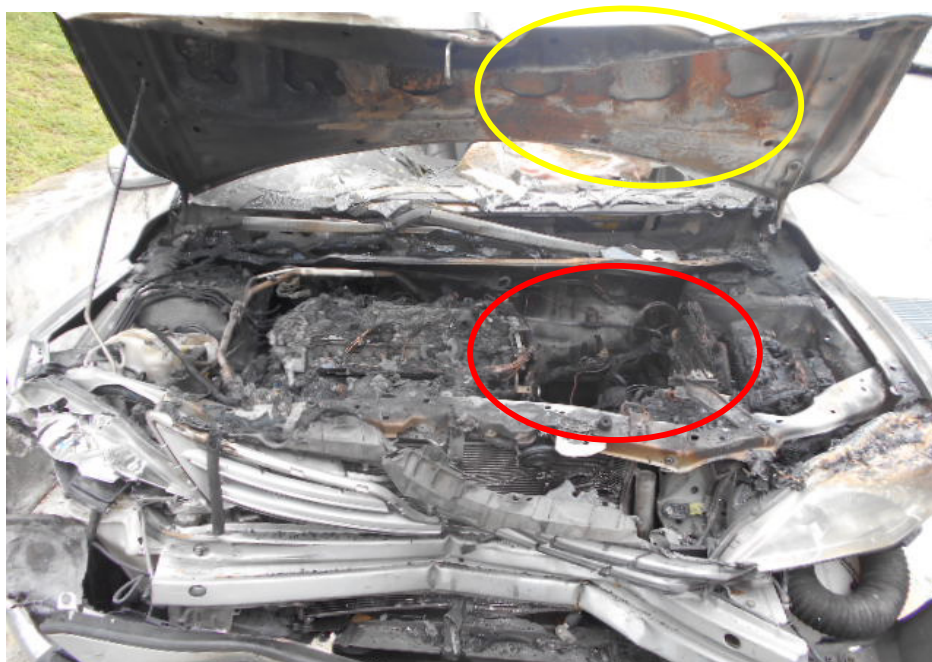
25. Correspondingly, the underside of the front bonnet at the centre left area was also found with similar high heat intensity burn marks (whitish burn marks). Rust had also started to develop at this area. Following the characteristic of heat rising upwards, the burn pattern of the front bonnet would then indicate that the origin of fire was at the centre left area of the Insured Vehicle's engine compartment.

Photo 11 shows a general view of where the fire to the Insured Vehicle had originated, which was around the centre left area of the engine compartment (red circle). This was established basing on the burn pattern (whitish burn marks and rust) that was found on the top side and the underside (yellow arrow) of the Insured Vehicle's front bonnet.

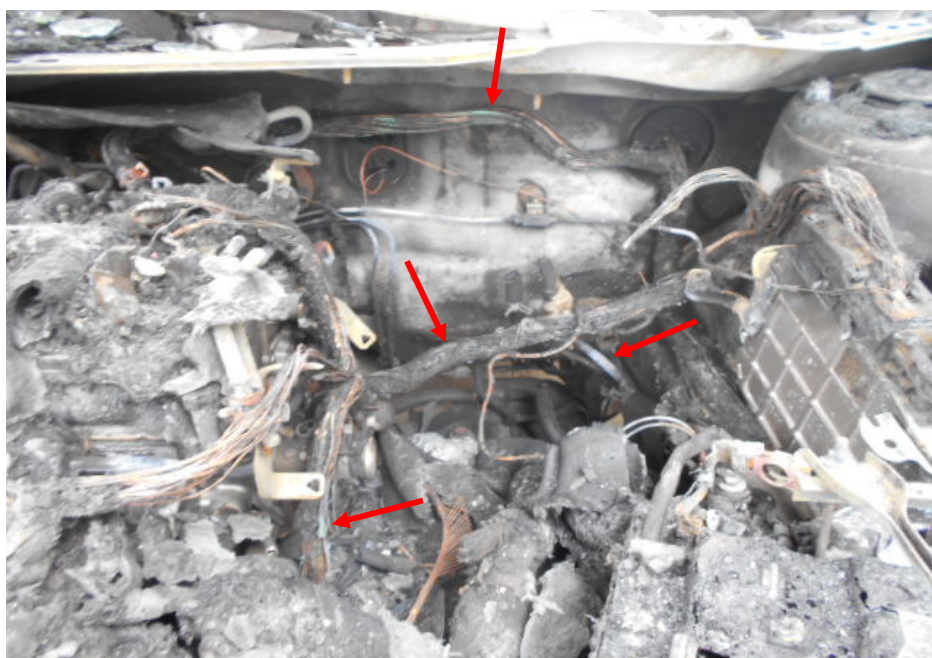
26. My examination of the centre left area of the engine compartment, during my inspection of the Insured Vehicle, revealed greenish residue on several stretches of original factory fitted wirings. The presence of greenish residue indicates internal heating of copper wires, a sign of an electrical short circuit occurring. The greenish residue is normally left behind from oxidation as a result of chemical reaction involving the copper wires. This physical evidence indicates that the cause of fire to the Insured Vehicle was due to electrical in nature. See photo 10 - 14 below.

Photo 12 shows the wirings around the centre left area of the engine compartment, which was where the fire to the Insured Vehicle had originated. Greenish residue was found on several stretches of wirings (arrowed). These wirings were originally fitted wirings. The presence of such greenish residue suggests occurrence of an electrical short circuit.

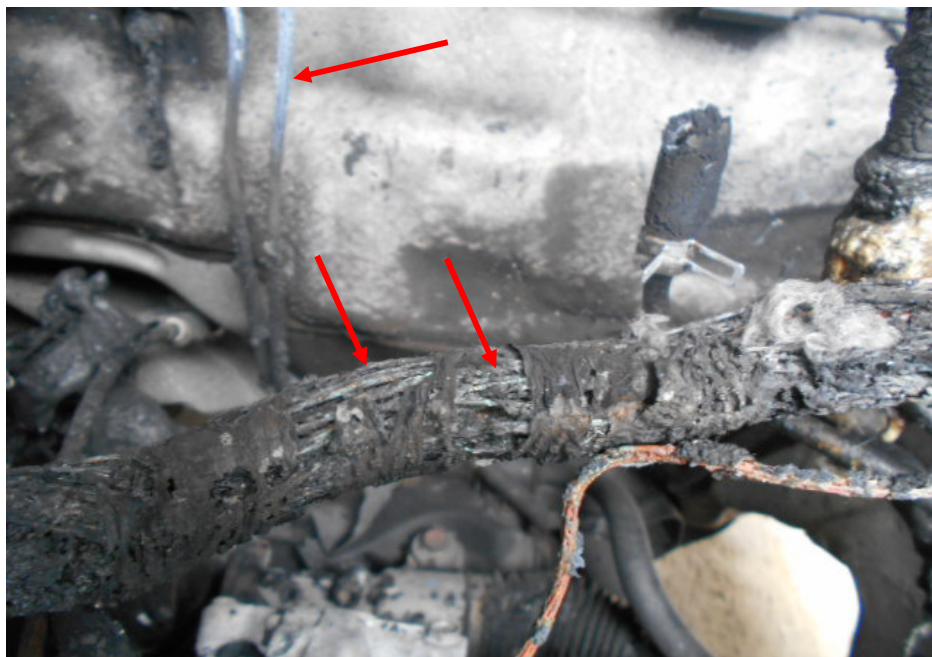
Photo 13 shows a closer view of the wirings around the centre left area of the engine compartment. Greenish residue was found on the wirings (red arrow). The presence of such greenish residue suggests occurrence of an electrical short circuit. These wirings are original factory fitted wirings.

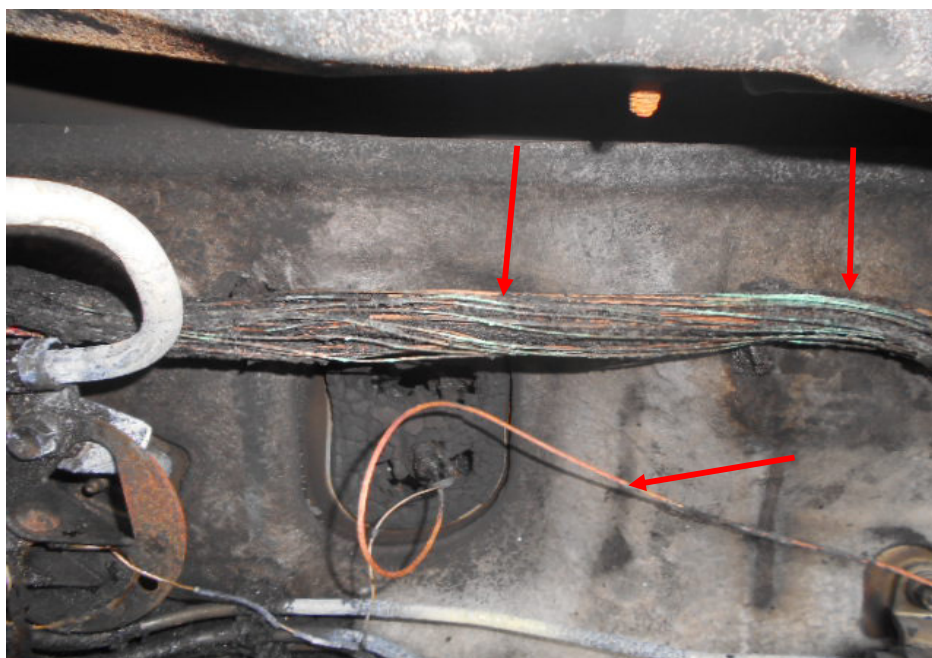
Photo 14 shows another stretch of original factory fitted wirings that were found with greenish residue. The presence of greenish residue indicates internal heating of copper wires, a sign of an electrical short circuit occurring. The greenish residue is normally left behind from oxidation as a result of chemical reaction involving the copper wires.

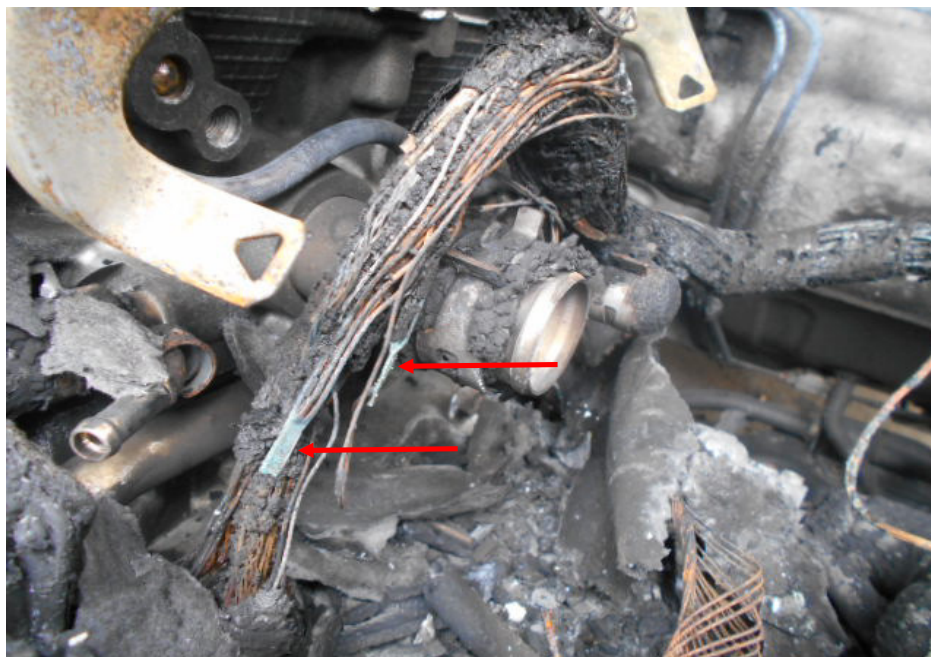
Photo 15 shows another stretch of wirings with greenish residue (arrowed) at the centre left area of the Insured Vehicle's engine compartment. The physical condition of the wirings as seen during my inspection of the Insured Vehicle supports the cause of fire being due to electrical in nature.
