Your Ref: TP/IP/67127/2018
Our Ref : CI/TPD19007272/P

Fatal Accident Investigation Team

MECHANICAL INSPECTION REPORT OF MOTOR BUS PC 6001C

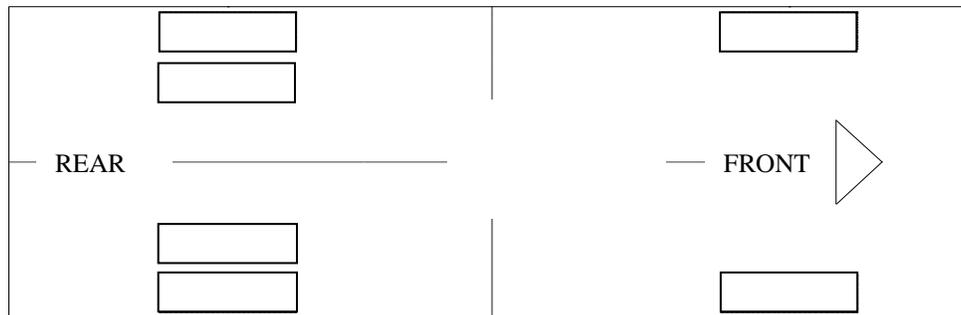
6. The 6 tyres fitted on the Motor Bus were all observed to be in serviceable condition and sufficiently inflated for vehicular operation. I did not find any tear, cut or burst mark(s) on the outer and the inner sidewalls as well as across the tread of the 6 tyres. The tyre brand, tyre size and remaining tread depth of the Motor Bus's 6 tyres were recorded as follows:-

Aeolus 295/80 R22.5 (7.7mm)

Akina 295/80 R22.5 (13.6mm)

Aeolus 295/80 R22.5 (4.5mm)

Aeolus 295/80 R22.5 (6.7mm)

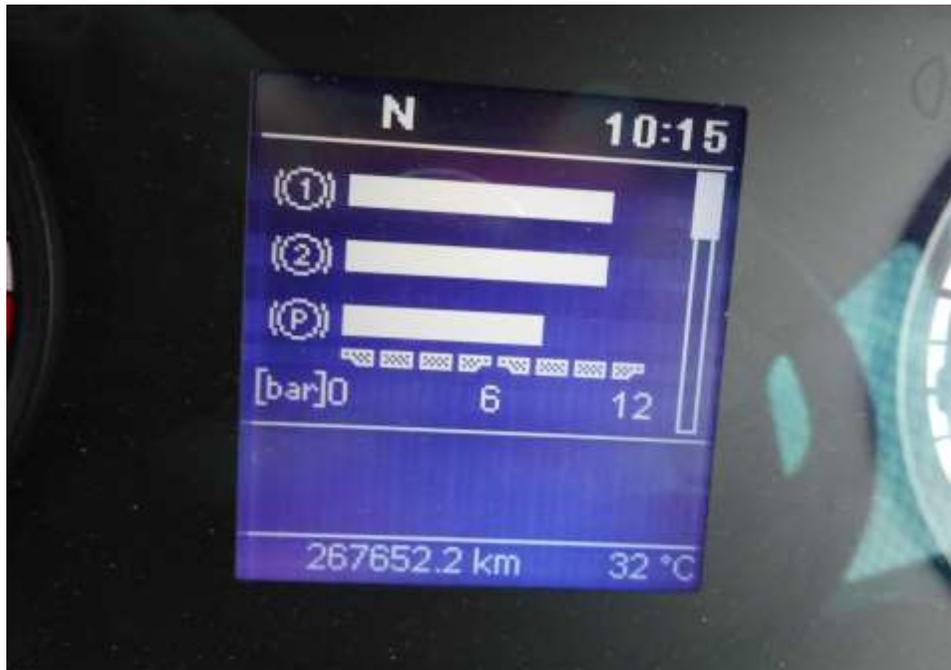
Photo 1 shows the mileage of the Motor bus at the time of my inspection was 267,652km.

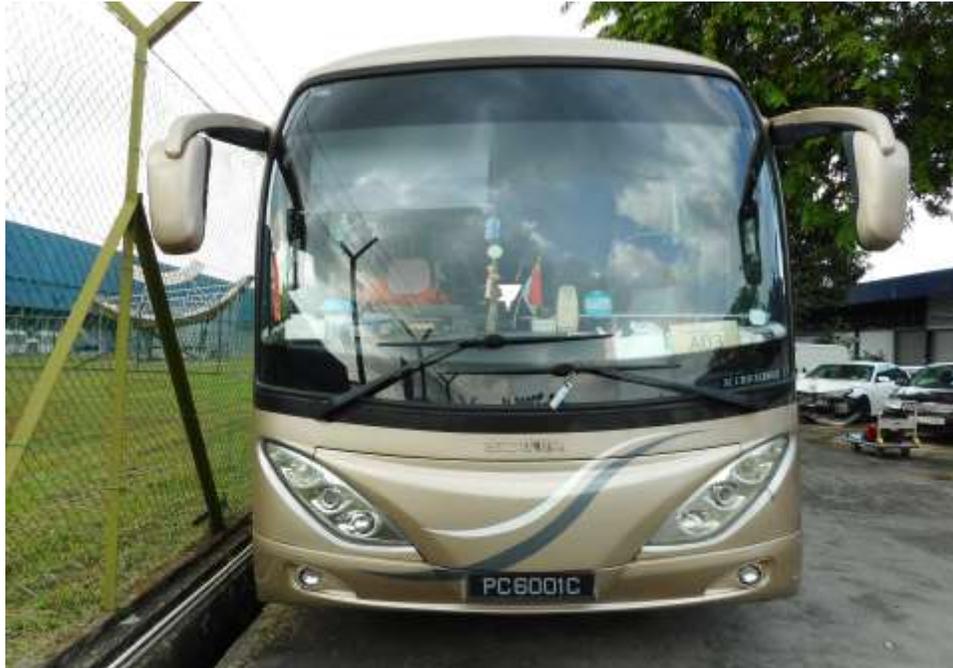
Photo 2 shows a general view of the front of the Motor Bus was observed to have sustained relatively minor damage to the front portion. Its left bumper was damaged as a result of the accident.

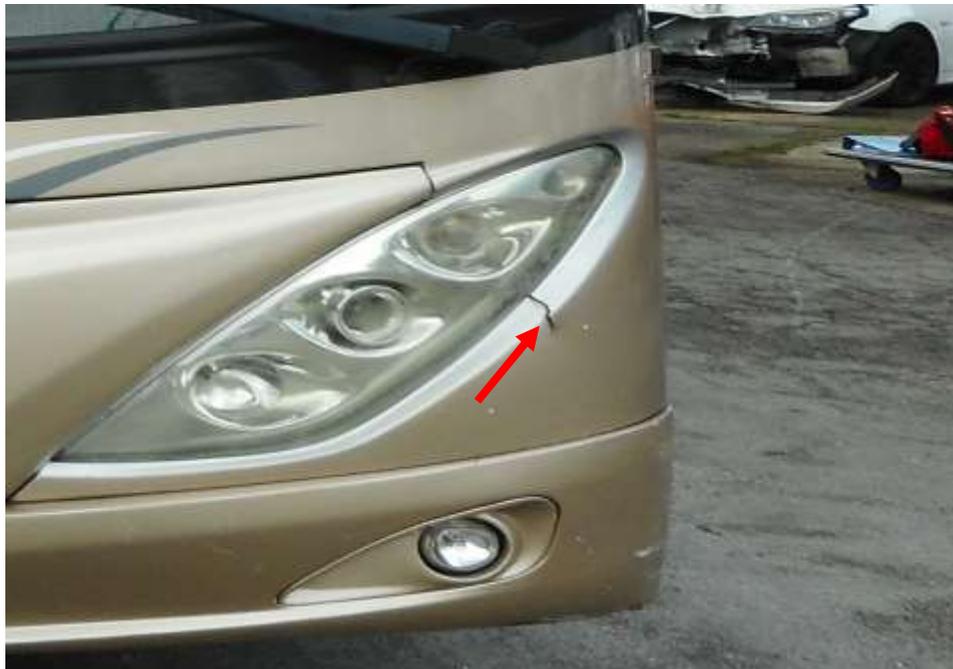
Photo 3 shows a close up view of the front of the Motor Bus's left bumper (arrowed) that was damaged as a result of the accident.

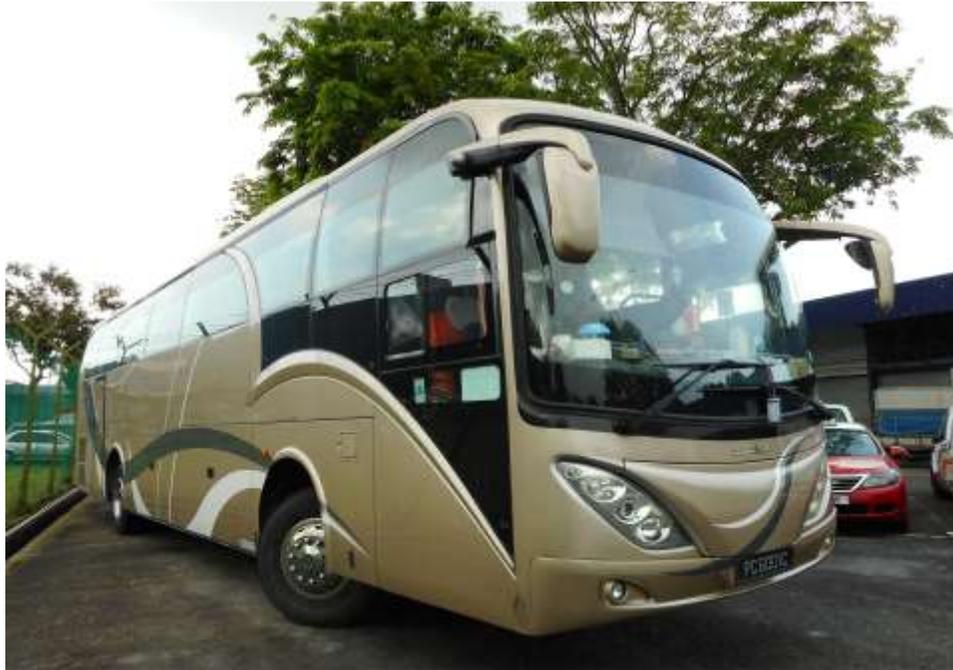
Photo 4 shows a general view of the right side of the Motor Bus was observed to be in good condition at the time of my inspection.

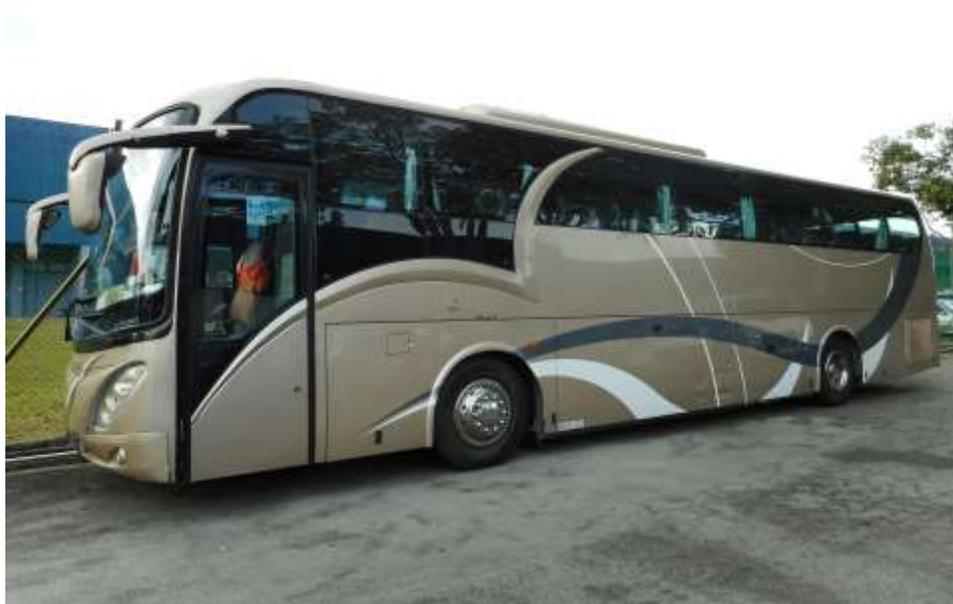
Photo 5 shows a general view of the left side of the Motor Bus was observed to be in good condition at the time of my inspection.

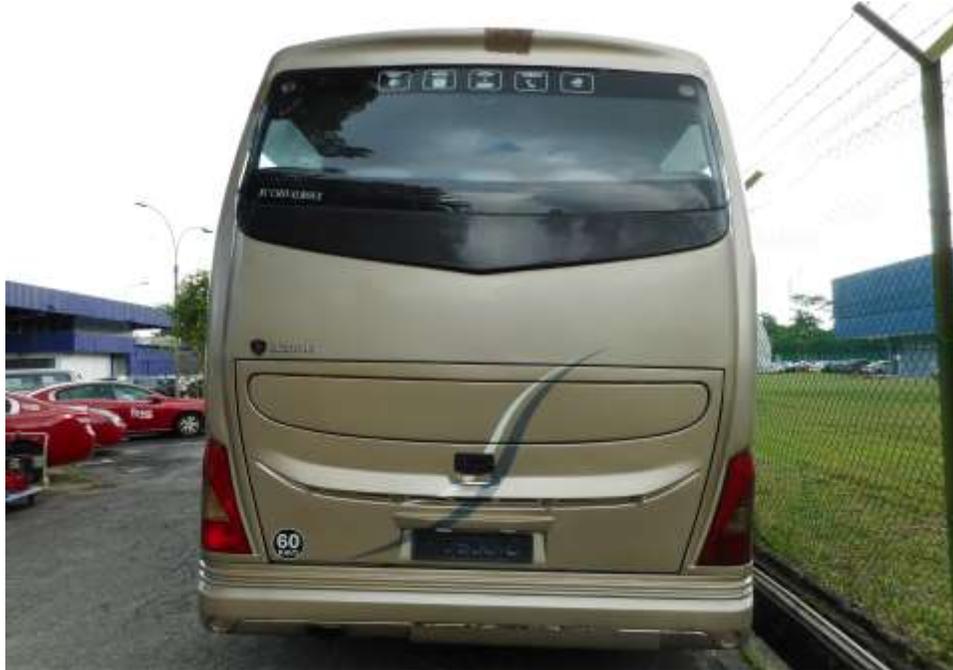
Photo 6 shows a general view of the rear of the Motor Bus was observed to be in good condition at the time of my inspection.

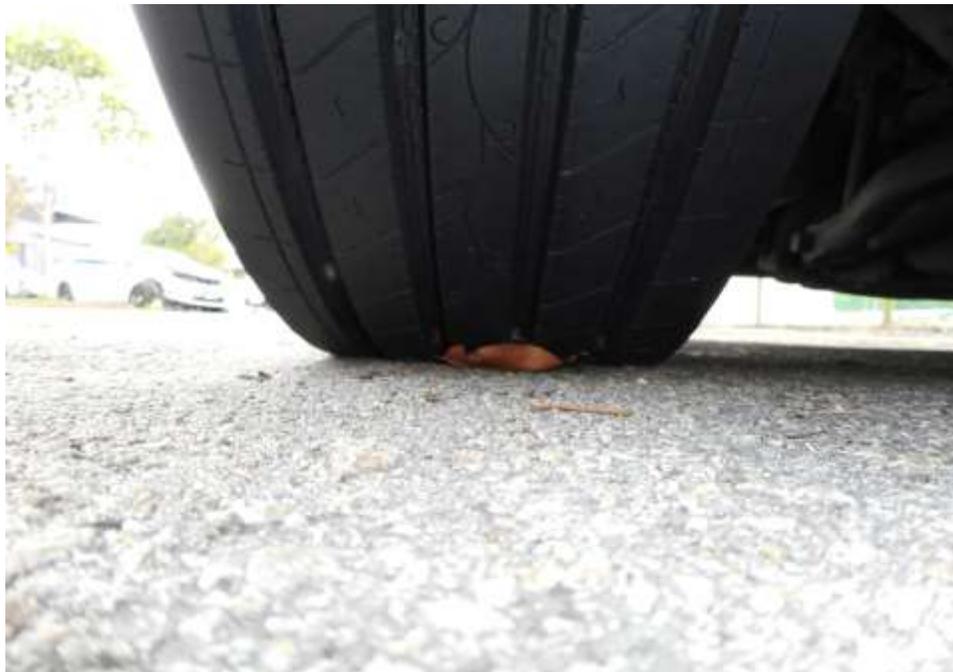
Photo 7 shows the condition of the front left tyre of the Motor Bus, which was observed to be in serviceable condition with remaining tread depth of approximately 13.6mm. The tyre, which was wrapped around standard alloy wheel rim, was also observed to be sufficiently inflated for vehicular operation with no tear, cut or burst mark(s) on the outer and the inner sidewalls.

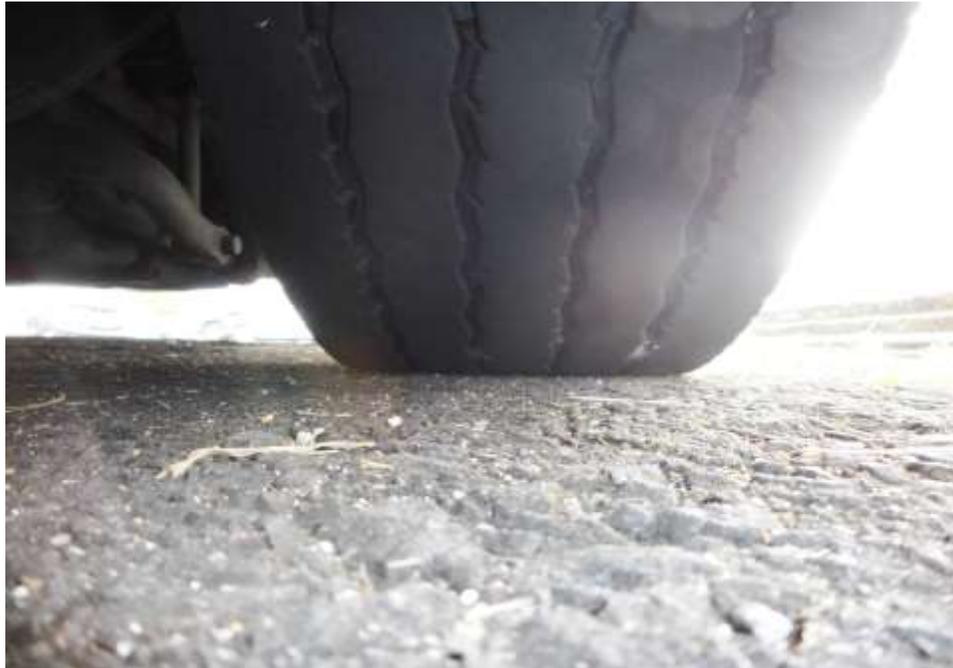
Photo 8 shows the condition of the front right tyre of the Motor Bus, which was observed to be in serviceable condition with remaining tread depth of approximately 6.7mm. The tyre, which was wrapped around standard alloy wheel rim, was also observed to be sufficiently inflated for vehicular operation with no tear, cut or burst mark(s) on the outer and the inner sidewalls.

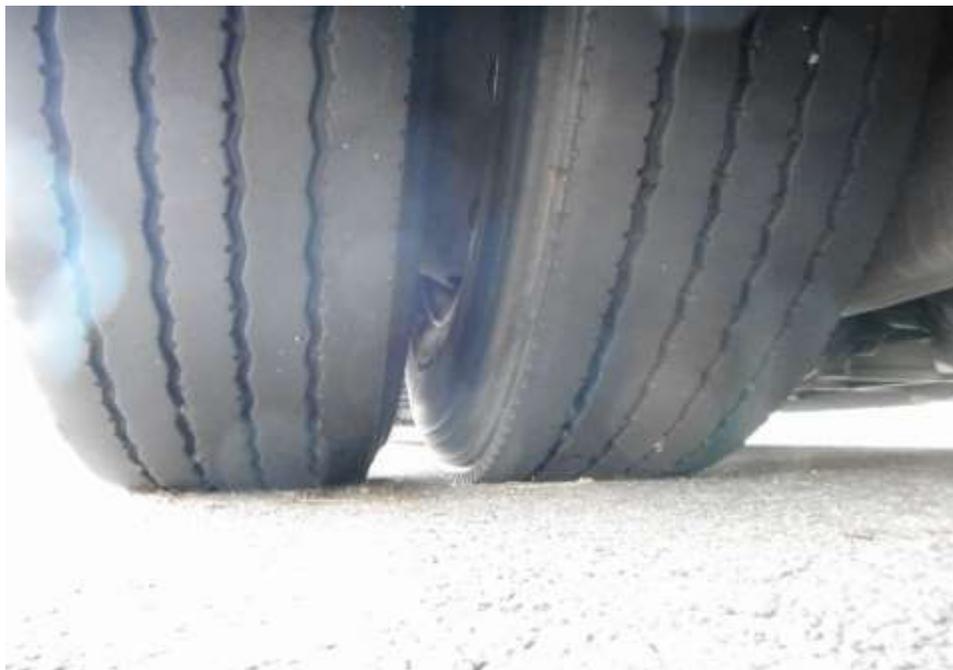
Photo 9 shows the condition of the rear left tyres of the Motor Bus, which were observed to be in serviceable condition with remaining tread depth of approximately 7.7mm. The tyres, which were wrapped around standard alloy wheels rims, were also observed to be sufficiently inflated for vehicular operation. There was also no damage found on all the 6 alloy wheel rims of the Motor Bus.

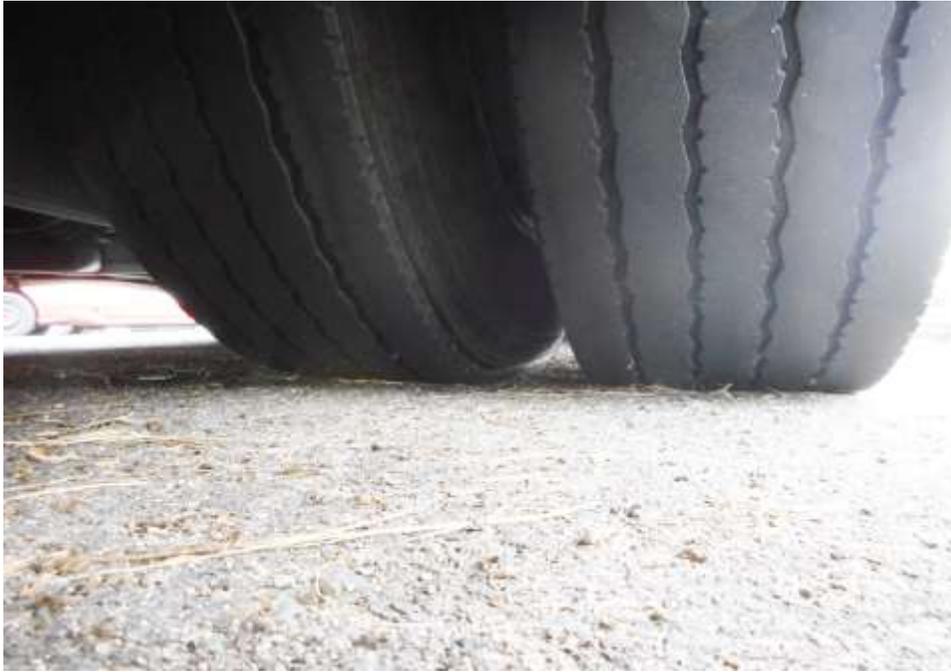
Photo 10 shows the condition of the rear right tyres of the Motor Bus, which were observed to be in serviceable condition with remaining, tread depth of approximately 4.5mm. The tyres, which were wrapped around standard alloy wheel rims, were also observed to be sufficiently inflated for vehicular operation with no tear, cut or burst mark(s) on the outer and the inner sidewalls. There was also no damage found on all the 6 alloy wheel rims of the Motor Bus.

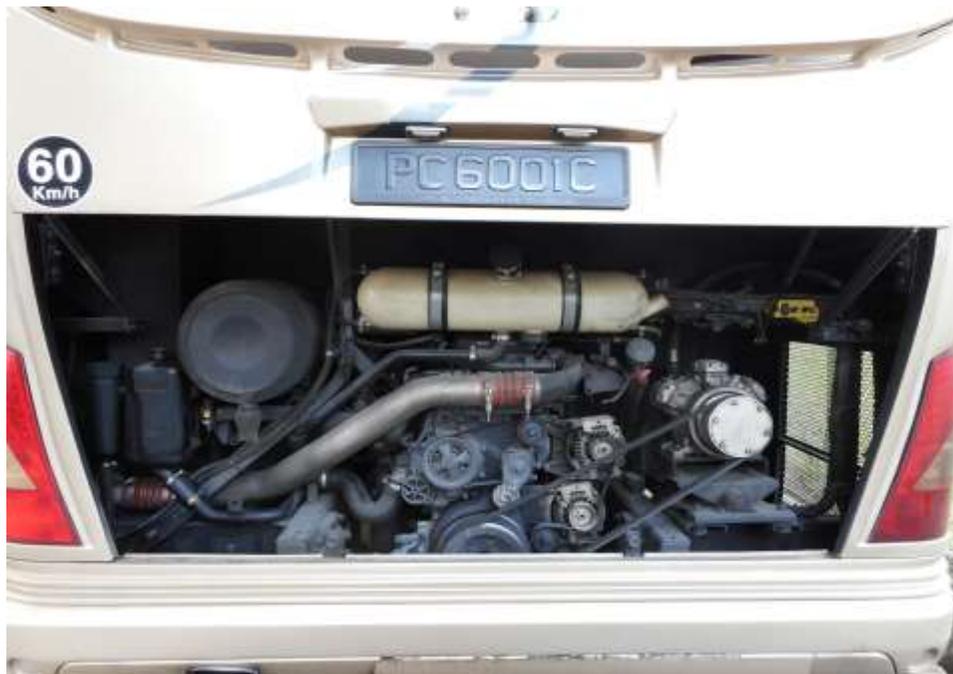
Photo 11 shows a general view of the Motor Bus engine compartment, which was accessed by lifting the rear exterior cabin of the Motor Bus. The various parts and components inside the engine compartment were unaffected by the accident. There was also no sign(s) or indication(s) of fresh fluid leakage and/or fluid stain within the engine compartment (photograph shows the engine compartment as viewed from the rear of the Motor Bus).

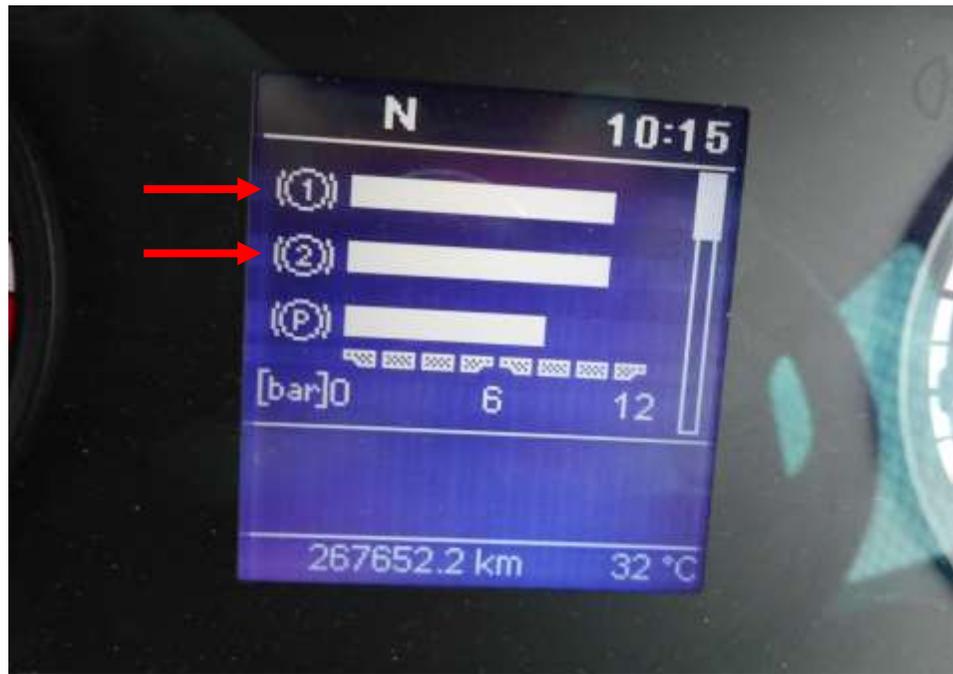
Photo 12 shows the air in the air brake cylinder of the Motor bus at the time of my inspection. The air in the cylinder (arrowed) was observed to be of sufficient level & serviceable at the time of the accident.

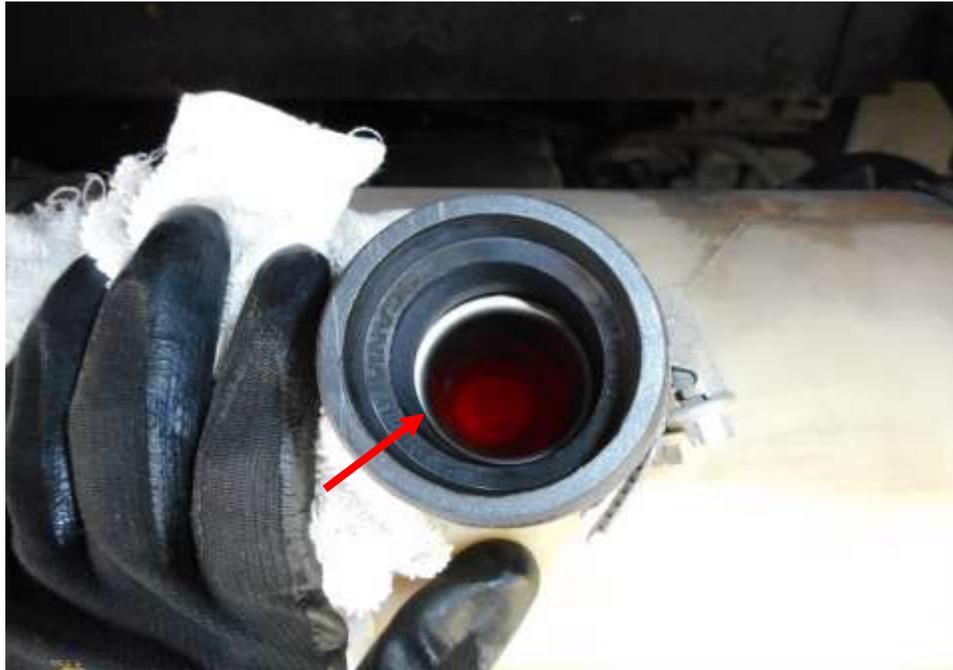
Photo 13 shows the engine coolant reservoir level of the Motor bus at the time of my inspection. The engine coolant was observed to be of sufficient level (arrowed) and without any visible contamination.

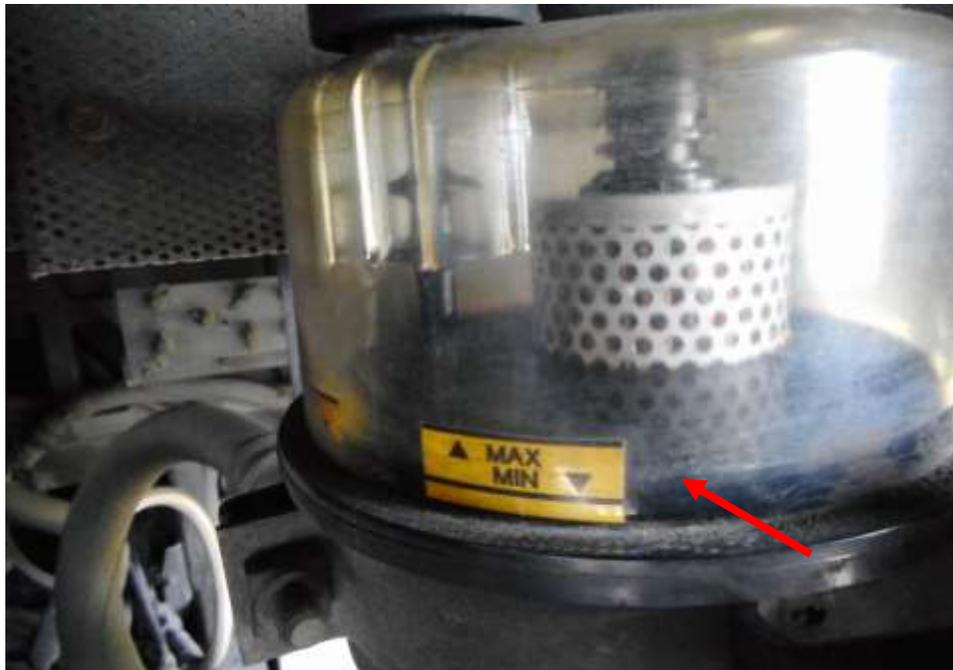
Photo 14 shows the power steering fluid reservoir of the Motor bus at the time of my inspection. The power steering fluid was observed to be of sufficient level (arrowed) and without any visible contamination.

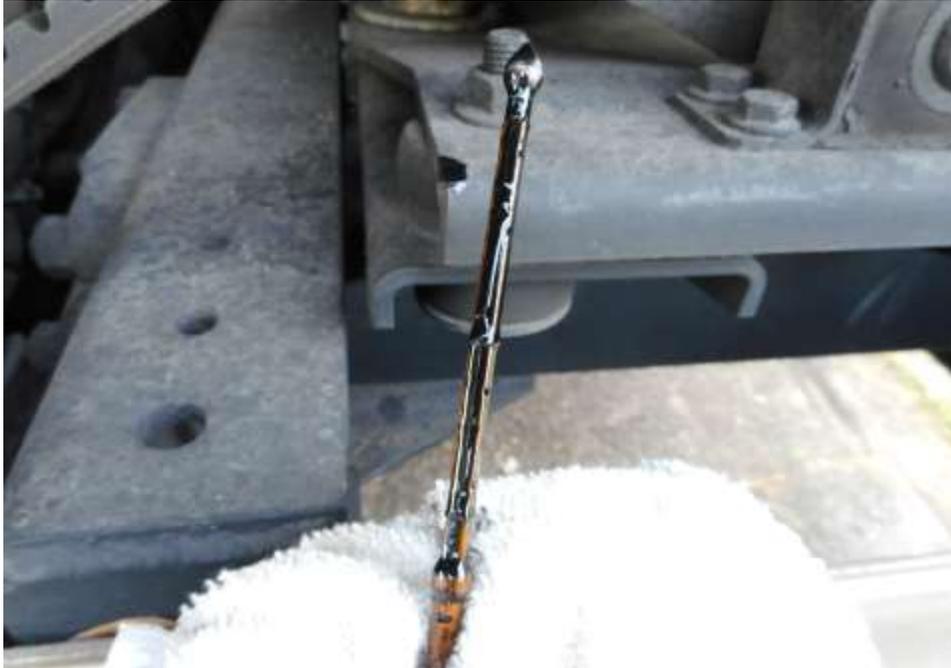
Photo 15 shows the engine dip stick of the Motor bus at the time of my inspection. The engine oil was observed to be of sufficient level and without any visible contamination.

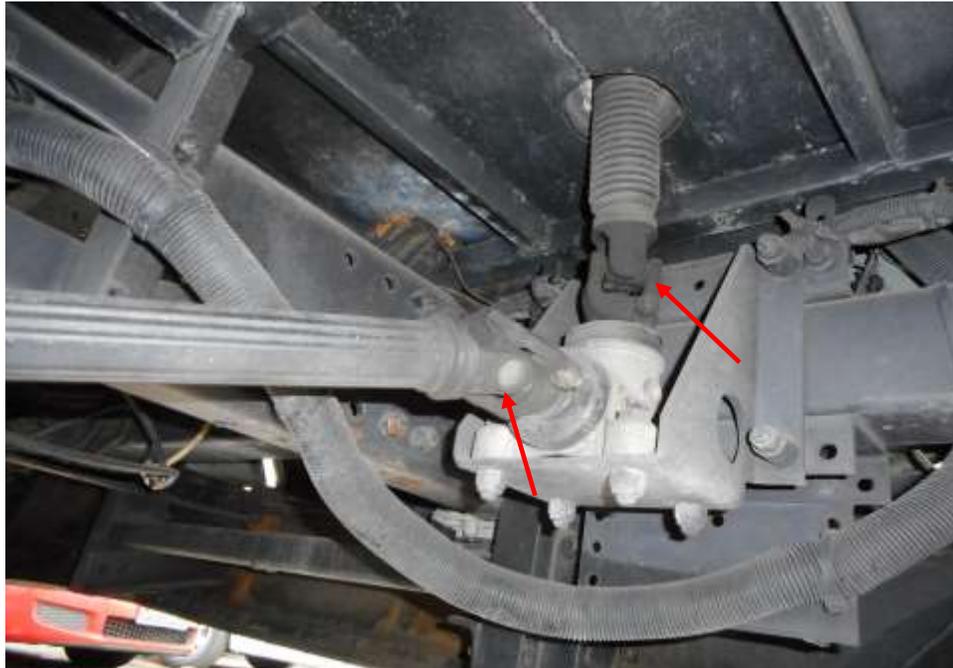
Photo 16 shows the front underside of the Motor Bus. My visual checks on the various mechanical components of the steering system like the steering box, steering shaft and steering linkages (arrowed) amongst others revealed all to be intact and in good condition.

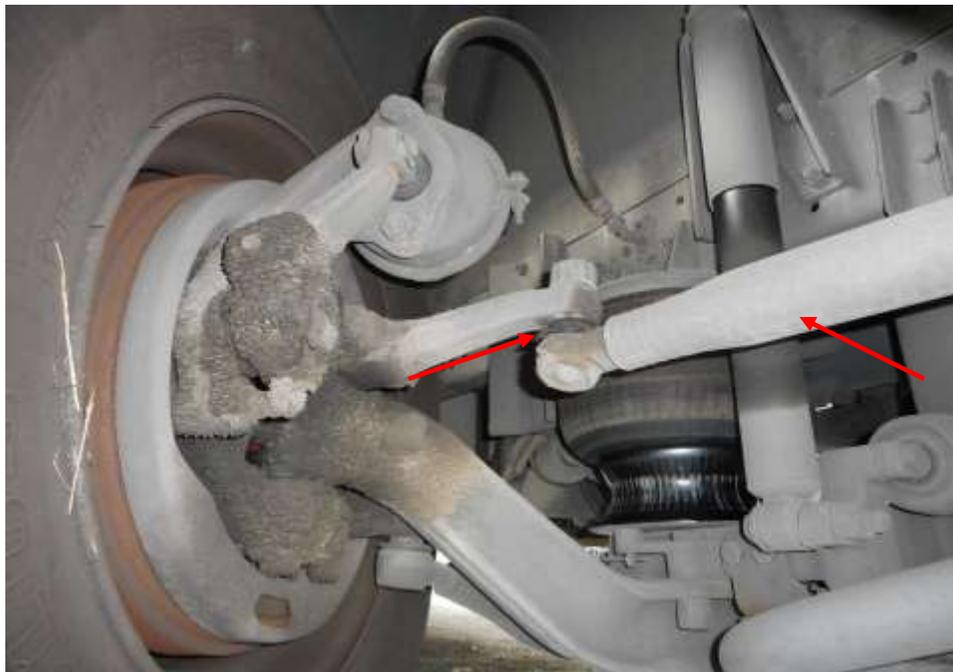
Photo 17 shows the undercarriage components at the front right wheel of the Motor Bus. The various undercarriage components of the Motor Bus were all observed to be intact and without any visible damage. This had included the steering rack and steering ball joints (arrowed) of the Motor Bus. Visual examinations of the mechanical components of the steering system appear to indicate that the Motor Bus's steering system was in serviceable condition.

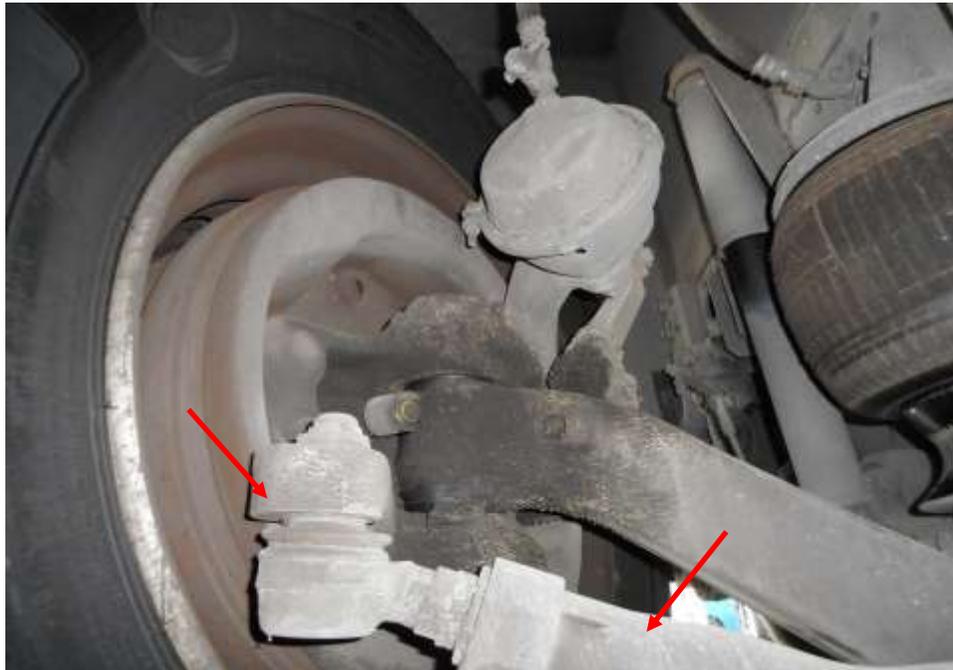
Photo 18 shows the undercarriage components at the front left wheel of the Motor Bus. The various undercarriage components of the Motor Bus were all observed to be intact and without any visible damage. This had included the steering rack and steering ball joints (arrowed) of the Motor Bus, which were observed to be securely attached to the front left wheel and front right wheel.

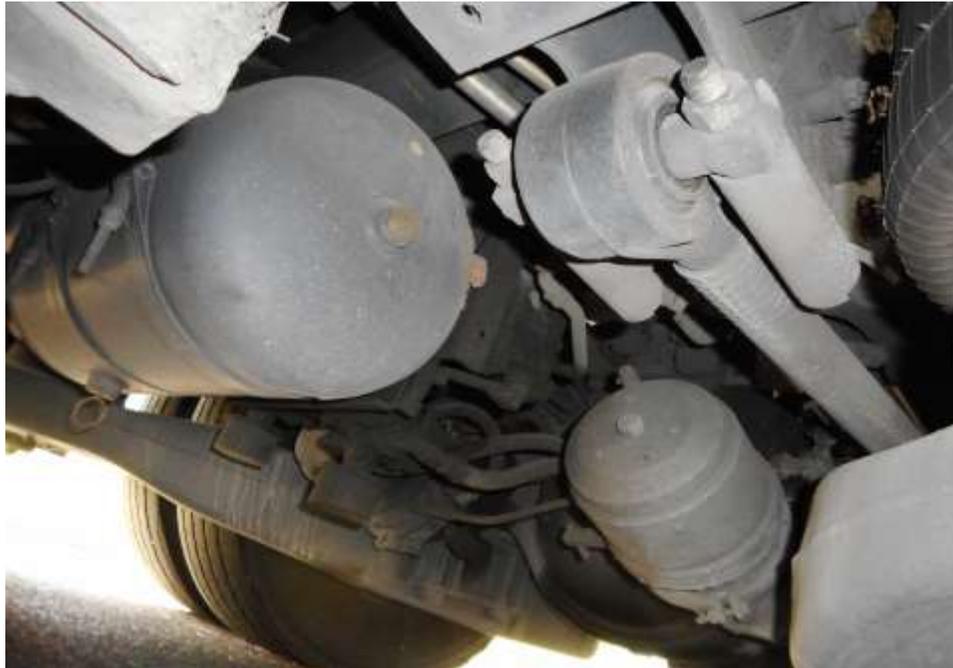
Photo 19 shows a general view of the air tank, valves, pipes and hoses, which are some of the components for the air-assisted braking system of the Motor Bus, observed to be intact and without any visible damage.

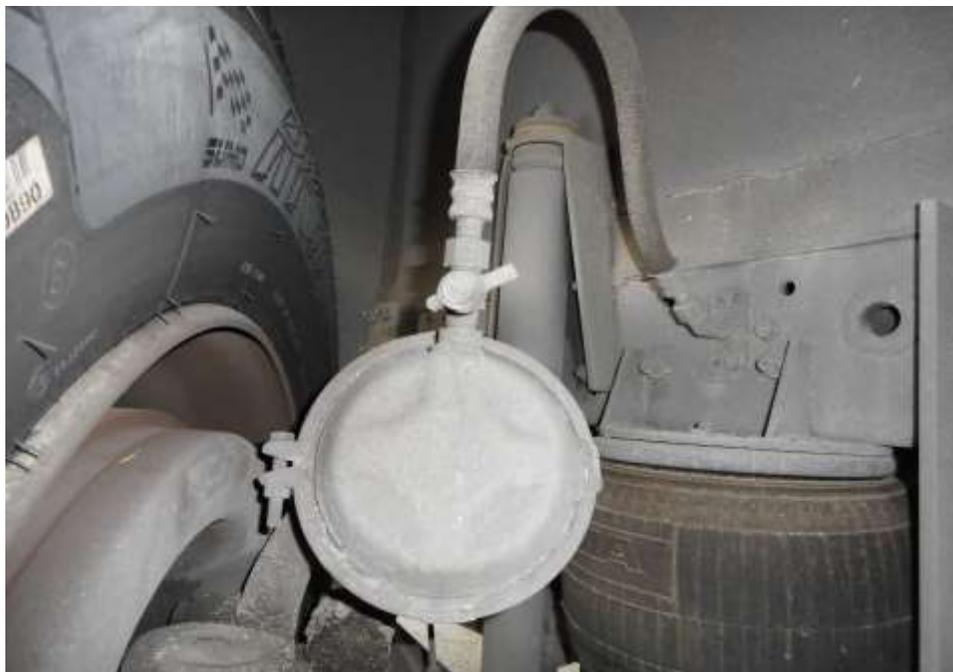
Photo 20 shows the brake air cylinder and air pipes at the front left wheel of the Motor Bus. My visual inspection of the mechanical components of the Motor Bus's braking system appear to suggest that its braking system was in serviceable condition at the material time of accident.

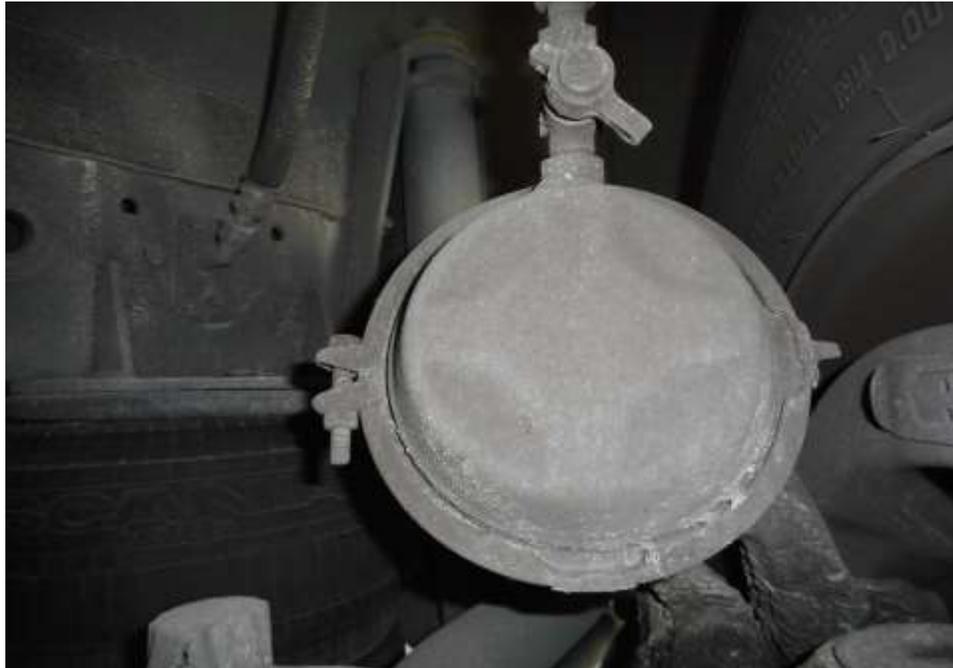
Photo 21 shows the brake air cylinder and air pipes at the front right wheel of the Motor Bus. My visual inspection of the mechanical components of the Motor Bus's braking system appear to suggest that its braking system was in serviceable condition at the material time of accident.

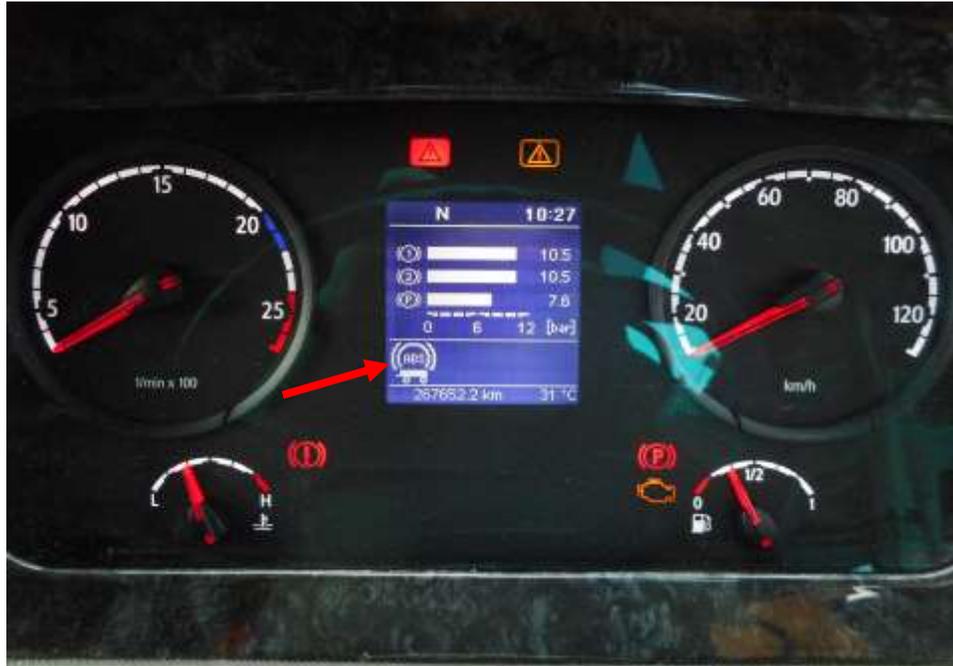
Photo 22 shows the warning light for Anti-Lock Brake System (ABS) and Traction Control (TC) (arrowed) appearing on the instrument panel of the Motor Bus during the self-test of its various electronic operating systems when its engine was cranked.

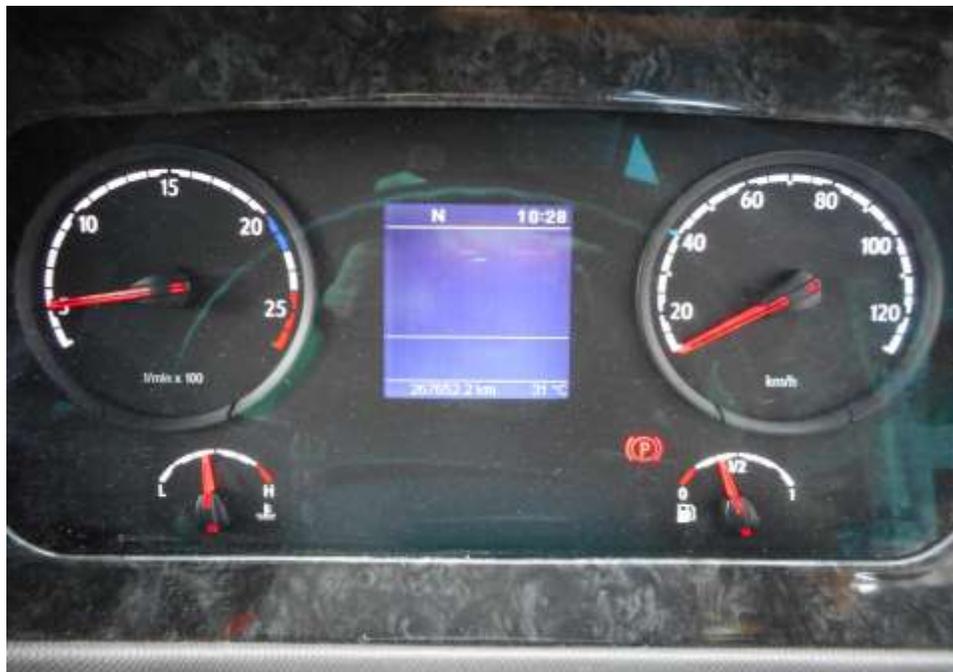
Photo 23 shows no warning lights illuminated on the instrument panel of the Motor Bus after the engine was cranked. This would suggest that there was no abnormality to the various electronic operating systems of the Motor Bus, like the ABS and TC etc.

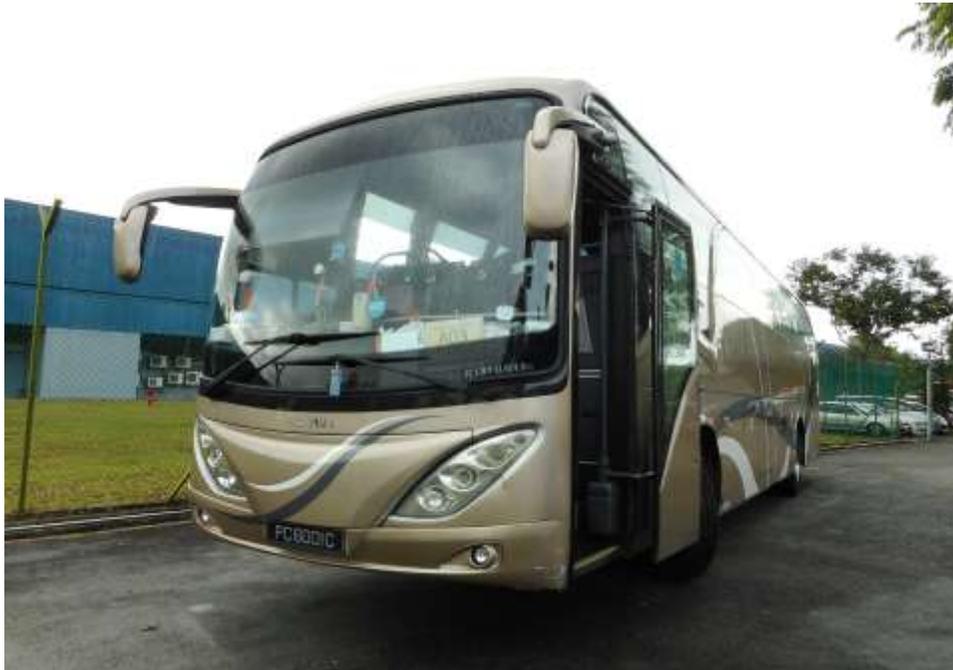
Photo 24 shows the front right wheel of the Motor bus turned to its full left. During my steering system test, I did not experience any abnormal free play and/or resistance when I had turned the steering wheel towards full left and full right. This would suggest that the steering system of the Motor bus was likely to be in serviceable condition at the material time of accident.
