From: Perry HE (SPF) <Perry_HE@spf.gov.sg>
Sent: Wednesday, 24 April 2019 1:51 PM
To: assignments
Cc: Kwee Huat TAN (SPF); Kim Pang CHAY (SPF); Ai Phing (LKKAuto); Shiau Chan (LKKAuto); Veron Chen (LKKAuto); Janice Lee (LKKAuto)
Subject: Appraisal Services for SPF vehicle at INDECO - QX311A

ACCIDENT/DAMAGE REPAIR AND AD HOC WORKS REQUEST FORM

Affiliated to Federation Internationale Des Experts En Automobile			
AUTOMOTIVE ENGINEERING & MGT DIVISION		Ref : CS/SPF19007500/Gtd3e2	
CONTRACT MANAGEMENT SECTION(SPORE POLICE FORCE) 1 MOUNT PLEASANT ROAD BLK 8 OLD POLICE ACADEMY SINGAPORE 298333		Date : 21-05-2019

4. Description of Damages			
THE VEHICLE SUSTAINED DAMAGES AT THE N/S BODY. DAMAGES SEE DETAILS.			
5. General Information			
Accident Date		Inspection Date	29/04/2019
Survey held at	INDECO ENGINEERS PTE LTD 39 DEFU LANE 12 . SINGAPORE 539139		
5a. Remarks

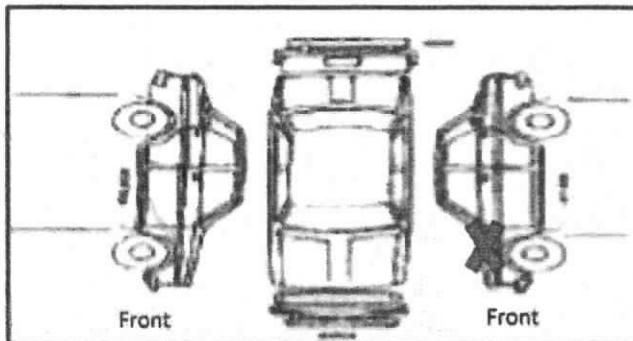
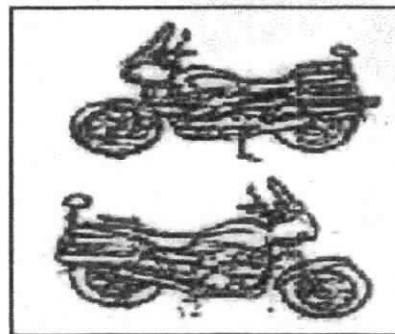
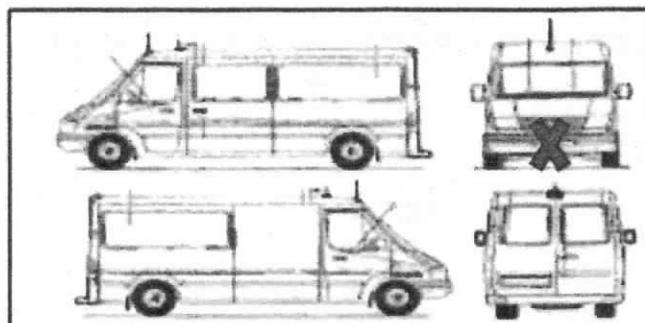
Whole front bumper damaged and dislodged, front left side of vehicle damaged

Pls mark affected area with **X**
