**INITIAL INSPECTION REPORT OF VEHICLE NO. SHB 9884B**

| Vehicle No.: | SHB9884B |

## ADJUSTMENT ON REPAIR COST FOR VEHICLE NO. SHB 9884B

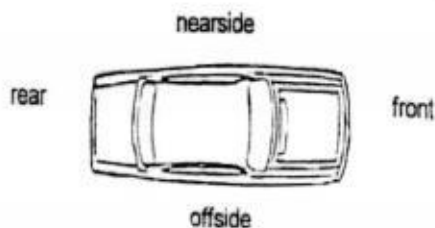
The vehicle sustained damages at the o/s front portion

Comments/Present Status:  
Damages Consistent
