Your Ref: TP/IP/67555/2018  
Our Ref : CI/TPD19007881/N

3 May 2019

**Fatal Accident Investigation Team**  
Traffic Police Department  
Singapore Police Force  
10 Ubi Avenue 3  
Singapore 408865

### **MECHANICAL INSPECTION REPORT OF MOTOR CAR SKU 9165H**

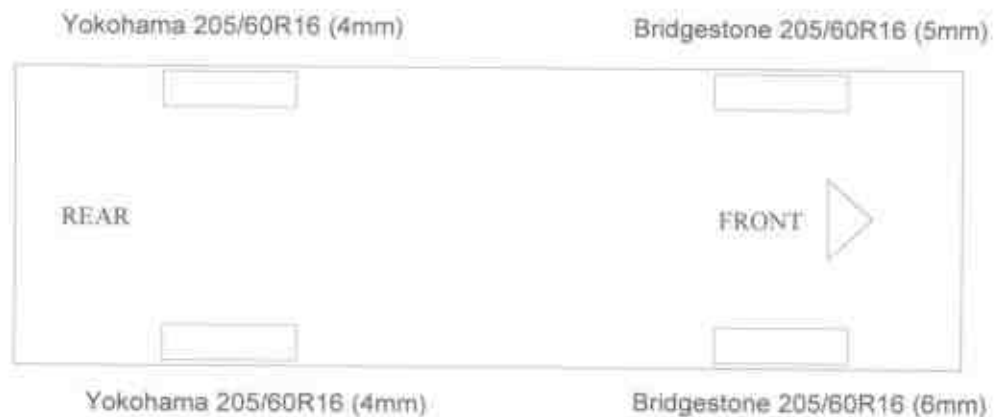
6. The condition of the Motor Car's 4 tyres was observed to be in serviceable condition. We did not find any tear, cut or burst mark(s) on the outer and the inner sidewalls as well as across the tread of the 4 tyres. The 4 tyres were also observed to be sufficiently inflated for vehicular operation. The tyre brand, tyre size and remaining tread depth of the 4 tyres were recorded as follows:-

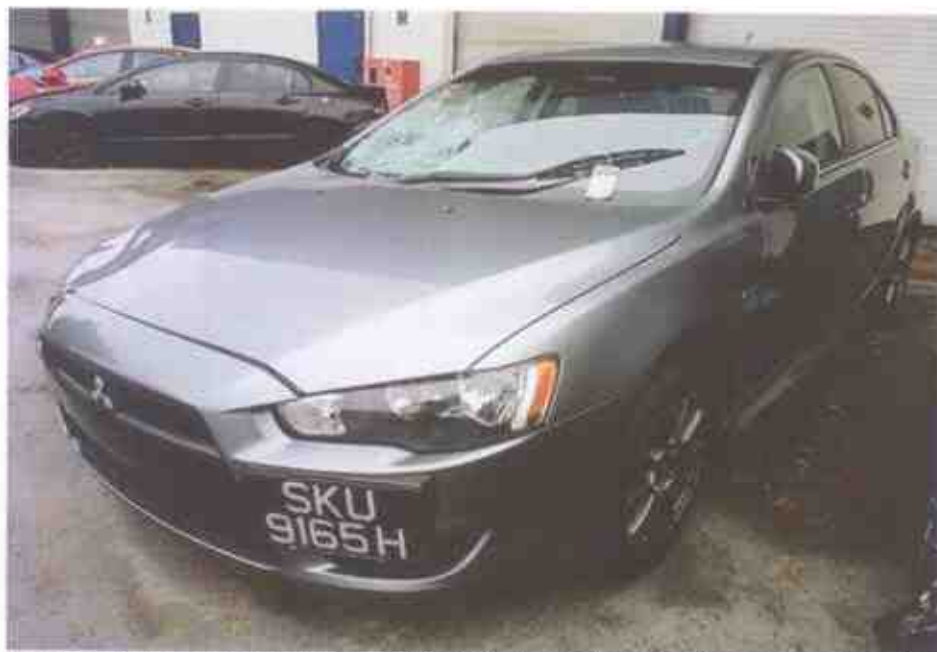
**Photo 1** shows a general view of the front left body of the Motor Car at the time of our inspection. The Motor Car was observed to be in good general condition except for some relatively minor impact damage at its left frontal portion. The mileage of the Motor Car was recorded to be 52, 061km.

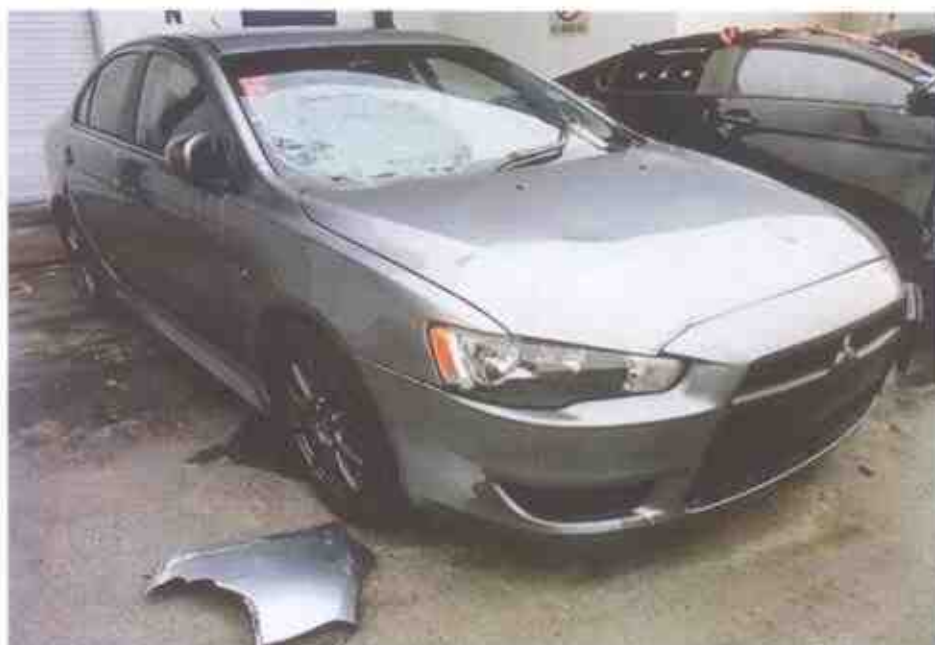
4. The mileage of the Motor Car at the time of our inspection was 52, 061km.
5. The Motor Car had sustained relatively minor impact damage that was confined to its right frontal portion. Its front bonnet was observed to have been dented; its front bumper was observed to be deformed while its front windscreen was observed to be cracked.

**Photo 2** shows a general view of the front right body of the Motor Car at the time of our inspection. The Motor Car was observed to be in good general condition. However we had observed relatively minor impact damage that was confined to its right frontal portion. Its front bonnet was observed to have been dented; its front bumper was observed to be deformed while its front windscreen was observed to be cracked.

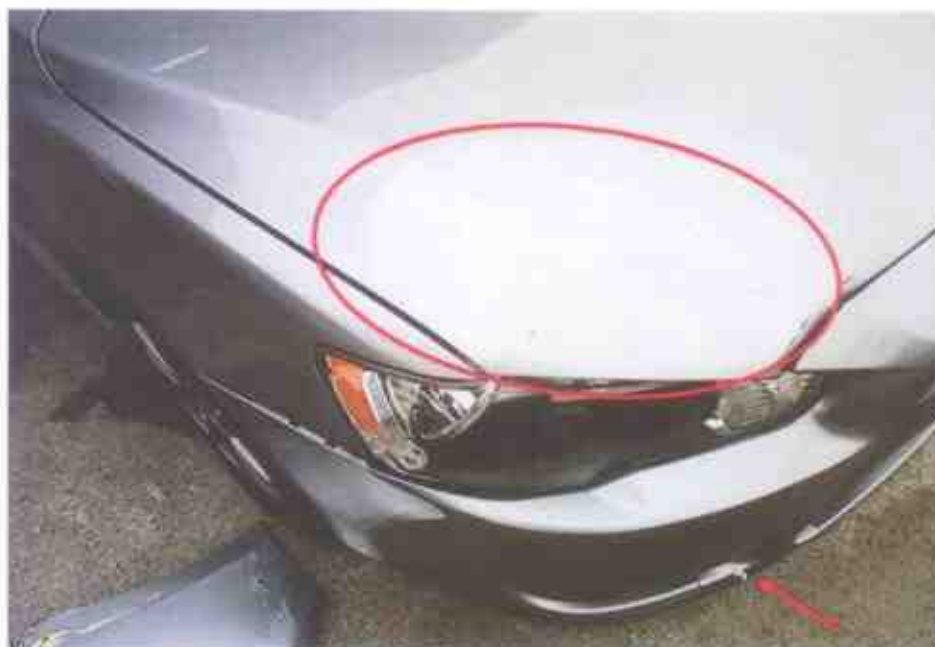
**Photo 3** shows a closer view of the dented front bonnet (circled) and deformed front bumper (arrowed) of the Motor Car at the time of our inspection

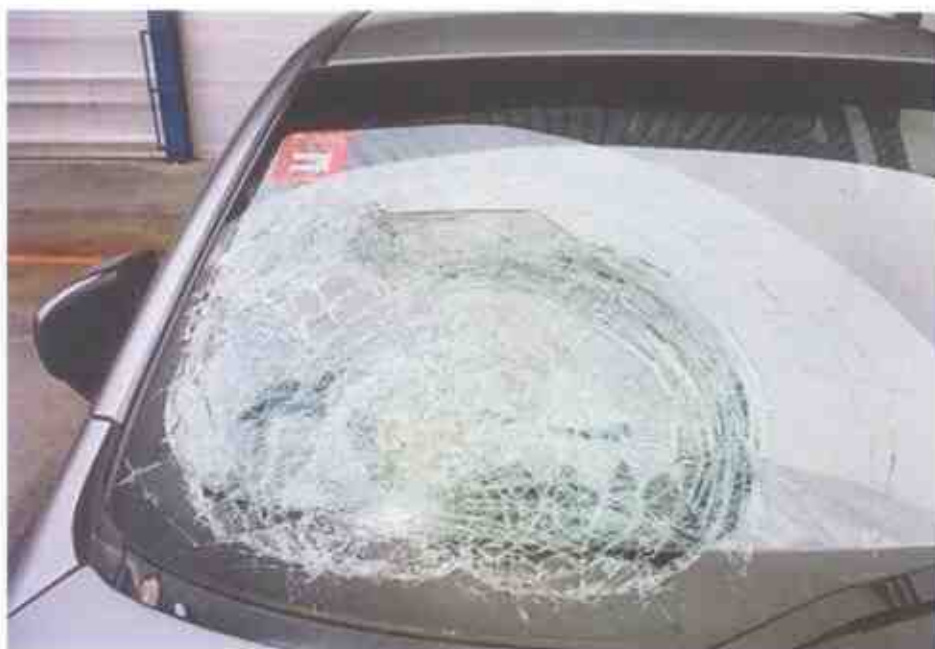
**Photo 4** shows a closer view of the cracked front windscreen of the Motor Car at the time of our inspection.

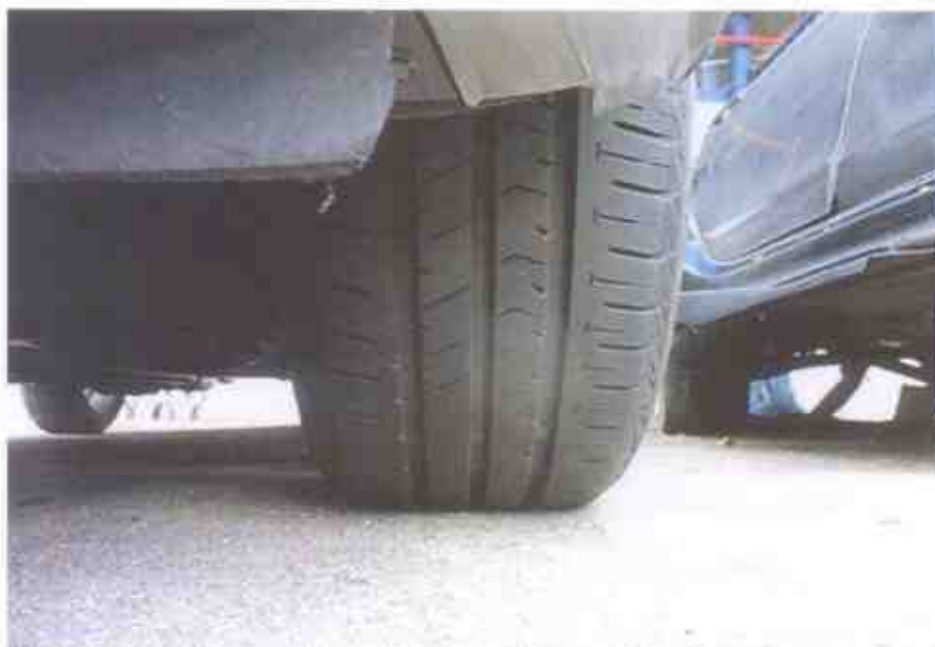
**Photo 6** shows the condition of the front left tyre of the Motor Car, which was observed to be in serviceable condition with remaining tread depth of approximately 5mm. The tyre, which was wrapped around alloy wheel rim, was also observed to be sufficiently inflated for vehicular operation. There was no tear, cut or burst mark(s) on the outer and the inner sidewalls as well as across the tread of the 4 tyres.

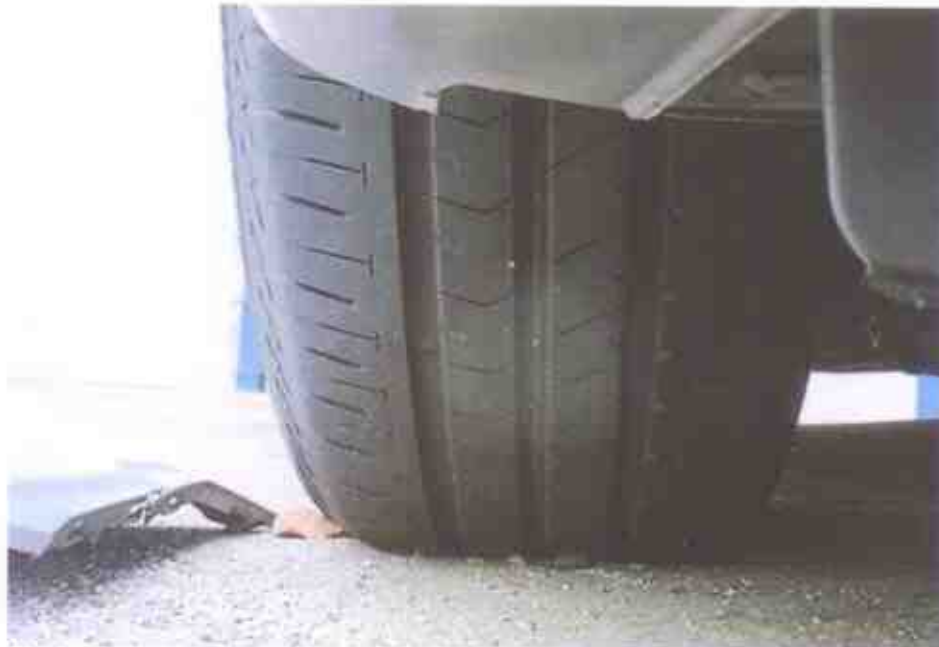
**Photo 7** shows the condition of the front right tyre of the Motor Car, which was observed to be in serviceable condition with remaining tread depth of approximately 6mm. The tyre, which was wrapped around alloy wheel rim, was also observed to be sufficiently inflated for vehicular operation.

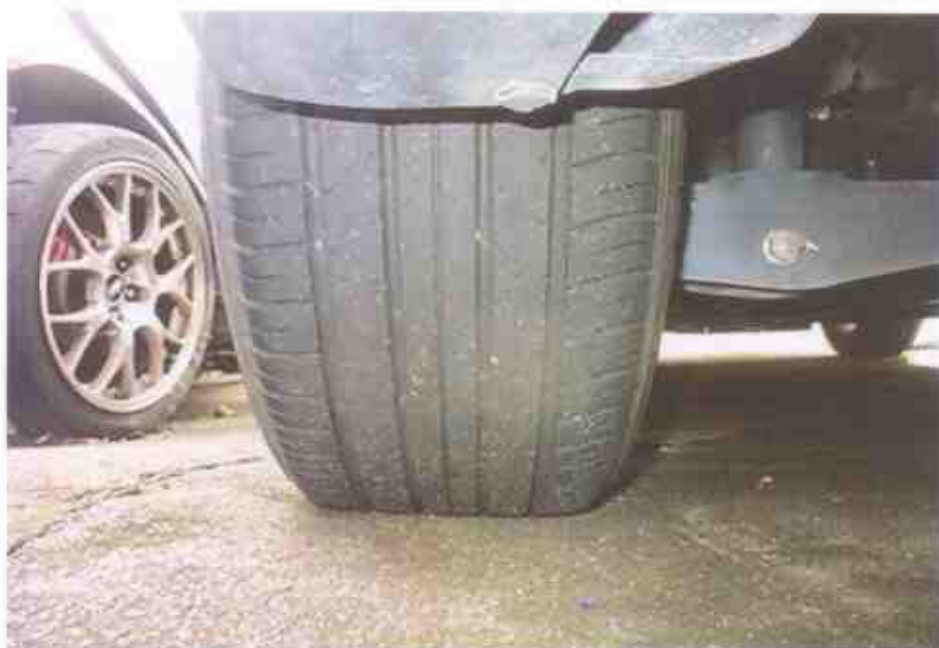
**Photo 8** shows the condition of the rear left tyre of the Motor Car, which was observed to be in serviceable condition with remaining tread depth of approximately 4mm. The tyre, which was wrapped around alloy wheel rim, was also observed to be sufficiently inflated for vehicular operation. There was also no damage found on the 4 wheel rims of the Motor Car.

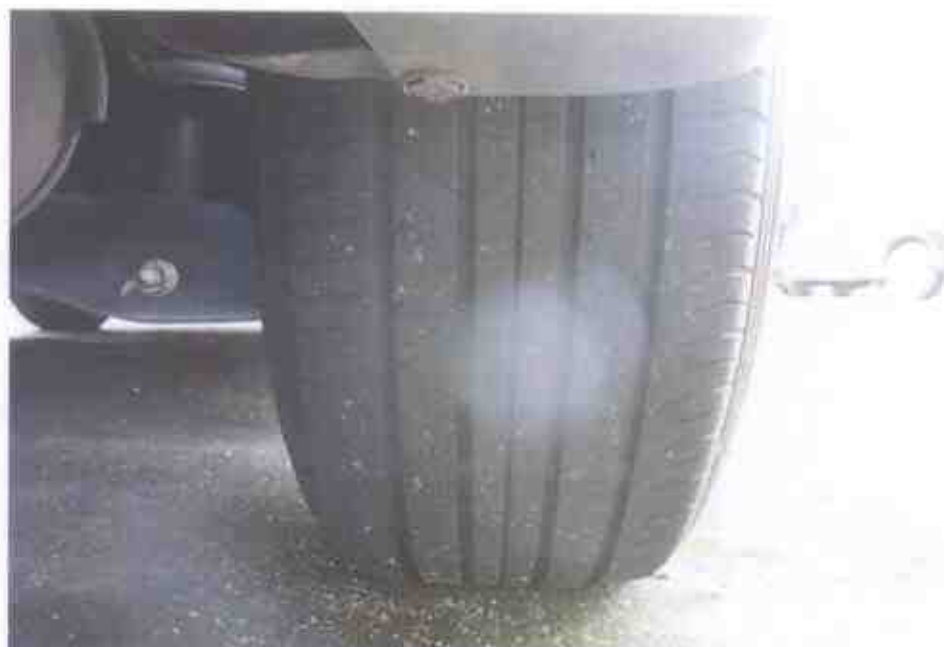
Photo 9 shows the condition of the rear right tyre of the Motor Car, which was observed to be in serviceable condition with remaining tread depth of approximately 4mm. There was also no tear, cut or burst mark(s) on the outer and the inner sidewalls as well as across the tread of the 4 tyres.

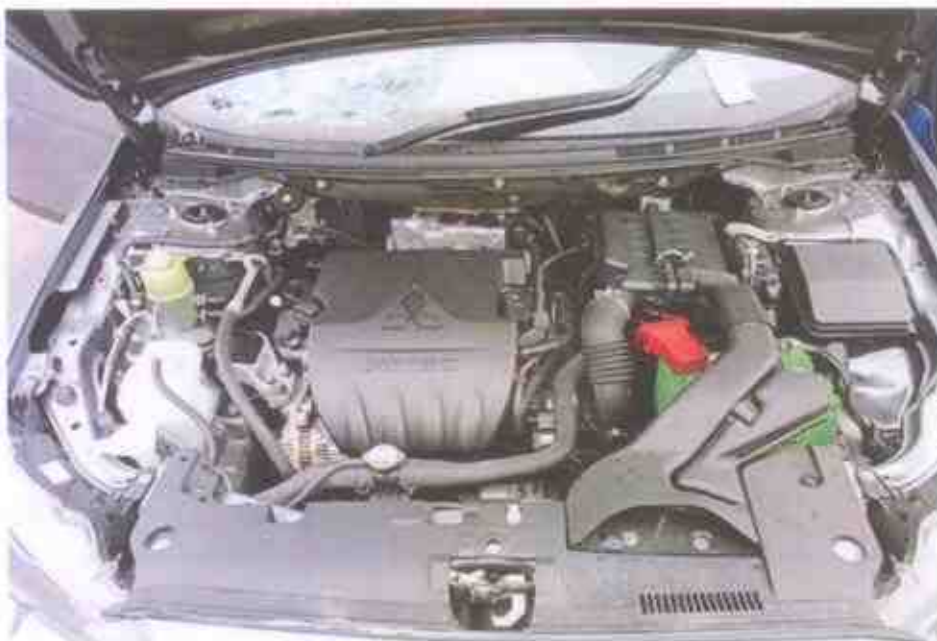
**Photo 10** shows a general view of the Motor Car's engine compartment. The various parts and components inside the engine compartment were unaffected by the accident. There was also no sign(s) or indication(s) of fluid leakage and/or fluid stain within the engine compartment.

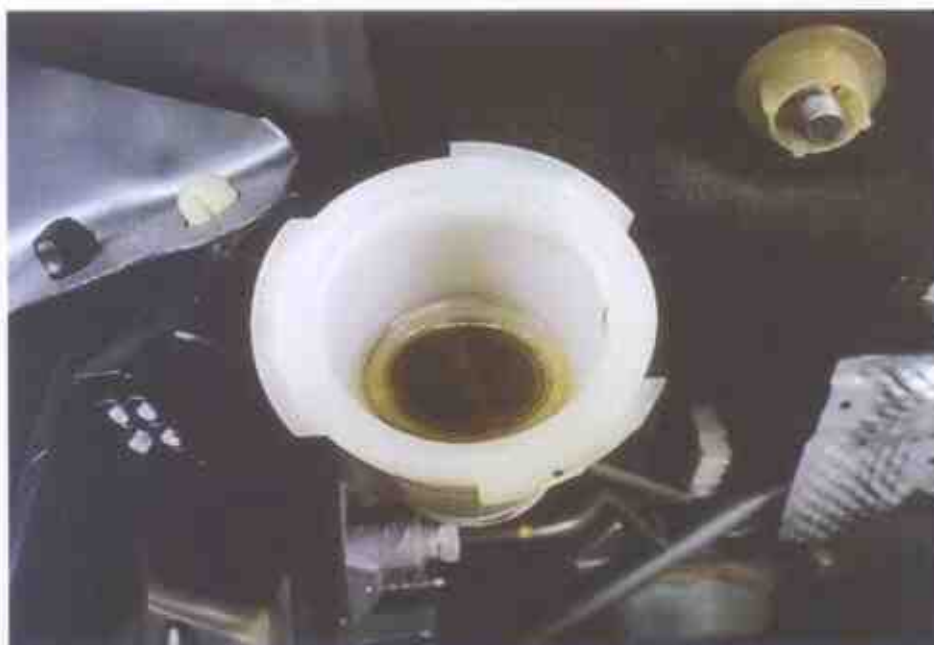
**Photo 11** shows the brake fluid reservoir of the Motor Car at the time of our inspection. The brake fluid was observed to be of sufficient level and without any visible contamination.

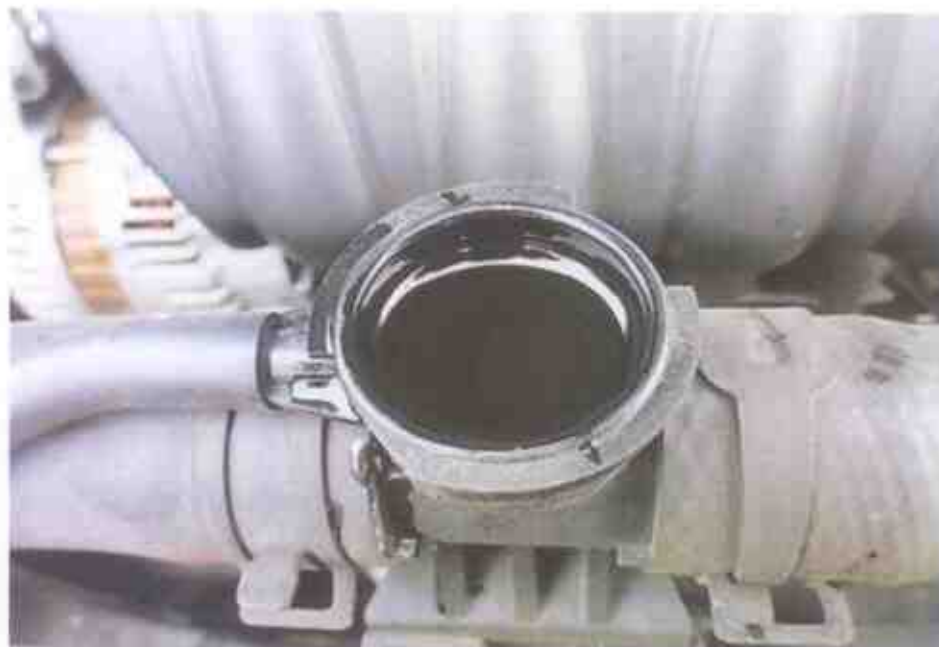
**Photo 12** shows checks being carried out to the engine coolant of the Motor Car at the time of our inspection. The engine coolant was observed to be of sufficient level and without any visible contamination.

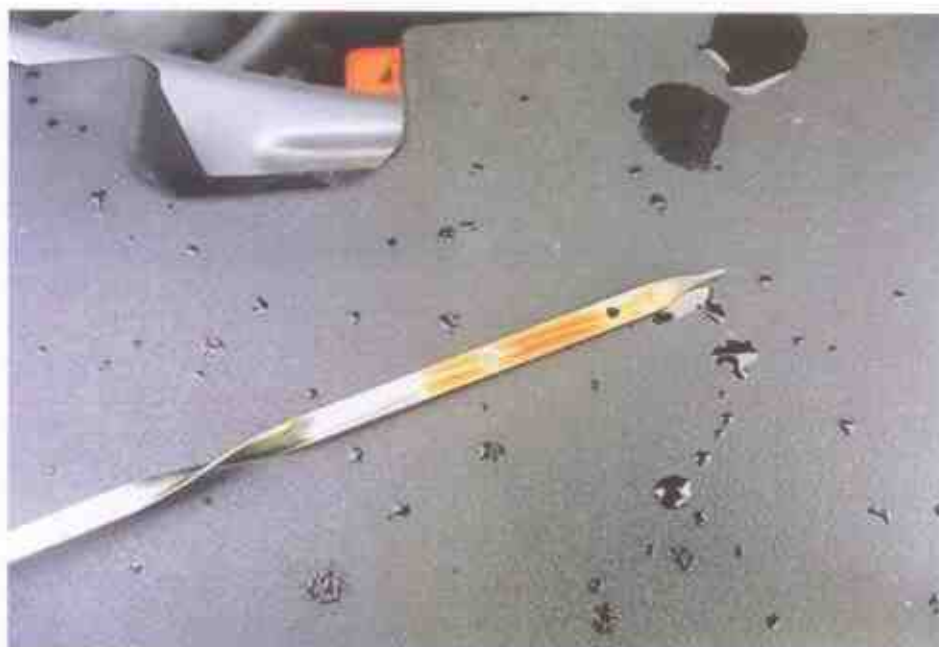
**Photo 13** shows the engine oil dip stick of the Motor Car at the time of our inspection. The engine oil was observed to be of sufficient level and without any visible contamination.

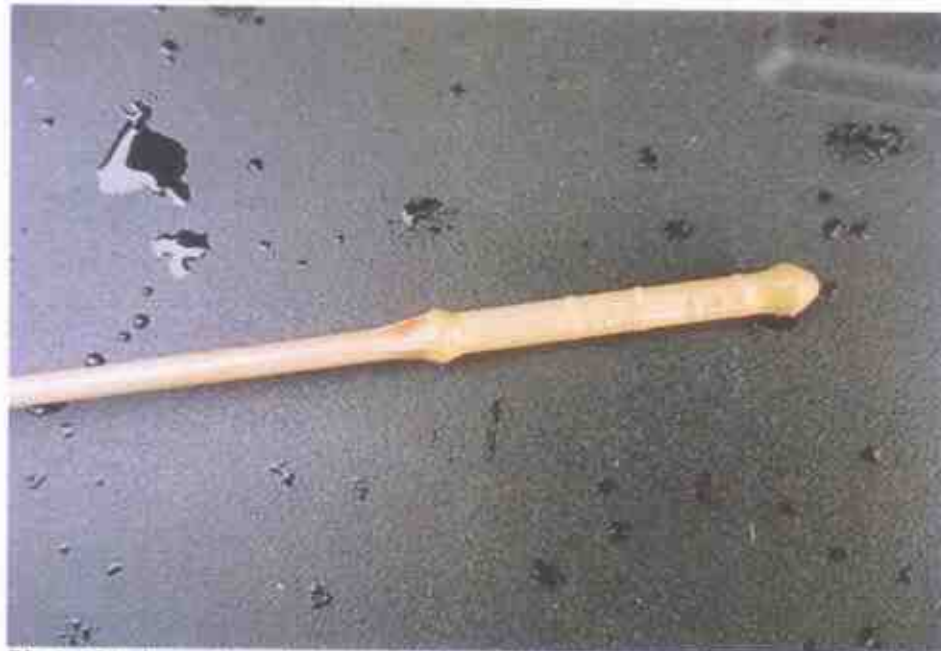
Photo 14 shows the auto transmission fluid (ATF) dip stick of the Motor Car at the time of our inspection. The ATF was observed to be of sufficient level and without any visible contamination.

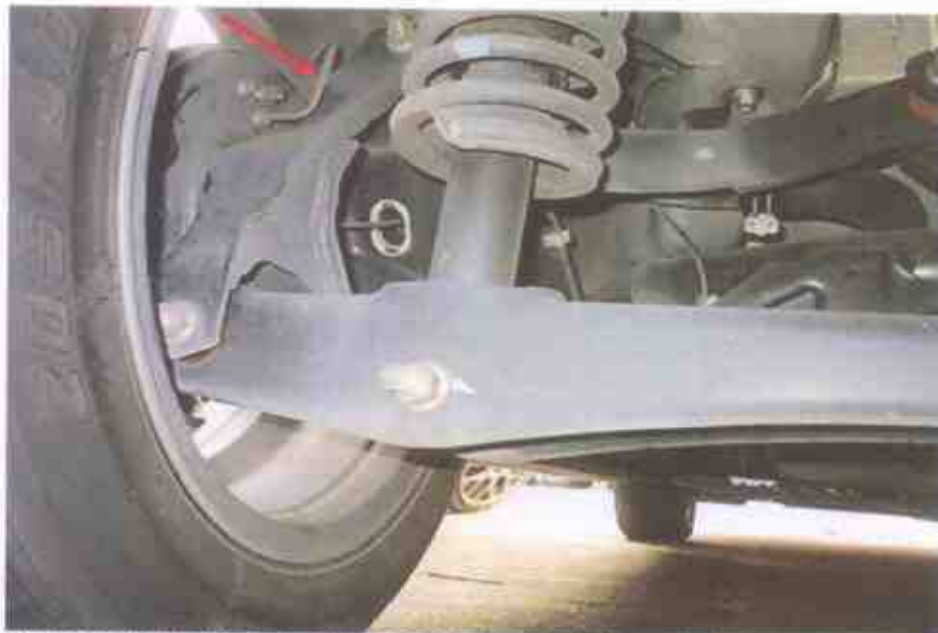
Photo 15 shows the brake hose/pipe (arrowed) at the rear left wheel of the Motor Car. We did not observe any leakage of brake fluid at the time of our inspection of the Motor Car. Static tests of the Motor Car's braking system had indicated that there was no internal leakage of pressure/vacuum. Hence the braking system was likely to be in serviceable condition at the material time of accident. The undercarriage components of the Motor Car were also all found to be intact and without any visible damage.

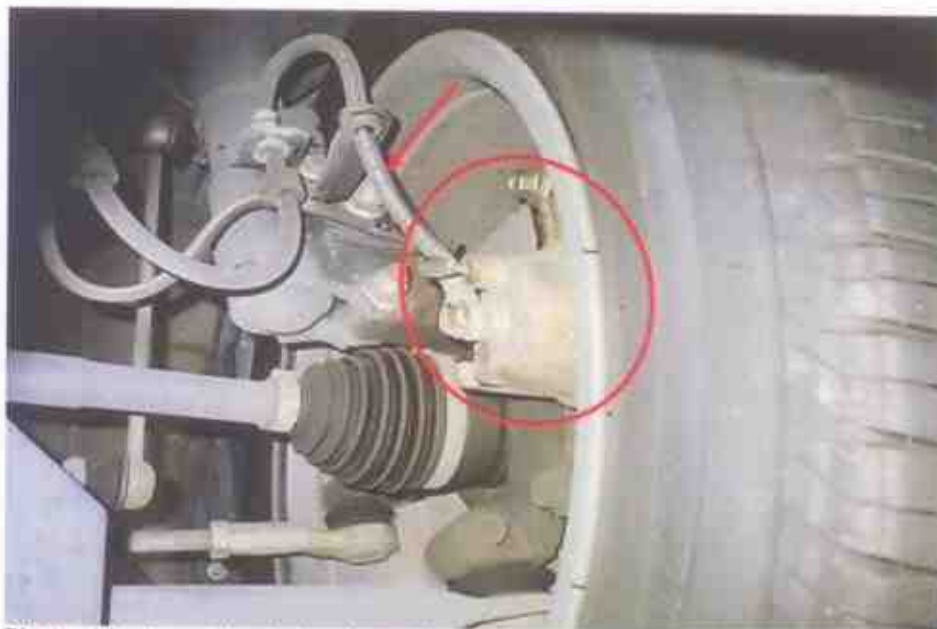
Photo 16 shows the brake hose/pipe (arrowed) at the front left wheel of the Motor Car. No leakage of brake fluid was observed. Visual examination of the various components of the braking system like the brake caliper (circled), brake pedal etc. had revealed all to be intact and without visible damage.

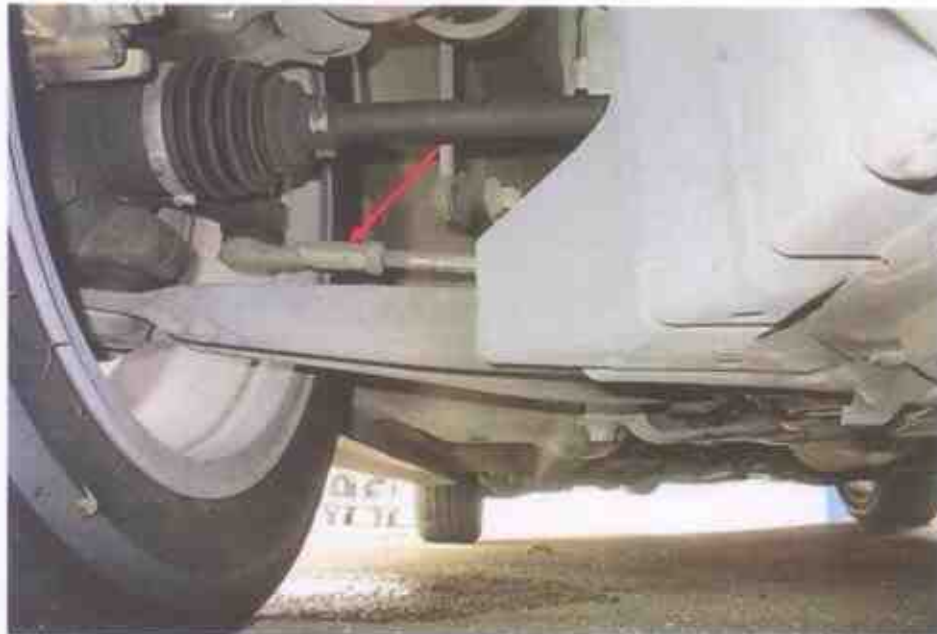
**Photo 17** shows the various undercarriage components at the front right wheel of the Motor Car, in particular the steering tie rod (arrowed). The various steering components were all found to be intact, suggesting that the steering system of the Motor Car was likely to be in serviceable condition at the material time of accident. There was also no sign of fluid stain observed on the various undercarriage components at the front right wheel of the Motor Car.

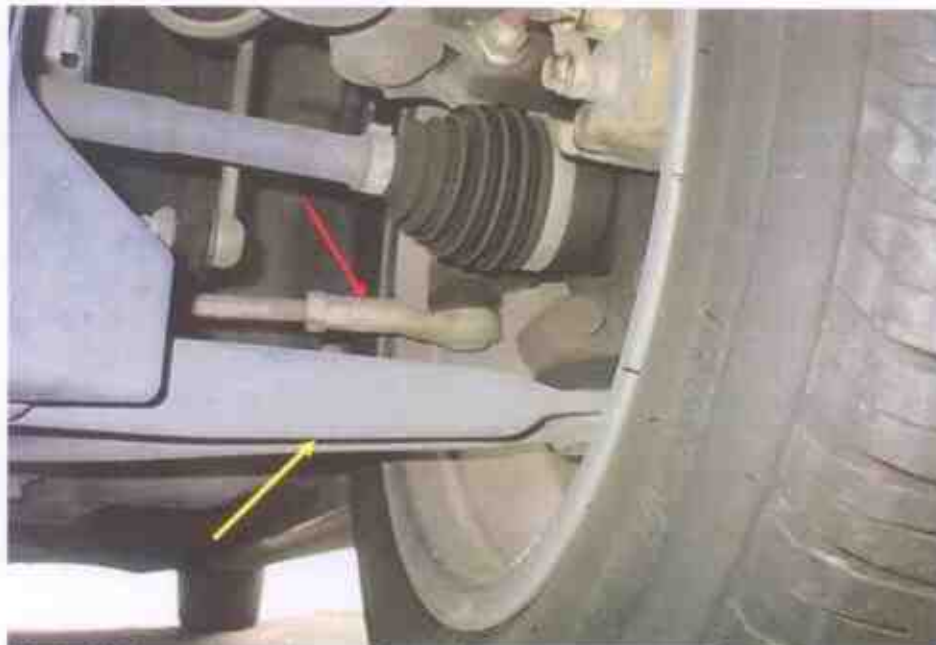
**Photo 18** shows the various undercarriage components at the front left wheel of the Motor Car, which had included the steering tie rod (red arrow) and left drive shaft (yellow arrow). The various undercarriage components of the Motor Car were all found to be intact without any visible damage.

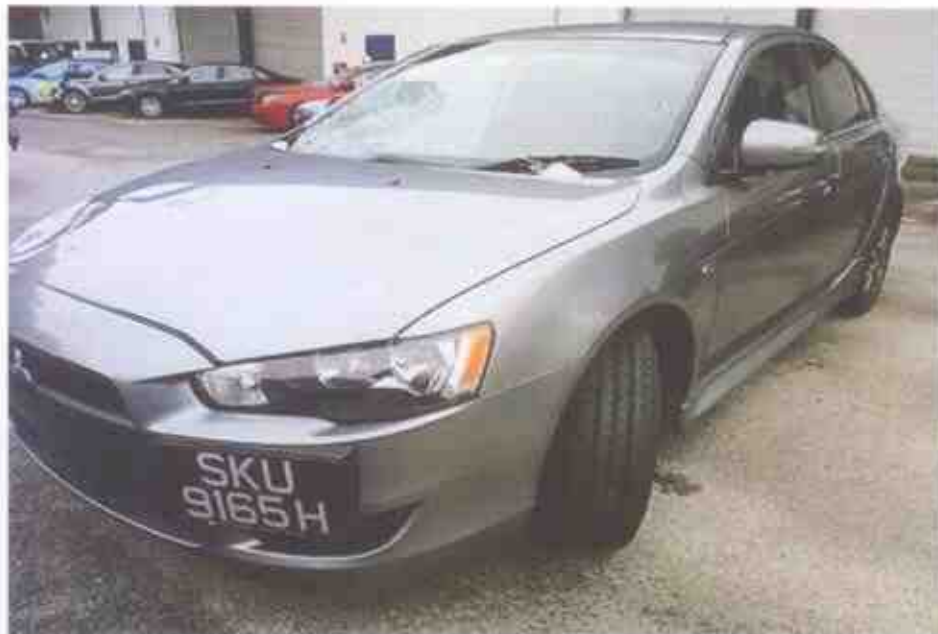
**Photo 19** shows the front left wheel of the Motor Car turned to its full left. During our steering system test, we did not experience any abnormal free play and/or resistance when we had turned the steering wheel towards the left and right. This would suggest that the steering system of the Motor Car was likely to be in serviceable condition at the material time of accident.

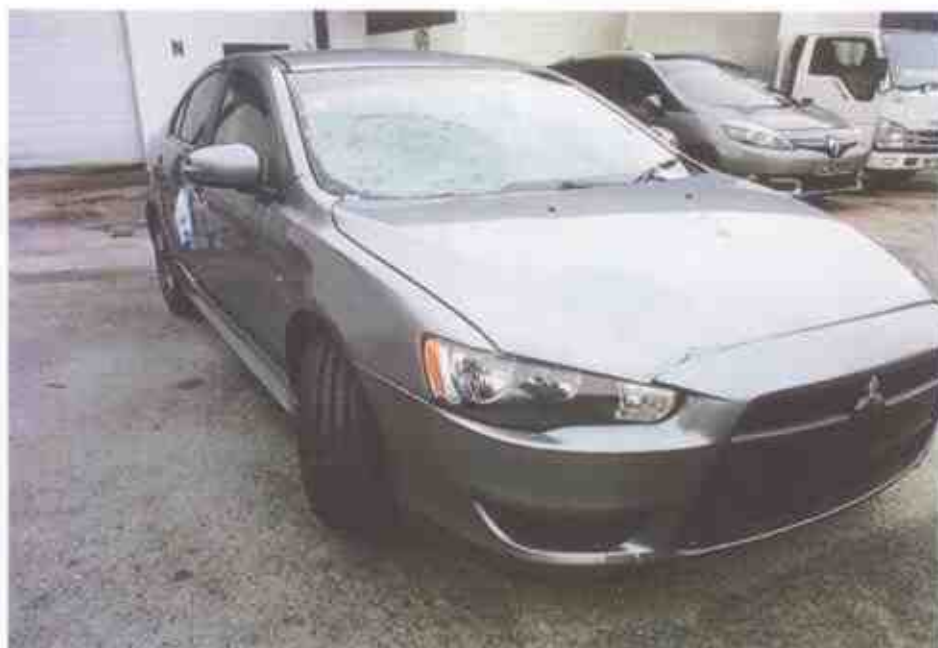
**Photo 20** shows the front right wheel of the Motor Car turned to its full right. During our steering system test, we did not experience any abnormal free play and/or resistance when we had turned the steering wheel towards the left and right. This would suggest that the steering system of the Motor Car was likely to be in serviceable condition at the material time of accident.

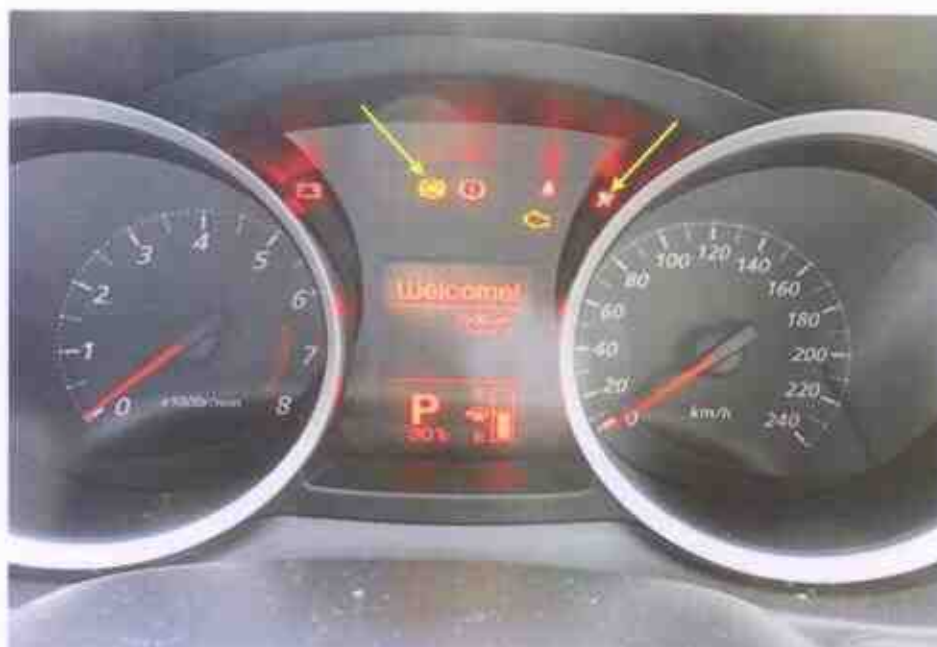
Photo 21 shows the warning lights for the various electronic operating systems of the Motor Car appearing on its instrument panel during the self-test when the engine is cranked, in particular the ABS light and SRS light (arrowed).

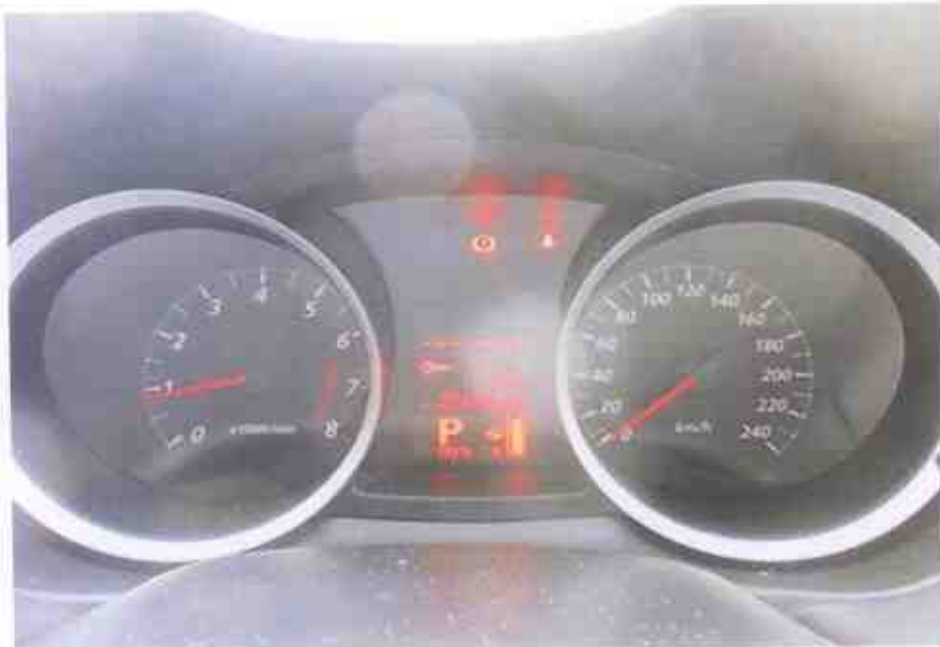
Photo 22 shows no warning lights illuminated on the instrument panel of the Motor Car after the engine was cranked. This would suggest that there was no abnormality to the various electronic operating systems of the Motor Car, like the ABS and SRS etc.
