Your Ref: TP/IP/11499/2019
Our Ref : CI/TPD18016725/P

29th May 2019

Fatal Accident Investigation Team

MECHANICAL INSPECTION REPORT OF MOTOR BUS JDS 8768

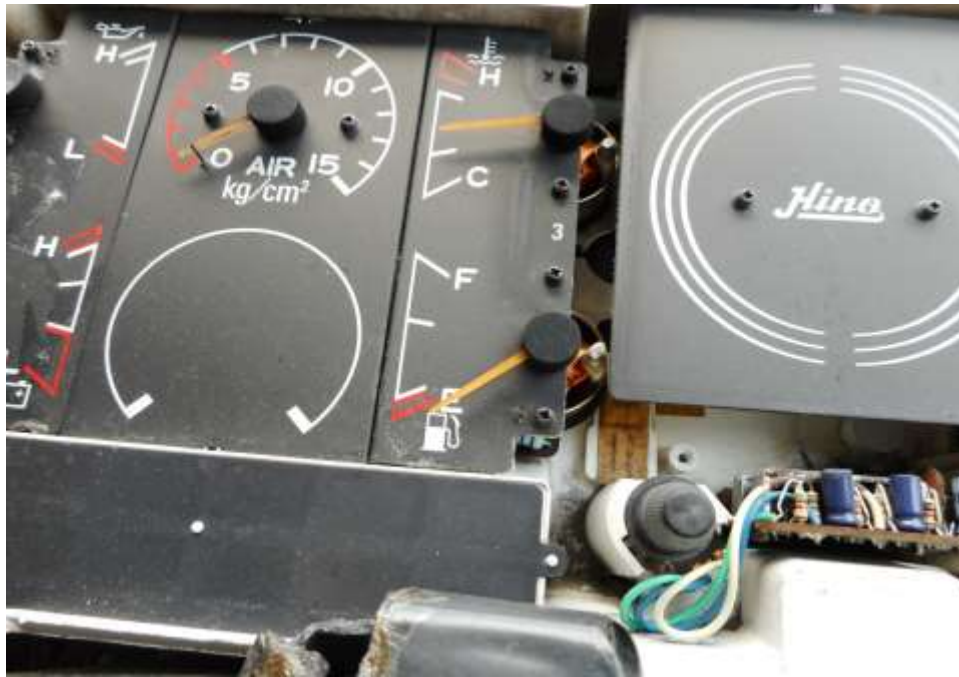
Photo 1 shows the damaged instrument cluster. Therefore no mileage is recorded at the time of our inspection.

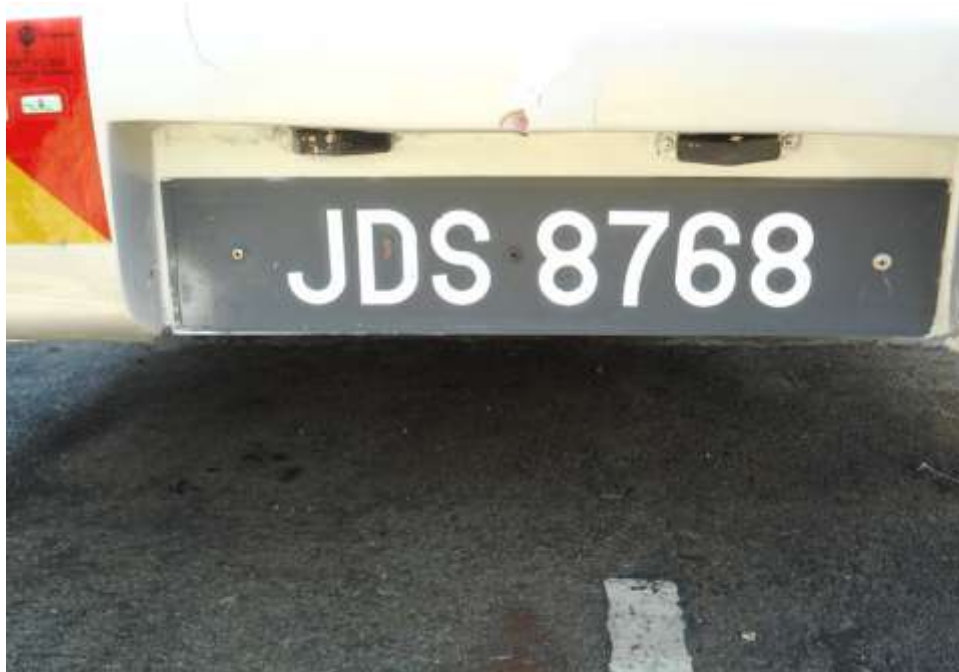
Photo 2 shows the number plate of the Motor Bus at the time of our inspection.

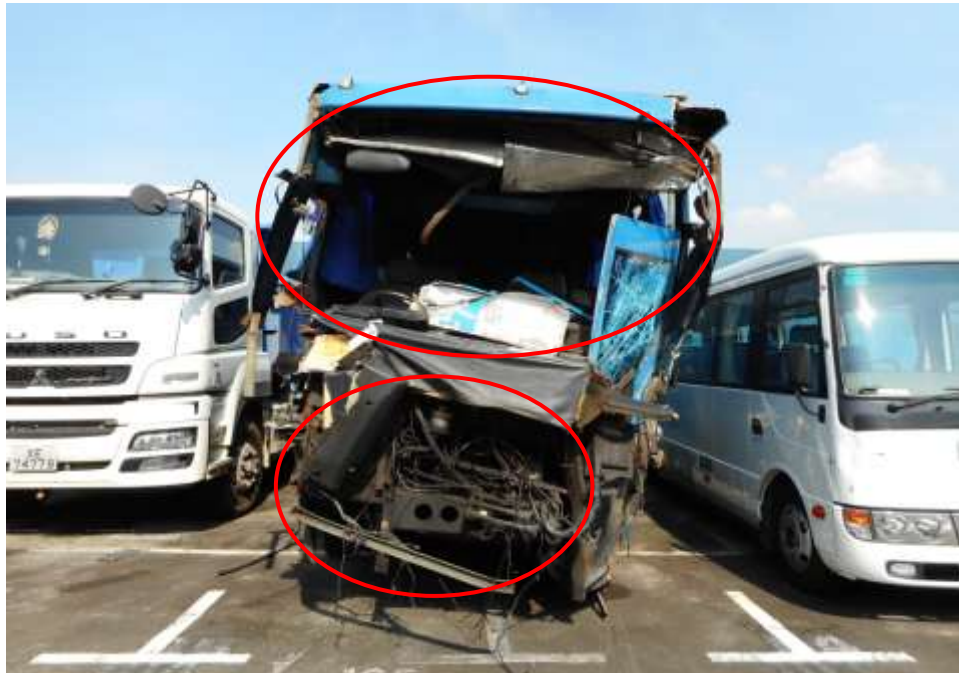
Photo 2 shows a general view of the front body of the Motor Bus at the time of our inspection. The Motor Bus was observed to have sustained extensive damages at its front portion and its entire front windshield (circled) was observed to be shattered and pushed inwards towards the rear as a result of the accident's collision.

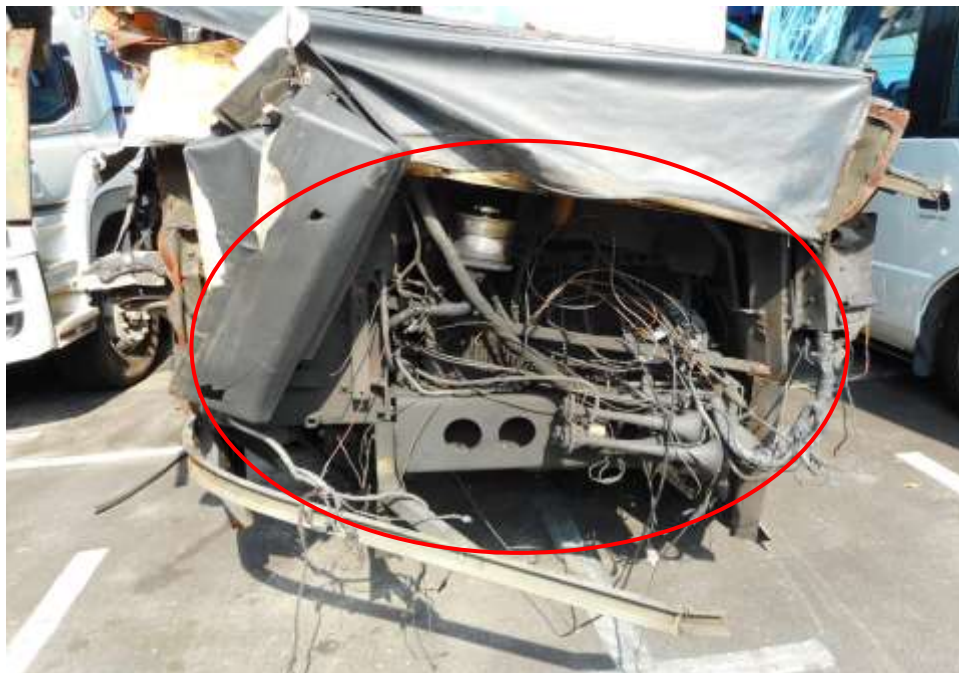
Photo 3 shows a general view of the front body of the Motor Bus at the time of our inspection. The Motor Bus was observed to have sustained extensive damages at its front portion (circled) as a result of the accident's collision.

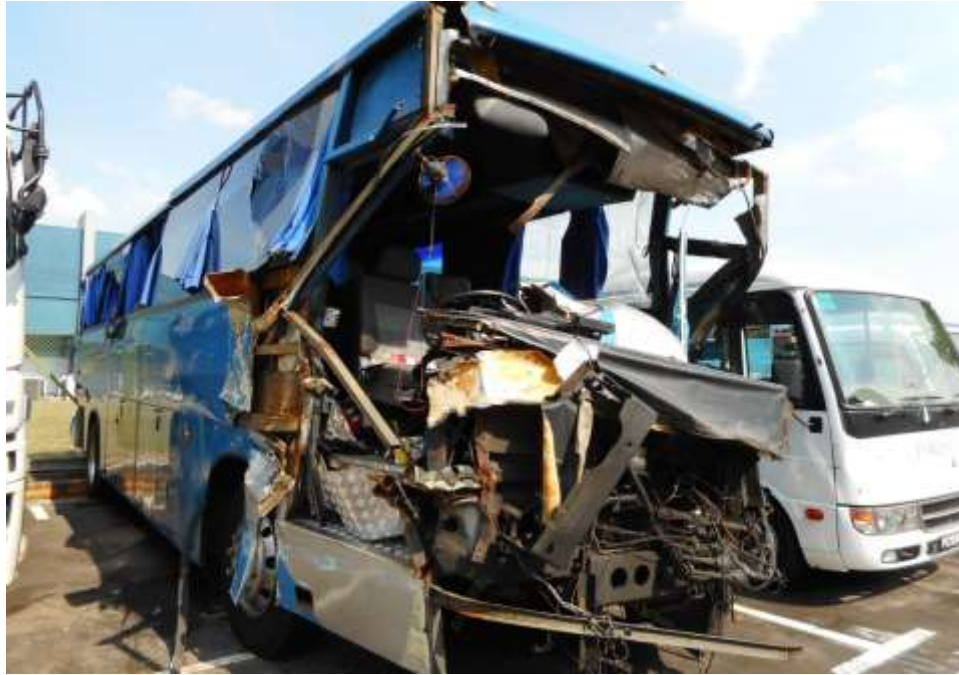
Photo 4 shows a general view of the front right side body of the Motor Bus at the time of our inspection. The Motor Bus was observed to have sustained extensive damages at its front right portion as a result of the accident's collision.

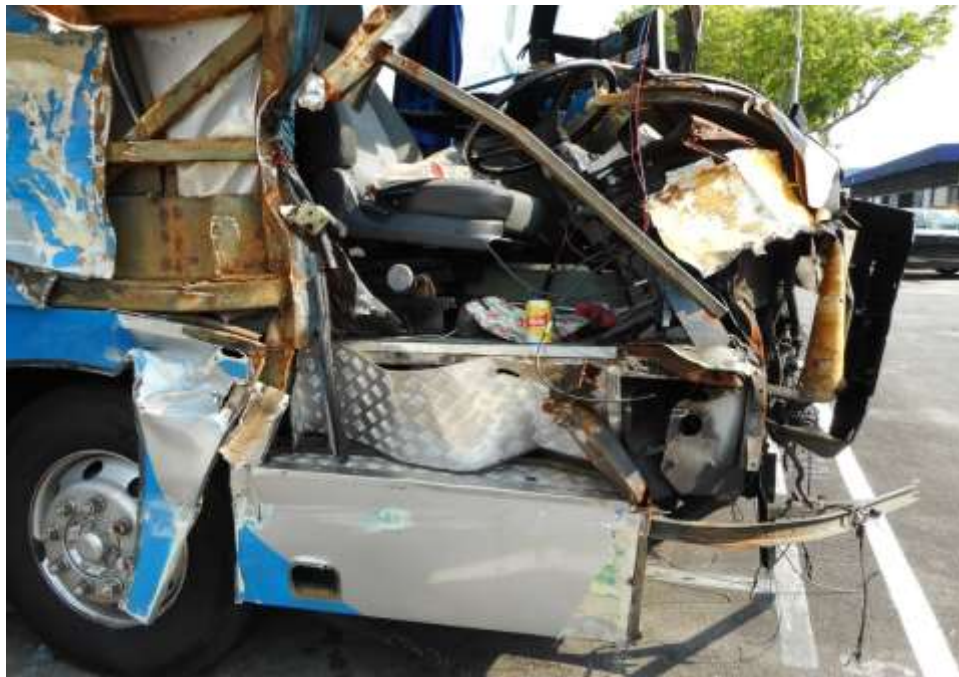
Photo 5 shows a close up view of the front right side body of the Motor Bus at the time of our inspection. The Motor Bus was observed to have sustained extensive damages at its front portion as a result of the accident's collision.

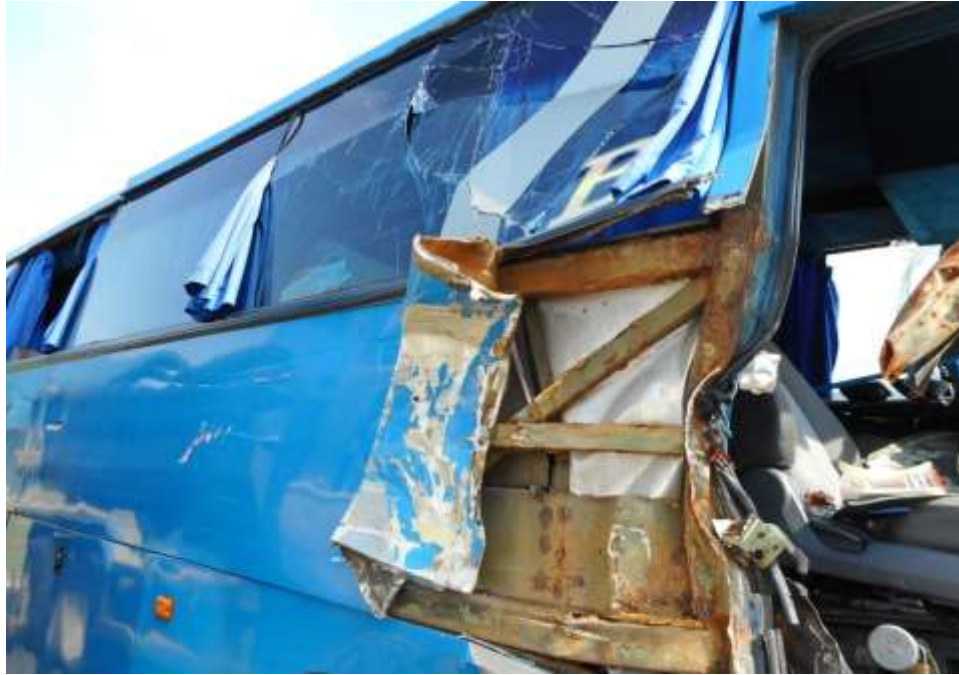
Photo 6 shows a close up view of the right side body of the Motor Bus at the time of our inspection. The Motor Bus was observed to have sustained extensive damages at its front portion as a result of the accident's collision.

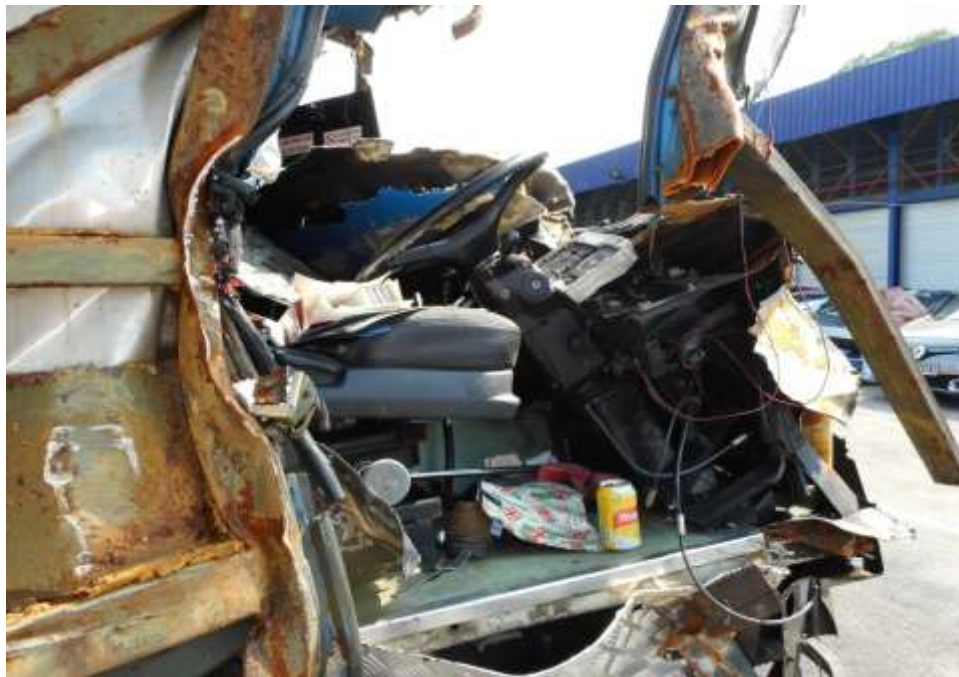
Photo 7 shows a close up view of the driver's cabin and its various driver systems at the time of our inspection and was observed to have sustained extensive damages, the operational road testing and electronics systems check of motor bus is immobilized as a result of the accident's collision.

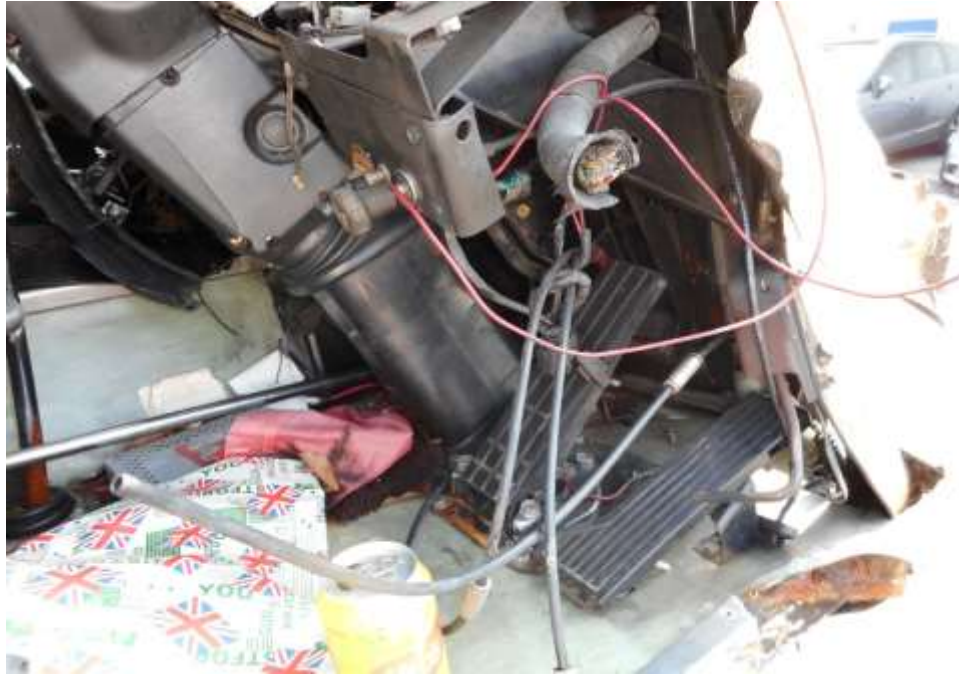
Photo 8 shows a close up view of the driver's foot well and its various driver systems at the time of our inspection and was observed to have sustained extensive damages, the operational road testing and electronics systems check of motor bus is immobilized as a result of the accident's collision.

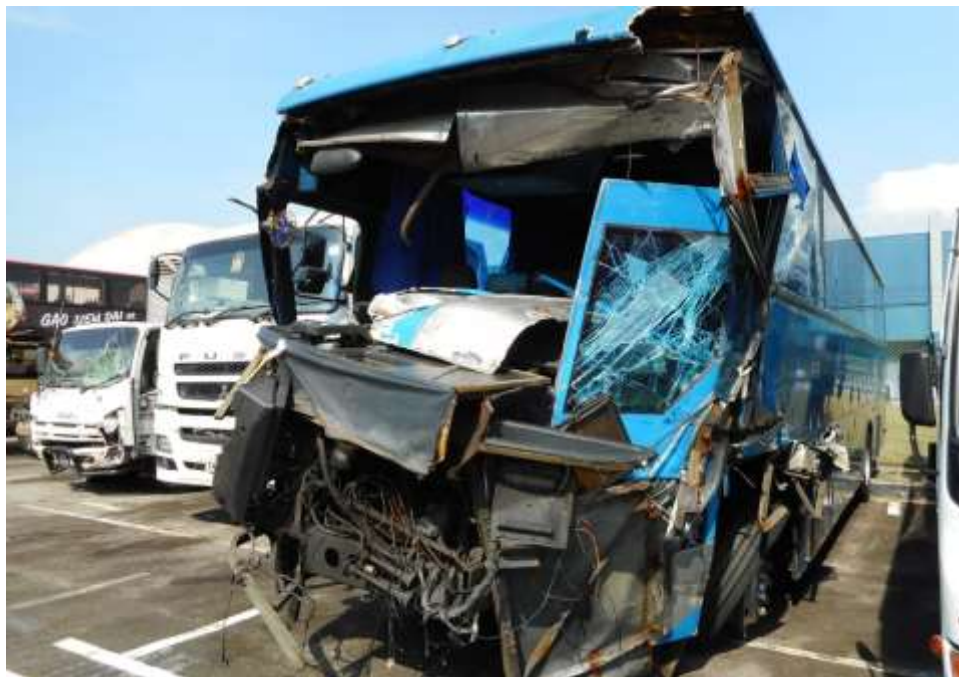
Photo 9 shows a general view of the front & left side body of the Motor Bus at the time of our inspection. The Motor Bus was observed to have sustained extensive damages at its side portion as a result of the accident's collision.

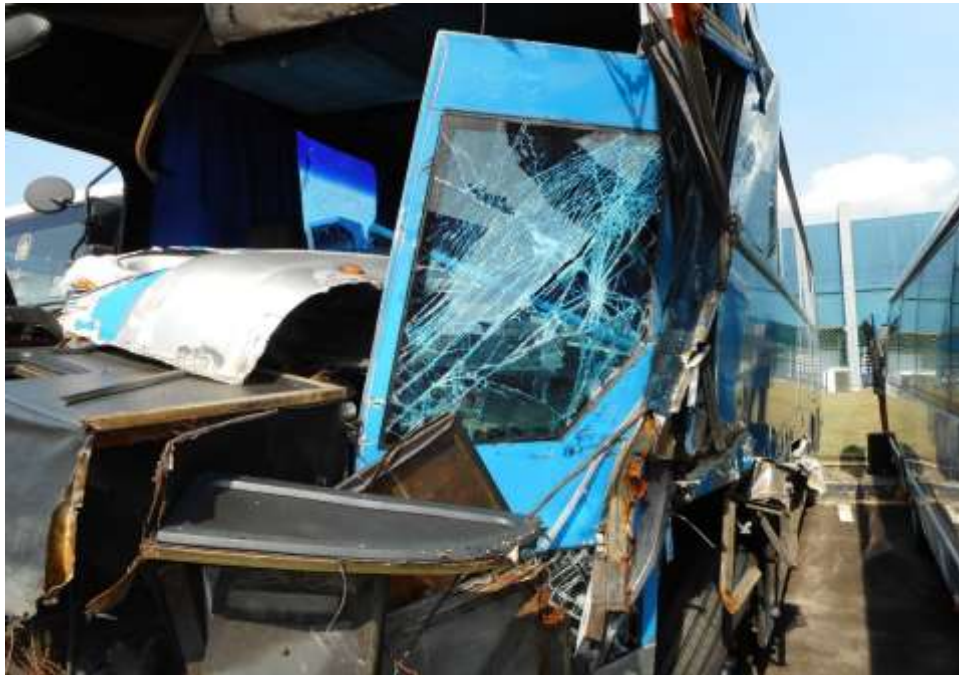
Photo 10 shows a close up view of the front and left side body of the Motor Bus at the time of our inspection. The Motor Bus was observed to have sustained extensive damages at its front entry/exit door upper portion as a result of the accident's collision.

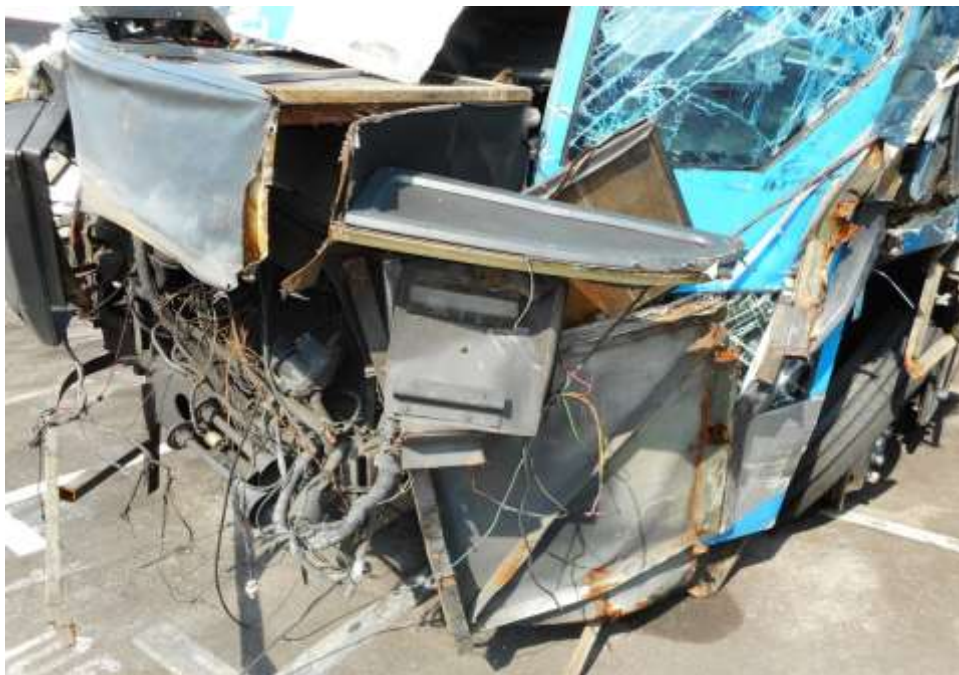
Photo 11 shows a close up view of the front and left side body of the Motor Bus at the time of our inspection. The Motor Bus was observed to have sustained extensive damages at its front entry/exit door lower portion as a result of the accident's collision.

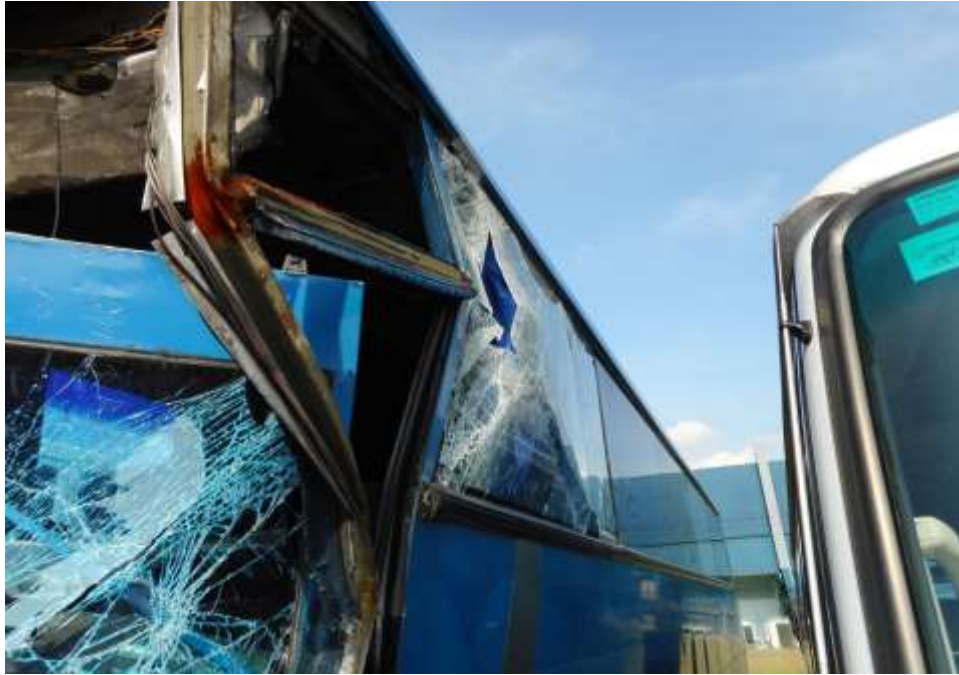
Photo 12 shows a close up view of the left side body of the Motor Bus at the time of our inspection. The Motor Bus was observed to have sustained extensive damages at its side windscreen as a result of the accident's collision.

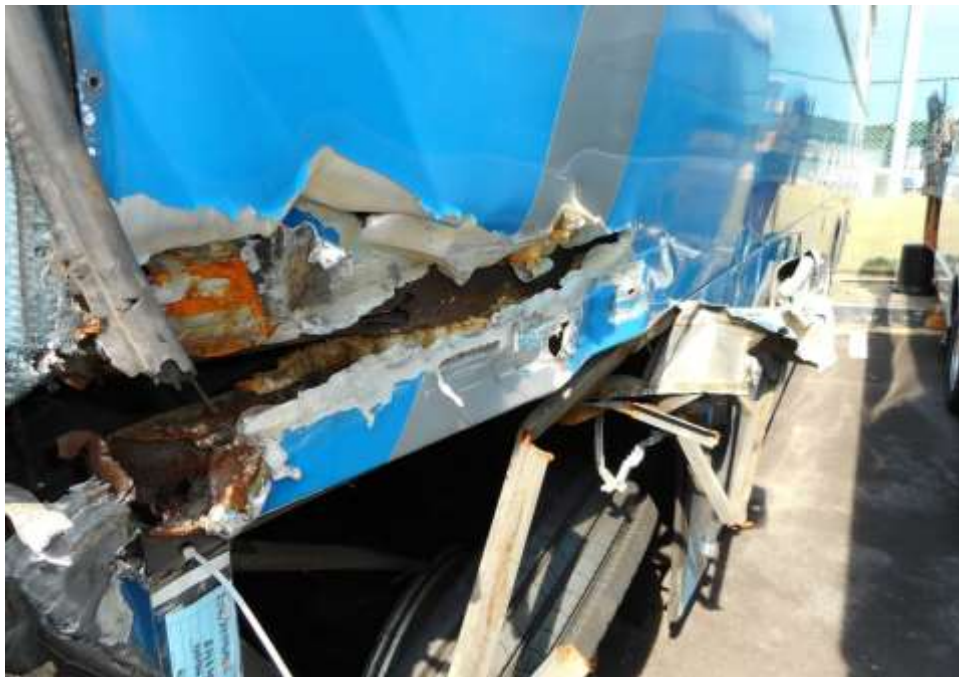
Photo 13 shows a close up view of the left side body of the Motor Bus at the time of our inspection. The Motor Bus was observed to have sustained extensive damages at its side wheel arch portion as a result of the accident's collision.

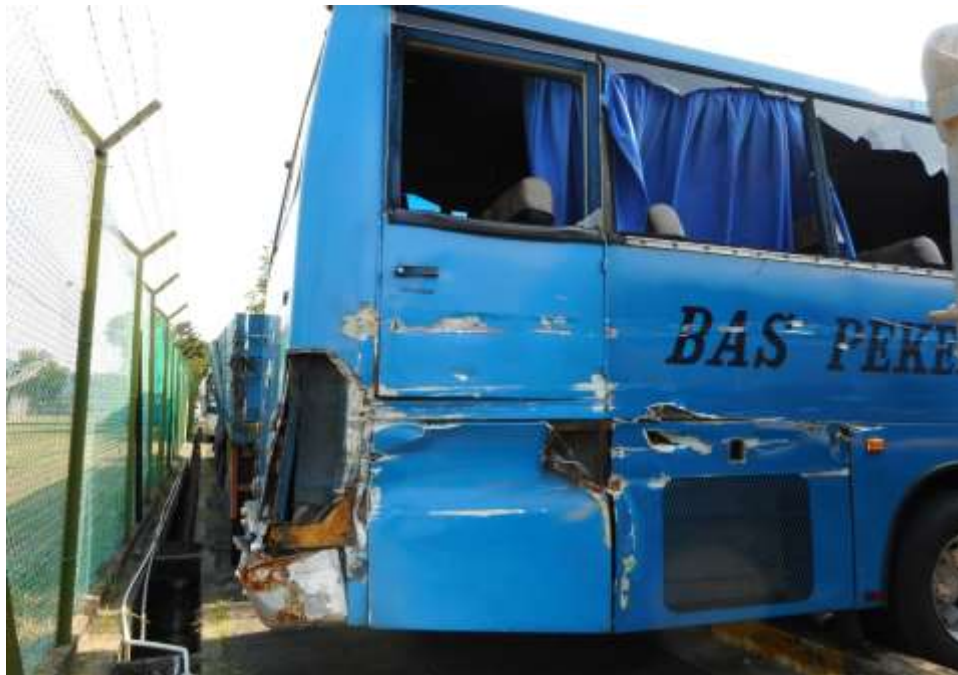
Photo 14 shows a general view of the rear right body of the Motor Bus at the time of our inspection. The Motor Bus was observed to have sustained extensive damages at its rear right portion as a result of the accident's collision.

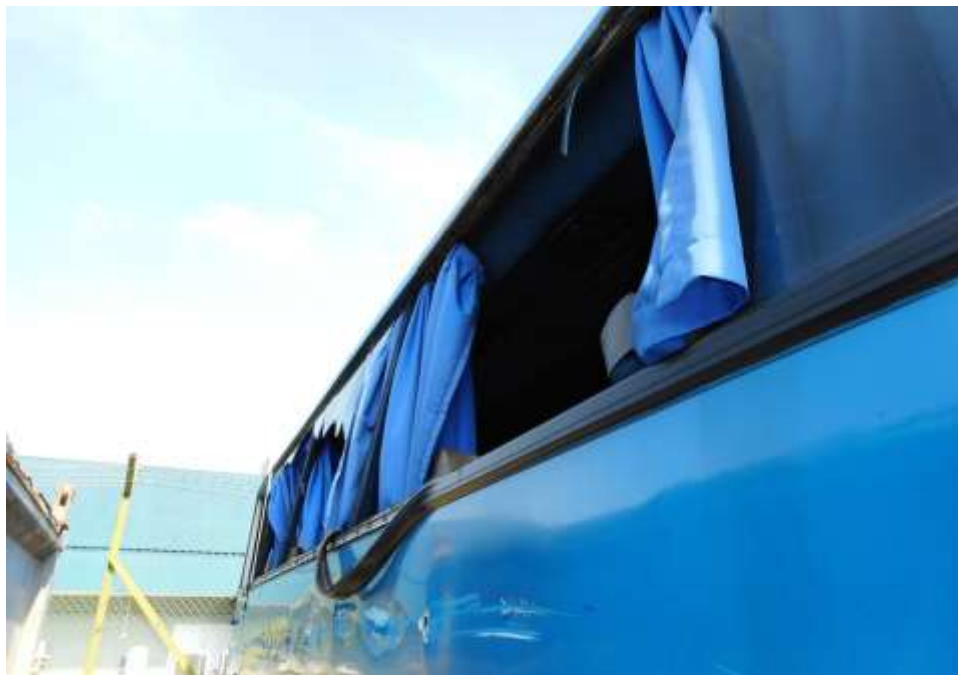
Photo 15 shows a close up view of the rear windscreen of the Motor Bus at the time of our inspection. The Motor Bus was observed to have sustained extensive damages at sections of its side windscreen and body panel portion as a result of the accident's collision.

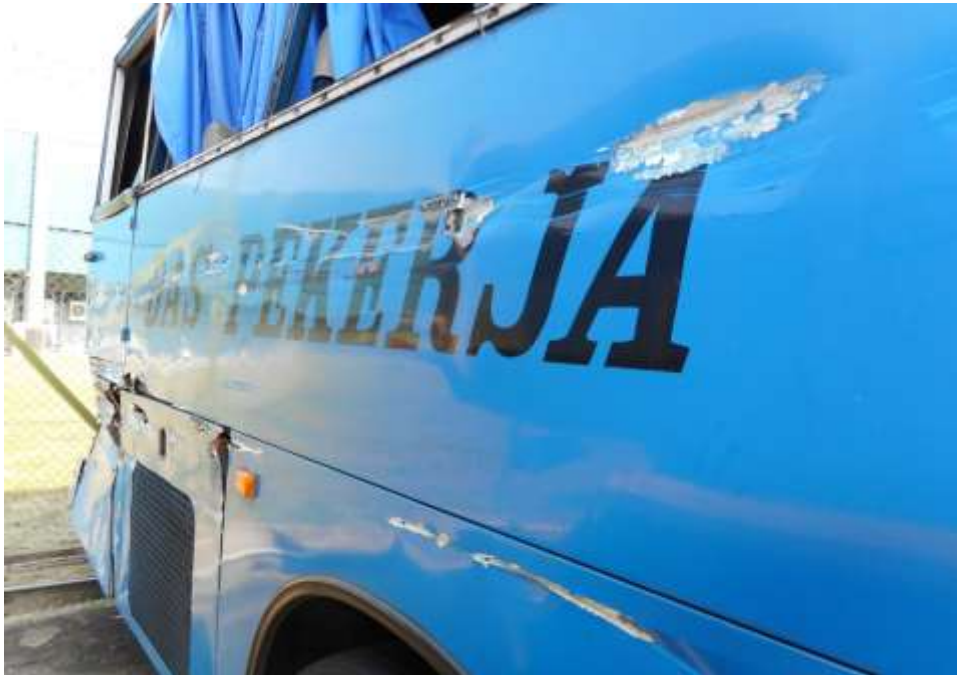
Photo 16 shows a close up view of the rear right body of the Motor Bus at the time of our inspection. The Motor Bus was observed to have sustained extensive damages at sections of its side windscreen and body panel portion as a result of the accident's collision.

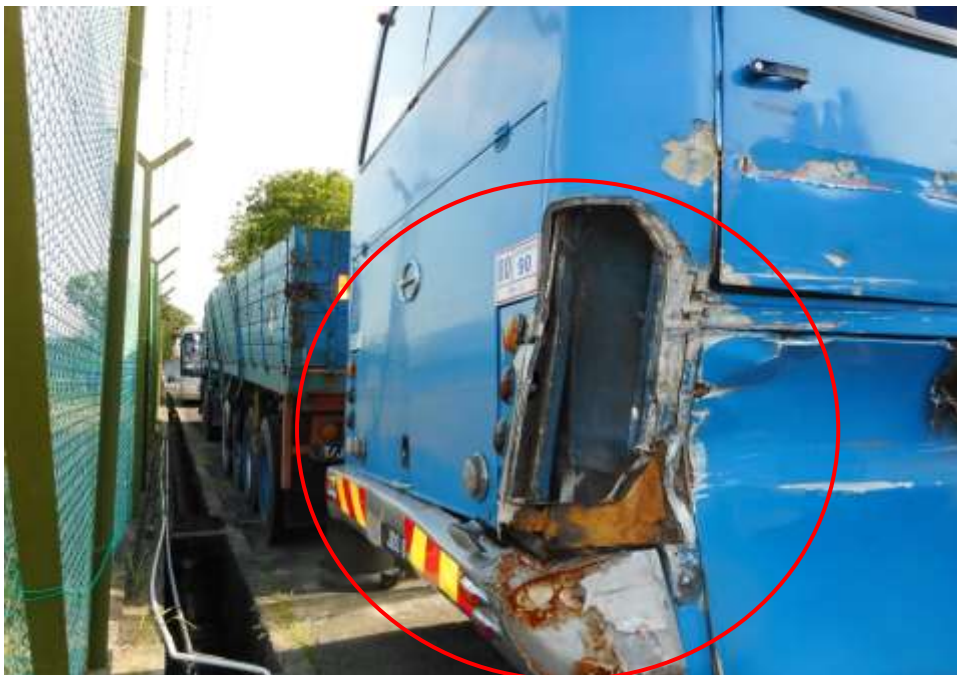
Photo 17 shows a general view of the rear right portion (circled) of the Motor Bus at the time of our inspection. The Motor Bus was observed to sustained extensive damages at its rear right portion as a result of the accident's collision.

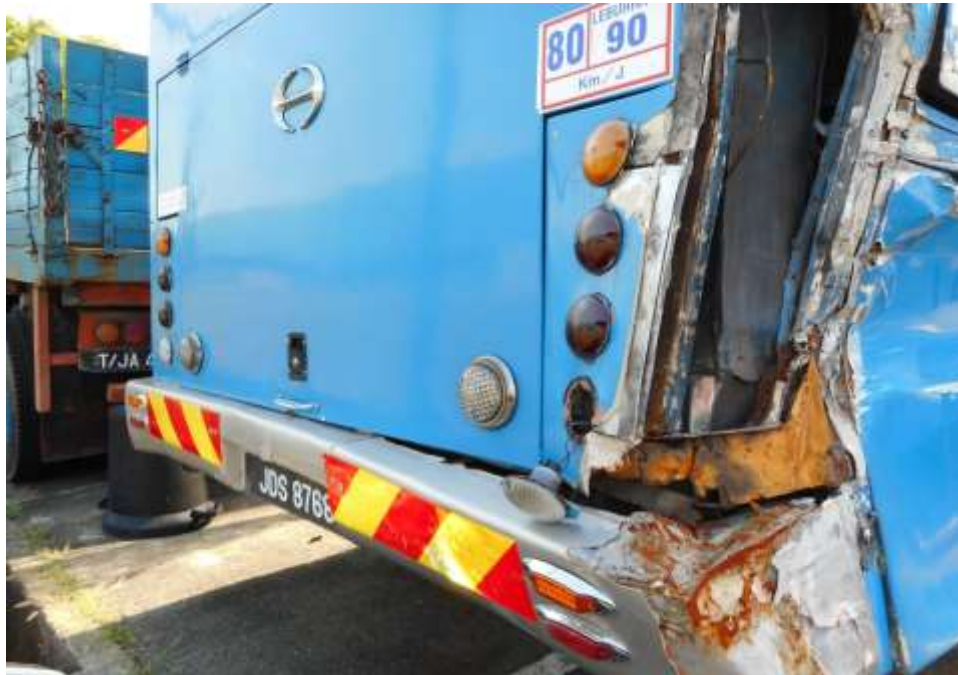
Photo 18 shows a close up view of the rear right portion of the Motor Bus at the time of our inspection. The Motor Bus was observed to sustained extensive damages at its rear right portion as a result of the accident's collision.

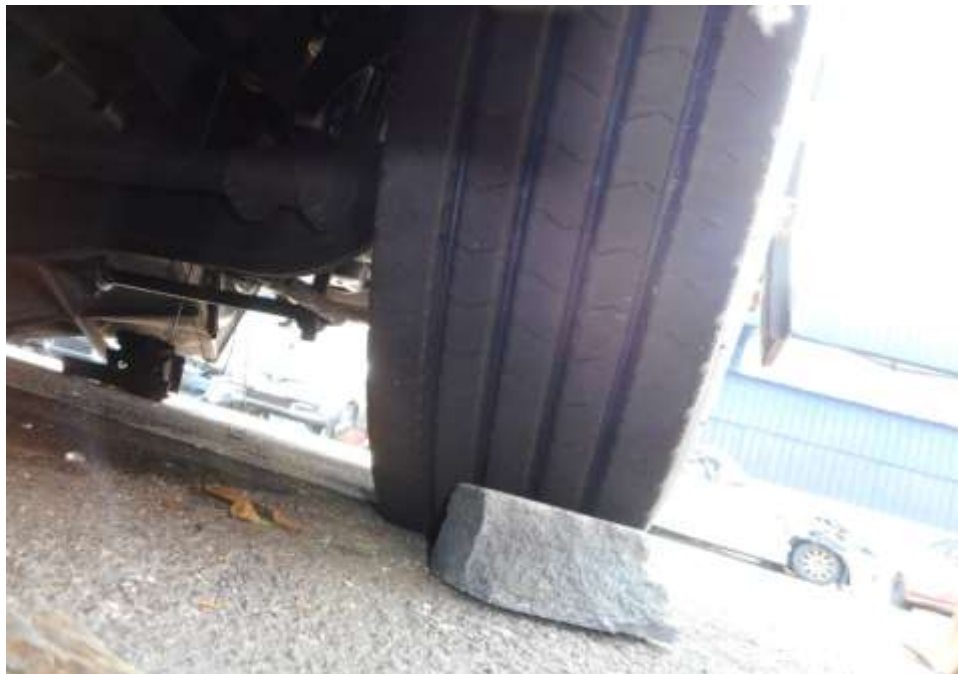
Photo 18 shows the condition of the front right tyre of the Motor Bus, which was observed to be in serviceable condition with remaining tread depth of approximately 14.2mm. The tyre was also observed to be sufficiently inflated for vehicular operation.

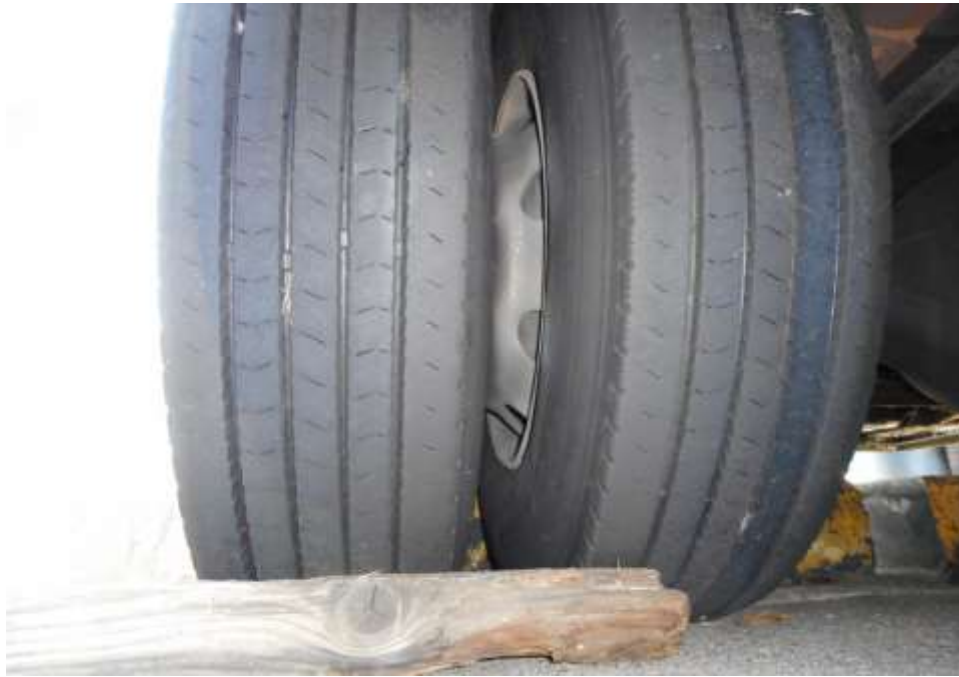
Photo 19 shows the condition of the rear right tyre of the Motor Bus, which was observed to be in serviceable condition with remaining tread depth of approximately 10.4mm. The tyre was also observed to be sufficiently inflated for vehicular operation.

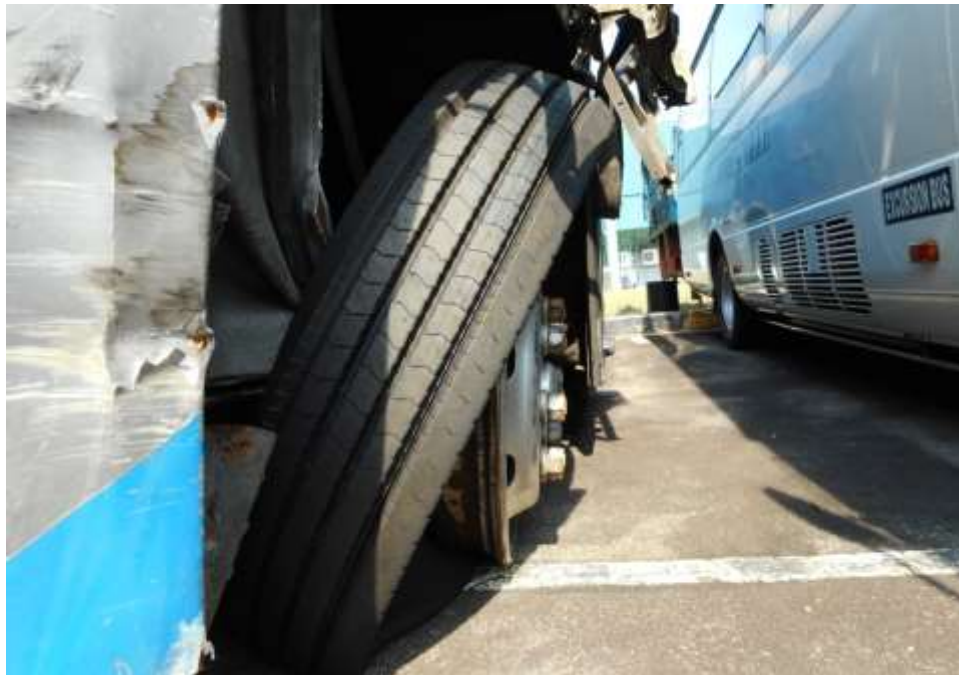
Photo 20 shows the condition of the front left tyres of the Motor Bus, which were observed to be deflated and dislodged from the rims likely due to the impact caused by the accident. With remaining tread depth of approximately 14mm.

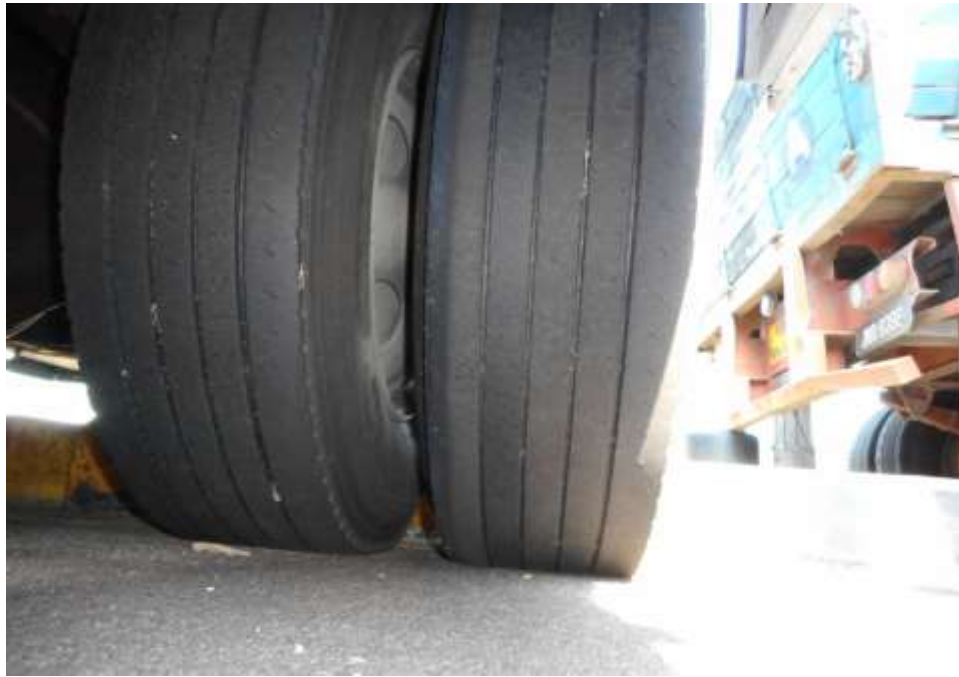
Photo 21 shows the condition of the rear right tyres of the Motor Bus, which were observed to be in serviceable condition with remaining tread depth of approximately 5.9mm. The tyres, which were wrapped around standard alloy wheel rims, were also observed to be sufficiently inflated for vehicular operation.

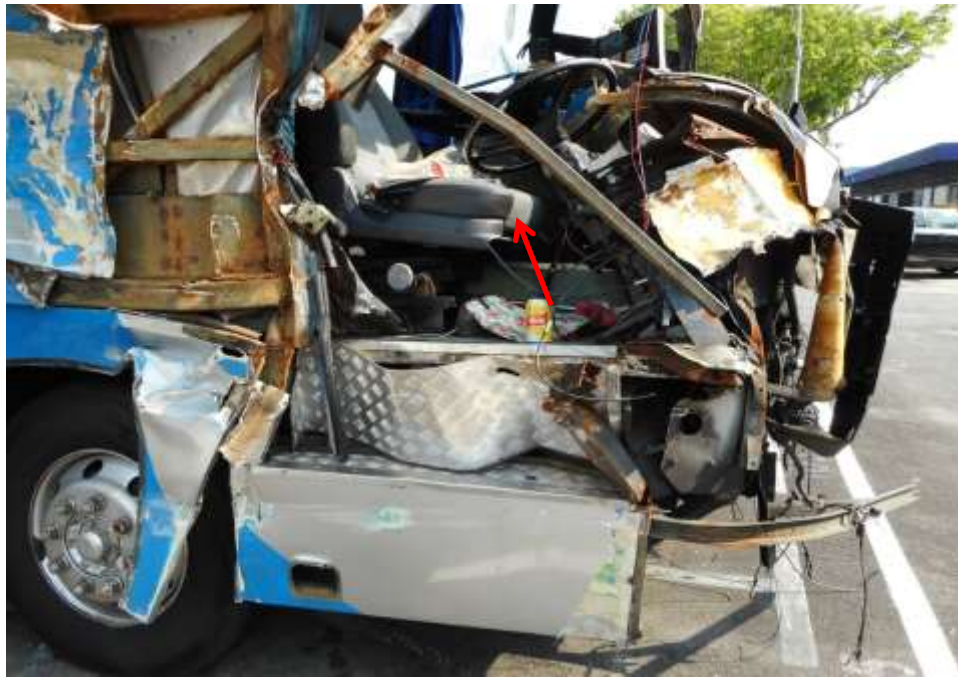
Photo 22 shows the general engine compartment of the Motor Bus located at the front of the Motor Bus. No inspection could be done due to the extensive induced frontal damage into the cabin area from the accident.

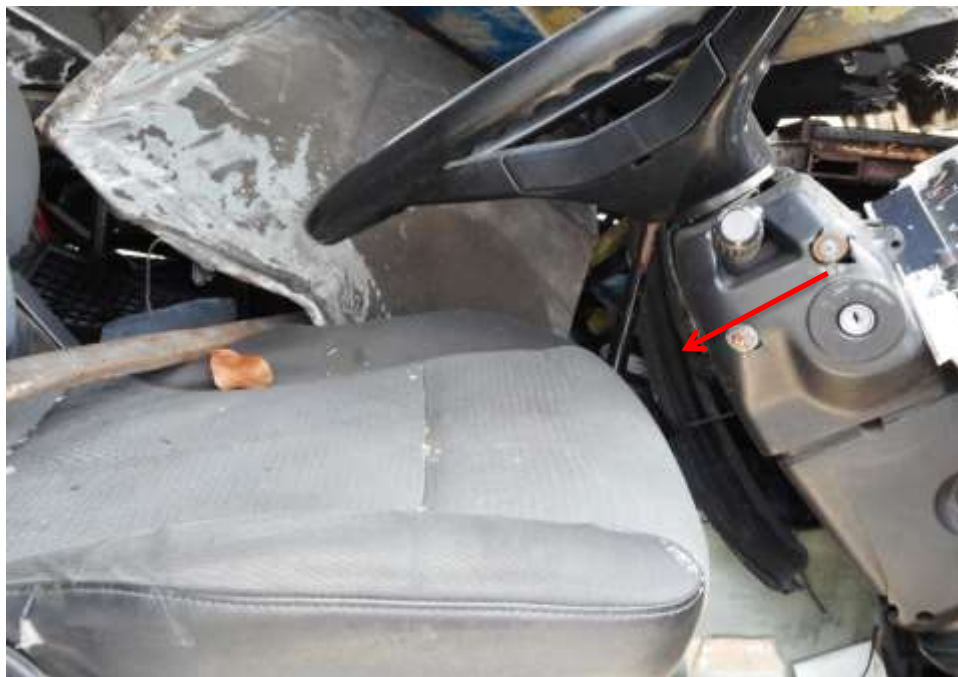
Photo 23 shows the close up engine compartment of the Motor Bus was located at the front of the Motor Bus. No inspection could be done due to the extensive induced frontal damage into the cabin area from the accident.

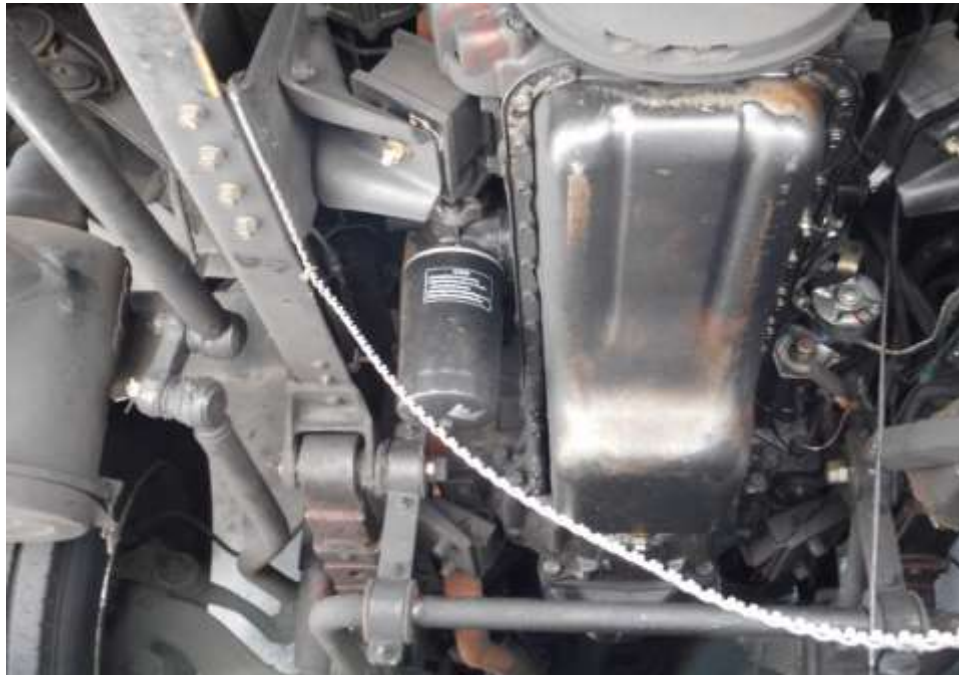
Photo 24 shows the engine undercarriage of the Motor Bus. No leakage or fluids was observed at time of our inspection.

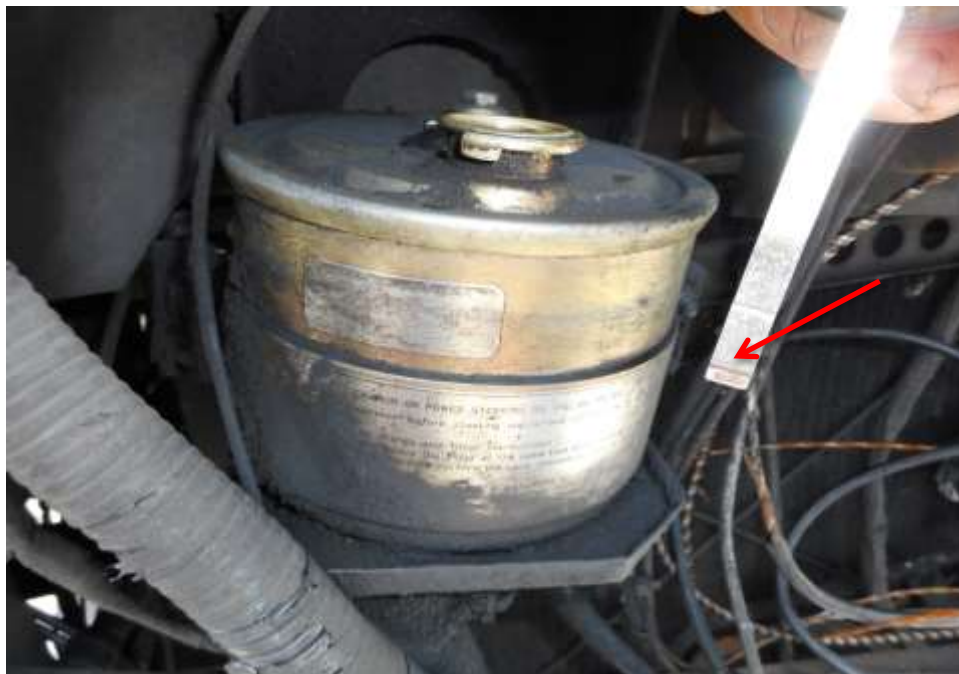
Photo 25 shows the power steering fluid of the Motor Bus. It was observed to have no fluid reading due to the induced damage to it likely cause by the accident at the time of our inspection

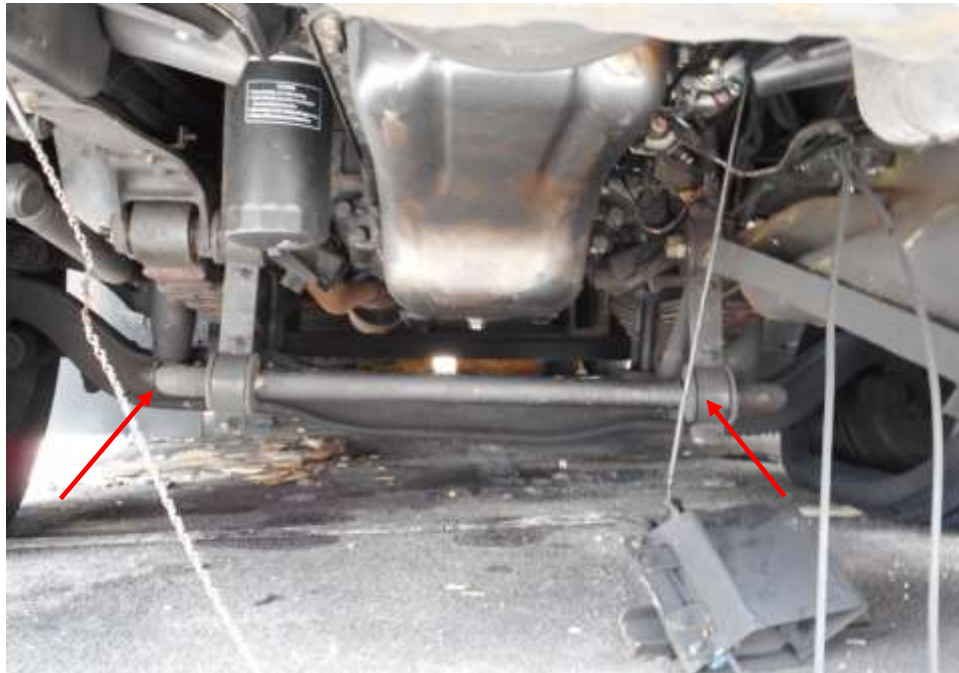
Photo 26 shows some of the mechanical components (arrowed) of the Motor Bus's steering system. The steering system of the Motor Bus shows to be intact and is likely to be in serviceable condition at the time of accident.

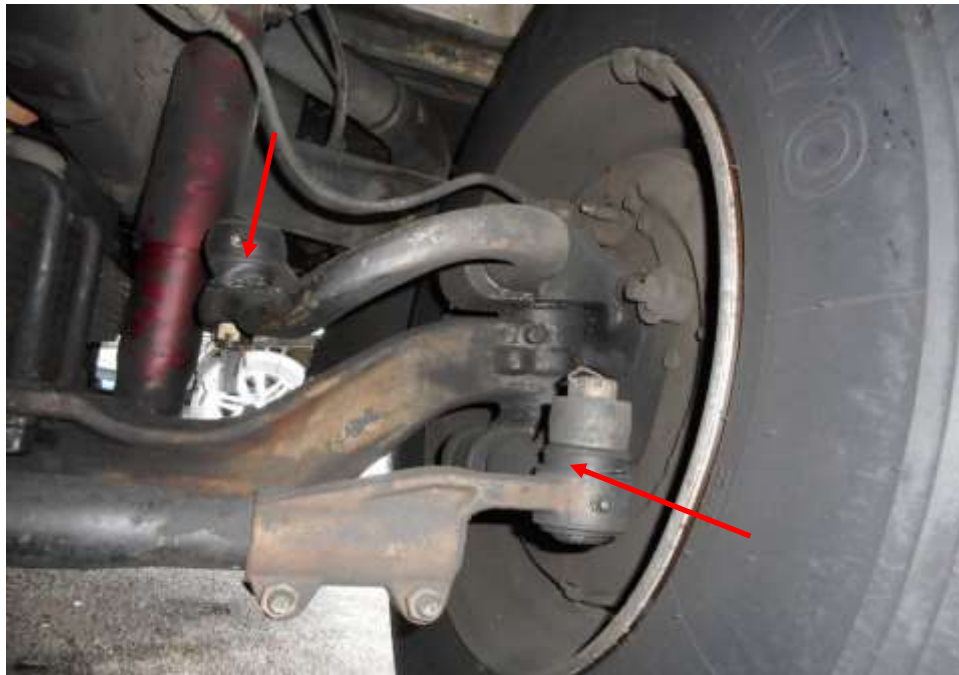
Photo 27 shows the front right wheel components of the front steering system of the Motor Bus. The various undercarriage components of the Motor Bus were all observed to be intact and without any visible damage. This had included the steering rack and steering ball joints (arrowed) of the Motor Bus, which were observed to be securely attached to the front right wheel.

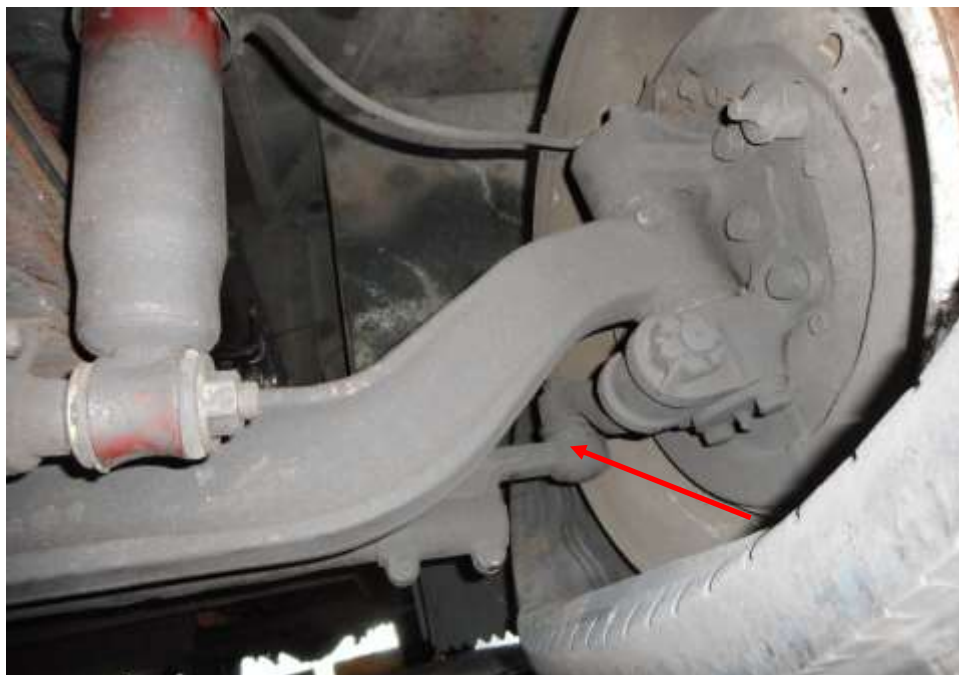
Photo 28 shows the front left wheel components of the front steering system of the Motor Bus. The various undercarriage components of the Motor Bus were all observed to be intact and without any visible damage. This had included the steering rack and steering ball joints (arrowed) of the Motor Bus, which were observed to be securely attached to the front left wheel.

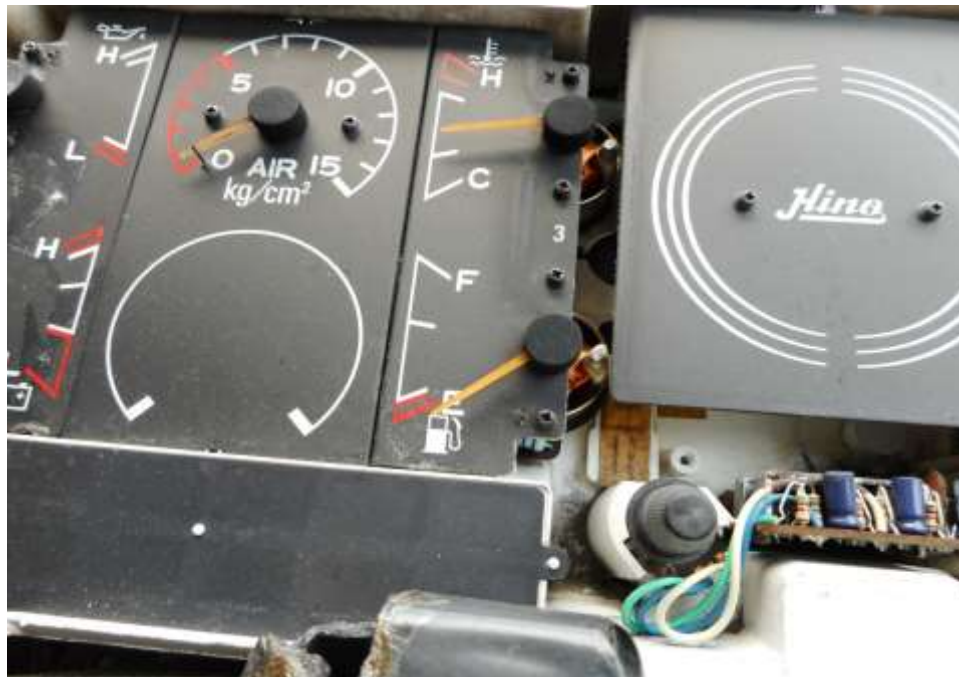
13.3 of air tanks in particular were observed to be also in serviceable condition. But the reading of the air built up of the air brake cylinder was (unable) to be viewed or tested due to the damage on the instruments panel in the driver's cabin. See photo 29.

Photo 29 shows the damaged instrument cluster. Therefore no reading is recorded for the air-braking system.

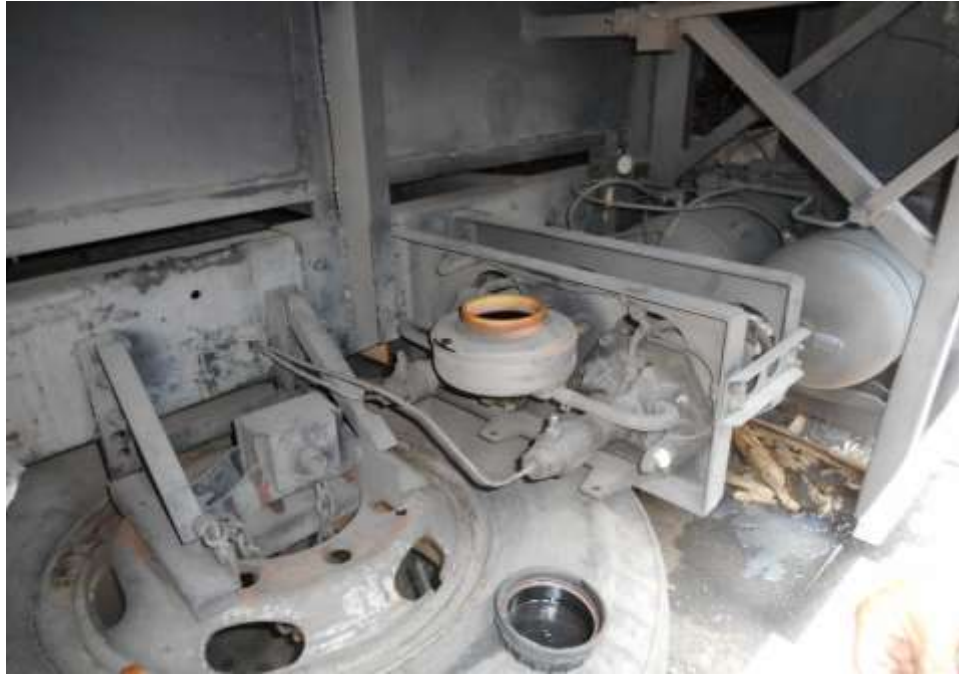
Photo 30 shows a general view of the air tank, valves, pipes and hoses, which are some of the components for the air-assisted braking system of the Motor Bus. This was at the underside of the Motor Bus's body. There were no damages observed at time of our inspection.
