Your Ref: TP/IP/11499/2019
Our Ref : CI/TPD18016725/P

29th May 2019

Fatal Accident Investigation Team

MECHANICAL INSPECTION REPORT OF MOTOR BUS JDS 8768

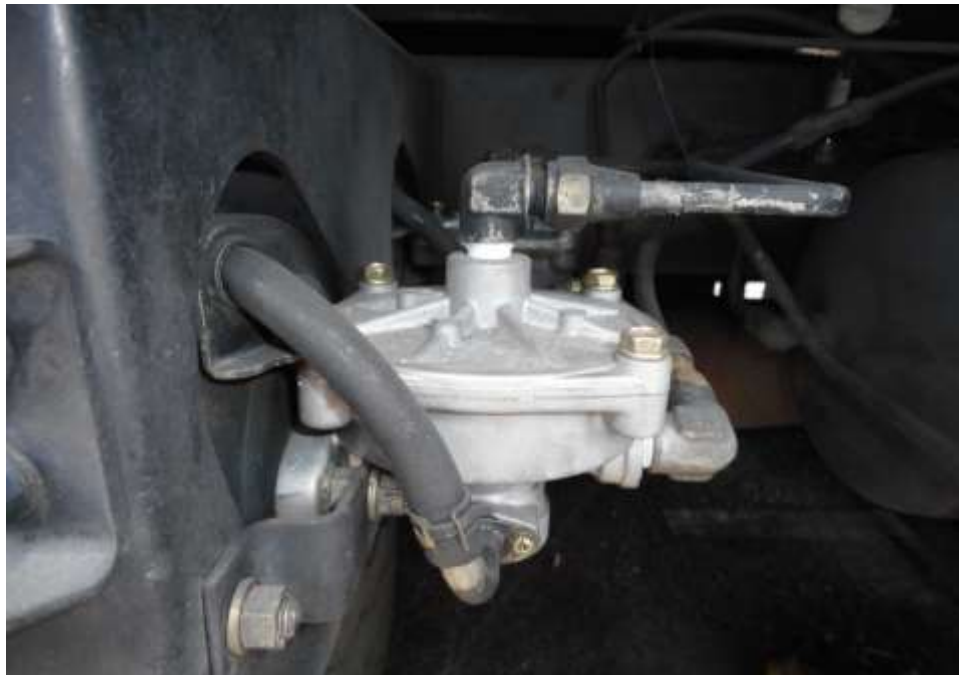
Photo 31 shows some of the Air-brake relay unit of the Motor Bus's braking system (including hoses). Visual check on the mechanical components shows that it was in serviceable condition at the time of accident.

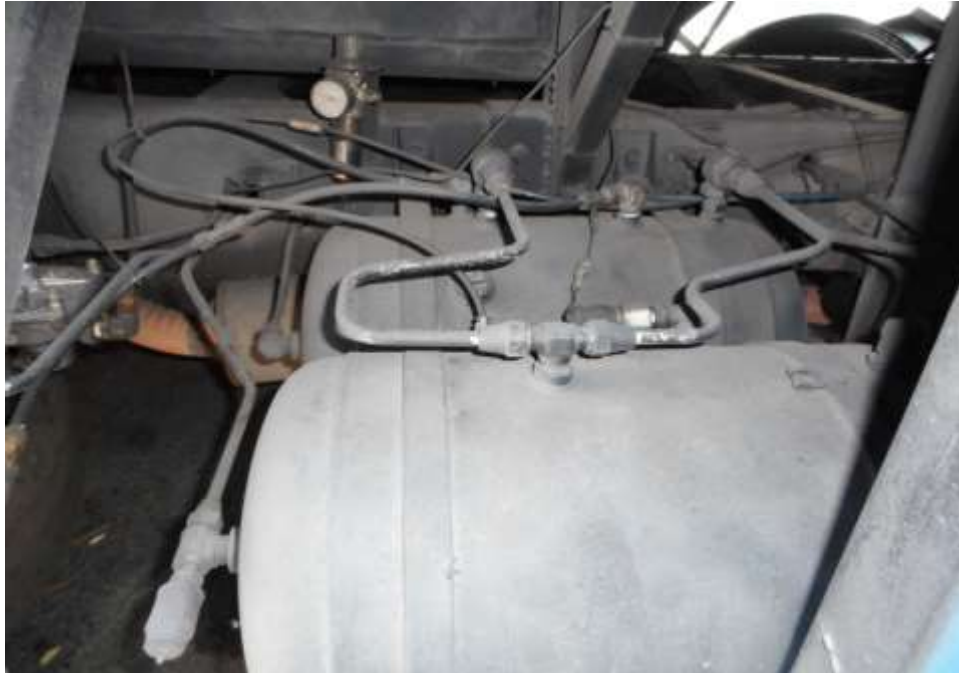
Photo 32 shows a close up view of first and second air cylinders, valves and hoses of the air-assisted braking system of the Motor Bus. This was at the underside of the Motor Bus's body. There were no damages observed at time of our inspection.

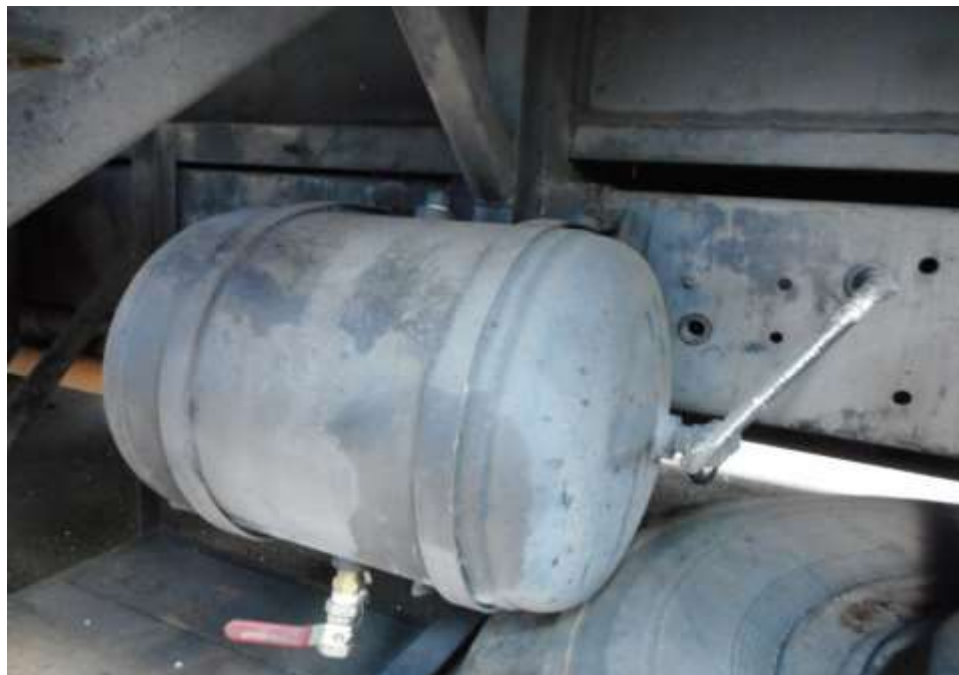
Photo 33 shows a close up view of the third air cylinder, valves and hoses of the air-assisted braking system of the Motor Bus. This was at the underside of the Motor Bus's body. There were no damages observed at time of our inspection.

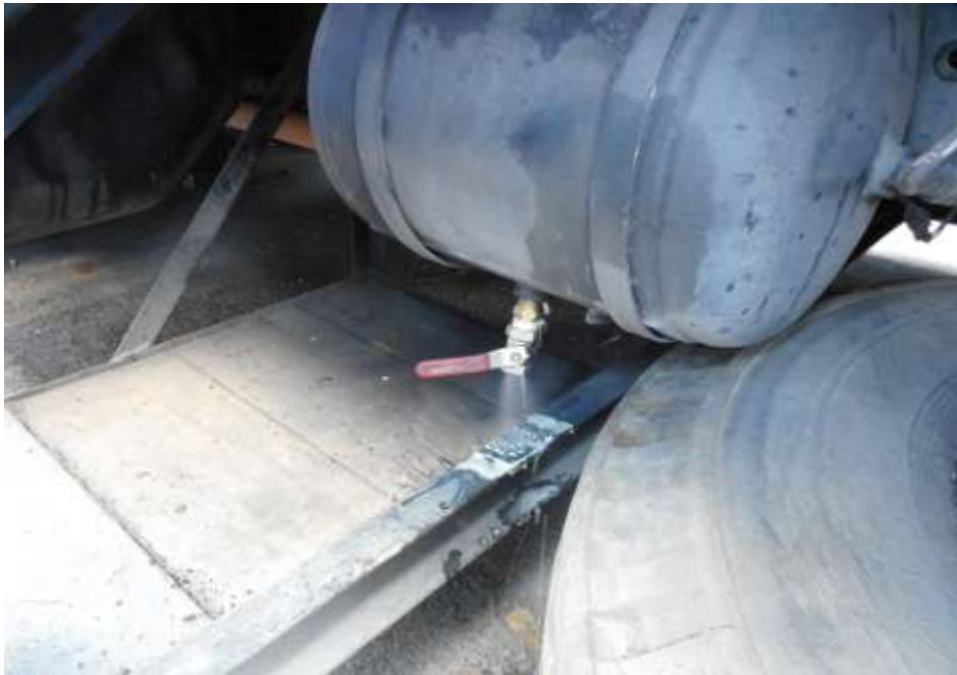
Photo 34 shows the release of residue air in cylinder indicating the air-cylinder was in serviceable condition during time of our inspection.
