Your Ref: TP/IP/19361/2019
Our Ref : CI/TPD19008241/N

INSPECTION REPORT OF MOTORCYCLE JQW 9445

1. We refer to your request dated 29 April 2019 to conduct a physical inspection of a motorcycle bearing registration number JQW 9445 (herein referred to as **"Motorcycle"**), which was involved in a fatal road traffic accident on 22 March 2019.
2. The purpose of this inspection is to primarily determine if there was any possible mechanical failure to the Motorcycle that may have contributed to the accident.
3. Following the request, we had carried out a physical inspection of the Motorcycle on 20 May 2019 at the premises of Traffic Police vehicle pound, 517 Airport Road Singapore 539942. We now set out below our observations and comments with respect to this inspection.

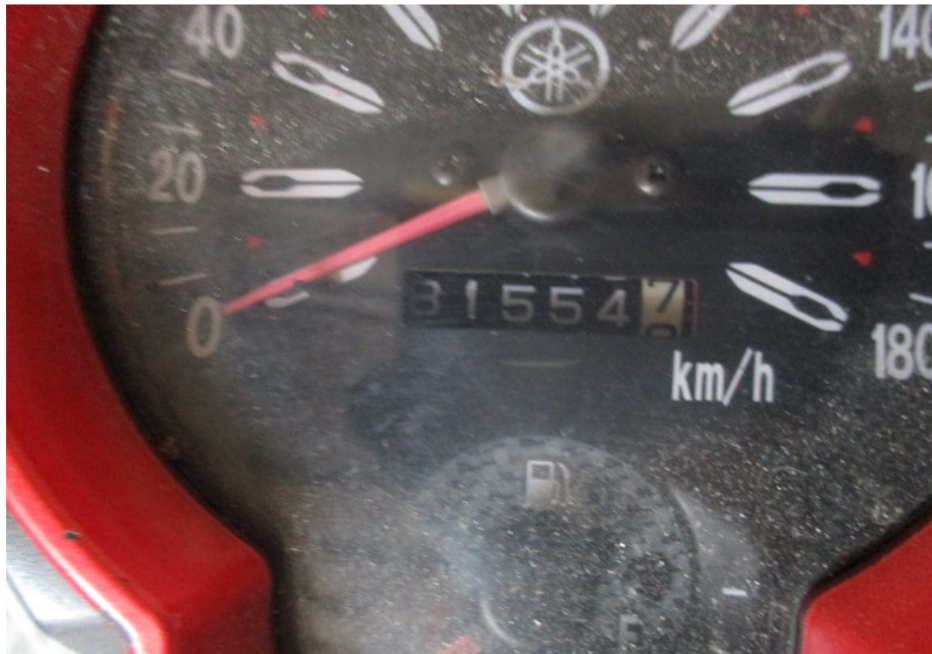
Photo 1 shows the speedometer gauge of the Motorcycle where the mileage recorded at the time of our inspection was 81, 554km.

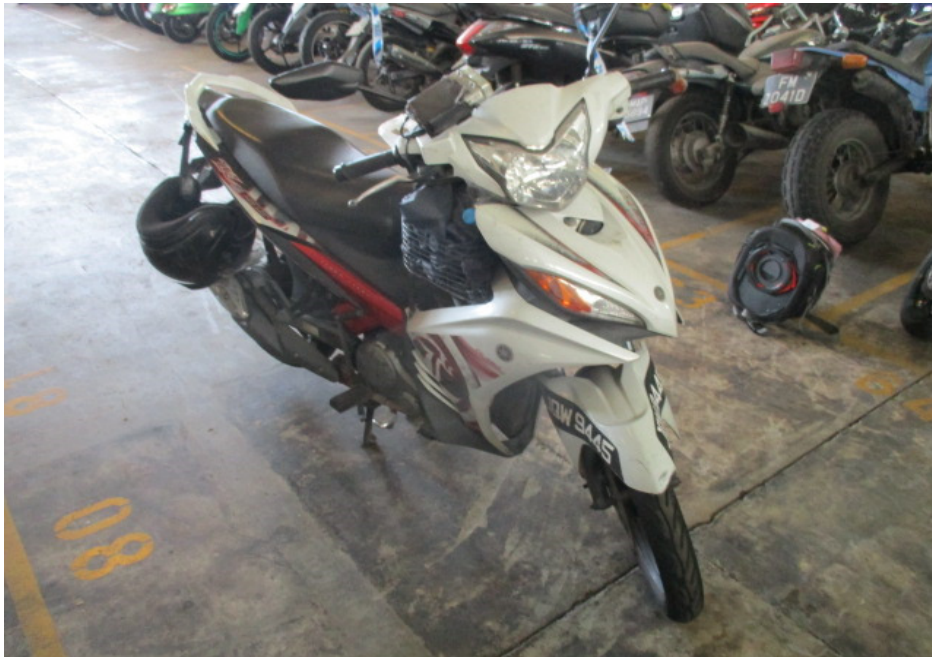
Photo 2 shows a general view of the right front body of the Motorcycle at the time of our inspection. The Motorcycle was observed to have sustained damages along its front and left side.

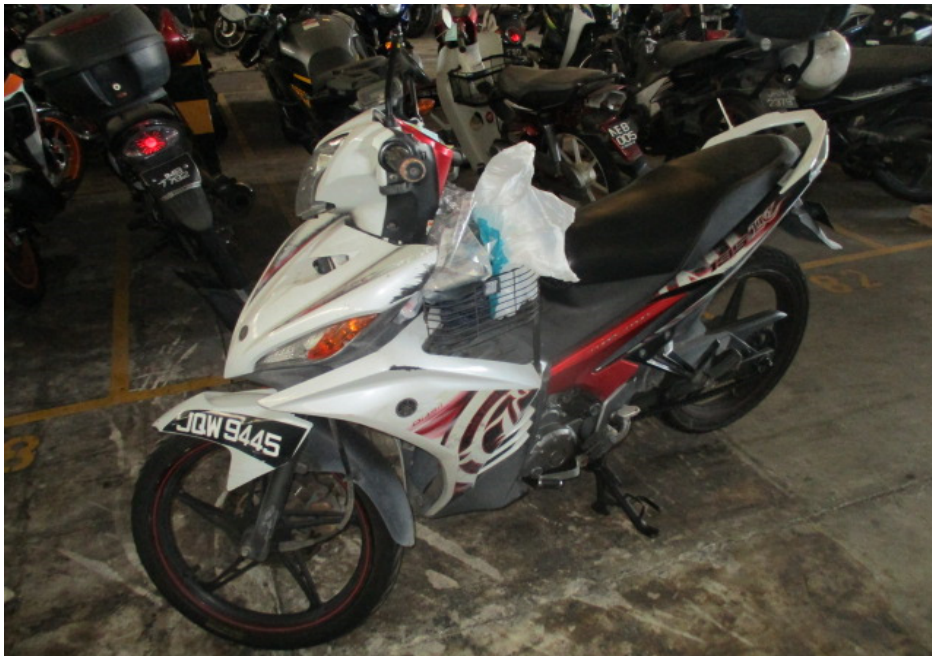
4. The mileage of the Motorcycle at the time of our inspection was 81, 554km.
5. The Motorcycle was observed to have sustained damages along its front and left side. The body parts that were found to have been damaged include its headlight assembly, front cowling, front mudguard, left side mirror, gear shift pedal, left front footrest and left rear side cover, amongst others.

Photo 3 shows a general view of the left front body of the Motorcycle at the time of our inspection. The Motorcycle was observed to have sustained damages along its front and left side. Amongst the body parts that were found to have been damaged include its headlight assembly, front cowling, front mudguard, left side mirror, gear shift pedal, left front footrest and left rear side cover, amongst others.

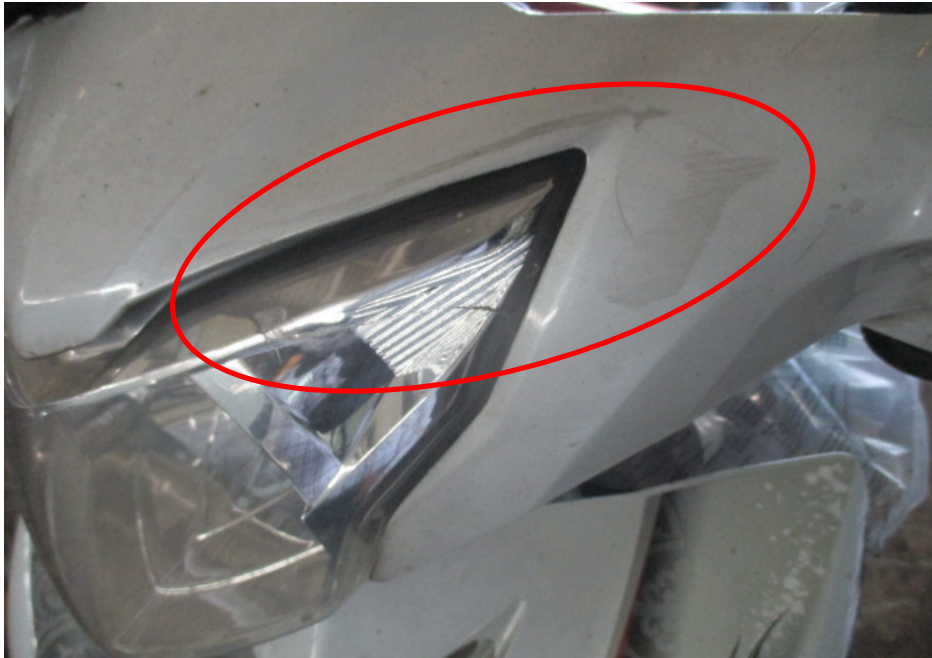
Photo 4 shows a closer view of the headlight assembly (circled) which was amongst the body parts at the front body of the Motorcycle that had sustained damage as a result of the accident.

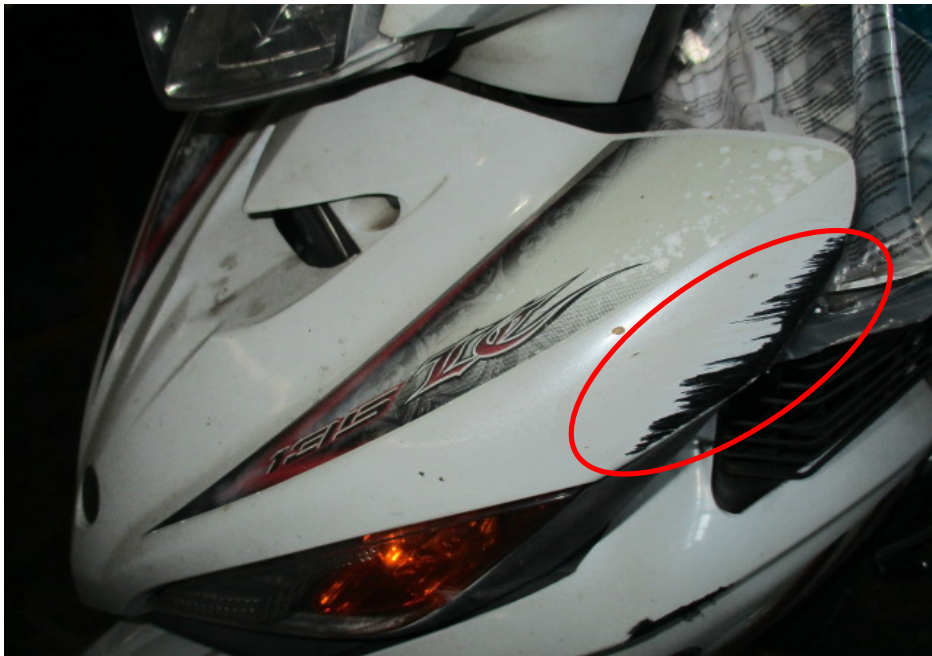
Photo 5 shows a close up view of the front cowling (circled) which was amongst the body parts of the Motorcycle that had sustained damage as a result of the accident.

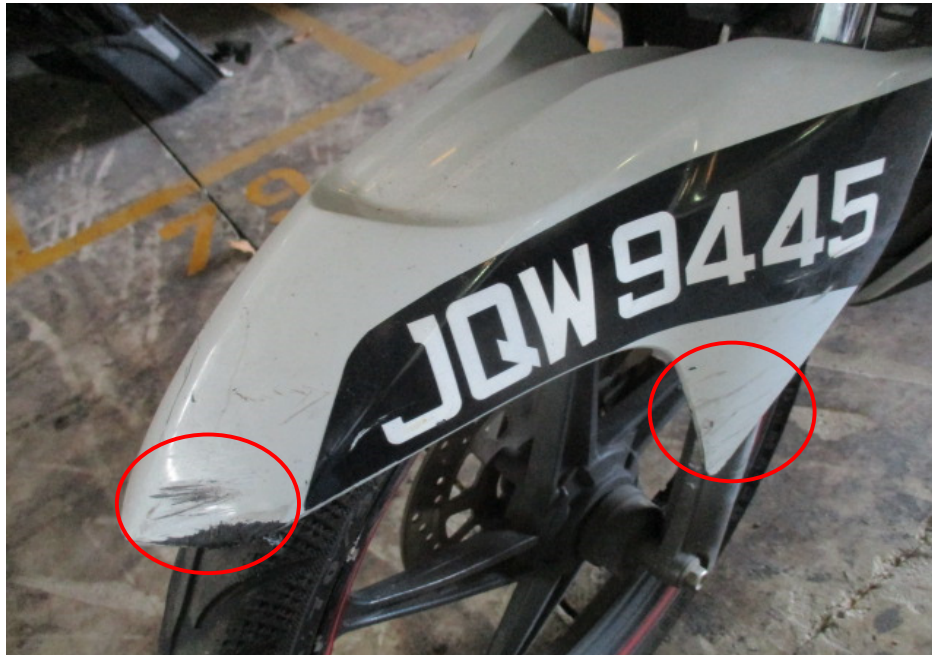
Photo 6 shows a closer view of the front mudguard (circled) which was amongst the body parts at the front body of the Motorcycle that had sustained damage as a result of the accident.

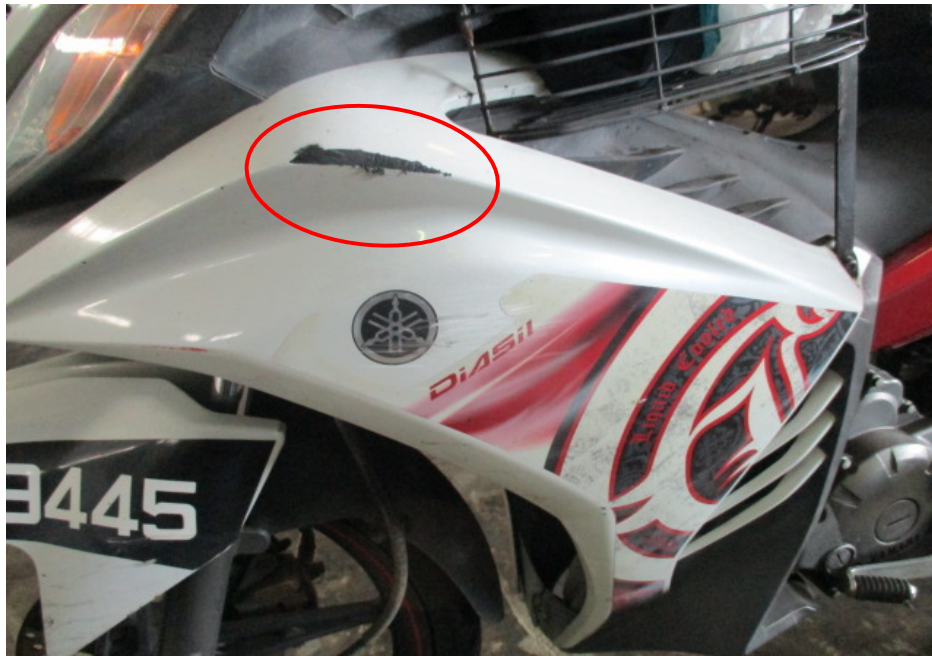
Photo 7 shows a closer view of the left cowling of the Motorcycle (circled) that had sustained damage as a result of the accident.

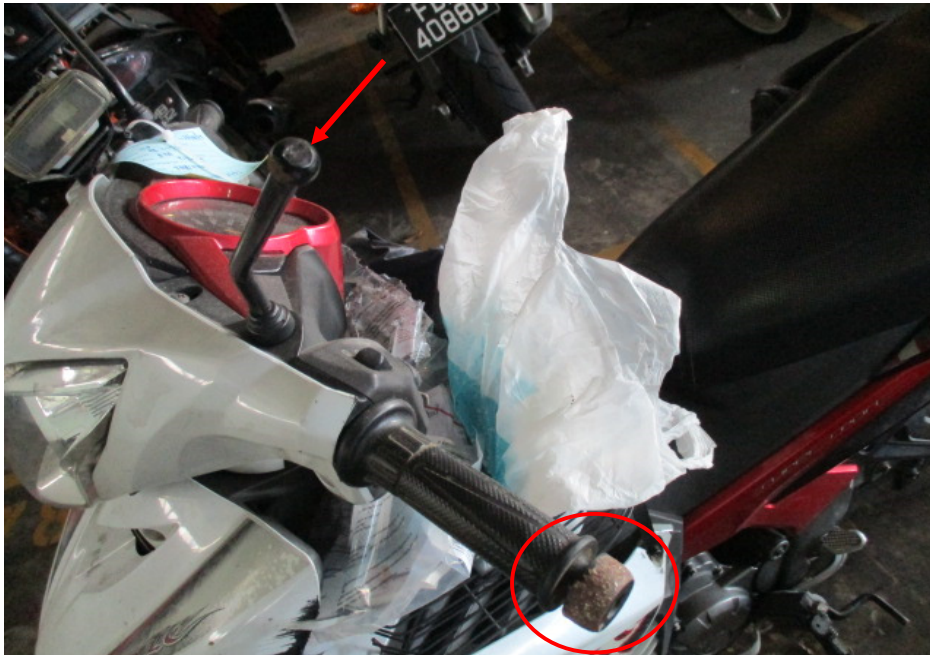
Photo 8 shows a closer view of the left side mirror (arrowed) and left handlebar end (circled) which were amongst the body parts of the Motorcycle that had sustained damage as a result of the accident.

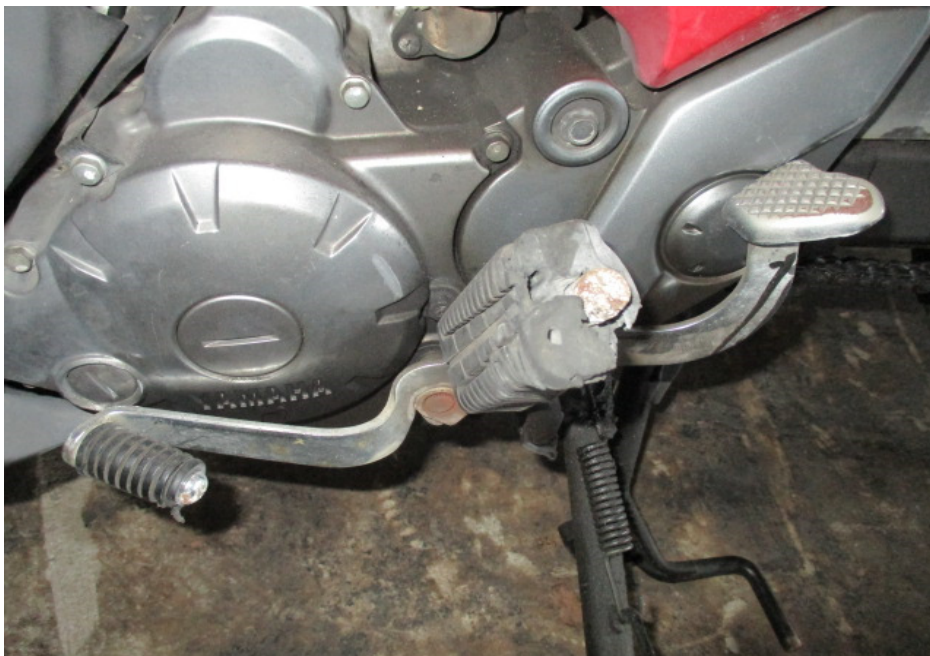
Photo 9 shows a closer view of the gear shift pedal, left front footrest and left front footrest bracket, which were amongst the body parts of the Motorcycle that had sustained damage as a result of the accident.

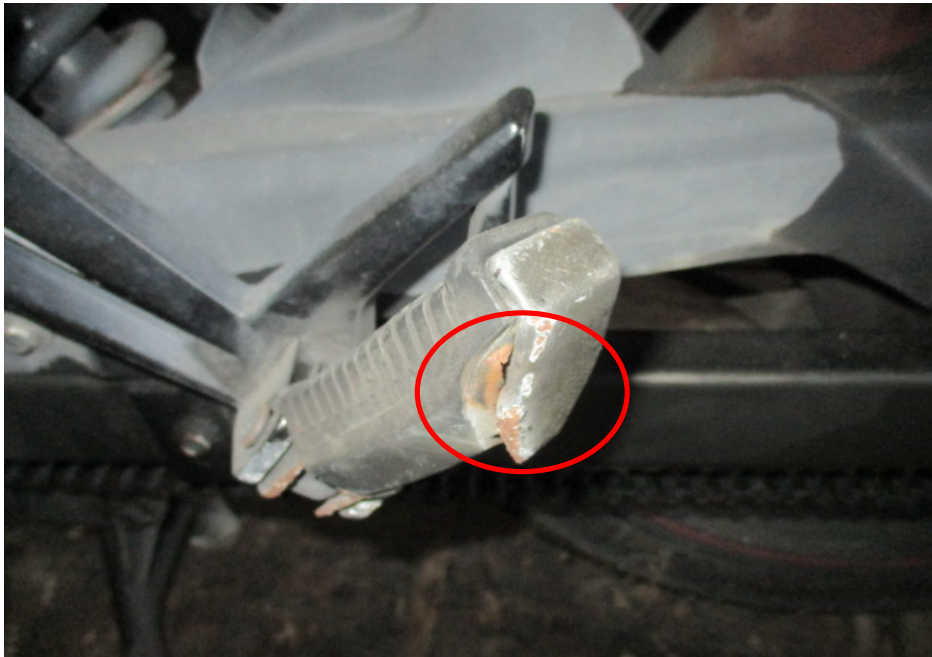
Photo 10 shows a closer view of the left pillion footrest (circled) which was amongst the body parts of the Motorcycle that had sustained damage as a result of the accident.

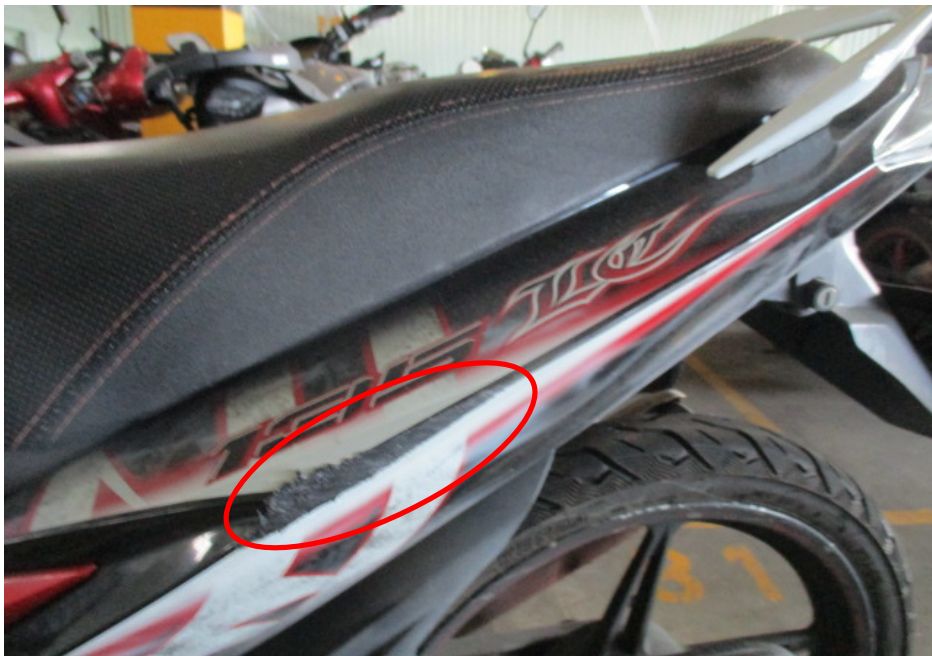
Photo 11 shows a closer view of the left rear side cover (circled) which was amongst the body parts of the Motorcycle that had sustained damage as a result of the accident.

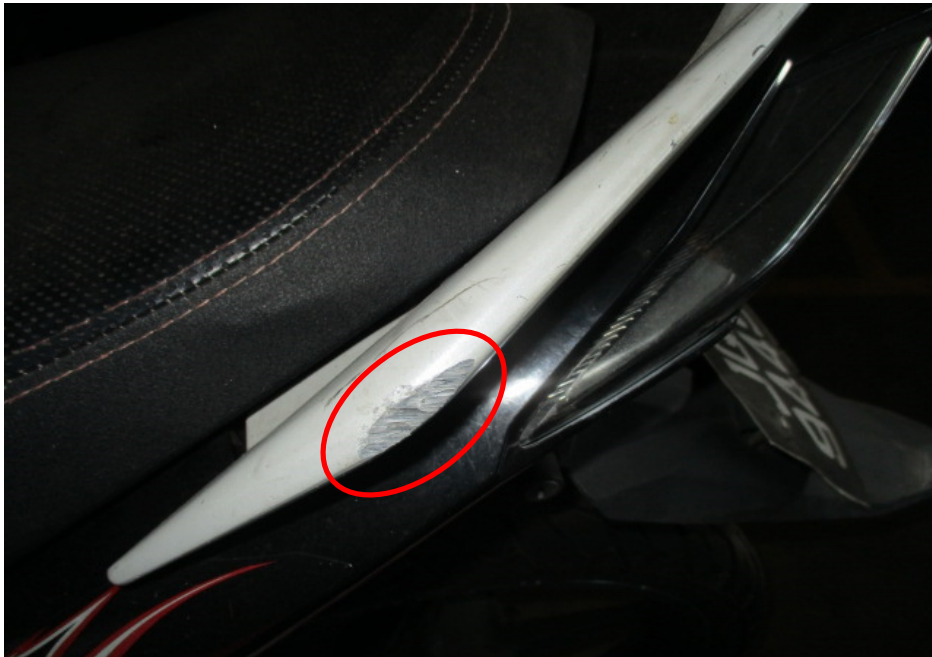
Photo 12 shows a closer view of the left pillion grab rail (circled) which was amongst the body parts of the Motorcycle that had sustained damage as a result of the accident.

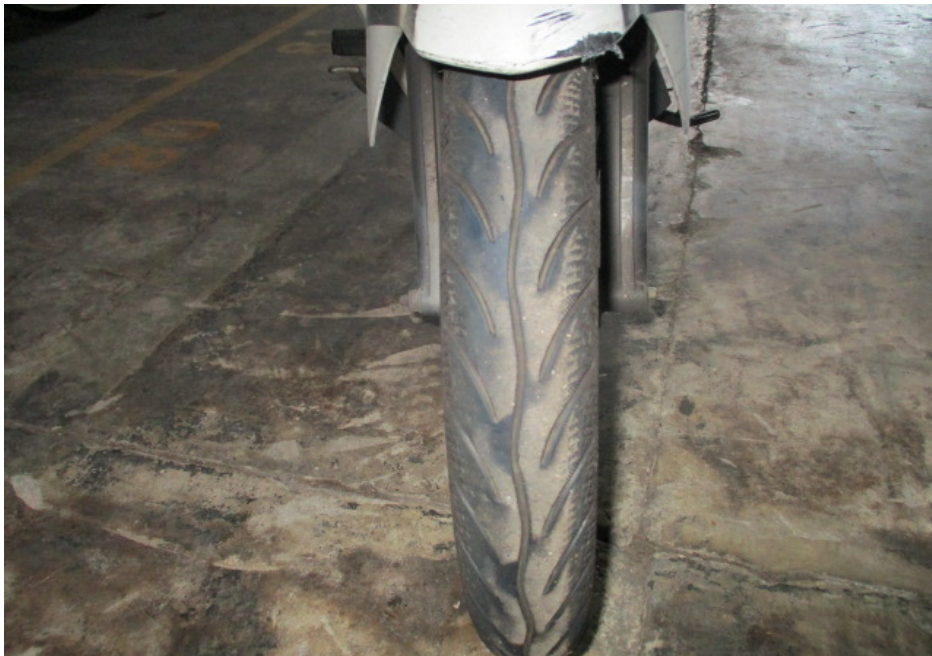
Photo 13 shows the condition of the Motorcycle's front tyre. The front tyre was observed to be in serviceable condition with remaining tread depth of approximately 3mm. There was no tear, burst mark(s) and/or punctured hole(s) on the sidewalls as well as across the tread of the front tyre.

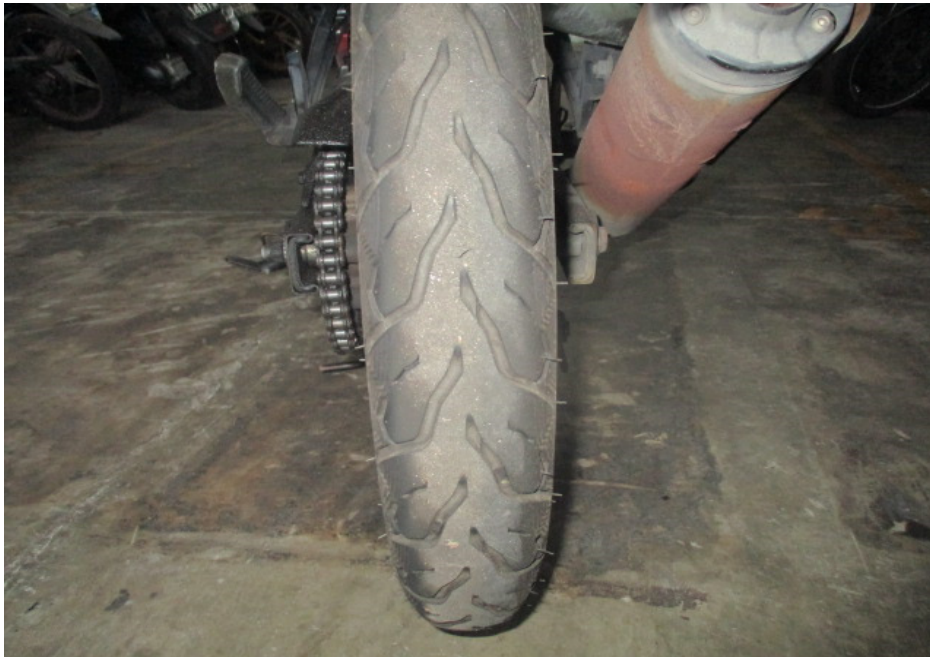
Photo 14 shows the condition of the Motorcycle's rear tyre. The rear tyre was observed to be in serviceable condition with remaining tread depth of approximately 3mm. The tyre was also observed to be sufficiently inflated for vehicular operation. We did not observe any tear, burst mark(s) and/or punctured hole(s) on the sidewalls as well as across the tread of the rear tyre.

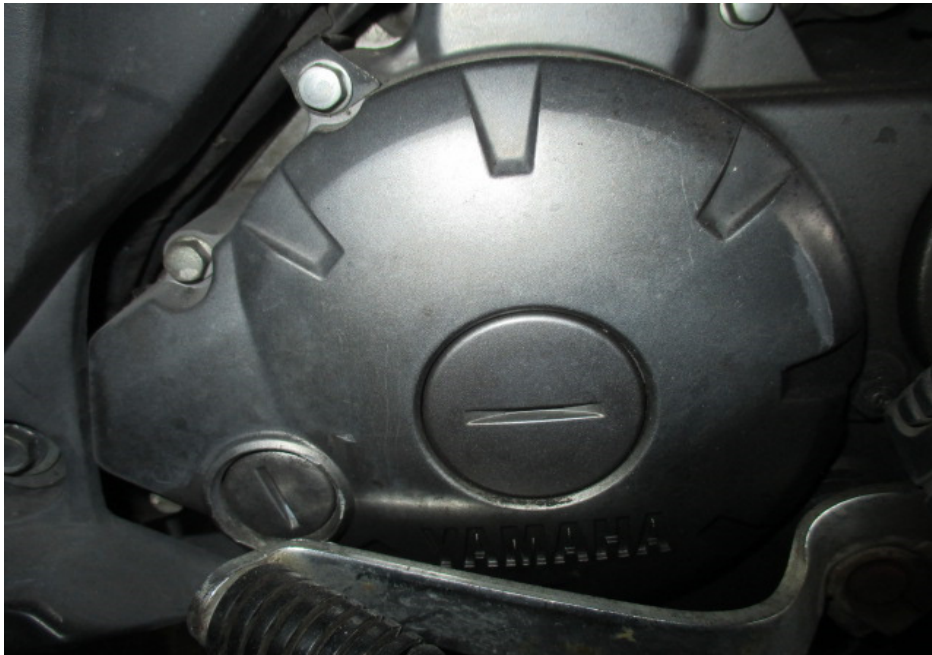
Photo 15 shows the left side of the engine of the Motorcycle at the time of our inspection. The various engine related parts and components were found to be intact with no visible damage. There was also no sign(s) or indication(s) of fluid leak observed around the left engine area of the Motorcycle.

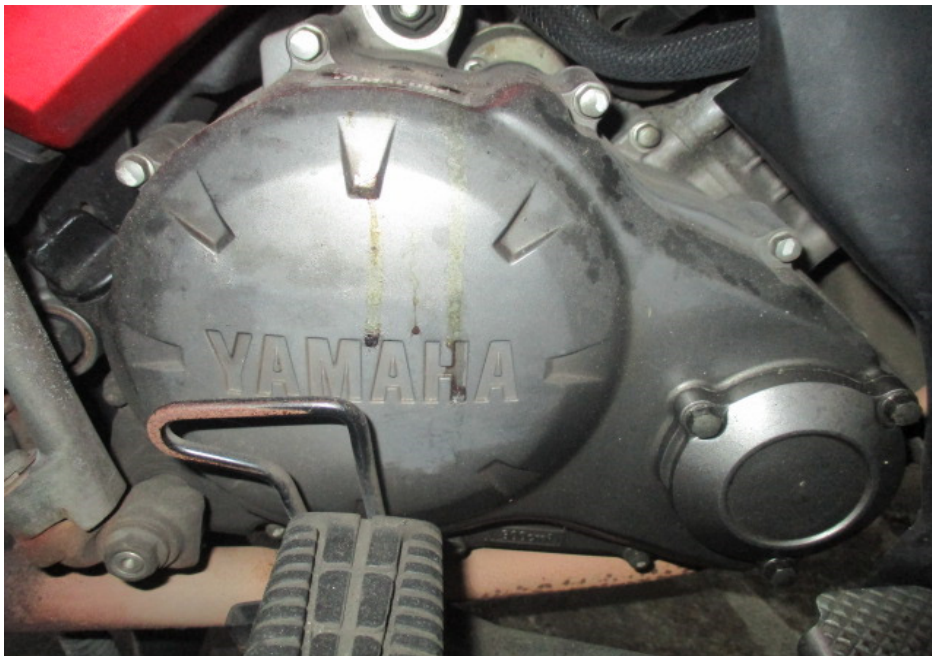
Photo 16 shows the right side of the engine of the Motorcycle at the time of our inspection. The various engine related parts and components were found to be intact with no visible damage. There was also no sign(s) or indication(s) of fluid leak observed around the right engine area of the Motorcycle.

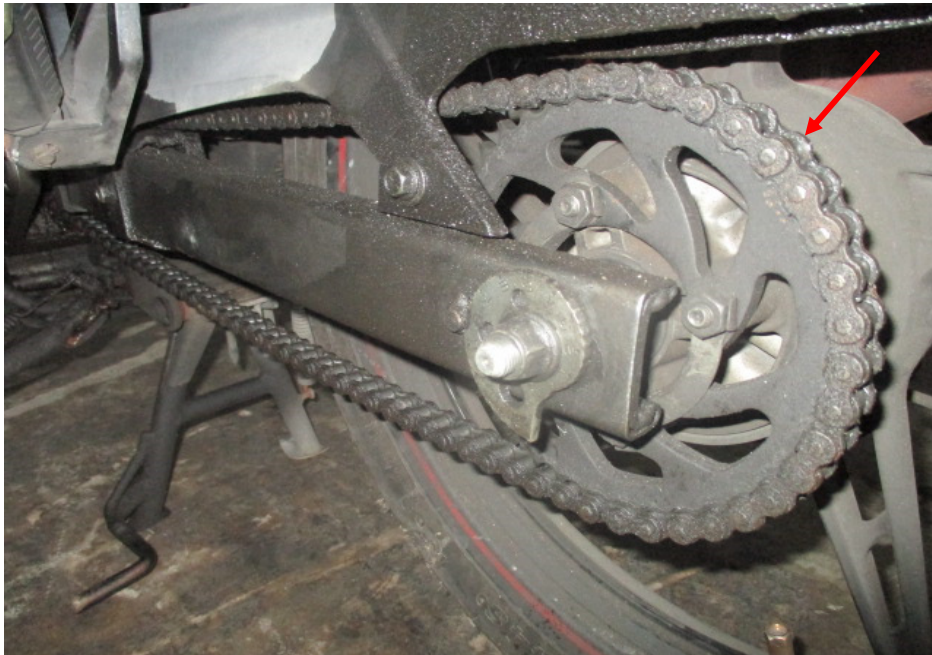
Photo 17 shows the general view of the gear train (arrowed) of the Motorcycle, which was observed to be intact with no misalignment. It was also adequately lubricated for operating purposes.

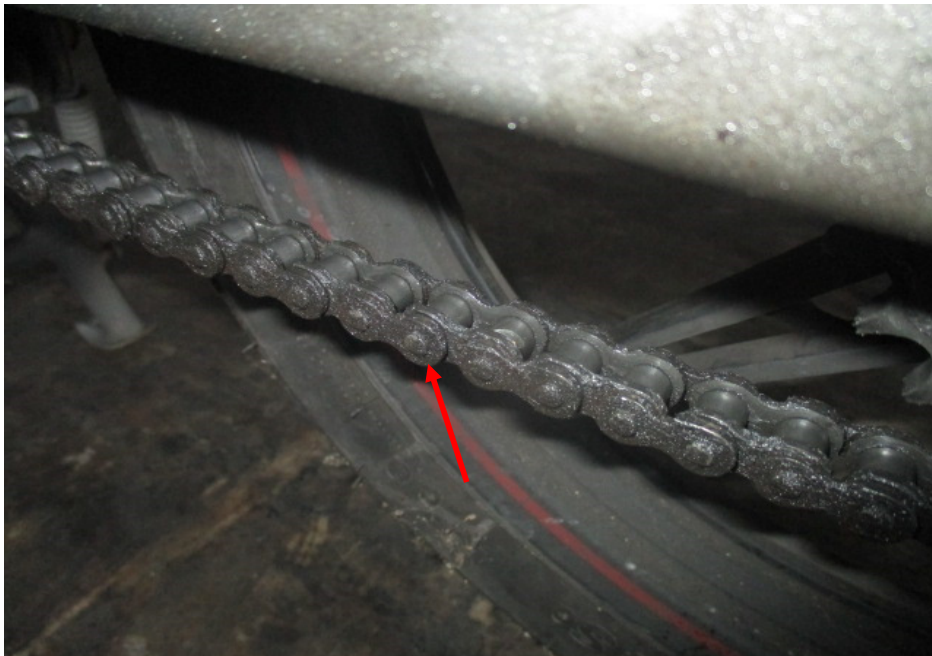
Photo 18 shows a closer view of the gear train (arrowed) of the Motorcycle, which was observed to be intact with no misalignment. It was also adequately lubricated for operating purposes.

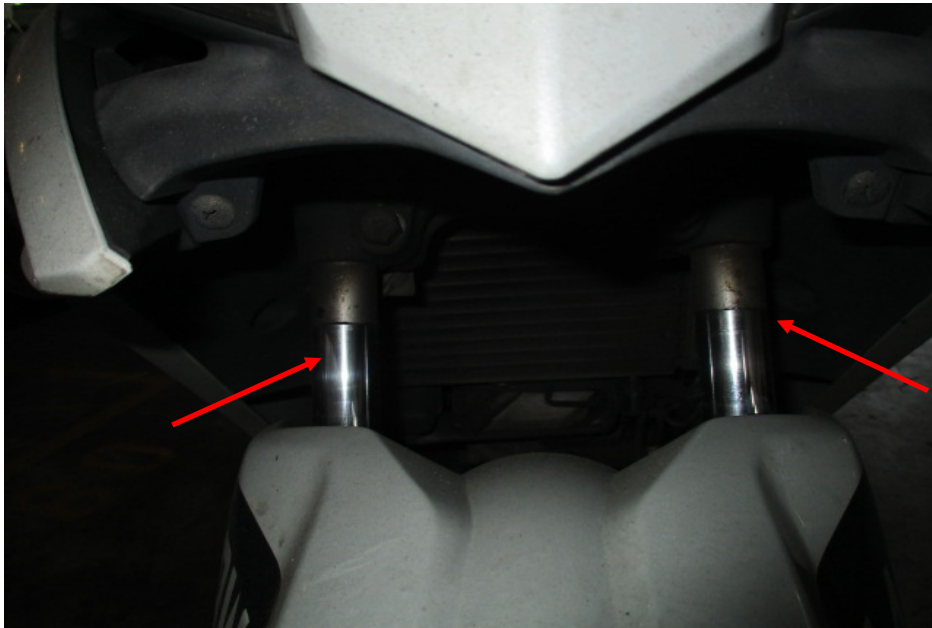
Photo 19 shows the front fork (arrowed) of the Motorcycle. The front fork and fork bracket of the Motorcycle were both found to be intact and undamaged. Turning the Motorcycle's handle bar towards the left and right did not produce any abnormal free play and/or resistance. The steering system of the Motorcycle was in serviceable condition at the time of our inspection.

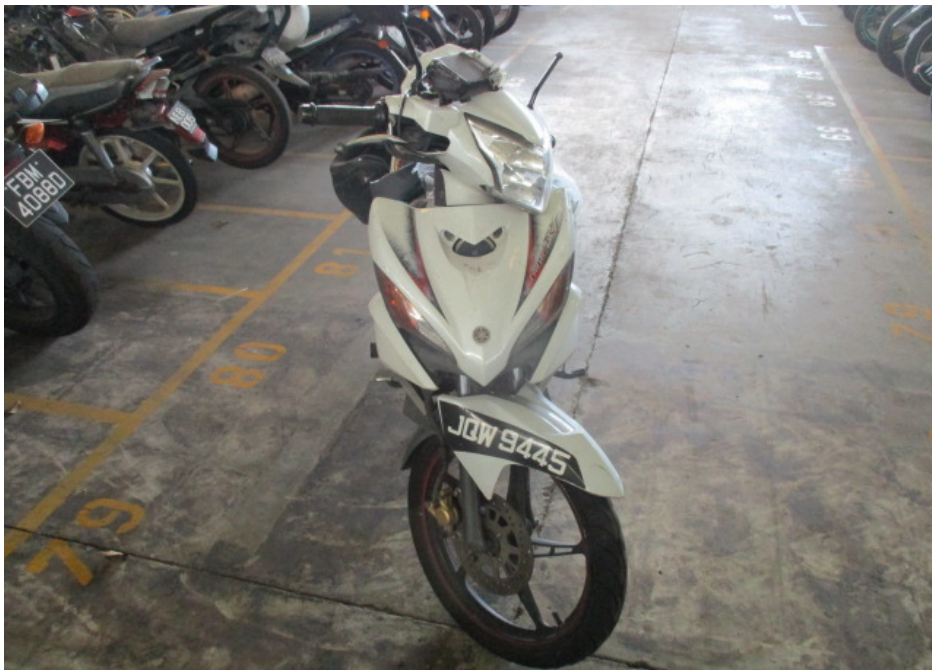
Photo 20 shows the front wheel of the Motorcycle turned towards its full left. Turning the Motorcycle's handle bar towards the left and right did not produce any abnormal free play and/or resistance. This would indicate that the steering system of the Motorcycle was in serviceable condition at the time of our inspection.

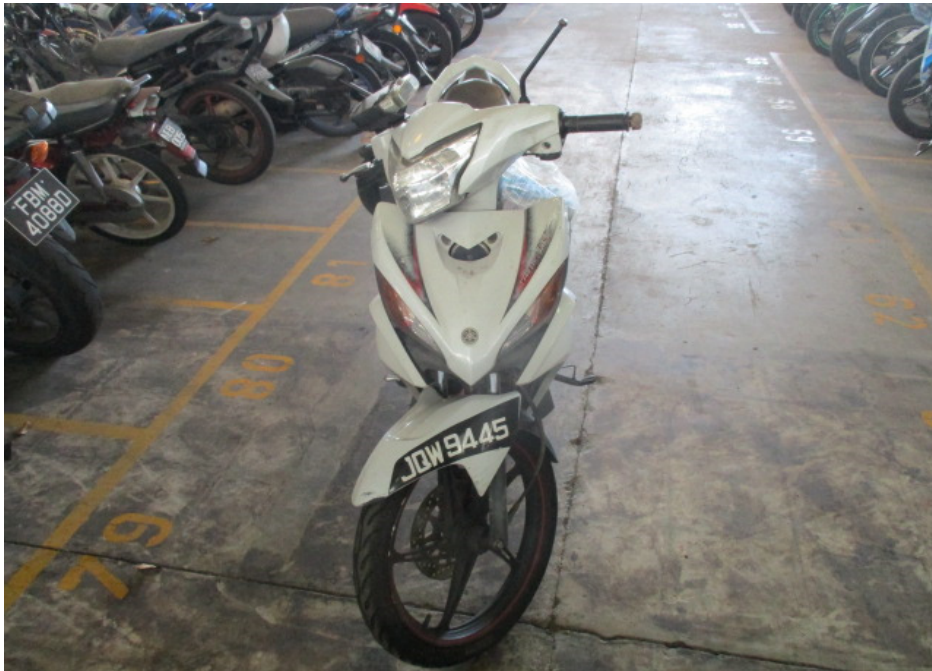
Photo 21 shows the front wheel of the Motorcycle turned towards its full right. Turning the Motorcycle's handle bar towards the left and right did not produce any abnormal free play and/or resistance. This would indicate that the steering system of the Motorcycle was in serviceable condition at the time of our inspection.

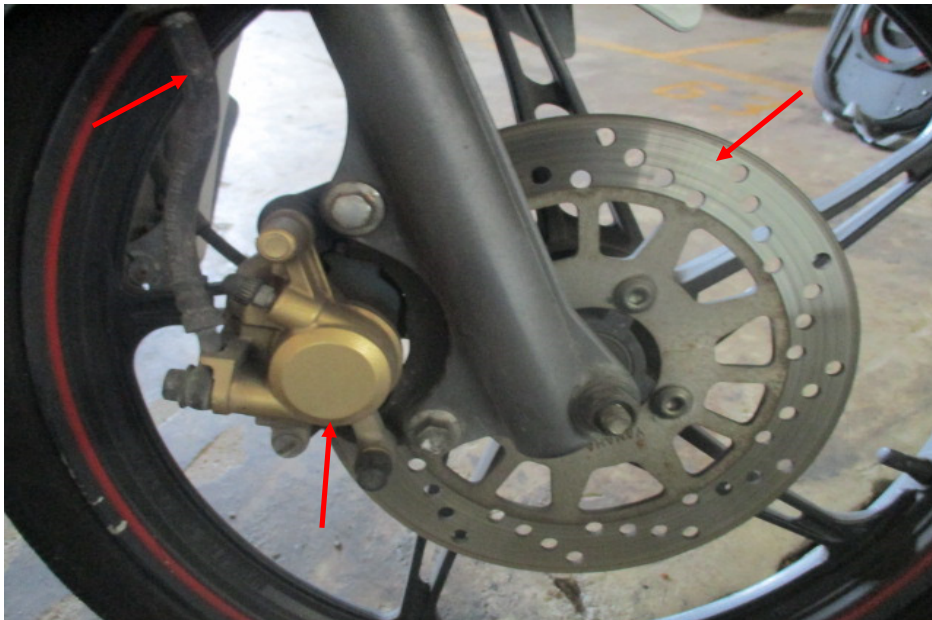
Photo 22 shows a close up view of the front brake caliper, front brake disc and front brake hose (arrowed) of the Motorcycle, which are all part of the components in the hydraulic front brake system of the Motorcycle. Our visual checks of these various components had revealed all to be intact with no visible damage. No leakage of brake fluid was also observed.

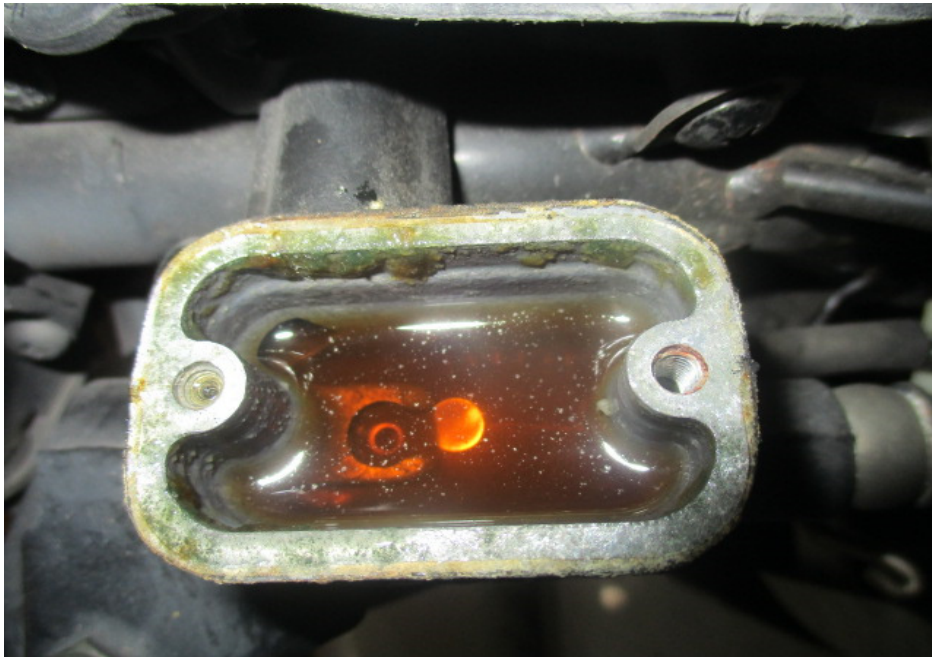
Photo 23 shows the brake fluid reservoir for the front brake of the Motorcycle. The brake fluid was observed to be of sufficient level and without contamination for operational purposes.

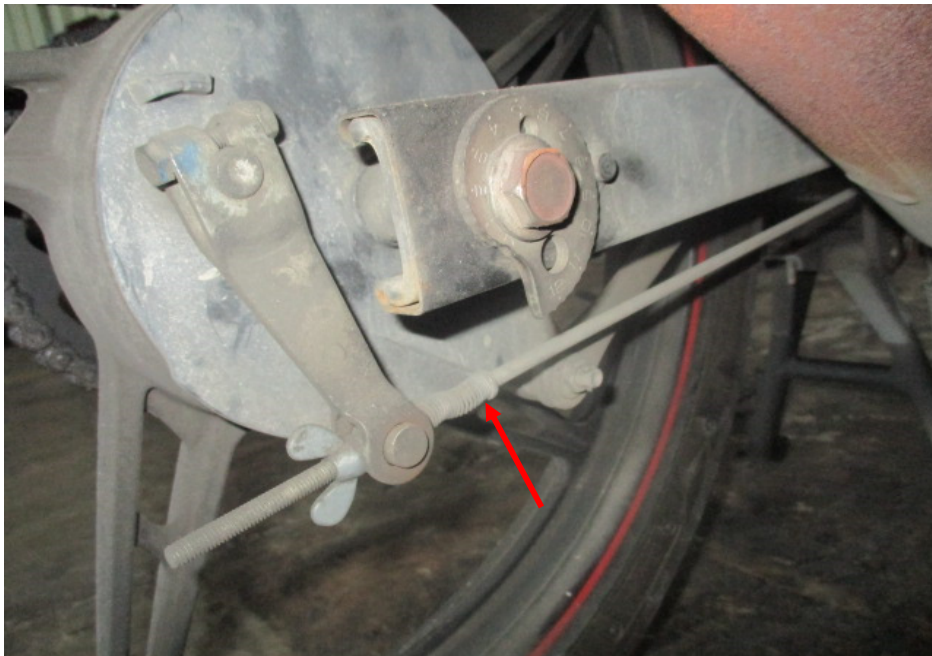
Photo 24 shows the rear wheel of the Motorcycle. The type of brake system for the rear wheel was of a mechanical type, controlled by the brake foot pedal of the Motorcycle. Our checks of the cable (arrowed), spring and drum which are all part of the components in the rear brake system of the Motorcycle reveal all to be intact and without damage.
