Your Ref: TP/IP/19361/2019
Our Ref : CI/TPD19008242/P

Fatal Accident Investigation Team

MECHANICAL INSPECTION REPORT OF MOTOR TAXI SHC 6160X

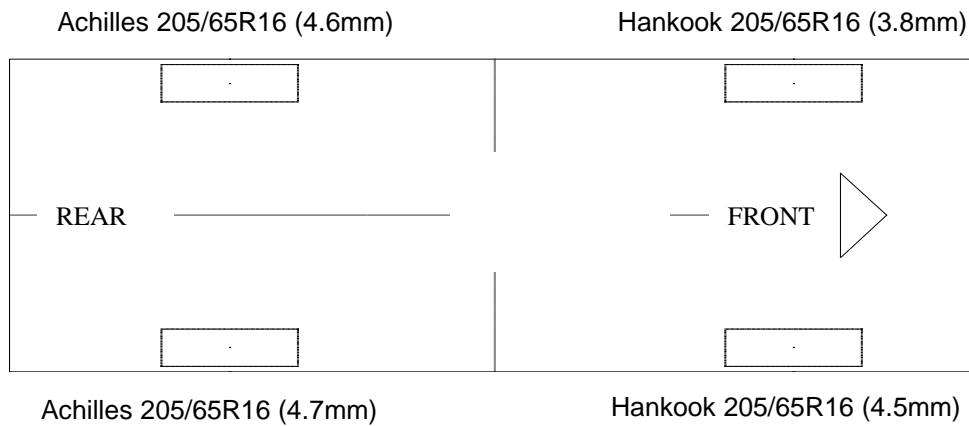
6. The condition of the Motor Taxi's 4 tyres was observed to be in serviceable condition. I did not find any tear, cut or burst mark(s) on the outer and the inner sidewalls as well as across the tread of the 4 tyres. The 4 tyres were also observed to be sufficiently inflated for vehicular operation. The tyre brand, tyre size and remaining tread depth of the 4 tyres were recorded as follows:-

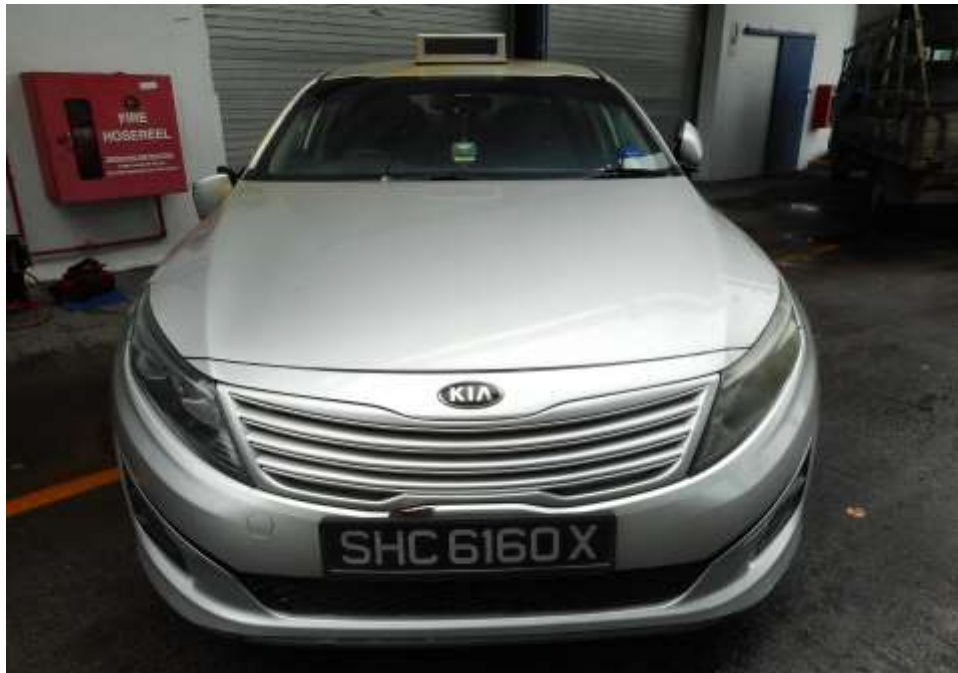
Photo 1 shows a front general view of the Motor Taxi's at the time of my inspection. The front portion of the Motor Taxi was observed to have been unaffected by the accident. The mileage of the Motor Taxi at the time of my inspection was recorded to be 364,863km.

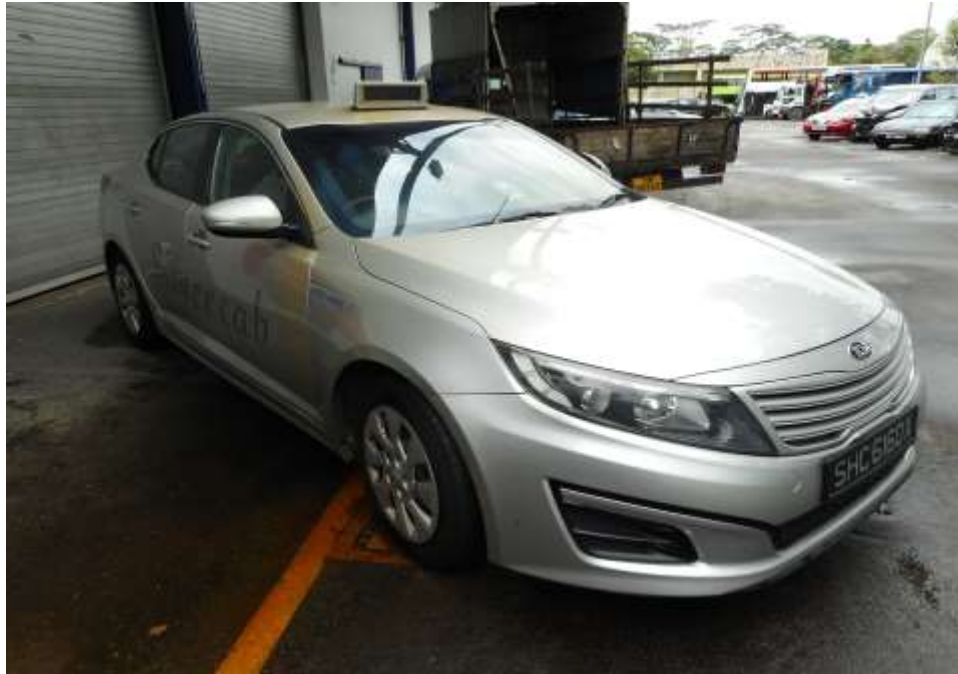
Photo 2 shows a general view of the Motor Taxi's right body panel at the time of my inspection. The right portion of the Motor Taxi was observed to have been unaffected by the accident.

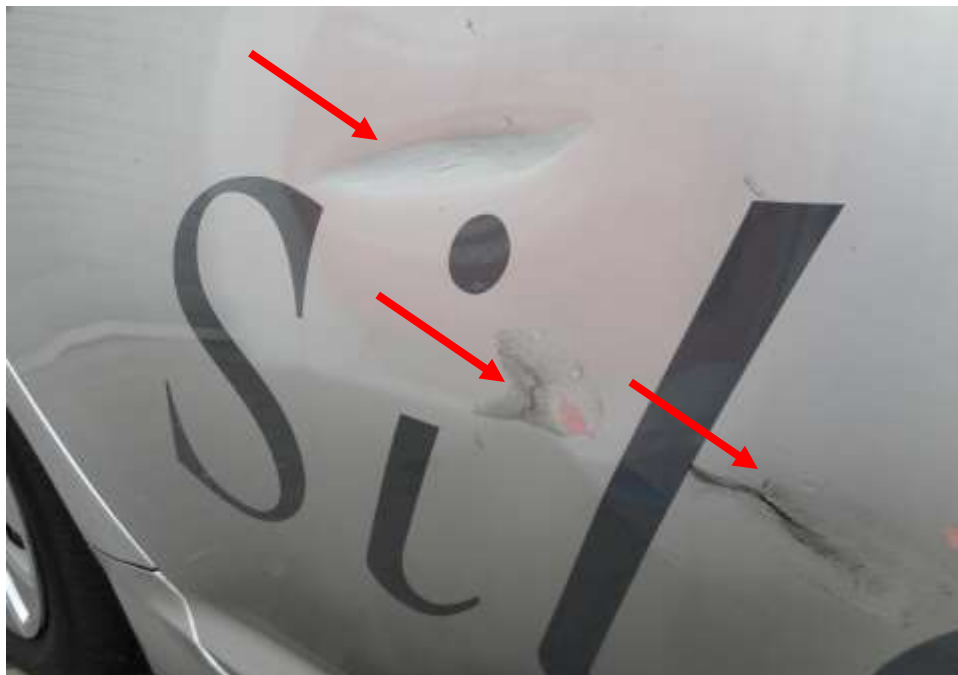
4. The mileage of the Motor Taxi at the time of my inspection was recorded 359,520km
5. The Motor Taxi was observed to have sustained relatively minor damage at its left portion. Its right door panel were amongst the body parts that were damaged as a result of the accident.

Photo 3 shows a general view of the Motor Taxi's right body panel at the time of my inspection. The right door panel portion (arrowed) of the Motor Taxi was observed to have sustained minor damages as a result of the accident.

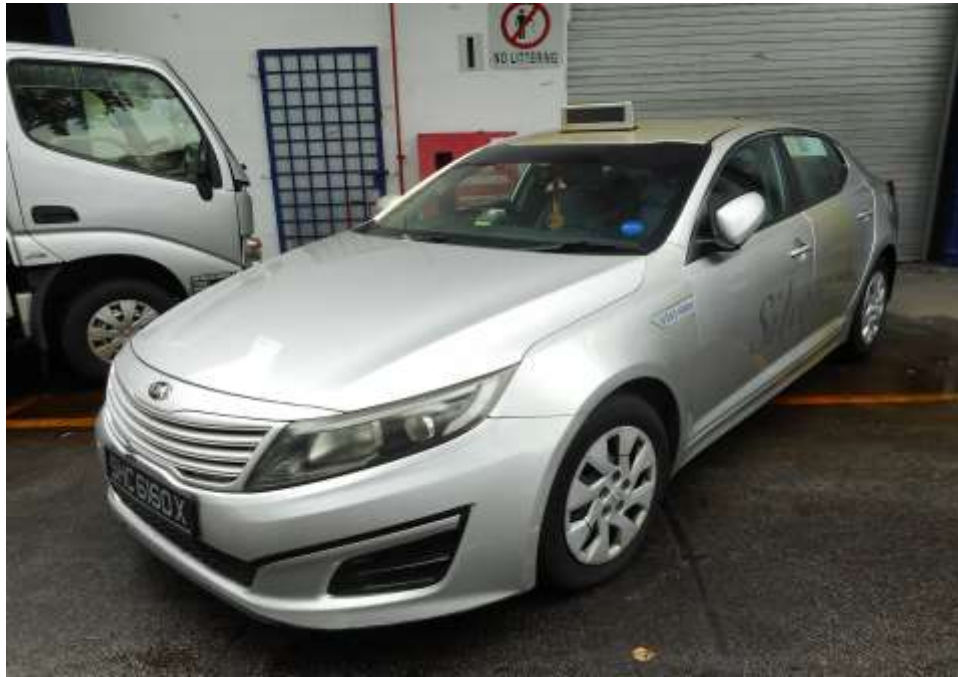
Photo 4 shows a general view of the Motor Taxi's left body panel at the time of my inspection. The left portion of the Motor Taxi was observed to have been unaffected by the accident.

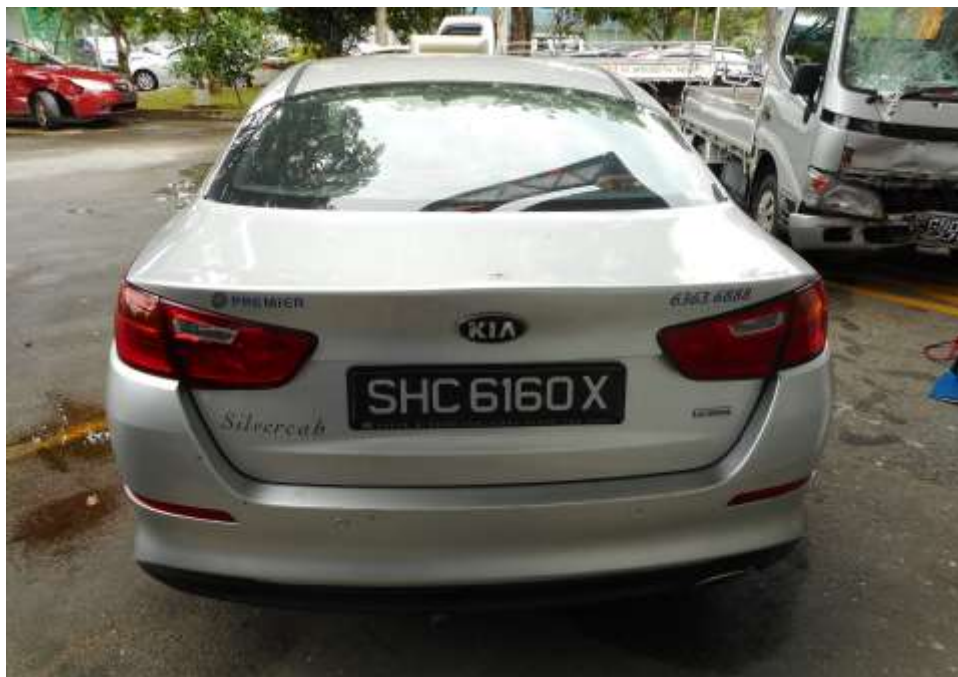
Photo 5 shows a general view of the Motor Taxi's rear body at the time of my inspection. The rear portion of the Motor Taxi was observed to have been unaffected by the accident.

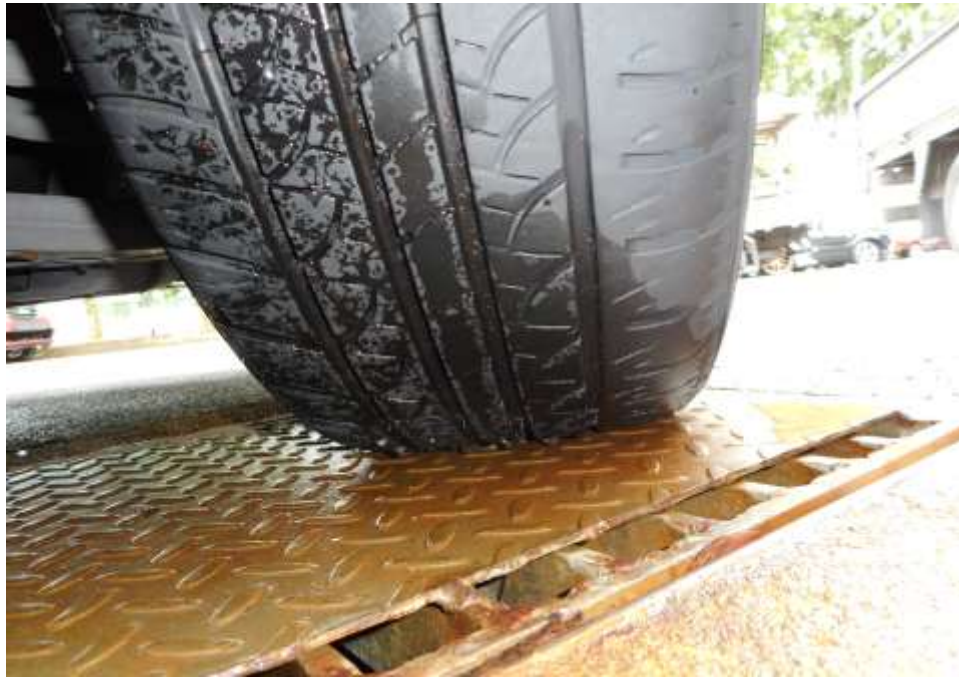
Photo 6 shows the condition of the front right tyre of the Motor Taxi, which was observed to be in serviceable condition with remaining tread depth of approximately 4.5mm. The tyre was sufficiently inflated for vehicular operation with no tear, cut or burst mark(s) on the outer and the inner sidewalls as well as across the tread. The 4 tyres of the Motor Taxi were wrapped around standard steel wheel rims without any damage.

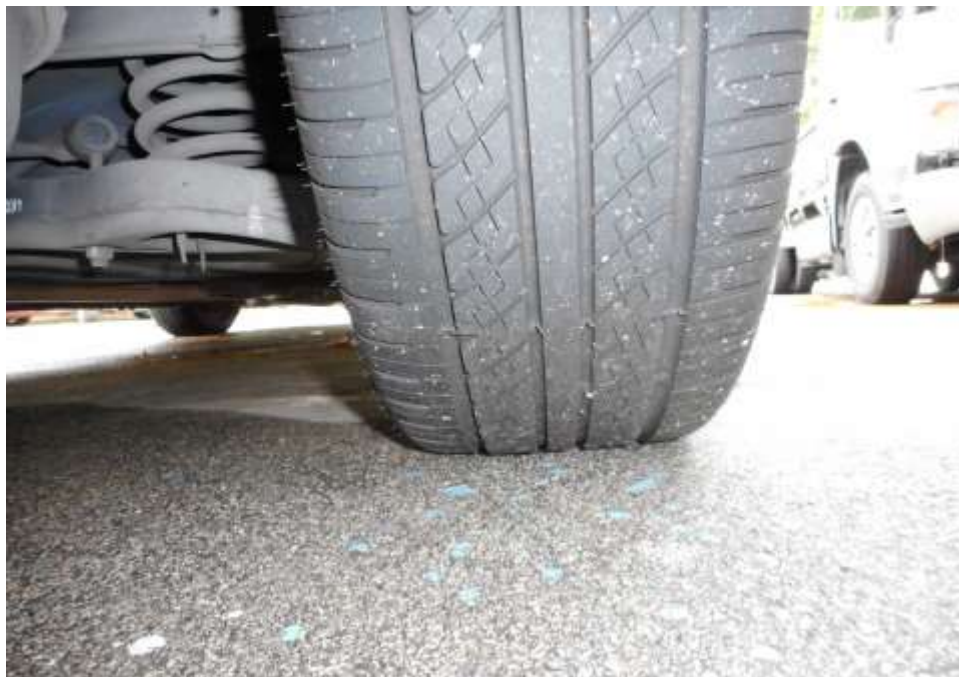
Photo 7 shows the condition of the rear right tyre of the Motor Taxi, which was observed to be in serviceable condition with remaining tread depth of approximately 4.7mm. The tyre was also observed to be sufficiently inflated for vehicular operation with no tear, cut or burst mark(s).

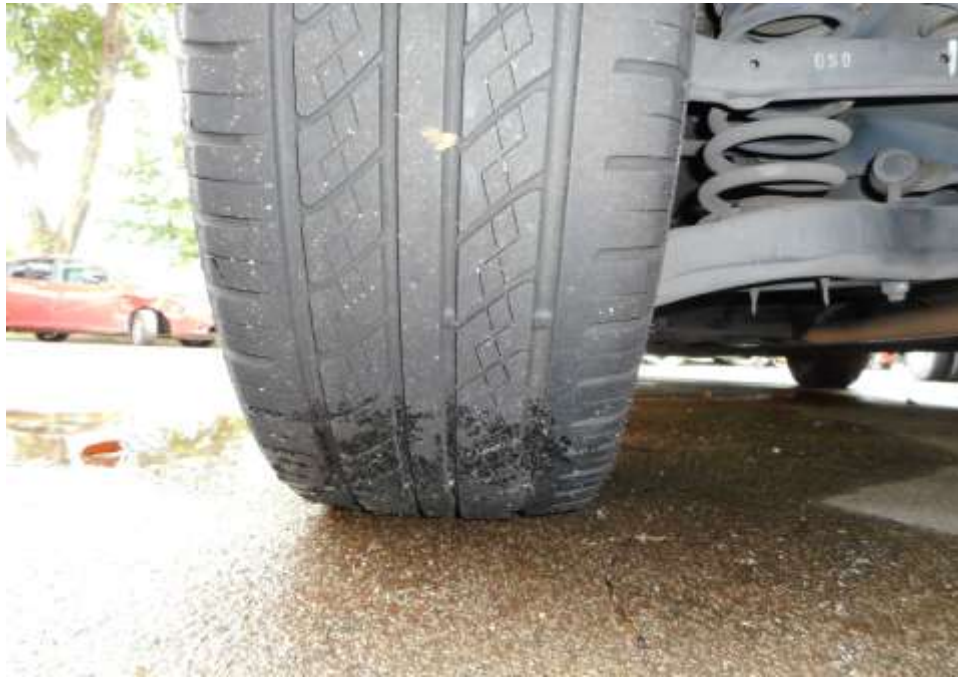
Photo 8 shows the condition of the rear left tyre of the Motor Taxi, which was observed to be in serviceable condition with remaining tread depth of approximately 4.6 mm. The tyre was also observed to be sufficiently inflated for vehicular operation with no tear, cut or burst mark(s).

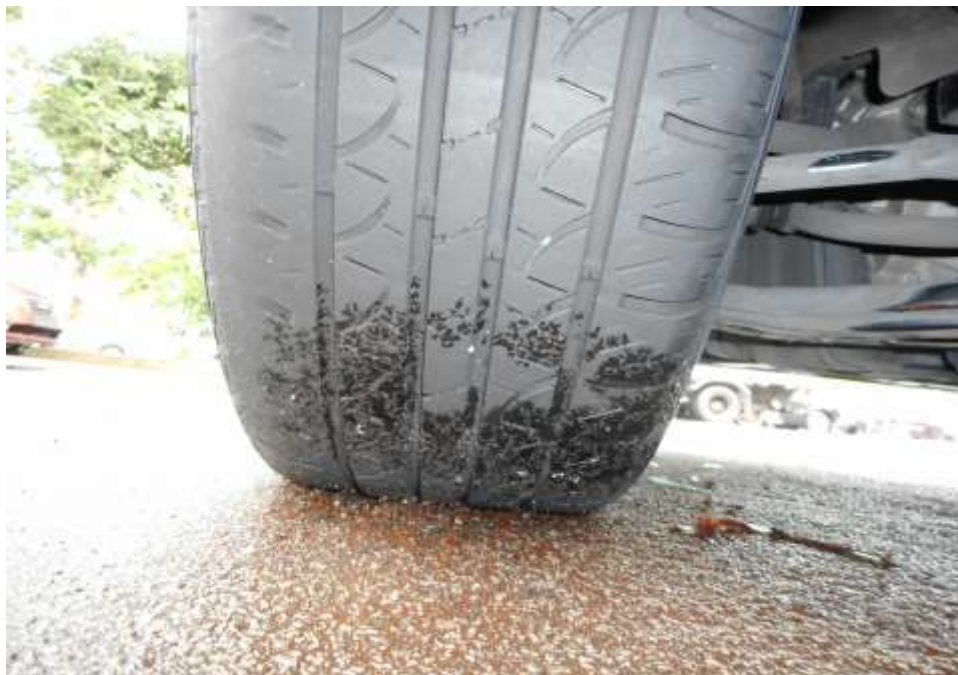
Photo 9 shows the condition of the front left tyre of the Motor Taxi, which was observed to be in serviceable condition with remaining tread depth of approximately 3.8mm. The tyre was also observed to be sufficiently inflated for vehicular operation with no tear, cut or burst mark(s).

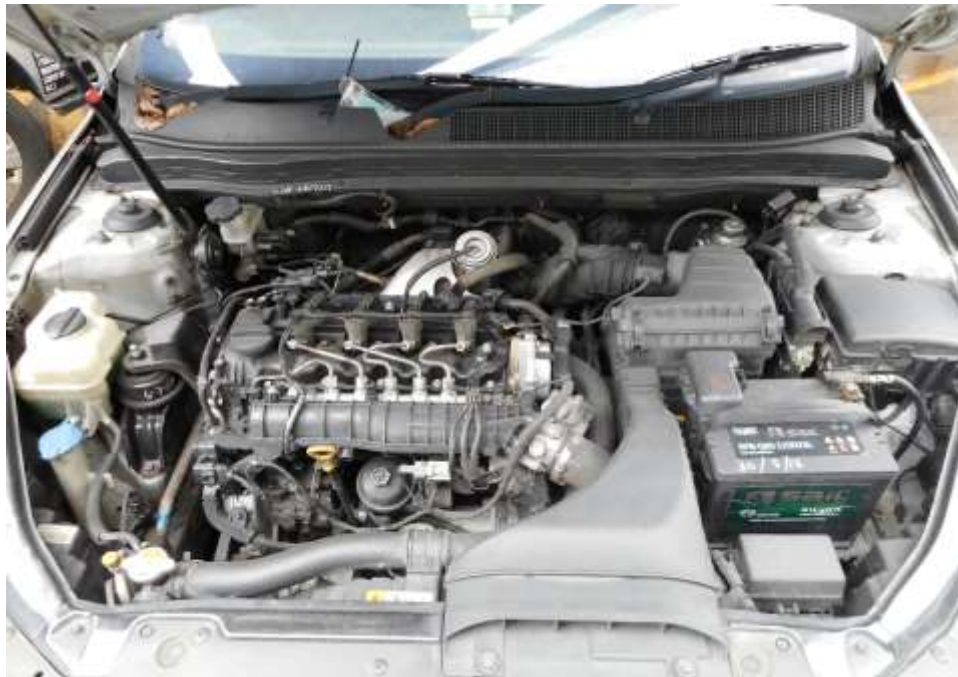
Photo 10 shows a general view of the Motor Taxi's engine compartment. The various parts and components inside the engine compartment were unaffected by the accident. There was also no sign(s) or indication(s) of fluid leakage and/or fluid stain within the engine compartment.

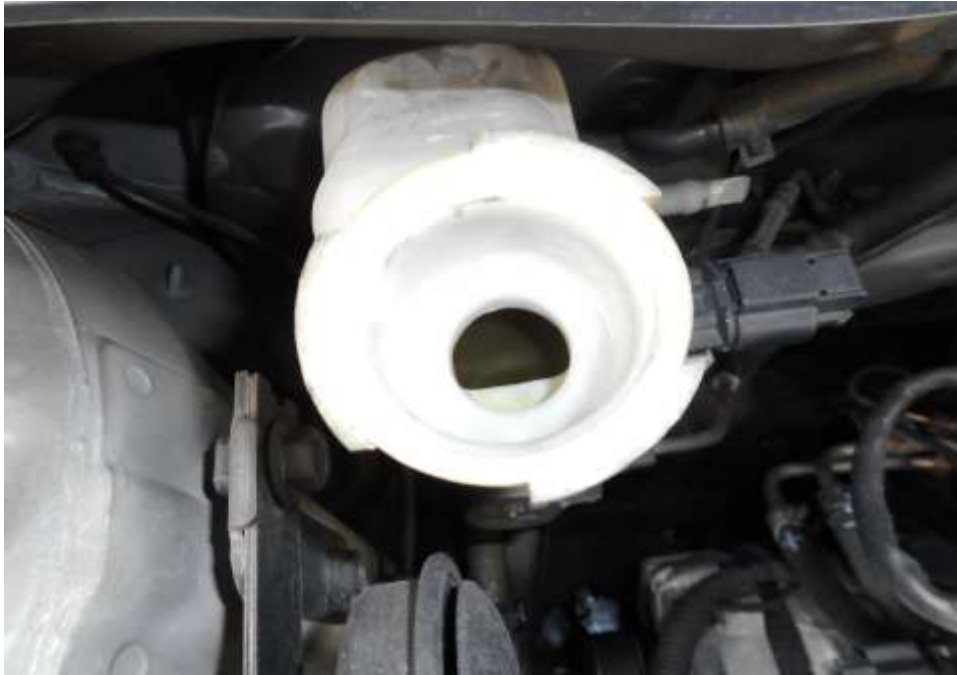
Photo 11 shows the brake fluid reservoir of the Motor Taxi at the time of my inspection. The brake fluid was observed to be of sufficient level and without any visible contamination.

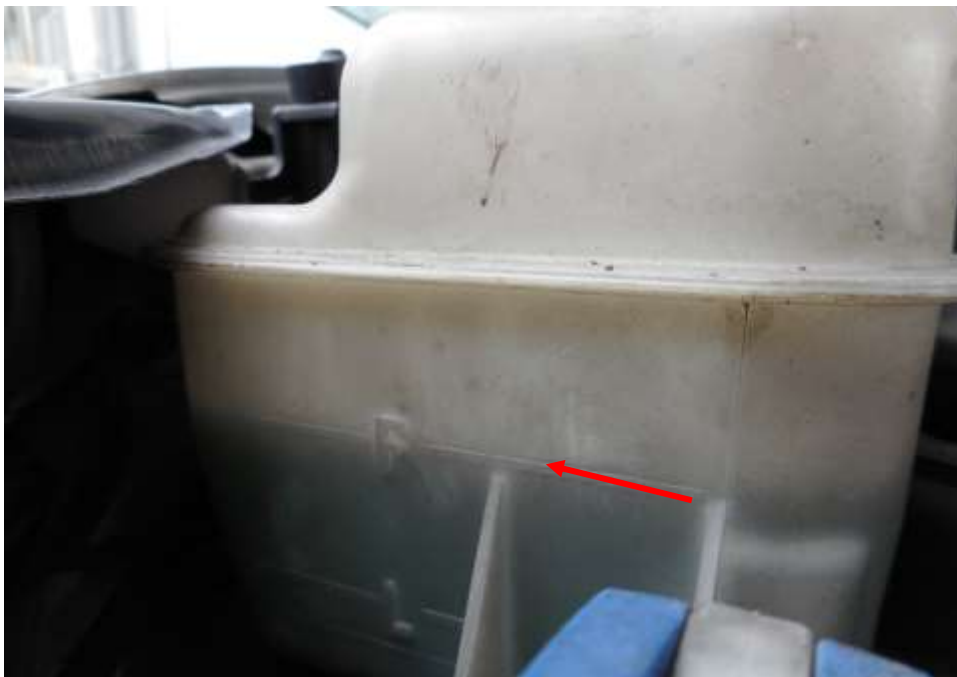
Photo 12 shows checks being carried out to the engine coolant of the Motor Taxi at the time of my inspection. The engine coolant was observed to be of sufficient level (arrowed) and without any visible contamination.

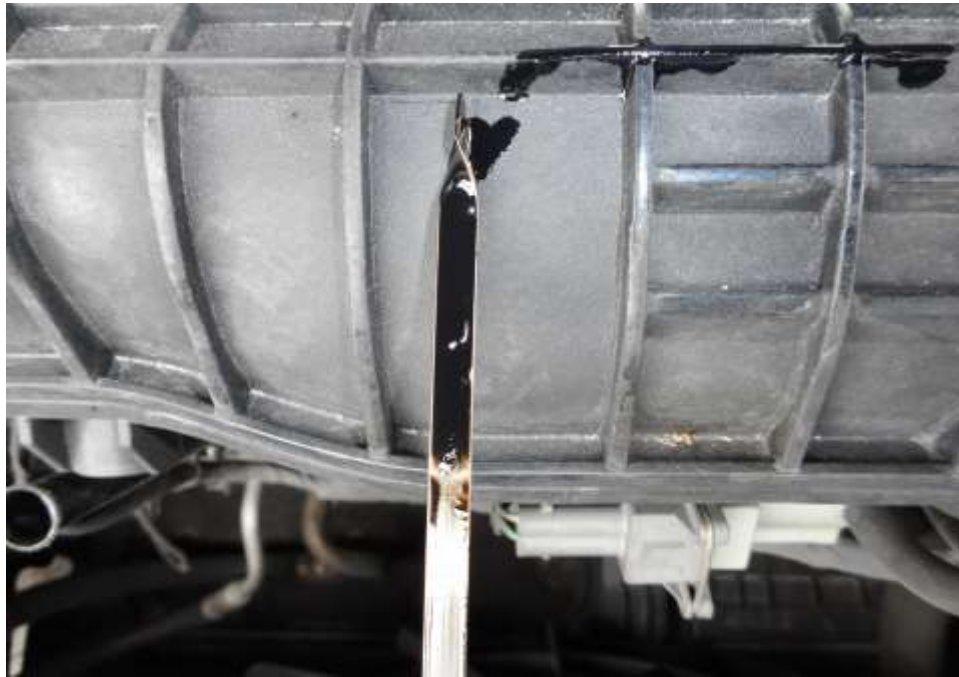
Photo 13 shows the engine oil dip stick of the Motor Taxi at the time of my inspection. The engine oil was observed to be of sufficient level and without any visible contamination.

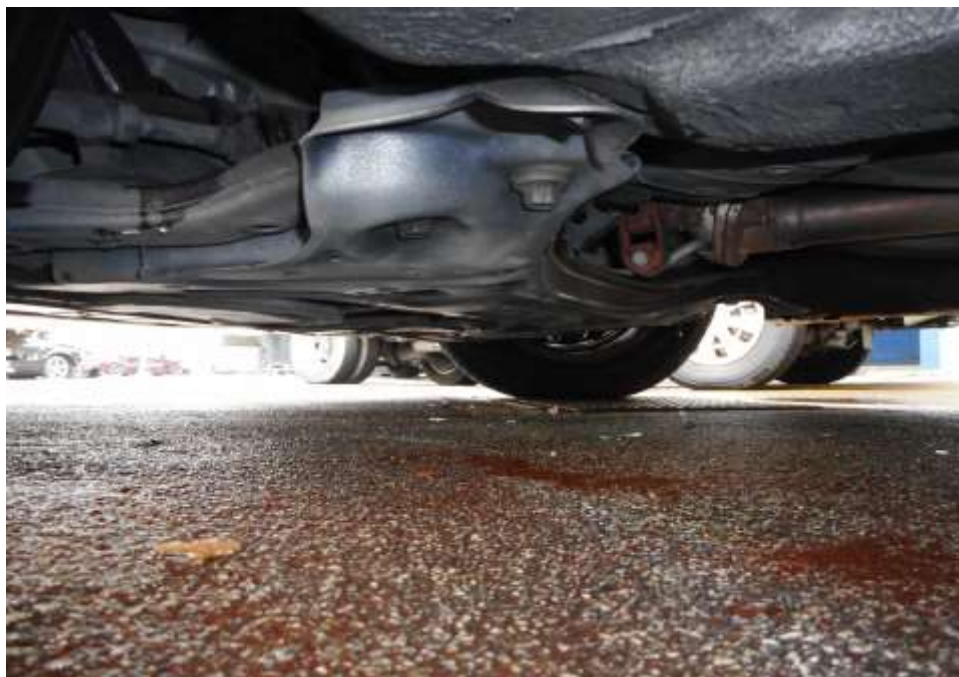
Photo 14 shows the undercarriage of the Motor Taxi, at the area where the engine housing and transmission housing are located. I did not find any sign(s) or indication(s) of fluid leak and/or fluid stain(s) on the underside of the Motor Taxi.

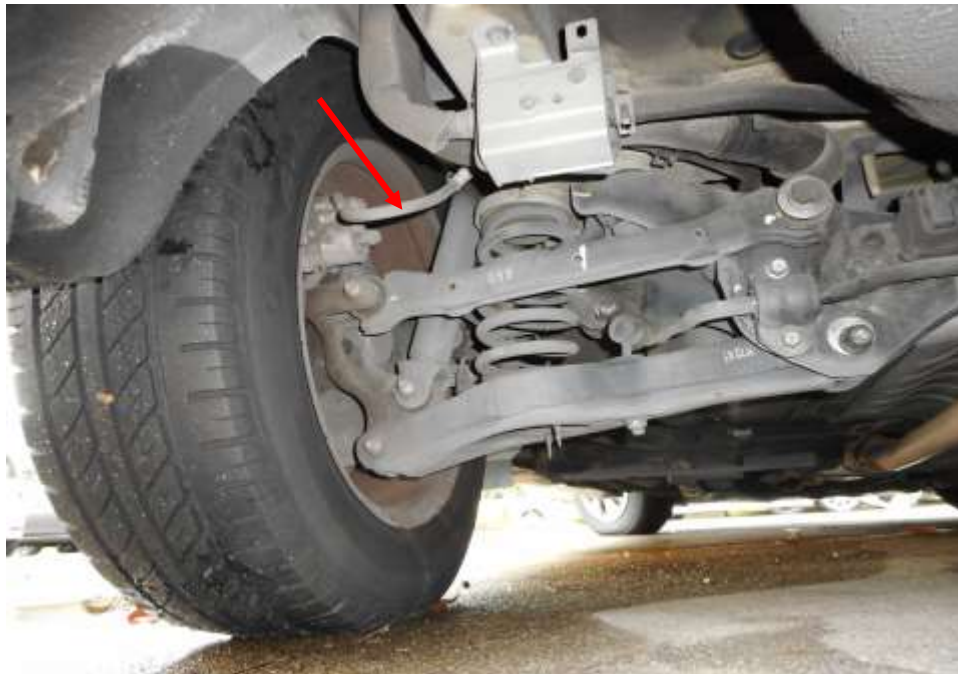
Photo 15 shows the brake hose/pipe (arrowed) at the rear left wheel of the Motor Taxi. I did not observe any leakage of brake fluid at the time of my inspection of the Motor Taxi. Static tests of the Motor Taxi's braking system had indicated that there was no internal leakage of pressure/vacuum. The undercarriage components of the Motor Taxi were also all found to be intact and without any visible damage.

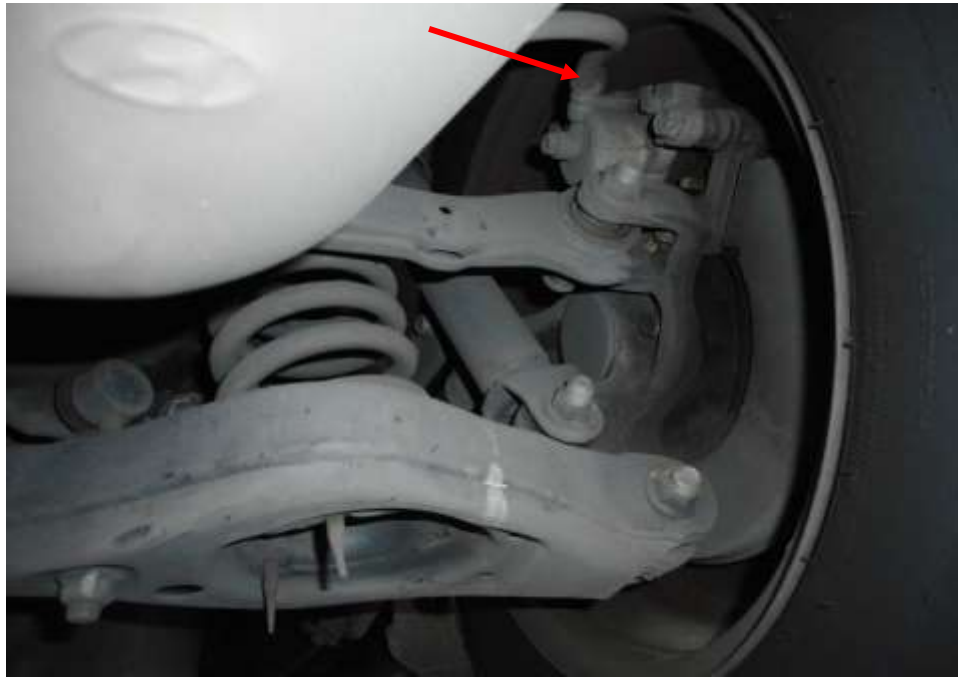
Photo 16 shows the brake hose/pipe (arrowed) at the rear right wheel of the Motor Taxi. I did not observe any leakage of brake fluid at the time of my inspection of the Motor Taxi. Static tests of the Motor Taxi's braking system had indicated that there was no internal leakage of pressure/vacuum. The undercarriage components of the Motor Taxi were also all found to be intact and without any visible damage.

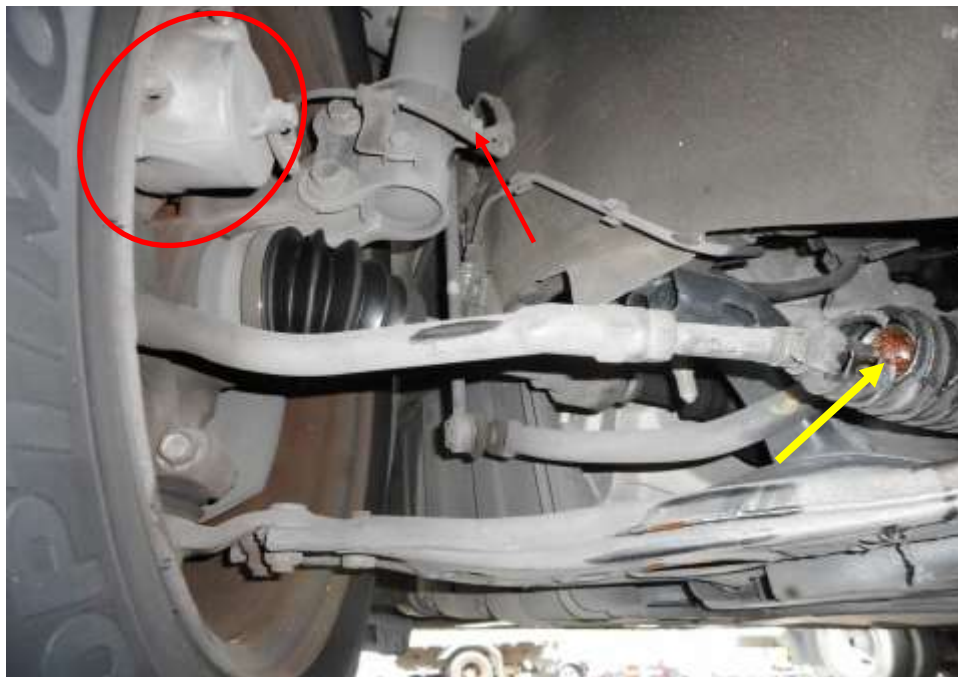
Photo 17 shows the brake hose/pipe (red arrow) at the front left wheel of the Motor Taxi. No leakage of brake fluid was observed. Visual examination of the various components, the inner rubber boot (yellow arrow) of the right steering rack was observed to be broken. However the other various components of the braking system like the brake caliper (circled), brake booster, brake pedal etc had revealed all to be intact and without visible damage.

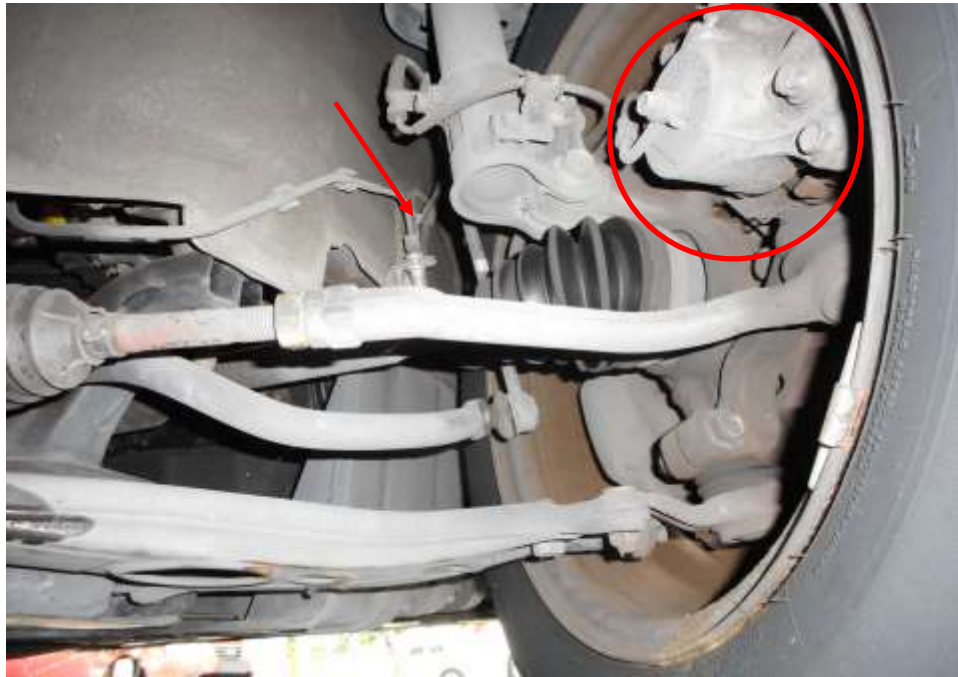
Photo 18 shows the brake hose/pipe (arrowed) at the front right wheel of the Motor Taxi. No leakage of brake fluid was observed. Visual examination of the various components of the braking system like the brake caliper (circled), brake booster, brake pedal etc had revealed all to be intact and without visible damage.

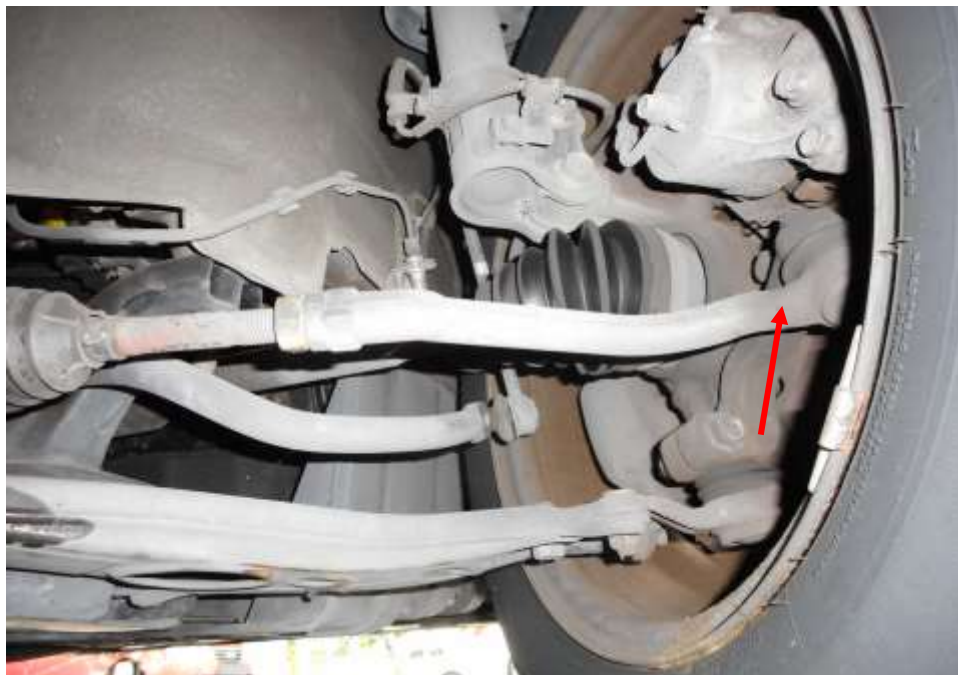
Photo 19 shows the various undercarriage components at the front right wheel of the Motor Taxi, in particular the steering tie rod (arrowed). The various steering components were all found to be intact, suggesting that the steering system of the Motor Taxi was likely to be in serviceable condition at the material time of accident. There was also no sign of fluid stain observed on the various undercarriage components at the front right wheel of the Motor Taxi.

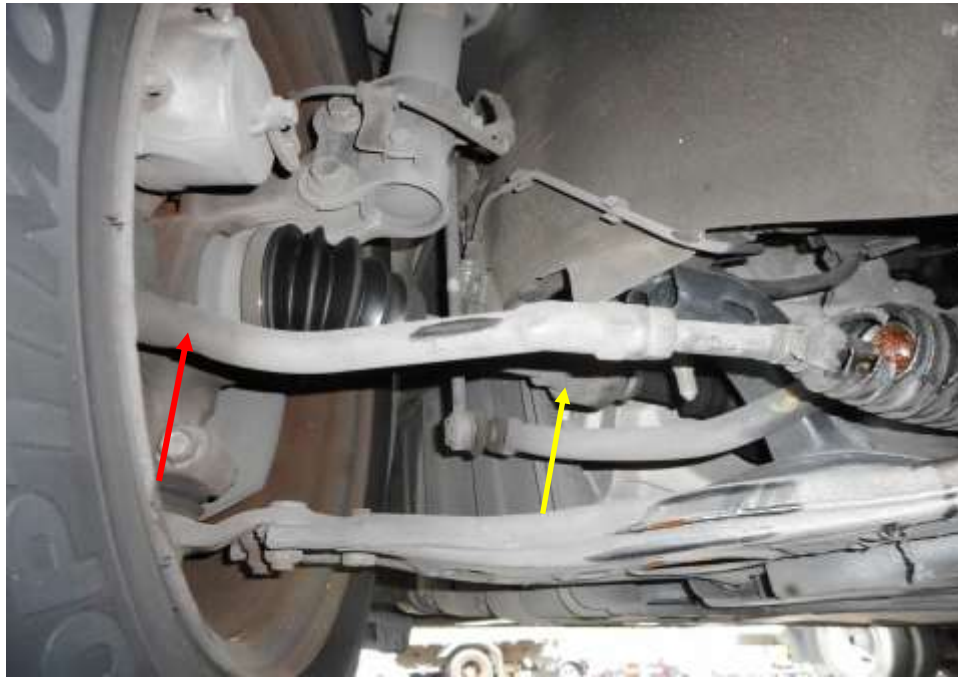
Photo 20 shows the various undercarriage components at the front left wheel of the Motor Taxi, which had included the steering tie rod (red arrow) and front left drive shaft (yellow arrow). The various undercarriage components of the Motor Taxi were all found to be intact without any visible damage.

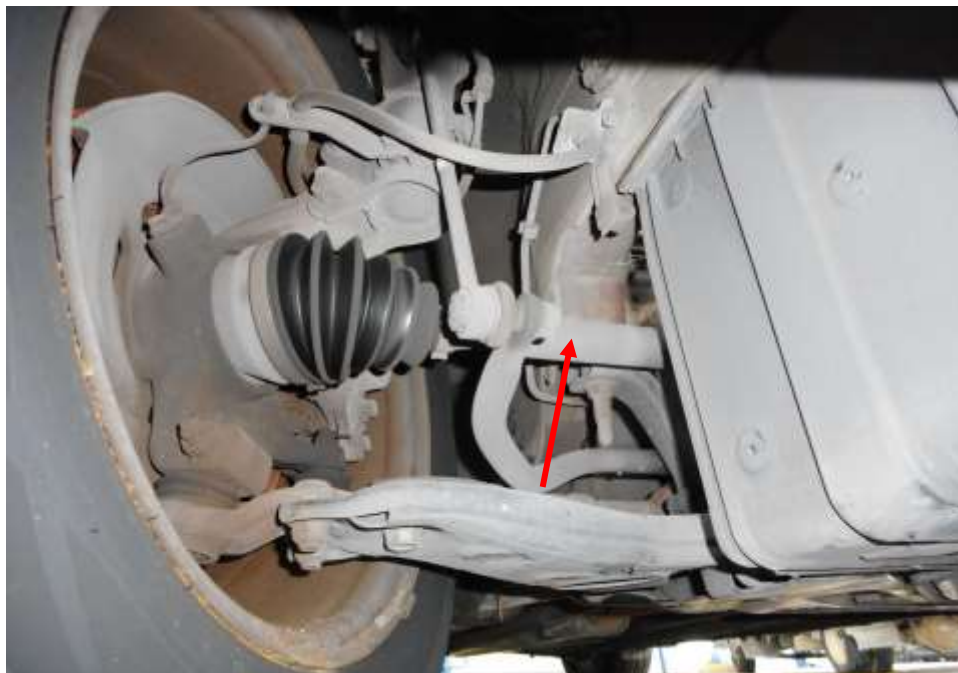
Photo 21 shows front left drive shaft (arrowed) undercarriage component at the front left wheel of the Motor Taxi, were found to be intact without any visible damage.

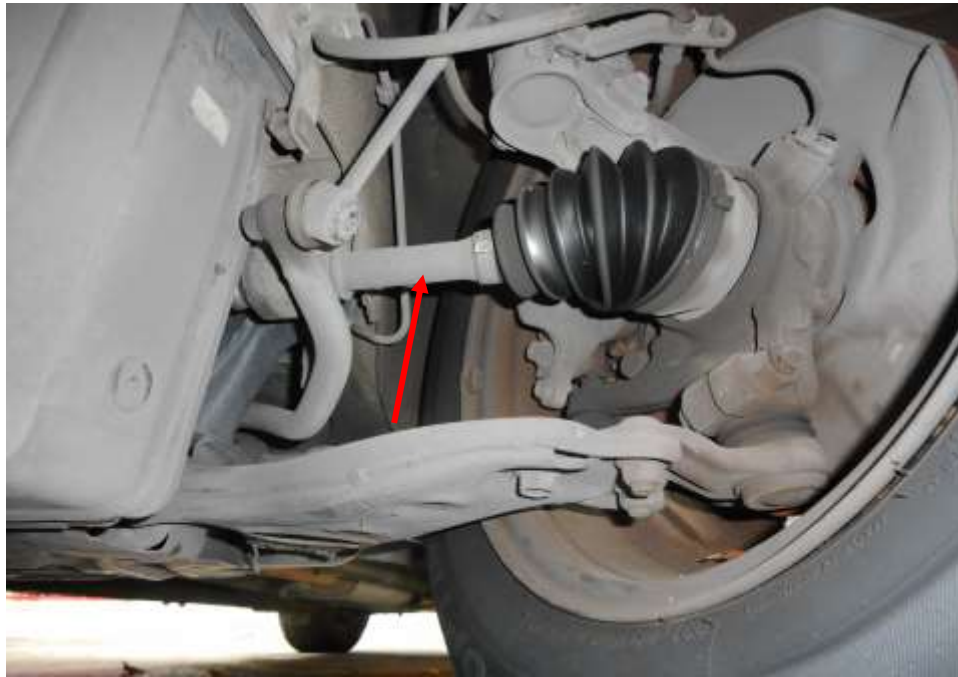
Photo 22 shows front right drive shaft (arrowed) undercarriage component at the front right wheel of the Motor Taxi, were found to be intact without any visible damage.

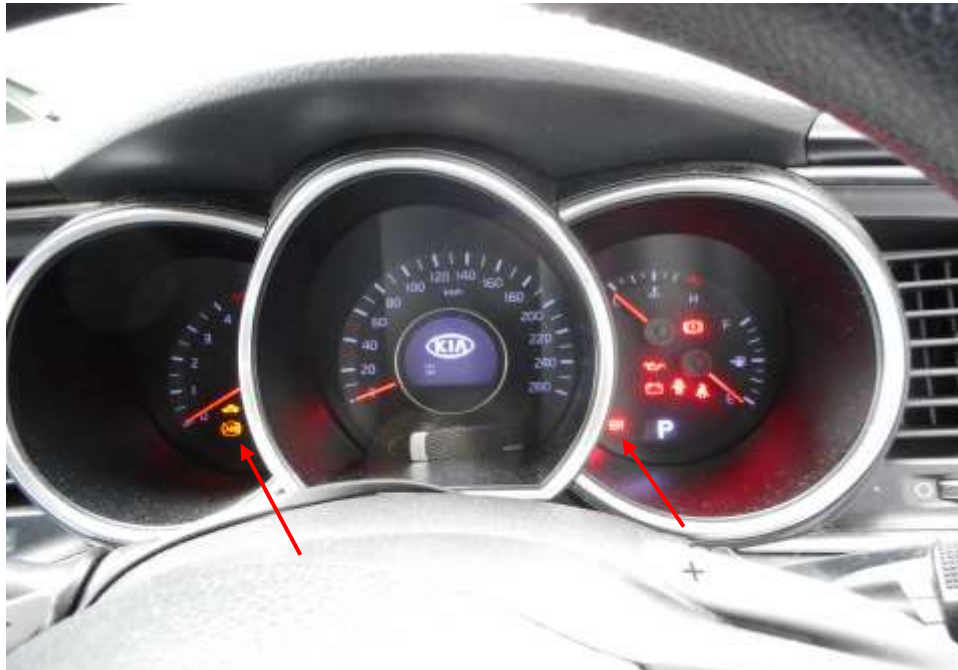
Photo 23 shows the warning light for Anti-Lock Brake System (ABS), Electric Power Steering System (EPS), Traction Control (TC) and Supplemental Restraint System (SRS) appearing on the instrument panel of the Motor Taxi during the self-test of its various electronic operating systems when its engine was cranked.

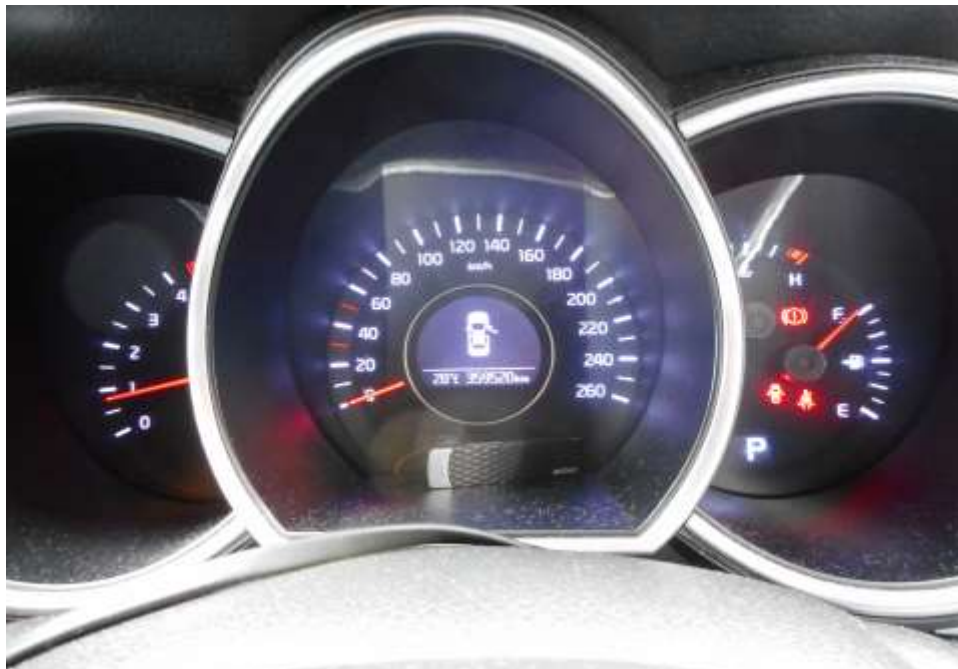
Photo 24 shows no warning lights illuminated on the instrument panel of the Motor Taxi after the engine was cranked. This would suggest that there was no abnormality to the various electronic operating systems of the Motor Taxi, like the ABS, EPS, TC and SRS etc.

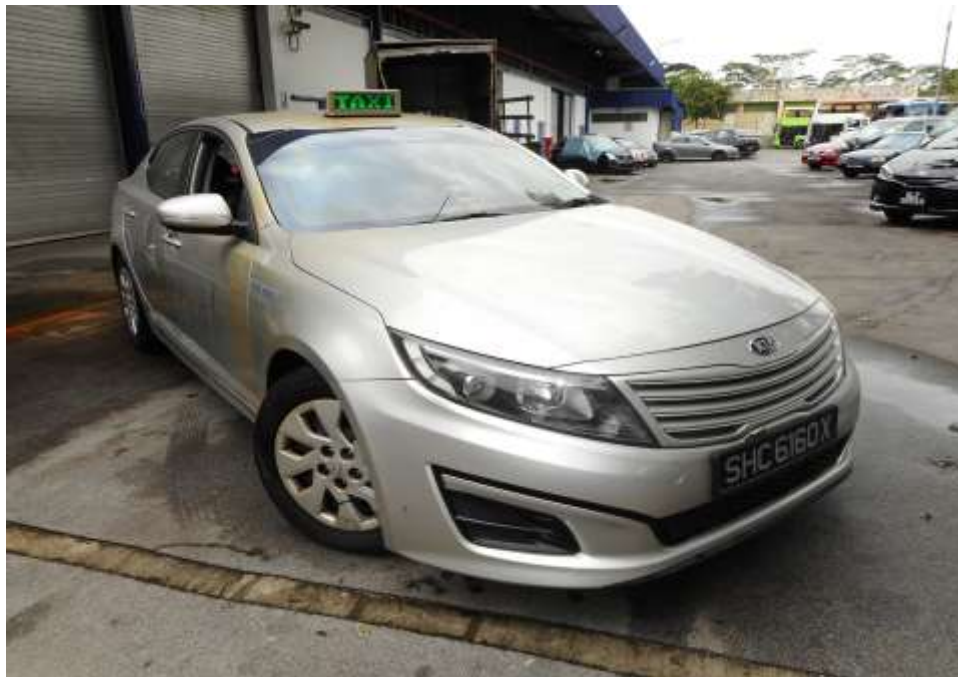
Photo 25 shows the front right wheel of the Motor Taxi turned to its full left. During my steering system test, I did not experience any abnormal free play and/or resistance when I had turned the steering wheel towards the left and right. This would suggest that the steering system of the Motor Taxi was likely to be in serviceable condition at the material time of accident.
