Your Ref: TP/IP/08411/2019
Our Ref : CI/TPD19008245/P

Fatal Accident Investigation Team

MECHANICAL INSPECTION REPORT OF MINI BUS PC 3215Y

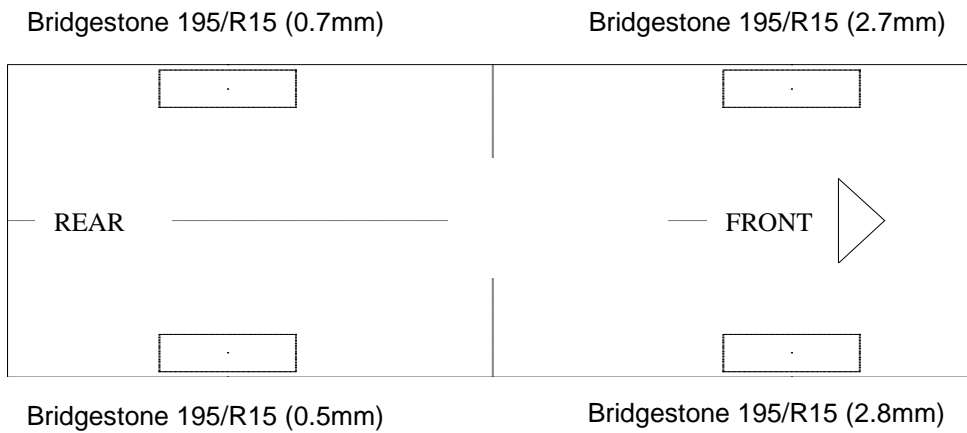
6. The condition of the Mini Bus's both rear left and right tyres was observed to be in unserviceable condition due to insufficient tread depth. However the both front tyres was observed to be in serviceable condition. I did not find any tear, cut or burst mark(s) on the outer and the inner sidewalls as well as across the tread of the 4 tyres. The 4 tyres were also observed to be sufficiently inflated for vehicular operation. The tyre brand, tyre size and remaining tread depth of the 4 tyres were recorded as follows:-

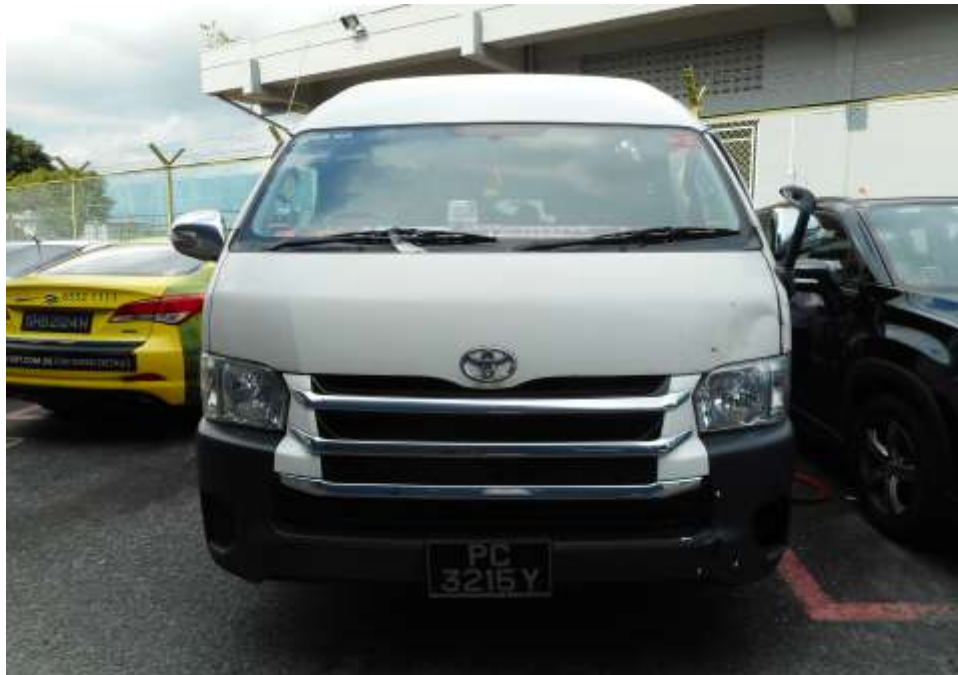
4. The mileage of the Mini Bus at the time of my inspection was 280,625km.
5. The Mini Bus was observed to have sustained relatively moderate damage at its frontal and left portion. Its front bonnet, front bumper and left sidling door panel and door panel were amongst the body parts that were damaged as a result of the accident.

Photo 1 shows a general view of the front body of the Mini Bus at the time of my inspection. The Mini Bus was observed to have sustained relatively moderate damage at its frontal and left portion, its front bonnet, front bumper and left sidling door panel and door panel were amongst the body parts that were damaged as a result of the accident. The mileage of the Mini Bus at the time of my inspection was recorded to be 280,625km.

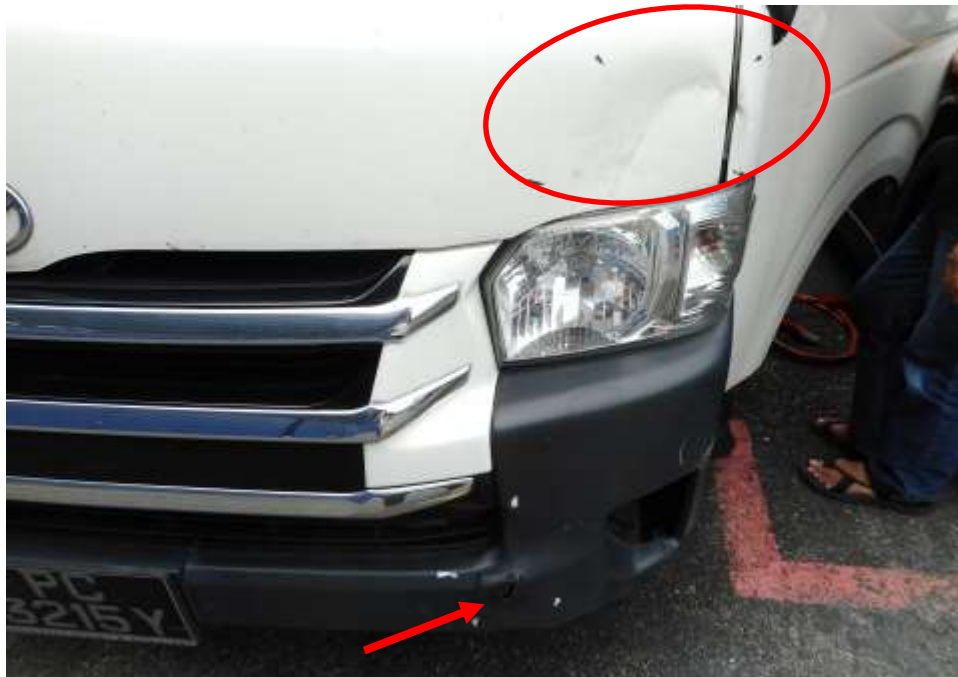
Photo 2 shows a close up view of the damaged front bonnet (circled) and bumper (arrowed) of the Mini Bus at the time of my inspection as a result of the accident.

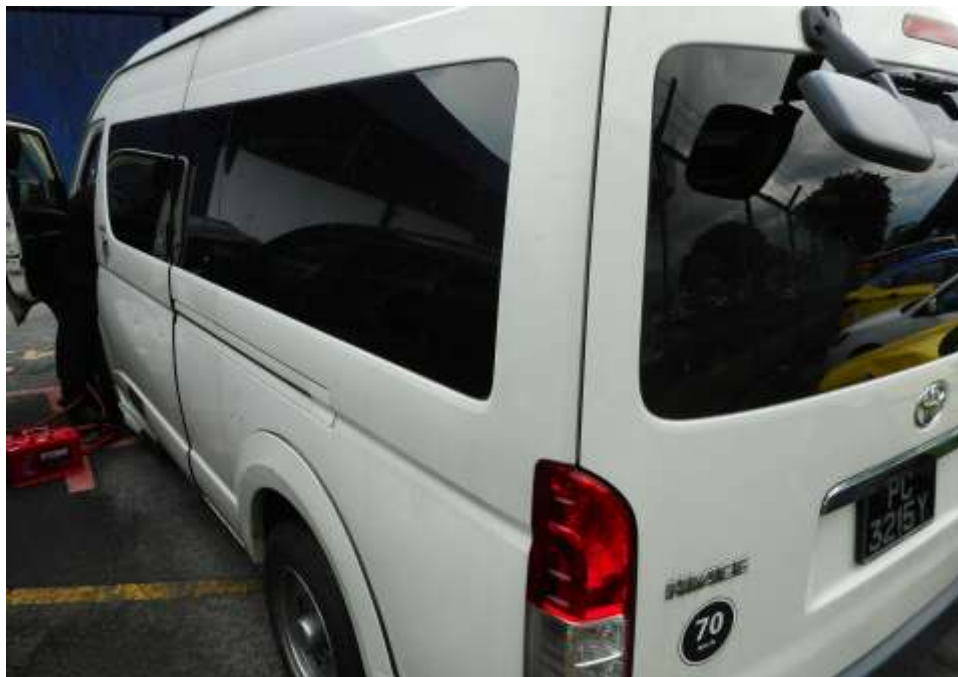
Photo 3 shows a general view of the damaged left sliding door panel and door panel (circled) and bumper (arrowed) of the Mini Bus at the time of my inspection as a result of the accident.

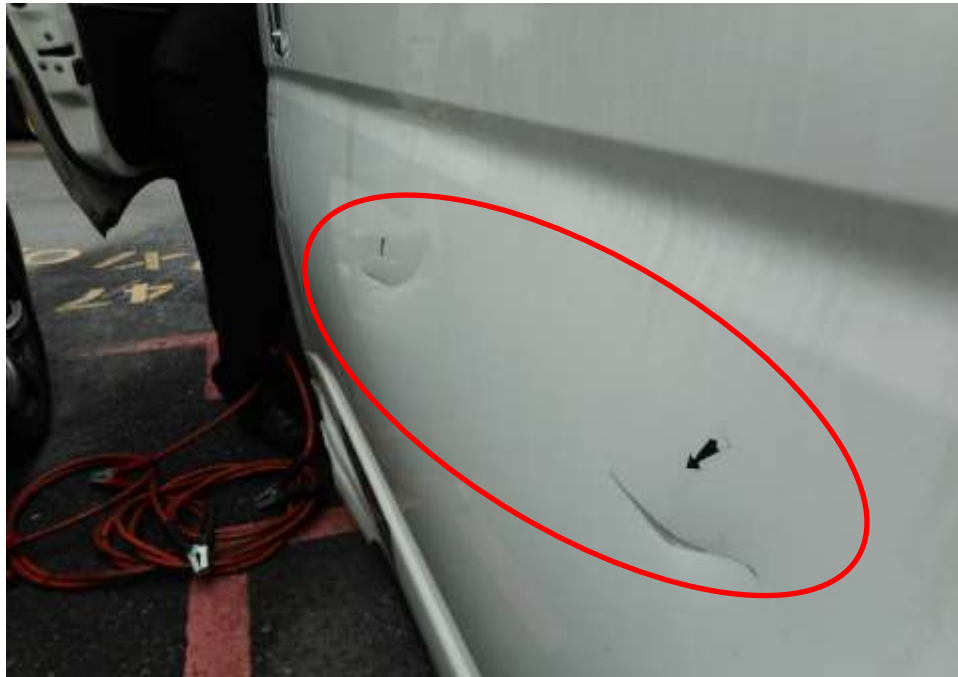
Photo 4 shows a close up view of the damaged left sliding door panel (circled) of the Mini Bus at the time of my inspection as a result of the accident.

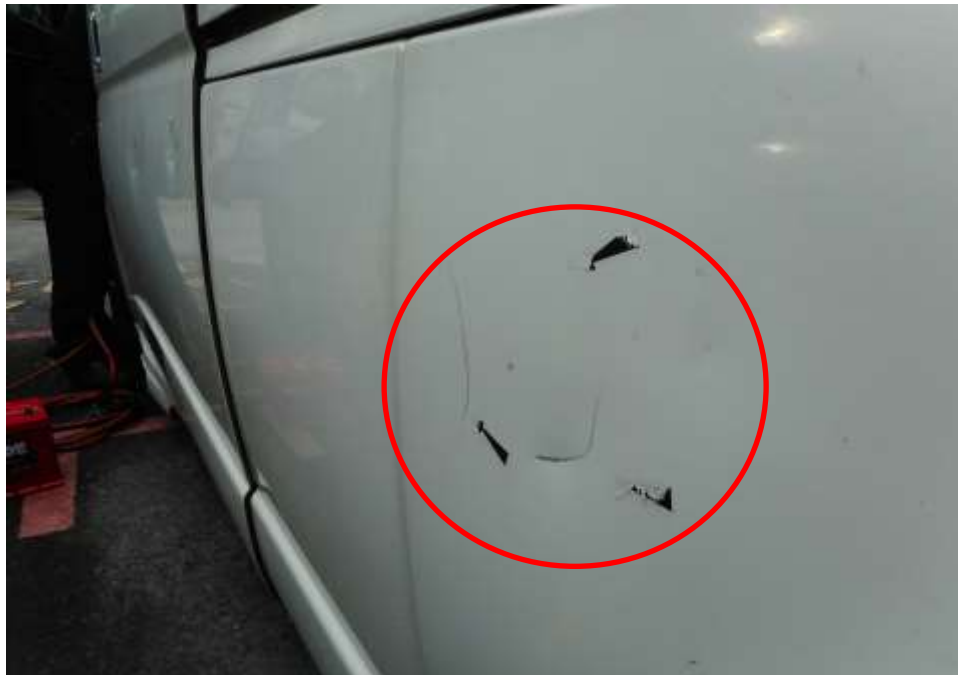
Photo 5 shows a close up view of the damaged left door panel (circled) of the Mini Bus at the time of my inspection as a result of the accident.

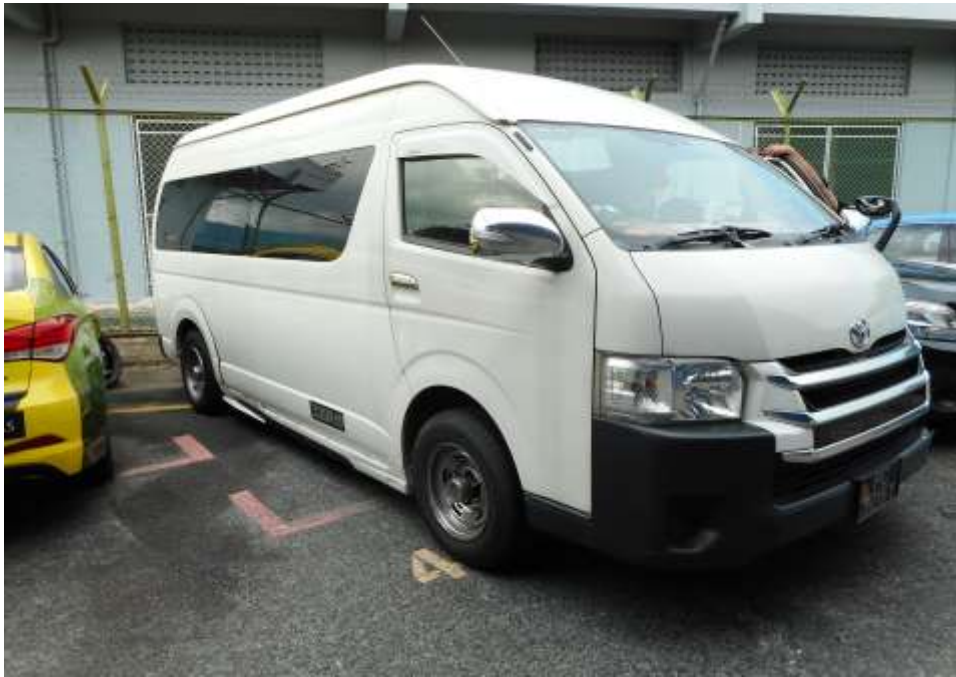
Photo 6 shows a general view of the Mini Bus's right body at the time of my inspection. The right portion of the Mini Bus was observed to have been unaffected by the accident.

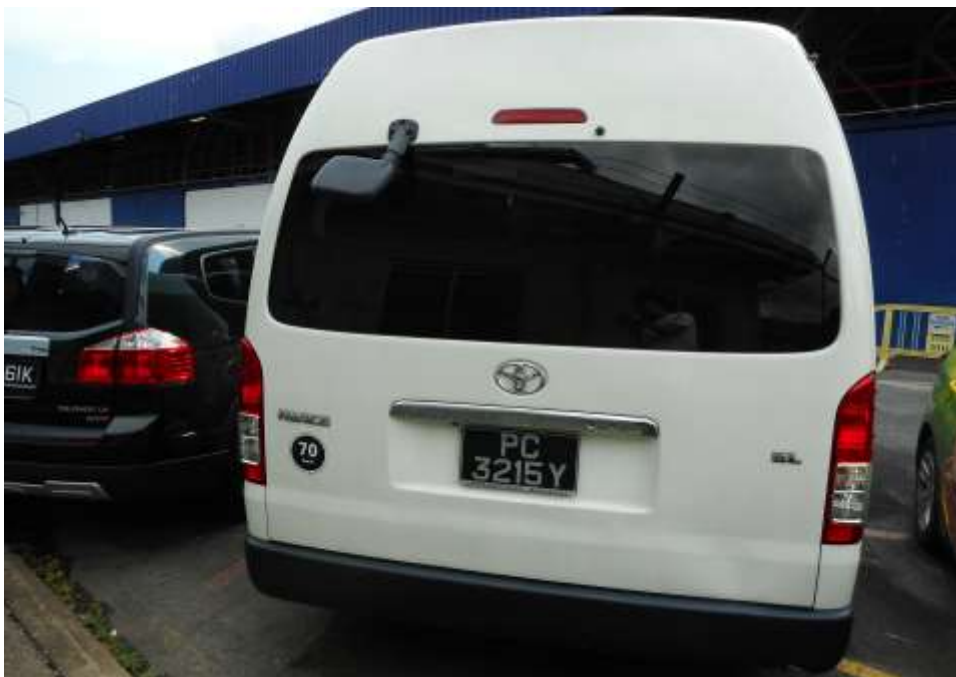
Photo 7 shows a general view of the Mini Bus's rear body at the time of my inspection. The rear portion of the Mini Bus was observed to have been unaffected by the accident.

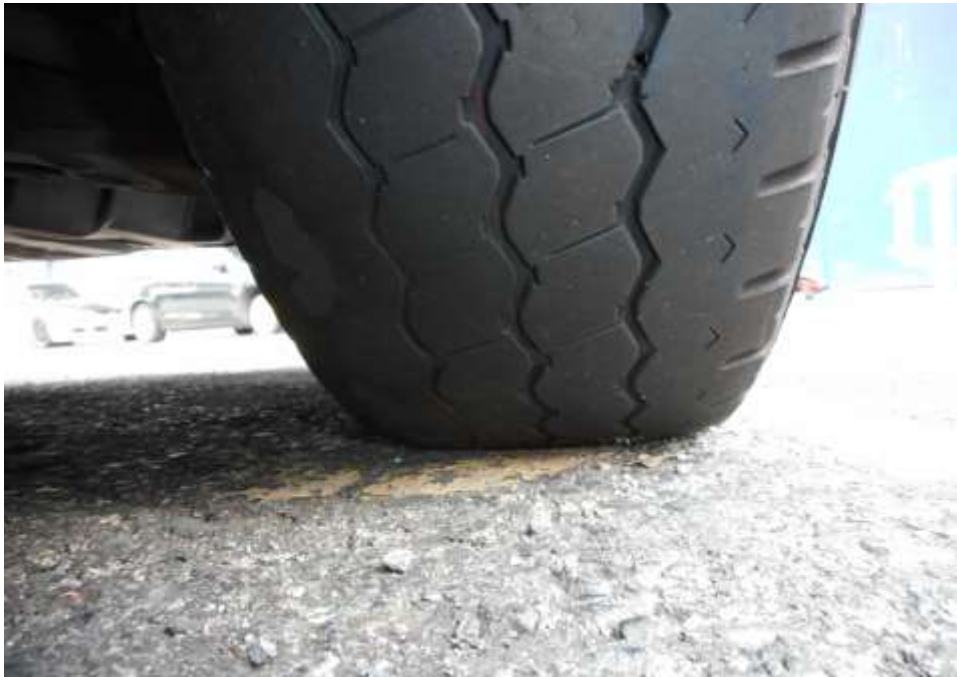
Photo 8 shows the condition of the front right tyre of the Mini Bus, which was observed to be in serviceable condition with remaining tread depth of approximately 2.8mm. The tyre was sufficiently inflated for vehicular operation with no tear, cut or burst mark(s) on the outer and the inner sidewalls as well as across the tread. The 4 tyres of the Mini Bus were wrapped around standard steel wheel rims without any damage.

18. The condition of the Mini Bus's both rear right and left tyres was observed to be in unserviceable condition due to insufficient tread depth of 0.5mm and 0.7mm. However, both front tyres were observed to be in serviceable condition with a tread depth of right 2.8mm and left 2.7mm. I did not find any tear, cut or burst mark(s) on the outer and the inner sidewalls as well as across the tread of the 4 tyres. The 4 tyres were observed to be sufficiently inflated for vehicular operation. Refer to photos 8 - 13

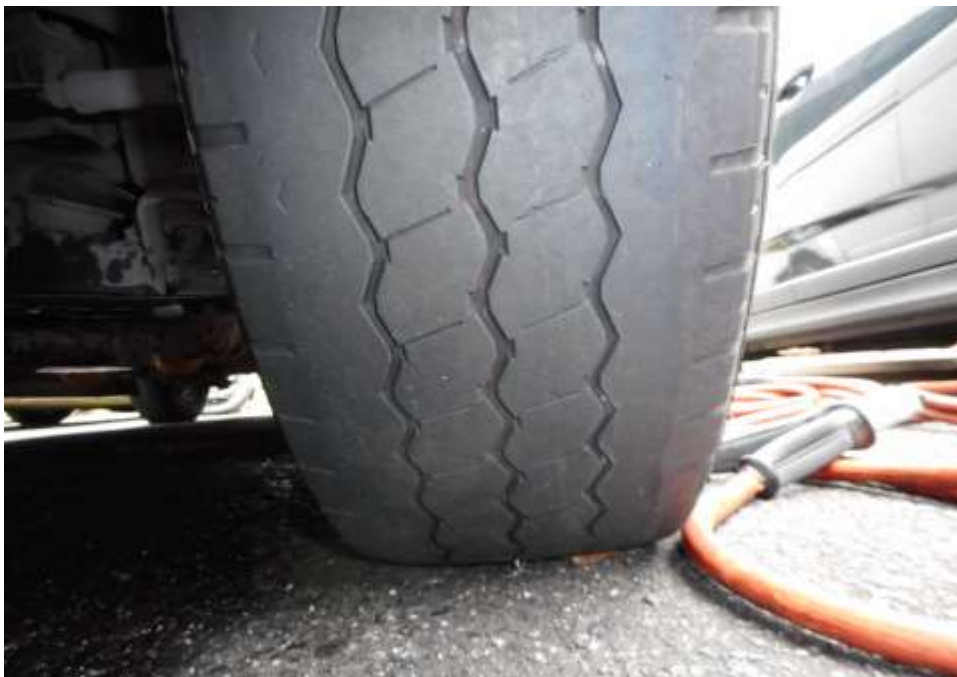
Photo 9 shows the condition of the front left tyre of the Mini Bus, which was observed to be in serviceable condition with remaining tread depth of approximately 2.7mm. There was also no tear, cut or burst mark(s) on the outer and the inner sidewalls as well as across the tread of the Mini Bus's 4 tyres.

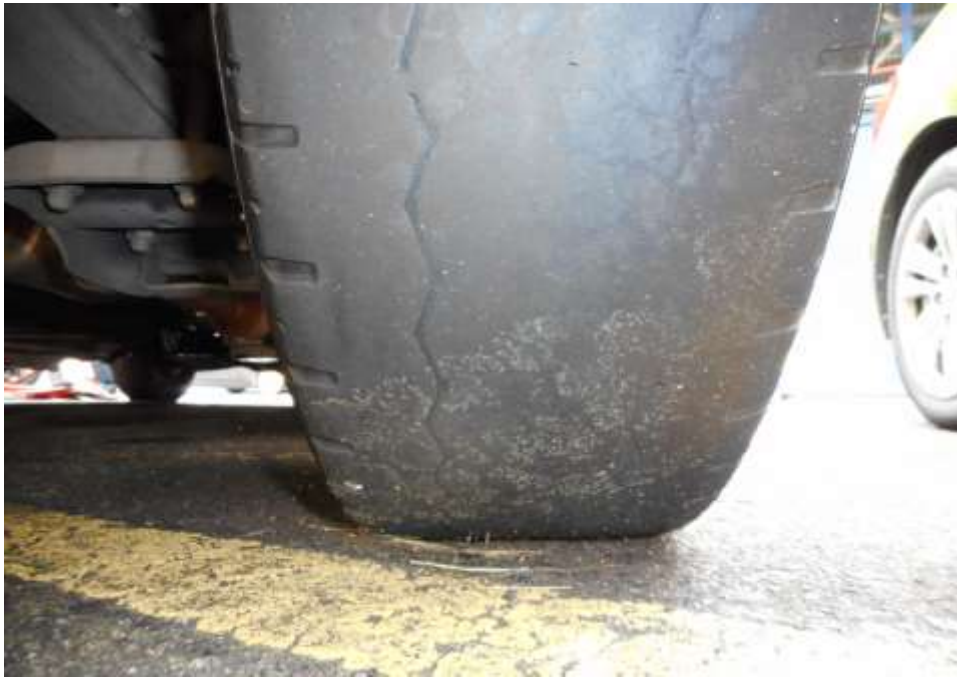
Photo 10 shows the condition of the rear right tyre of the Mini Bus. The tyre was observed to be sufficiently inflated for vehicular operation with no tear, cut or burst mark(s). However was observed to be in unserviceable condition with remaining tread depth of approximately 0.5mm.

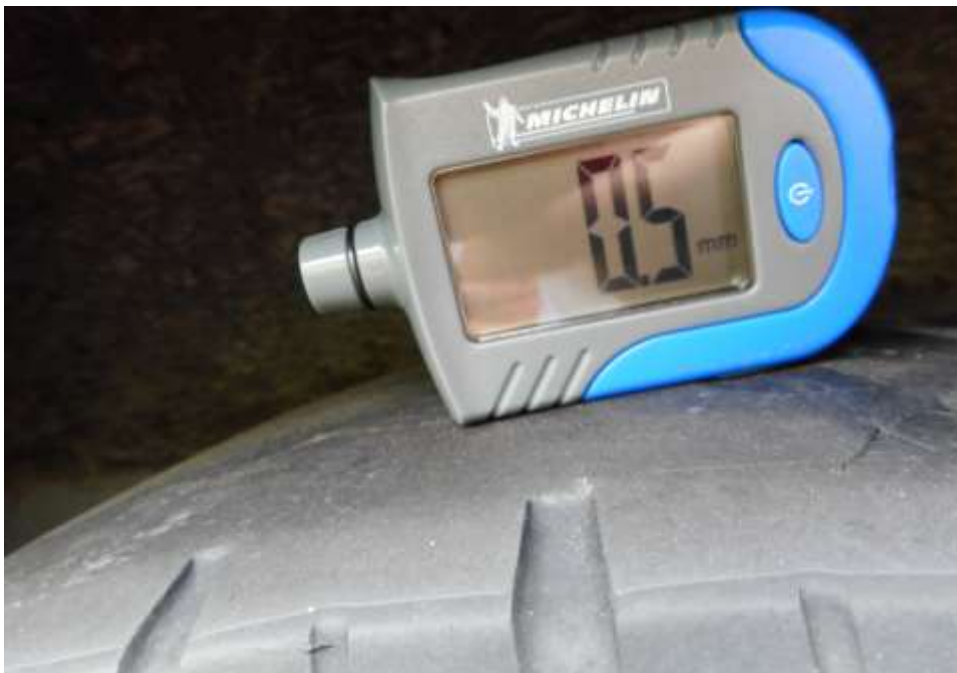
Photo 11 shows the tread depth measurement of the rear right tyre of the Mini Bus. The tyre was observed to be of unserviceable condition with remaining tread depth of approximately 0.5mm, at the time of inspection.

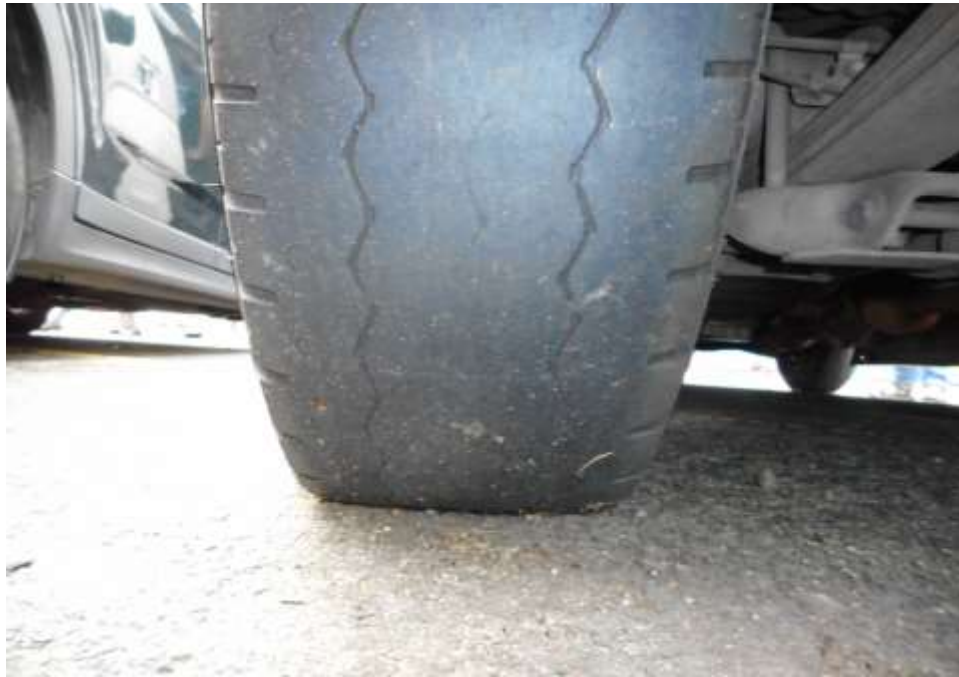
Photo 12 shows the condition of the rear left tyre of the Mini Bus. The tyre was observed to be sufficiently inflated for vehicular operation with no tear, cut or burst mark(s). However was observed to be in unserviceable condition with remaining tread depth of approximately 0.7mm.

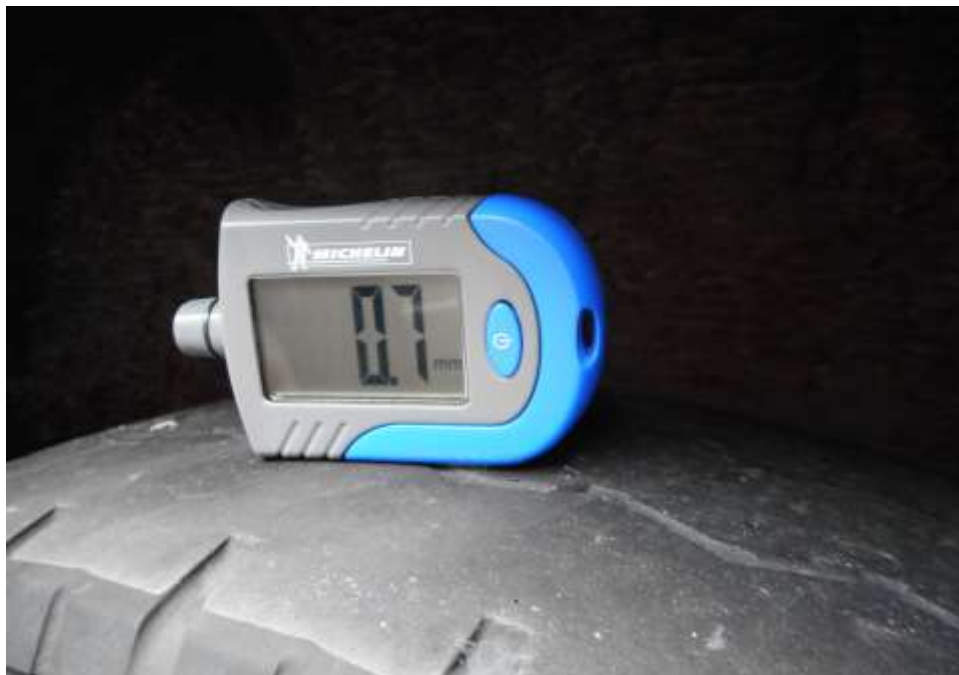
Photo 13 shows the tread depth measurement of the rear left tyre of the Mini Bus. The tyre was observed to be of unserviceable condition with remaining tread depth of approximately 0.7mm, at the time of inspection.

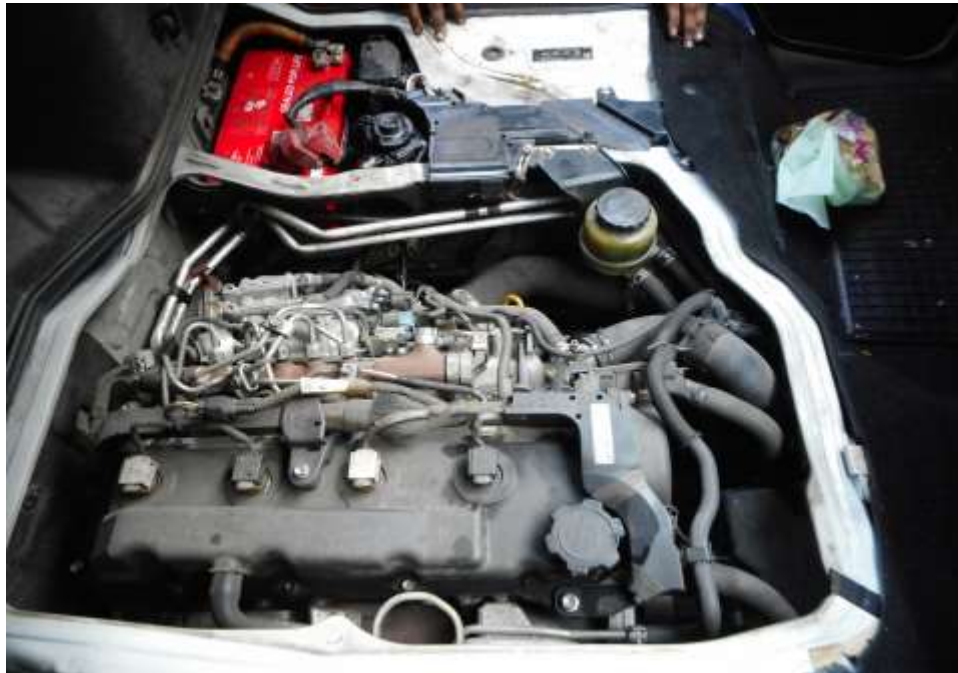
Photo 14 shows a general view of the Mini Bus's engine compartment. The various parts and components inside the engine compartment were unaffected by the accident. There was also no sign(s) or indication(s) of fluid leakage and/or fluid stain within the engine compartment.

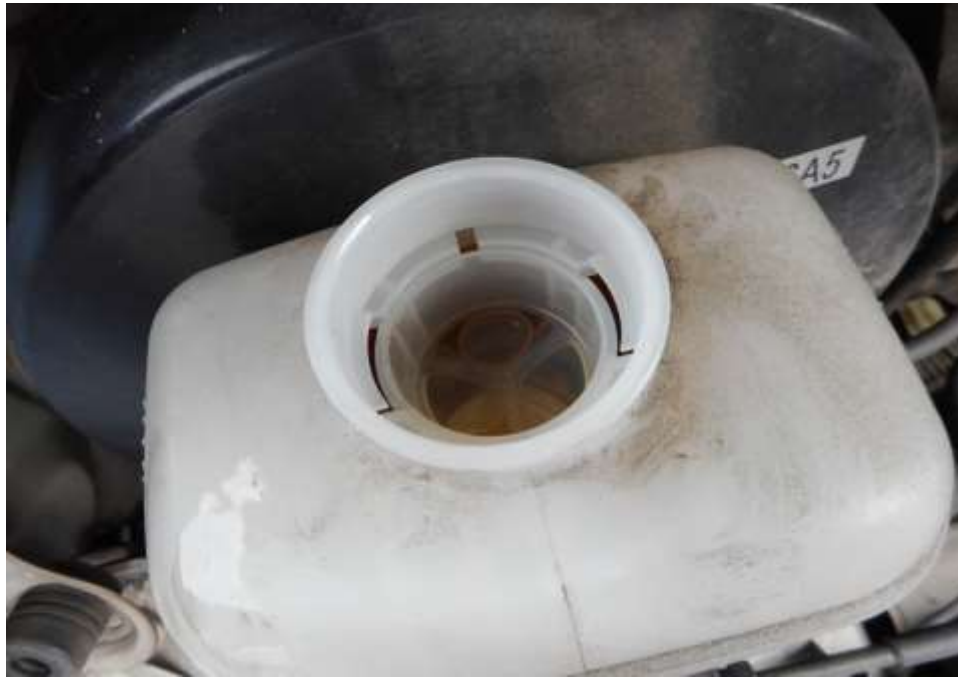
Photo 15 shows the brake fluid reservoir of the Mini Bus at the time of my inspection. The brake fluid was observed to be of sufficient level and without any visible contamination.

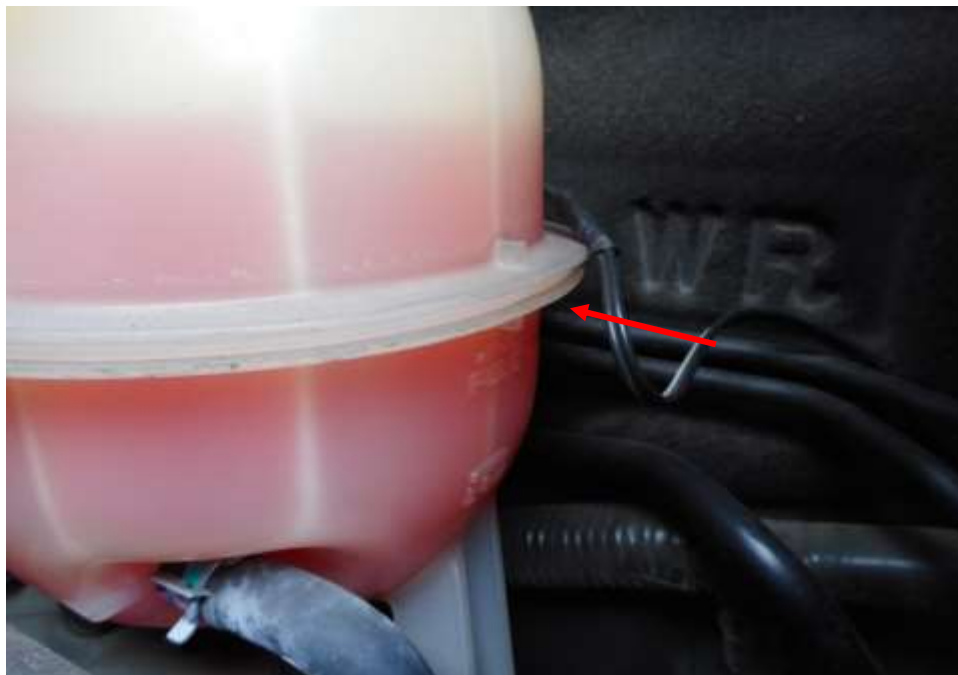
Photo 16 shows checks being carried out to the engine coolant of the Mini Bus at the time of my inspection. The engine coolant was observed to be of sufficient level (arrowed) and without any visible contamination.

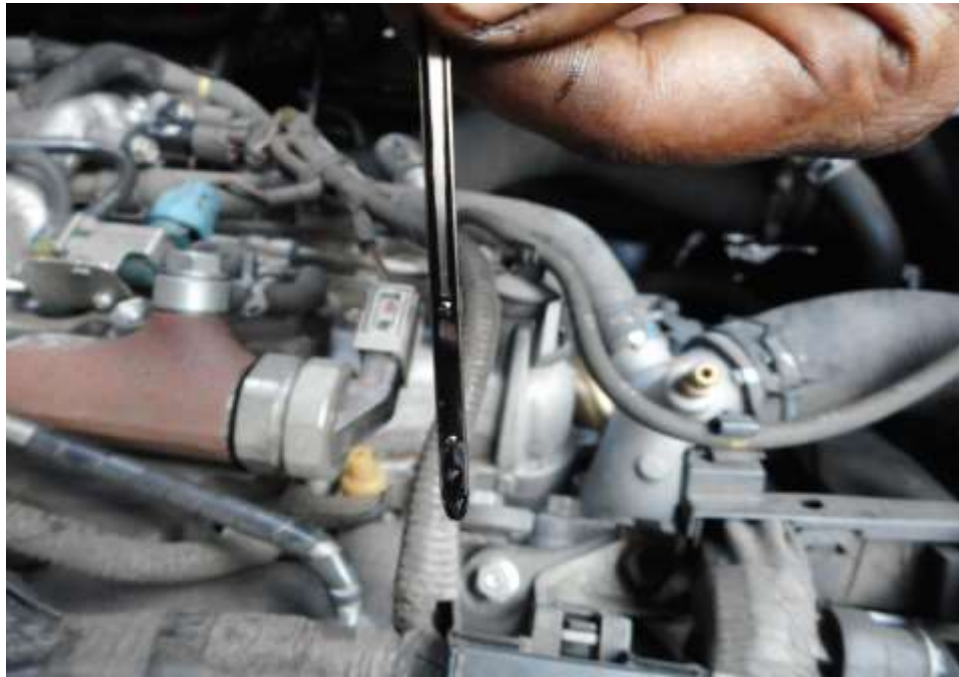
Photo 17 shows the engine oil dip stick of the Mini Bus at the time of my inspection. The engine oil was observed to be of sufficient level and without any visible contamination.

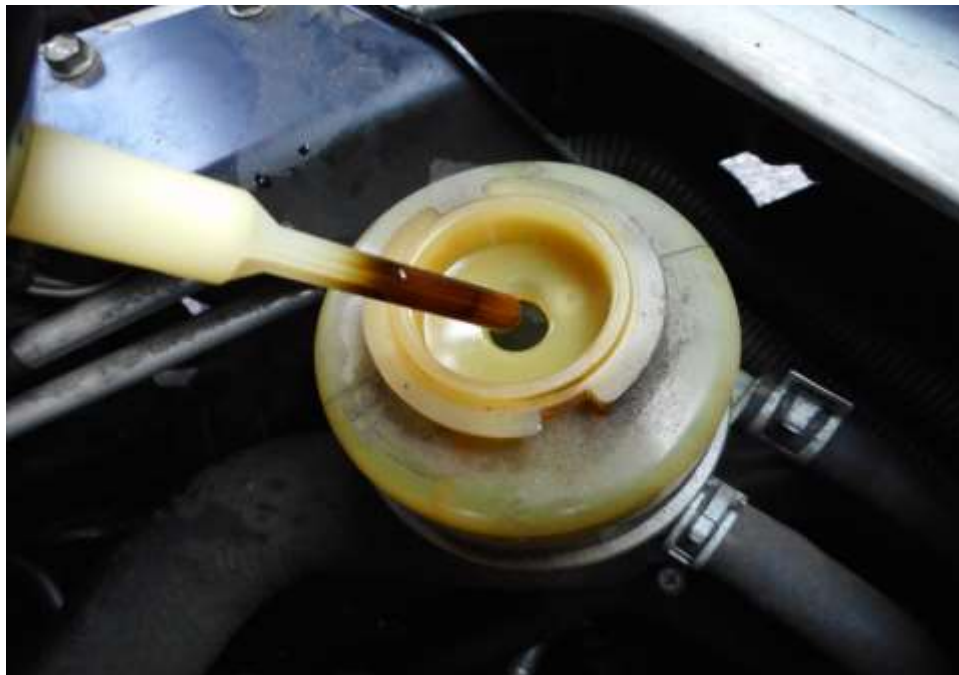
Photo 18 shows the power steering dip stick of the Mini Bus at the time of my inspection. The power steering fluid was observed to be of sufficient level and without any visible contamination.

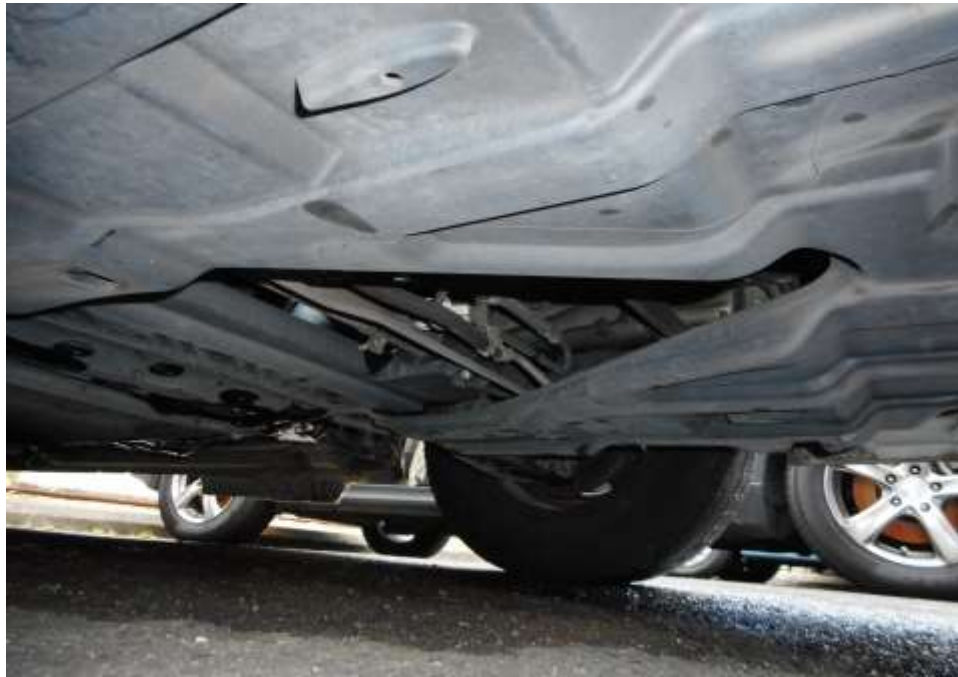
Photo 19 shows the undercarriage of the Mini Bus, at the area where the engine housing and transmission housing are located. I did not find any sign(s) or indication(s) of fluid leak and/or fluid stain(s) on the underside of the Mini Bus.

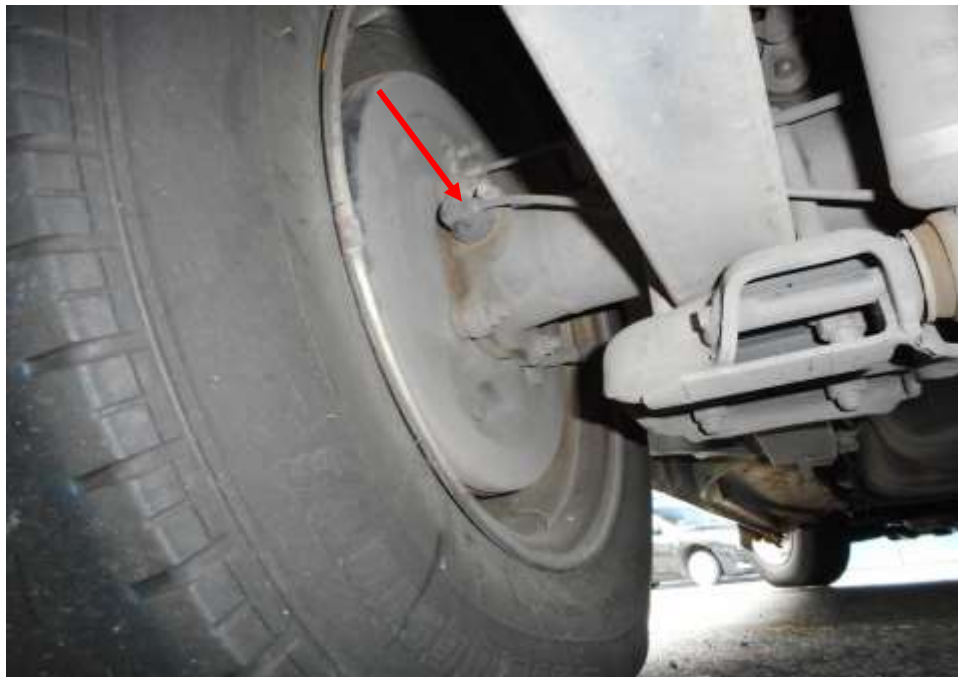
Photo 20 shows the brake hose/pipe (arrowed) at the rear left wheel of the Mini Bus. I did not observe any leakage of brake fluid at the time of my inspection of the Mini Bus. Static tests of the Mini Bus's braking system had indicated that there was no internal leakage of pressure/vacuum. The undercarriage components of the Mini Bus were also all found to be intact and without any visible damage.

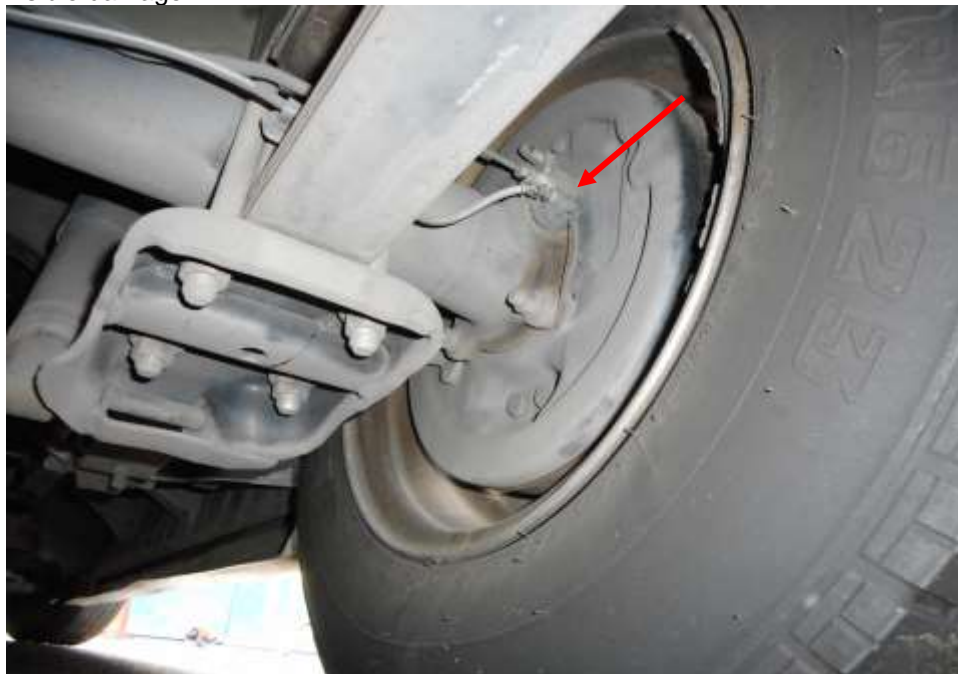
Photo 21 shows the brake hose/pipe (arrowed) at the rear right wheel of the Mini Bus. I did not observe any leakage of brake fluid at the time of my inspection of the Mini Bus. Static tests of the Mini Bus's braking system had indicated that there was no internal leakage of pressure/vacuum. The undercarriage components of the Mini Bus were also all found to be intact and without any visible damage.

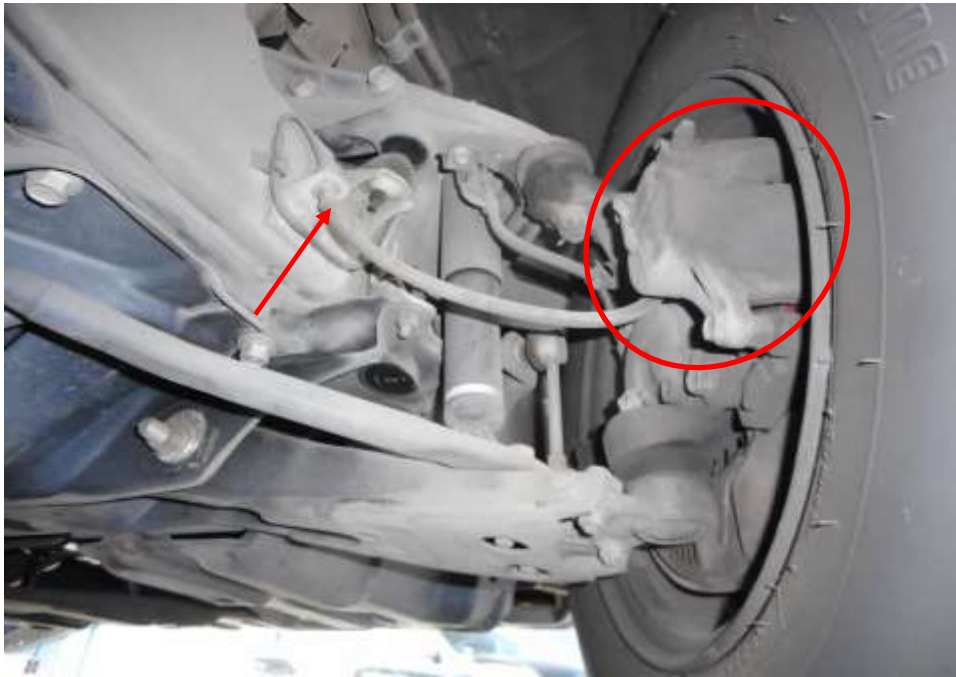
Photo 22 shows the brake hose/pipe (arrowed) at the front right wheel of the Mini Bus. No leakage of brake fluid was observed. Visual examination of the various components of the braking system like the brake caliper (circled), brake booster, brake pedal etc had revealed all to be intact and without visible damage.

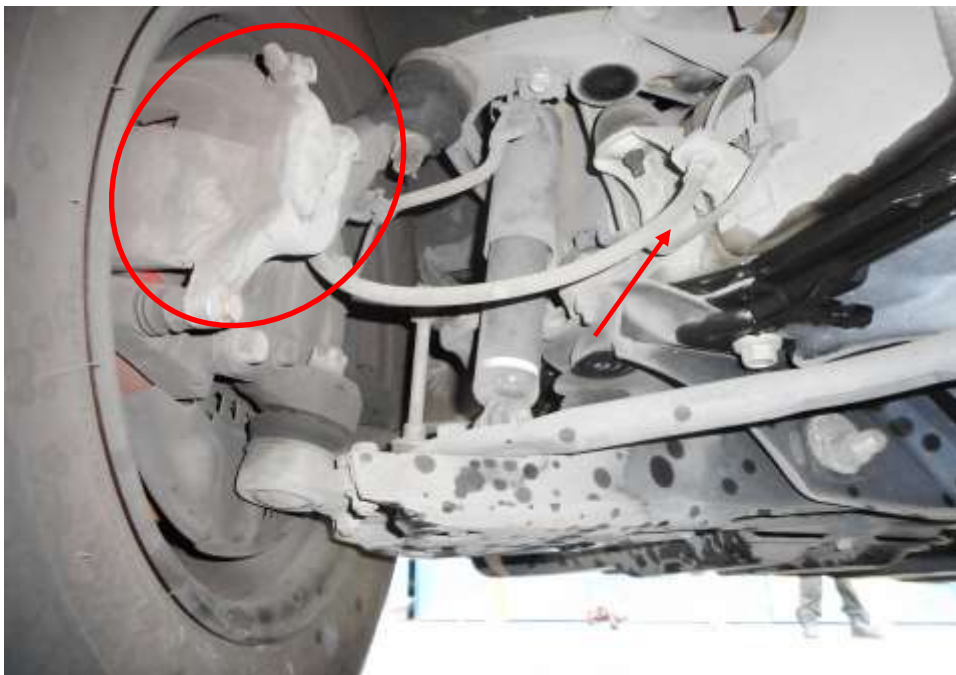
Photo 23 shows the brake hose/pipe (arrowed) at the front left wheel of the Mini Bus. No leakage of brake fluid was observed. Visual examination of the various components of the braking system like the brake caliper (circled), brake booster, brake pedal etc had revealed all to be intact and without visible damage.

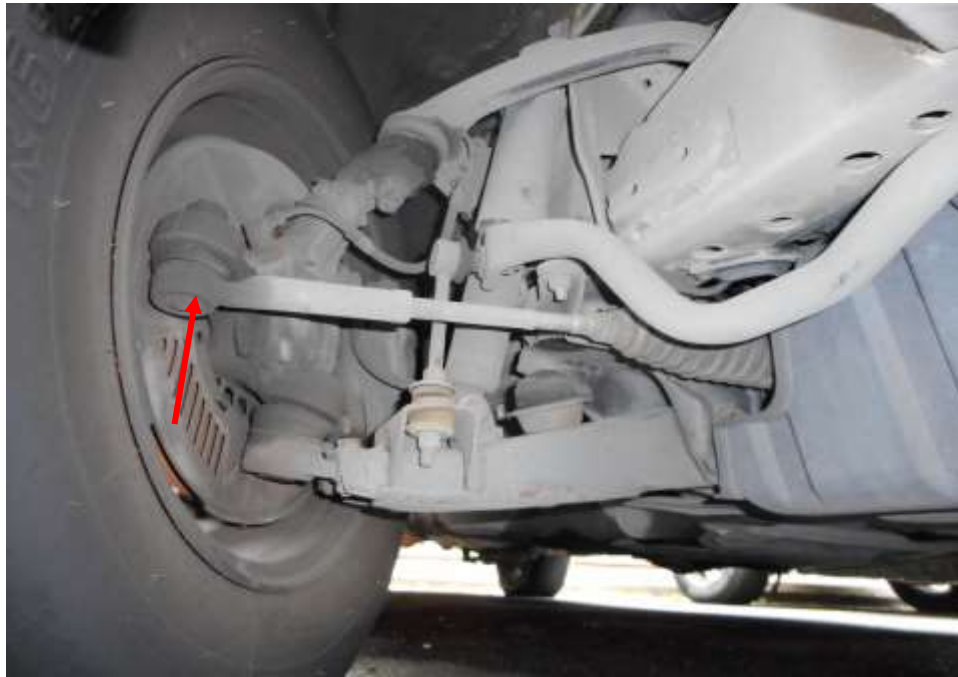
Photo 24 shows the various undercarriage components at the front right wheel of the Mini Bus, in particular the steering tie rod (arrowed). The various steering components were all found to be intact, suggesting that the steering system of the Mini Bus was likely to be in serviceable condition at the material time of accident. There was also no sign of fluid stain observed on the various undercarriage components at the front right wheel of the Mini Bus.

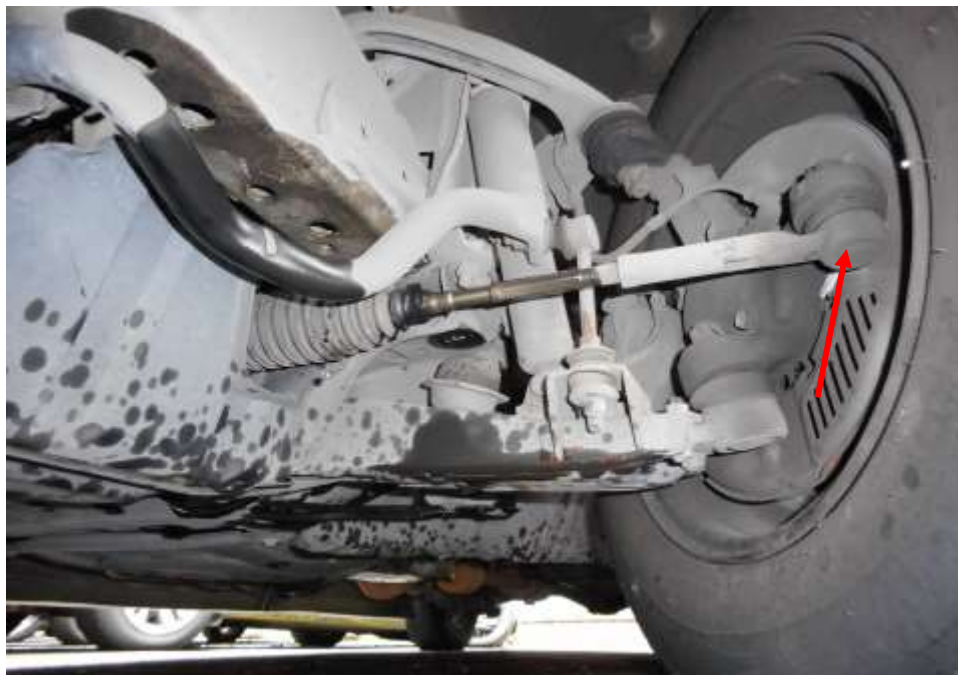
Photo 25 shows the various undercarriage components at the front left wheel of the Mini Bus, which had included the steering tie rod (red arrow) the various undercarriage components of the Mini Bus were all found to be intact without any visible damage.

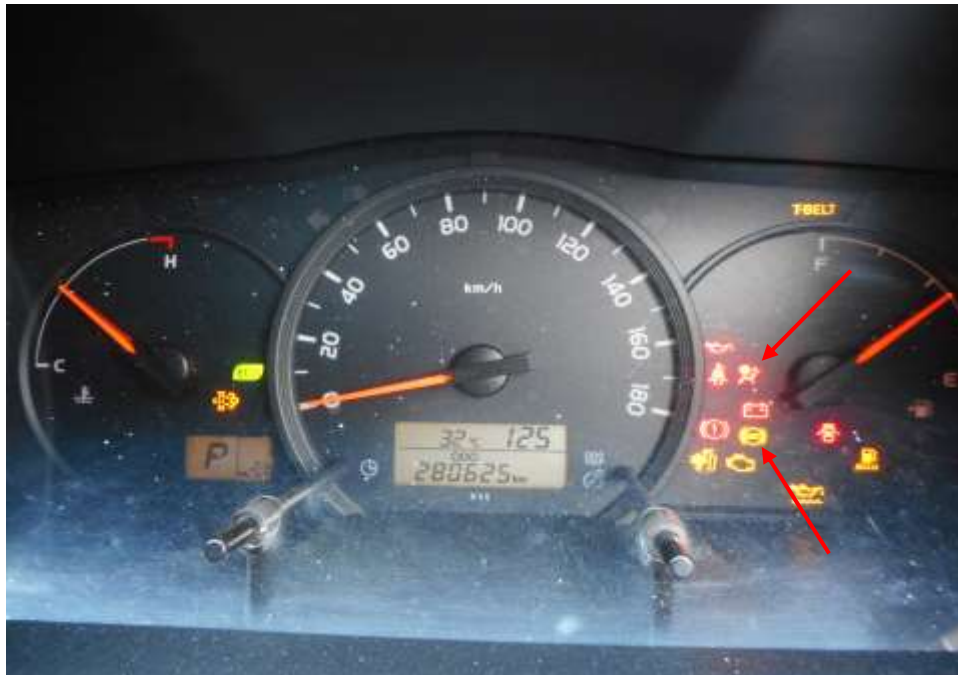
Photo 26 shows the warning light for Anti-Lock Brake System (ABS) and Supplemental Restraint System (SRS) appearing on the instrument panel of the Mini Bus during the self-test of its various electronic operating systems when its engine was cranked.

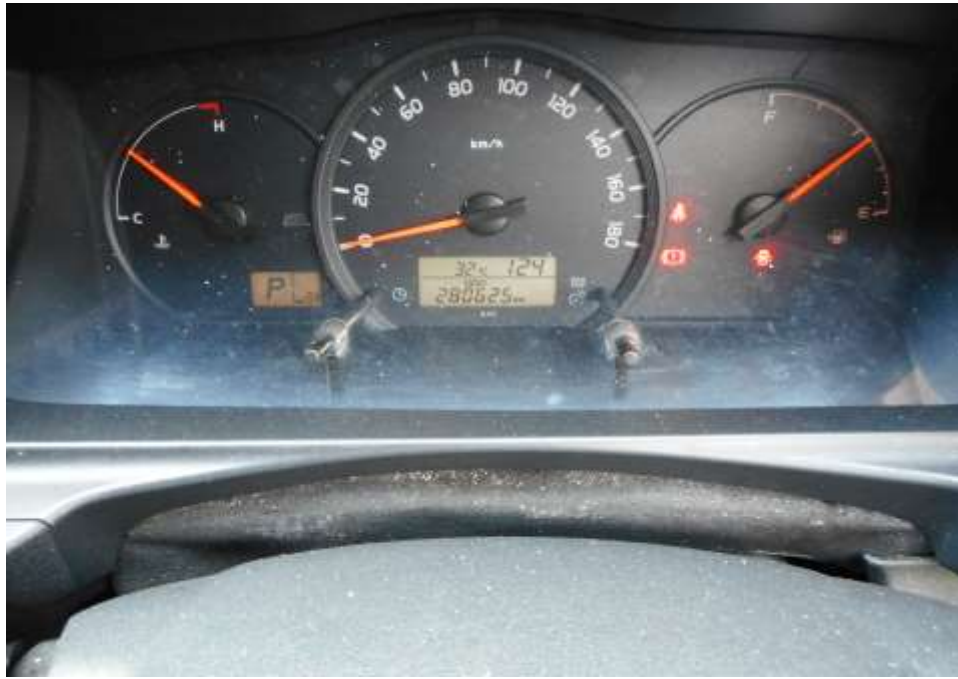
Photo 27 shows no warning lights illuminated on the instrument panel of the Mini Bus after the engine was cranked. This would suggest that there was no abnormality to the various electronic operating systems of the Mini Bus, like the ABS and SRS etc.

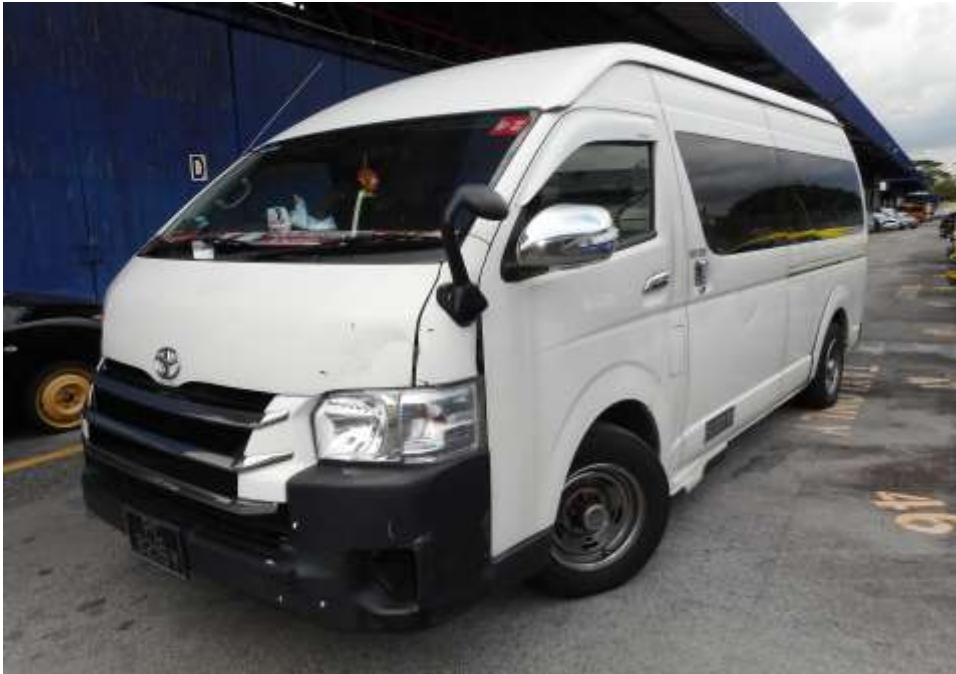
Photo 28 shows the front left wheel of the Mini Bus turned to its full right. During my steering system test, I did not experience any abnormal free play and/or resistance when I had turned the steering wheel towards the left and right. This would suggest that the steering system of the Mini Bus was likely to be in serviceable condition at the material time of accident.
