Your Ref: TP/IP/21525/2019
Our Ref : CI/TPD19008246/P

03rd June 2019

MECHANICAL INSPECTION REPORT OF MOTOR TAXI SHB 8760G

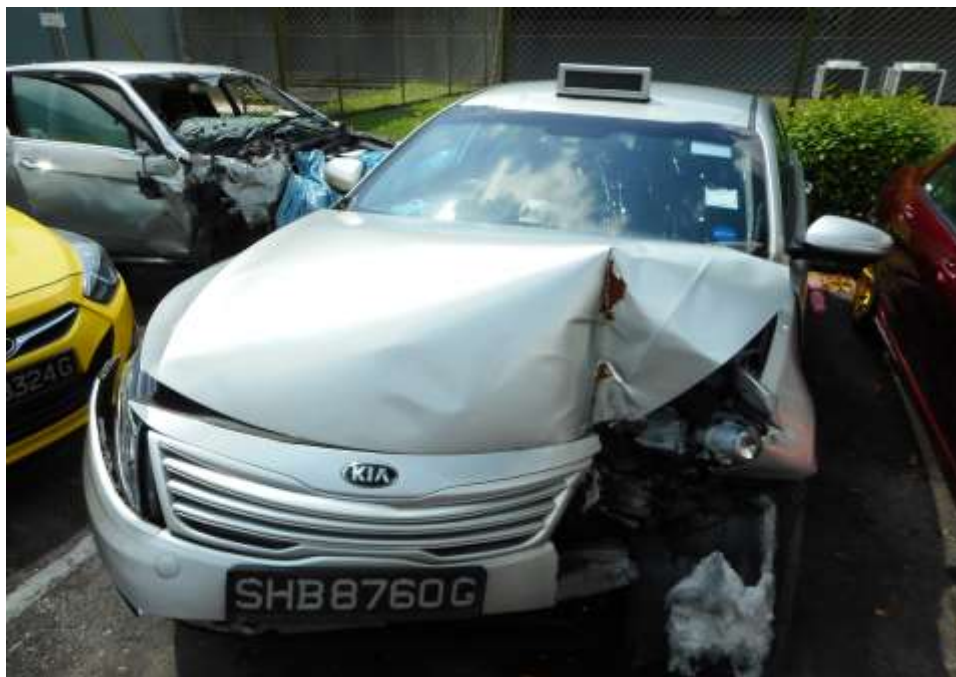
Photo 1 shows a general view of the front body of the Motor Taxi at the time of my inspection. The Motor Taxi was observed to have sustained impact damage that was confined to its frontal body. Its front windscreen, front bumper, front bonnet, front left headlamp and front left fender were amongst the body parts that were damaged as a result of the accident. The mileage of the Motor Taxi was not recorded due to the extent of damage, which had affected the ignition system of the Motor Taxi.

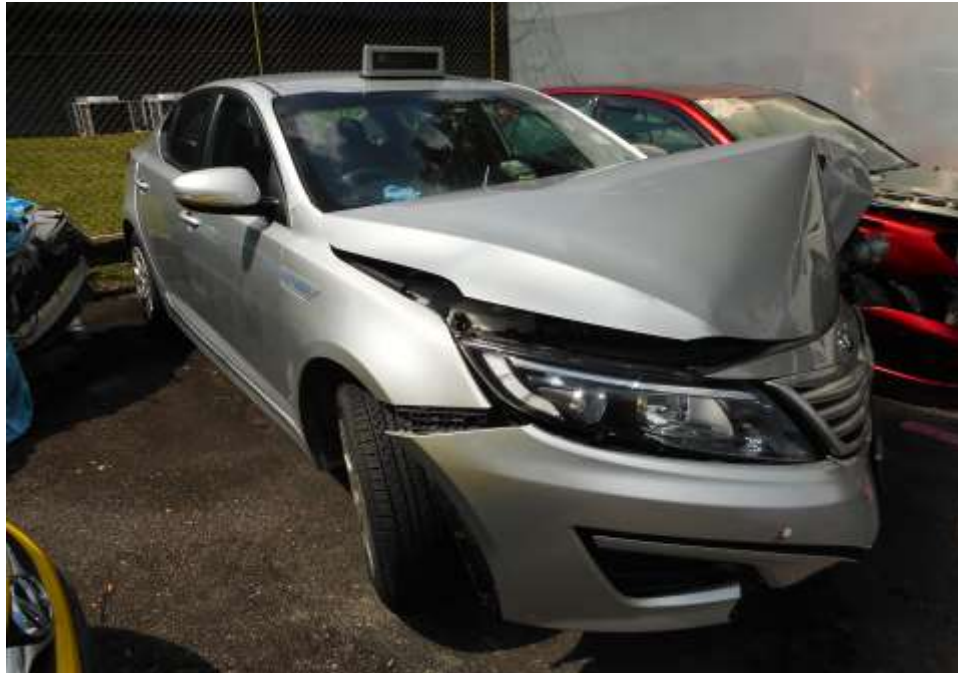
Photo 2 shows a general view of the front right body of the Motor Taxi at the time of my inspection. The Motor Taxi was observed to have sustained impact damage that was confined to its frontal body. Its front bumper and front bonnet were amongst the body parts that were damaged as a result of the accident. The mileage of the Motor Taxi was not recorded due to the extent of damage, which had affected the ignition system of the Motor Taxi.

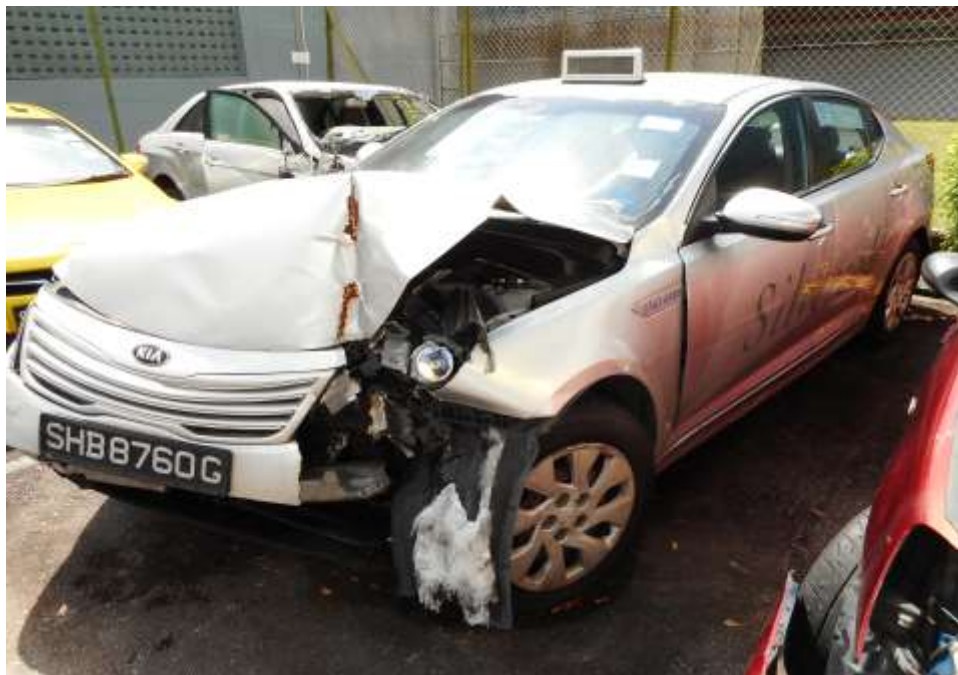
Photo 3 shows a general view of the front left body of the Motor Taxi at the time of my inspection. The Motor Taxi was observed to have sustained impact damage that was confined to its frontal body. Its front windscreen, front bumper, front bonnet, front left headlamp and front left fender were amongst the body parts that were damaged as a result of the accident

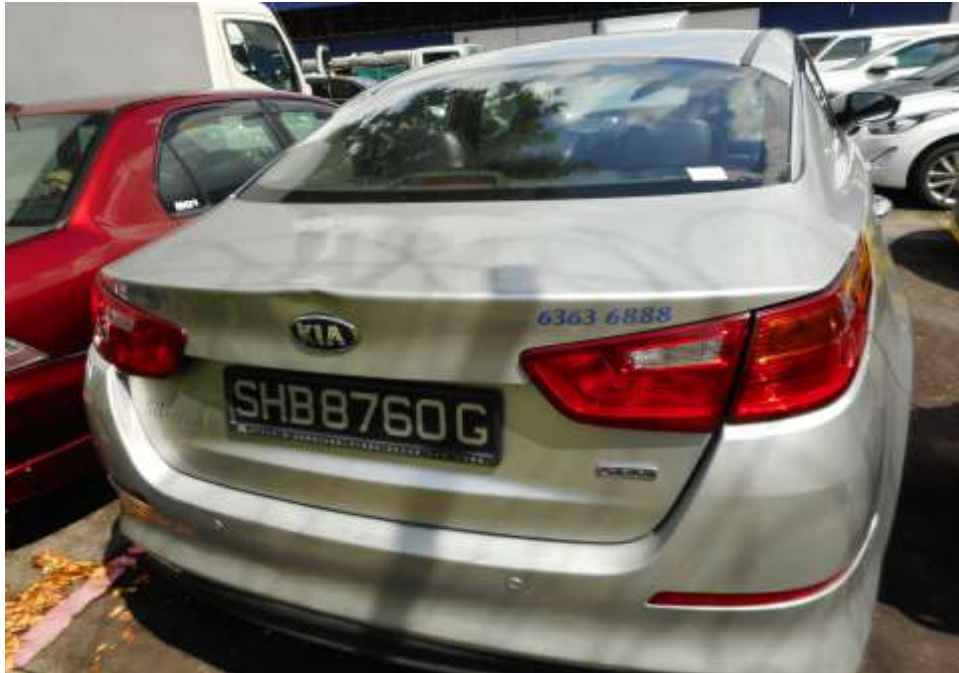
Photo 4 shows a general view of the Motor Taxi's rear right body at the time of my inspection. The rear body of the Motor Taxi was observed to be unaffected.

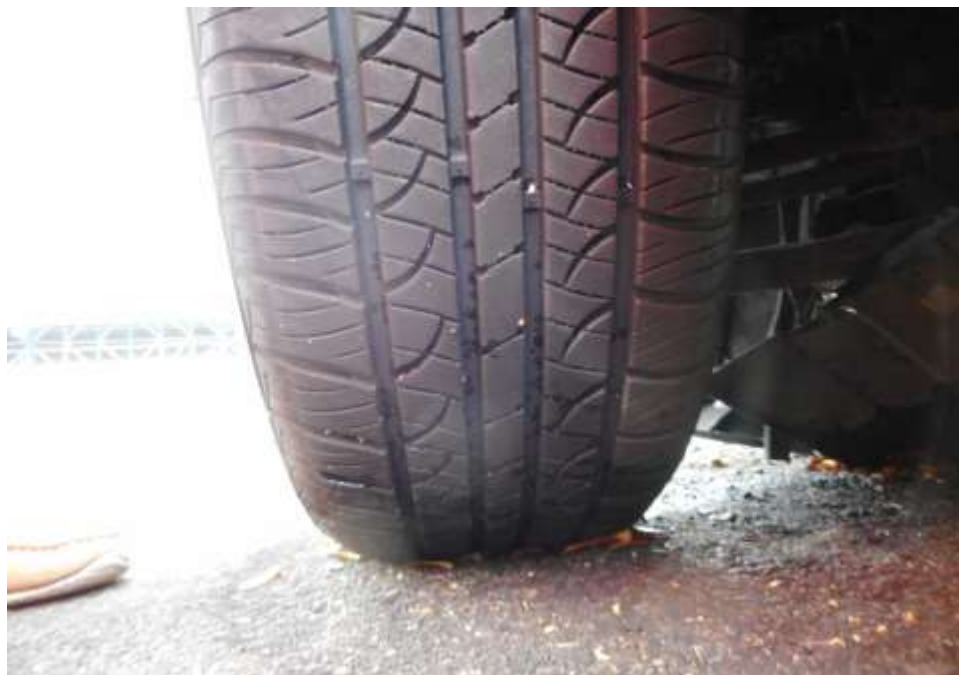
Photo 5 shows the condition of the front left tyre of the Motor Taxi, which was observed to be in serviceable condition with remaining tread depth of approximately 6.7mm. The tyre, which was wrapped around standard wheel rim, was also observed to be sufficiently inflated for vehicular operation. There was no tear, cut or burst mark(s) on the outer and the inner sidewalls as well as across the tread of the tyre.

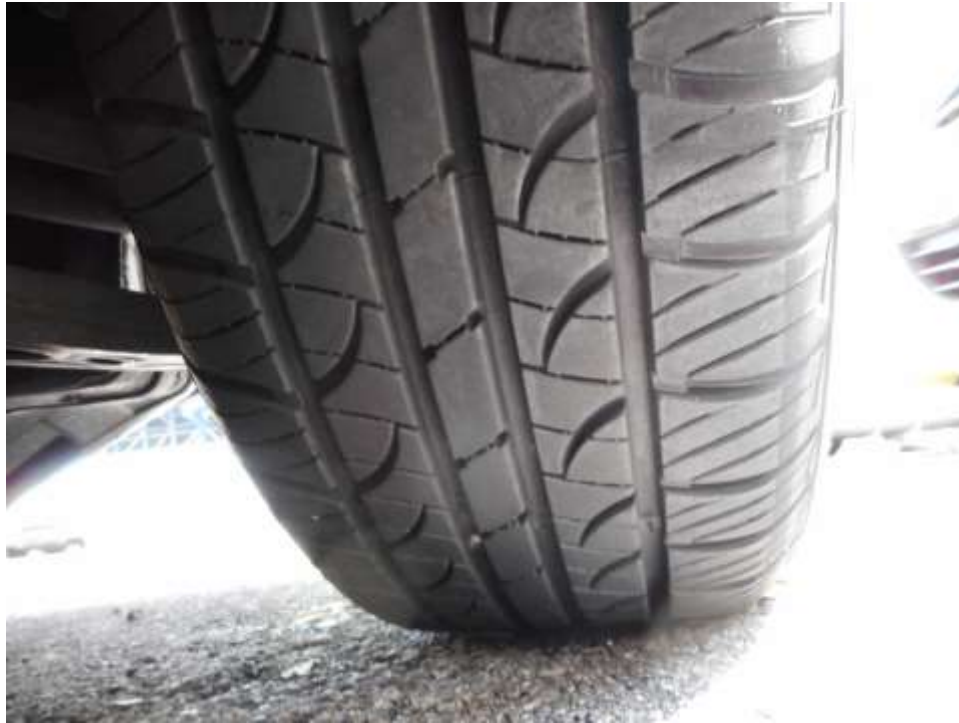
Photo 6 shows the condition of the front right tyre of the Motor Taxi, which was observed to be in serviceable condition with remaining tread depth of approximately 6.8mm. The tyre, which was wrapped around standard wheel rim, was also observed to be sufficiently inflated for vehicular operation.

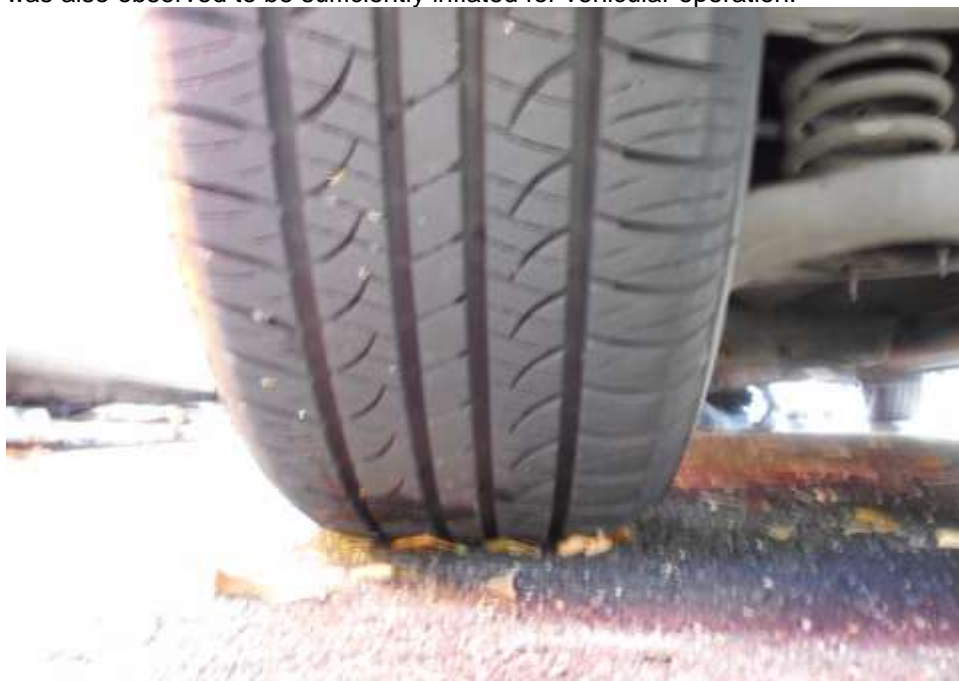
Photo 7 shows the condition of the rear left tyre of the Motor Taxi, which was observed to be in serviceable condition with remaining tread depth of approximately 6.7mm. The tyre, which was wrapped around standard wheel rim, was also observed to be sufficiently inflated for vehicular operation. The 4 tyres of the Motor Taxi were wrapped around standard wheel rims that were without any damage.

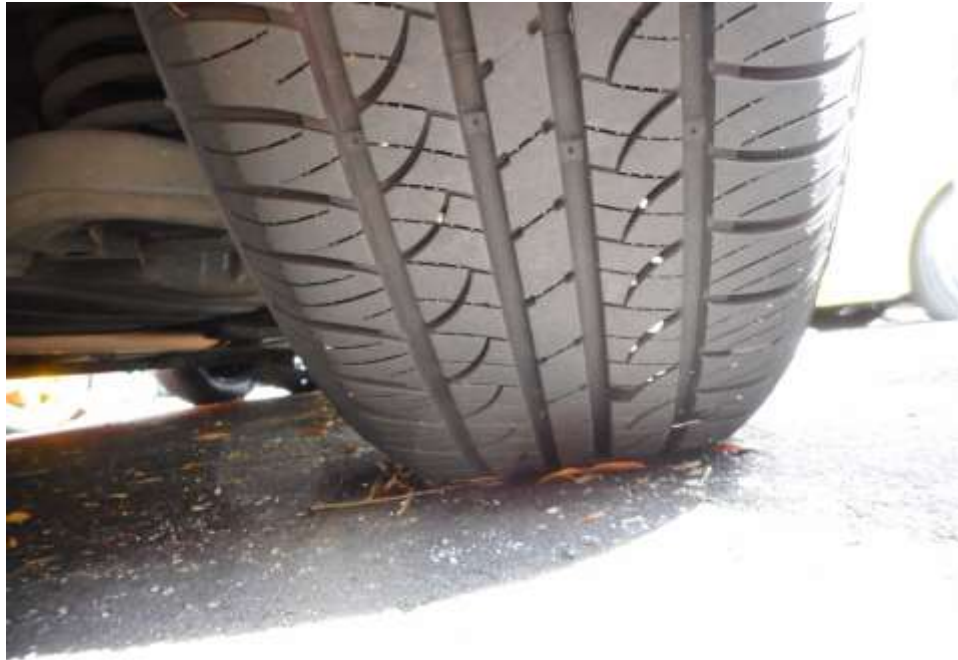
Photo 8 shows the condition of the rear right tyre of the Motor Taxi, which was observed to be in serviceable condition with remaining tread depth of approximately 7.8mm. There was no tear, cut or burst mark(s) on the outer and the inner sidewalls as well as across the tread of the tyre.

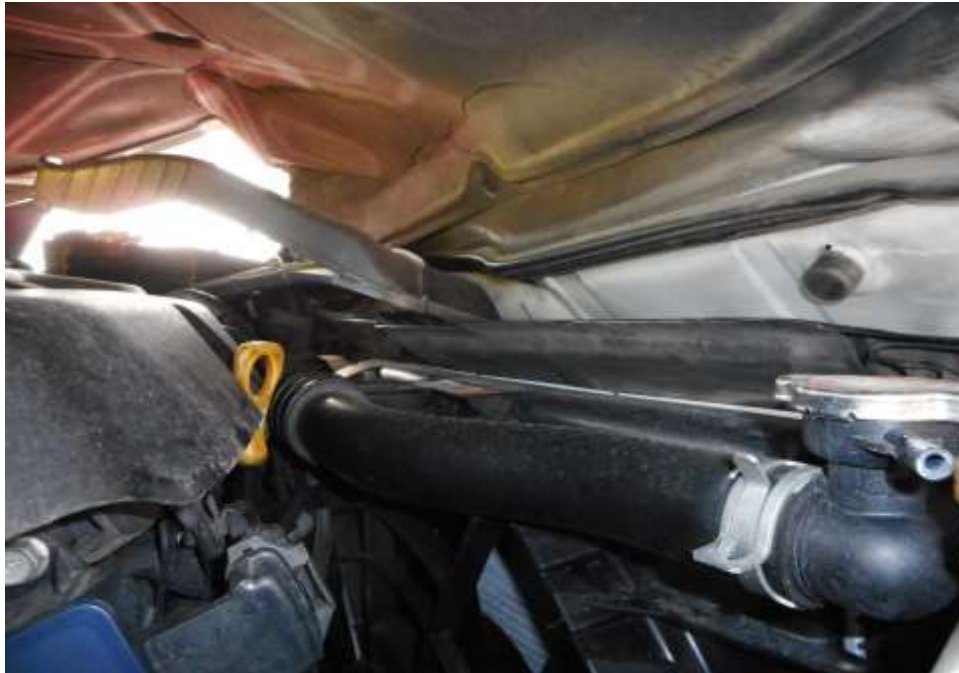
8. The impact from the collision had affected the engine compartment of the Motor Taxi. Parts towards the front of the engine compartment were observed to be damaged. The locking mechanism and the hinges of the Motor Taxi's front bonnet were also affected and I was unable to unlock and lift the front bonnet to carry out examination of the Motor Taxi's engine compartment. The various operating fluids like its engine coolant, brake fluid and transmission fluid etc were hence unable to be inspected. As a result of the accident.
9. My subsequent checks on the underside of the various steering components which had included the steering rack and pinion, tie rods, tie rod ends and ball joints revealed that these components are intact. See photo 9 & 10 below.

Photo 9 shows the close up view of the Motor Taxi's engine compartment. Parts towards the front of the engine compartment were observed to be damaged. The bonnet locking mechanism and the hinges of the Motor Taxi's front bonnet were damaged and unable to be opened as a result of the accident.

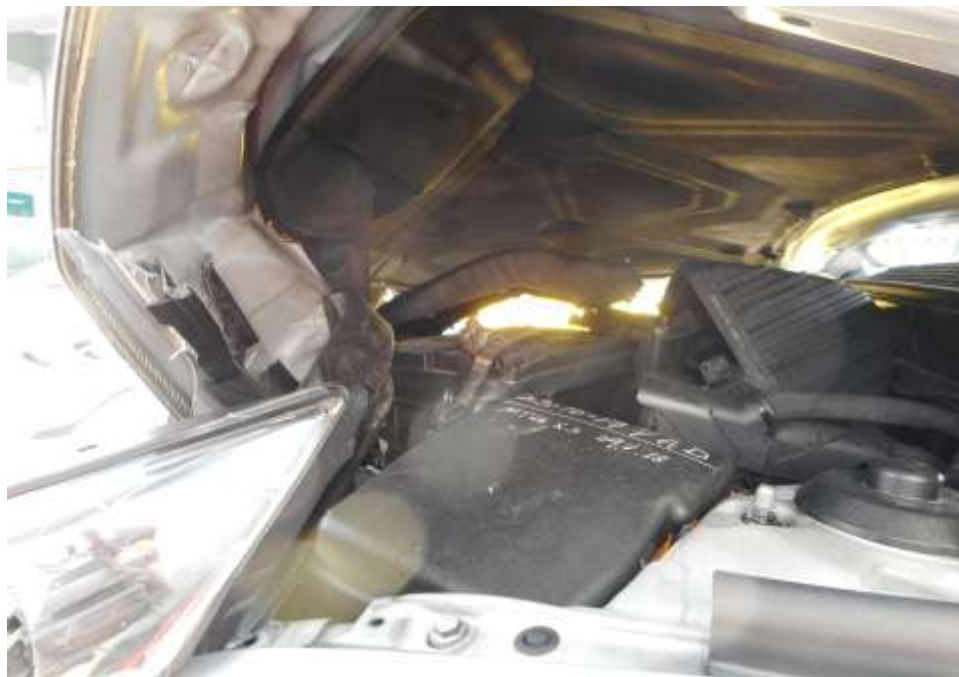
Photo 10 shows the close up view of the Motor Taxi's engine compartment. Parts that were mainly towards the front of the engine compartment were pushed inwards as a result of the impact force onto the frontal body of the Motor Taxi. The front support panel, front bumper reinforcement, cooling fan, air condenser, radiator and battery were all observed to have been damaged.

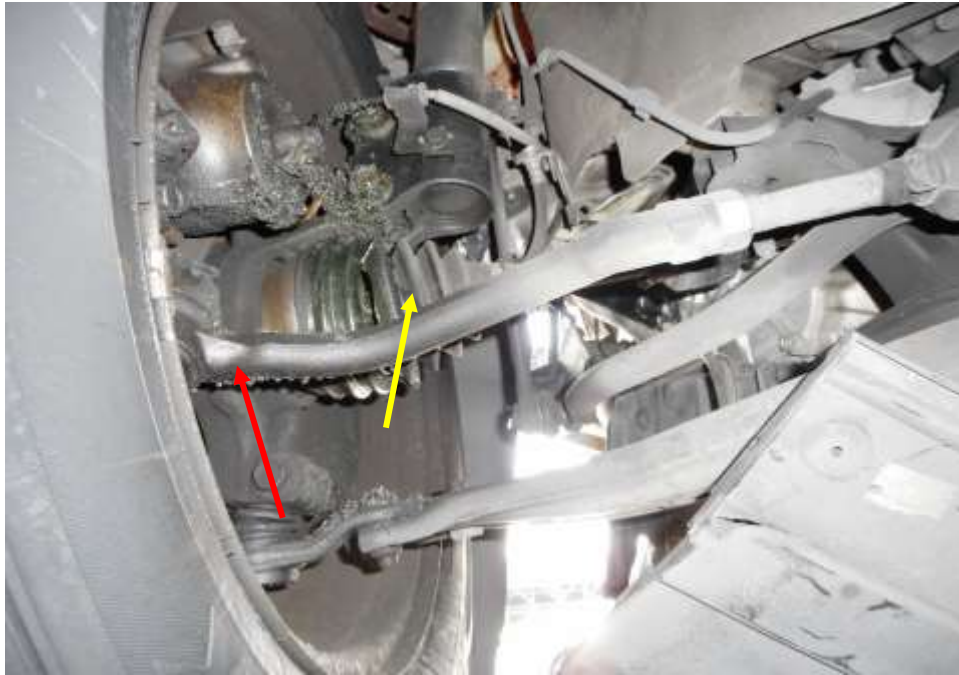
Photo 11 shows the various undercarriage components at the front left wheel of the Motor Taxi, in particular the steering tie rod (red arrow) and front left drive shaft (yellow arrow). There was a broken rubber boot found at the outer side of the drive shaft CV joint. However the various steering components were all found to be intact

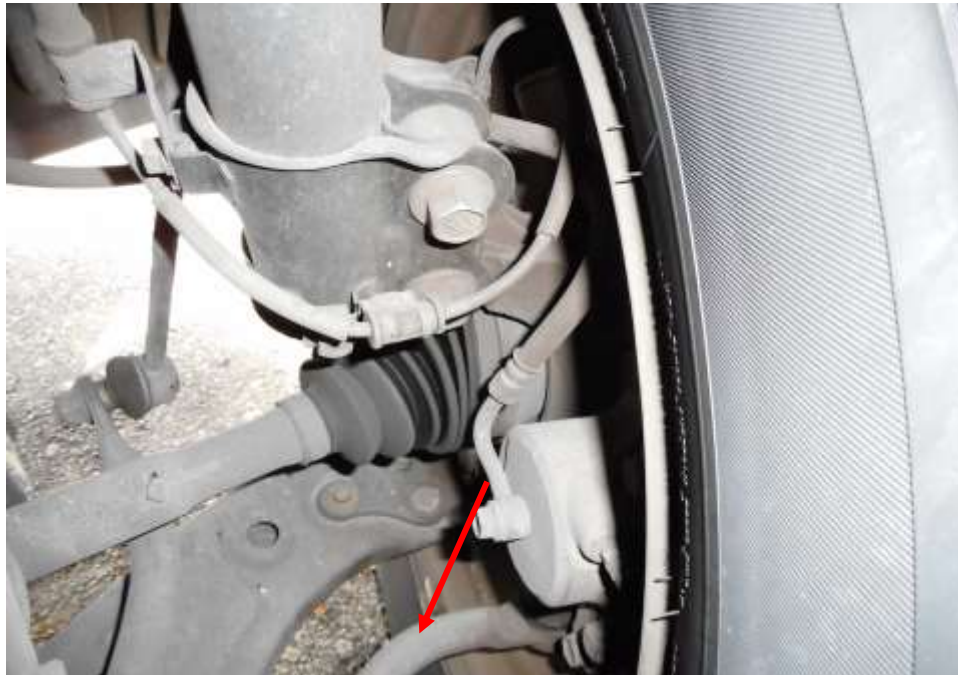
Photo 12 shows the various undercarriage components at the front right wheel of the Motor Taxi, in particular the steering tie rod (arrowed). The various steering components were all found to be intact

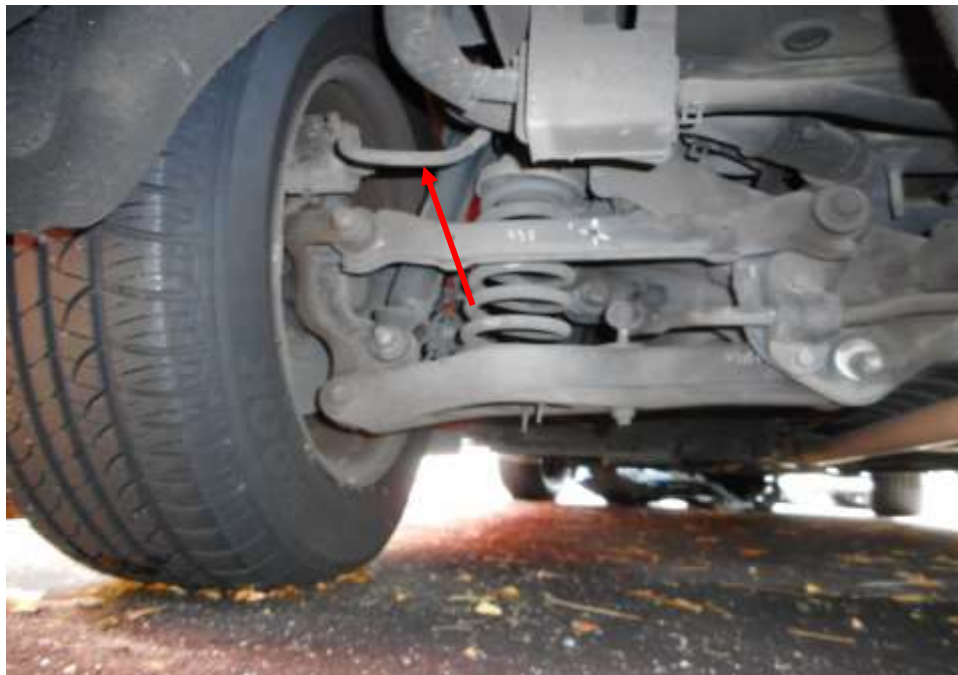
Photo 13 shows the various undercarriage components at the rear left wheel of the Motor Taxi, in particular the brake hose (arrowed). I did not observe any leakage of brake fluid at the 4 wheels of the Motor Taxi. My visual inspection of the various mechanical components of the Motor Taxi's braking system revealed all to be intact and without visible damage.

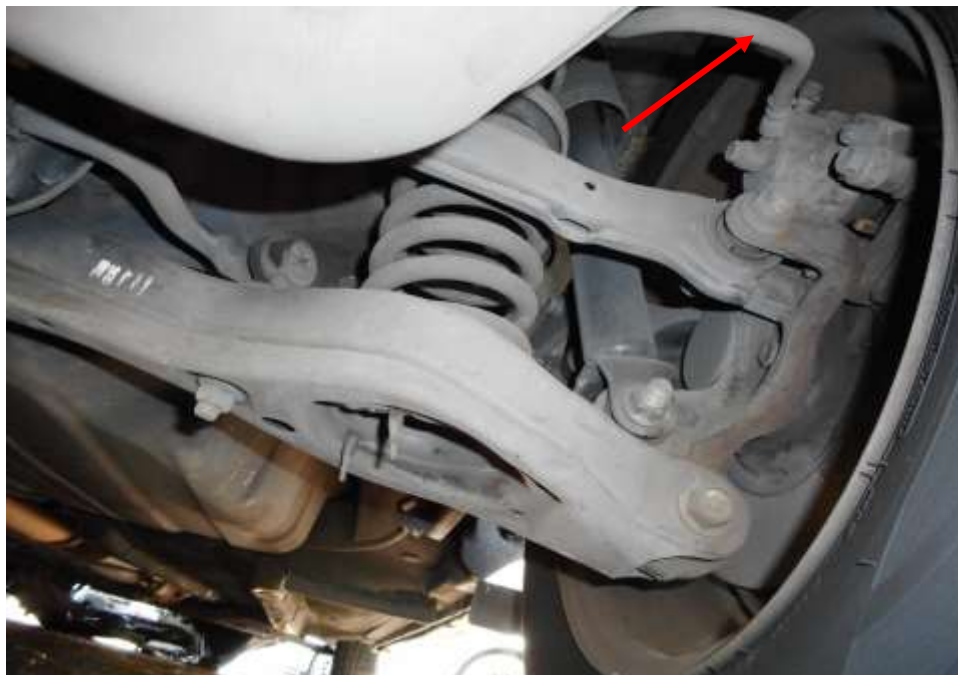
Photo 14 shows the various undercarriage components at the rear right wheel of the Motor Taxi, in particular the brake hose (arrowed). I did not observe any leakage of brake fluid at the 4 wheels of the Motor Taxi. My visual inspection of the Motor Taxi's various mechanical braking components revealed all to be intact without visible damage.

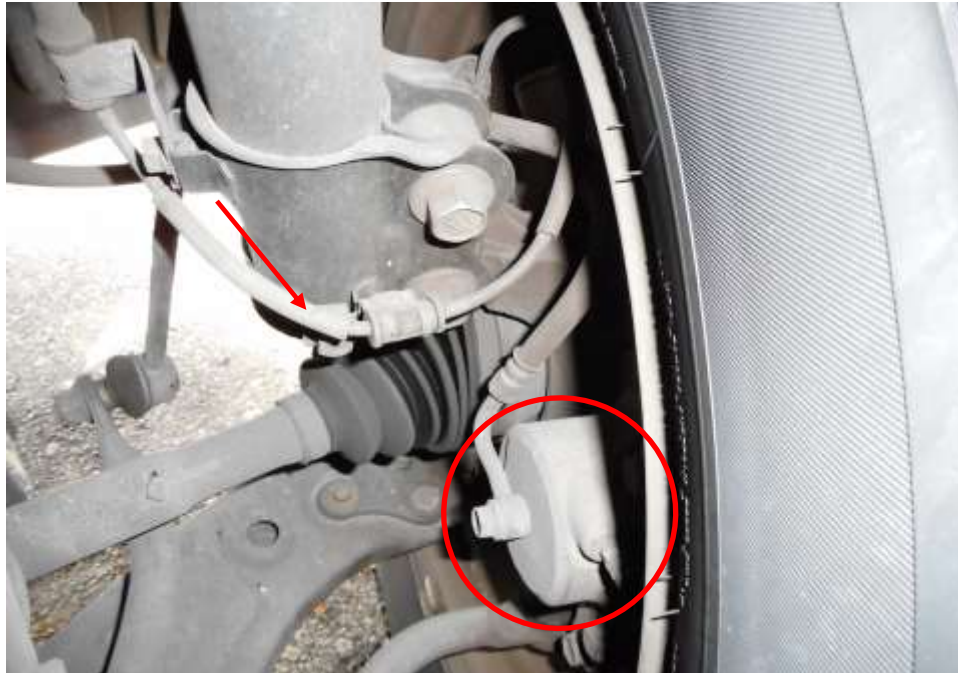
Photo 17 shows the brake hose/pipe (arrowed) at the front right wheel of the Motor Taxi. There was no brake fluid leak observed. Visual examination of the various components of the braking system like the brake caliper (circled), revealed all to be intact and without visible damage.

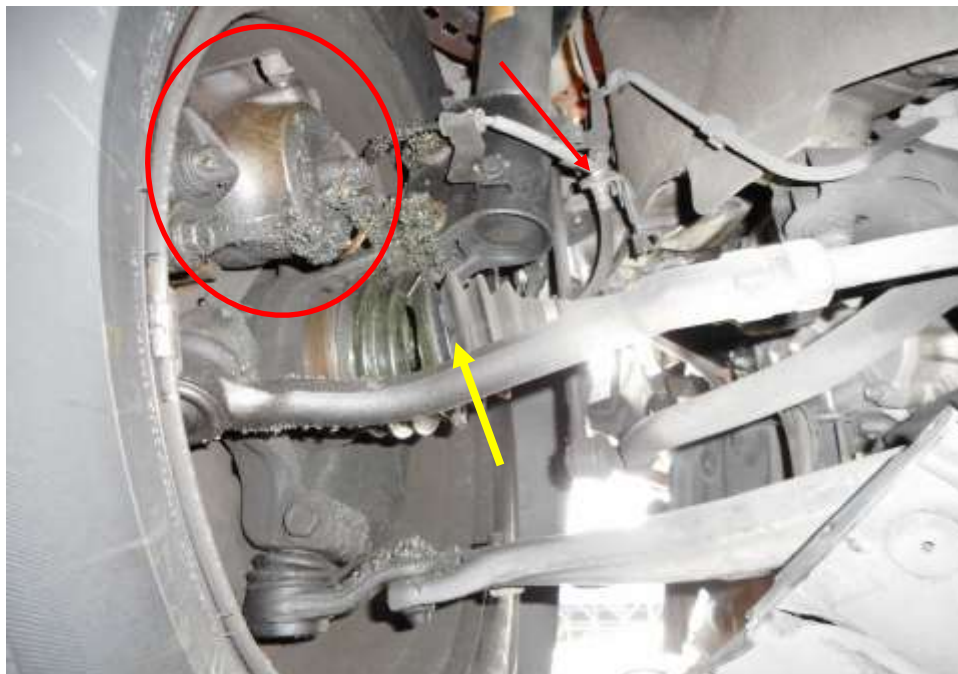
Photo 18 shows the brake hose/pipe (arrowed) at the front right wheel of the Motor Taxi. There was grease found on the brake caliper, it was caused by the broken boot of the drive shaft which splattered grease around the brake caliper (yellow arrow). However there was no brake fluid leak observed on and around the brake caliper itself. Visual examination of the various components of the braking system like the brake caliper (circled), had revealed all to be intact and without visible damage.
