Your Ref: TP/IP/22973/2019
Our Ref : CI/TPD19008249/N

Fatal Accident Investigation Team

INSPECTION REPORT OF MOTORCYCLE FBD 690M

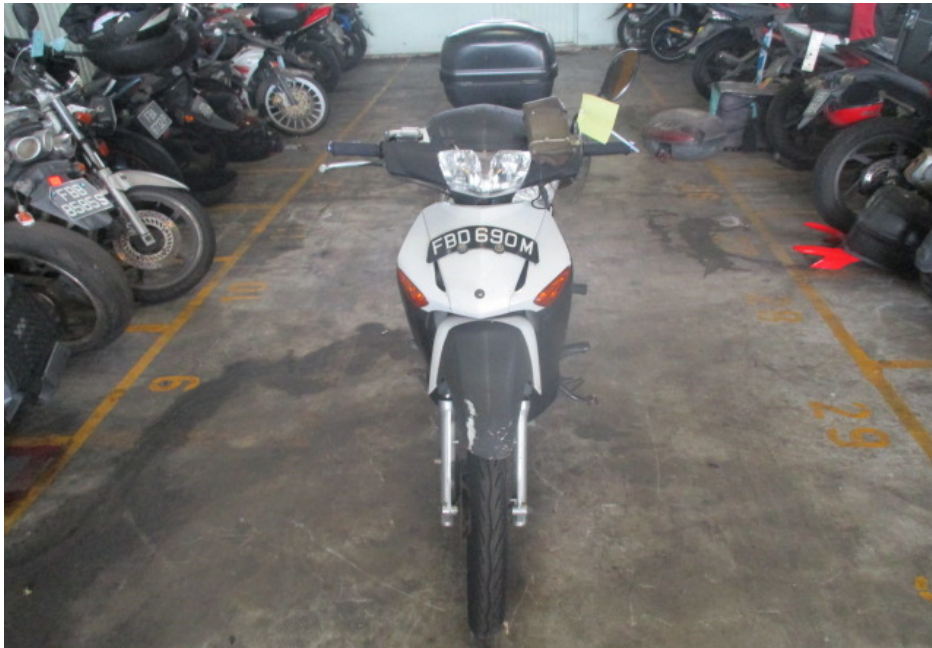
Photo 1 shows a general view of the front body of the Motorcycle at the time of our inspection. The Motorcycle was observed to have sustained damages along its front and right side. The mileage of the Motorcycle could not be recorded at the time of our inspection due to a flat battery.

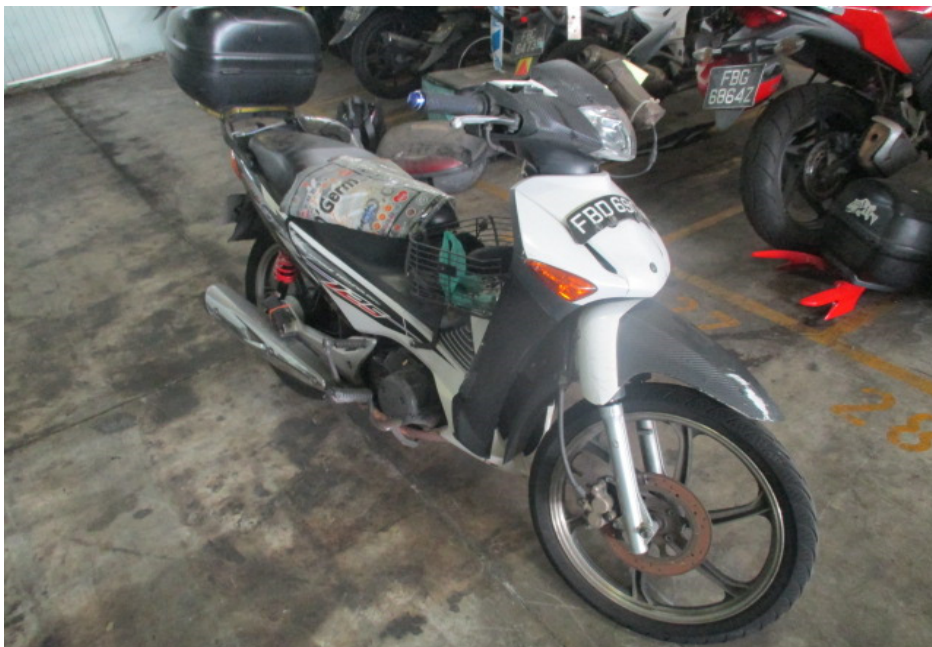
Photo 2 shows a general view of the right front body of the Motorcycle at the time of our inspection. The Motorcycle was observed to have sustained damages along its front and right side. Amongst the body parts that were found to have been damaged include its headlight assembly, front mudguard, right side mirror, front brake lever, right cowling, right front footrest, right rear side cover, exhaust muffler and top box, amongst others.

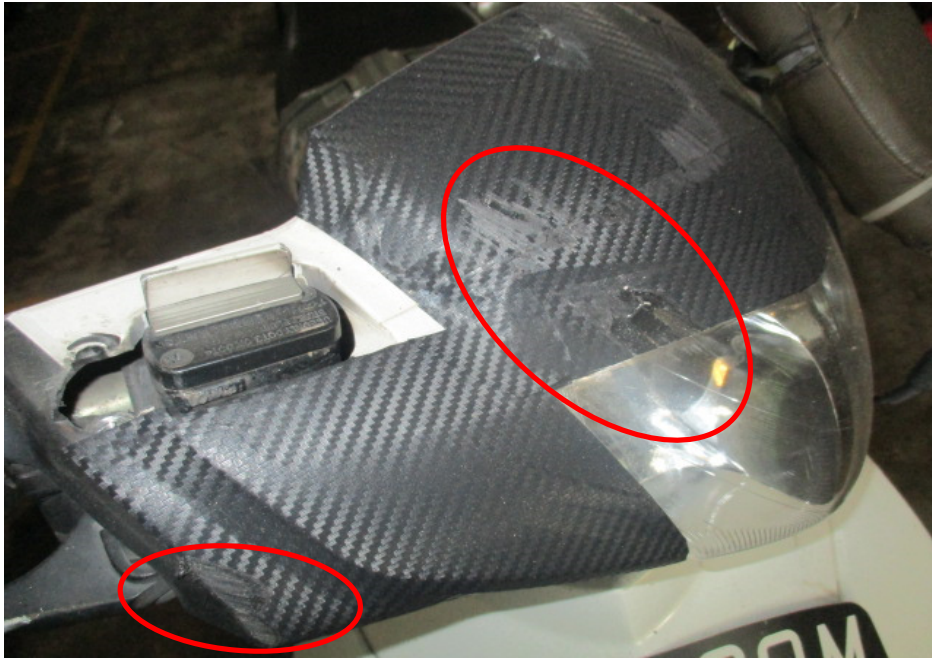
Photo 3 shows a closer view of the headlight assembly (circled) which was amongst the body parts at the front body of the Motorcycle that had sustained damage as a result of the accident.

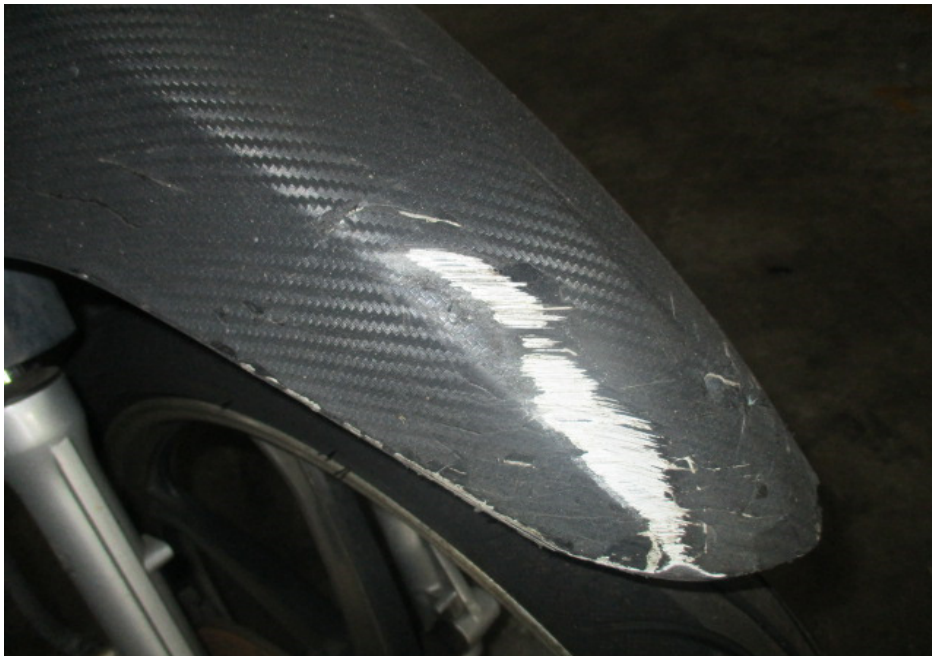
Photo 4 shows a closer view of the front mudguard which was amongst the body parts at the front body of the Motorcycle that had sustained damage as a result of the accident.

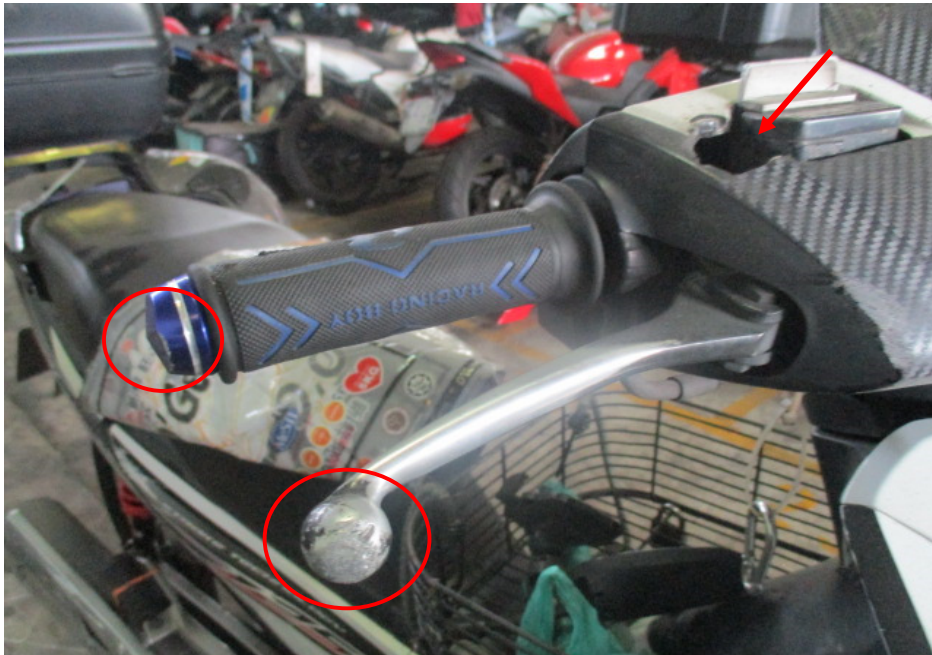
Photo 5 shows a closer view of the front brake lever and right handlebar end (circled) as well as the dislodged right side mirror (arrowed) which were amongst the body parts of the Motorcycle that had sustained damage as a result of the accident.

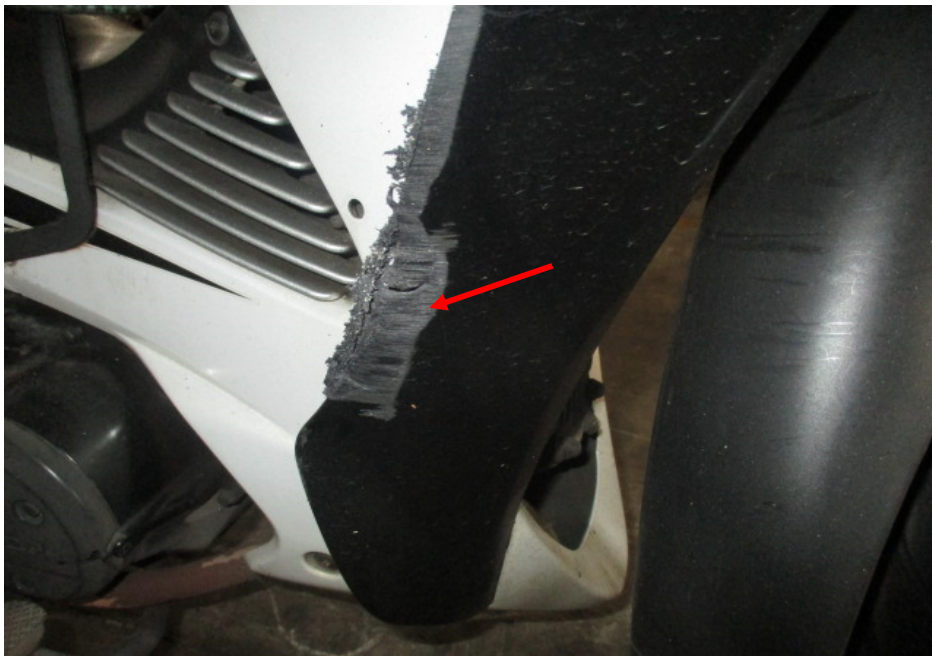
Photo 6 shows a closer view of the right cowl of the Motorcycle that had sustained damage as a result of the accident (arrowed).

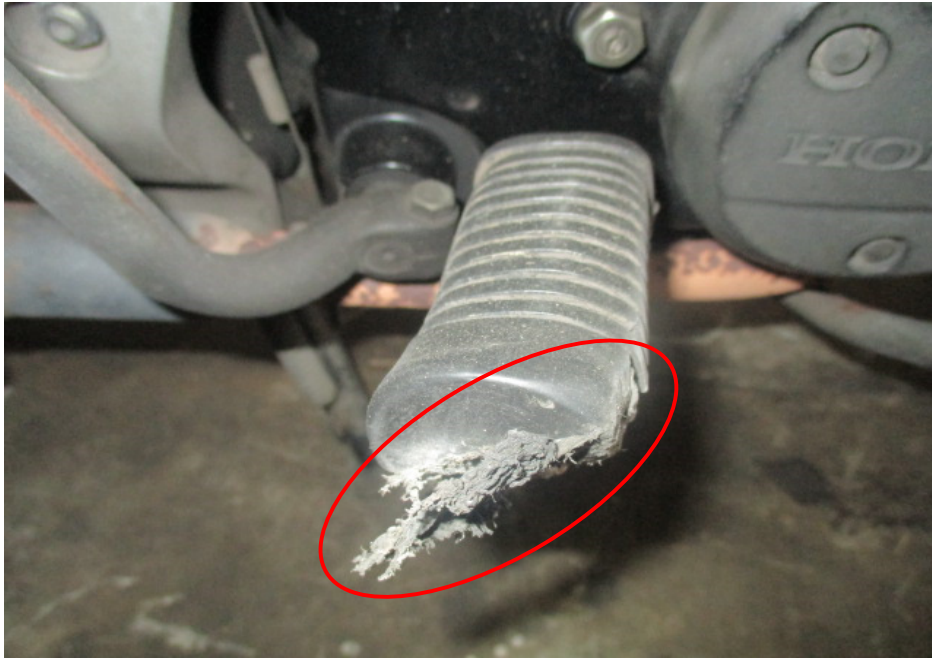
Photo 7 shows a closer view of the right front footrest (circled) which was amongst the body parts of the Motorcycle that had sustained damage as a result of the accident.

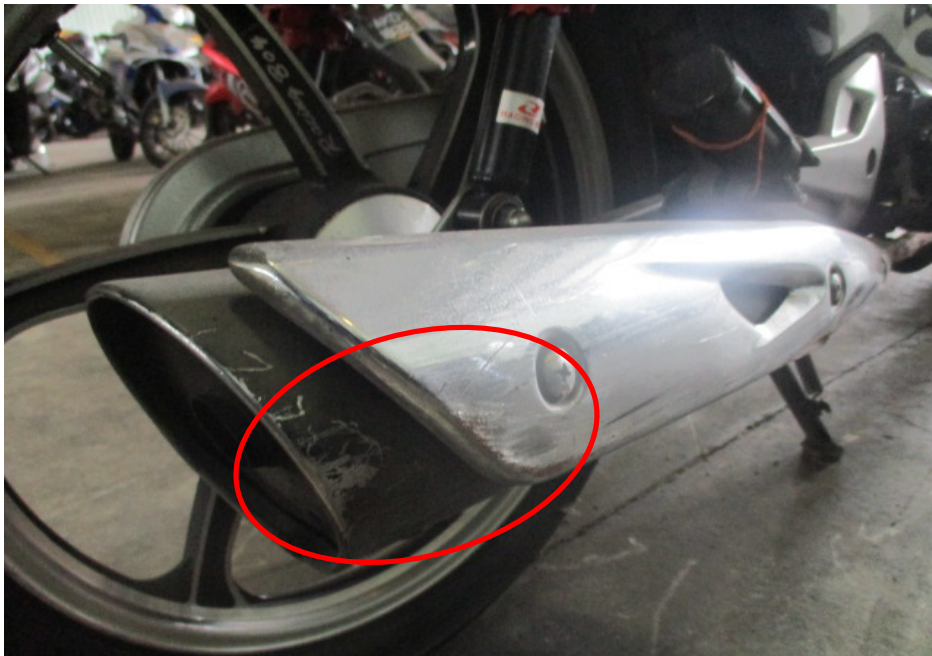
Photo 8 shows a close up view of the exhaust muffler and exhaust muffler heat shield (circled) which were amongst the body parts of the Motorcycle that had sustained damage as a result of the accident.

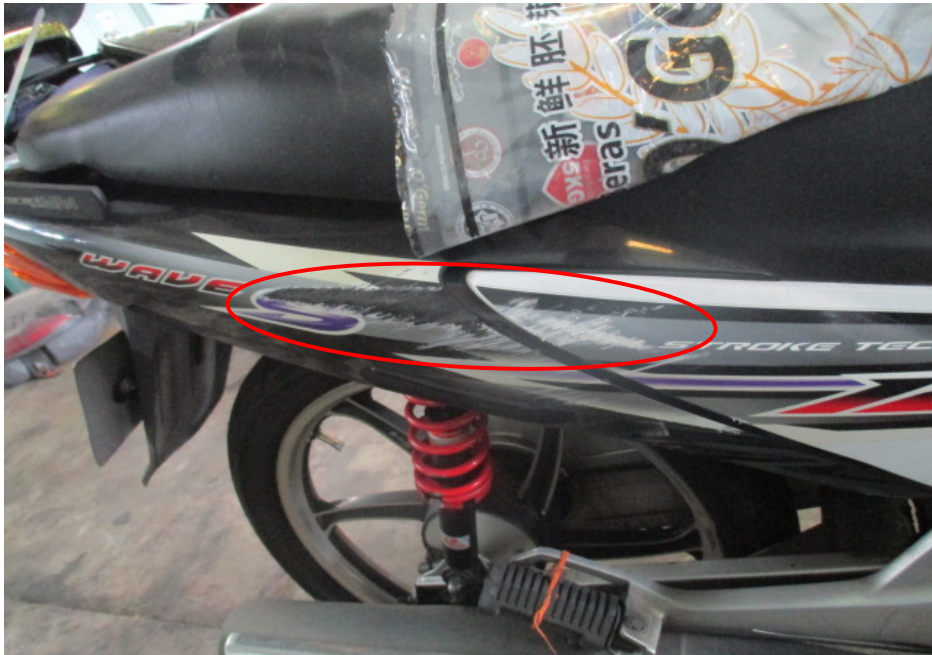
Photo 9 shows a close up view of the right rear side cover (circled) which was amongst the body parts of the Motorcycle that had sustained damage as a result of the accident.

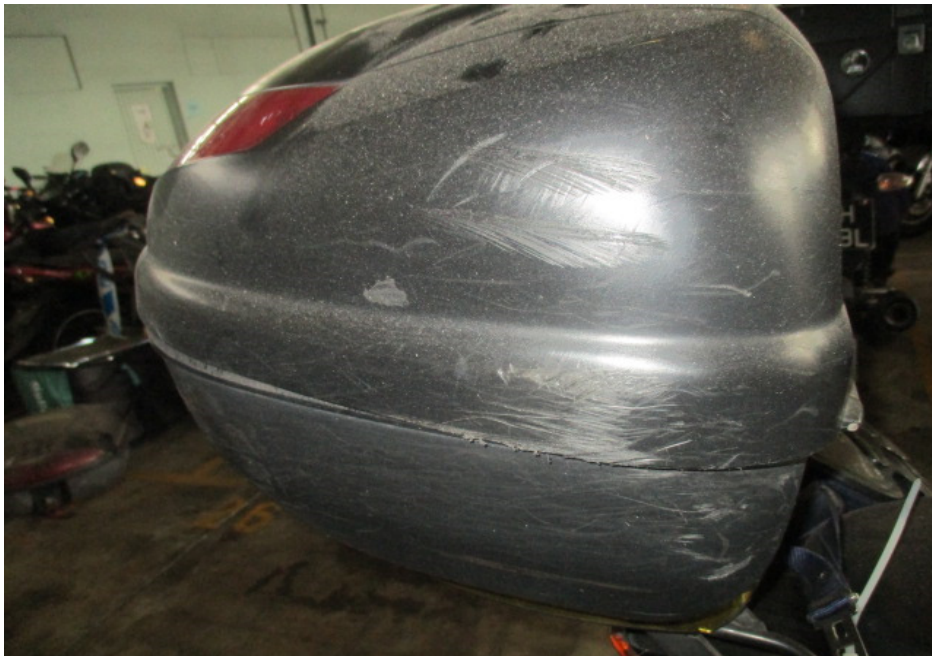
Photo 10 shows the top box of the Motorcycle which was observed to have sustained damages of grazing nature as a result of the accident.

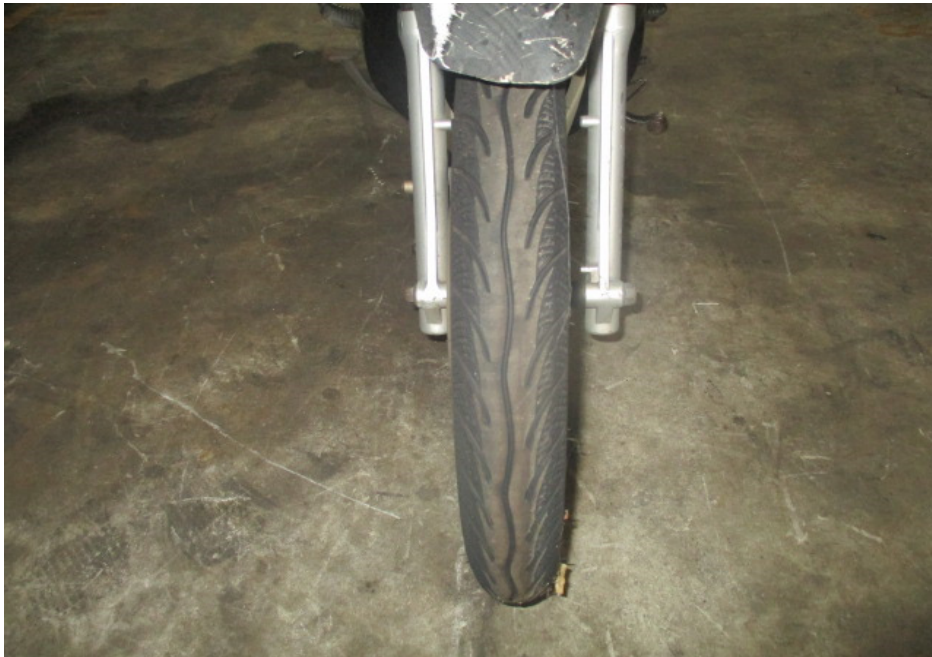
Photo 11 shows the condition of the Motorcycle's front tyre. The front tyre was observed to be in serviceable condition with remaining tread depth of approximately 3mm. There was no tear, burst mark(s) and/or punctured hole(s) on the sidewalls as well as across the tread of the front tyre.

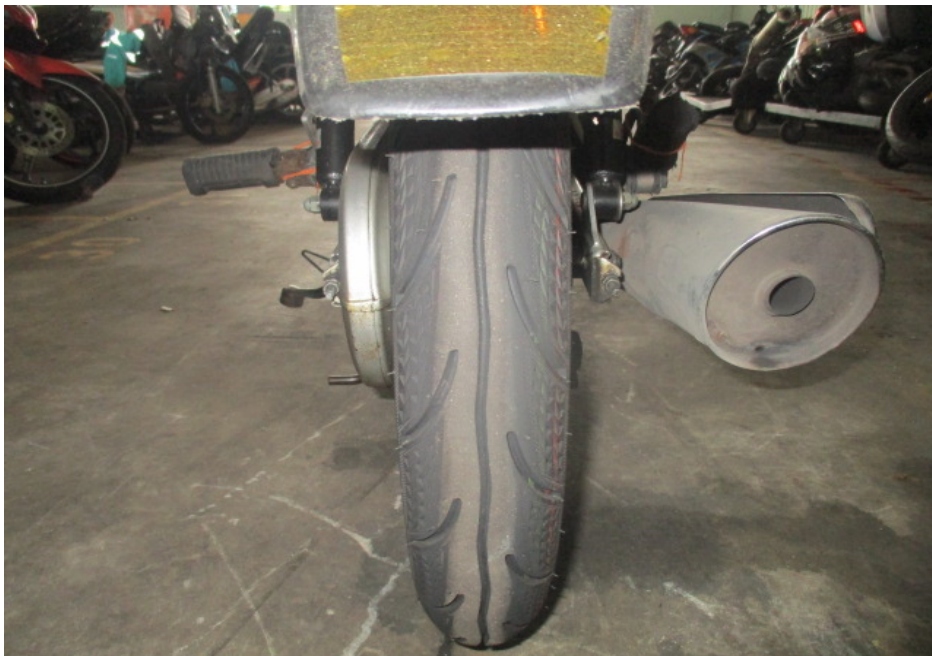
Photo 12 shows the condition of the Motorcycle's rear tyre. The rear tyre was observed to be in serviceable condition with remaining tread depth of approximately 3mm. The tyre was also observed to be sufficiently inflated for vehicular operation. We did not observe any tear, burst mark(s) and/or punctured hole(s) on the sidewalls as well as across the tread of the rear tyre.

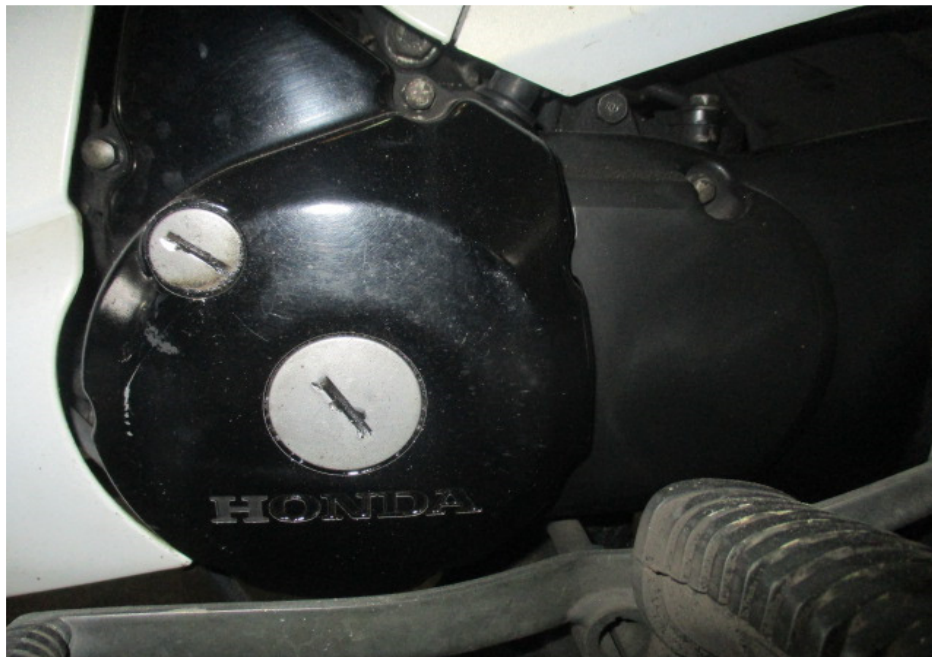
Photo 13 shows the left side of the engine of the Motorcycle at the time of our inspection. The various engine related parts and components were found to be intact with no visible damage. There was also no sign(s) or indication(s) of fluid leak observed around the left engine area of the Motorcycle.

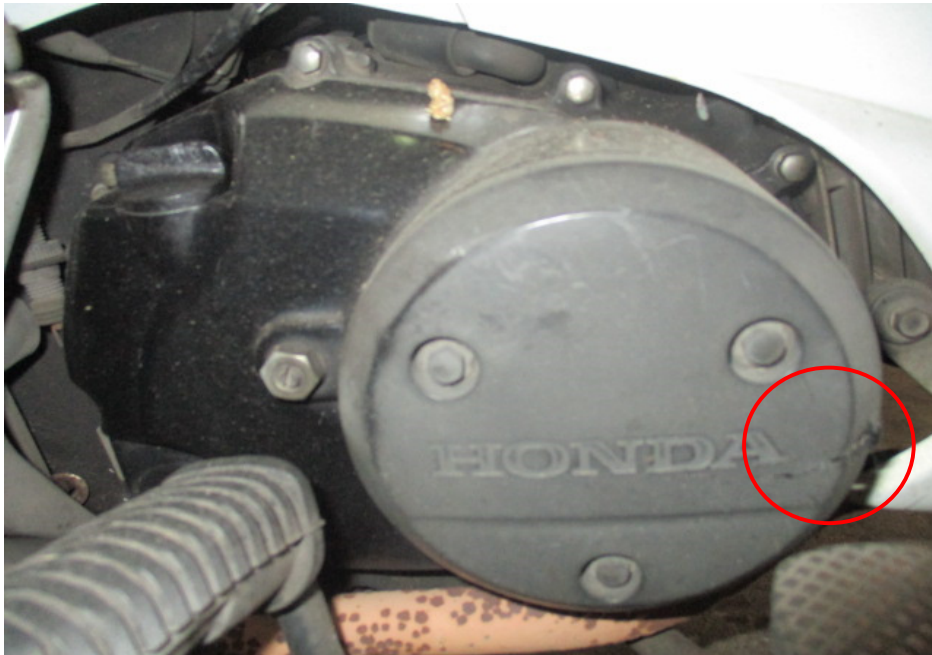
Photo 14 shows the right side of the engine of the Motorcycle at the time of our inspection. The outer engine cover had sustained a crack as a result of the accident (circled) however the engine components were still intact. There was also no fluid leak and/or fluid stain found around the right engine area of the Motorcycle.

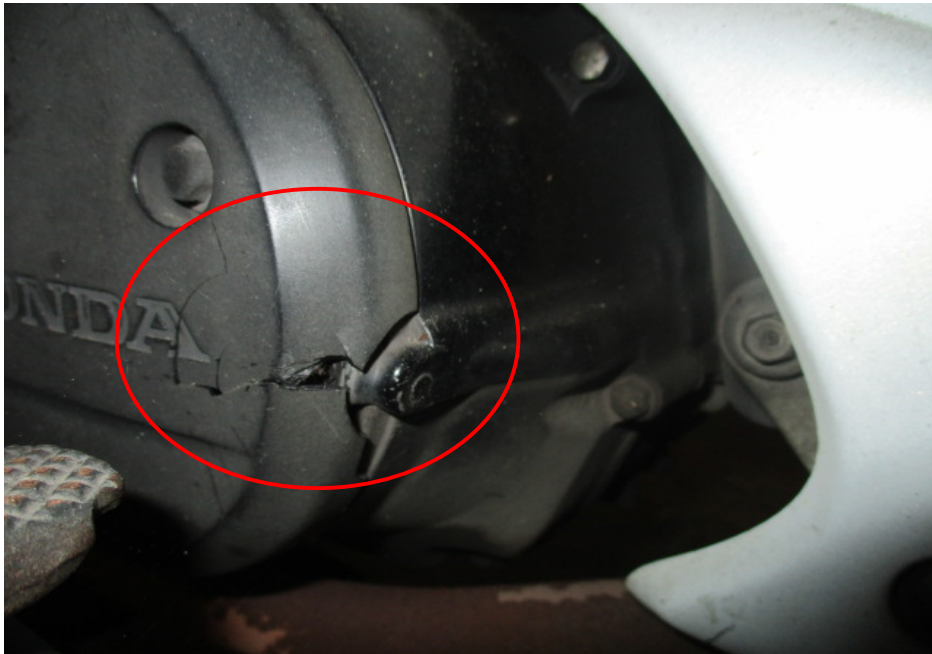
Photo 15 shows a close up of the crack sustained to the outer engine cover on the right side of the engine of the Motorcycle (circled). However we observed that the engine components were still intact. There was also no fluid leak and/or fluid stain found around the right engine area of the Motorcycle.

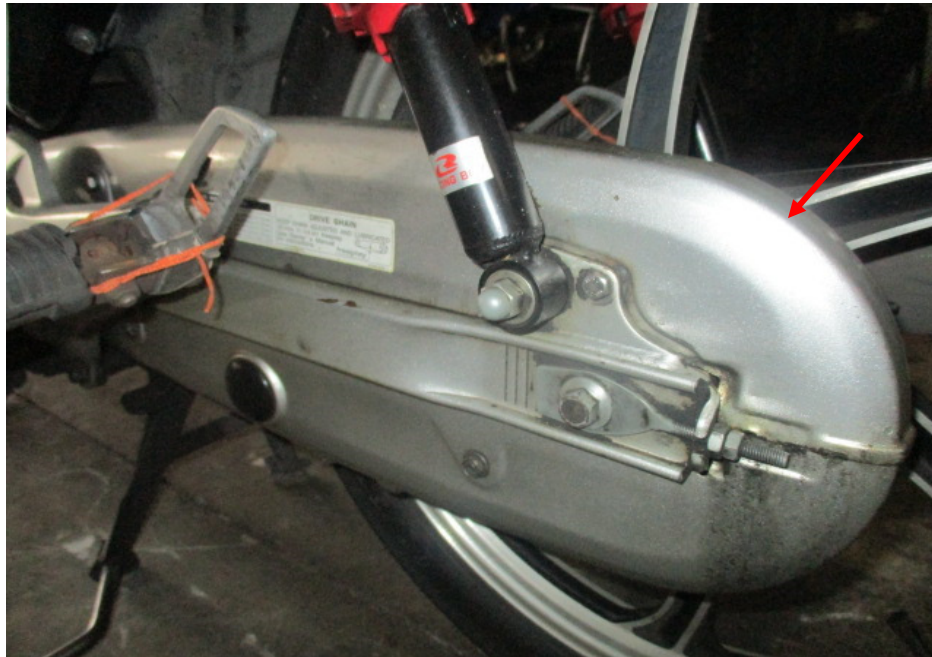
Photo 16 shows the general view of the gear train (arrowed) of the Motorcycle, which was observed to be intact with no misalignment.

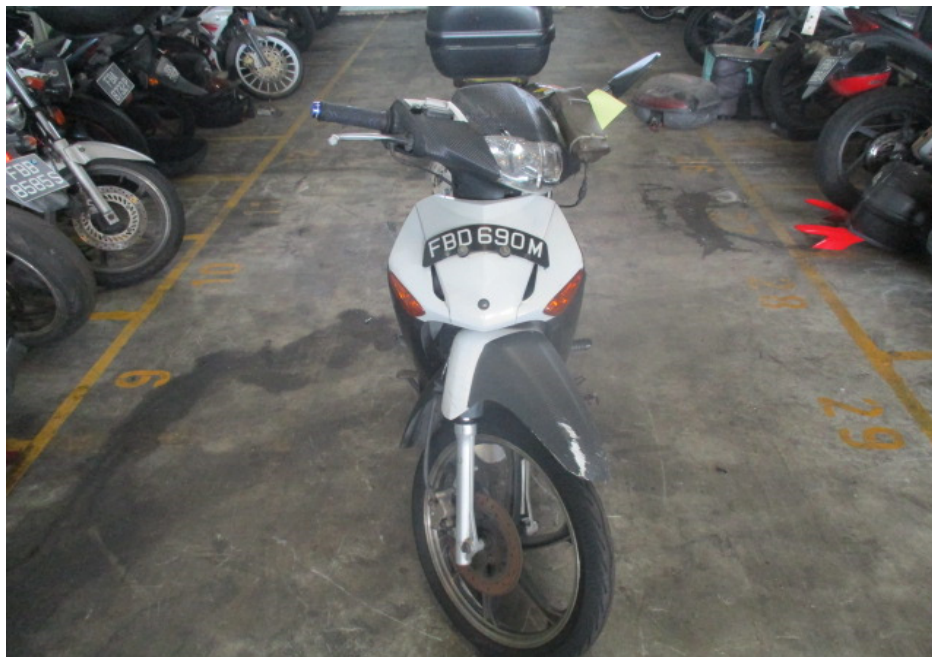
Photo 17 shows the front wheel of the Motorcycle turned towards its full left. Turning the Motorcycle's handle bar towards the left and right did not produce any abnormal free play and/or resistance. This would indicate that the steering system of the Motorcycle was in serviceable condition at the time of our inspection.

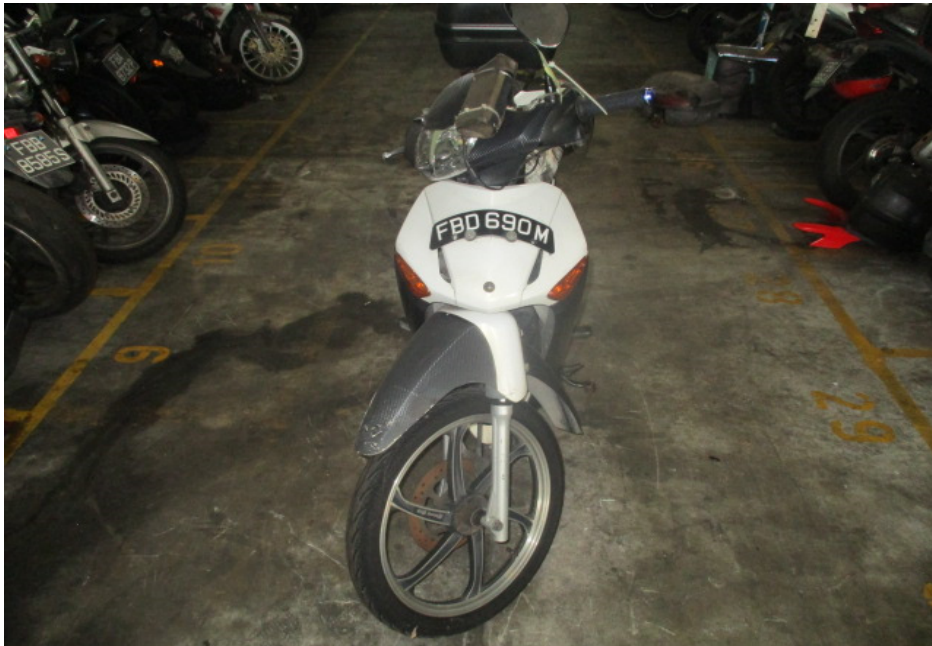
Photo 18 shows the front wheel of the Motorcycle turned towards its full right. Turning the Motorcycle's handle bar towards the left and right did not produce any abnormal free play and/or resistance. This would indicate that the steering system of the Motorcycle was in serviceable condition at the time of our inspection.

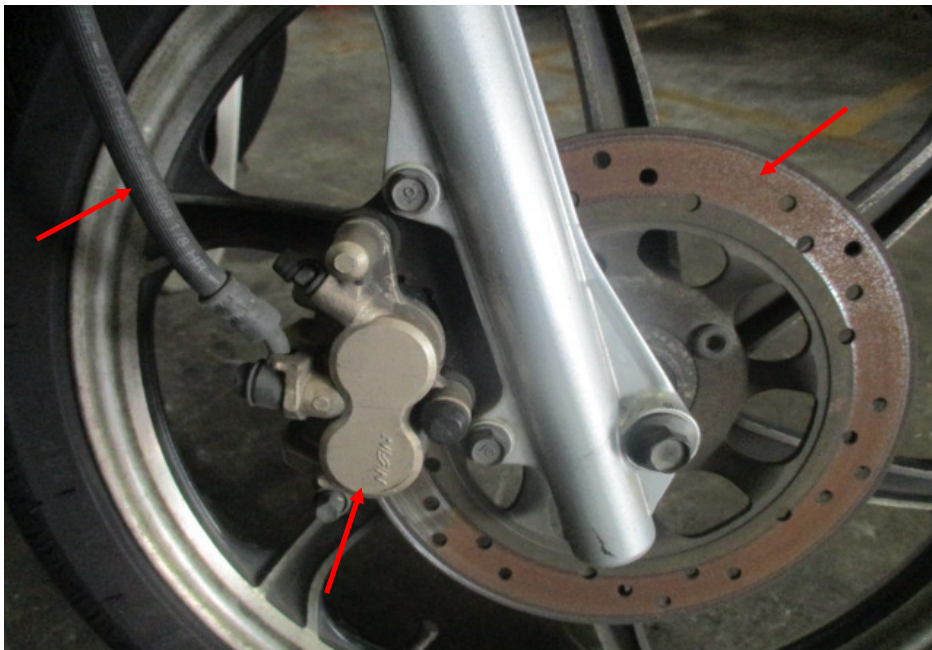
Photo 19 shows a close up view of the front brake caliper, front brake disc and front brake hose (arrowed) of the Motorcycle, which are all part of the components in the hydraulic front brake system of the Motorcycle. Our visual checks of these various components had revealed all to be intact with no visible damage. No leakage of brake fluid was also observed.

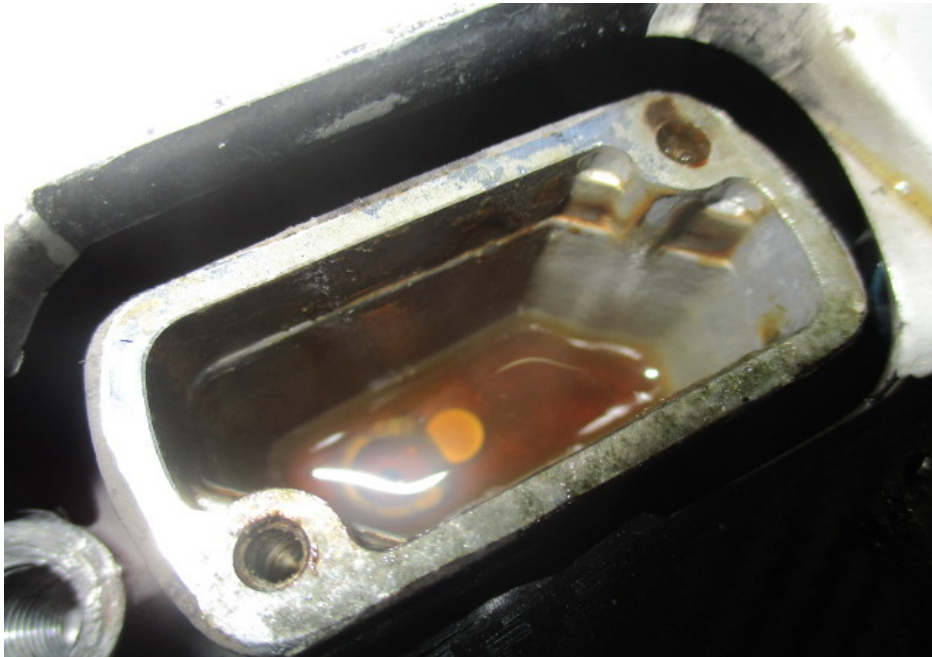
Photo 20 shows the brake fluid reservoir for the front brake of the Motorcycle. The brake fluid was observed to be of sufficient level and without contamination for operational purposes.

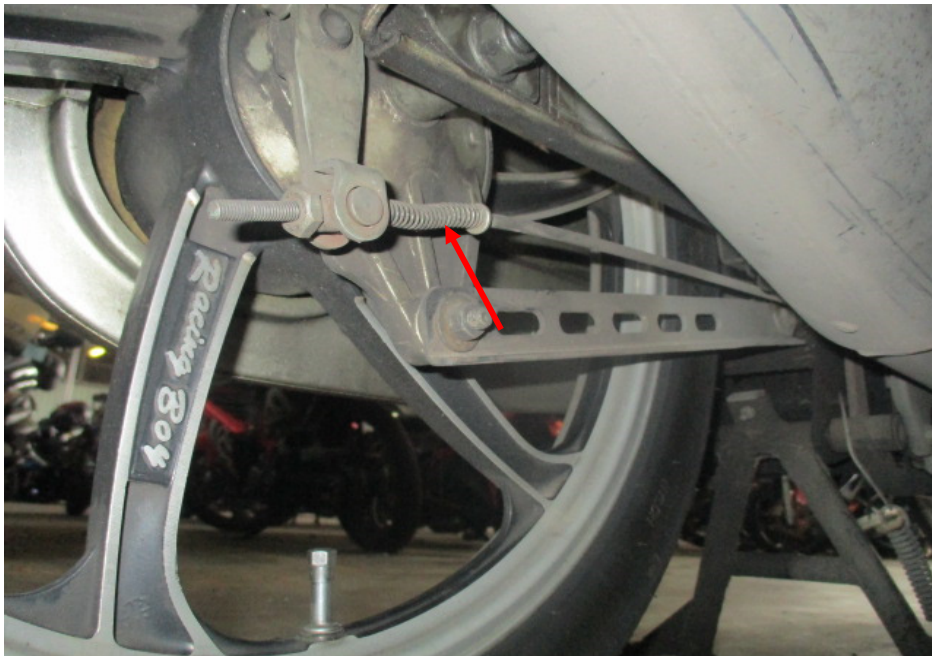
Photo 21 shows the rear wheel of the Motorcycle. The type of brake system for the rear wheel was of a mechanical type, controlled by the brake foot pedal of the Motorcycle. Our checks of the cable (arrowed), spring and drum which are all part of the components in the rear brake system of the Motorcycle reveal all to be intact and without damage.
