Your Ref: TP/IP/17985/2019  
Our Ref :CI/TPD19008251/N

**Fatal Accident Investigation Team**

**INSPECTION REPORT OF MOTORCYCLE FBG 8909R**

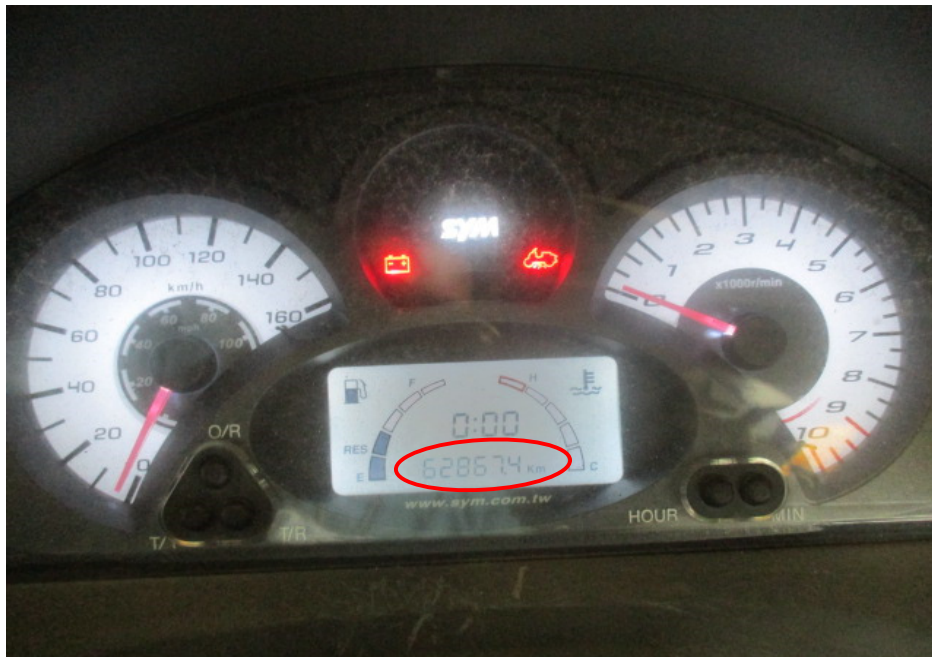
4. The mileage of the Motorcycle recorded at the time of our inspection was 62,867km.
5. The Motorcycle was observed to have sustained minor damages at the frontal and right portion. The body parts that were found to have been damaged include its front mudguard, front brake lever, right side mirror, right cowling, right rear side cover, right pillion foot rest, exhaust muffler, top box rack and top box, amongst others as a result of the accident. See photos 1 – 11 below.

**Photo 1** shows the speedometer gauge of the Motorcycle where the mileage recorded at the time of our inspection was 62, 867km (circled).

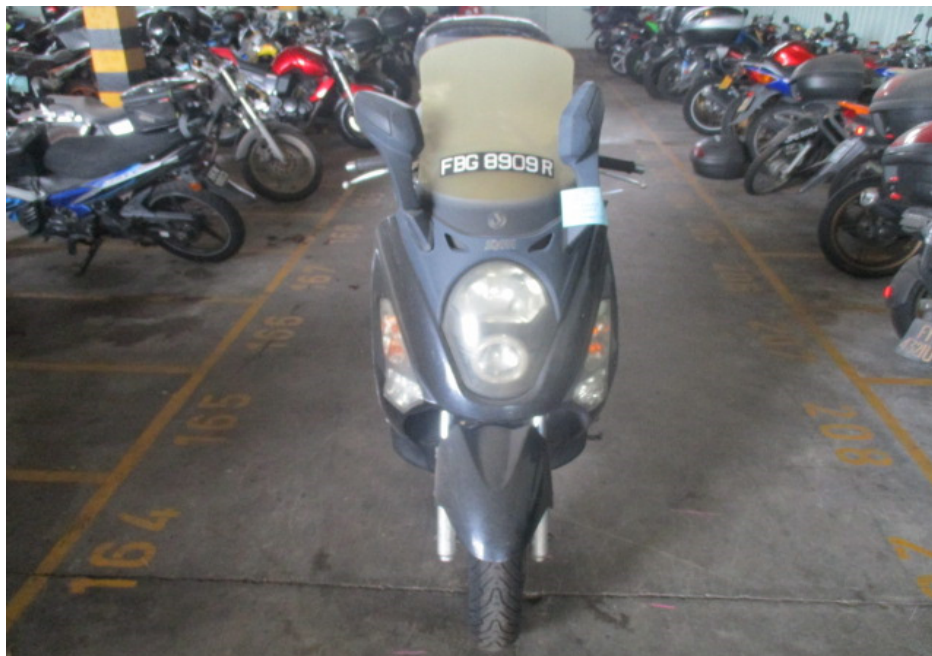
**Photo 2** shows a general view of the front body of the Motorcycle at the time of our inspection. The Motorcycle was observed to have sustained minor damages at the frontal and right portion.

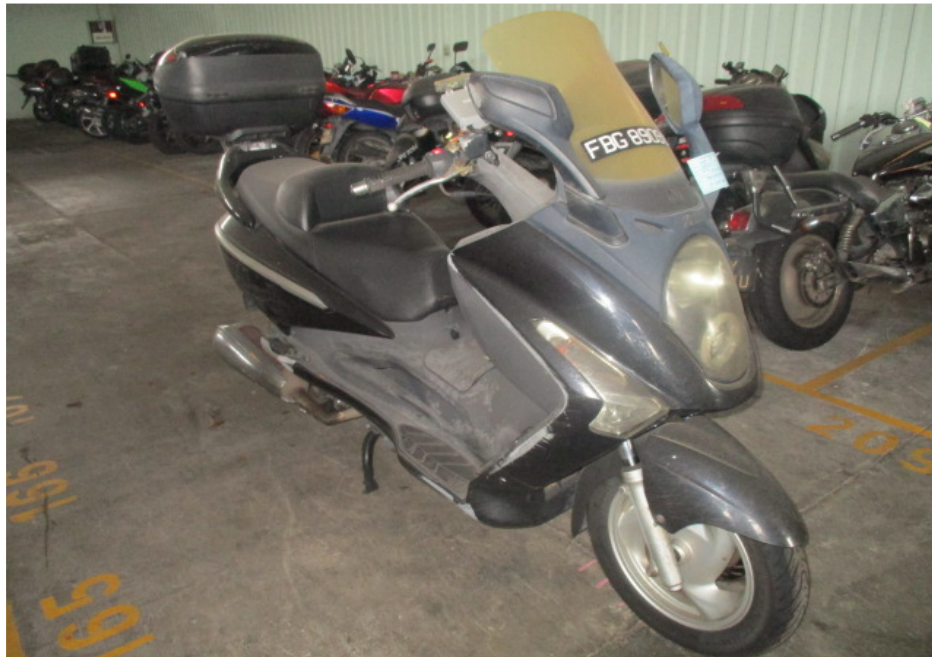
**Photo 3** shows a general view of the right front body of the Motorcycle at the time of our inspection. The Motorcycle was observed to have sustained minor damages at the frontal and right portion. The body parts that were found to have been damaged include its front mudguard, front brake lever, right side mirror, right cowling, right rear side cover, right pillion foot rest, exhaust muffler, top box rack and top box, amongst others as a result of the accident.

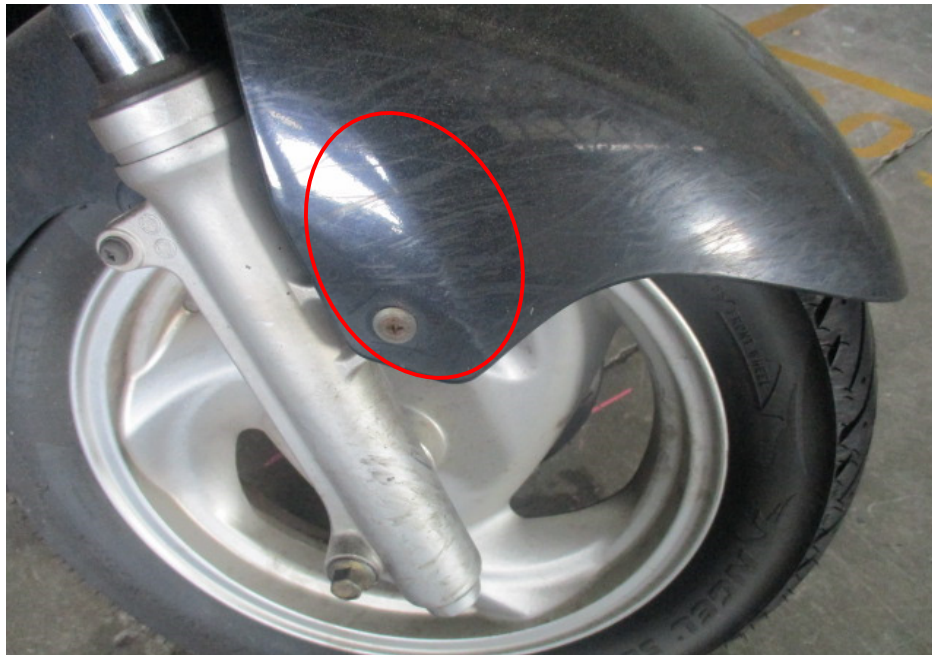
**Photo 4** shows a closer view of the front mudguard (circled) which was amongst the body parts at the front body of the Motorcycle that had sustained damage as a result of the accident.

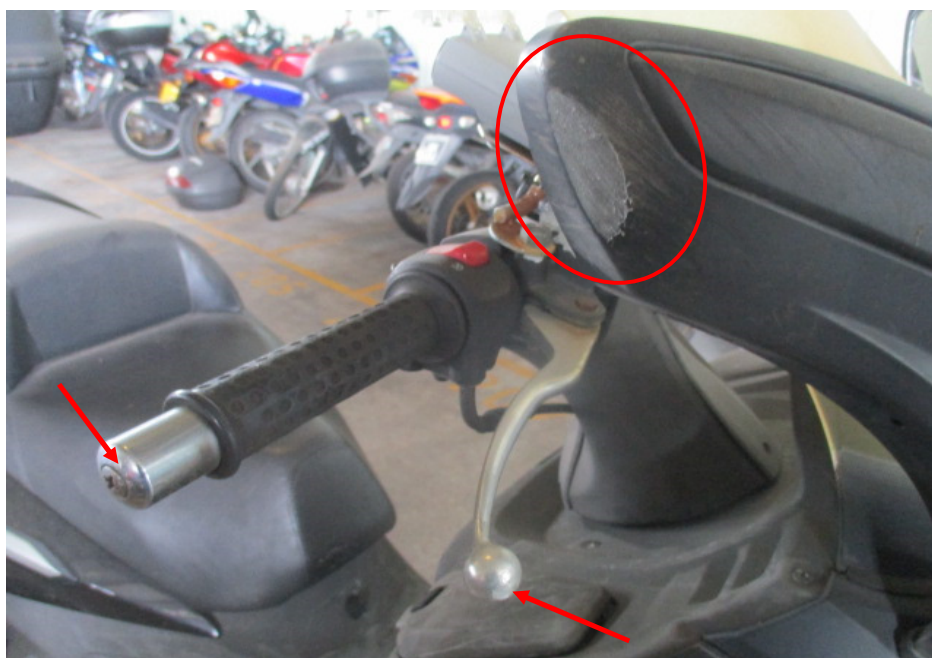
**Photo 5** shows a closer view of the front brake lever and right handlebar end (arrowed) as well as the right side mirror (circled) of the Motorcycle which were observed to be damaged due to the accident

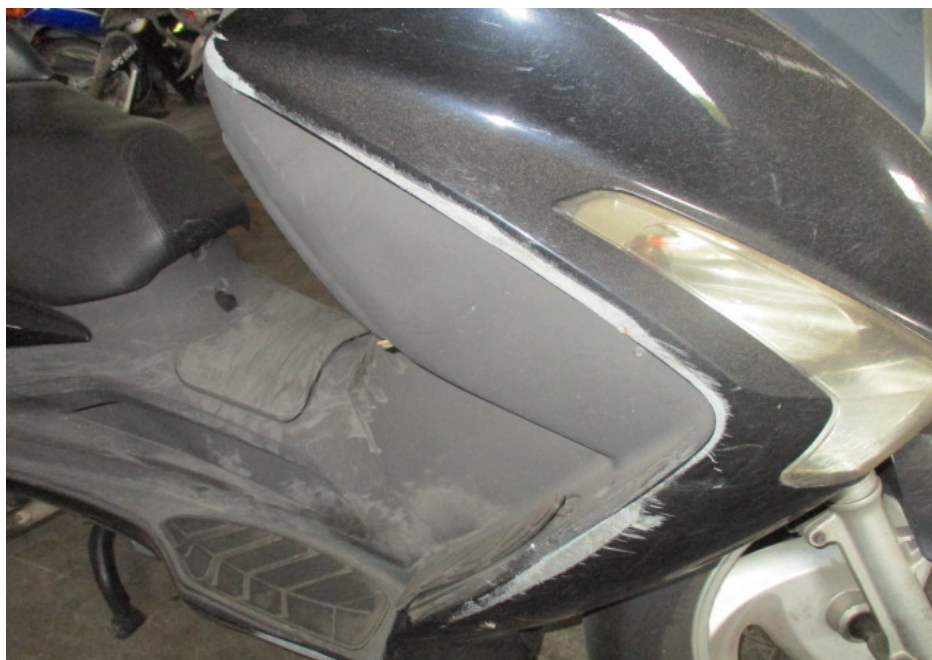
**Photo 6** shows a closer view of the right cowling which was amongst the body parts at the front body of the Motorcycle that had sustained damage as a result of the accident.

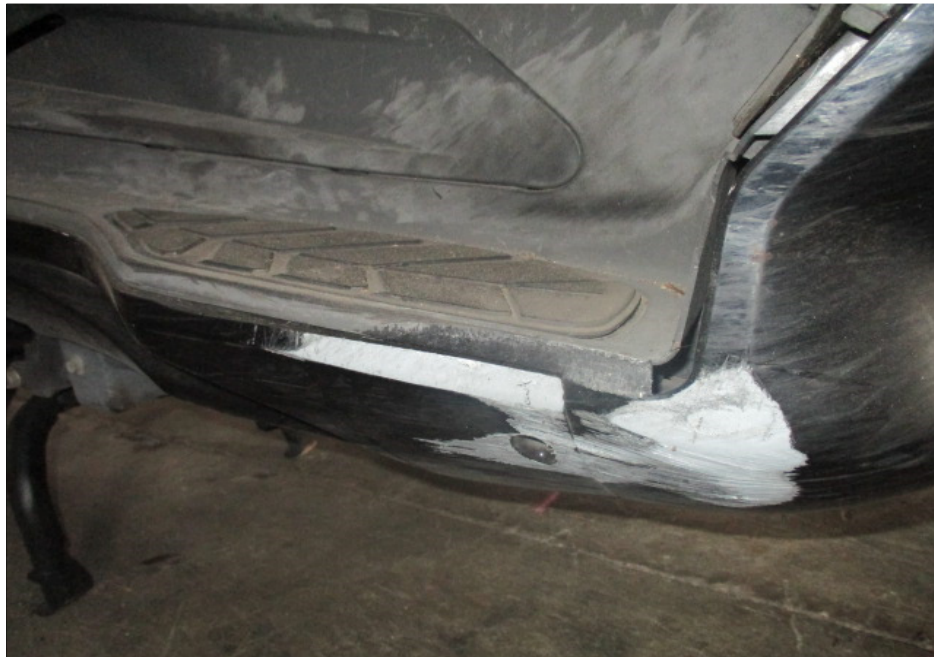
**Photo 7** shows a closer view of the right bottom cowling of the Motorcycle which was observed to be damaged due to the accident.

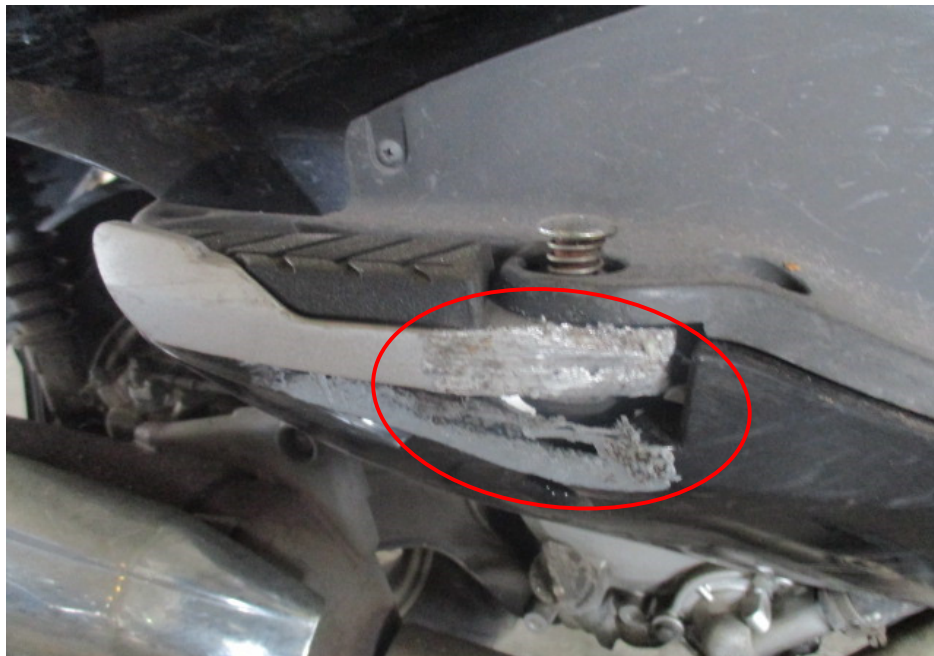
**Photo 8** shows a closer view of the damaged right pillion footrest (circled) of the Motorcycle at the time of our inspection.

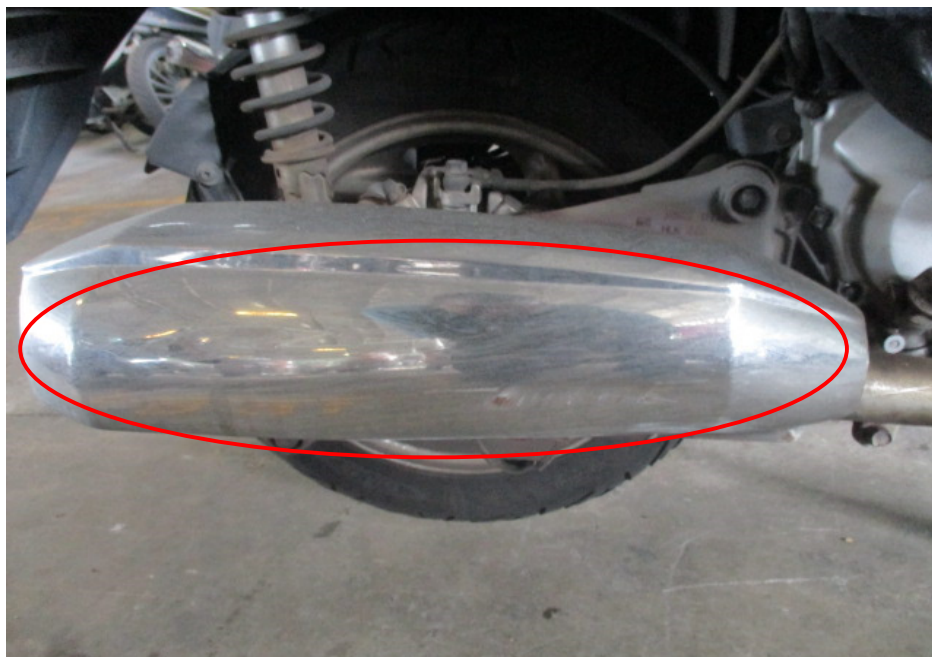
**Photo 9** shows a closer view of the exhaust muffler of the Motorcycle which had sustained damage due to the accident (circled).

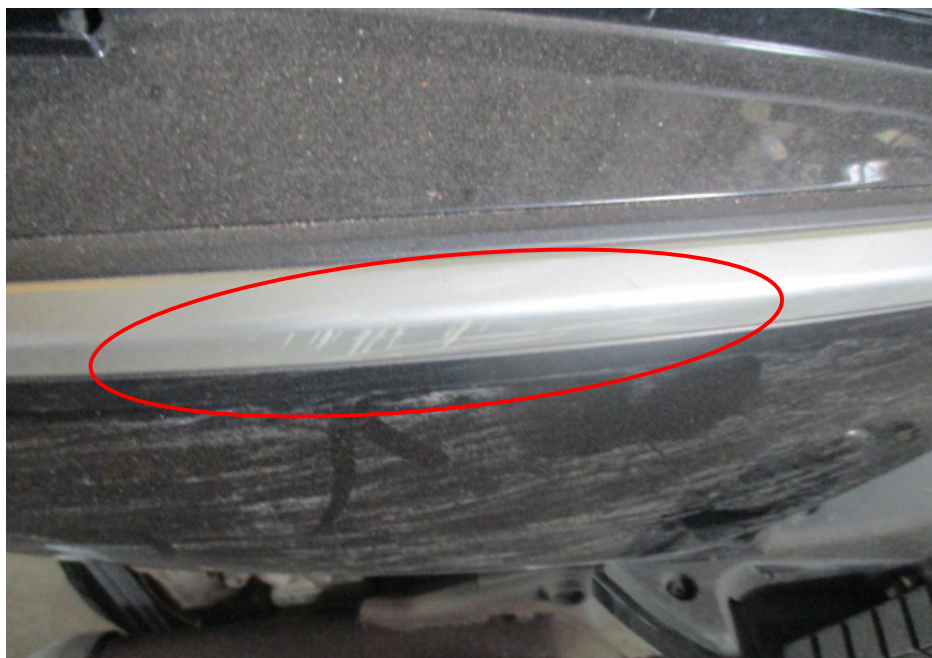
**Photo 10** shows a closer view of the damaged right rear side cover of the Motorcycle which was observed to have sustained scratches due to the accident (circled).

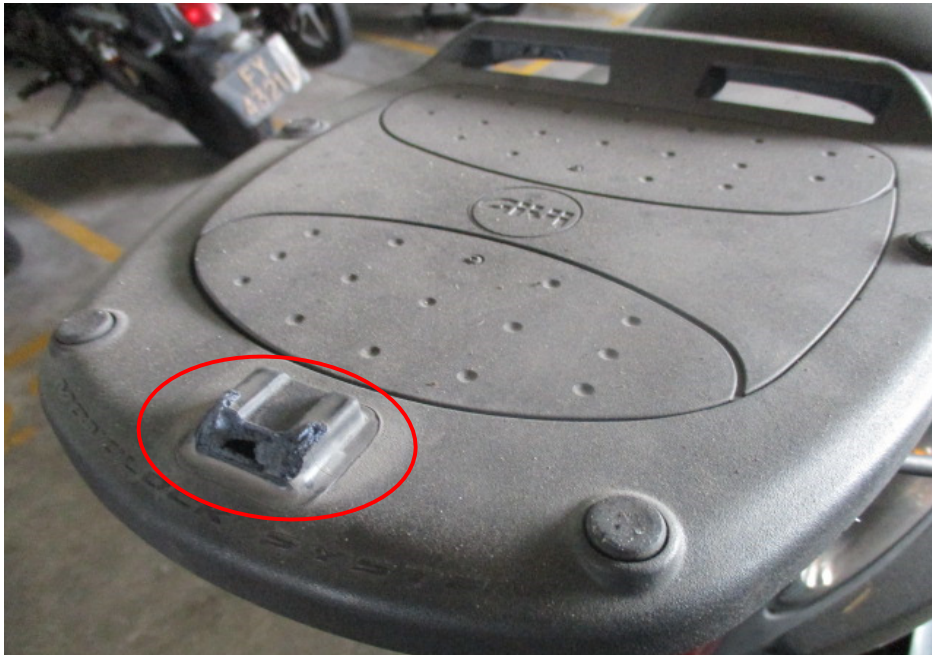
**Photo 11** shows the broken top box rack of the Motorcycle (circled).

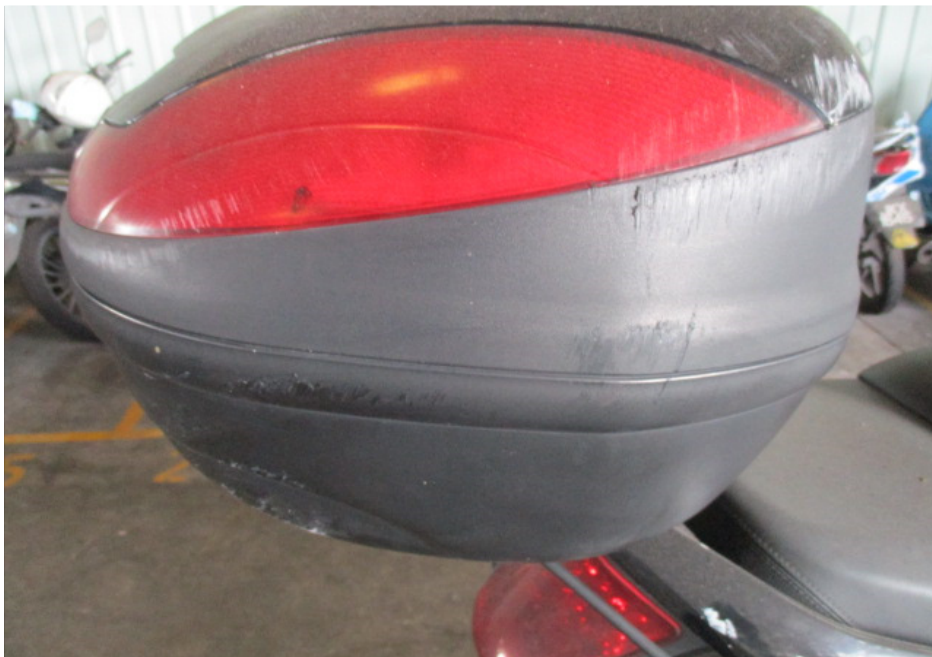
**Photo 11** shows a closer view of the top box of the Motorcycle which was observed to have sustained scratches due to the accident.

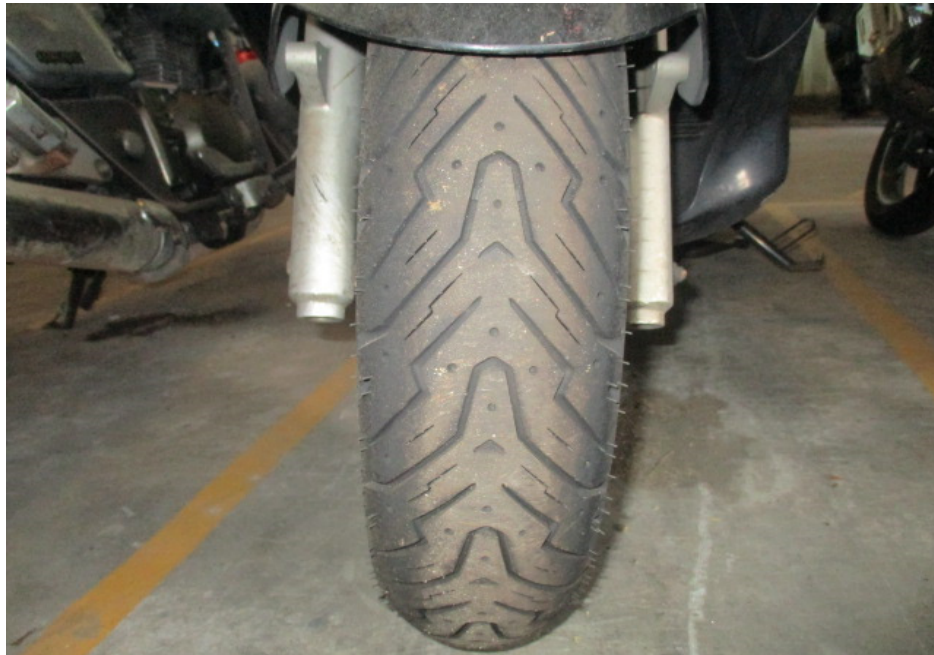
**Photo 12** shows the condition of the Motorcycle's front tyre. The front tyre was observed to be in serviceable condition with remaining tread depth of approximately 3mm. There was no tear, burst mark(s) and/or punctured hole(s) on the sidewalls as well as across the tread of the front tyre.

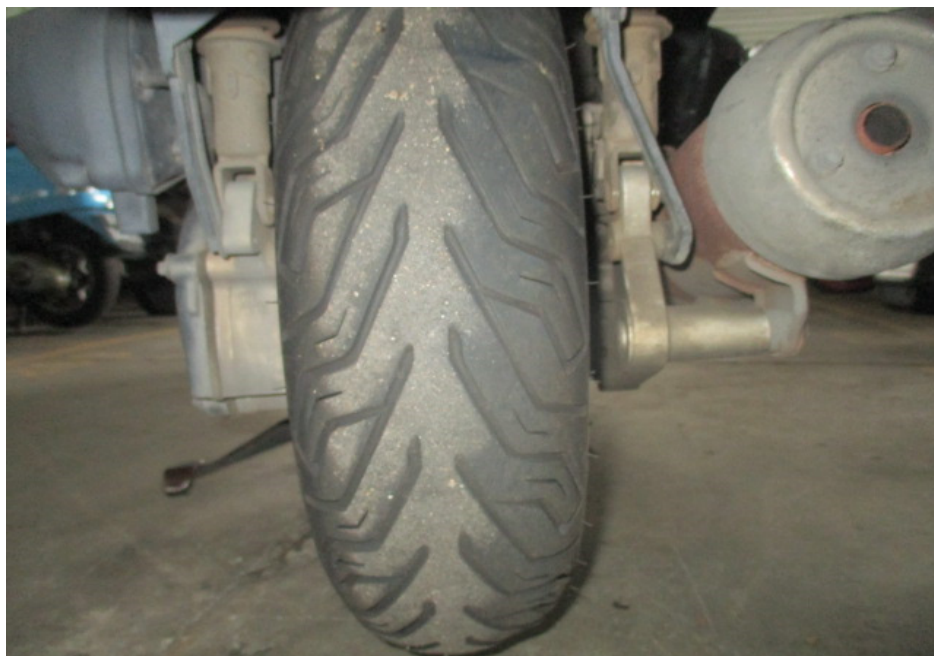
**Photo 13** shows the condition of the Motorcycle's rear tyre. The rear tyre was observed to be in serviceable condition with remaining tread depth of approximately 3mm. The tyre was also observed to be sufficiently inflated for vehicular operation. We did not observe any tear, burst mark(s) and/or punctured hole(s) on the sidewalls as well as across the tread of the rear tyre.

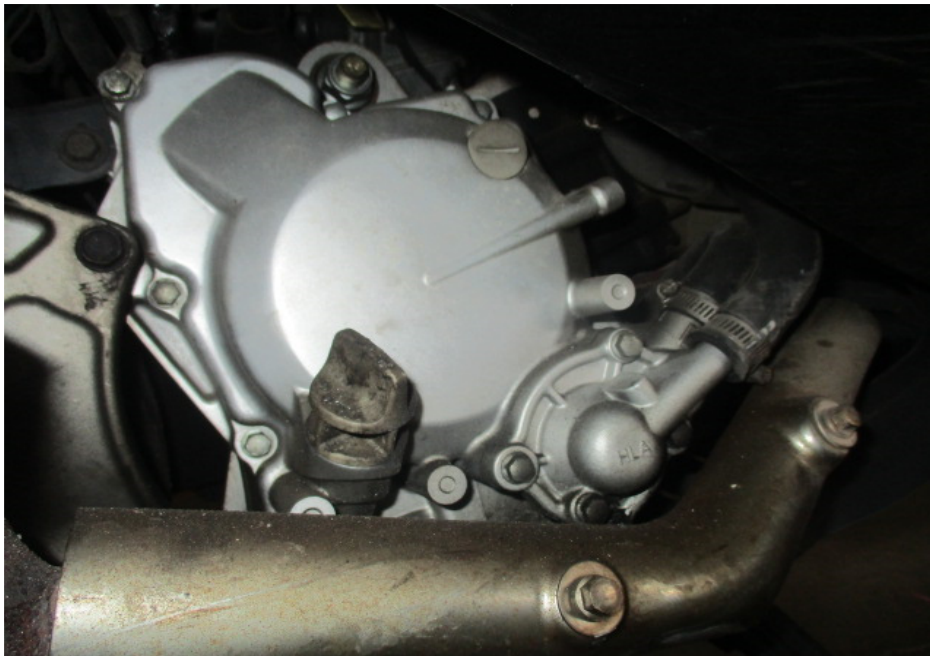
**Photo 14** shows the right side of the engine of the Motorcycle at the time of our inspection. The various engine related parts and components were found to be intact with no visible damage. There was also no sign(s) or indication(s) of fluid leak observed around the right engine area of the Motorcycle.

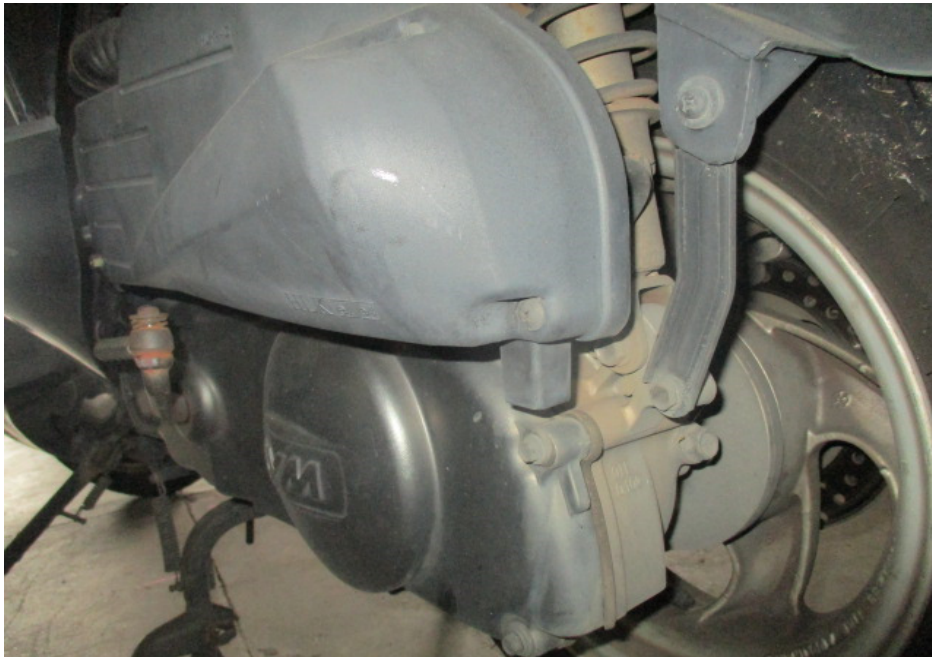
**Photo 15** shows the drive train of the Motorcycle which was found to be intact without any misalignment.

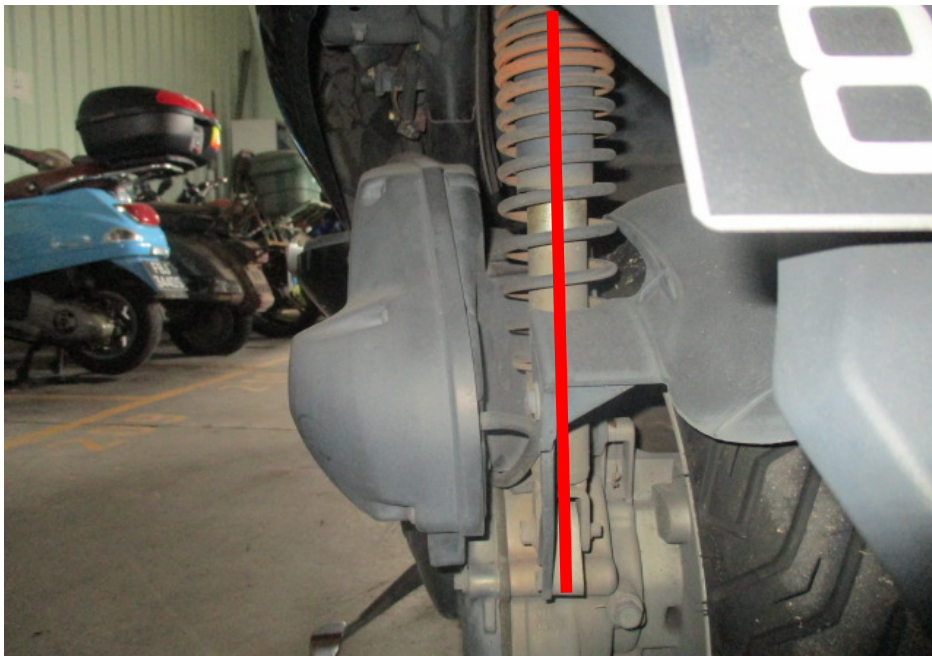
**Photo 16** shows the left shock absorber of the motorcycle which was found to be intact without any misalignment.

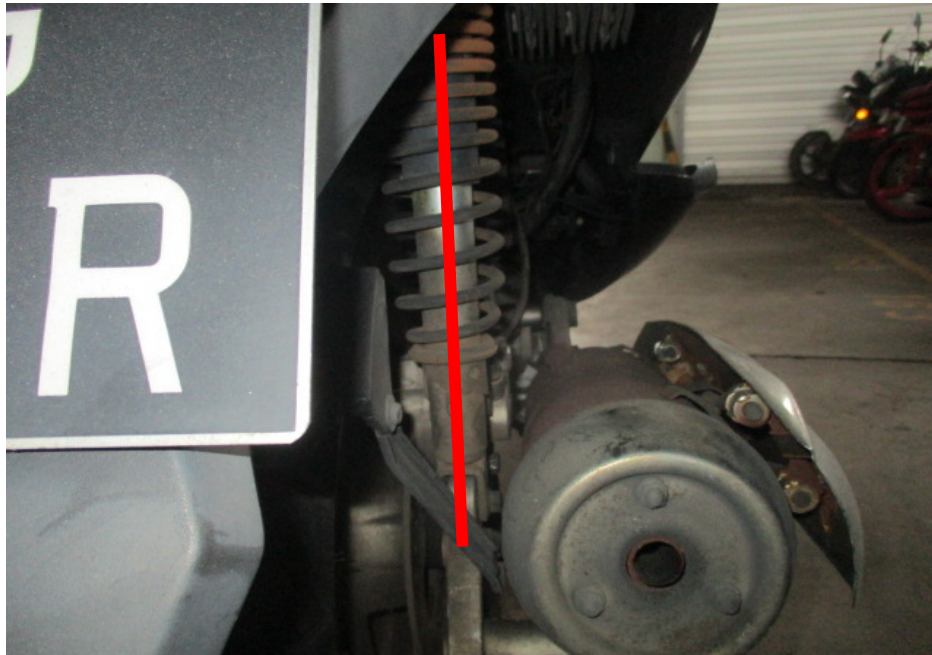
**Photo 17** shows the right shock absorber of the motorcycle which was found to be intact without any misalignment.

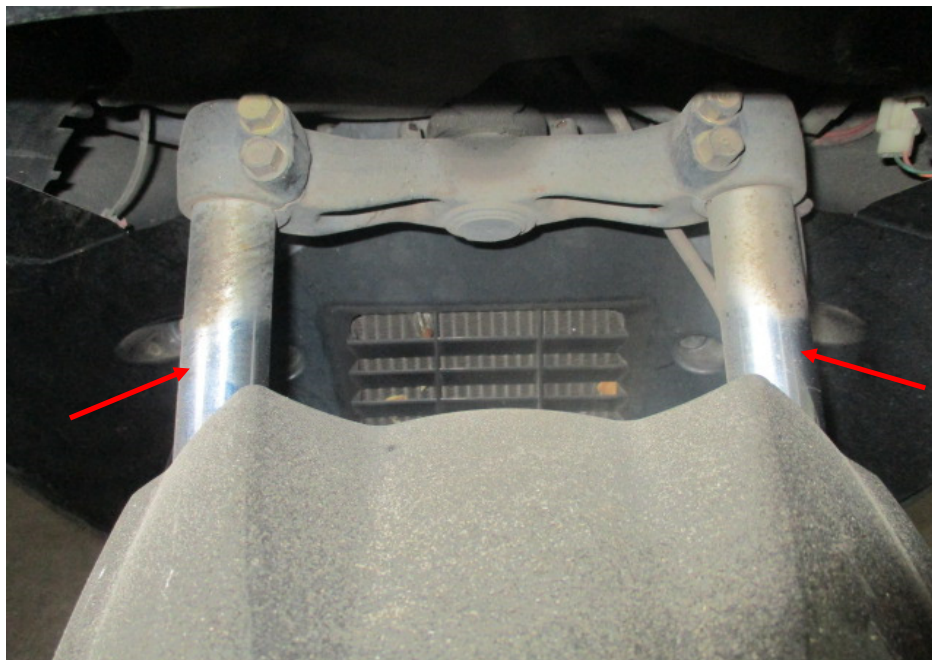
**Photo 18** shows the front forks (arrowed) of the Motorcycle. The front forks and fork brackets of the Motorcycle were both found to be intact and undamaged. Turning the Motorcycle's handle bar towards the left and right did not produce any abnormal free play and/or resistance. The steering system of the Motorcycle was in serviceable condition at the time of our inspection.

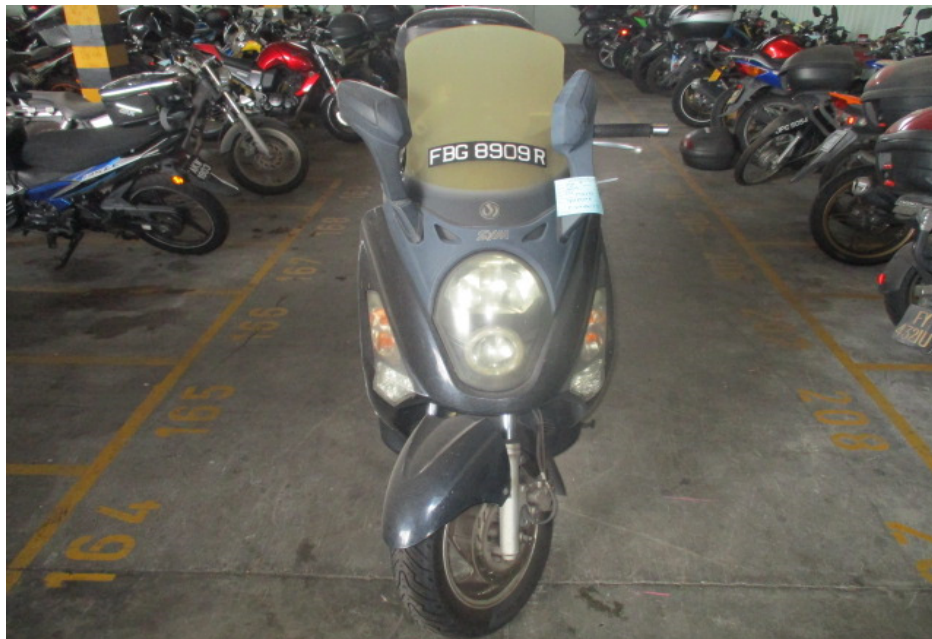
**Photo 19** shows the front wheel of the Motorcycle turned towards its full right. Turning the Motorcycle's handle bar towards the left and right did not produce any abnormal free play and/or resistance. This would indicate that the steering system of the Motorcycle was in serviceable condition at the time of our inspection.

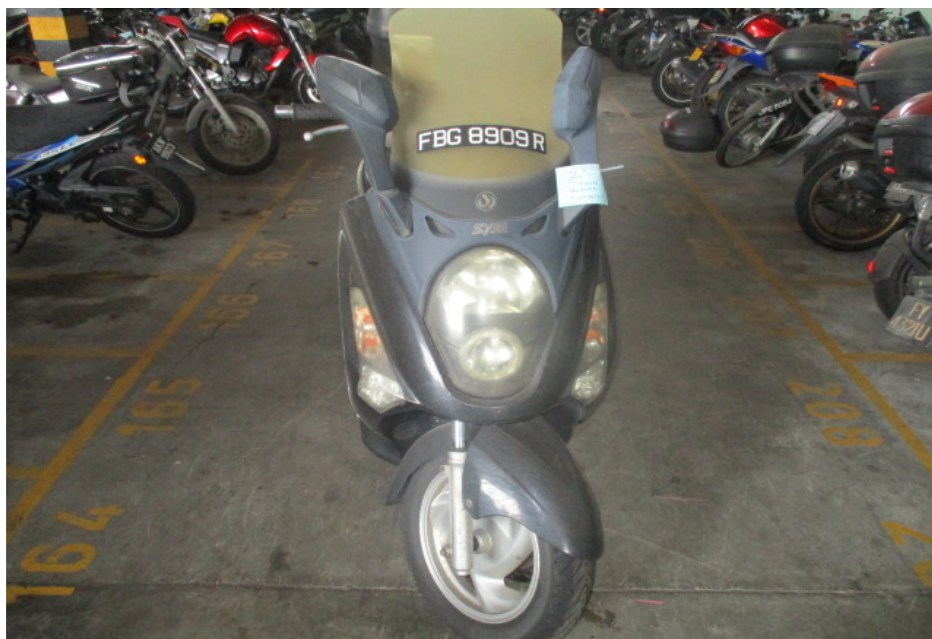
**Photo 20** shows the front wheel of the Motorcycle turned towards its full left. Turning the Motorcycle's handle bar towards the left and right did not produce any abnormal free play and/or resistance. This would indicate that the steering system of the Motorcycle was in serviceable condition at the time of our inspection.

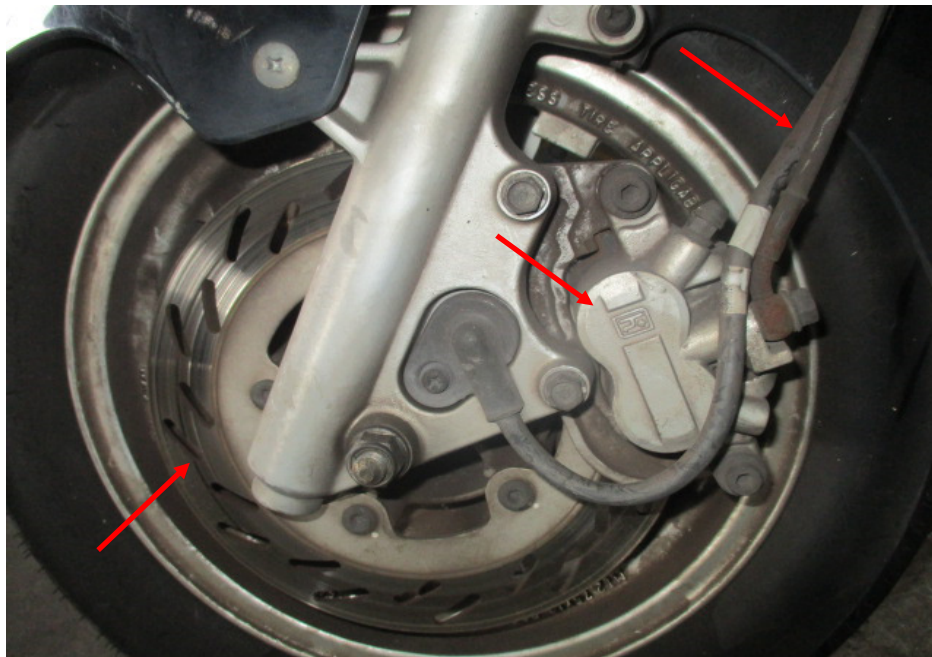
**Photo 21** shows a close up view of the front brake caliper, front brake disc and front brake hose (arrowed) of the Motorcycle, which are all part of the components in the hydraulic front brake system of the Motorcycle. Our visual checks of these various components had revealed all to be intact with no visible damage. No leakage of brake fluid was also observed.

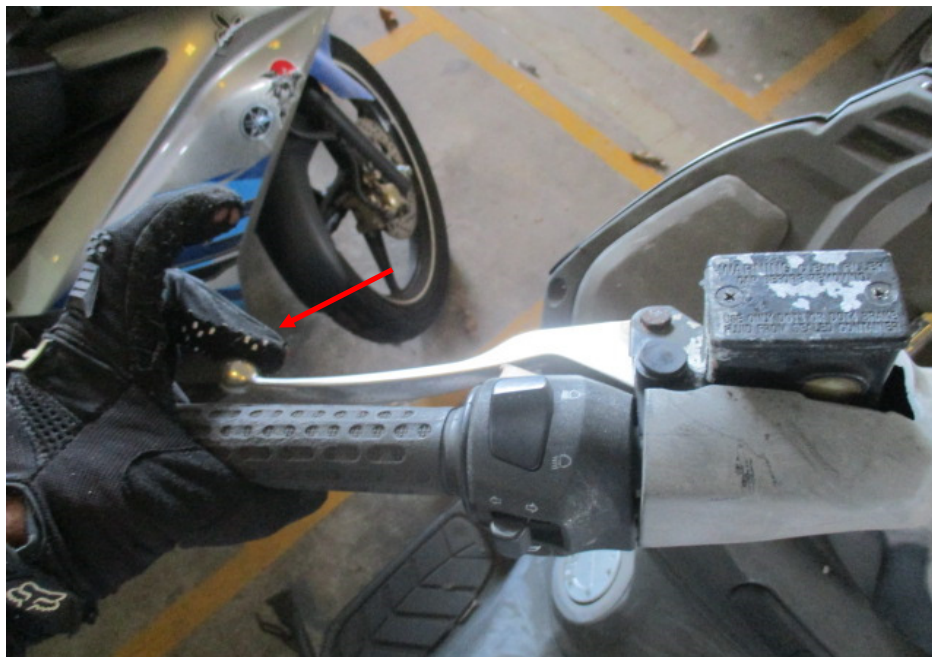
**Photo 22** shows the rear brake lever being depressed. There was some resistance felt (spongy like feel) upon pressing the rear brake lever (arrowed). This would indicate that there is no leakage of pressure/vacuum in the brake system.

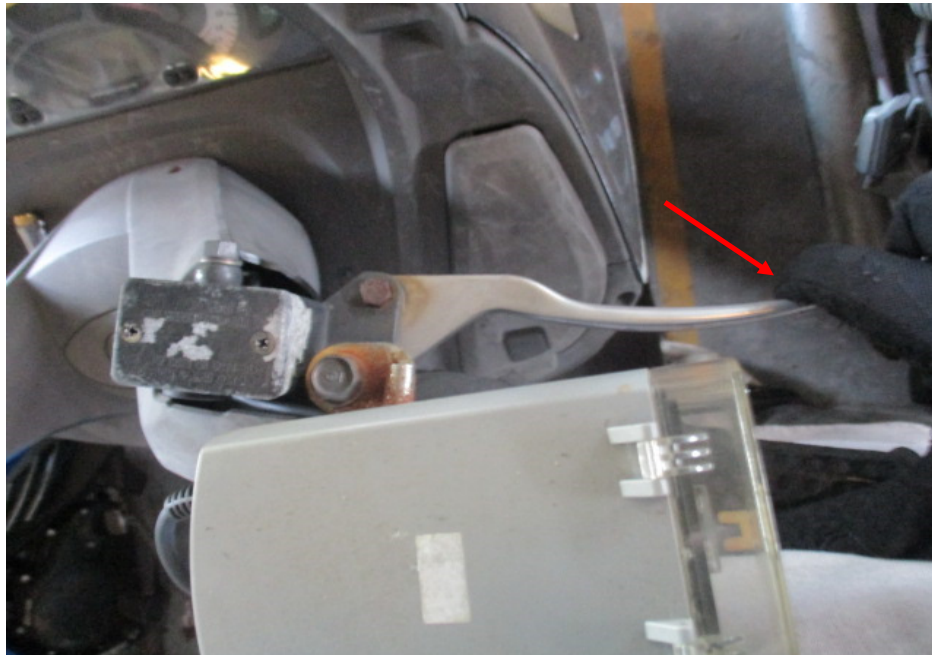
**Photo 23** shows the front brake lever being depressed. There was some resistance felt (spongy like feel) upon pressing the front brake lever (arrowed). This would indicate that there is no leakage of pressure/vacuum in the brake system.

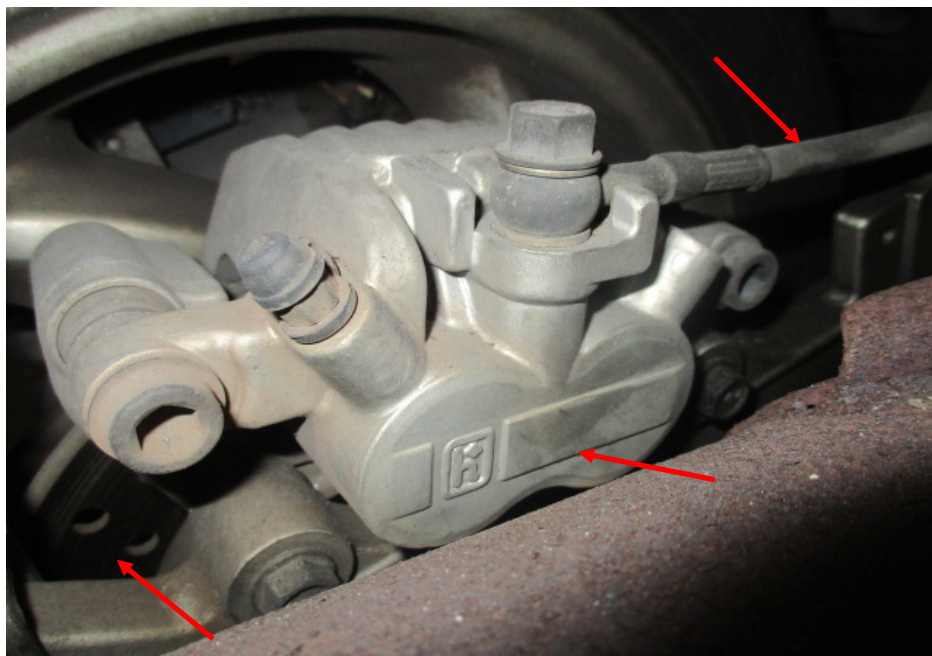
**Photo 24** shows a close up view of the rear brake caliper, rear brake disc and rear brake hose (arrowed) of the Motorcycle, which are all part of the components in the hydraulic rear brake system of the Motorcycle. Our visual checks of these various components revealed all to be intact with no visible damage. No leakage of brake fluid was also observed.
