Your Ref: TP/IP/12567/2019
Our Ref : CI/TPD19008252/N

13 June 2019

MECHANICAL INSPECTION REPORT OF MOTORCYCLE JJG 4808

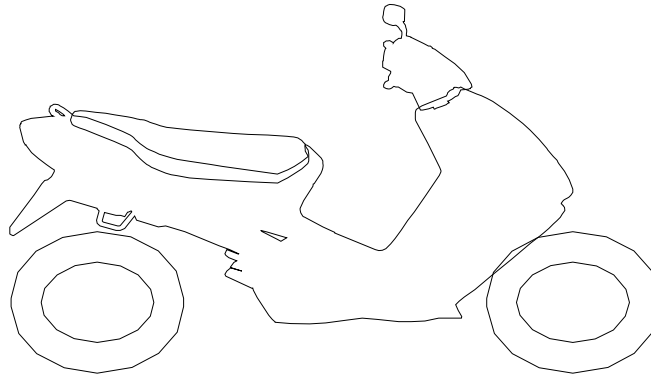
7. However we did observe that the front tyre was punctured as a result of the accident. The tread pattern of the front tyre was clearly visible.

Crystal 80/90 R17 (3mm)

Maxxis 70/90 R17 (3mm)

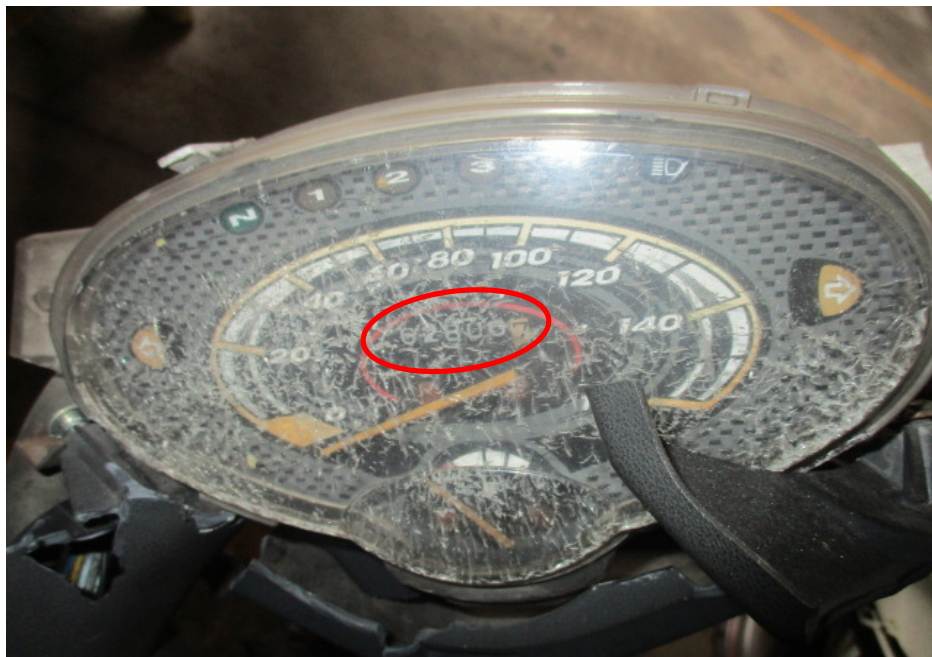
Photo 1 shows a closer view of the speedometer gauge of the Motorcycle which was damaged as a result of the accident. The mileage of the Motorcycle at the time of our inspection was 62, 800 (circled).

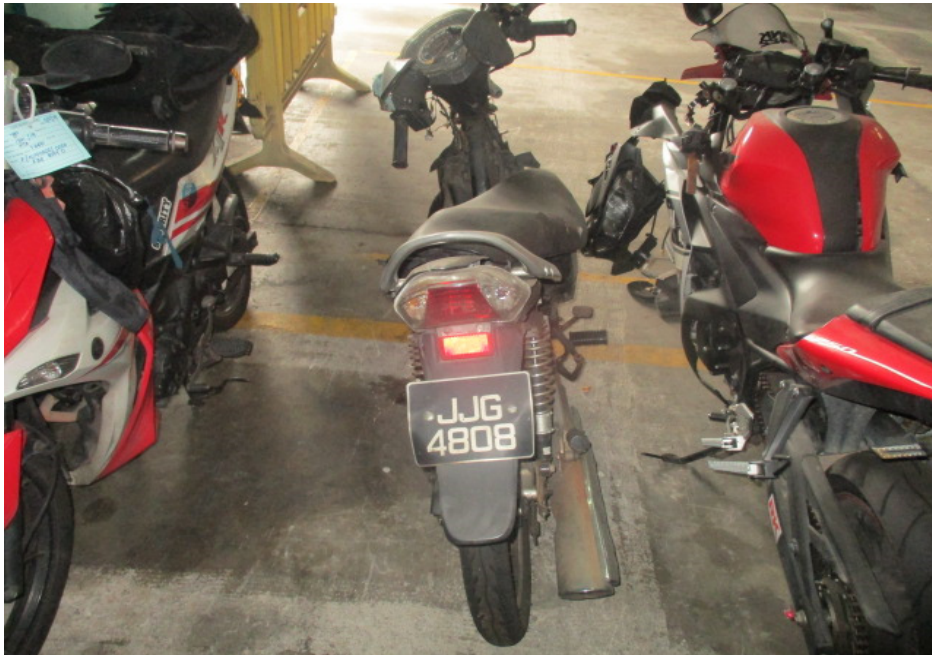
Photo 2 shows a general view of the rear body of the Motorcycle at the time of our inspection. The Motorcycle had sustained damages at its frontal and left portion.

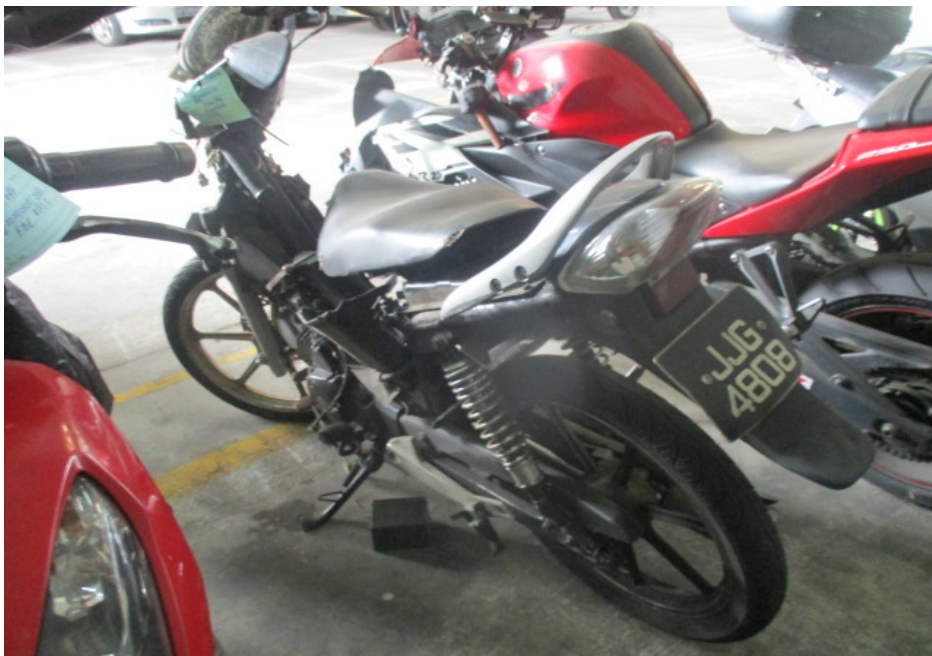
Photo 3 shows a general view of the left rear body of the Motorcycle at the time of our inspection. Body parts that were found to have been damaged include its front fork assembly, headlight assembly, speedometer gauge, front mudguard, front wheel rim, side mirrors, front brake lever, handlebars, left side cowling, left front footrest, left pillion footrest bracket, left pillion grab rail and seat, amongst others.

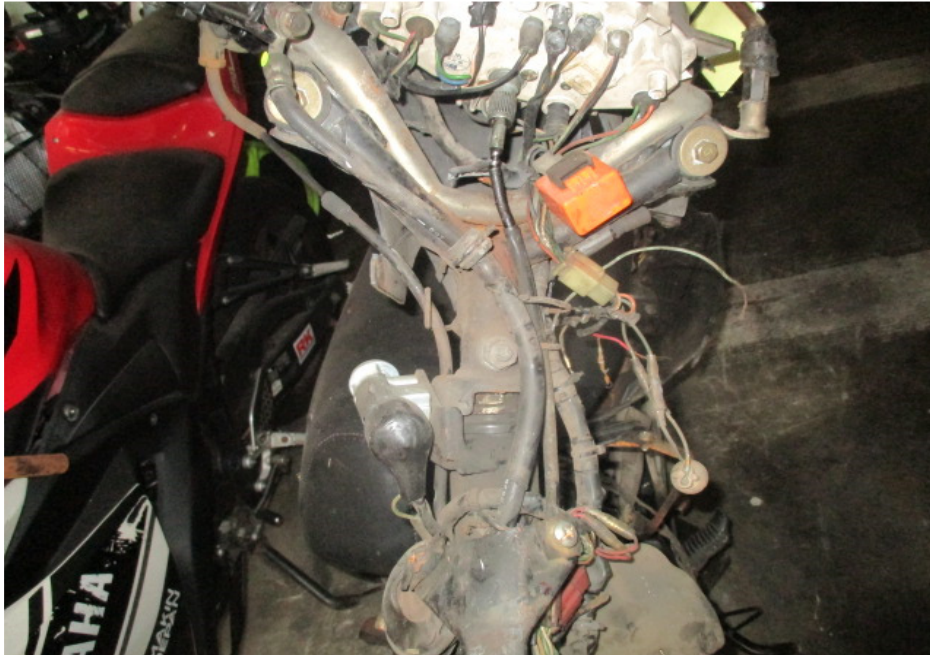
Photo 4 shows a closer view of the headlamp assembly of the Motorcycle. These parts were amongst the body parts of the Motorcycle which were damaged as a result of the accident.

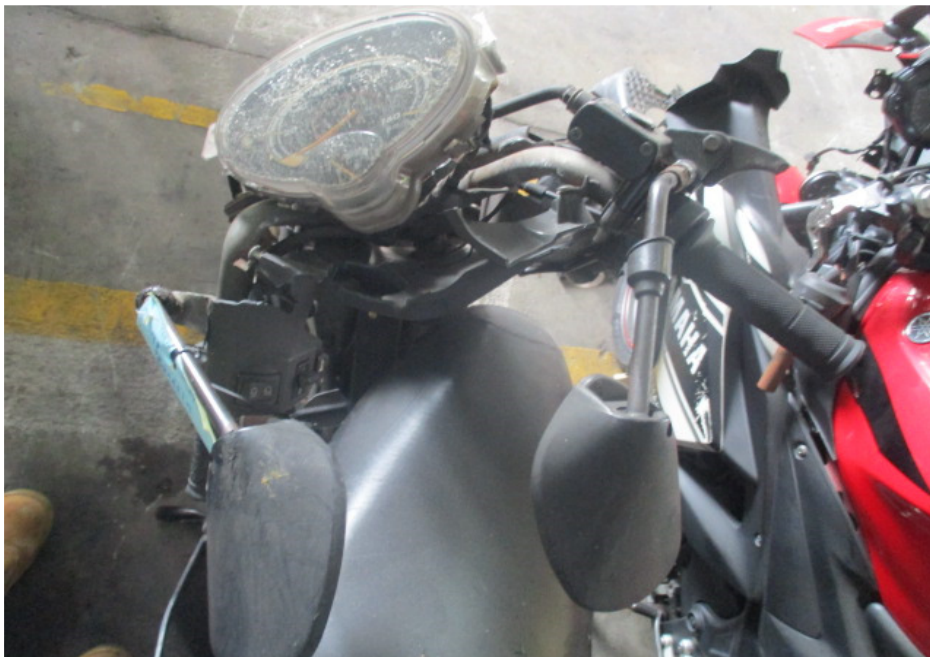
Photo 5 shows a closer view of the speedometer gauge, side mirrors and handlebars of the Motorcycle. These parts were amongst the body parts of the Motorcycle which were damaged as a result of the accident.

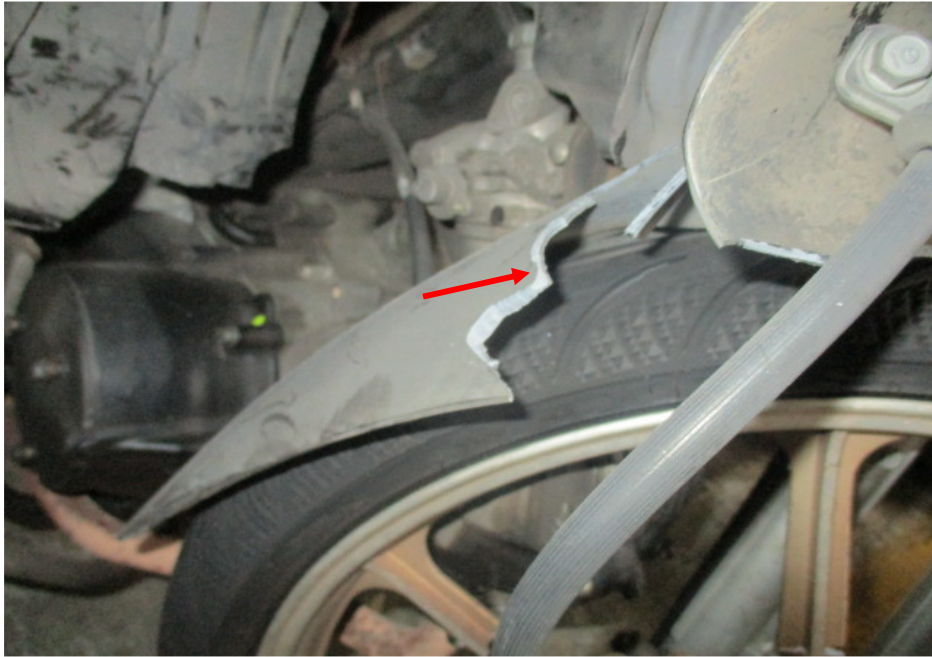
Photo 6 shows a close up view of the broken front mudguard (arrowed) of the Motorcycle which was amongst the body parts at the front body of the Motorcycle that had sustained damage as a result of the accident.

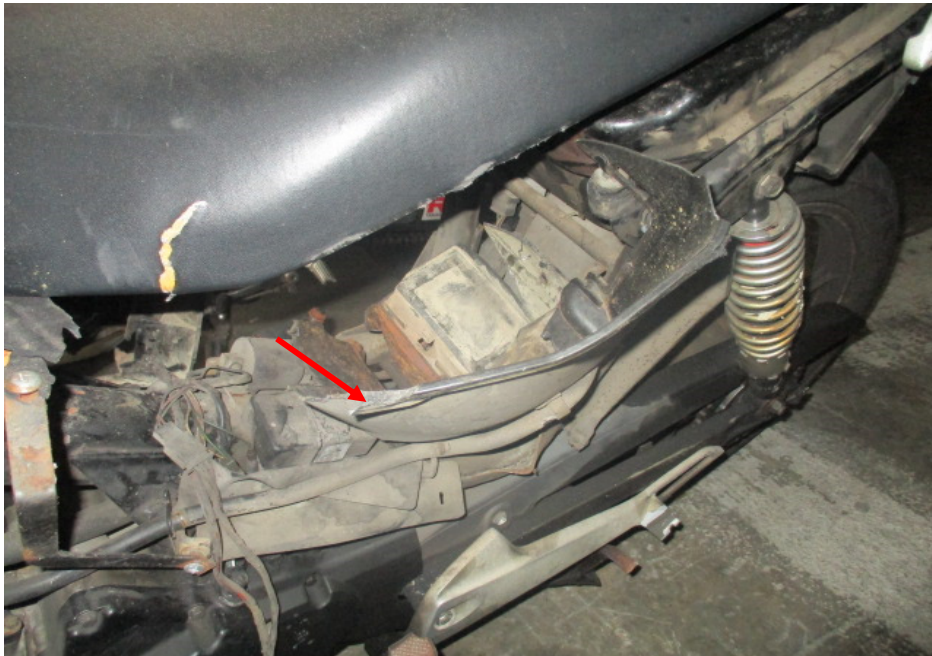
Photo 7 shows the left side cowling (arrowed) which was amongst the body parts of the Motorcycle damaged as a result of the accident.

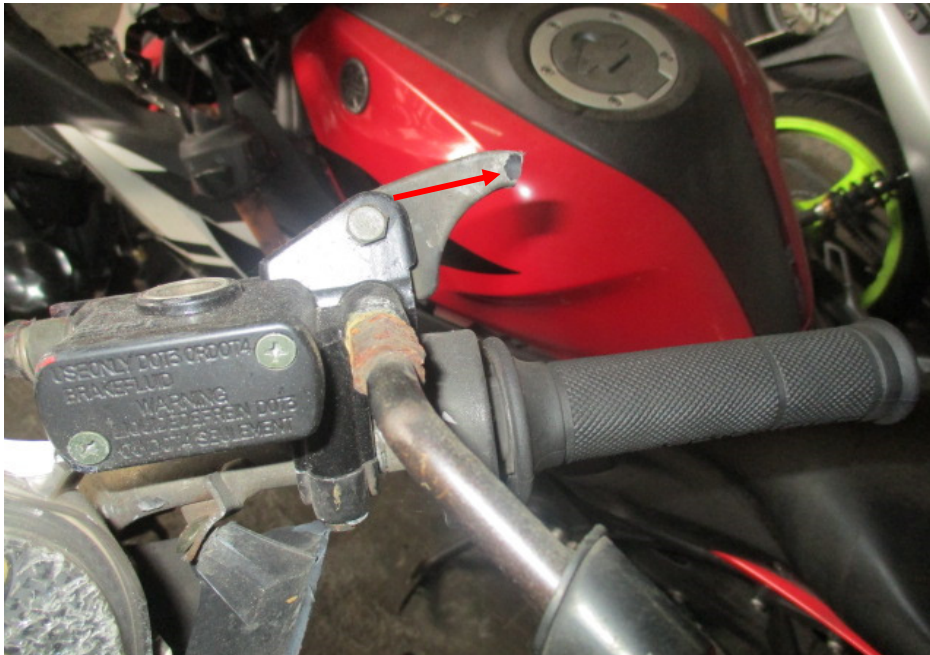
Photo 8 shows a close up view of the broken front brake lever (arrowed) of the Motorcycle which was amongst the body parts of the Motorcycle damaged as a result of the accident.

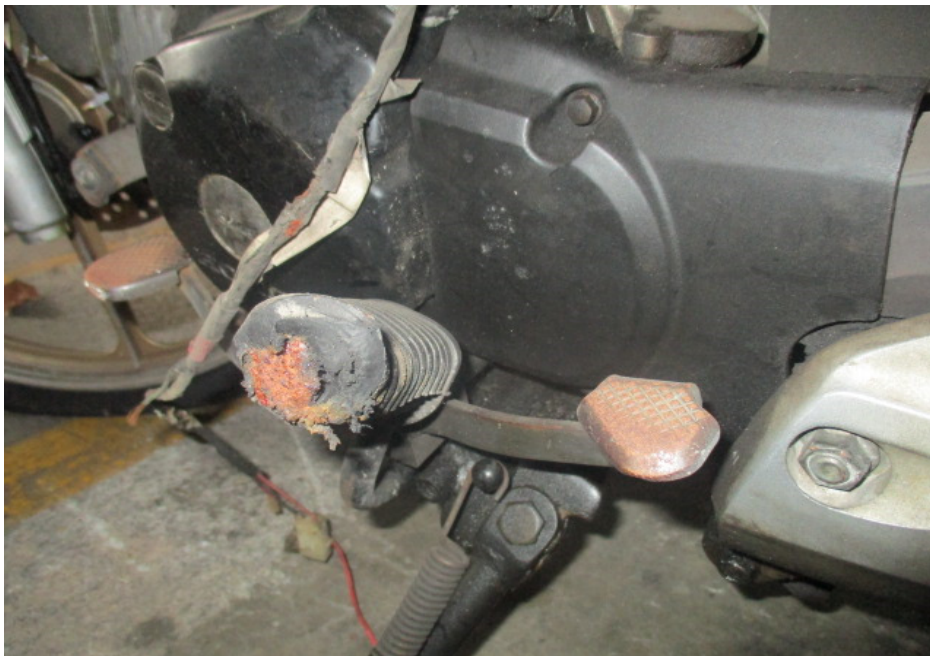
Photo 9 shows the damaged gear shift pedal, left front footrest and left front footrest bracket, which were amongst the body parts of the Motorcycle that had sustained damage as a result of the accident.

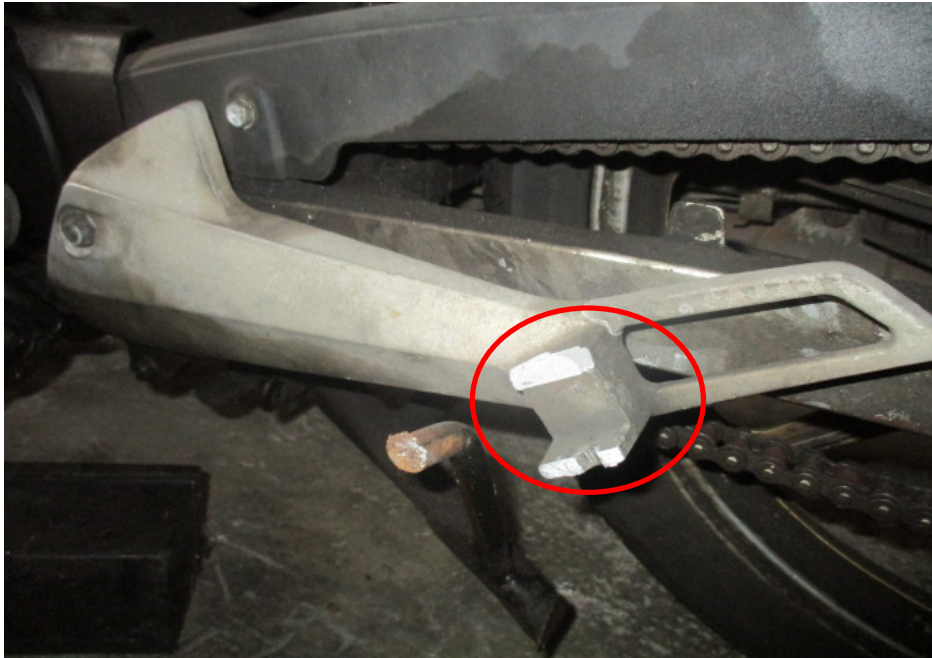
Photo 10 shows a closer view of the left pillion footrest bracket (circled), which was amongst the body parts of the Motorcycle that had sustained damage as a result of the accident.

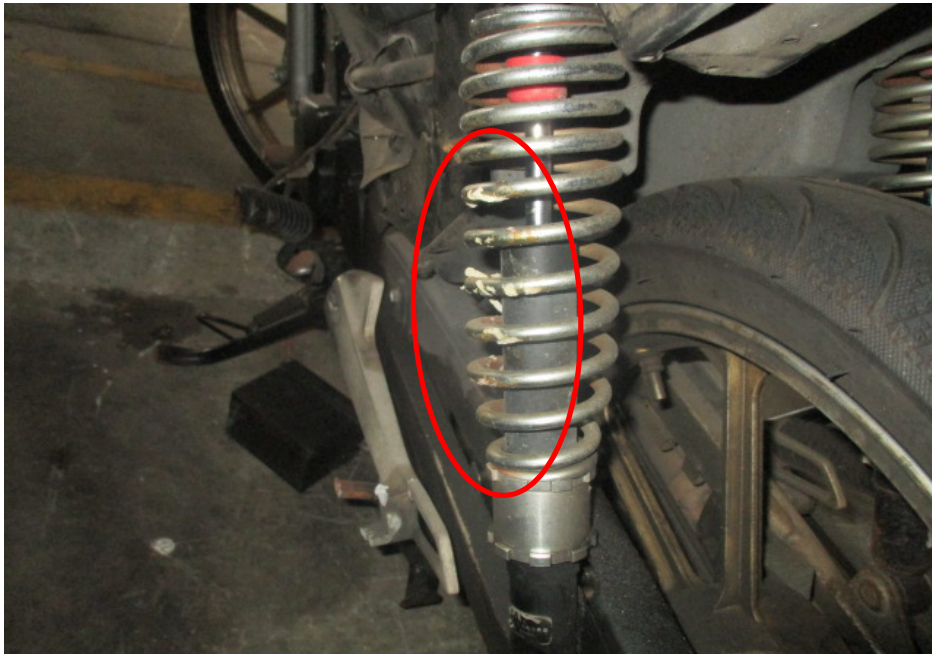
Photo 11 shows a close up view of the shock absorber on the left side of the Motorcycle which was amongst the body parts at the rear body of the Motorcycle damaged as a result of the accident (circled).

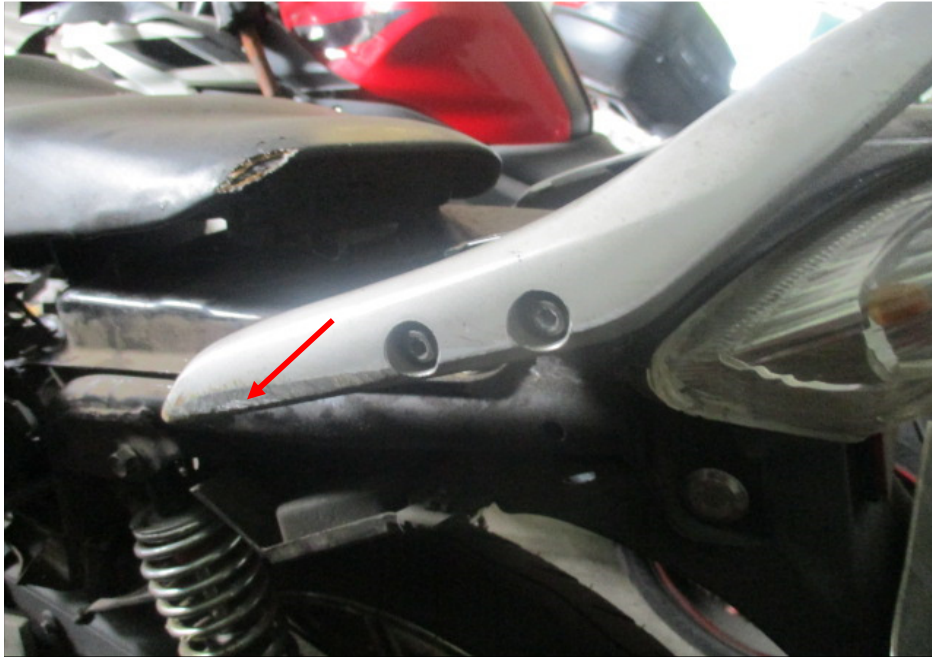
Photo 12 shows a closer view of the pillion grab rail of the Motorcycle which sustained damages of grazing nature (arrowed) as a result of the accident.

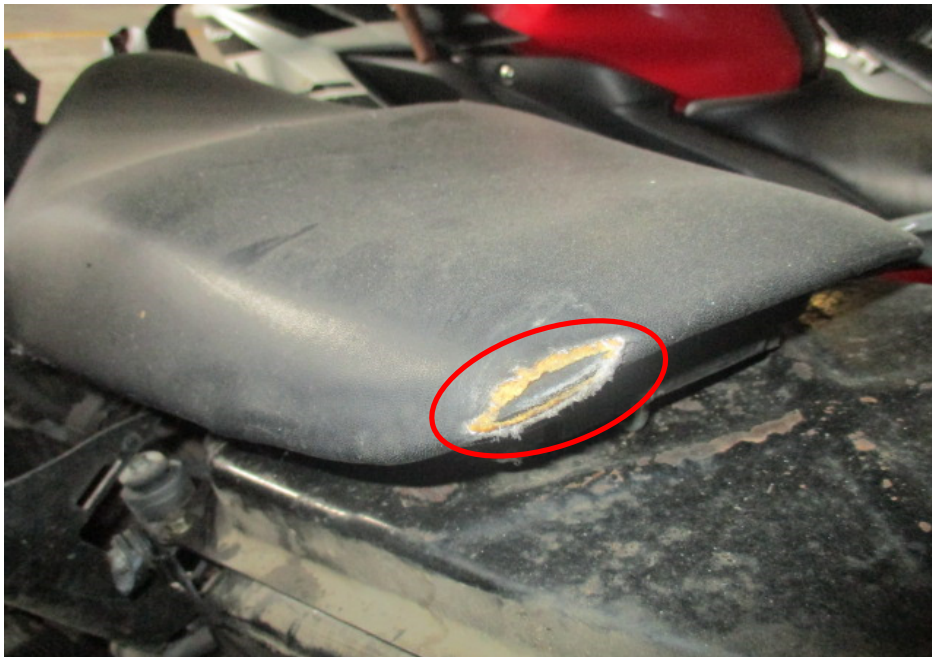
Photo 13 shows the seat of the Motorcycle which was observed to be torn as a result of the accident (circled).

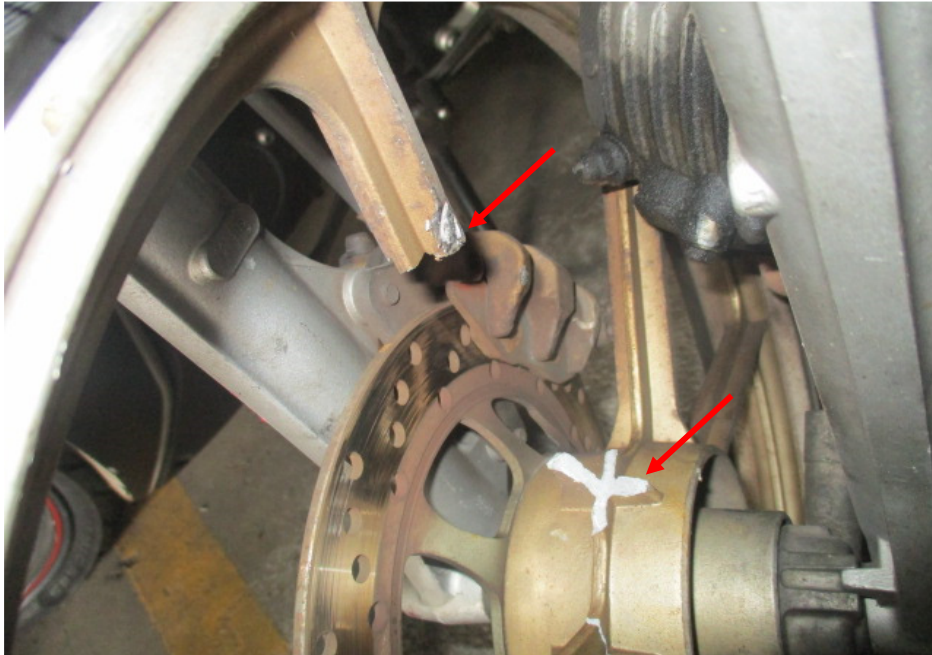
8. The 2 tyres were wrapped around alloy wheel rims. At the time of our inspection, we did not observe any visible damage on the rear wheel rim of the Motorcycle. However we did observe that the front wheel rim was broken. See photos 1 – 17 below.

Photo 14 shows the broken front wheel rim (arrowed) of the Motorcycle at the time of our inspection.

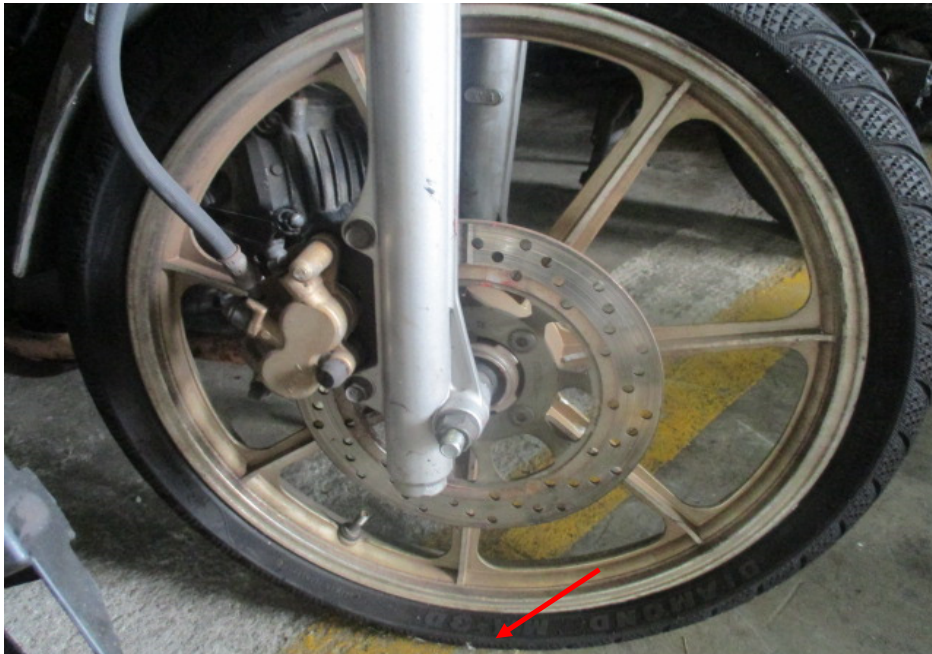
Photo 15 shows the front tyre of the Motorcycle at the time of our inspection. We observed that the front tyre was punctured (arrowed).

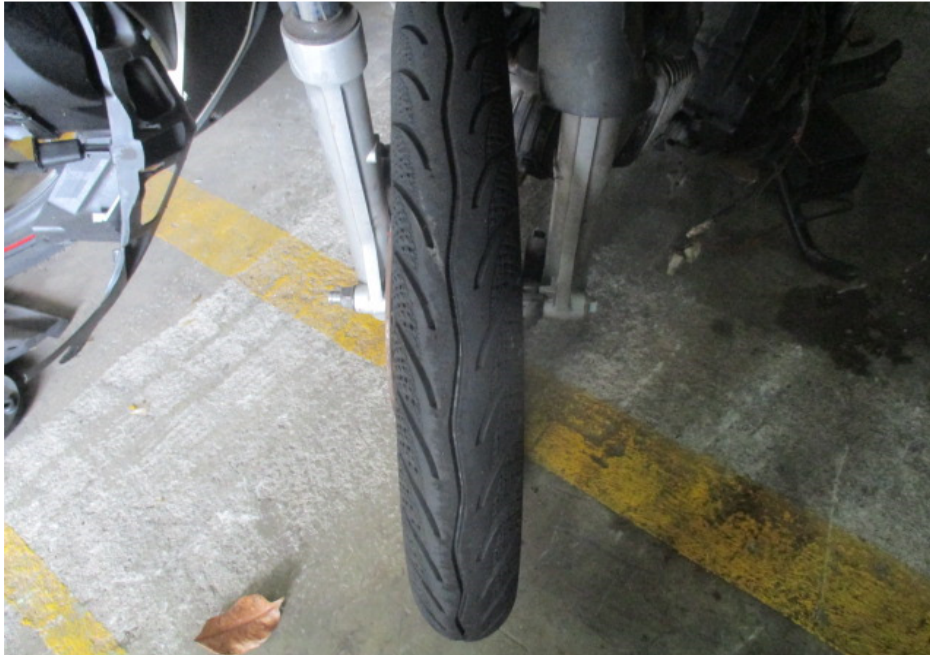
Photo 16 shows the condition of the Motorcycle's front tyre. The front tyre was observed to be in serviceable condition with remaining tread depth of approximately 3mm. The tyre was observed to be punctured. However we did not observe any tear and/or burst mark(s) on the sidewalls as well as across the tread of the front tyre.

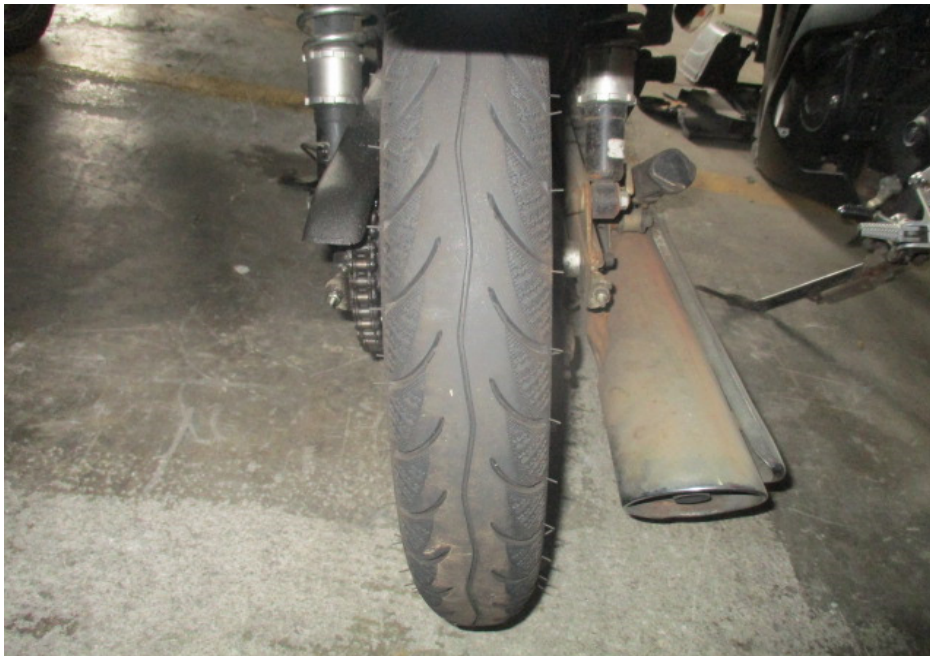
6. The condition of the Motorcycle's rear tyre was observed to be in serviceable condition. The tread pattern of the front tyre was clearly visible. We did not observe any tear, burst mark(s) and/or punctured hole(s) on the sidewalls as well as across the tread of front tyre. The rear tyre was observed to be sufficiently inflated for vehicular operation.

Photo 17 shows the condition of the Motorcycle's rear tyre. The rear tyre was observed to be in serviceable condition with remaining tread depth of approximately 3mm. The tyre was also observed to be sufficiently inflated for vehicular operation. We did not observe any tear, burst mark(s) and/or punctured hole(s) on the sidewalls as well as across the tread of the rear tyre.

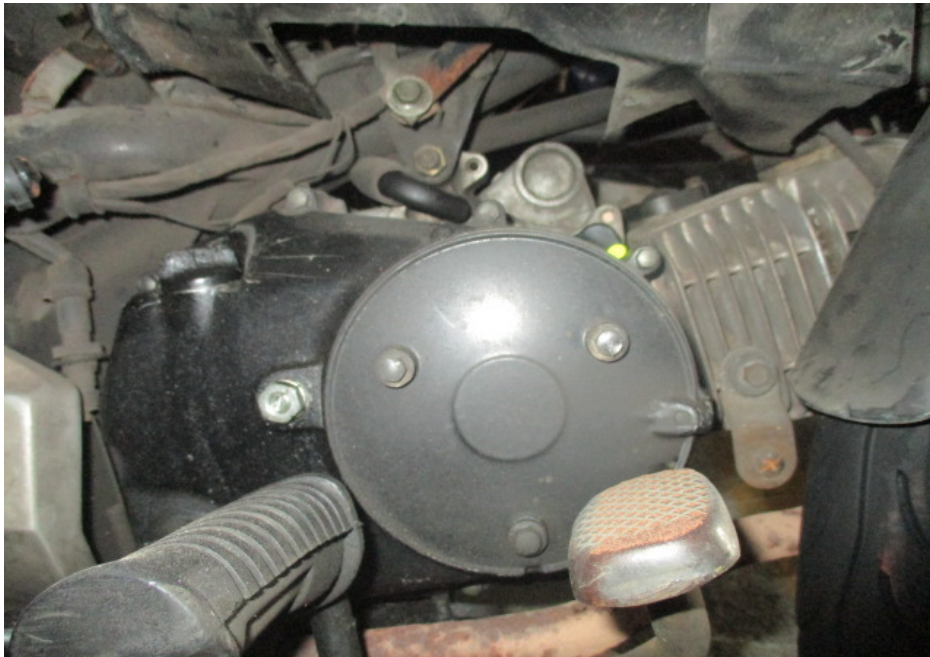
Photo 18 shows the right side of the engine of the Motorcycle at the time of our inspection. The various engine related parts and components were found to be intact with no visible damage. There was also no sign(s) or indication(s) of fluid leak observed around the right engine area of the Motorcycle.

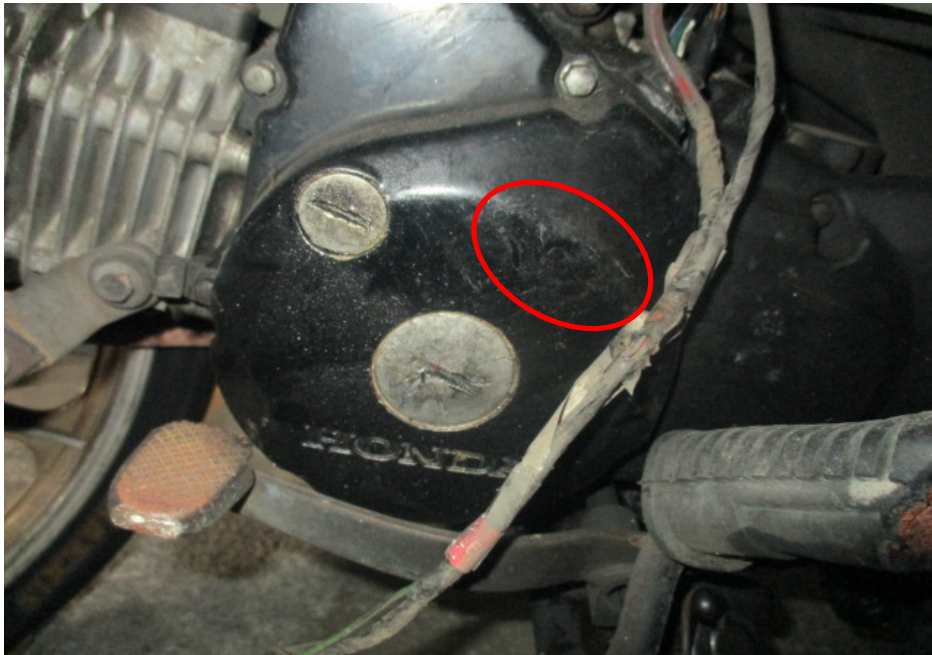
Photo 19 shows the left side of the engine of the Motorcycle at the time of our inspection. The various left engine components had sustained damage of grazing nature as a result of the accident (circled) however the engine components were still intact. There was also no fluid leak and/or fluid stain found around the left engine area of the Motorcycle.

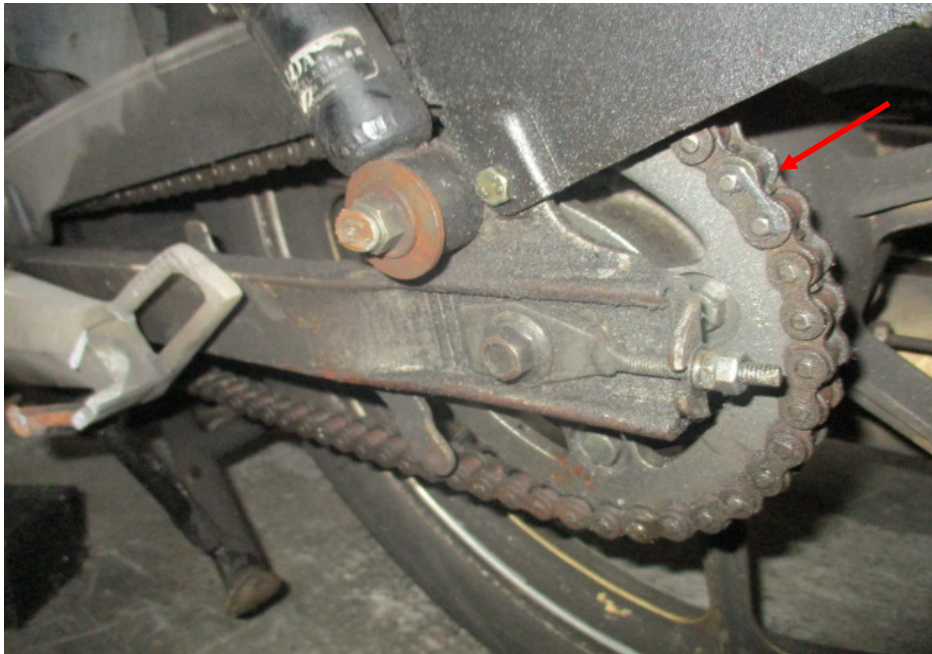
Photo 20 shows the general view of the gear train (arrowed) of the Motorcycle, which was observed to be intact with no misalignment. It was also adequately lubricated for operating purposes.

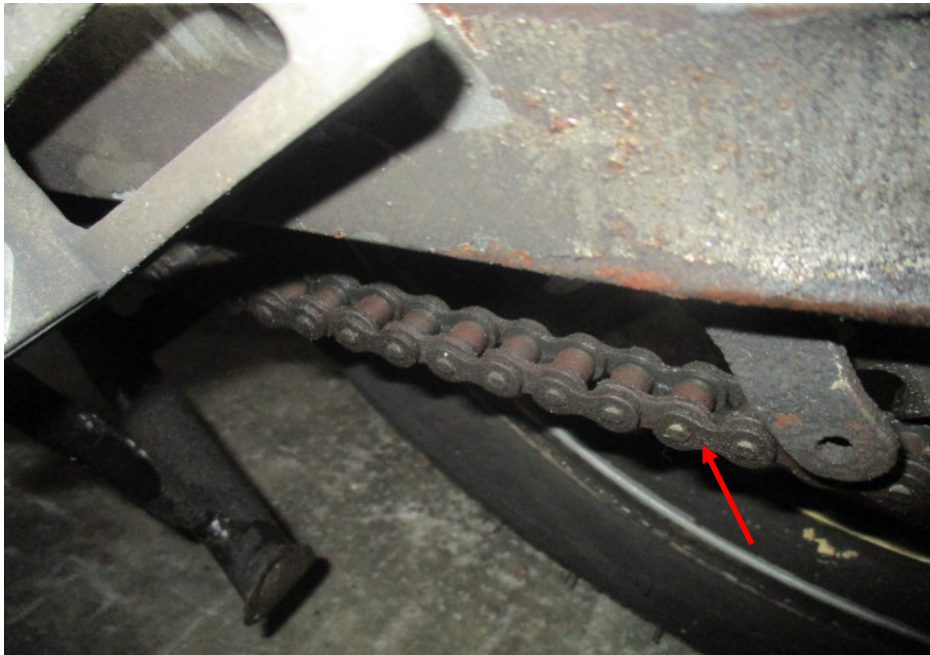
Photo 21 shows a closer view of the gear train (arrowed) of the Motorcycle, which was observed to be intact with no misalignment. It was also adequately lubricated for operating purposes.

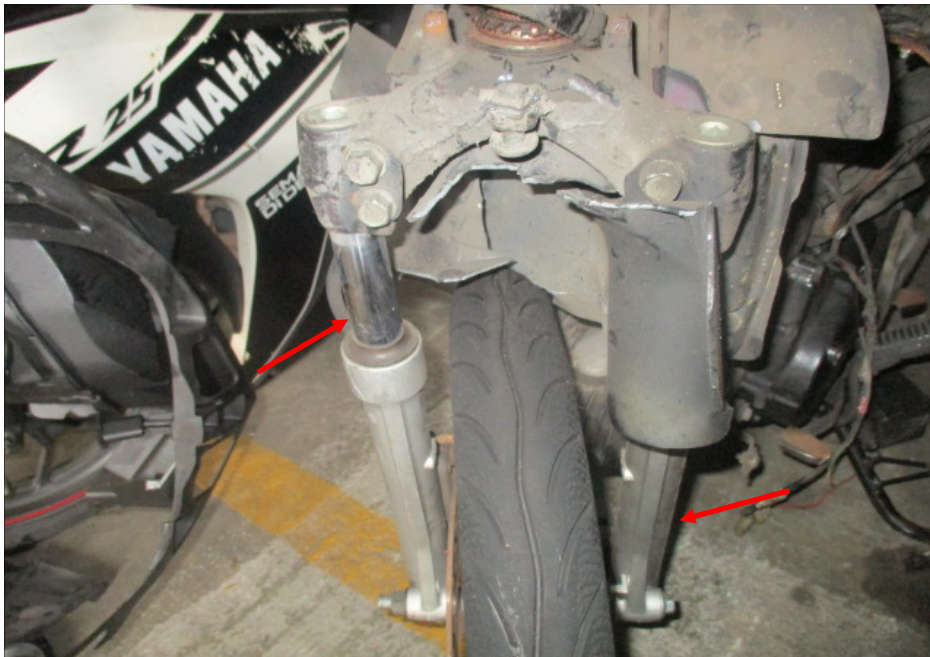
11. For this case, we were not able to conduct any test(s) on the steering system of the Motorcycle due to the damage of its front fork. The front fork was found to be bent inwards as a result of the accident.

Photo 22 shows the front fork of the Motorcycle. The front fork (arrowed) was observed to be bent inwards as a result of the accident. We were hence not able to conduct any tests on the steering system of the Motorcycle.

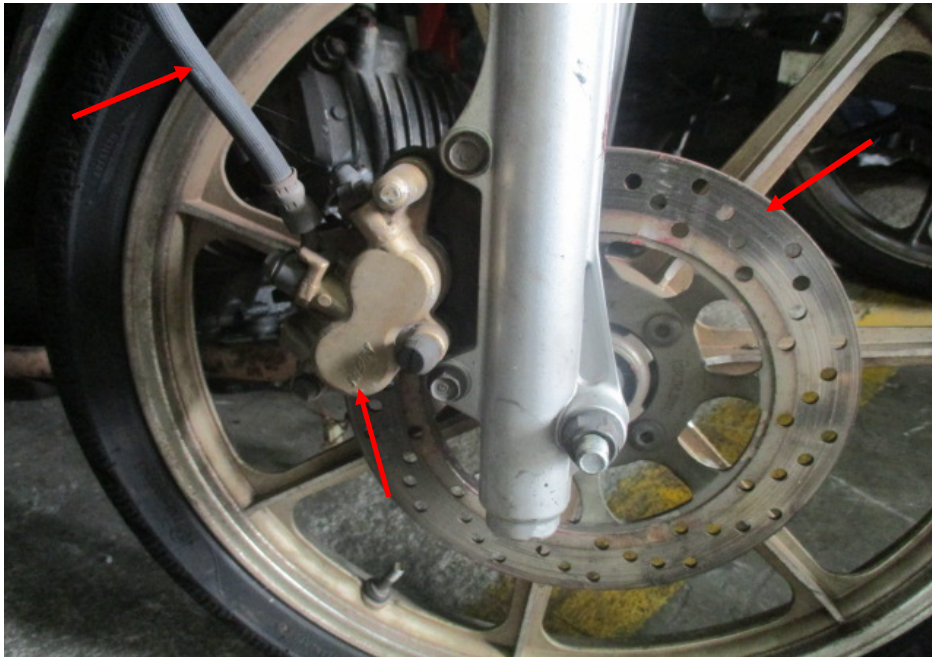
Photo 23 shows a close up view of the front brake caliper, front brake disc and front brake hose (arrowed) of the Motorcycle, which are all part of the components in the hydraulic front brake system of the Motorcycle. Our visual checks of these various components had revealed all to be intact with no visible damage. No leakage of brake fluid was also observed.

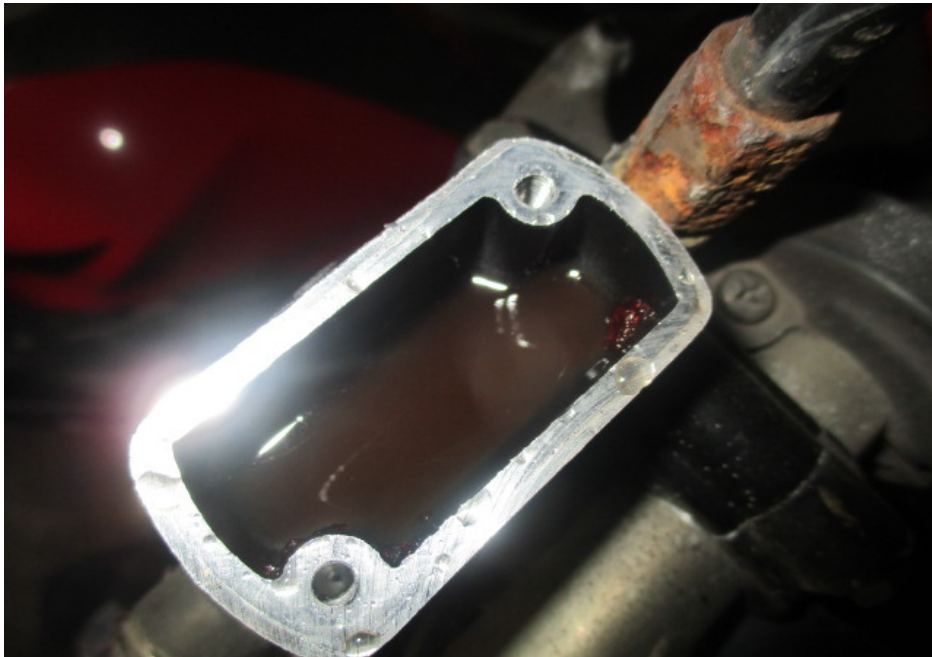
Photo 24 shows the brake fluid reservoir for the front brake of the Motorcycle. The brake fluid was observed to be of sufficient level and without contamination for operational purposes.

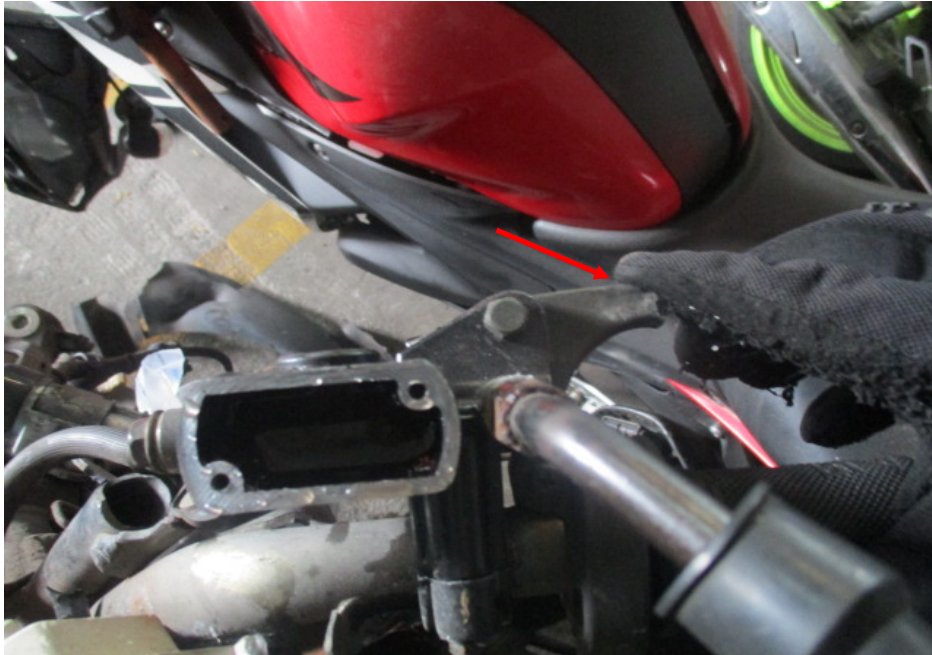
13. Static brake tests conducted on the Motorcycle had appear to indicate that the braking system of the Motorcycle was in serviceable condition. There was some resistance felt (spongy like feel) upon pressing the brake lever. This would indicate that there was no leakage of pressure/vacuum in the brake system. Our checks on the brake fluid for the front brake of the Motorcycle was revealed to be of sufficient level and without contamination for operational purposes.

Photo 25 shows the front brake lever being depressed. There was some resistance felt (spongy like feel) upon pressing the front brake lever (arrowed). This would indicate that there is no leakage of pressure/vacuum in the brake system.

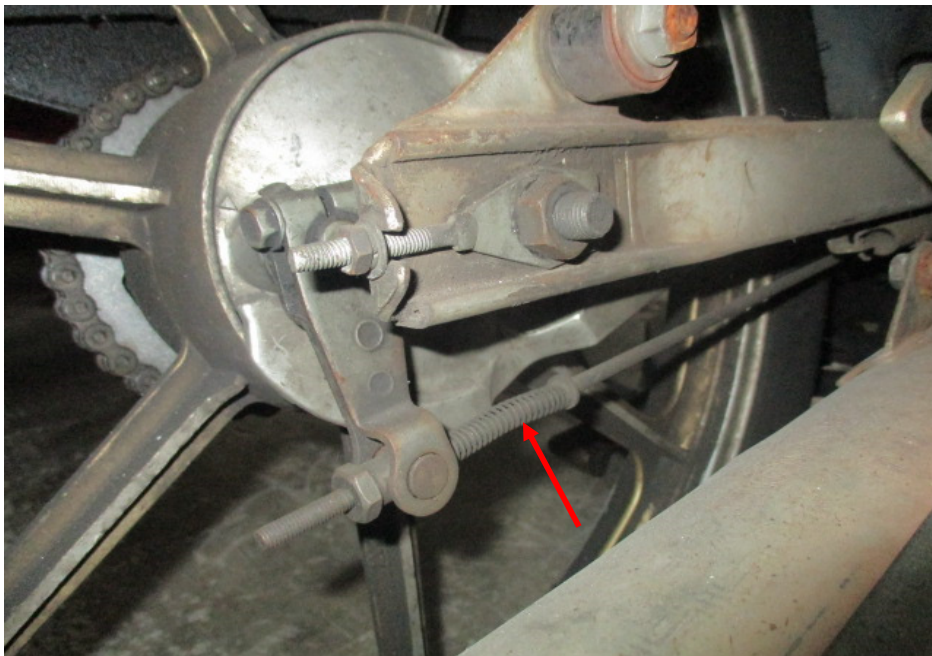
15. We subsequently carried out an operational test of the Motorcycle's rear braking system. This was done by firstly putting the Motorcycle on its main stand. We then proceeded to turn the rear wheel, allowing it to spin freely, simulating the Motorcycle in motion. We thereafter engaged the rear brake pedal of the Motorcycle. At the end of the short operational test, we did not observe any abnormal behaviour of the Motorcycle's rear braking system. The rear wheel of the Motorcycle was able to stop rotating immediately upon depressing the brake pedal. See photos 22 - 26 below.

Photo 26 shows the rear wheel of the Motorcycle. The type of brake system for the rear wheel was of a mechanical type, controlled by the brake foot pedal of the Motorcycle. Our checks of the cable (arrowed), spring and drum which are all part of the components in the rear brake system of the Motorcycle reveal all to be intact and without damage.
