Your Ref: TP/IP/12567/2019
Our Ref : CI/TPD19008253/P

Fatal Accident Investigation Team

MECHANICAL INSPECTION REPORT OF MOTOR CAR SGU 3335X

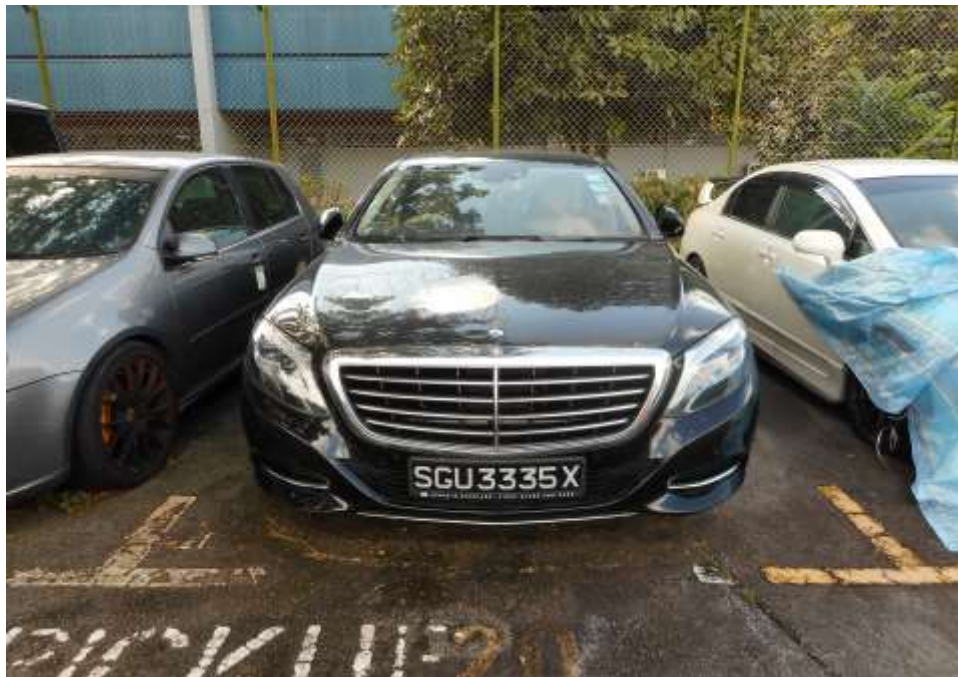
Photo 1 shows a general view of the front body of the Motor Car at the time of my inspection. The Motor car was observed to have sustained relatively minor damage at its right portion. Its rear right door panel were amongst the body parts that were damaged as a result of the accident. The mileage of the Motor Car at the time of my inspection was recorded to be 95,370km.

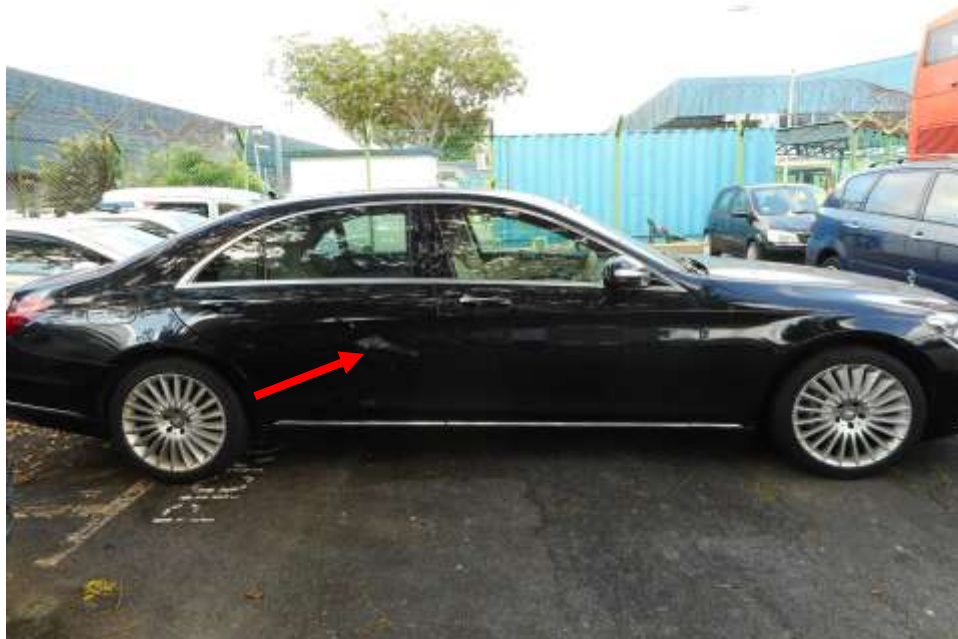
Photo 2 shows a general view of the damaged at its rear right door panel (arrowed) of the Motor Car as a result of the accident.

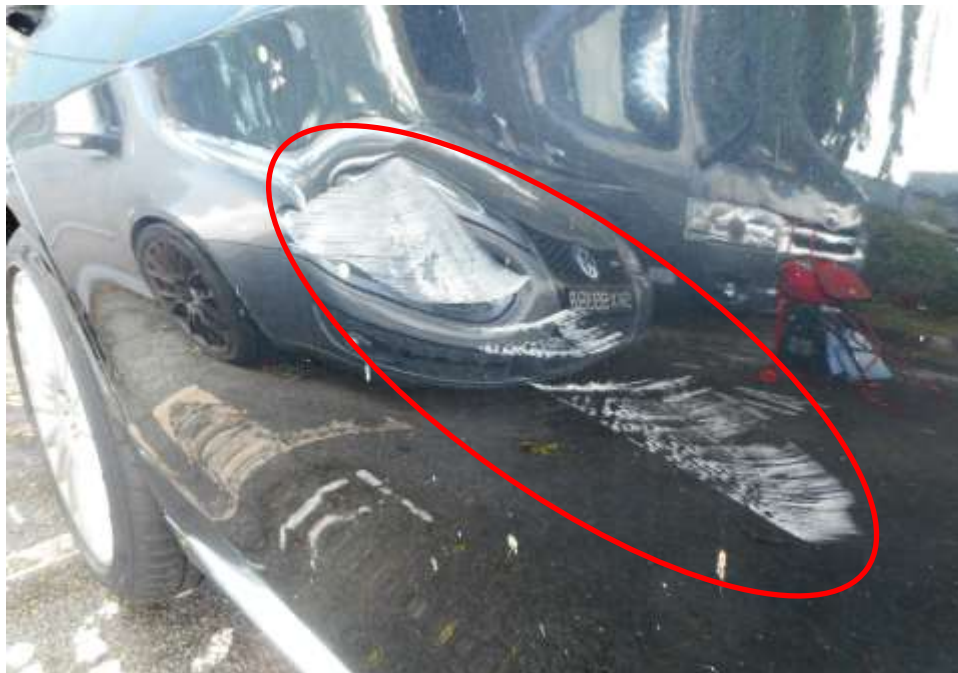
Photo 3 shows a close up view of the damaged at its rear right door panel (circled) of the Motor Car as a result of the accident.

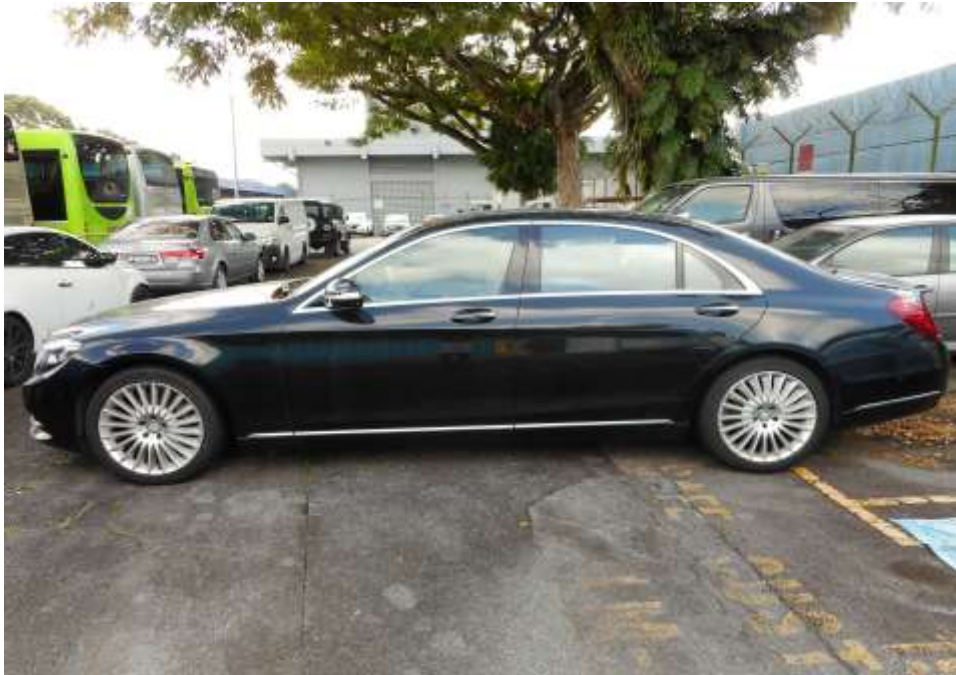
Photo 4 shows a general view of the Motor Car's left side body at the time of my inspection. The left portion of the Motor Car was observed to have been unaffected by the accident.

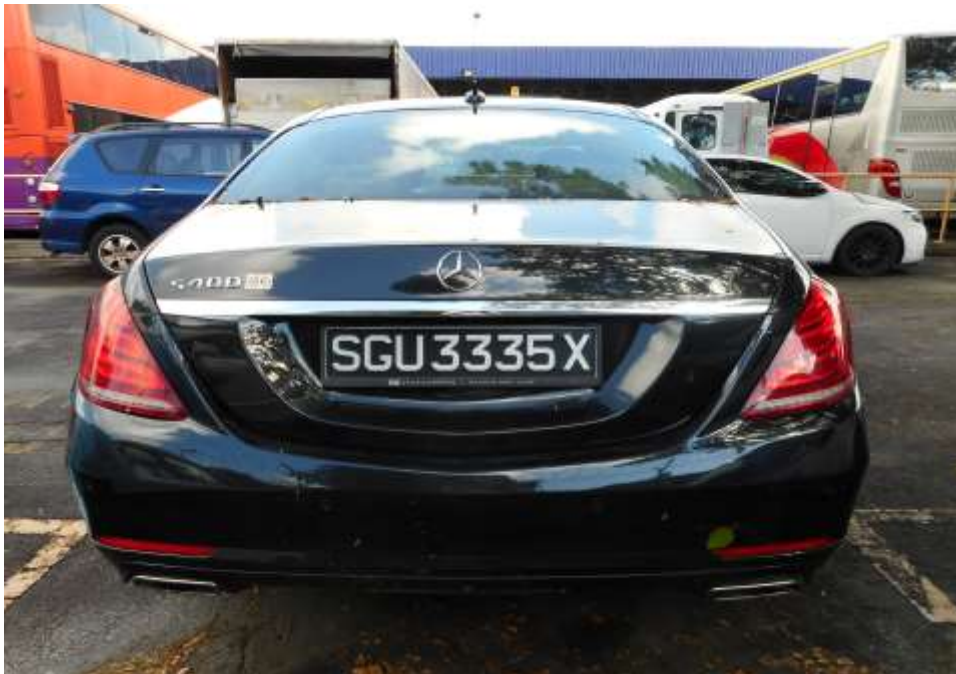
Photo 5 shows a general view of the Motor Car's rear body at the time of my inspection. The rear portion of the Motor Car was observed to have been unaffected by the accident.

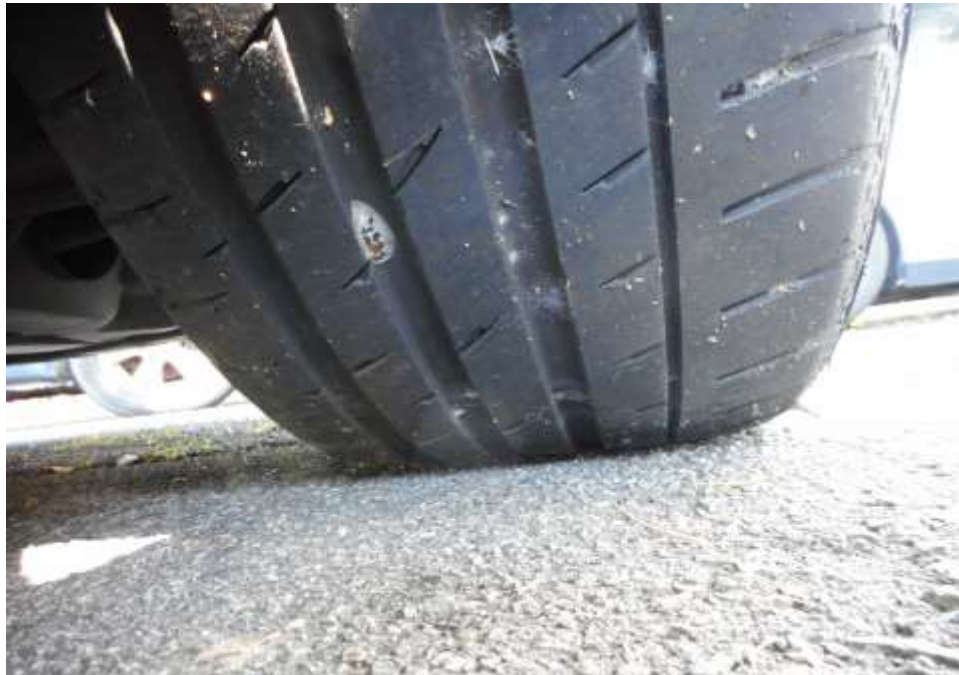
Photo 6 shows the condition of the front right tyre of the Motor Car, which was observed to be in serviceable condition with remaining tread depth of approximately 4.4mm. The tyre was sufficiently inflated for vehicular operation with no tear, cut or burst mark(s) on the outer and the inner sidewalls as well as across the tread. The 4 tyres of the Motor Car were wrapped around standard alloy wheel rims without any damage.

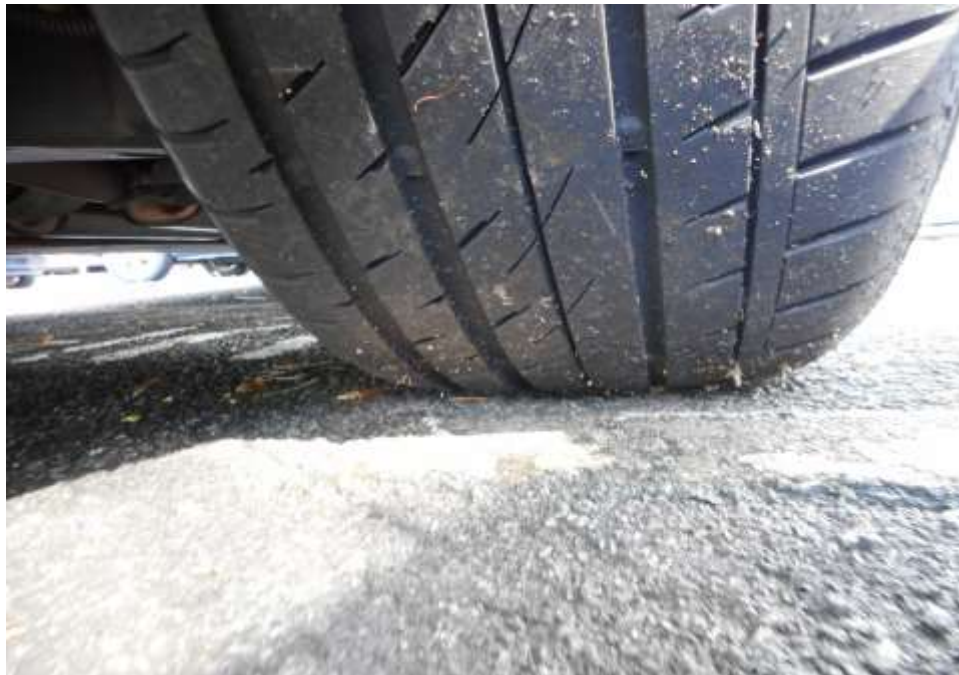
Photo 7 shows the condition of the rear right tyre of the Motor Car, which was observed to be in serviceable condition with remaining tread depth of approximately 6.1mm. The tyre was also observed to be sufficiently inflated for vehicular operation with no tear, cut or burst mark(s).

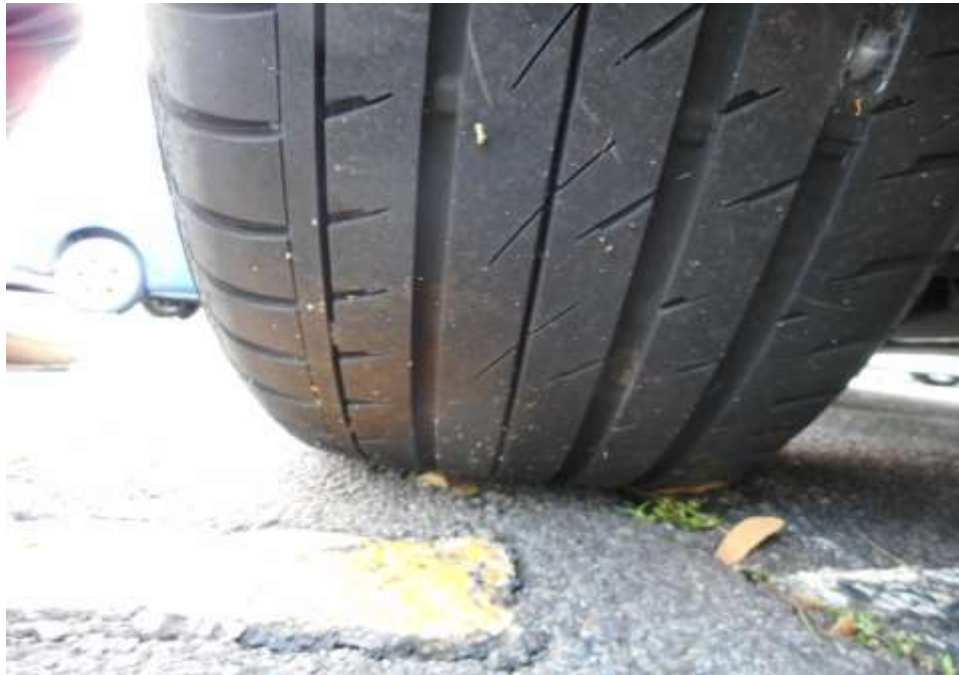
Photo 8 shows the condition of the rear left tyre of the Motor Car, which was observed to be in serviceable condition with remaining tread depth of approximately 6.3mm. The tyre, which was wrapped around alloy wheel rim, was also observed to be sufficiently inflated for vehicular operation. The 4 tyres of the Motor Car were wrapped around standard alloy wheel rims that were without any significant damage apart for some relatively minor kerb grazing type of damage on the outer side of the wheel rims

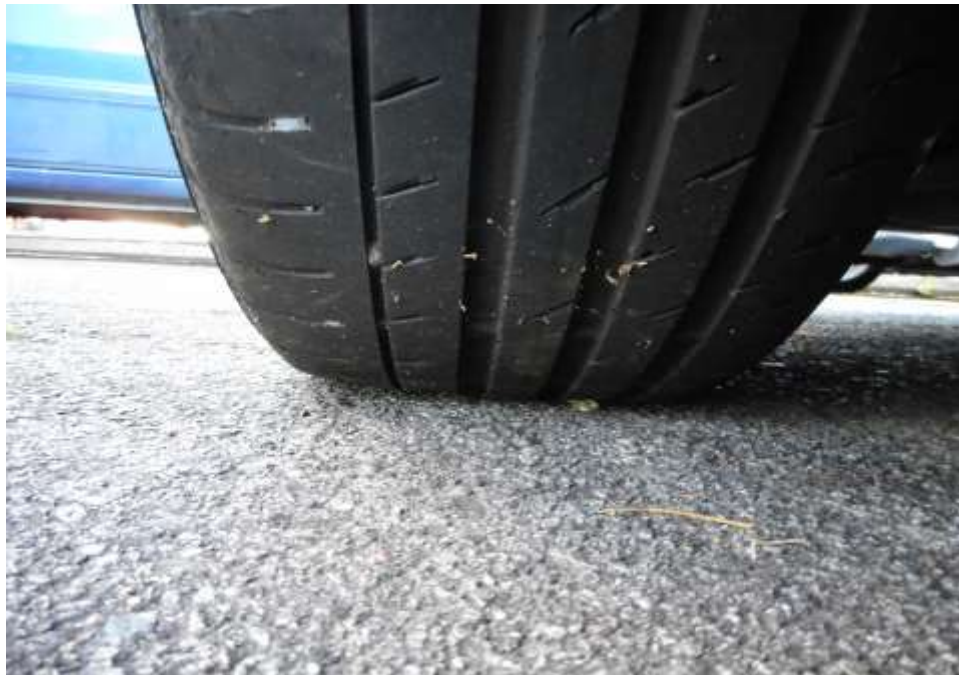
Photo 9 shows the condition of the rear right tyre of the Motor Car, which was observed to be in serviceable condition with remaining tread depth of approximately 4.4mm. There was also no tear, cut or burst mark(s) on the outer and the inner sidewalls as well as across the tread of the Motor Car's 4 tyres.

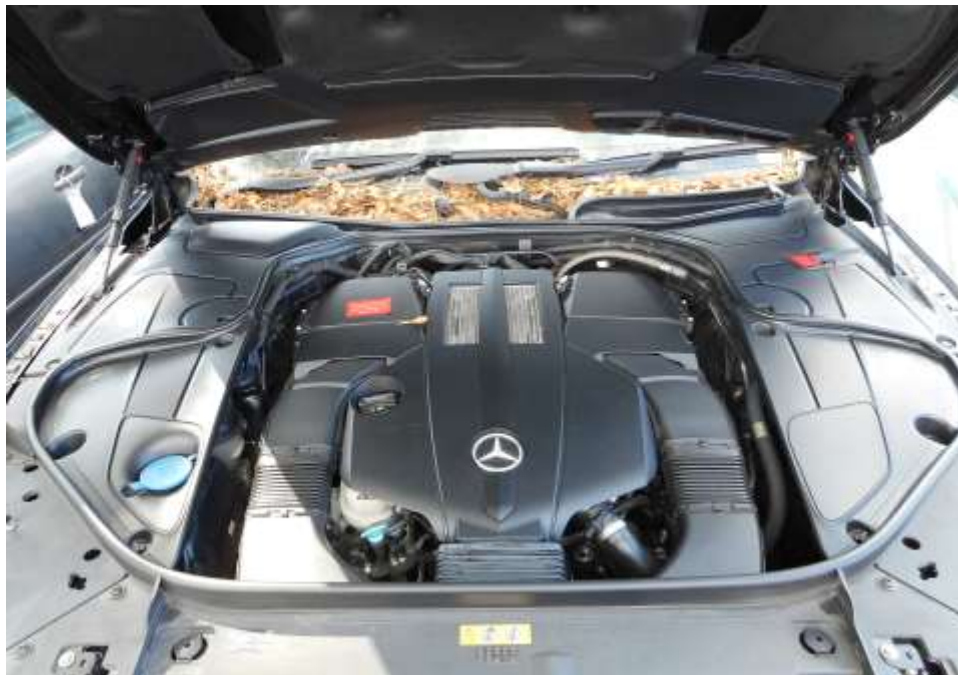
Photo 10 shows a general view of the Motor Car's engine compartment. The various parts and components inside the engine compartment were unaffected by the accident. There was also no sign(s) or indication(s) of fluid leakage and/or fluid stain within the engine compartment.

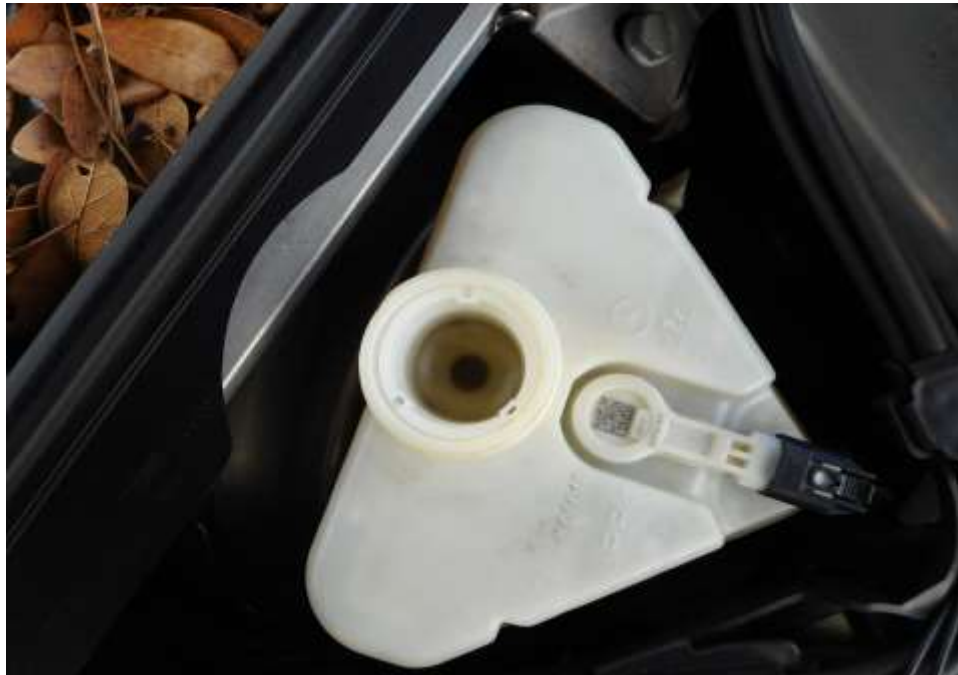
Photo 11 shows the brake fluid reservoir of the Motor Car at the time of my inspection. The brake fluid was observed to be of sufficient level and without any visible contamination.

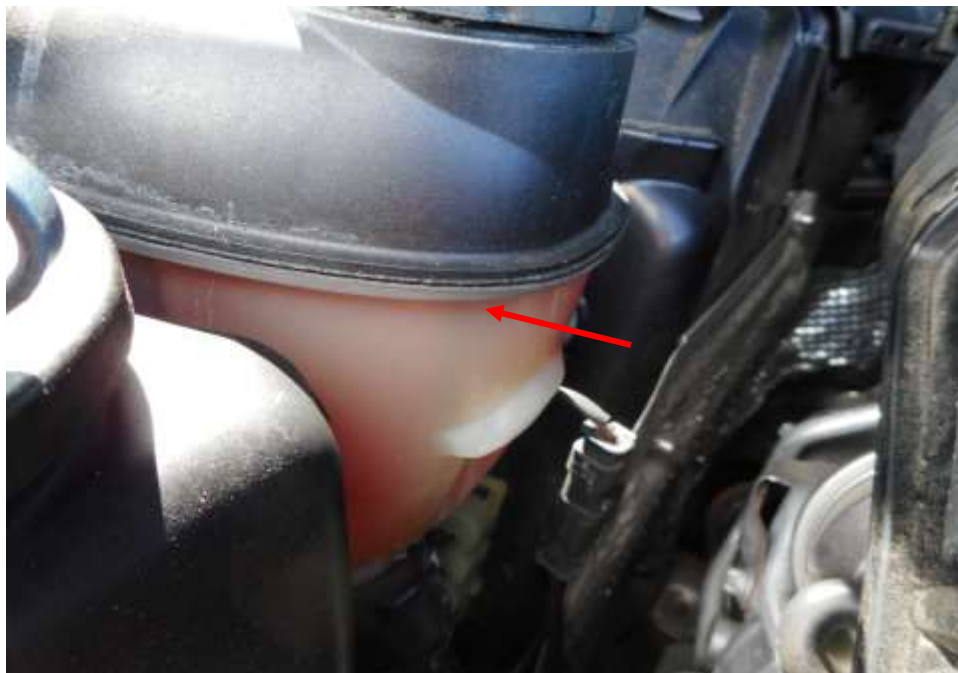
Photo 12 shows checks being carried out to the engine coolant of the Motor Car at the time of my inspection. The engine coolant was observed to be of sufficient level (arrowed) and without any visible contamination.

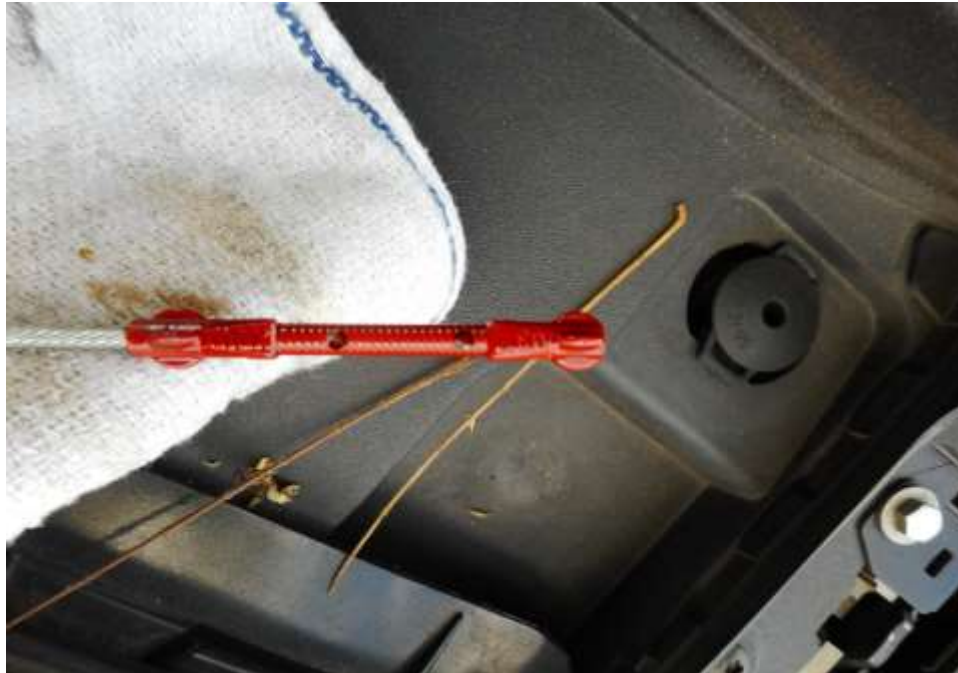
Photo 13 shows the engine oil dip stick of the Motor Car at the time of my inspection. The engine oil was observed to be of sufficient level and without any visible contamination.

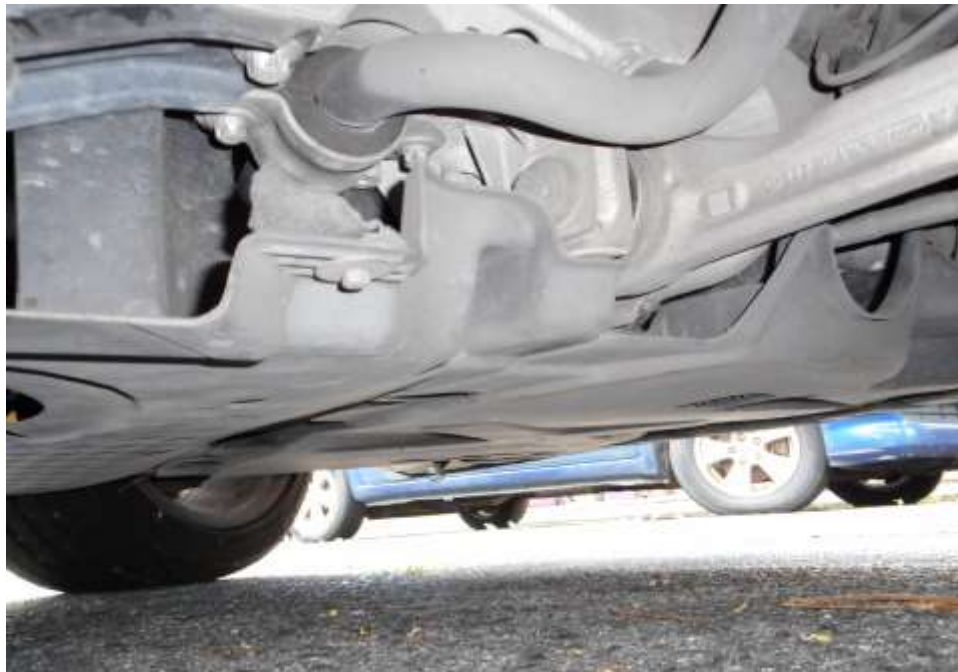
Photo 14 shows the undercarriage of the Motor Car, at the area where the engine housing and transmission housing are located. I did not find any sign(s) or indication(s) of fluid leak and/or fluid stain(s) on the underside of the Motor Car.

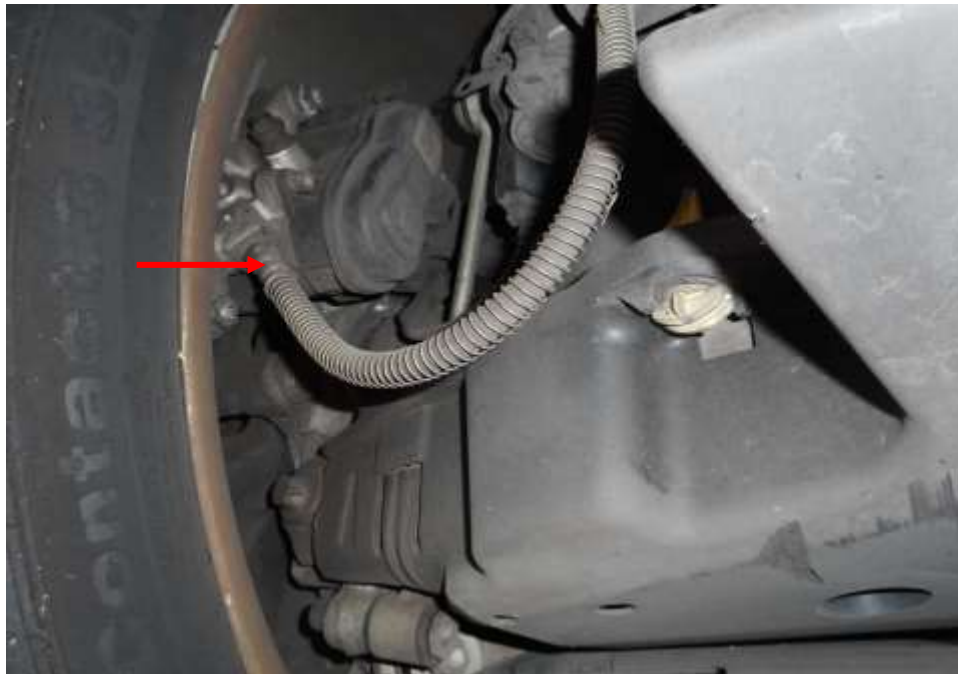
Photo 15 shows the brake hose/pipe (arrowed) at the rear left wheel of the Motor Car. I did not observe any leakage of brake fluid at the time of my inspection of the Motor Car. Static tests of the Motor Car's braking system had indicated that there was no internal leakage of pressure/vacuum. The undercarriage components of the Motor Car were also all found to be intact and without any visible damage.

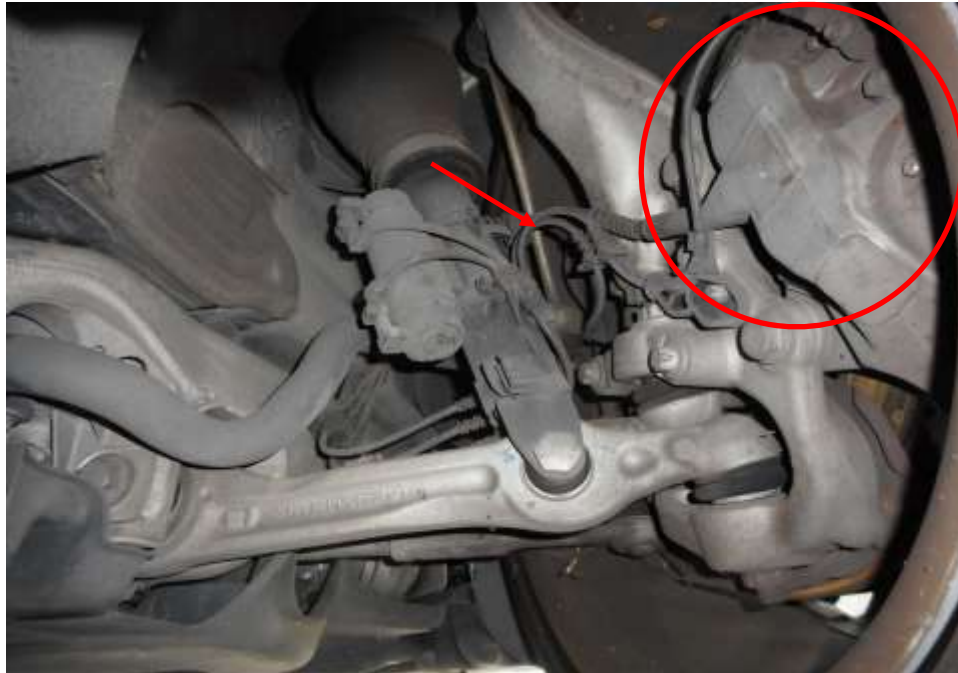
Photo 16 shows the brake hose/pipe (arrowed) at the front right wheel of the Motor Car. No leakage of brake fluid was observed. Visual examination of the various components of the braking system like the brake caliper (circled), brake booster, brake pedal etc had revealed all to be intact and without visible damage.

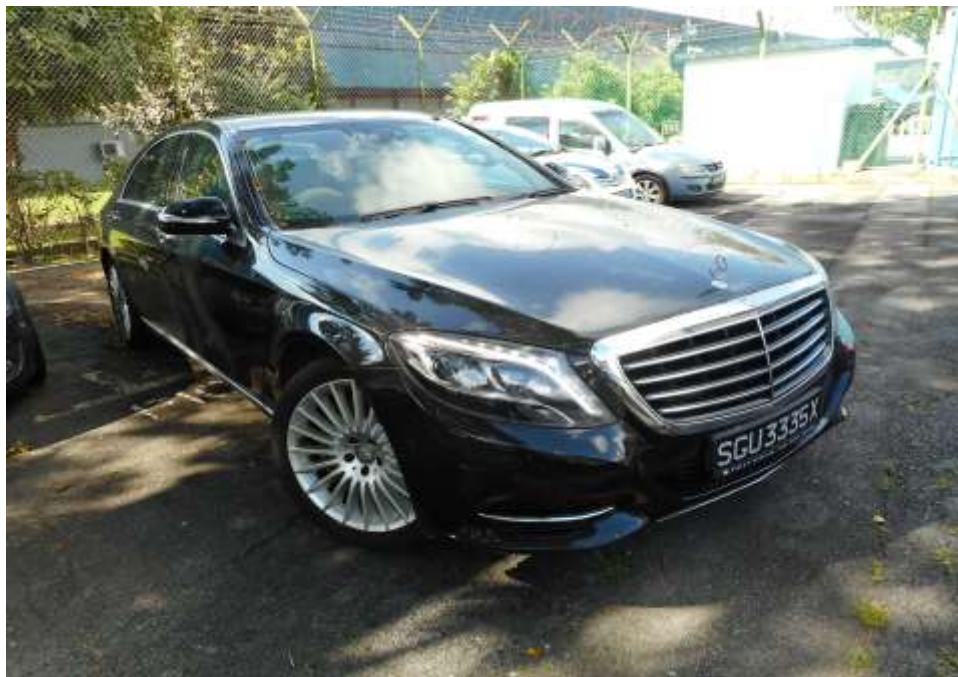
Photo 17 shows the front right wheel of the Motor Car turned to its full left. During my steering system test, I did not experience any abnormal free play and/or resistance when I had turned the steering wheel towards the left and right. This would suggest that the steering system of the Motor Car was likely to be in serviceable condition at the material time of accident.

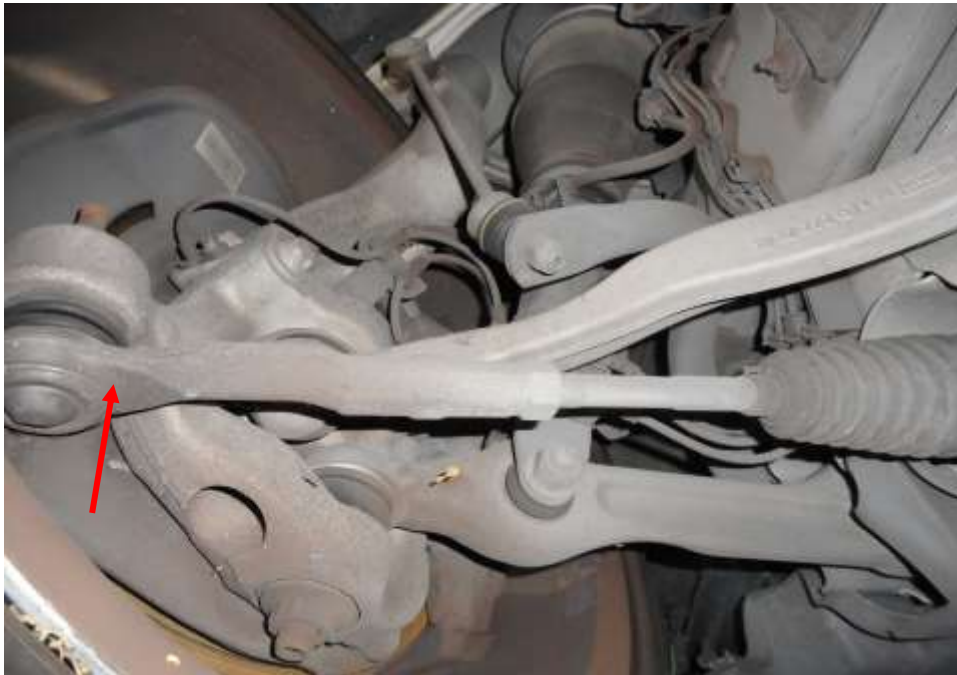
Photo 18 shows the various undercarriage components at the front right wheel of the Motor Car, in particular the steering tie rod (arrowed). The various steering components were all found to be intact, suggesting that the steering system of the Motor Car was likely to be in serviceable condition at the material time of accident. There was also no sign of fluid stain observed on the various undercarriage components at the front right wheel of the Motor Car.

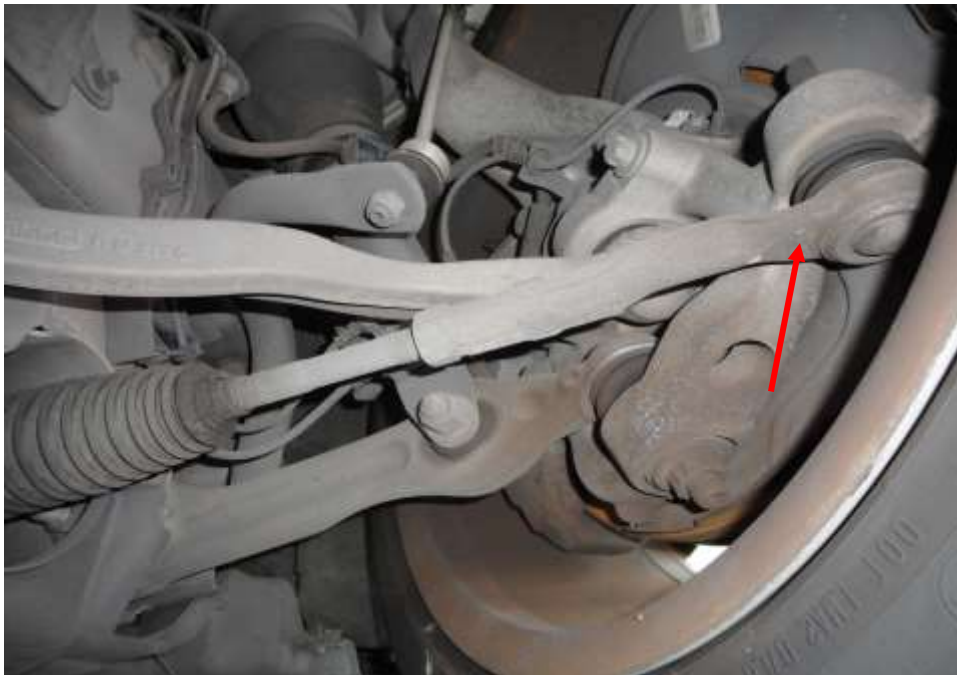
Photo 19 shows the various undercarriage components at the front left wheel of the Motor Car, which had included the steering tie rod (red arrow). The various undercarriage components of the Motor Car were all found to be intact without any visible damage.

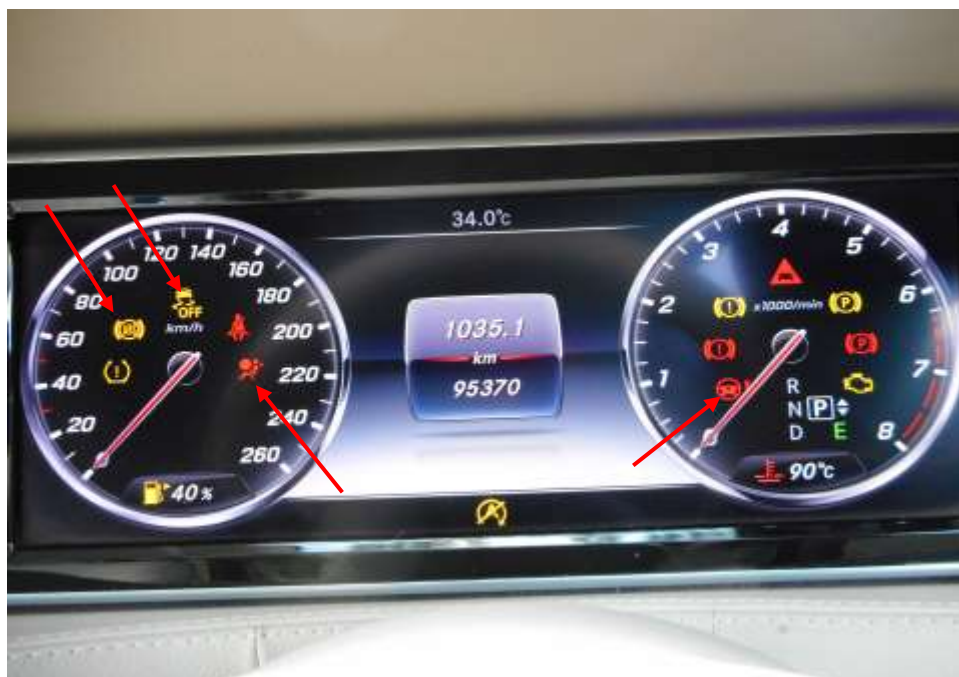
Photo 20 shows the warning light for Anti-Lock Brake System (ABS), Electric Power Steering System (EPS), Traction Control (TC) and Supplemental Restraint System (SRS) appearing on the instrument panel of the Motor Car during the self-test of its various electronic operating systems when its engine was cranked.

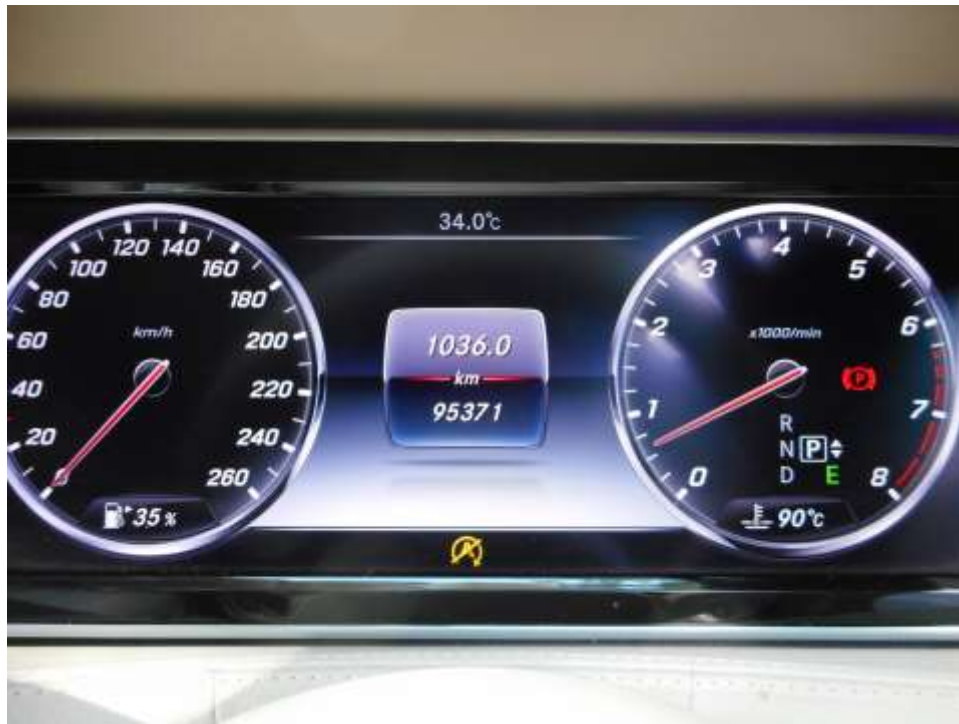
Photo 21 shows no warning lights illuminated on the instrument panel of the Motor Car after the engine was cranked. This would suggest that there was no abnormality to the various electronic operating systems of the Motor Car, like the ABS, EPS, TC and SRS etc.
