Your Ref: TP/IP/012567/2019  
Our Ref : CI/TPD19008254/P

**Fatal Accident Investigation Team**

**MECHANICAL INSPECTION REPORT OF MOTOR TAXI SHD 6208M**

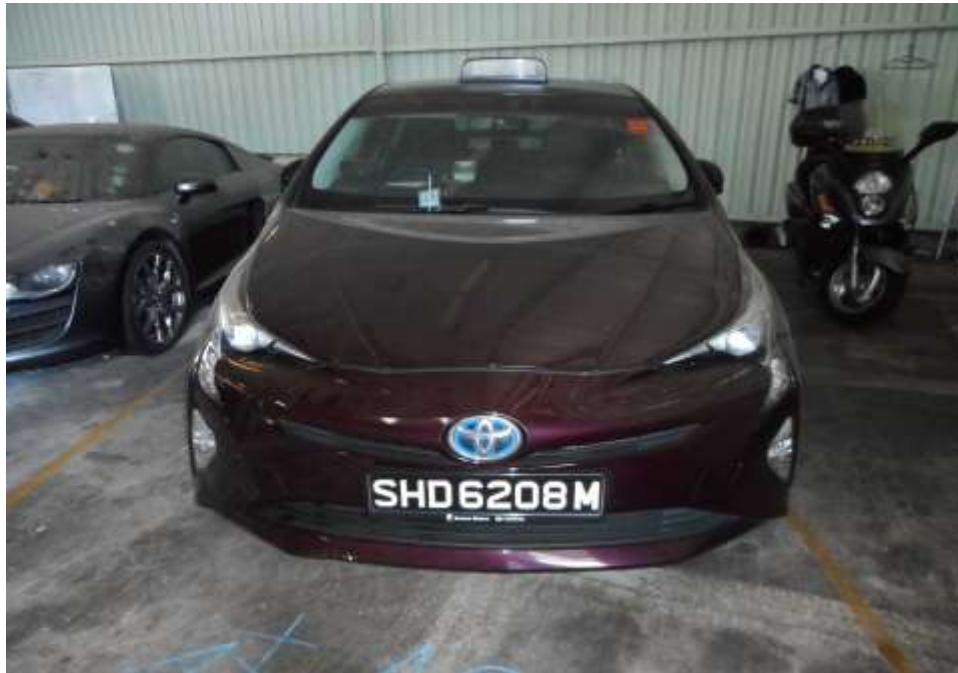
4. The mileage of the Motor Taxi at the time of my inspection was 129,574km.
5. The Motor Taxi was observed to have sustained relatively minor damage at its frontal portion. Its front bumper was amongst the body parts that were damaged as a result of the accident.

**Photo 1** shows a general view of the front right body of the Motor Taxi at the time of my inspection. The Motor Taxi was observed to have sustained relatively minor damage at its frontal portion. Its front bumper was amongst the body parts that were damaged as a result of the accident. The mileage of the Motor Taxi at the time of my inspection was recorded to be 129,574km.

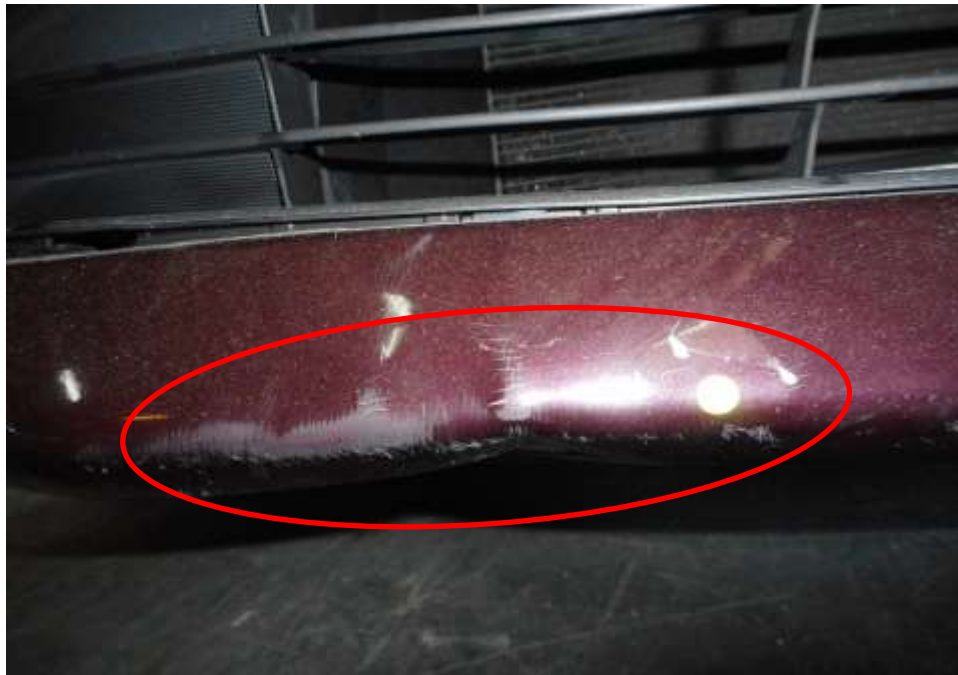
**Photo 2** shows a close up view of the damaged front bumper (circled) of the Motor Taxi as a result of the accident

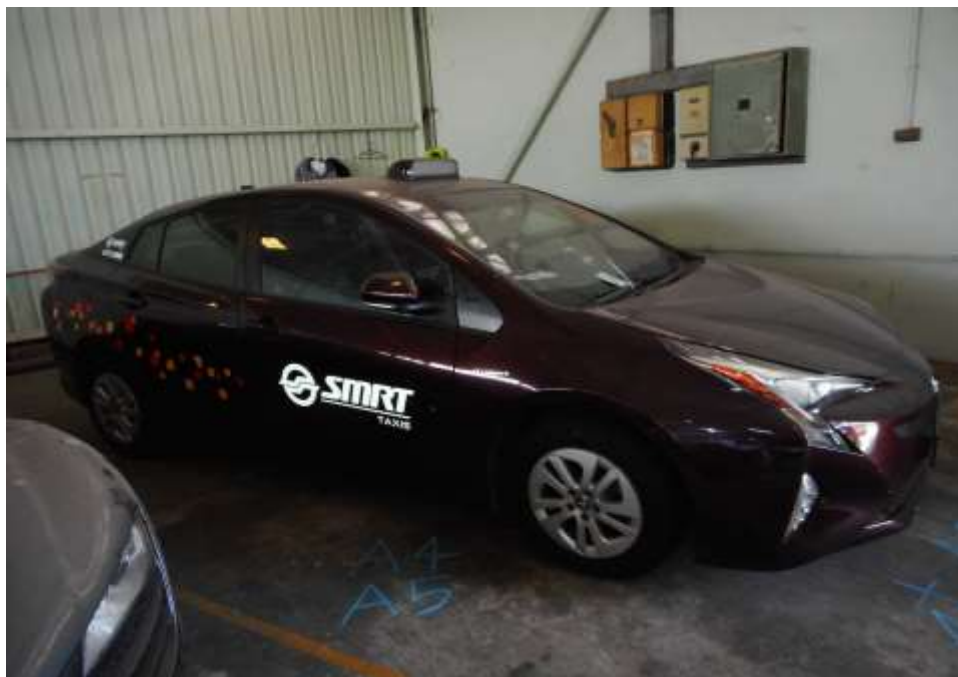
**Photo 3** shows a general view of the Motor Taxi's right body at the time of my inspection. The right portion of the Motor Taxi was observed to have been unaffected by the accident.

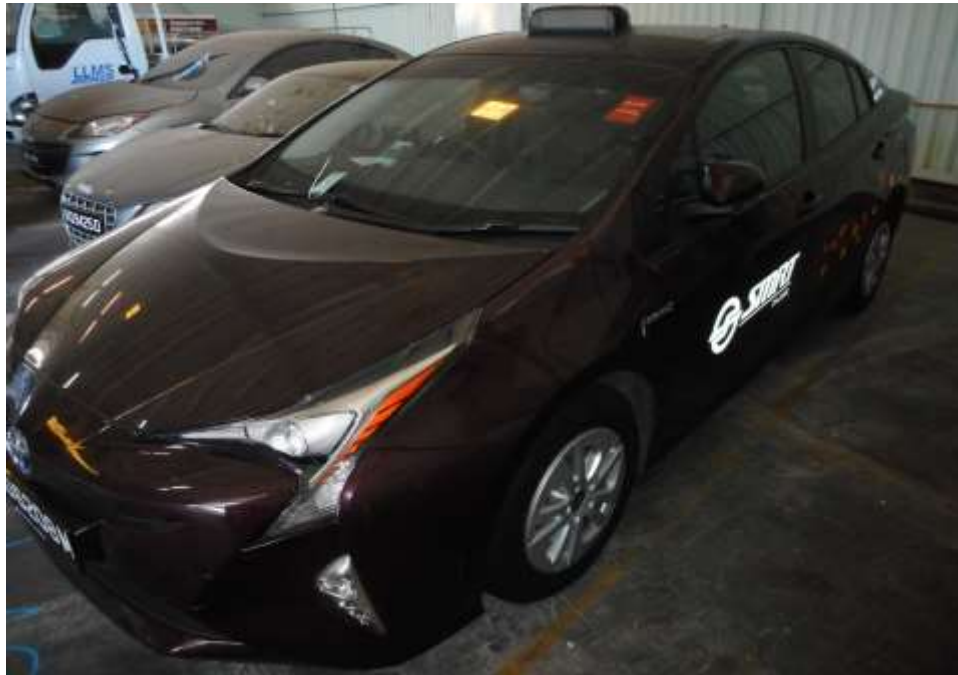
**Photo 4** shows a general view of the Motor Taxi's left body at the time of my inspection. The left portion of the Motor Taxi was observed to have been unaffected by the accident.

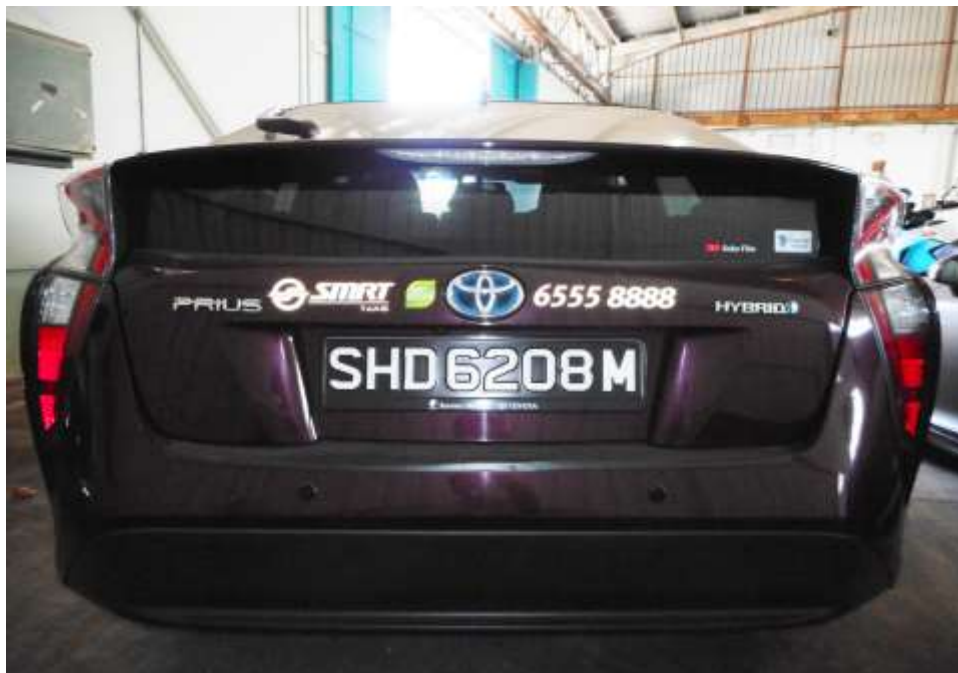
**Photo 5** shows a general view of the Motor Taxi's rear body at the time of my inspection. The rear portion of the Motor Taxi was observed to have been unaffected by the accident.

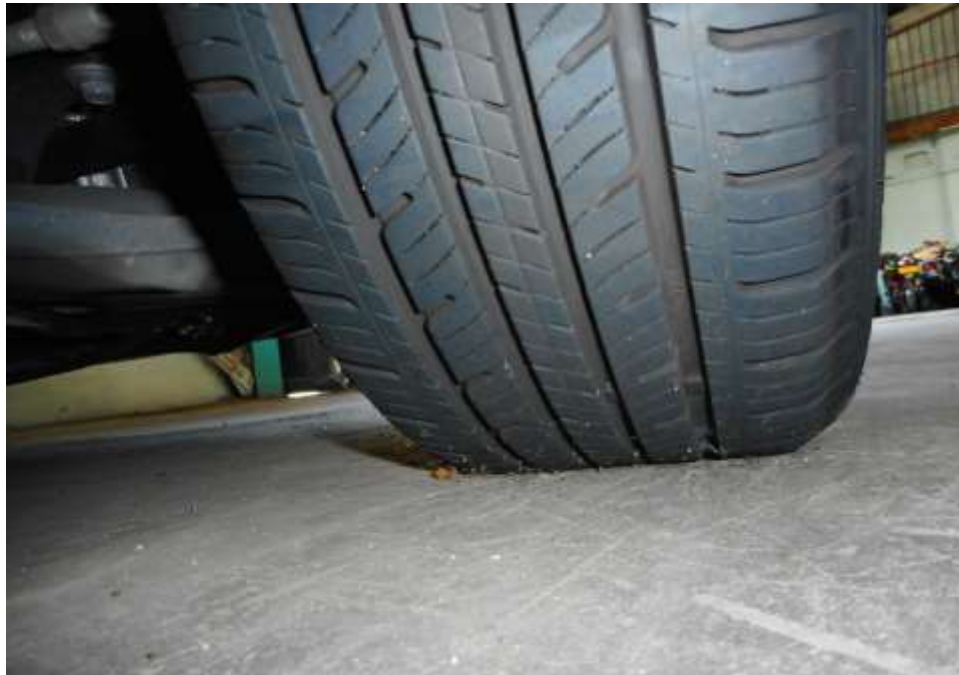
**Photo 6** shows the condition of the front right tyre of the Motor Taxi, which was observed to be in serviceable condition with remaining tread depth of approximately 6.6mm. The tyre was sufficiently inflated for vehicular operation with no tear, cut or burst mark(s) on the outer and the inner sidewalls as well as across the tread. The 4 tyres of the Motor Taxi were wrapped around standard alloy wheel rims without any damage.

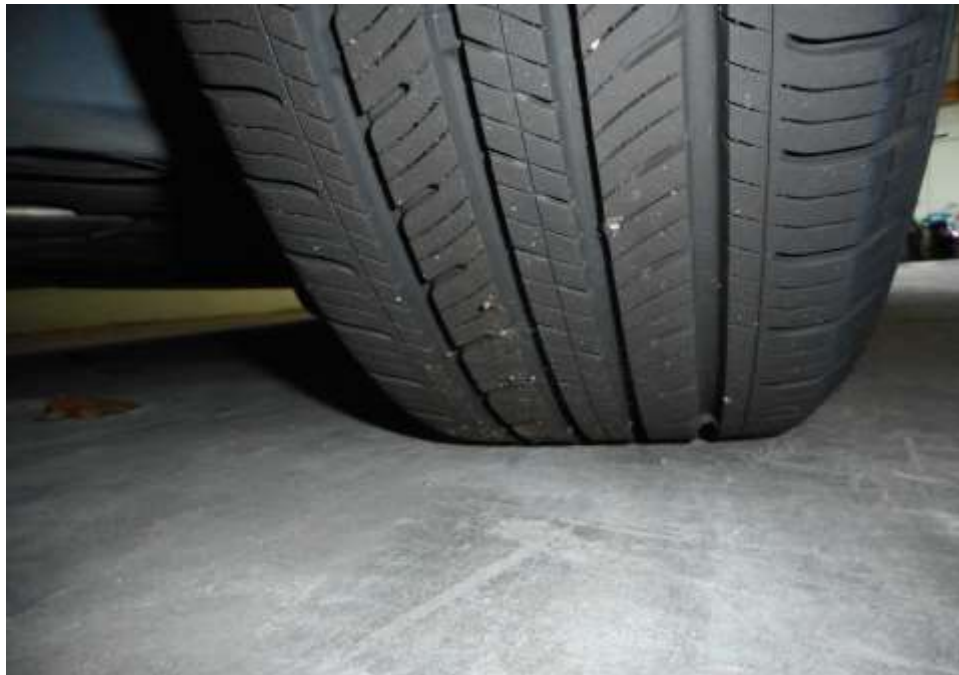
**Photo 7** shows the condition of the rear right tyre of the Motor Taxi, which was observed to be in serviceable condition with remaining tread depth of approximately 6.7mm. The tyre was also observed to be sufficiently inflated for vehicular operation with no tear, cut or burst mark(s).

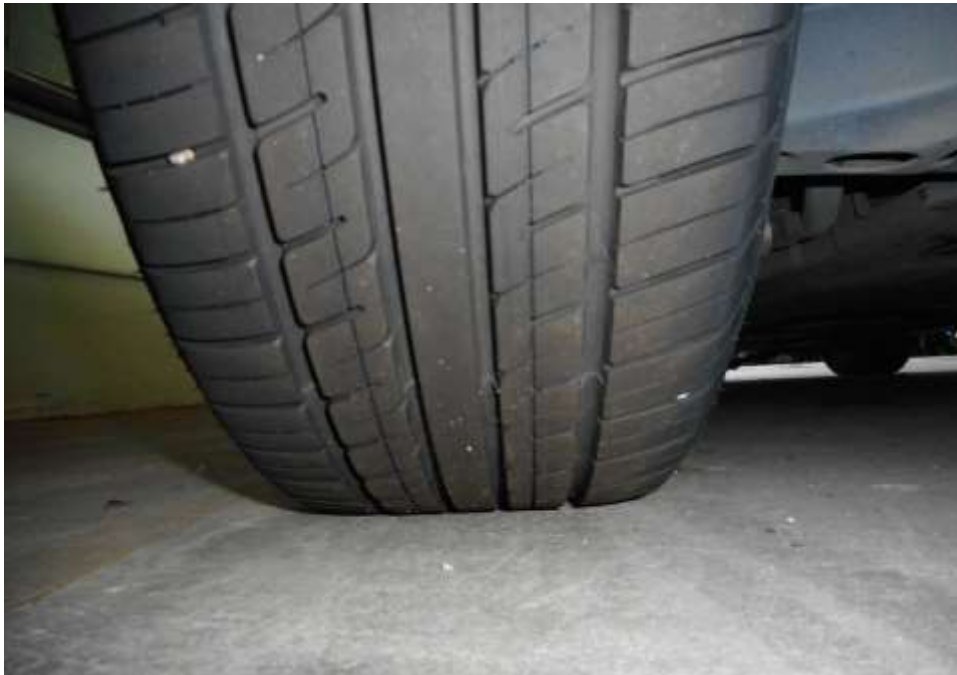
**Photo 8** shows the condition of the rear left tyre of the Motor Taxi, which was observed to be in serviceable condition with remaining tread depth of approximately 6.3mm. The tyre, which was wrapped around alloy wheel rim, was also observed to be sufficiently inflated for vehicular operation. The 4 tyres of the Motor Taxi were wrapped around standard alloy wheel rims that were without any significant damage apart for some relatively minor kerb grazing type of damage on the outer side of the wheel rims

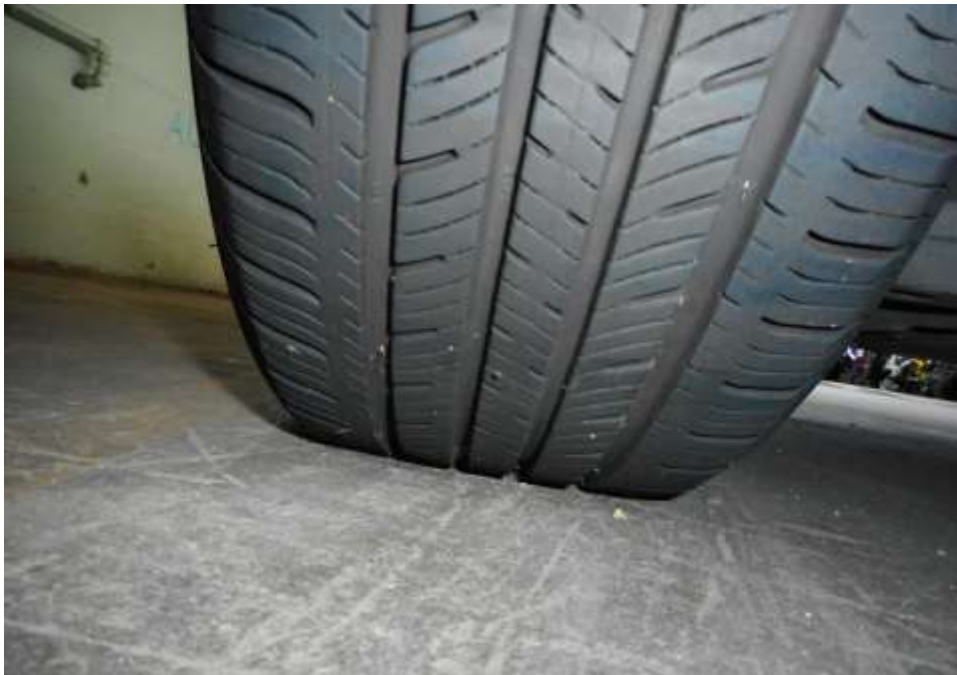
**Photo 9** shows the condition of the front left tyre of the Motor Taxi, which was observed to be in serviceable condition with remaining tread depth of approximately 6.4mm. There was also no tear, cut or burst mark(s) on the outer and the inner sidewalls as well as across the tread of the Motor Taxi's 4 tyres.

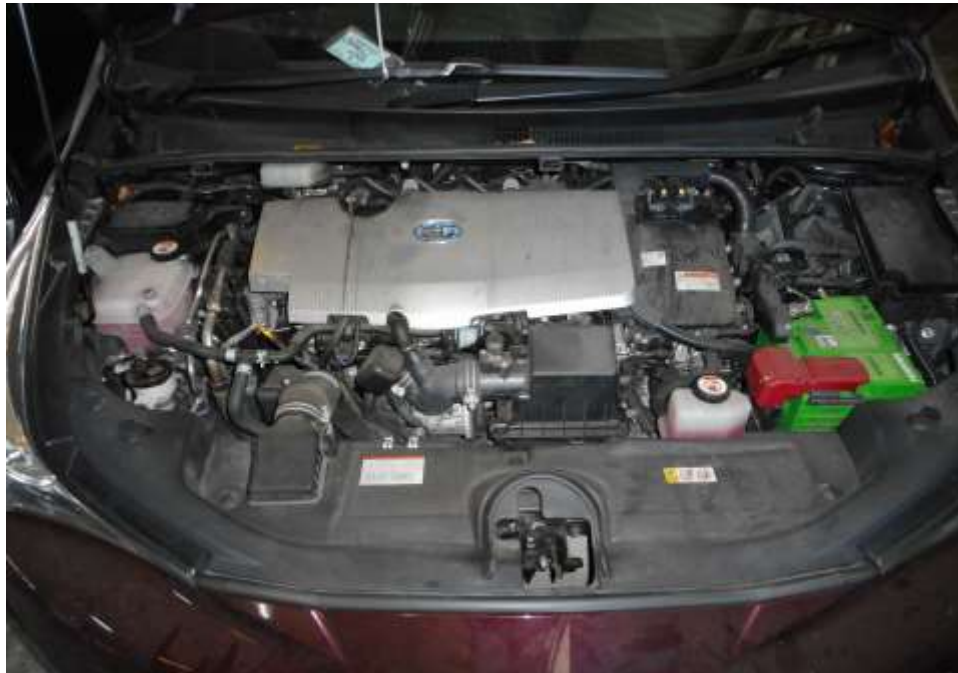
**Photo 10** shows a general view of the Motor Taxi's engine compartment. The various parts and components inside the engine compartment were unaffected by the accident. There was also no sign(s) or indication(s) of fluid leakage and/or fluid stain within the engine compartment.

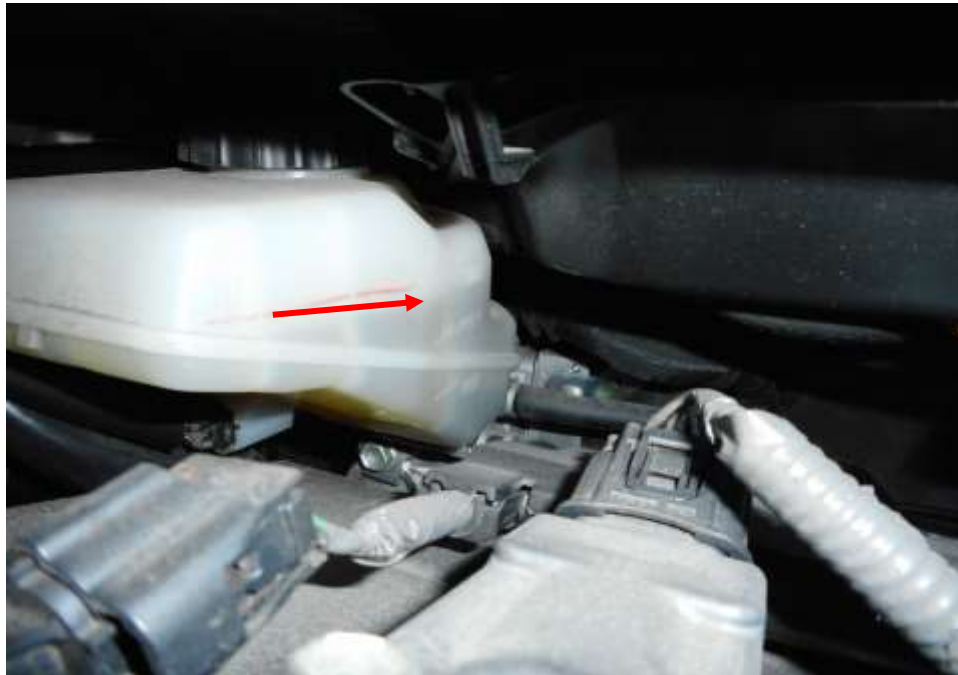
**Photo 11** shows the brake fluid reservoir of the Motor Taxi at the time of my inspection. The brake fluid was observed to be of sufficient level (arrowed) and without any visible contamination.

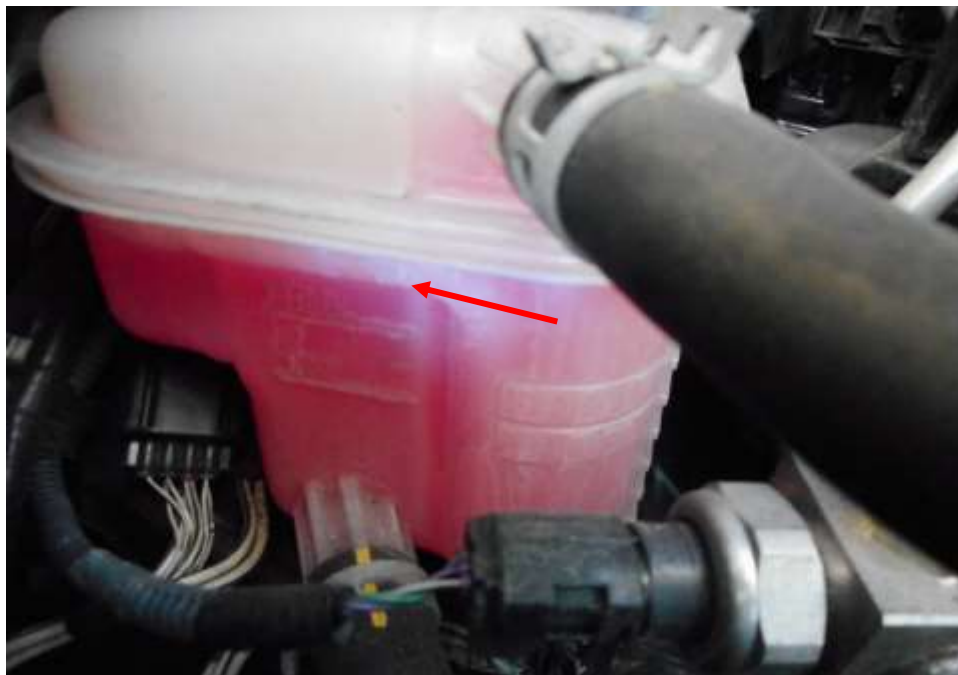
**Photo 12** shows checks being carried out to the engine coolant of the Motor Taxi at the time of my inspection. The engine coolant was observed to be of sufficient level (arrowed) and without any visible contamination.

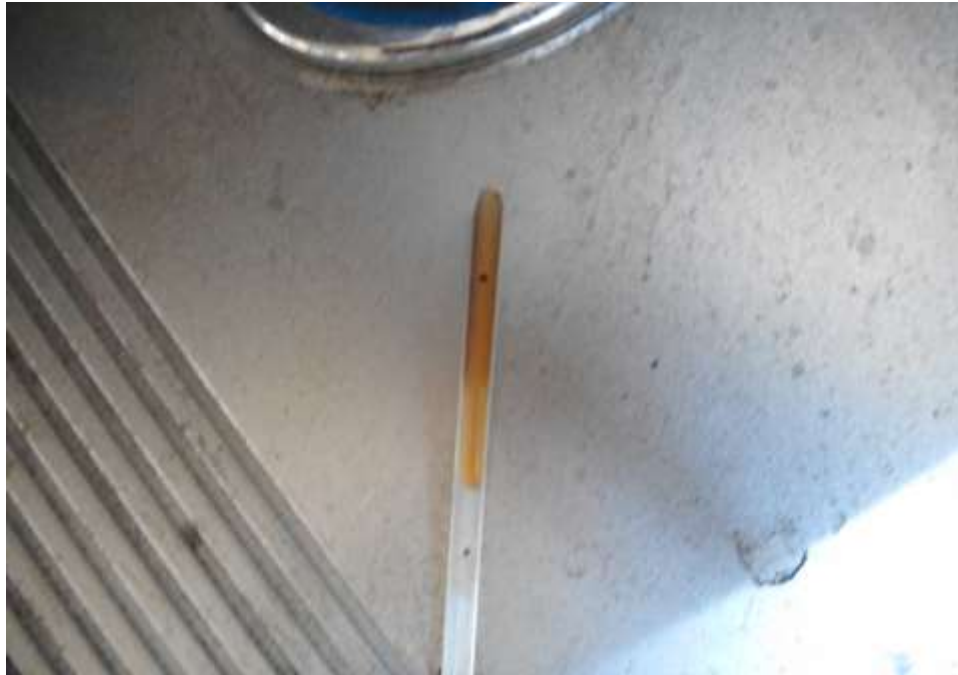
**Photo 13** shows the engine oil dip stick of the Motor Taxi at the time of my inspection. The engine oil was observed to be of sufficient level and without any visible contamination.

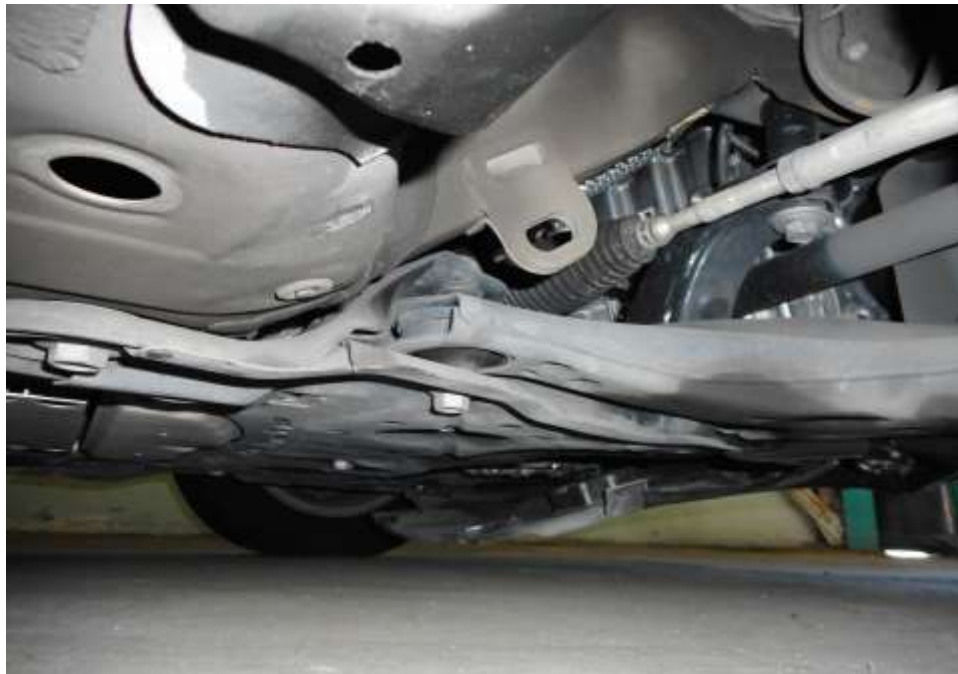
**Photo 14** shows the undercarriage of the Motor Taxi, at the area where the engine housing and transmission housing are located. I did not find any sign(s) or indication(s) of fluid leak and/or fluid stain(s) on the underside of the Motor Taxi.

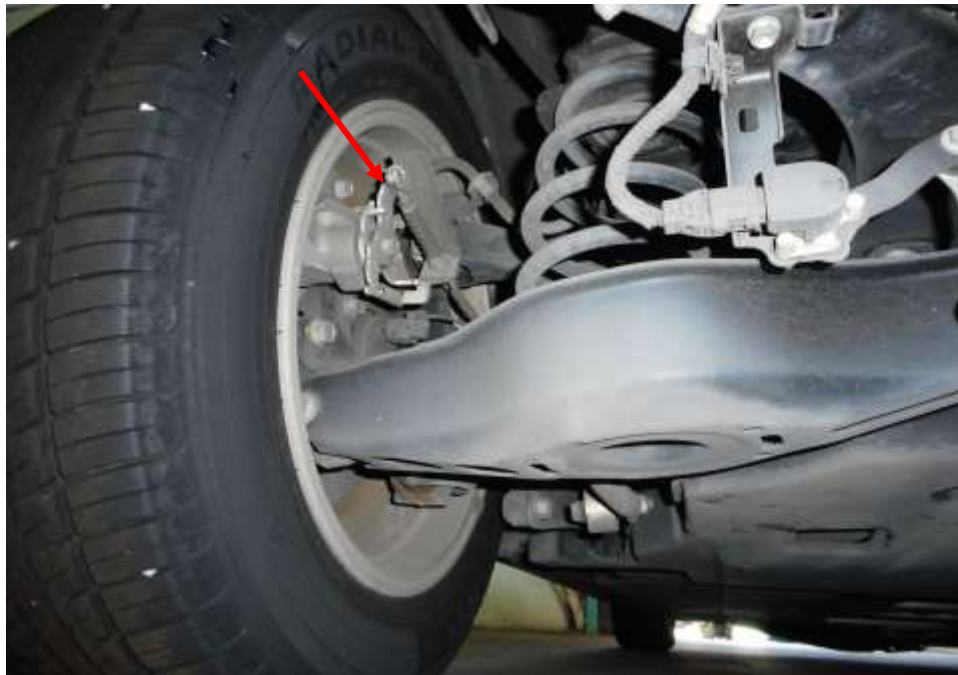
**Photo 15** shows the brake hose/pipe (arrowed) at the rear left wheel of the Motor Taxi. I did not observe any leakage of brake fluid at the time of my inspection of the Motor Taxi. Static tests of the Motor Taxi's braking system had indicated that there was no internal leakage of pressure/vacuum. The undercarriage components of the Motor Taxi were also all found to be intact and without any visible damage.

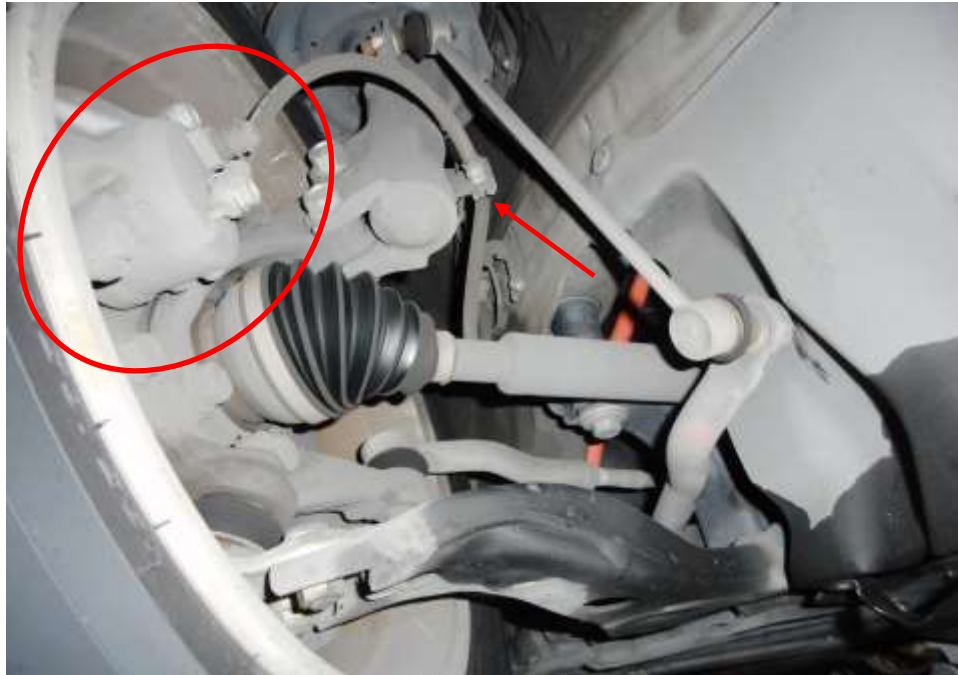
**Photo 16** shows the brake hose/pipe (arrowed) at the front right wheel of the Motor Taxi. No leakage of brake fluid was observed. Visual examination of the various components of the braking system like the brake caliper (circled), brake booster, brake pedal etc had revealed all to be intact and without visible damage.

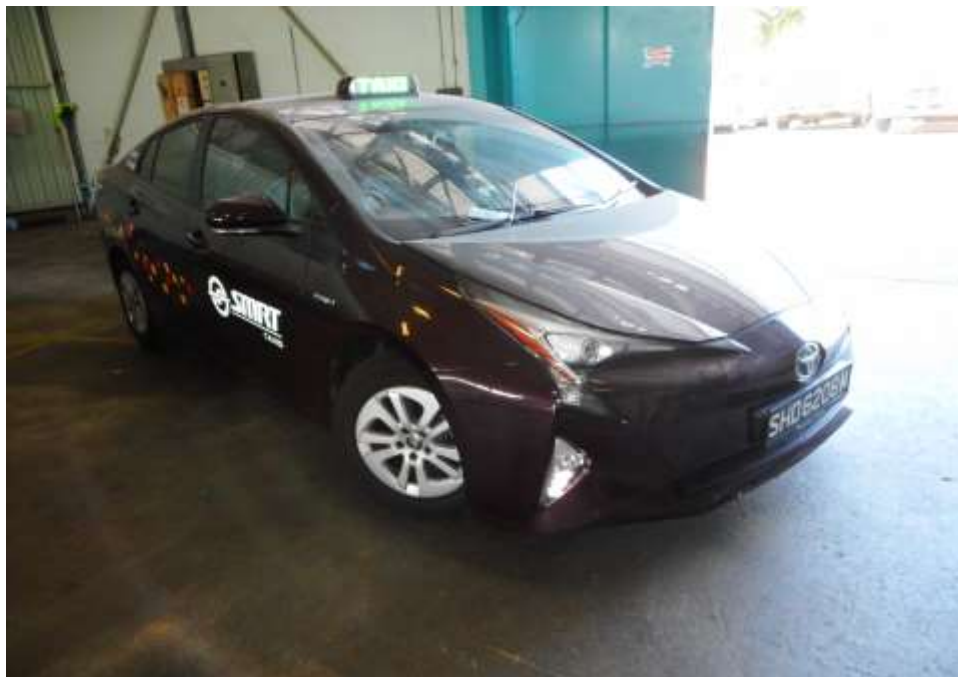
**Photo 17** shows the front right wheel of the Motor Taxi turned to its full left. During my steering system test, I did not experience any abnormal free play and/or resistance when I had turned the steering wheel towards the left and right. This would suggest that the steering system of the Motor Taxi was likely to be in serviceable condition at the material time of accident.

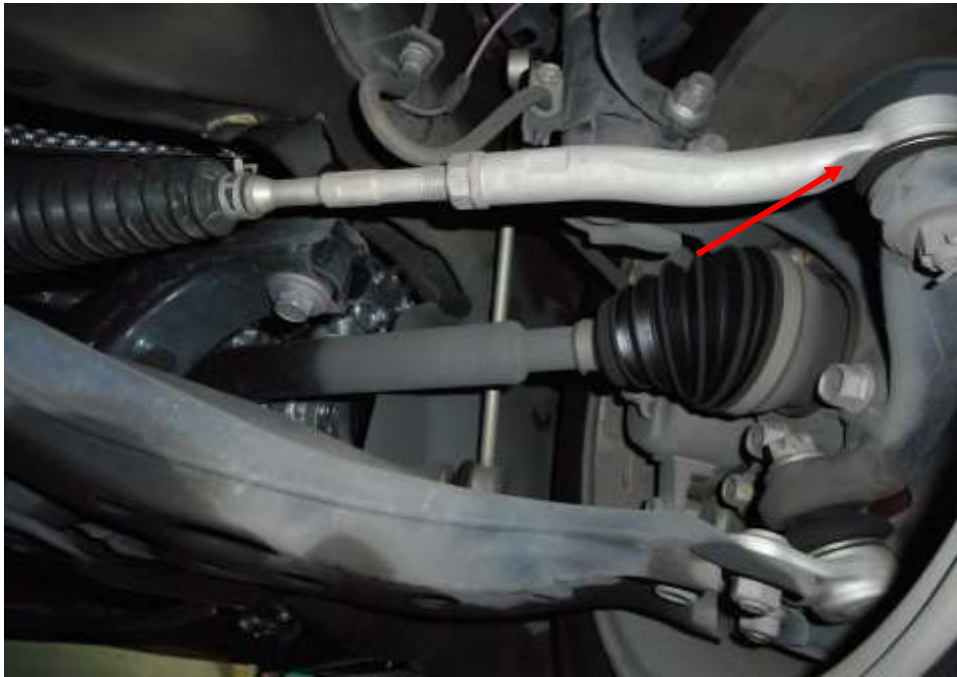
**Photo 18** shows the various undercarriage components at the front right wheel of the Motor Taxi, in particular the steering tie rod (arrowed). The various steering components were all found to be intact, suggesting that the steering system of the Motor Taxi was likely to be in serviceable condition at the material time of accident. There was also no sign of fluid stain observed on the various undercarriage components at the front right wheel of the Motor Taxi.

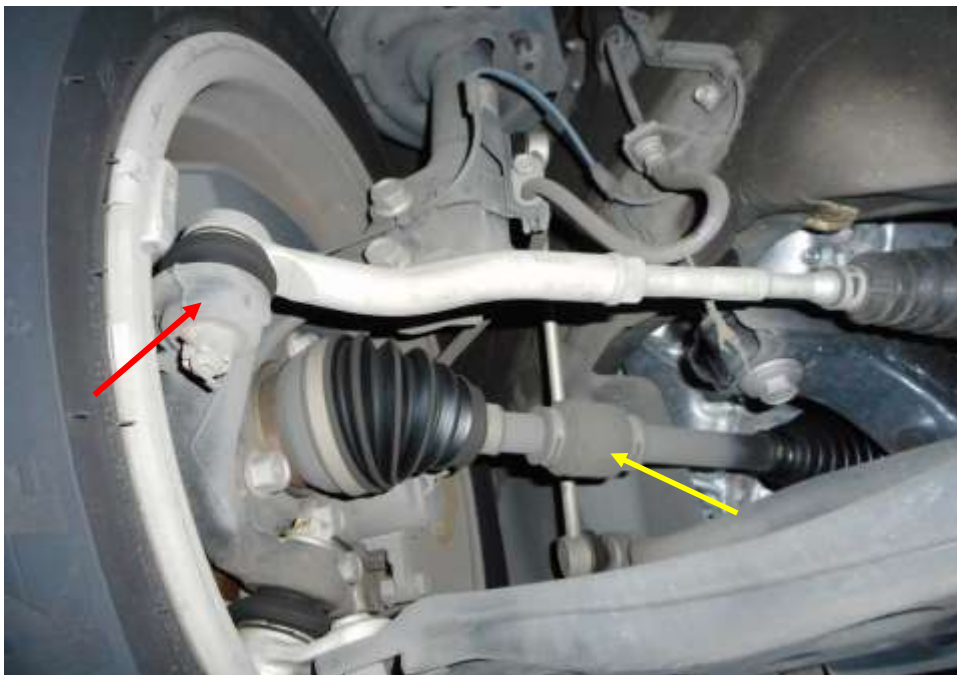
**Photo 19** shows the various undercarriage components at the front left wheel of the Motor Taxi, which had included the steering tie rod (red arrow) and front left drive shaft (yellow arrow). The various undercarriage components of the Motor Taxi were all found to be intact without any visible damage.

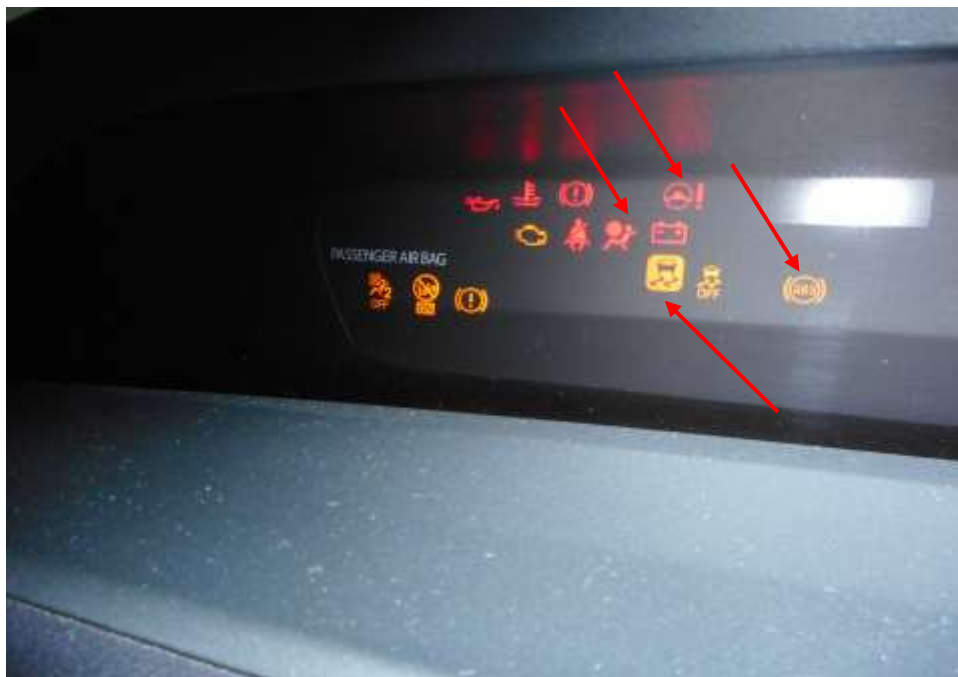
**Photo 20** shows the warning light for Anti-Lock Brake System (ABS), Electric Power Steering System (EPS), Traction Control (TC) and Supplemental Restraint System (SRS) appearing on the instrument panel of the Motor Taxi during the self-test of its various electronic operating systems when its engine was cranked.

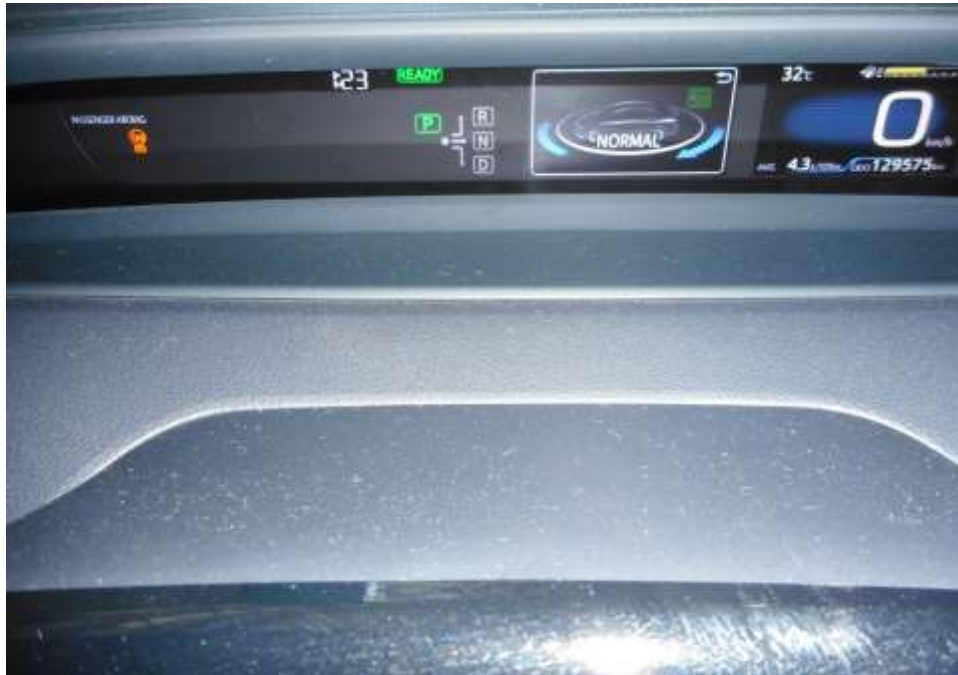
**Photo 21** shows no warning lights illuminated on the instrument panel of the Motor Taxi after the engine was cranked. This would suggest that there was no abnormality to the various electronic operating systems of the Motor Taxi, like the ABS, EPS, TC and SRS etc.
