## ACCIDENT DAMAGED VEHICLE INSPECTION REPORT

Registration No : PC8020J  
Make : TOYOTA  
Model : HIACE HOH ROOF COMMUTER TURBO AUTO  
Year : 2013

## VEHICLE DAMAGE INSPECTION REPORT

Reg No: PC8020J

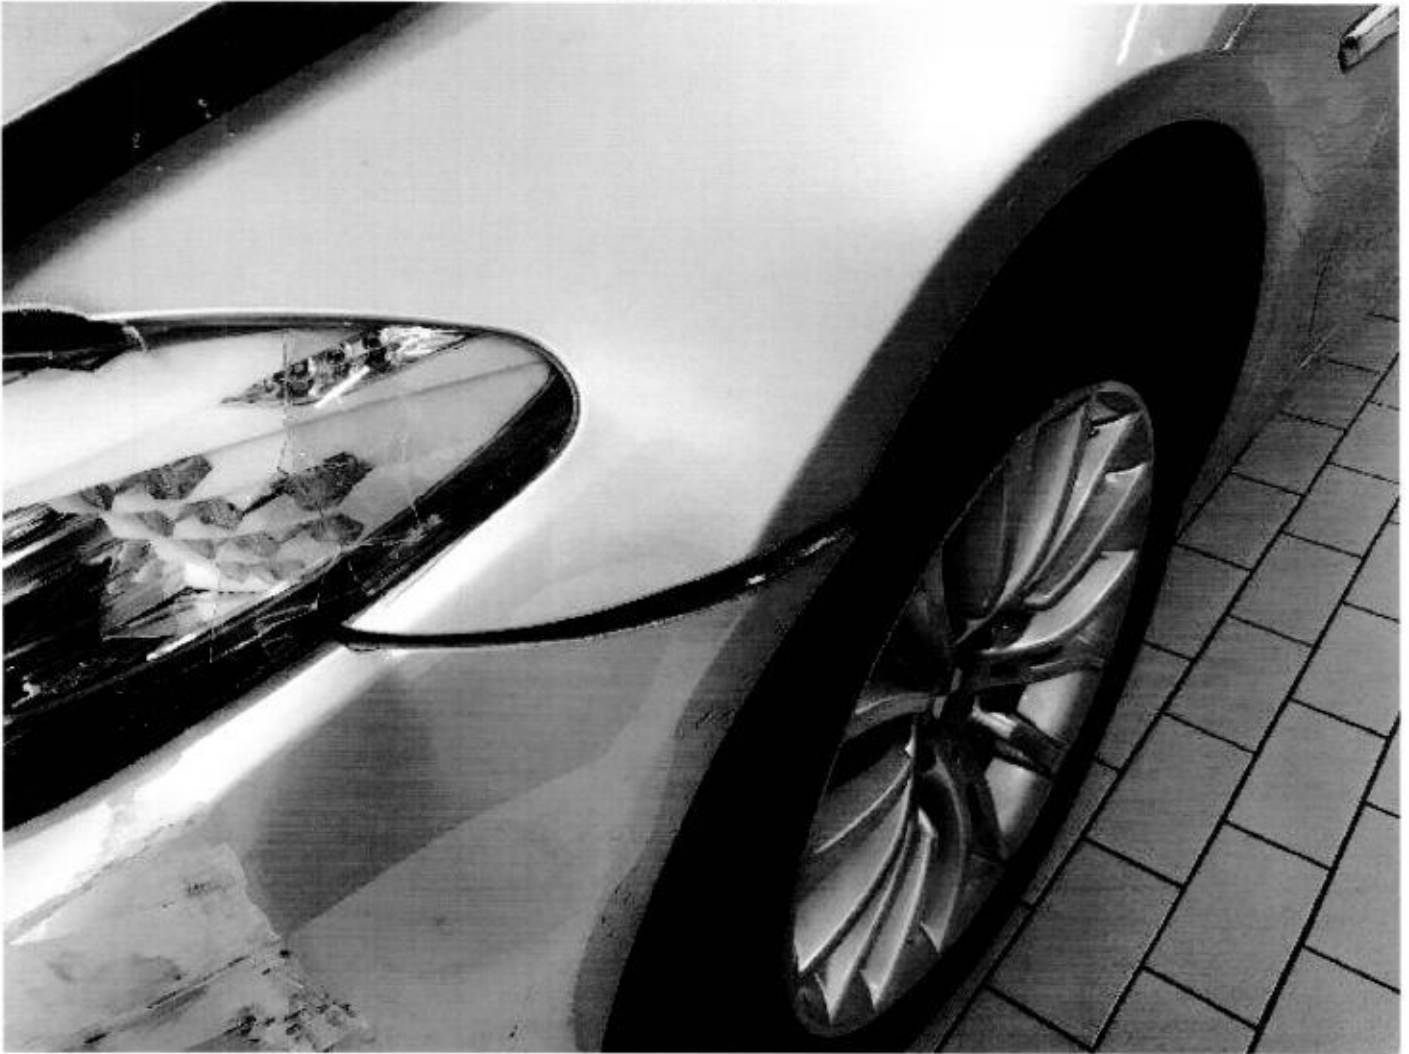
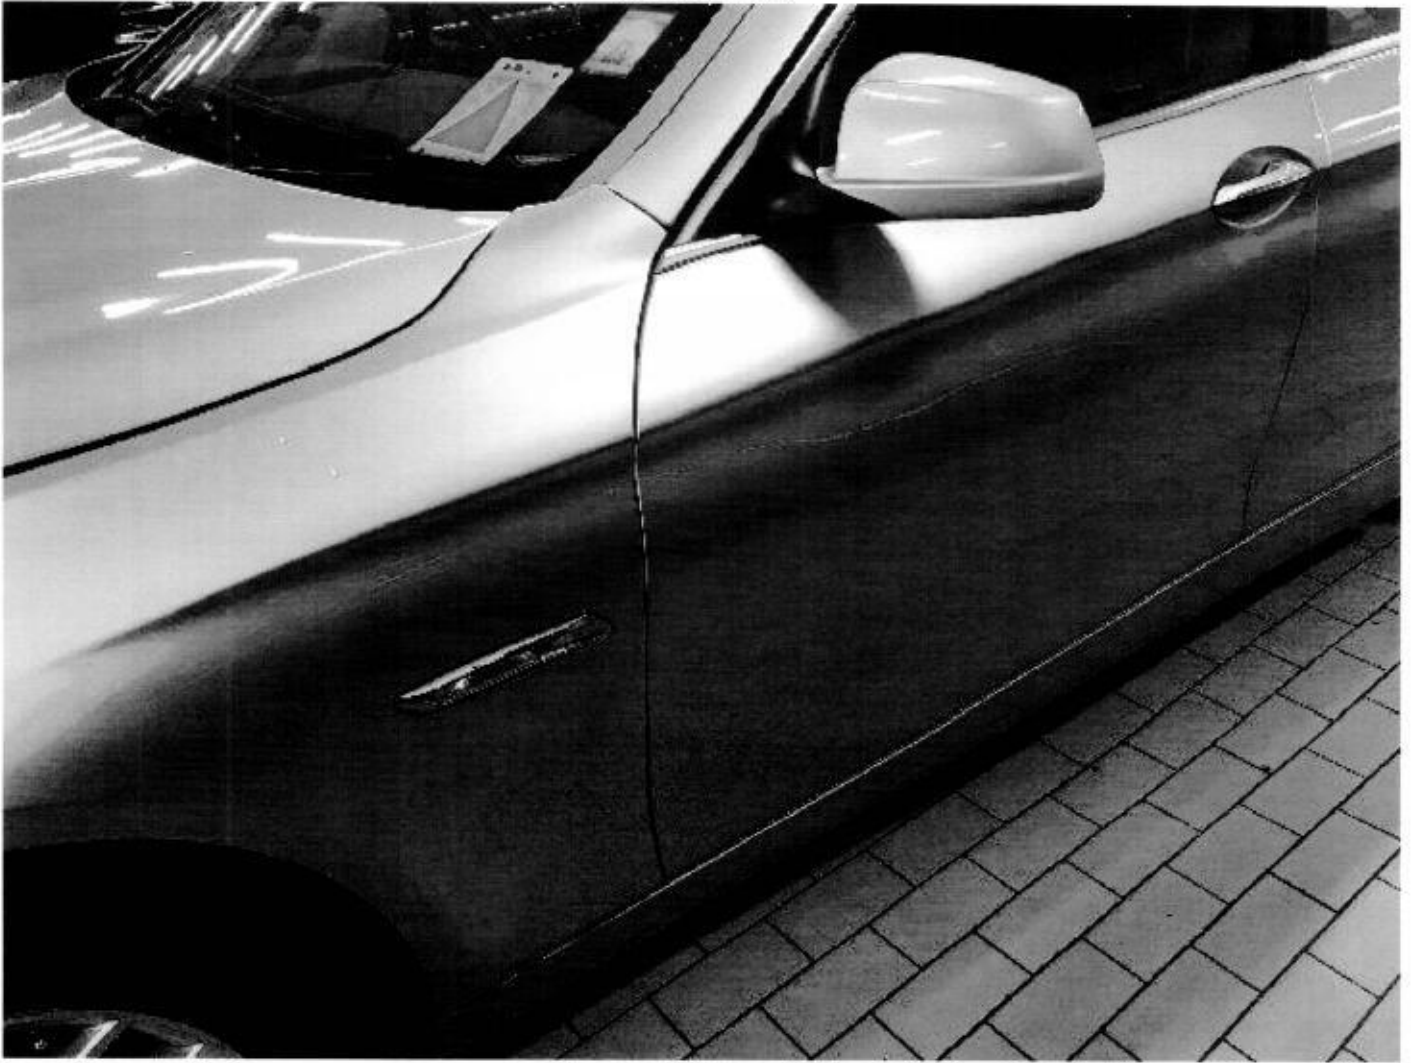
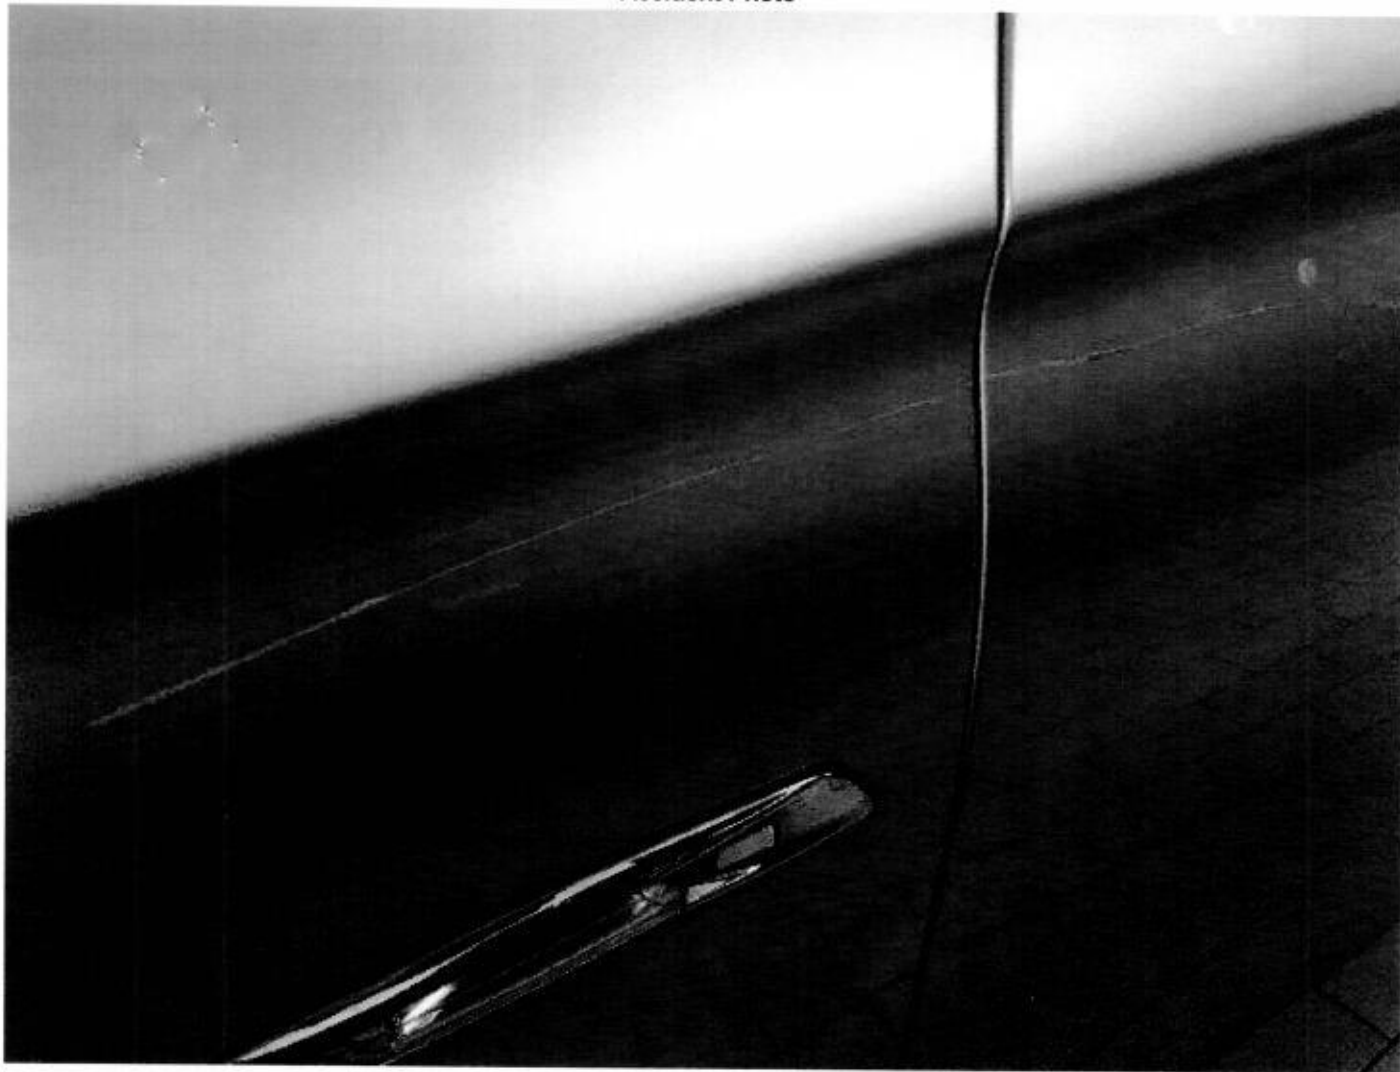
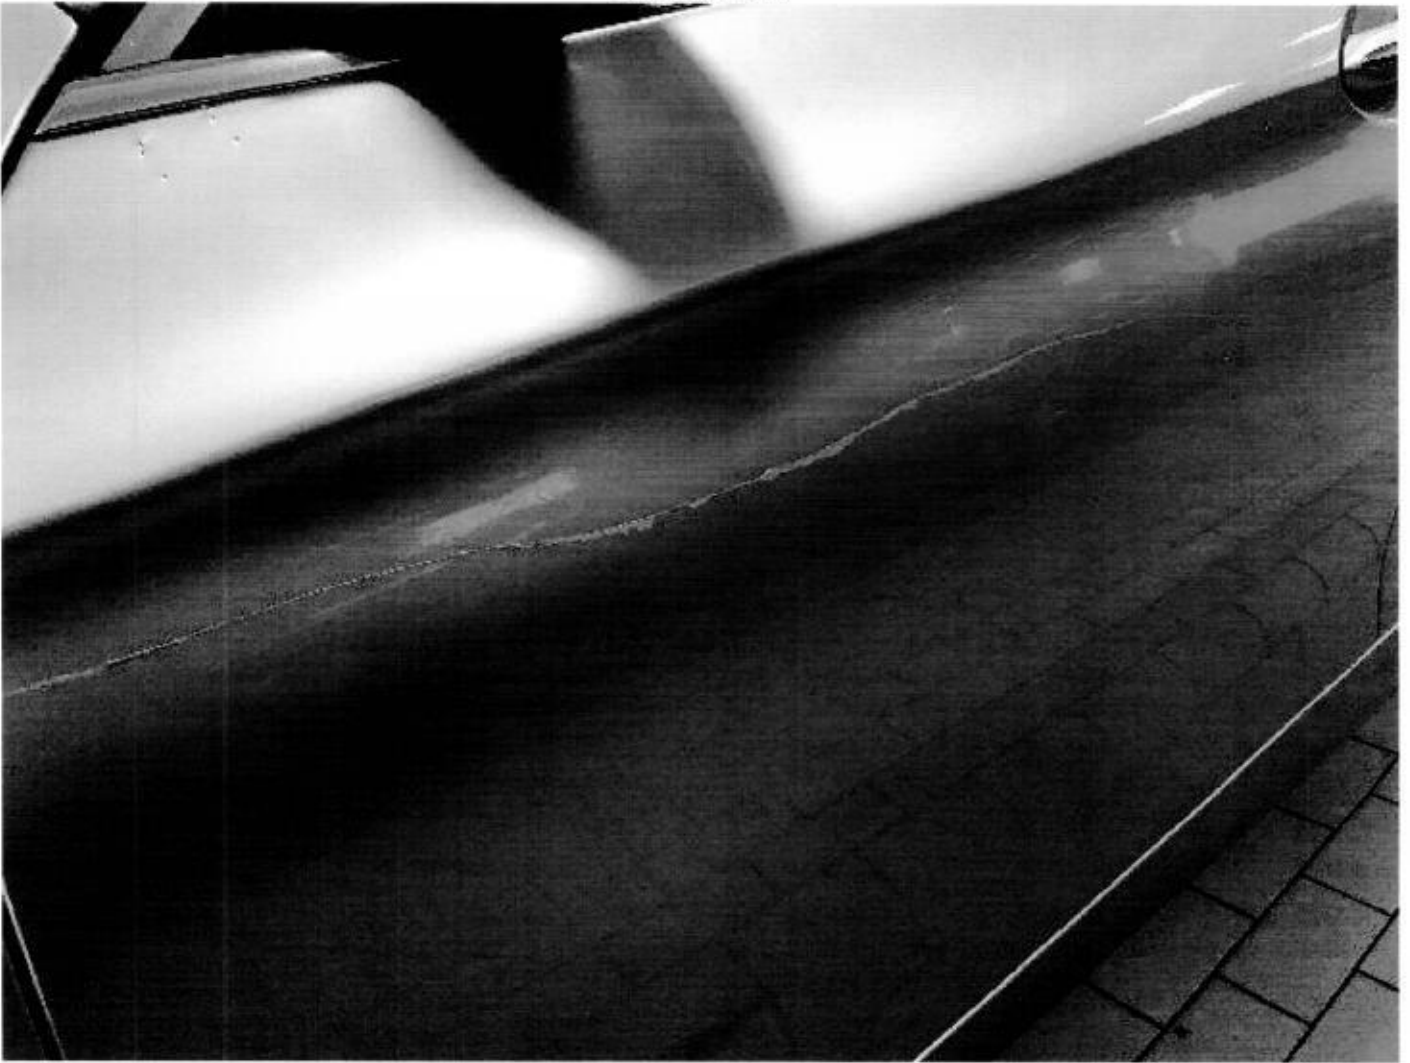
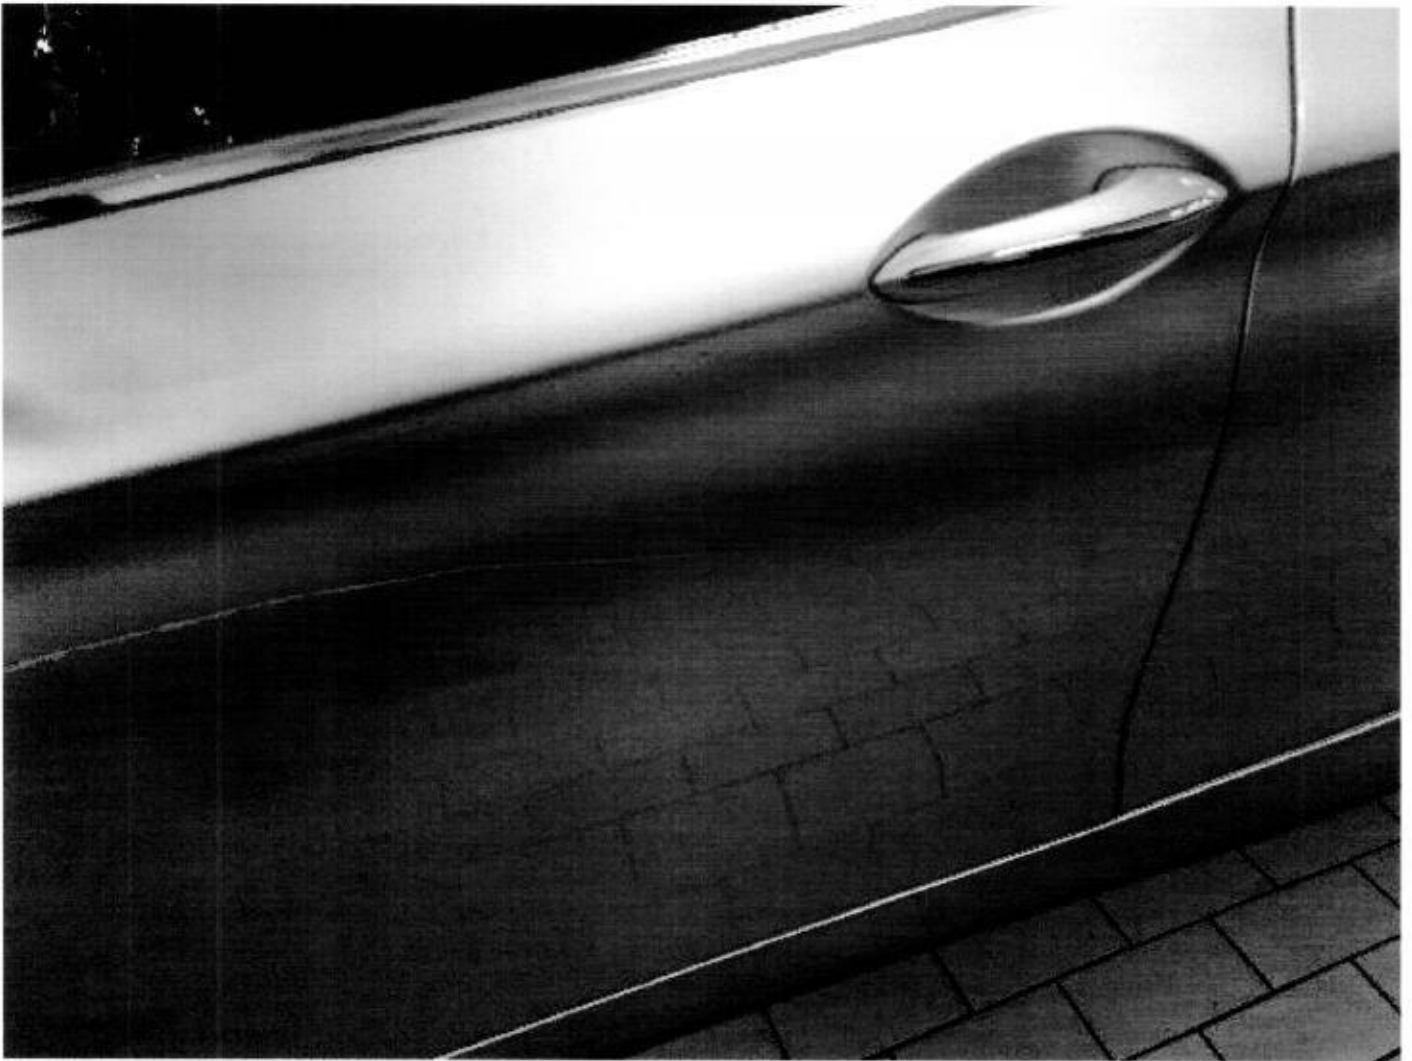
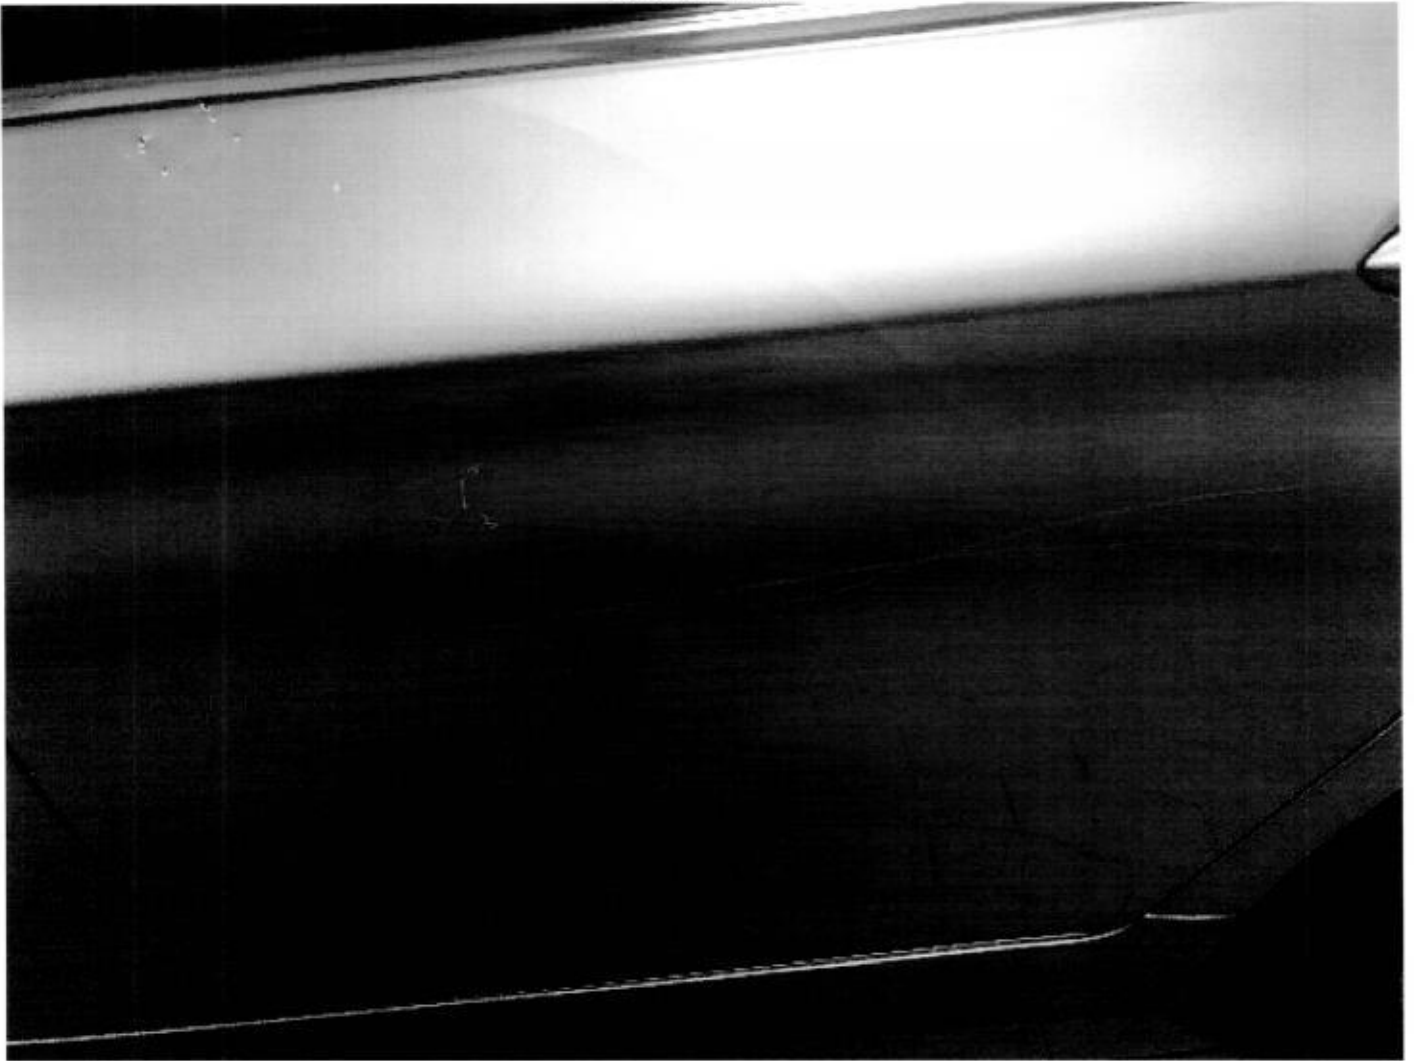
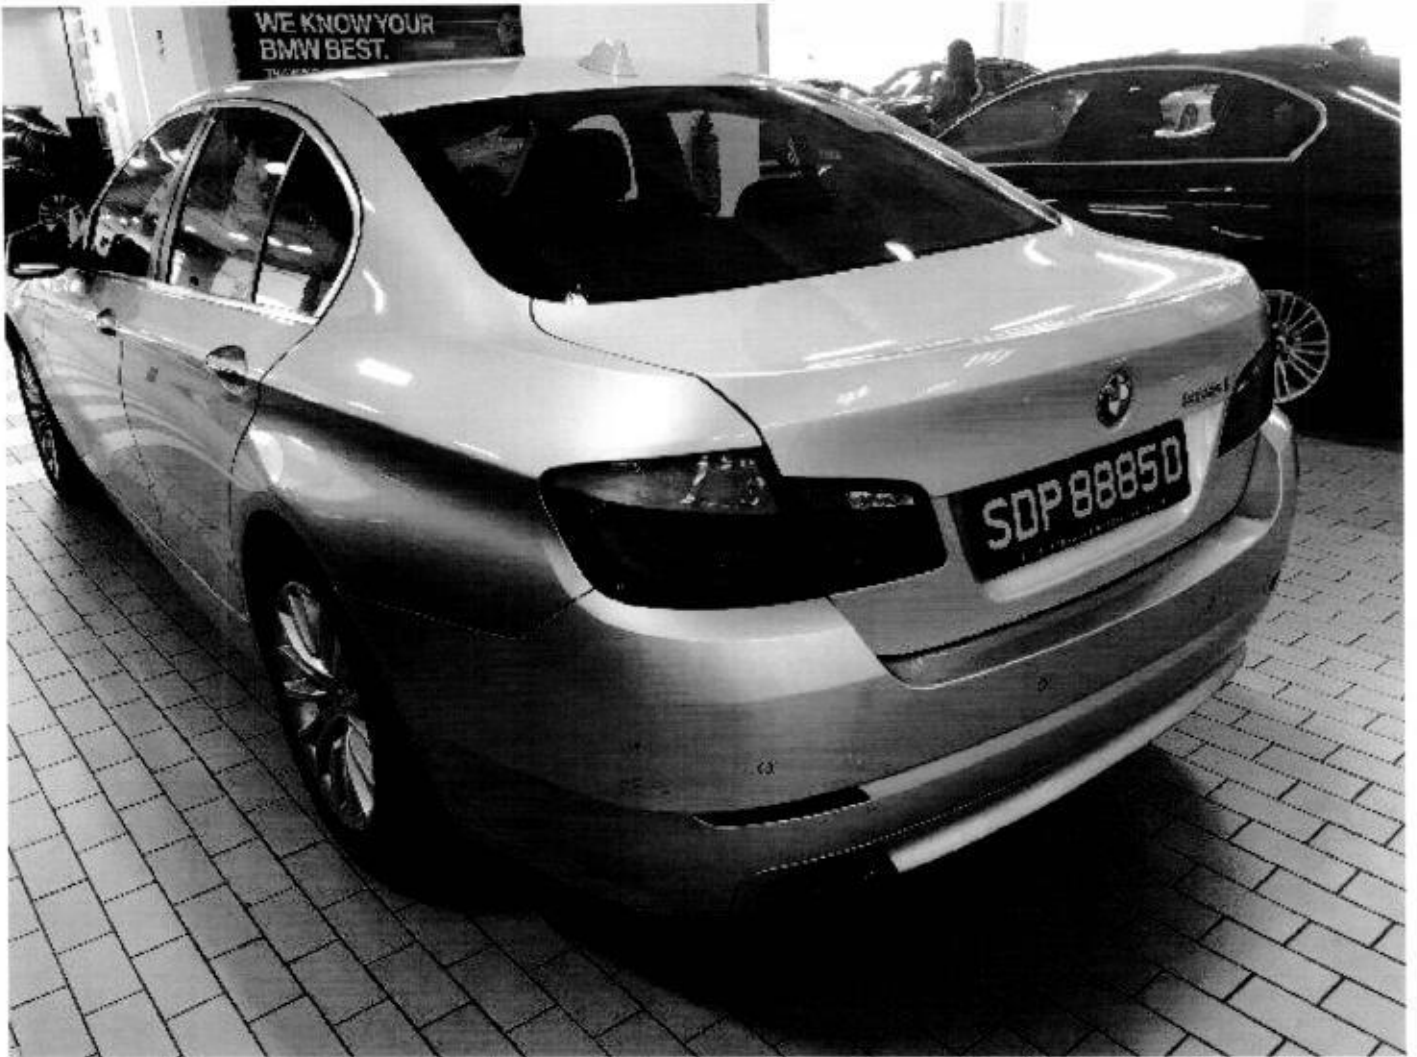
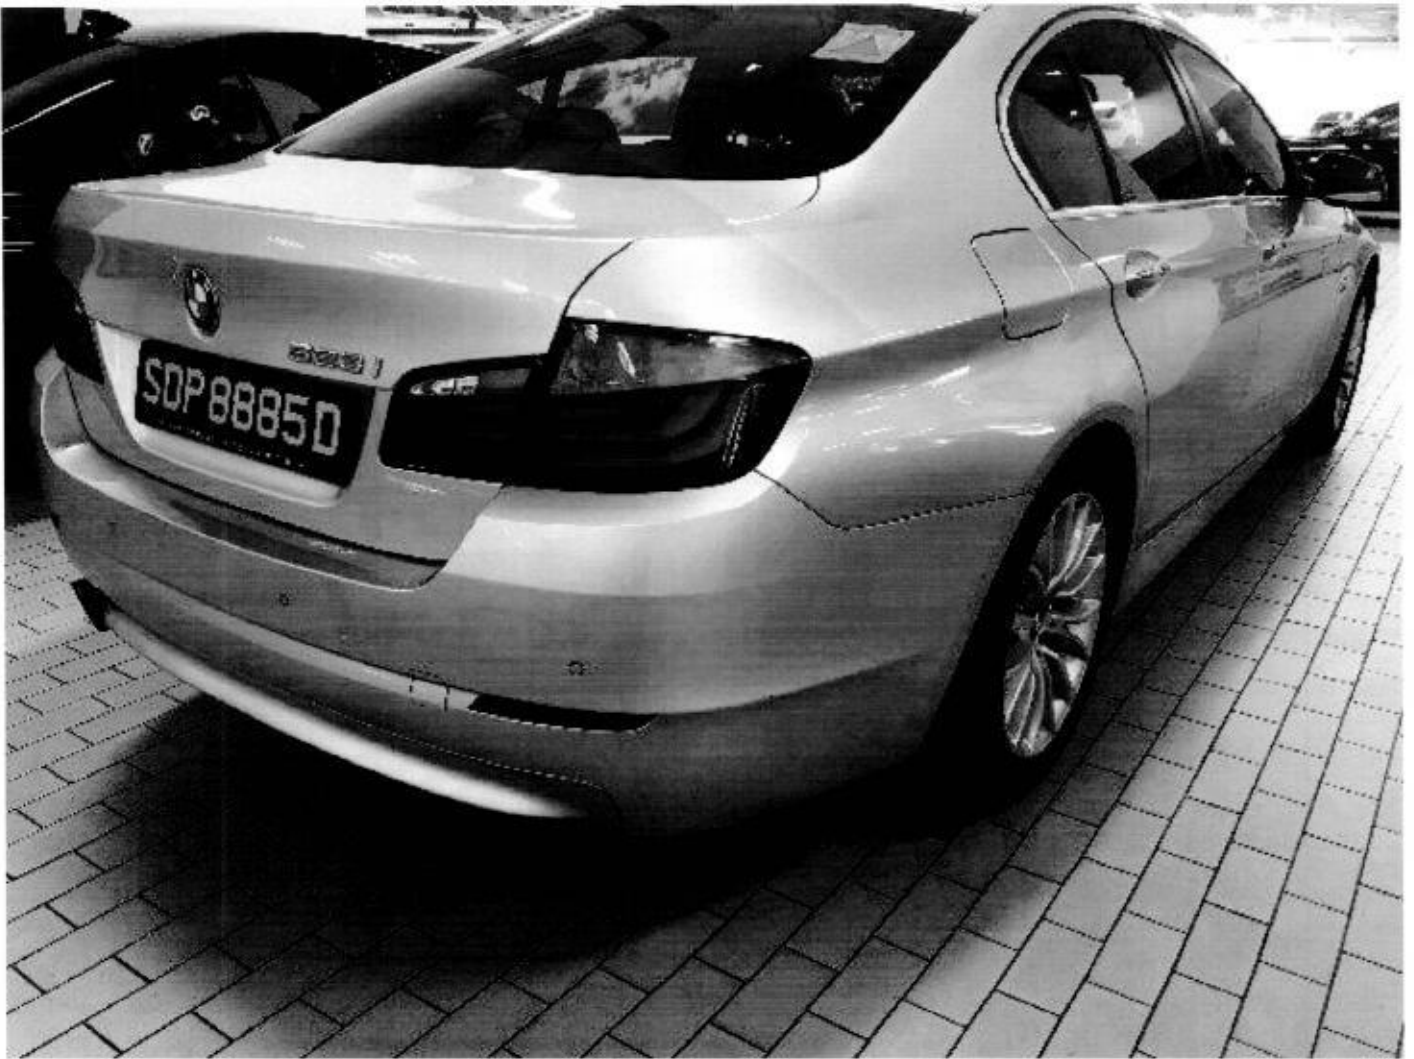
Accident Photo

The vehicle sustained damage at the left side portion.  
For details, refer to assessment for repairs and photographs attached.

The impact was confined to the left portion of the vehicle.  
The damages appeared to be consistent as per the accident report statement.  
Please refer the attached schedule and photographs for details.
