Your Ref: TP/IP/22757/2019
Our Ref : CI/TPD19008257/P

Fatal Accident Investigation Team

MECHANICAL INSPECTION REPORT OF MOTOR LORRY XD 1356L

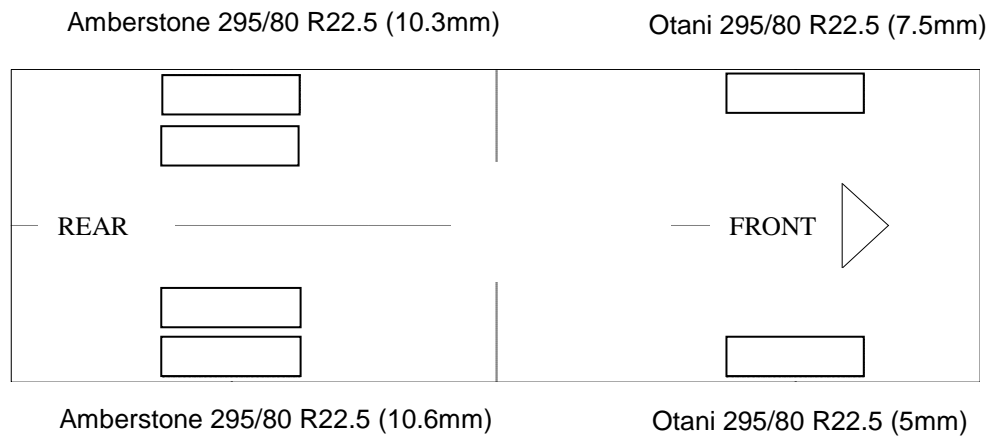
6. The 2 front tyres and 4 rear tyres of the Motor Lorry were observed to be in serviceable condition and sufficiently inflated for vehicular operation. I did not find any tear, cut or burst mark(s) on the outer and the inner sidewalls as well as across the tread of the 6 tyres. The tyre brand, tyre size and remaining tread depth of the 6 tyres of the Motor Lorry were recorded as follows:-

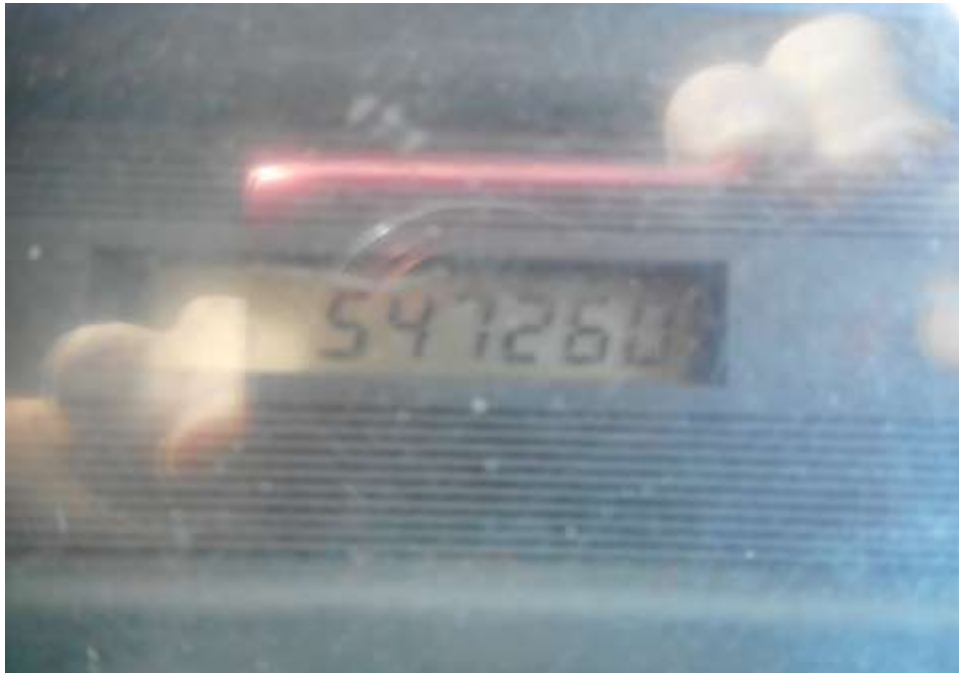
Photo 1 shows a general view of the instrument cluster of the Motor Lorry at the time of my inspection. The mileage of the Motor Lorry was 547,260km

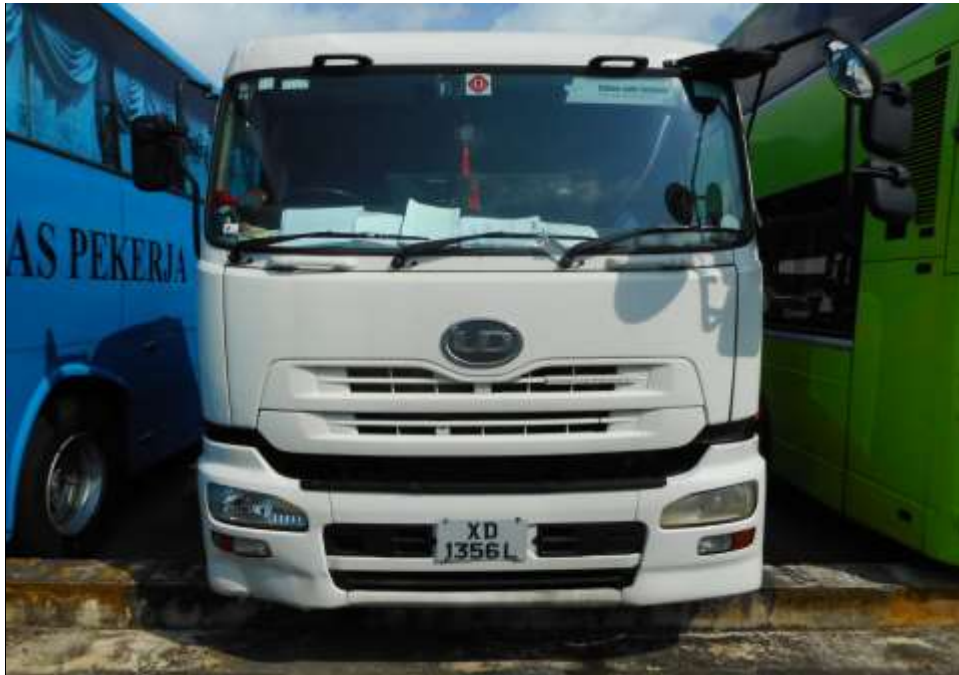
4. The mileage of the Motor Lorry at the time of my inspection was 547,260km.
5. The Motor Lorry was observed to have sustained minor damages at its frontal portion. Its front bumper was damage as a result of the accident at the time of my inspection.

Photo 2 shows a general view of the front body of the Motor Lorry at the time of my inspection. The Motor Lorry was observed to have sustained minor damage to its frontal portion; its front bumper was damaged as a result of the accident.

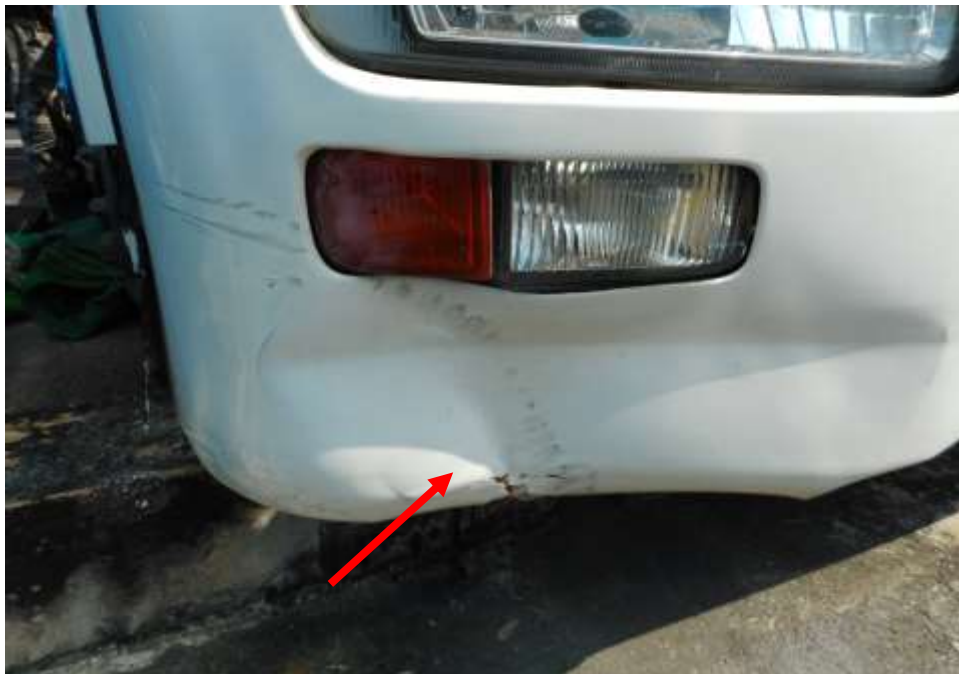
Photo 3 shows a close up view of the front body of the Motor Lorry at the time of my inspection. The Motor Lorry was observed to have sustained minor damage to its frontal portion; its front bumper was damaged (arrowed) as a result of the accident.

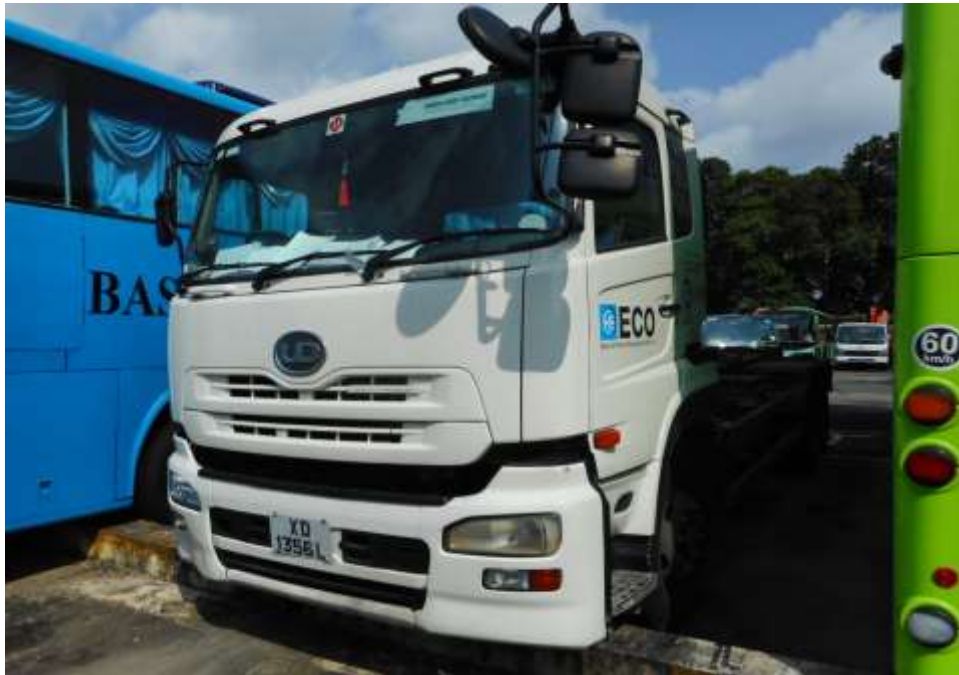
Photo 4 shows a general view of the left body of the Motor Lorry at the time of my inspection. The Motor Lorry was observed to be in good general condition.

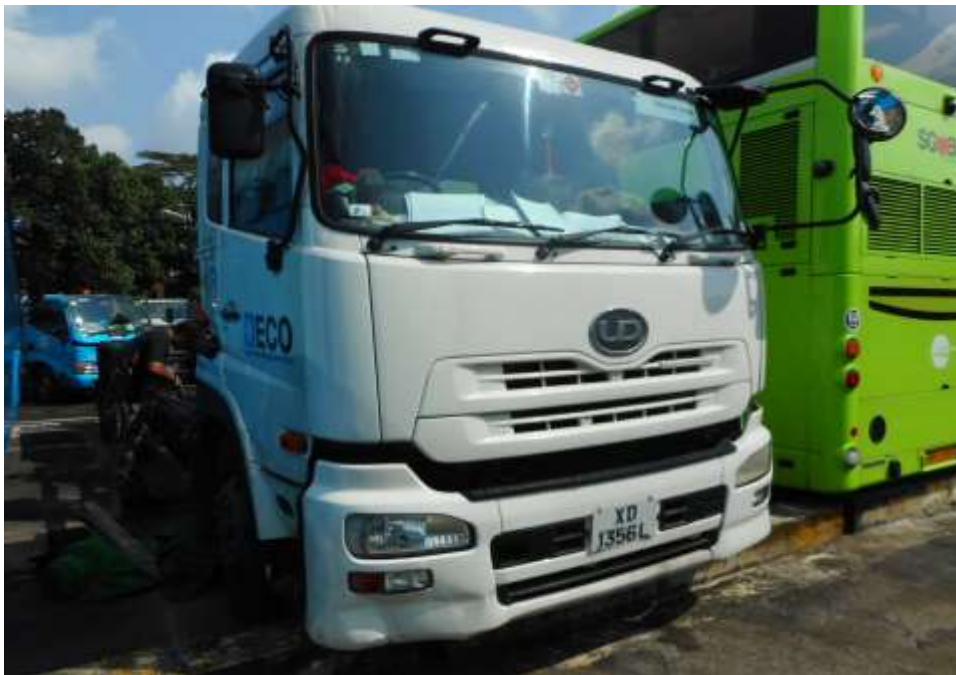
Photo 5 shows a general view of the front right body of the Motor Lorry at the time of my inspection. The Motor Lorry was observed to be in good general condition.

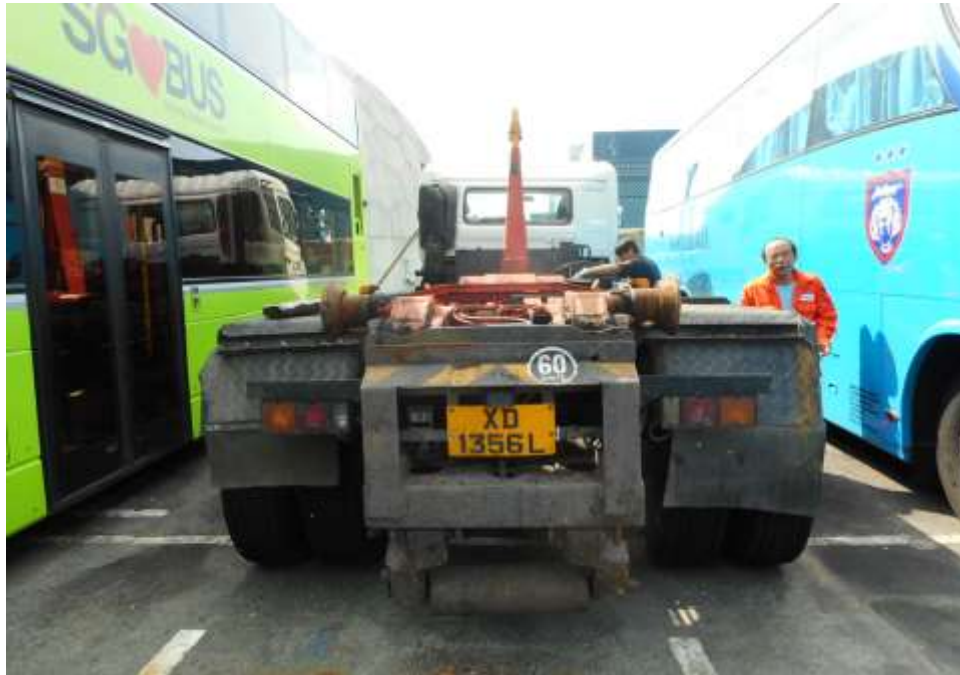
Photo 6 shows a general view of the Motor Lorry's rear body at the time of my inspection. There was no damage found to the rear portion of the Motor Lorry.

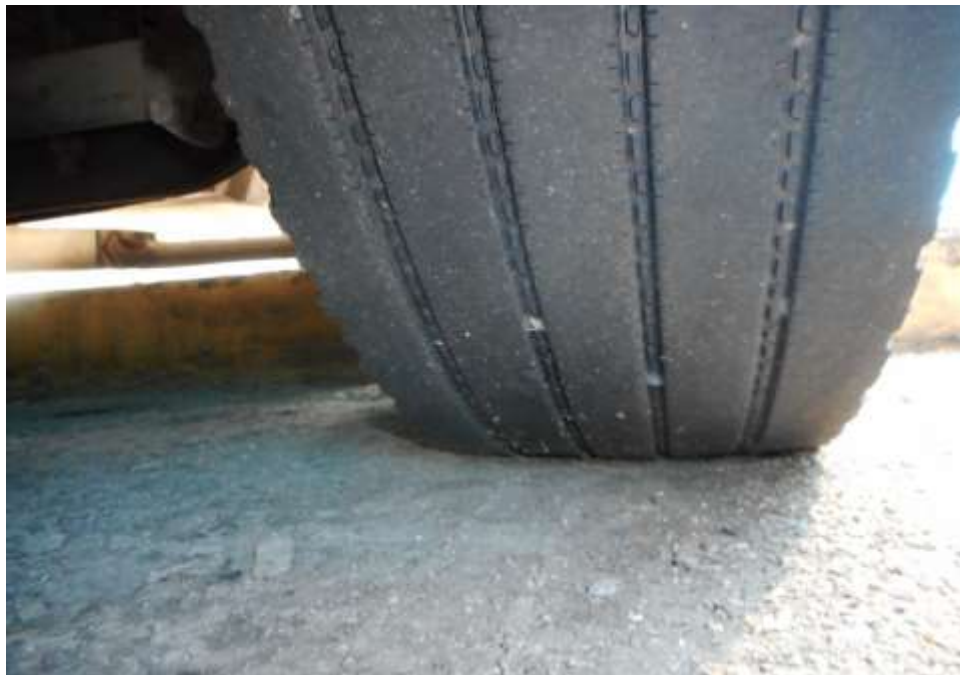
Photo 7 shows the condition of the front right tyre of the Motor Lorry, which was observed to be in serviceable condition with remaining tread depth of approximately 5 mm. The tyre, which was wrapped around standard steel wheel rim, was also observed to be sufficiently inflated for vehicular operation. There was no tear, cut or burst mark(s) on the outer and the inner sidewalls as well as across the tread of the 6 tyres that were fitted on the Motor Lorry.

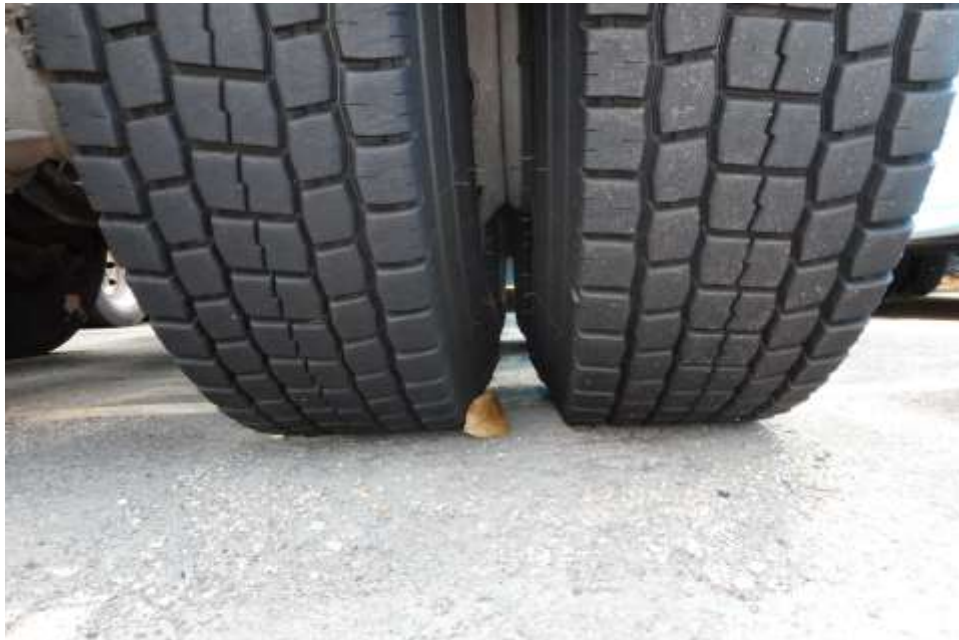
Photo 8 shows the condition of the rear right tyre of the Motor Lorry, which was observed to be in serviceable condition with remaining tread depth of approximately 10.6mm. The tyre, which was wrapped around standard steel wheel rim, was also observed to be sufficiently inflated for vehicular operation.

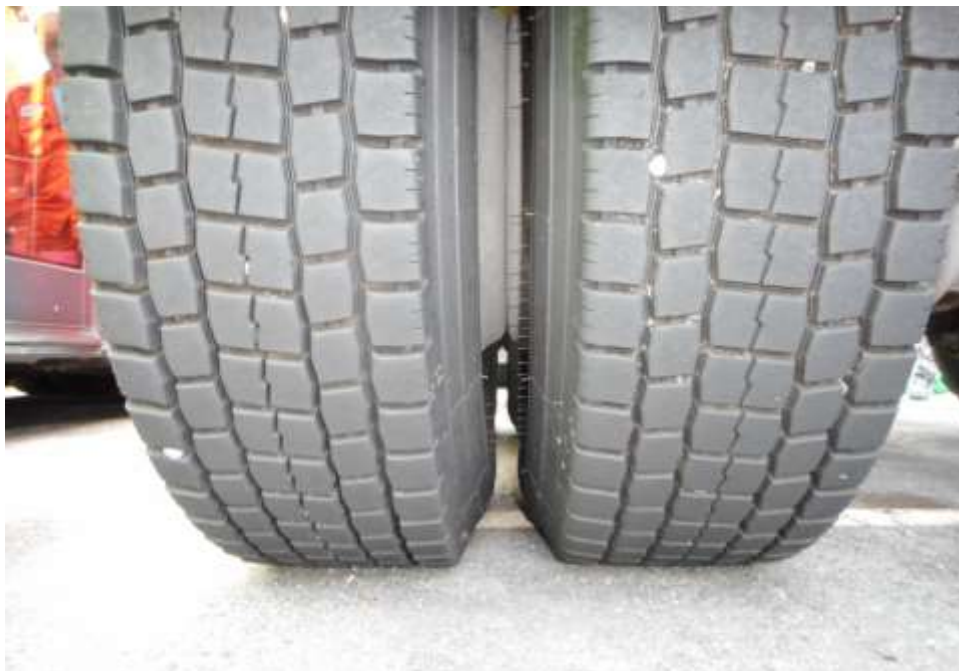
Photo 9 shows the condition of the rear left tyres of the Motor Lorry, which was observed to be in serviceable condition with remaining tread depth of approximately 10.3mm. The tyres, which were wrapped around standard steel wheel rim, were also observed to be sufficiently inflated for vehicular operation. There was also no damage found on all 6 steel wheel rims of the Motor Lorry.

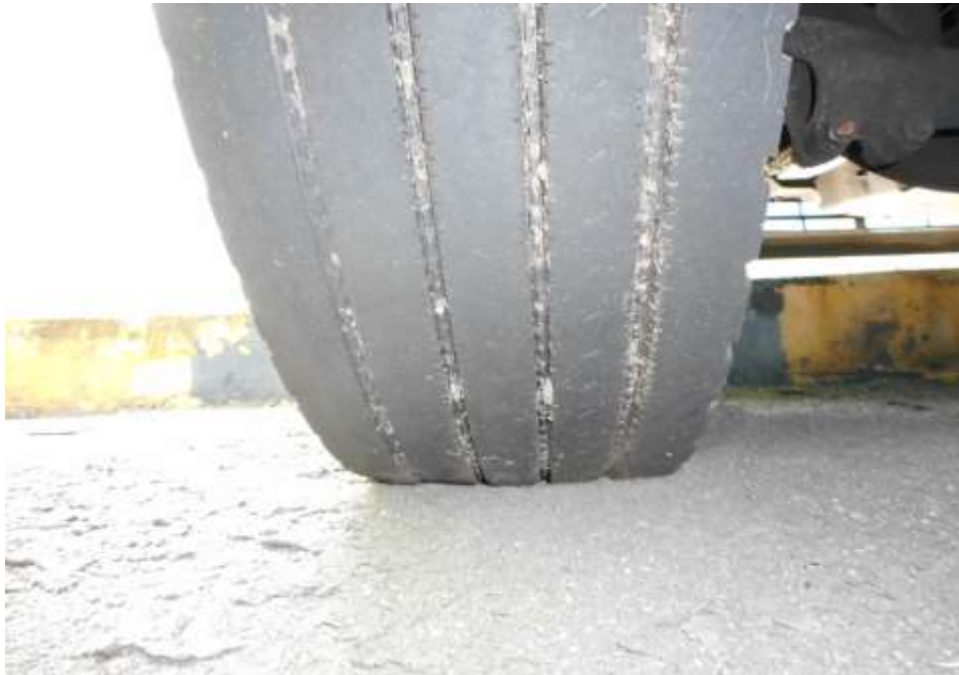
Photo 10 shows the condition of the front left tyres of the Motor Lorry, which were observed to be in serviceable condition with remaining tread depth of approximately 7.5mm. There was also no tear, cut or burst mark(s) on the outer and the inner sidewalls as well as across the tread of the 6 tyres that were fitted on the Motor Lorry.

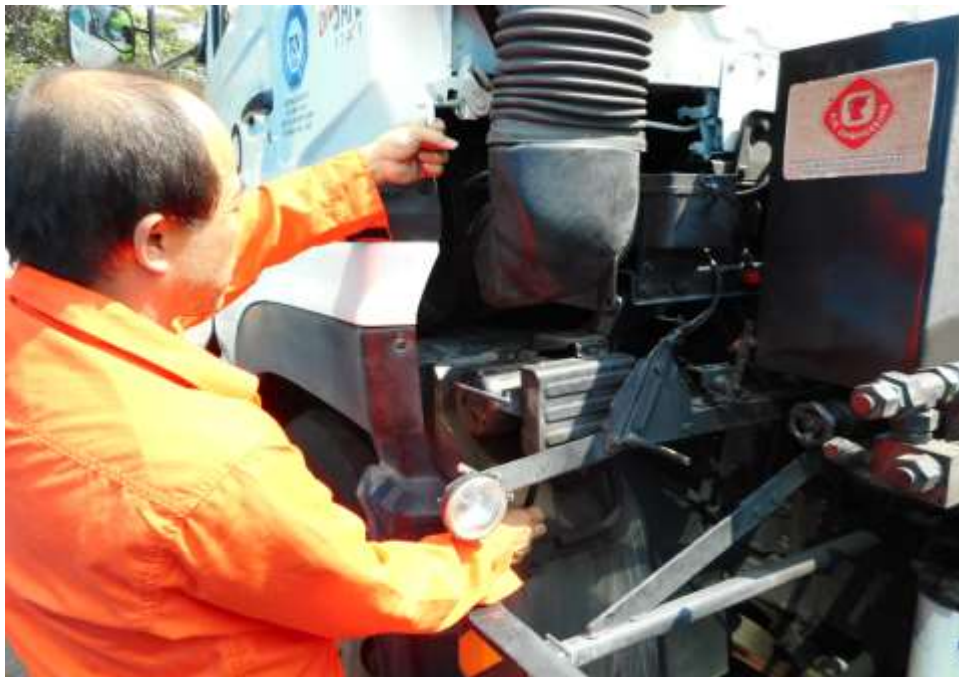
8. The examination of the Motor Lorry's engine compartment beneath the lorry's cabin was unable to be conducted due to the faulty cabin lifter mechanism of the Motor Lorry despite multiple attempts to operate it. (Unable to operate)
9. However the reading of air brake cylinder for the air brakes can be visually read on the instrument cluster of the Motor Lorry.
10. My subsequent checks on the underside of the Motor Lorry also revealed no fluid stain. Visually, the various undercarriage components of the Motor Lorry were all observed to be intact and without any visible damage. See photo 11 & 12 below.

Photo 11 shows the mechanic attempting to operate the Motor Lorry's cabin lifter mechanism by the Motor Lorry. There was no movement to the cabin lifter despite multiple attempts to operate it. (Unable to operate)

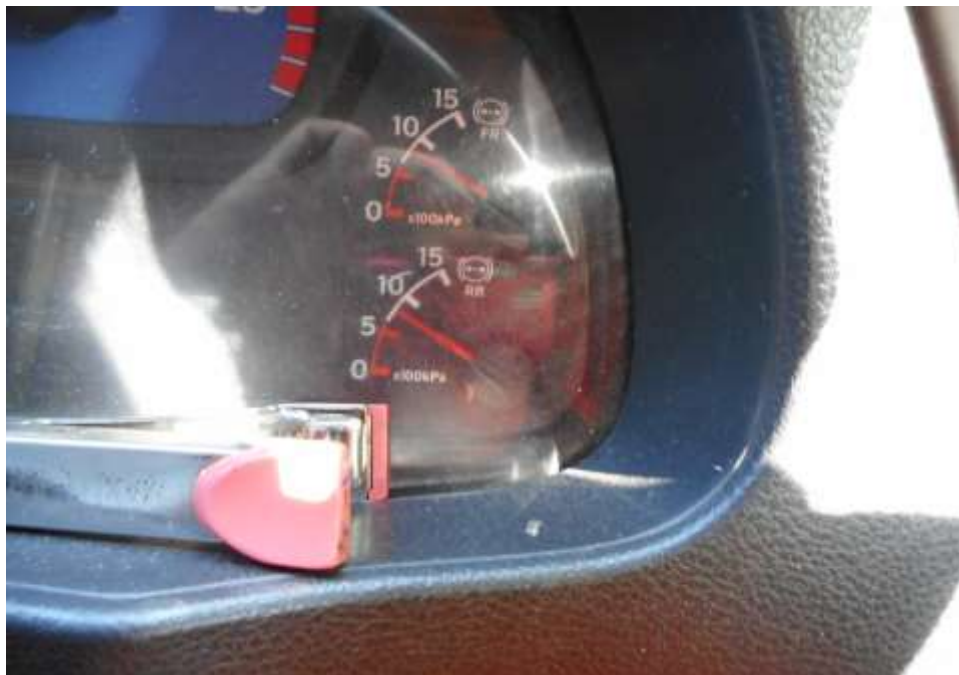
Photo 12 shows the air in the air brake cylinder of the Motor Lorry at the time of my inspection. The air in the cylinder was observed to be of sufficient level & serviceable at the time of the accident.

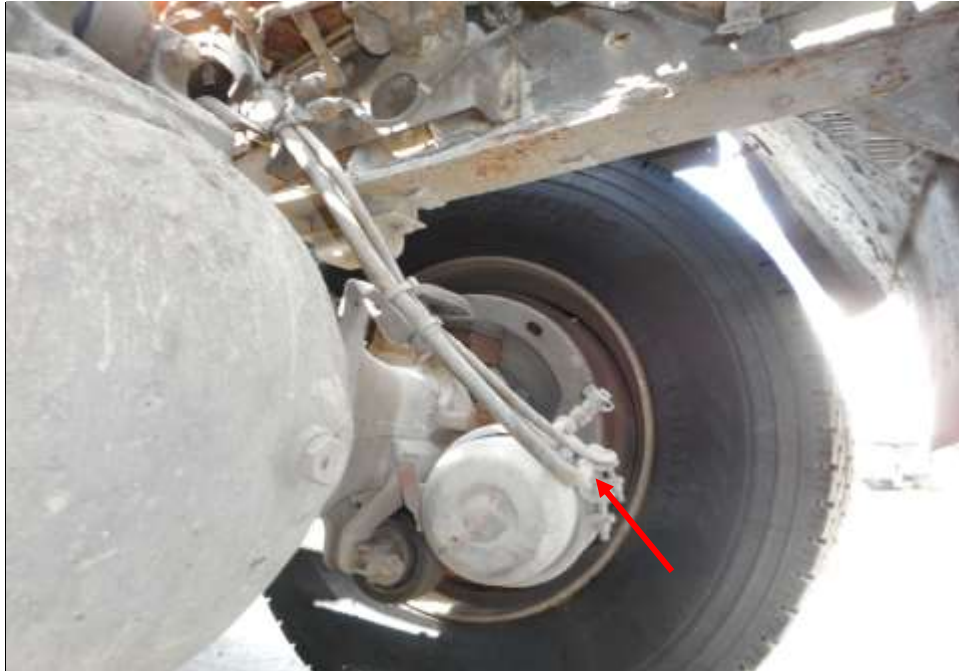
Photo 13 shows the brake pipe (arrowed) at the rear right wheel of the Motor Lorry. I did not observe any leakage of brake fluid at the time of my inspection of the Motor Lorry. My static tests of the Motor Lorry's braking system, along with my visual examination of the various mechanical components in the braking system, had indicated that there was no internal leakage of pressure/vacuum. Hence the braking system of the Motor Lorry was likely to be in serviceable condition at the material time of accident.

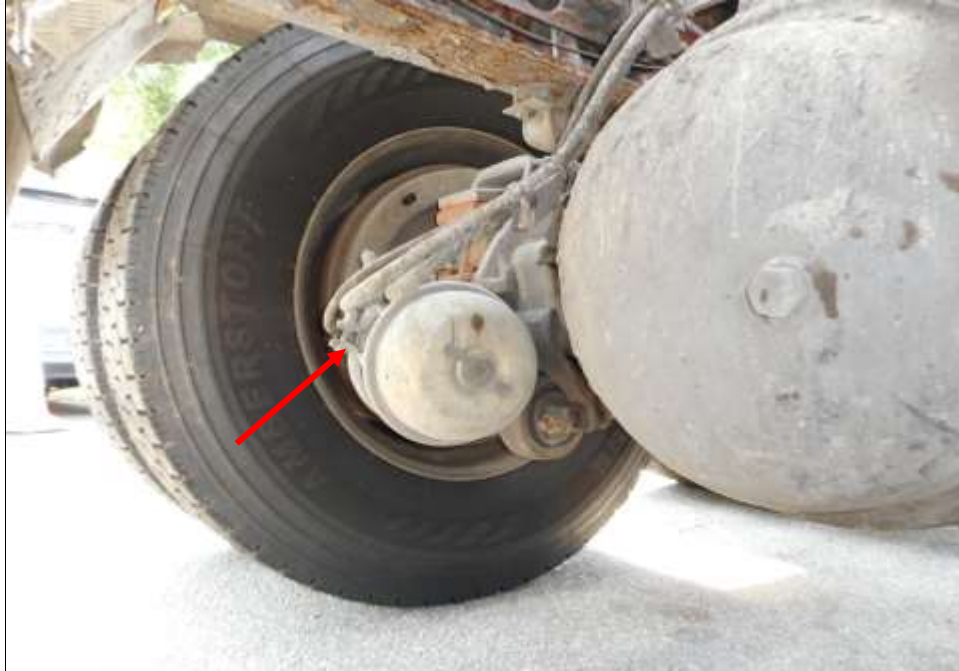
Photo 14 shows the brake pipe (arrowed) at the rear left wheel of the Motor Lorry. I did not observe any leakage of brake fluid at the time of my inspection of the Motor Lorry. My static tests of the Motor Lorry's braking system, along with my visual examination of the various mechanical components in the braking system, had indicated that there was no internal leakage of pressure/vacuum. Hence the braking system of the Motor Lorry was likely to be in serviceable condition at the material time of accident.

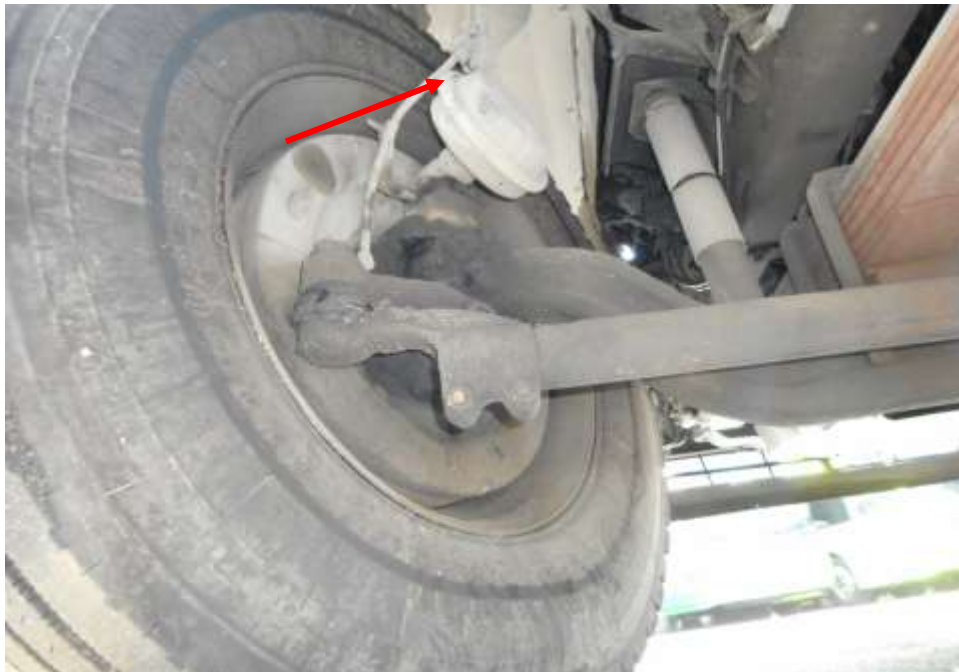
Photo 15 shows the brake pipe (arrowed) at the front right wheel of the Motor Lorry. I did not observe any leakage of brake fluid at the time of my inspection of the Motor Lorry. My static tests of the Motor Lorry's braking system, along with my visual examination of the various mechanical components in the braking system, had indicated that there was no internal leakage of pressure/vacuum. Hence the braking system of the Motor Lorry was likely to be in serviceable condition at the material time of accident.

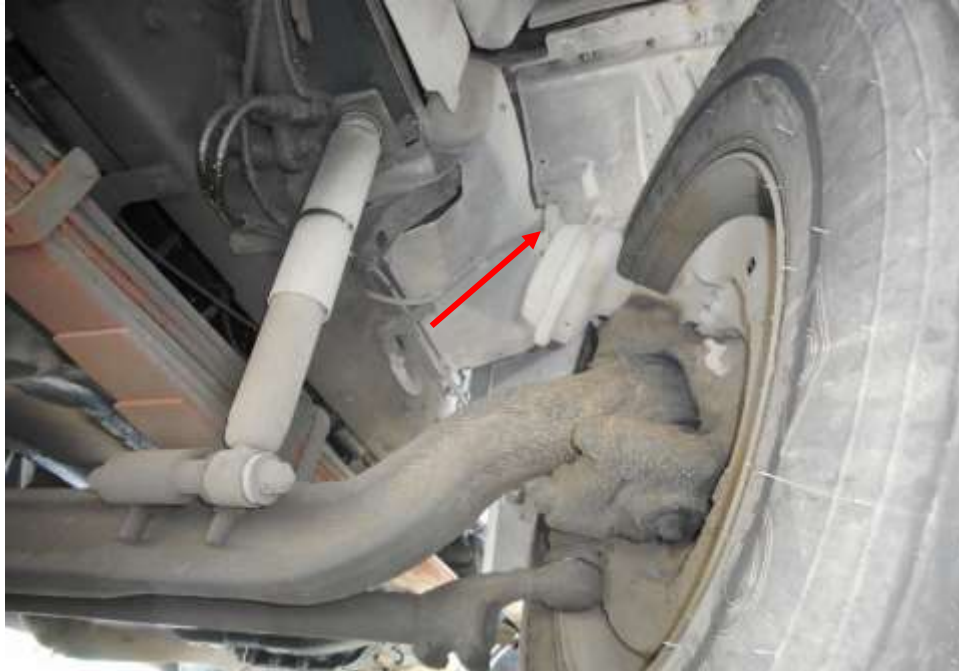
Photo 16 shows the brake pipe (arrowed) at the front left wheel of the Motor Lorry. I did not observe any leakage of brake fluid at the time of my inspection of the Motor Lorry. My static tests of the Motor Lorry's braking system, along with my visual examination of the various mechanical components in the braking system had indicated that there was no internal leakage of pressure/vacuum. Hence the braking system of the Motor Lorry was likely to be in serviceable condition at the material time of accident.

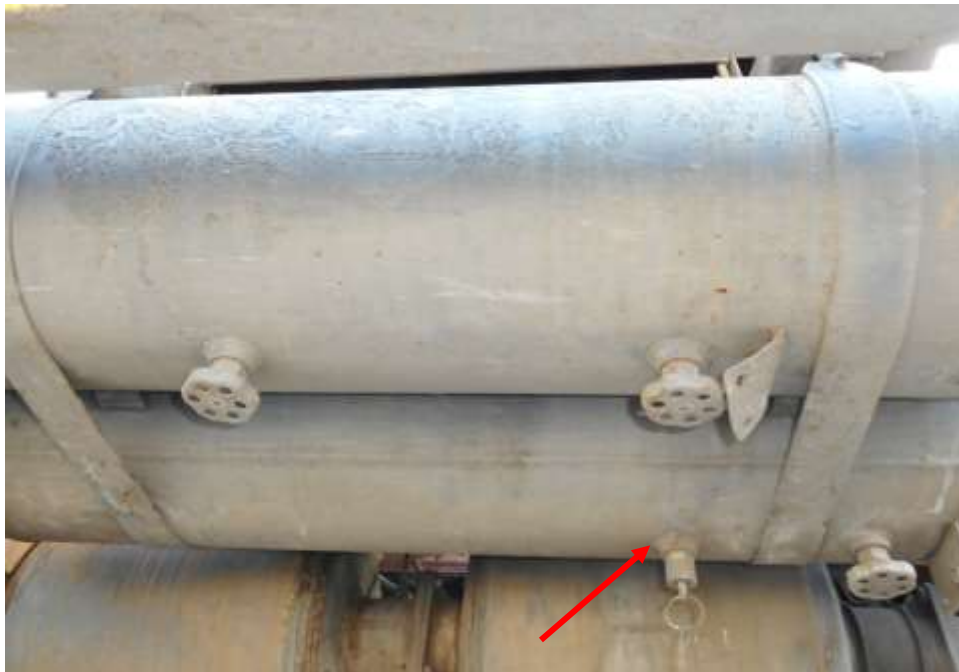
Photo 17 shows the air brake cylinder (arrowed) at the undercarriage of the Motor Lorry. I did not observe any leakage of air brake fluid at the time of my inspection of the Motor Lorry. My static tests of the Motor Lorry's braking system, along with my visual examination of the various mechanical components in the braking system had indicated that there was no internal leakage of pressure/vacuum. Hence the braking system of the Motor Lorry was likely to be in serviceable condition at the material time of accident.

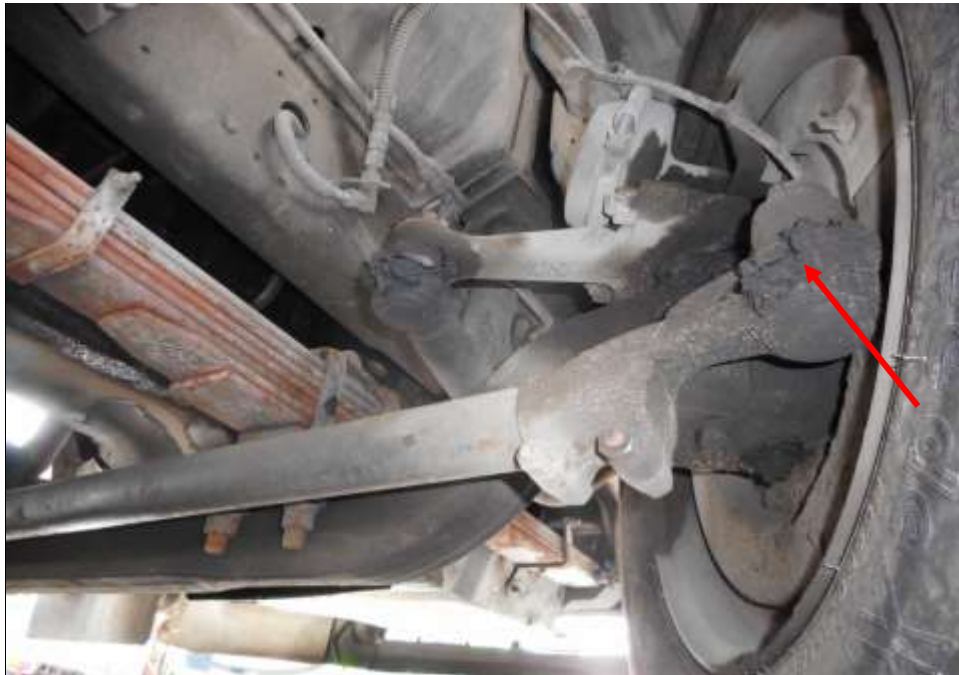
Photo 18 shows the various undercarriage components at the front right wheel of the Motor Lorry, in particular the steering tie rod end (arrowed). The various steering components were all found to be intact, suggesting that the steering system of the Motor Lorry was likely to be in serviceable condition at the material time of accident. There was also no sign of fluid stain(s) observed on the various undercarriage components.

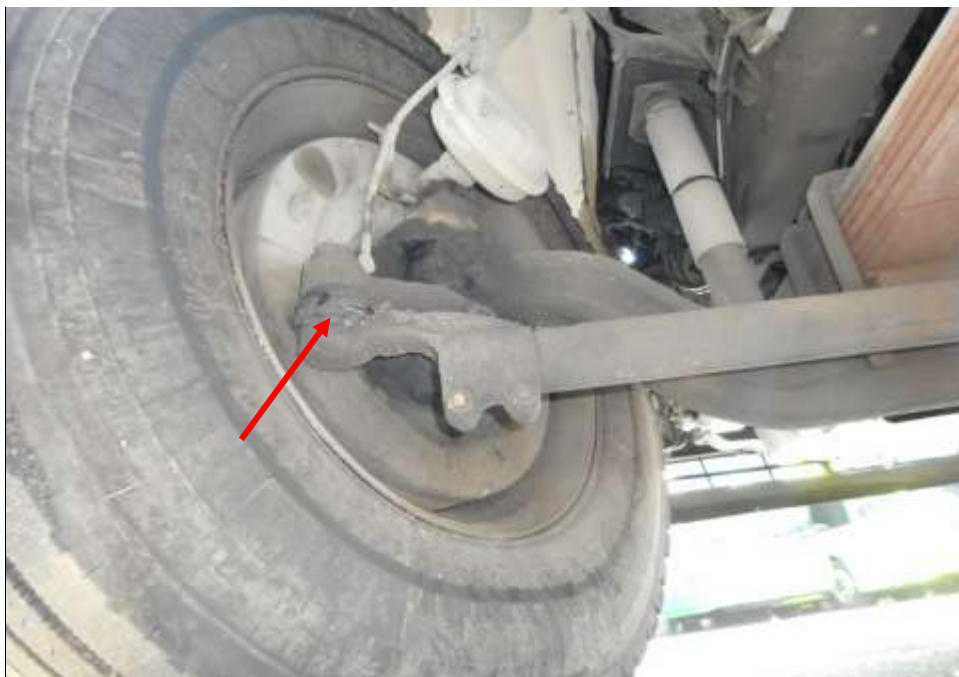
Photo 19 shows the various undercarriage components at the front left wheel of the Motor Lorry, in particular the steering tie rod end (arrowed). The various undercarriage components of the Motor Lorry were all found to be intact without any visible damage. There was also no sign of fluid stain(s) observed on the various undercarriage components.

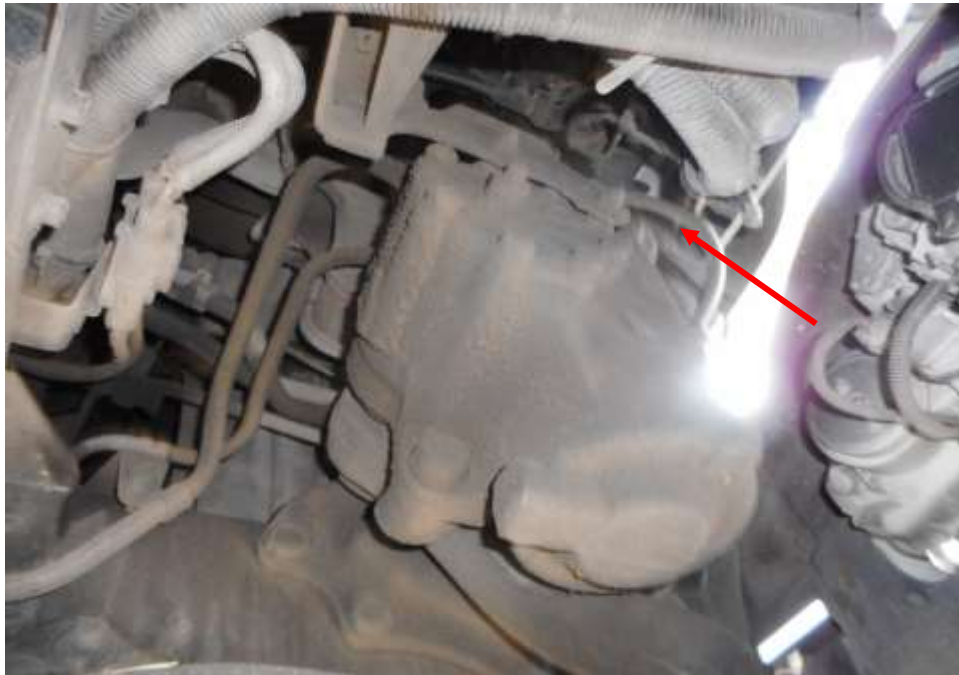
Photo 20 shows the steering box component (arrowed) at the undercarriage of the Motor Lorry was found to be intact without any visible damage. There was also no sign of fluid stain(s) observed on the various undercarriage components.

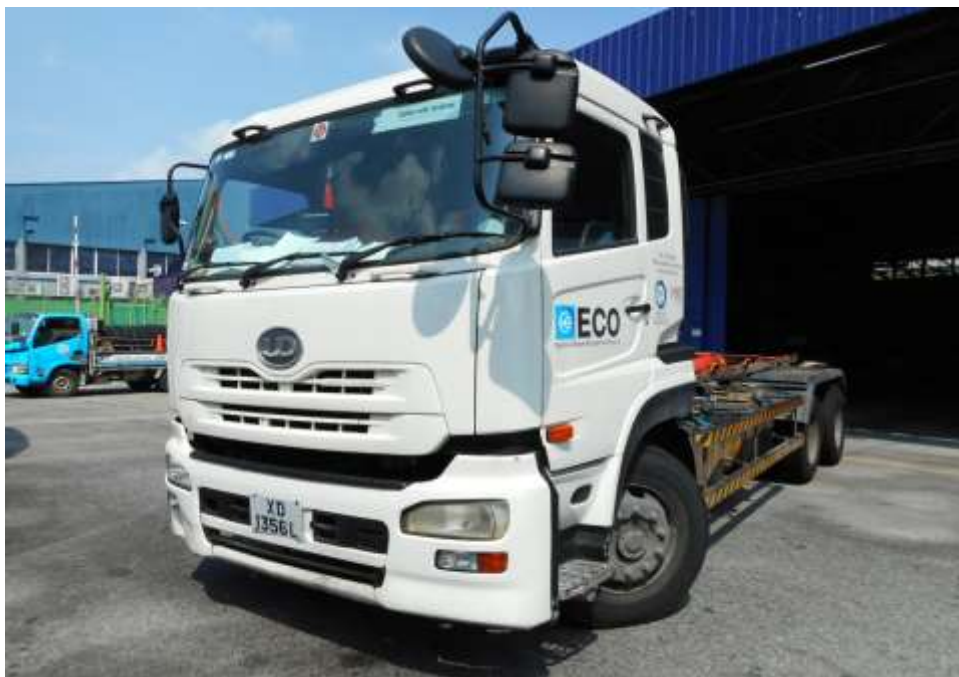
Photo 21 shows the front left wheel of the Motor Lorry turned to its full right. During my steering system test, I did not experience any abnormal free play and/or resistance when I had turned the steering wheel towards full left and full right. This would suggest that the steering system of the Motor Lorry was likely to be in serviceable condition at the material time of accident.

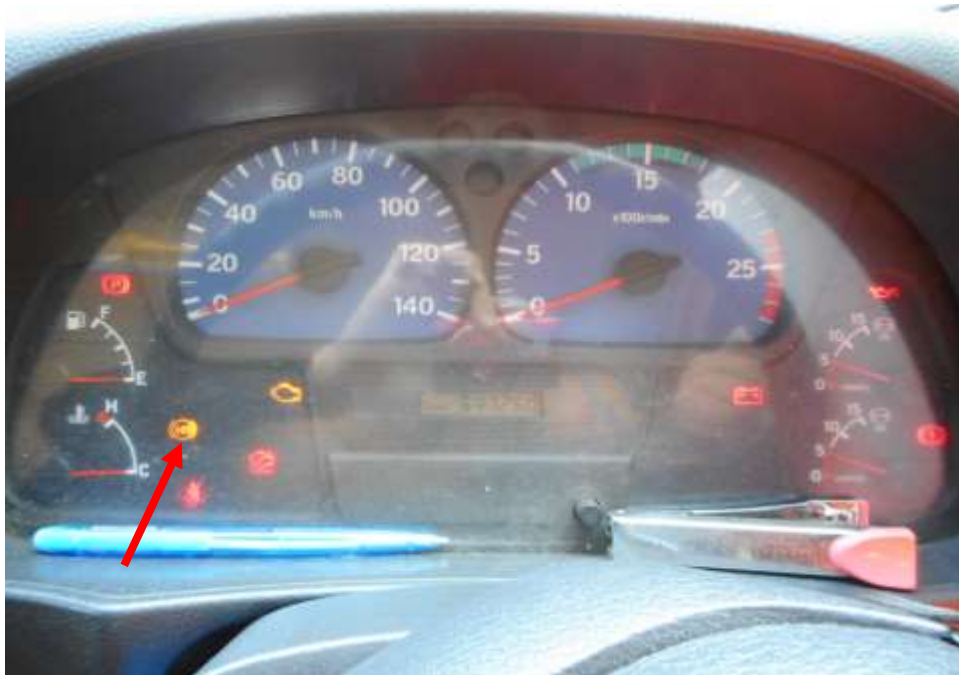
Photo 22 shows the warning light for Anti-Lock Brake System (ABS) (arrowed) appearing on the instrument panel of the Motor Lorry during the self-test of its various electronic operating systems when its engine was cranked.

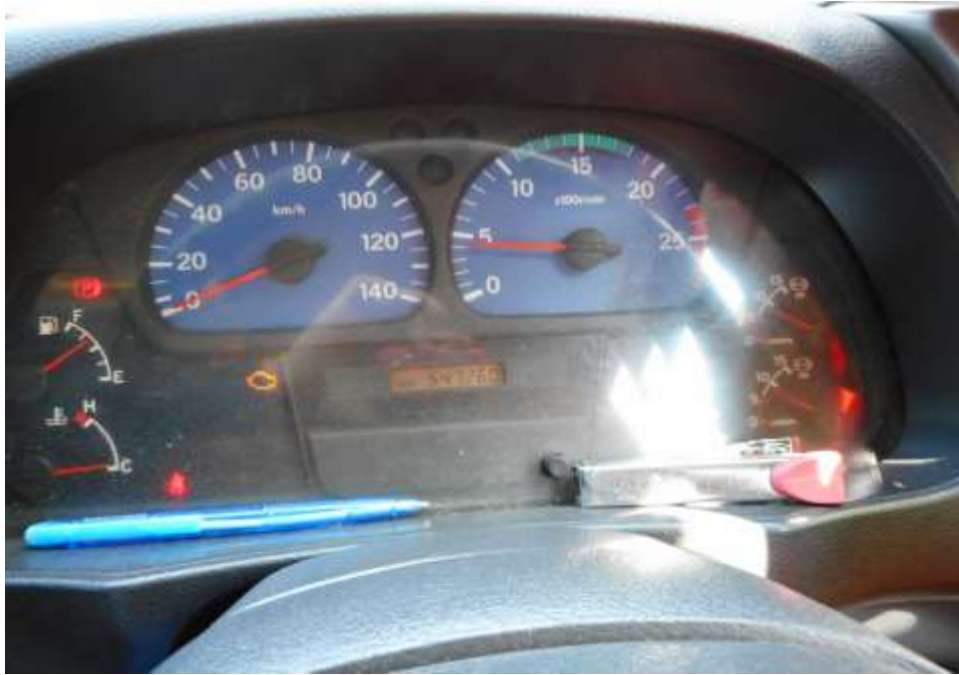
13. The Motor Lorry automatic self-test of the functionality of its various electronic operating systems like the Anti-Lock Brake System (ABS) during cranking of the engine had indicated that these systems were in working condition and without abnormality. This can be established from the warning lights disappearing from the instrument panel after the self-test. See photo 22 & 23.

Photo 23 shows no warning lights illuminated on the instrument panel of the Motor Lorry after the engine was cranked. This would suggest that there was no abnormality to the various electronic operating systems of the Motor Lorry, like the ABS etc.
