Your Ref: TP/IP/019355/2019
Our Ref : CI/TPD19008260/P

Fatal Accident Investigation Team

MECHANICAL INSPECTION REPORT OF MOTOR TAXI SHC 4495T

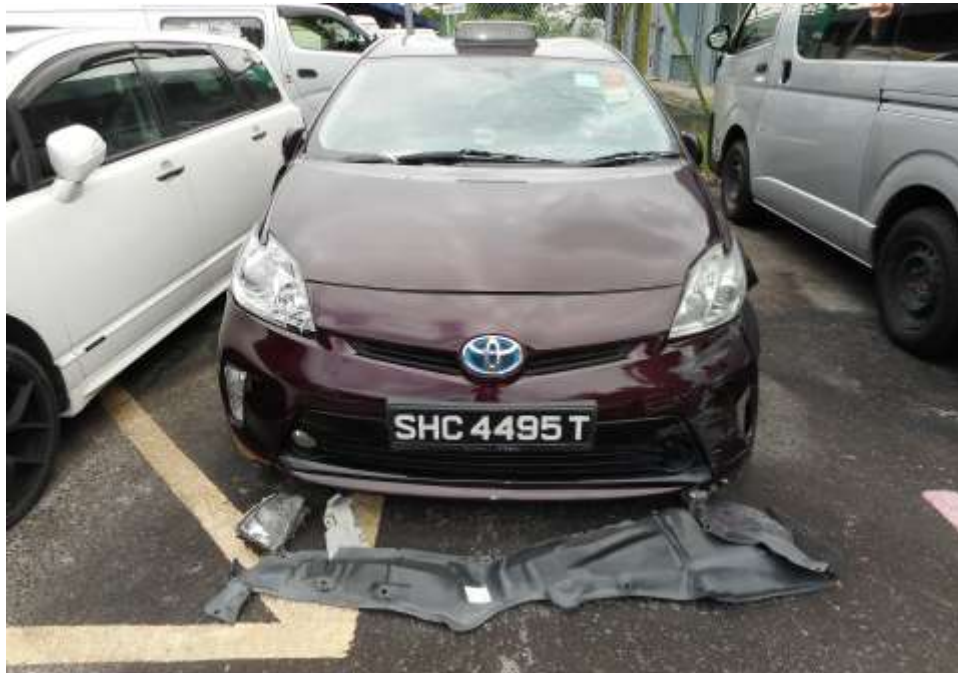
4. The mileage of the Motor Taxi at the time of my inspection was recorded 427,218km
5. The Motor Taxi was observed to have sustained damage at its frontal portion. Its front windscreen, bonnet, bumper, right headlamp and left fog lamp were amongst the body parts that were damaged as a result of the accident.

Photo 1 shows a general view of the front right body of the Motor Taxi at the time of my inspection. The Motor Taxi observed to have sustained damage at its frontal portion. Its front windscreen, bonnet, bumper, right headlamp and left fog lamp were amongst the body parts that were damaged as a result of the accident. The mileage of the Motor Taxi at the time of my inspection was recorded to be 427,218km.

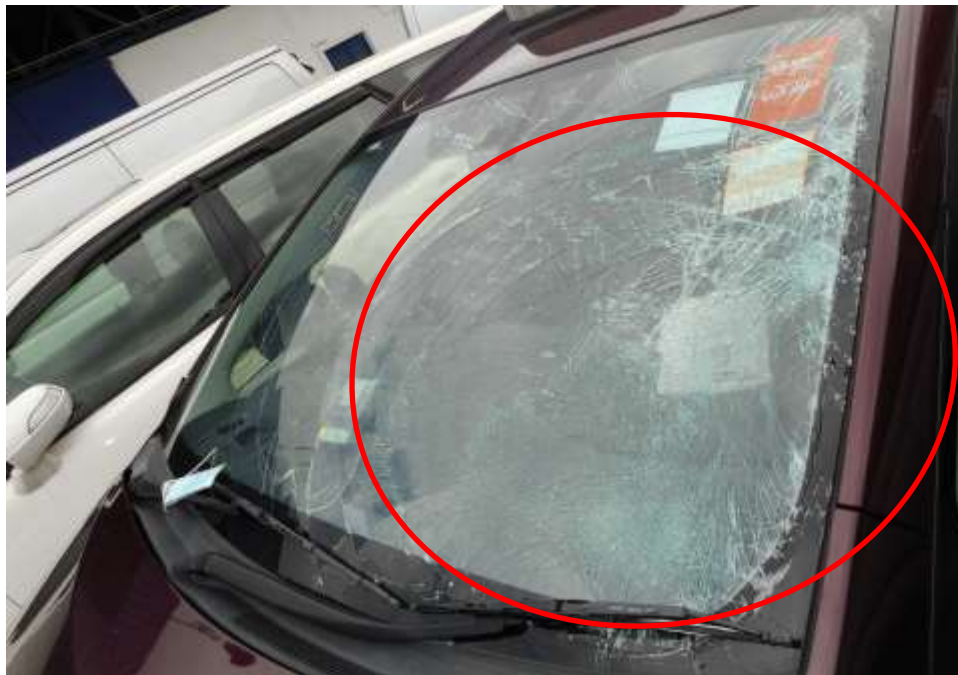
Photo 2 shows a close-up view of the damaged front windscreen (circled) of the Motor Taxi as a result of the accident.

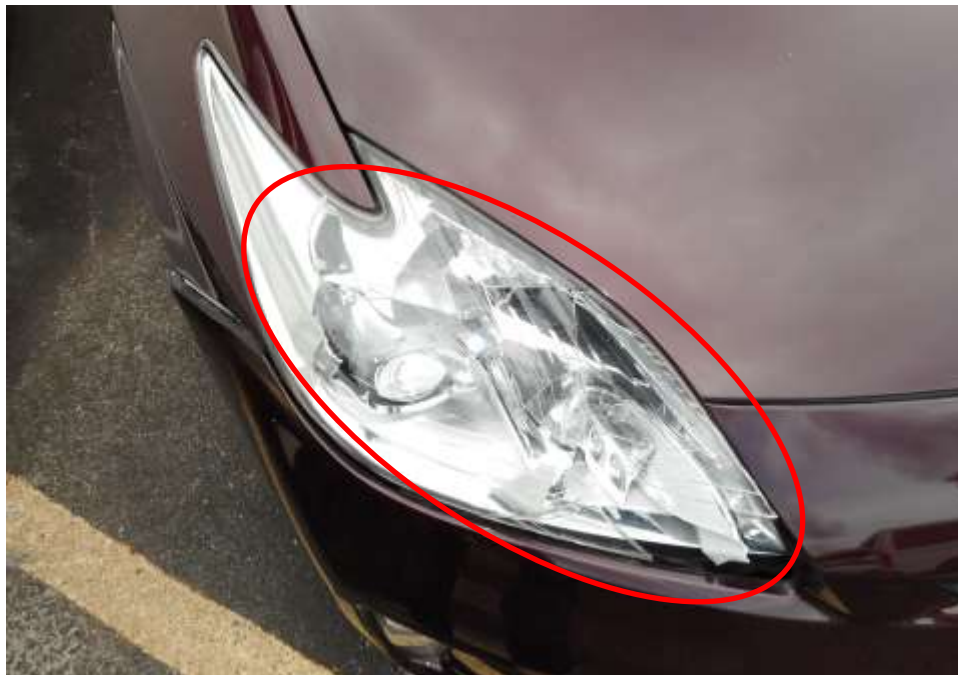
Photo 3 shows a close-up view of the Motor Taxi's right headlamp. Its front right headlamp (circled) was damaged as a result of the accident.

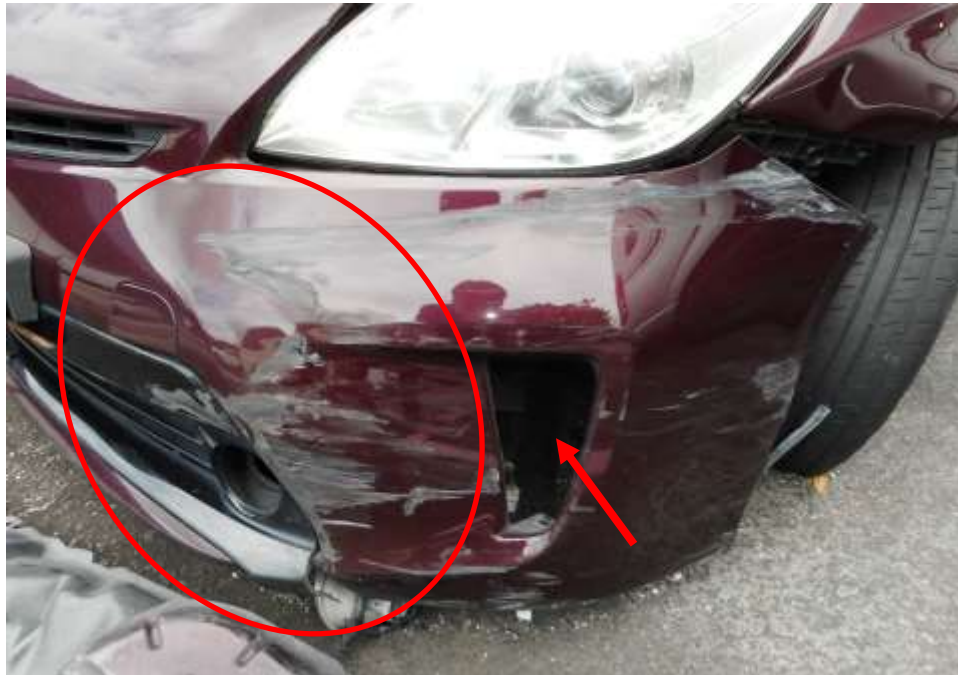
Photo 4 shows a close-up view of the front body of the Motor Taxi at the time of my inspection. The Motor Taxi was observed to have sustained relatively minor damage at its frontal portion. Its front bumper (circled) and fog lamp (arrowed) was damaged as a result of the accident.

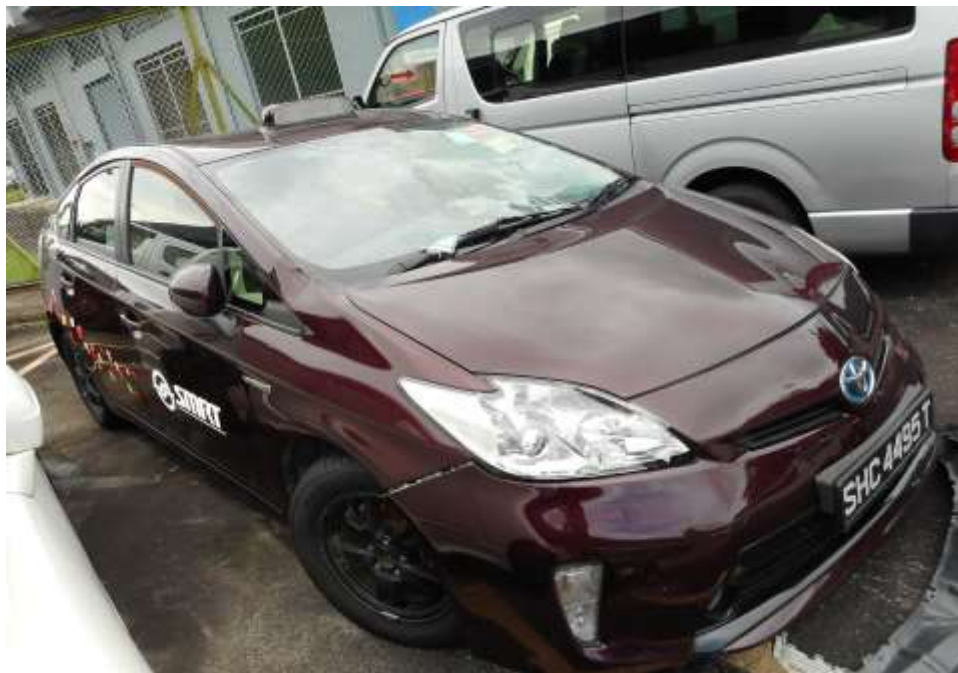
Photo 5 shows a general view of the Motor Taxi's right body panel at the time of my inspection. The right portion of the Motor Taxi was observed to have been unaffected by the accident.

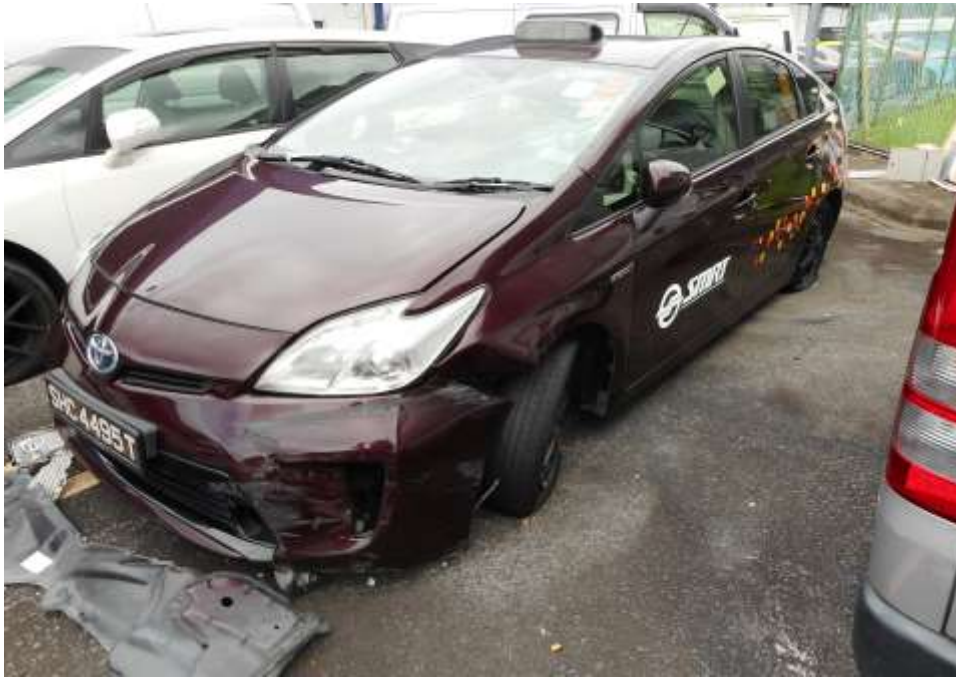
Photo 6 shows a general view of the Motor Taxi's left body panel at the time of my inspection. The left portion of the Motor Taxi was observed to have been unaffected by the accident.

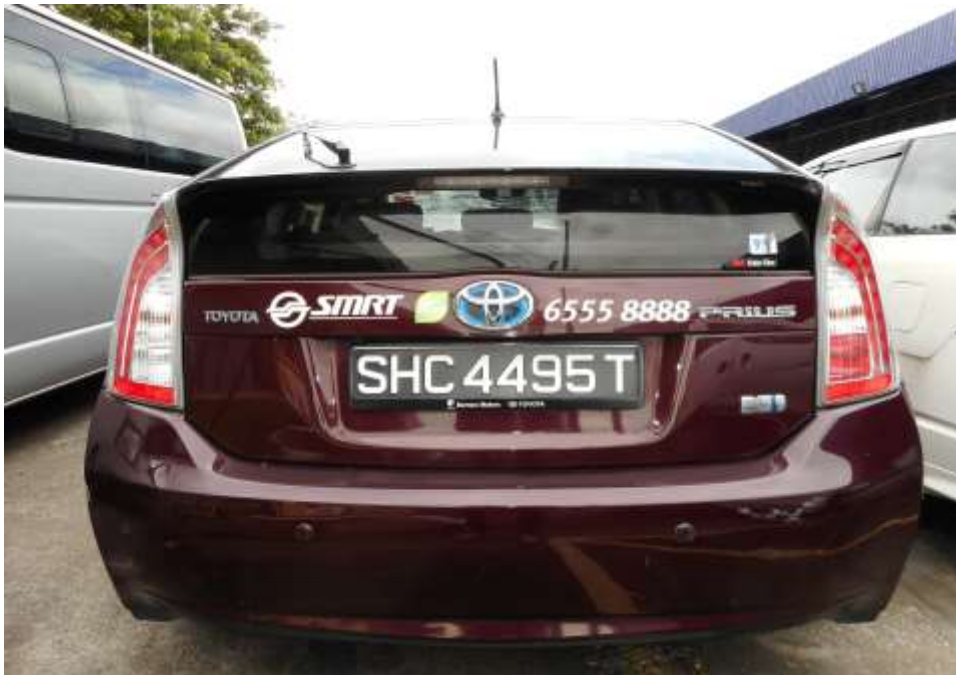
Photo 7 shows a general view of the Motor Taxi's rear left body at the time of my inspection. The rear portion of the Motor Taxi was observed to have been unaffected by the accident.

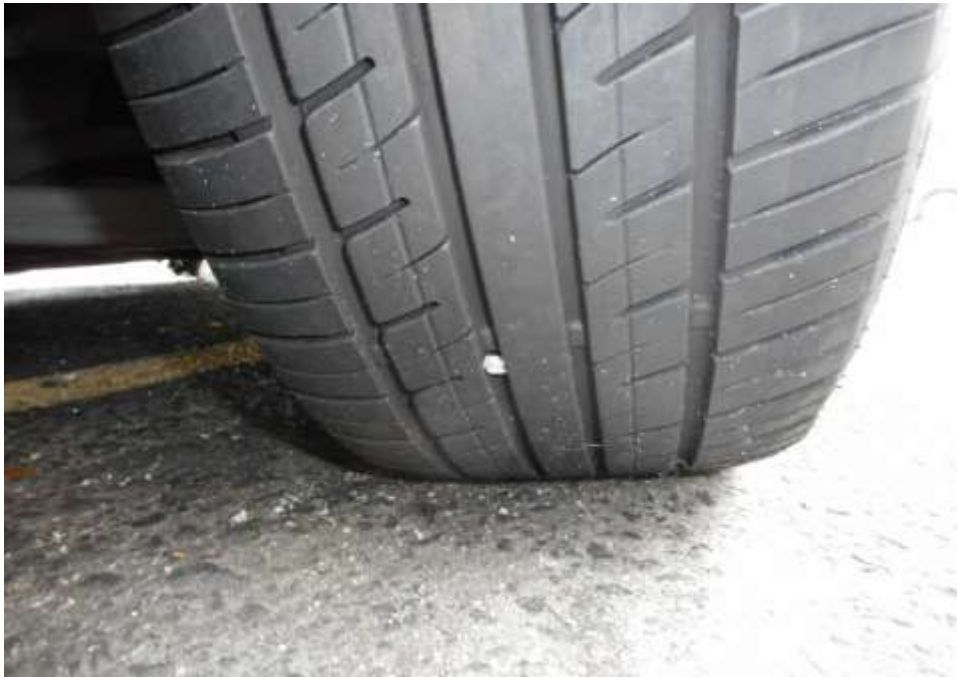
Photo 8 shows the condition of the front right tyre of the Motor Taxi, which was observed to be in serviceable condition with remaining tread depth of approximately 5.3mm. The tyre was sufficiently inflated for vehicular operation with no tear, cut or burst mark(s) on the outer and the inner sidewalls as well as across the tread. The 4 tyres of the Motor Taxi were wrapped around standard alloy wheel rims without any damage.

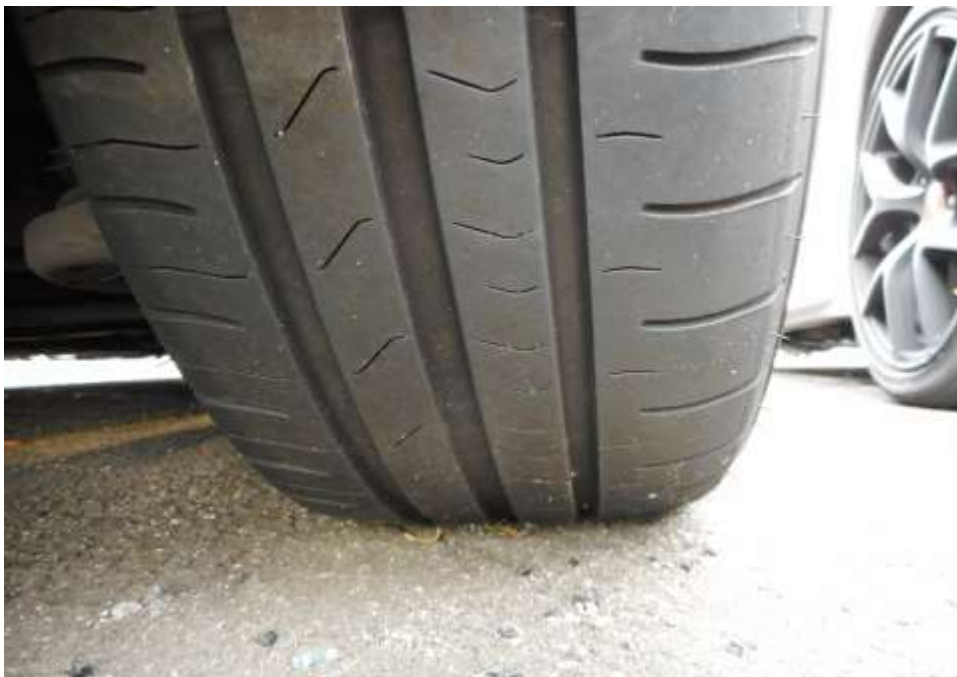
Photo 9 shows the condition of the rear right tyre of the Motor Taxi, which was observed to be in serviceable condition with remaining tread depth of approximately 5.5mm. The tyre was also observed to be sufficiently inflated for vehicular operation with no tear, cut or burst mark(s).

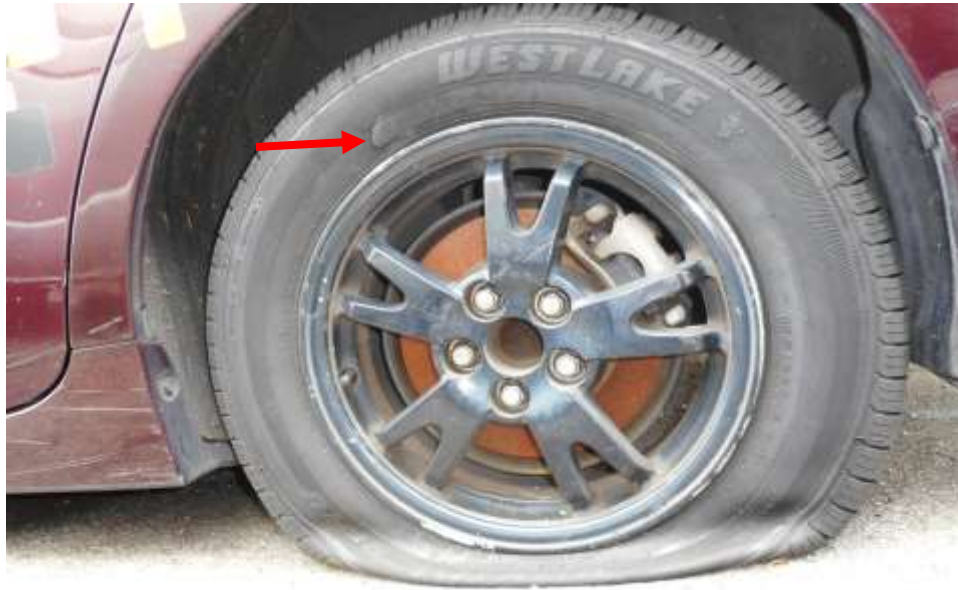
6. The condition of the Motor Taxi's tyres was observed, the left front and rear tyres we observed to have been cut and deflated as a result of the accident; however the other two tyres found to be in serviceable condition. I did not find any tear, cut or burst mark(s) on the outer and the inner sidewalls as well as across the tread of the 2 tyres. The 2 tyres were also observed to be sufficiently inflated for vehicular operation. The tyre brand, tyre size and remaining tread depth of the 4 tyres were recorded as follows: -

Photo 10 shows the condition of the rear left tyre of the Motor Taxi, which was observed to have cut marks (arrowed) and delated as a result of the accident. The remaining tread depth of approximately 6.5mm.

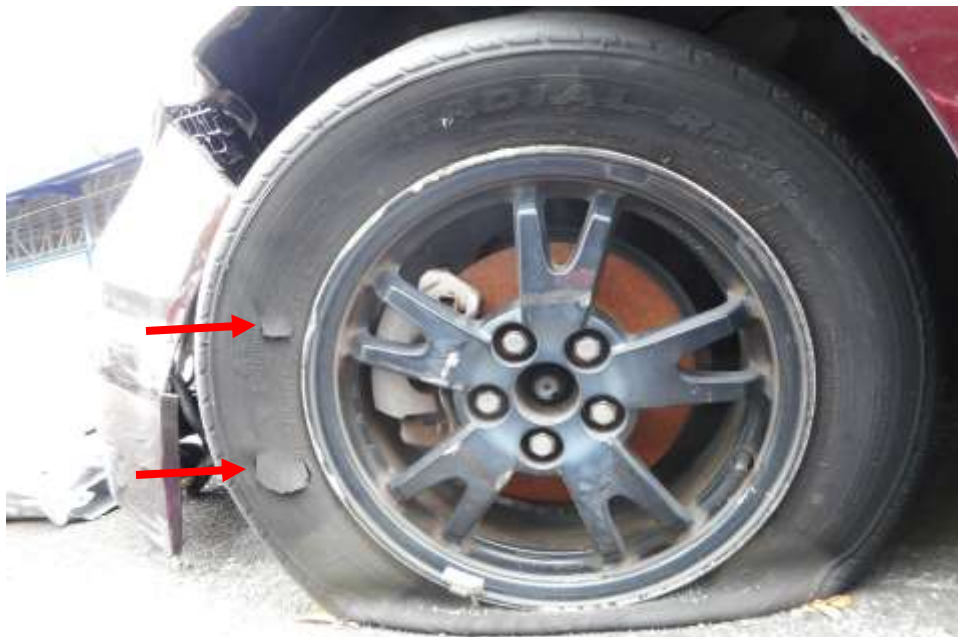
Photo 11 shows the condition of the front left tyre of the Motor Taxi, which was observed to have cut marks (arrowed) and delated as a result of the accident. The remaining tread depth of approximately 3.5mm.

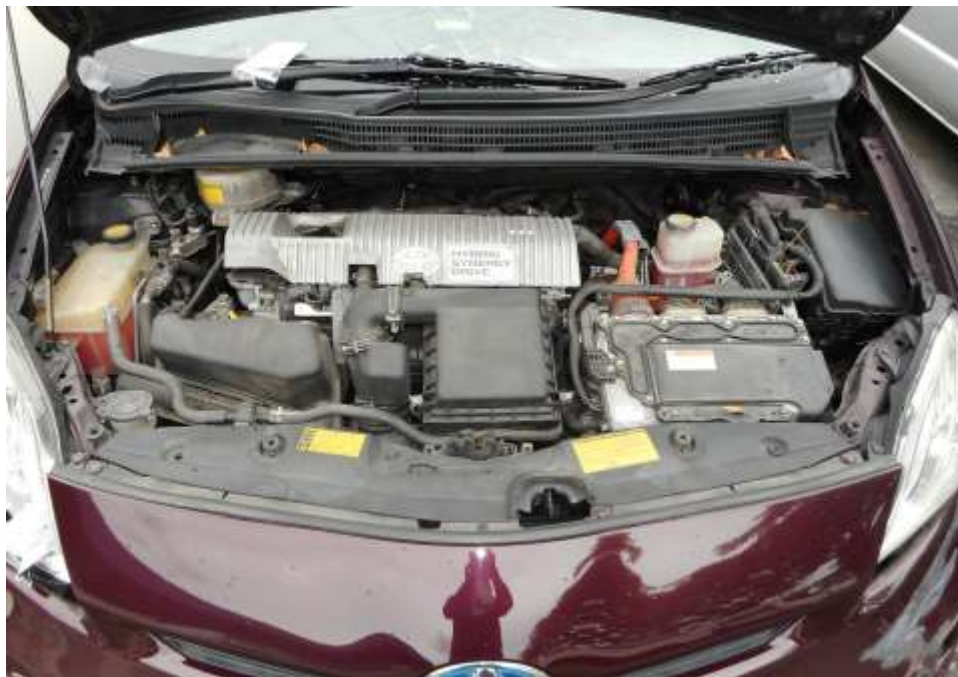
Photo 11 shows a general view of the Motor Taxi's engine compartment. The various parts and components inside the engine compartment were unaffected by the accident. There was also no sign(s) or indication(s) of fluid leakage and/or fluid stain within the engine compartment.

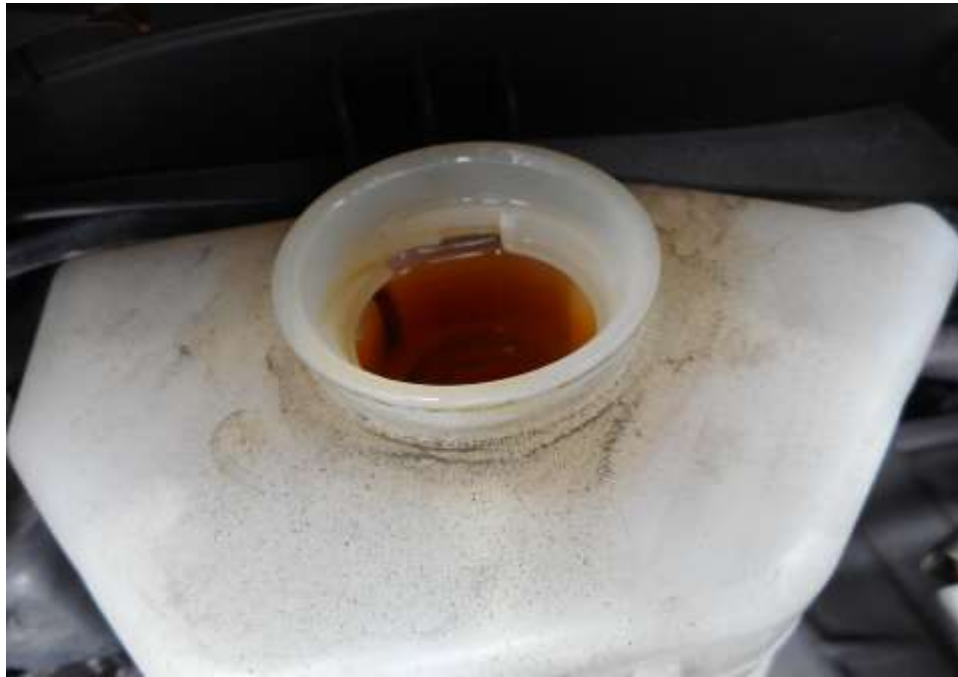
Photo 12 shows the brake fluid reservoir of the Motor Taxi at the time of my inspection. The brake fluid was observed to be of sufficient level and without any visible contamination.

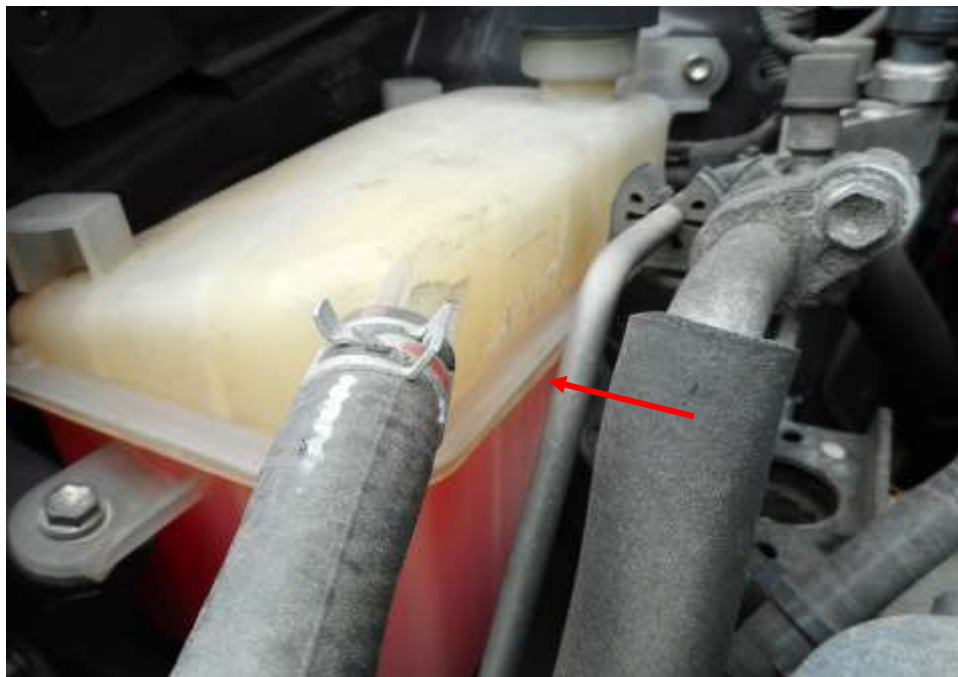
Photo 13 shows checks being carried out to the engine coolant of the Motor Taxi at the time of my inspection. The engine coolant was observed to be of sufficient level (arrowed) and without any visible contamination.

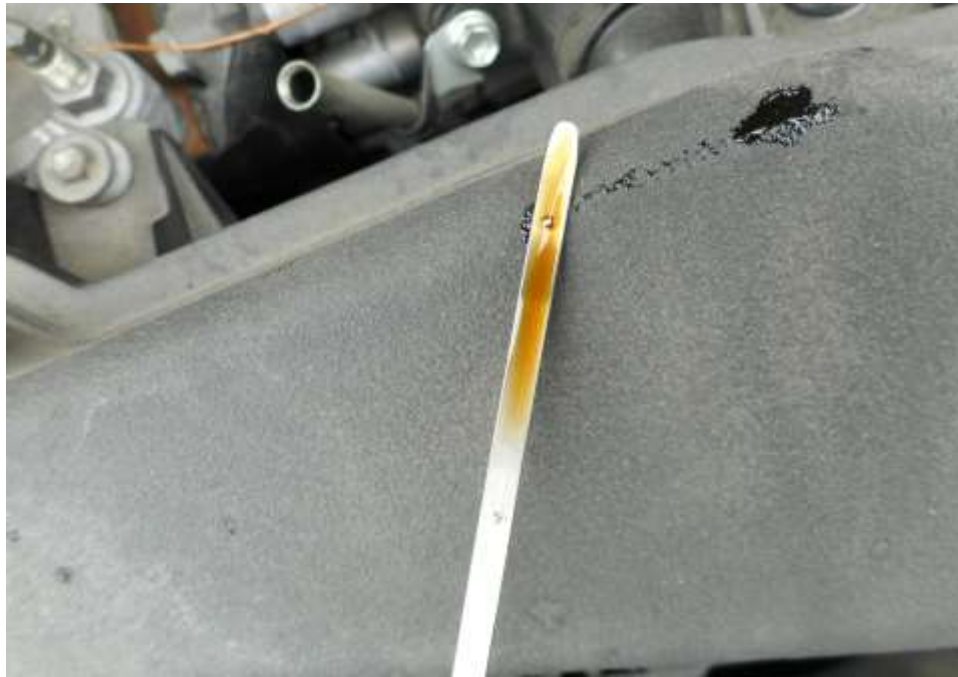
Photo 14 shows the engine oil dip stick of the Motor Taxi at the time of my inspection. The engine oil was observed to be of sufficient level and without any visible contamination.

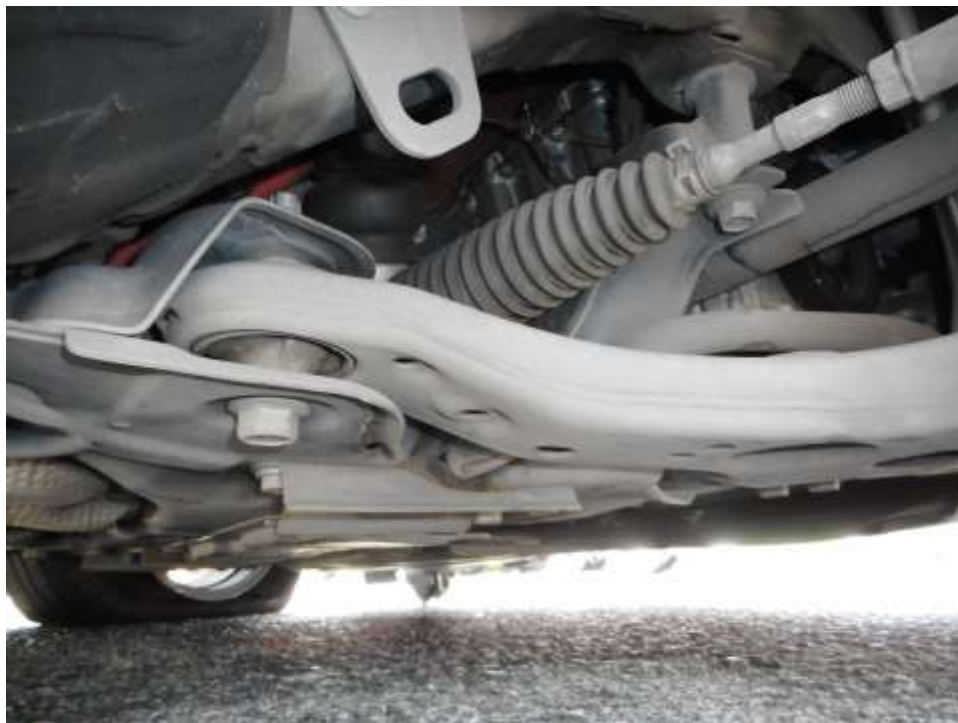
Photo 15 shows the undercarriage of the Motor Taxi, at the area where the engine housing and transmission housing are located. I did not find any sign(s) or indication(s) of fluid leak and/or fluid stain(s) on the underside of the Motor Taxi.

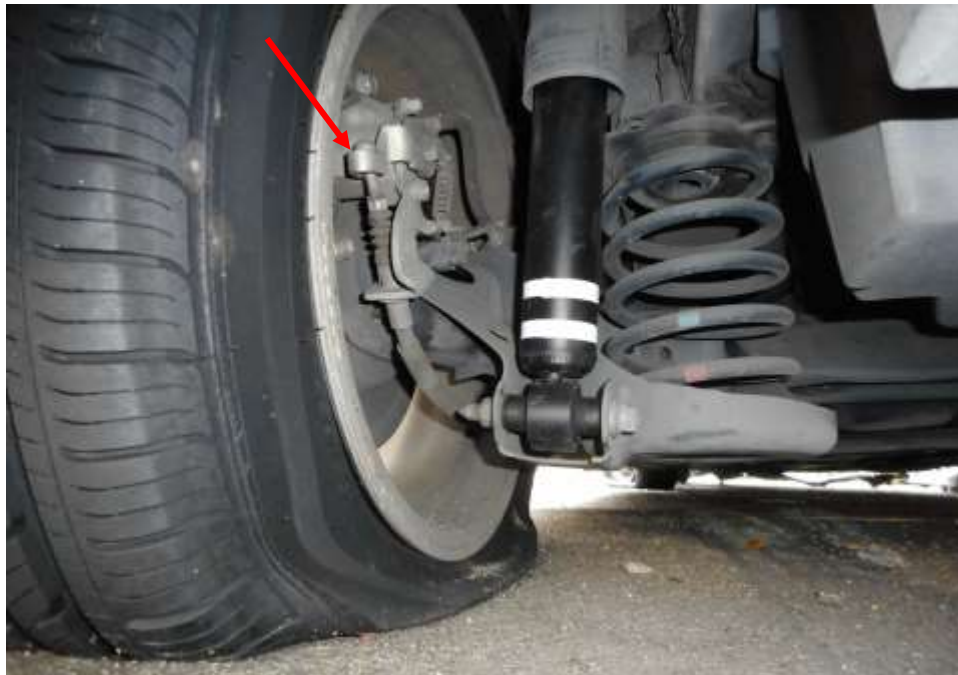
Photo 16 shows the brake hose/pipe (arrowed) at the rear left wheel of the Motor Taxi. I did not observe any leakage of brake fluid at the time of my inspection of the Motor Taxi. Static tests of the Motor Taxi's braking system had indicated that there was no internal leakage of pressure/vacuum. The undercarriage components of the Motor Taxi were also all found to be intact and without any visible damage.

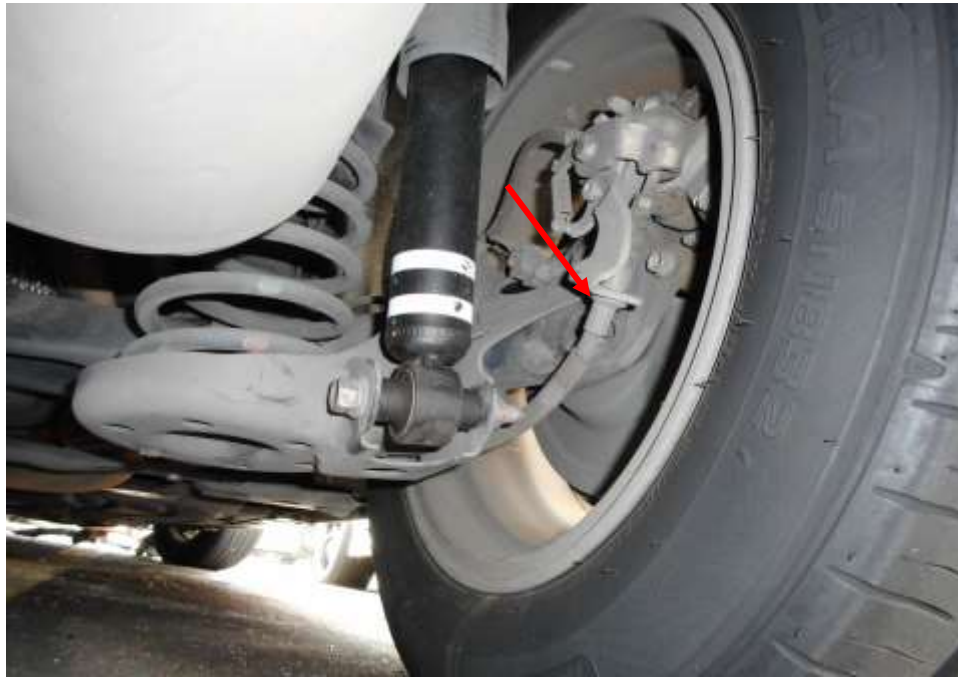
Photo 17 shows the brake hose/pipe (arrowed) at the rear right wheel of the Motor Taxi. I did not observe any leakage of brake fluid at the time of my inspection of the Motor Taxi. Static tests of the Motor Taxi's braking system had indicated that there was no internal leakage of pressure/vacuum. The undercarriage components of the Motor Taxi were also all found to be intact and without any visible damage.

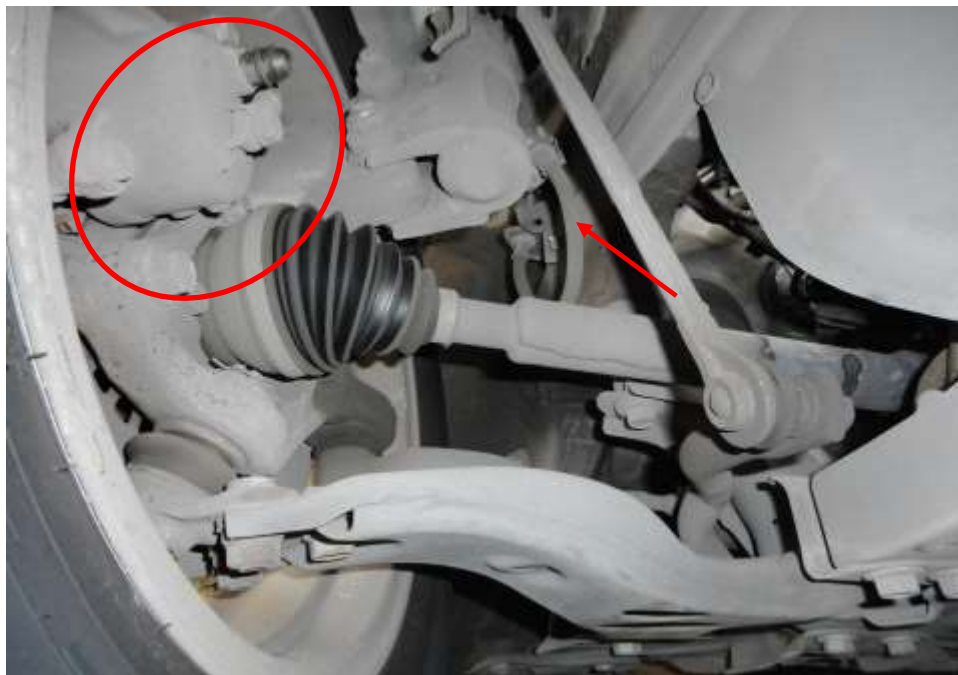
Photo 18 shows the brake hose/pipe (arrowed) at the front right wheel of the Motor Taxi. No leakage of brake fluid was observed. Visual examination of the various components of the braking system like the brake caliper (circled), brake booster, brake pedal etc had revealed all to be intact and without visible damage.

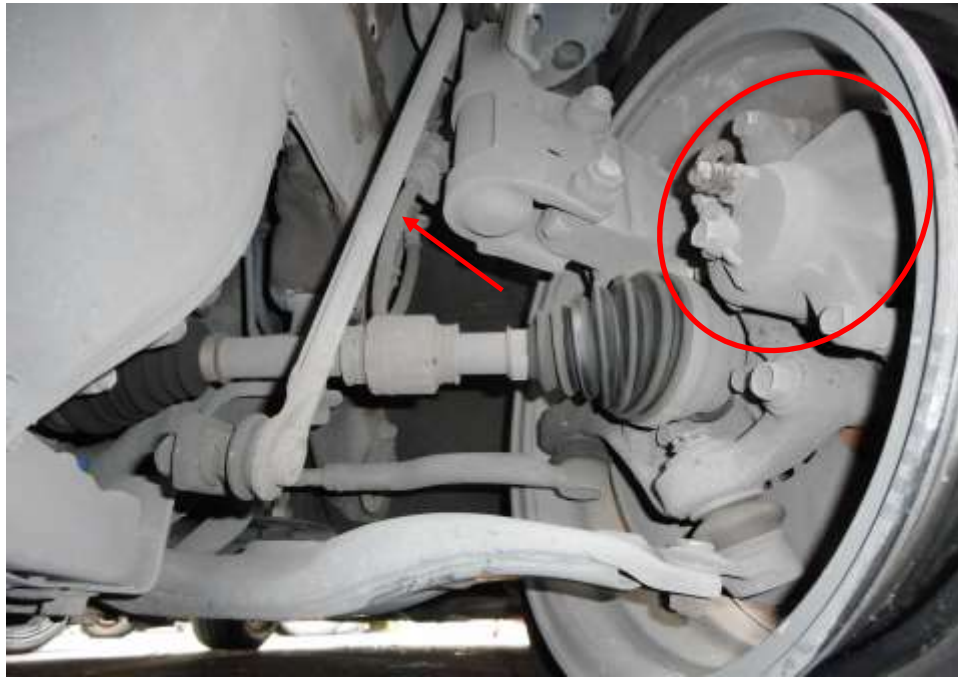
Photo 19 shows the brake hose/pipe (arrowed) at the front left wheel of the Motor Taxi. No leakage of brake fluid was observed. Visual examination of the various components of the braking system like the brake caliper (circled), brake booster, brake pedal etc had revealed all to be intact and without visible damage.

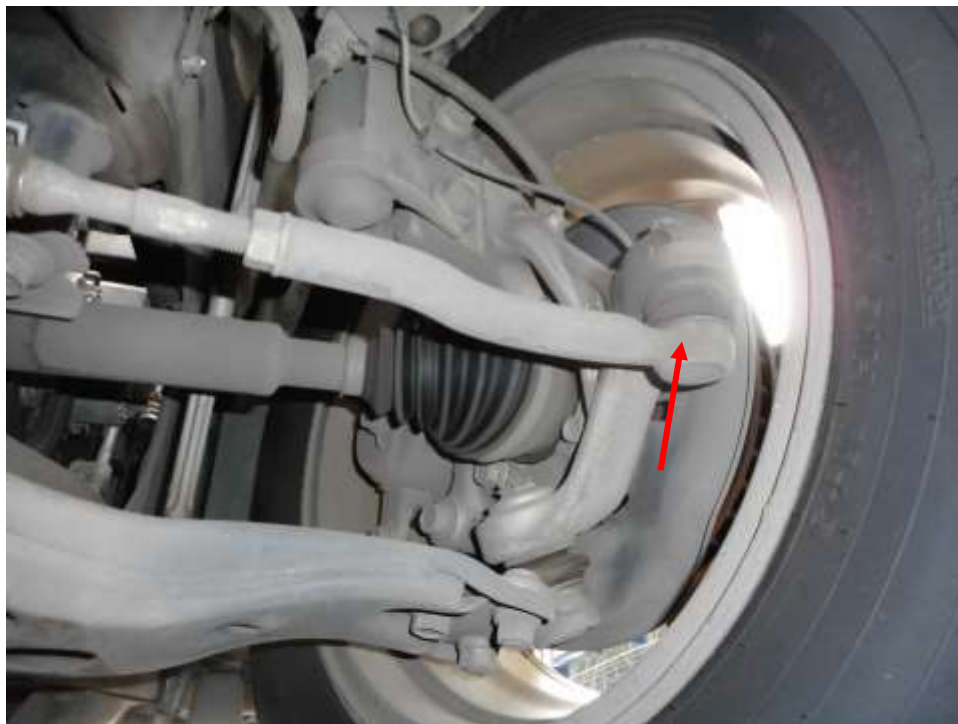
Photo 20 shows the various undercarriage components at the front right wheel of the Motor Taxi, in particular the steering tie rod (arrowed). The various steering components were all found to be intact, suggesting that the steering system of the Motor Taxi was likely to be in serviceable condition at the material time of accident. There was also no sign of fluid stain observed on the various undercarriage components at the front right wheel of the Motor Taxi.

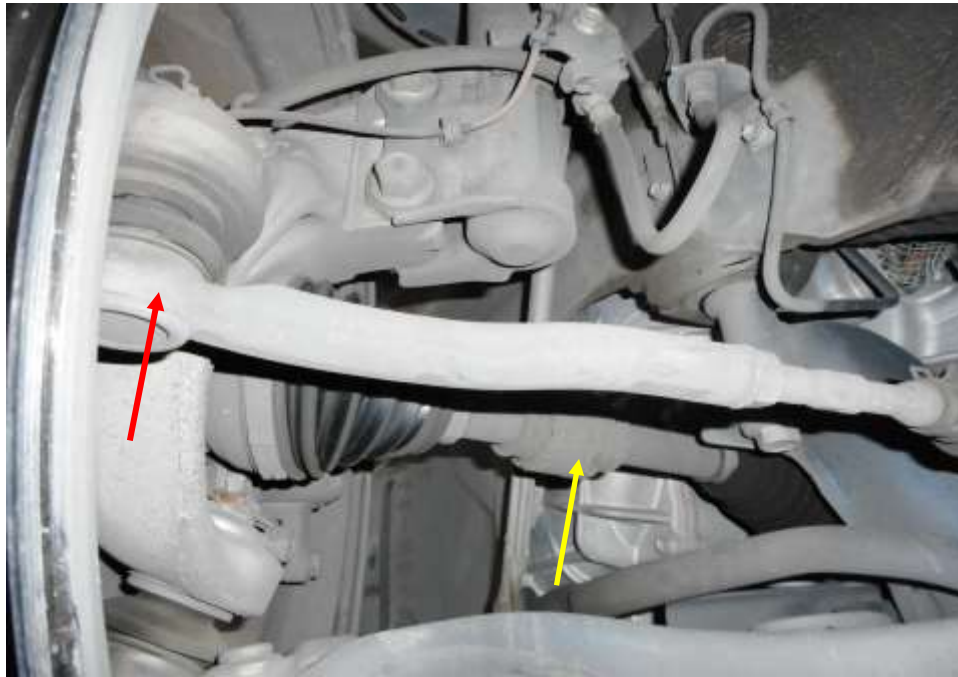
Photo 21 shows the various undercarriage components at the front left wheel of the Motor Taxi, which had included the steering tie rod (red arrow) and front left drive shaft (yellow arrow). The various undercarriage components of the Motor Taxi were all found to be intact without any visible damage.

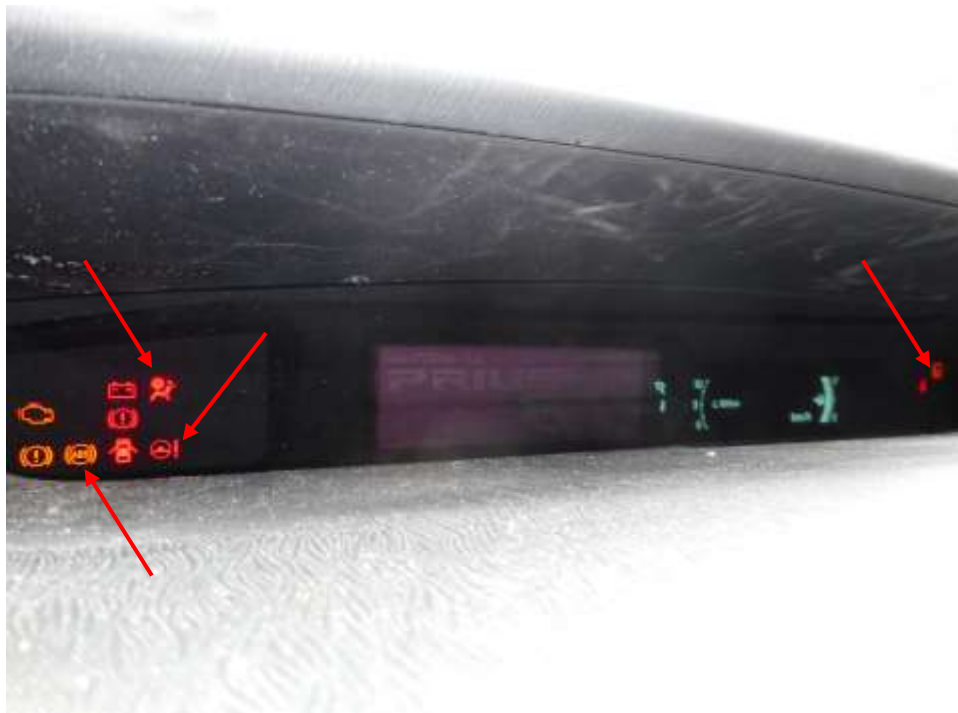
Photo 22 shows the warning light for Anti-Lock Brake System (ABS), Electric Power Steering System (EPS), Traction Control (TC) and Supplemental Restraint System (SRS) appearing on the instrument panel of the Motor Taxi during the self-test of its various electronic operating systems when its engine was cranked.

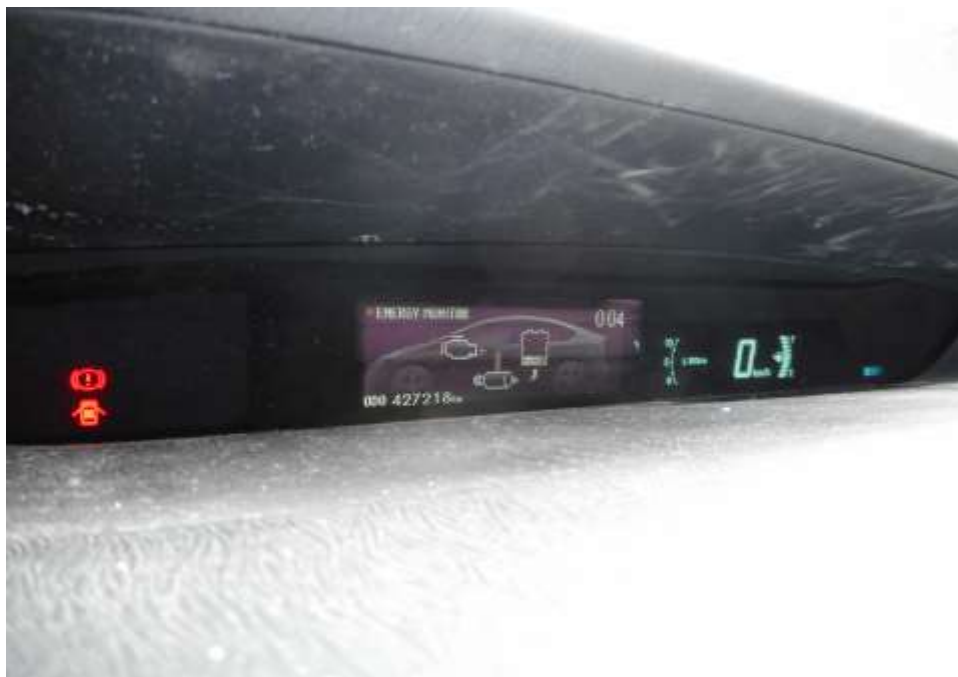
Photo 23 shows no warning lights illuminated on the instrument panel of the Motor Taxi after the engine was cranked. This would suggest that there was no abnormality to the various electronic operating systems of the Motor Taxi, like the ABS, EPS, TC and SRS etc.

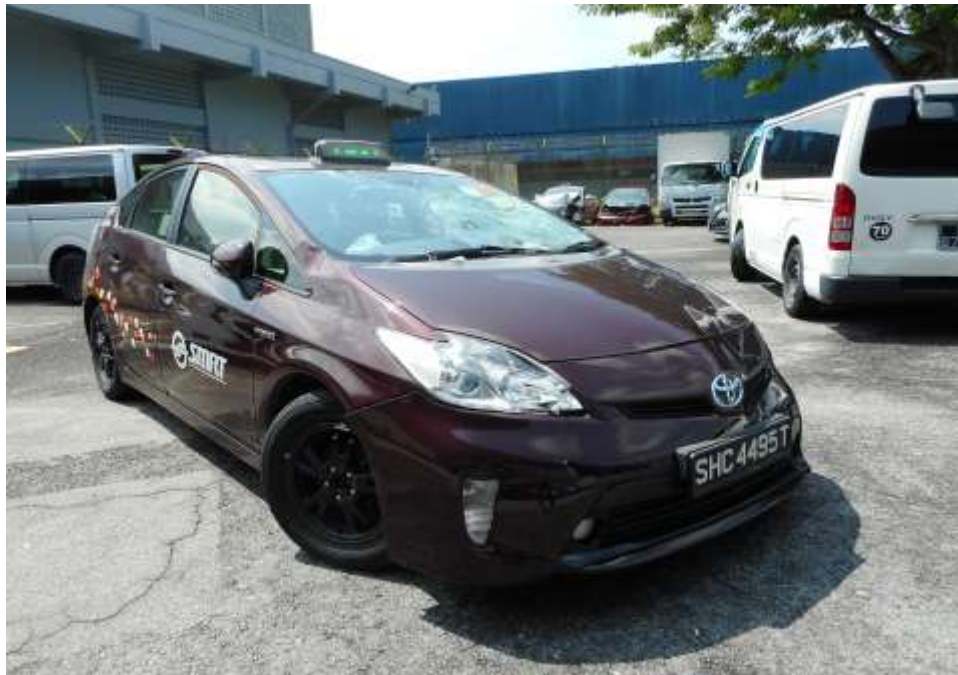
Photo 24 shows the front right wheel of the Motor Taxi turned to its full left. During my steering system test, I did not experience any abnormal free play and/or resistance when I had turned the steering wheel towards the left and right. This would suggest that the steering system of the Motor Taxi was likely to be in serviceable condition at the material time of accident.
