Your Ref: TP/IP/13597/2019
Our Ref : CI/TPD19008261/P

Fatal Accident Investigation Team

MECHANICAL INSPECTION REPORT OF MOTOR CAR SLR 7884H

1. I refer to your request on 29th April 2019 to conduct a physical inspection of a Motor car bearing registration number SLR 7884H (herein referred to as "**Motor Car**"), which was involved in a road traffic accident on 7th March 2019.
2. The objective of the inspection is to determine if there was any possible mechanical failure to the Motor car that may have contributed to the accident.
3. Following the request, I had carried out a physical inspection of the Motor Car on 18th June 2019 at the premises of Traffic Police vehicle pound, 517 Airport Road Singapore 539942. I now set out below my observations and comments with respect to this inspection.

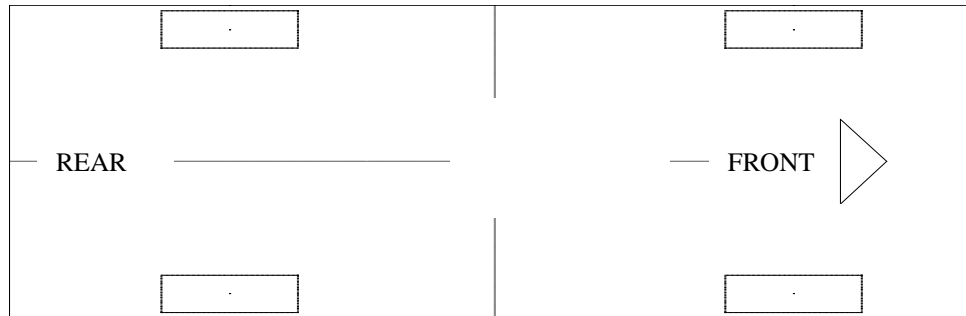
6. The condition of the Motor car's 4 tyres was observed to be in serviceable condition. I did not find any tear, cut or burst mark(s) on the outer and the inner sidewalls as well as across the tread of the 4 tyres. The 4 tyres were also observed to be sufficiently inflated for vehicular operation. The tyre brand, tyre size and remaining tread depth of the 4 tyres were recorded as follows:-

Yokohama 205/55R16 (6.5mm)

Yokohama 205/55R16 (6.7mm)

Yokohama 205/55R16 (7mm)

Yokohama 205/55R16 (6.8mm)

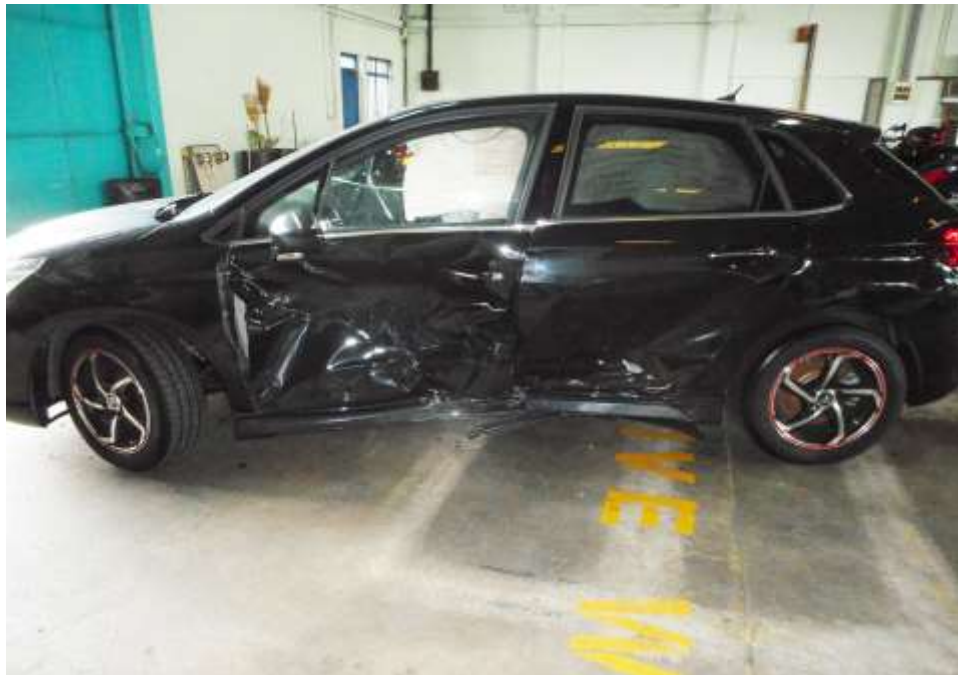
4. The mileage of the Motor car at the time of my inspection was 29,131km.
5. The Motor car was observed to have sustained damage at its left side portion. Its left door panel was amongst the body parts that were damaged as a result of the accident. Both front and rear passengers' side curtain air-bag's was deployed as a result of the accident

Photo 1 shows a general view of the Motor Car's left side body at the time of my inspection. The Motor car was observed to have sustained damage at its left portion. It's left door panels were amongst the body parts that were damaged and both the front and rear passengers' side curtain air-bag's was deployed as a result of the accident. The mileage of the Motor Car at the time of my inspection was recorded to be 29,131km.

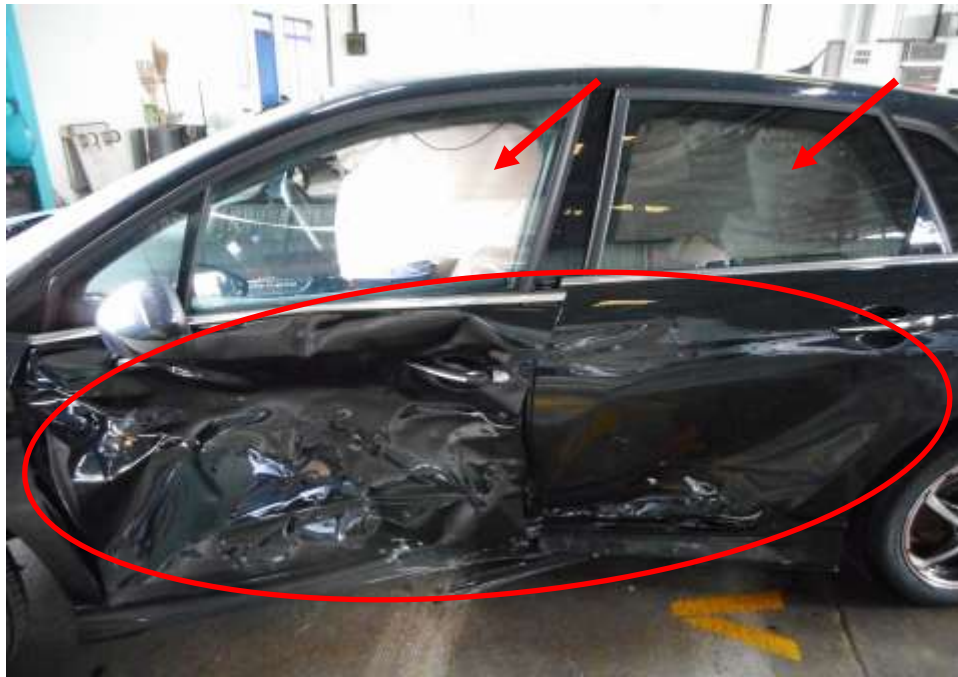
Photo 2 shows the close up view of the Motor Car's left side body at the time of my inspection. The Motor car was observed to have sustained damage at its left portion. Its left door panels (circled) were amongst the body parts that were damaged and both the front and rear passenger side curtain air-bags (arrowed) was deployed as a result of the accident

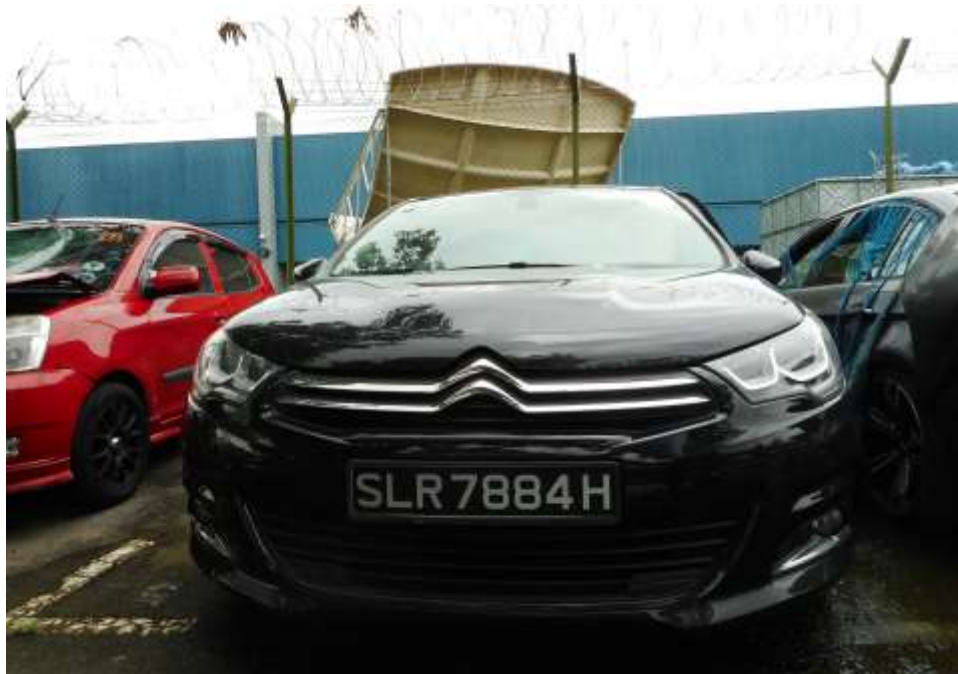
Photo 3 shows a general view of the front body of the Motor Car at the time of my inspection. The front portion of the Motor Car was observed to have been unaffected by the accident.

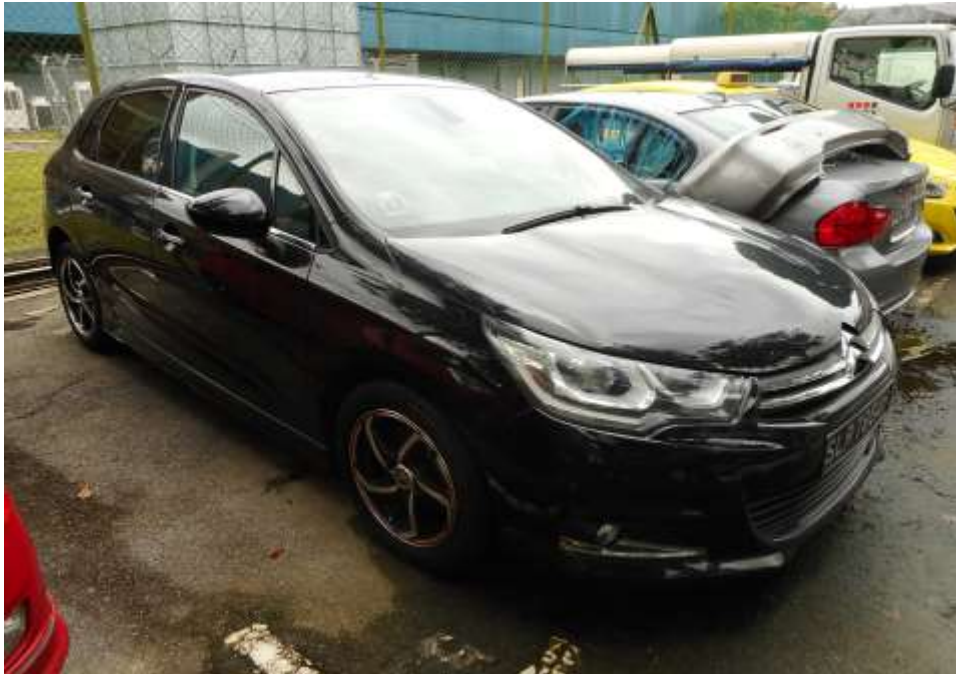
Photo 4 shows a general view of the Motor Car's right body at the time of my inspection. The right portion of the Motor Car was observed to have been unaffected by the accident.

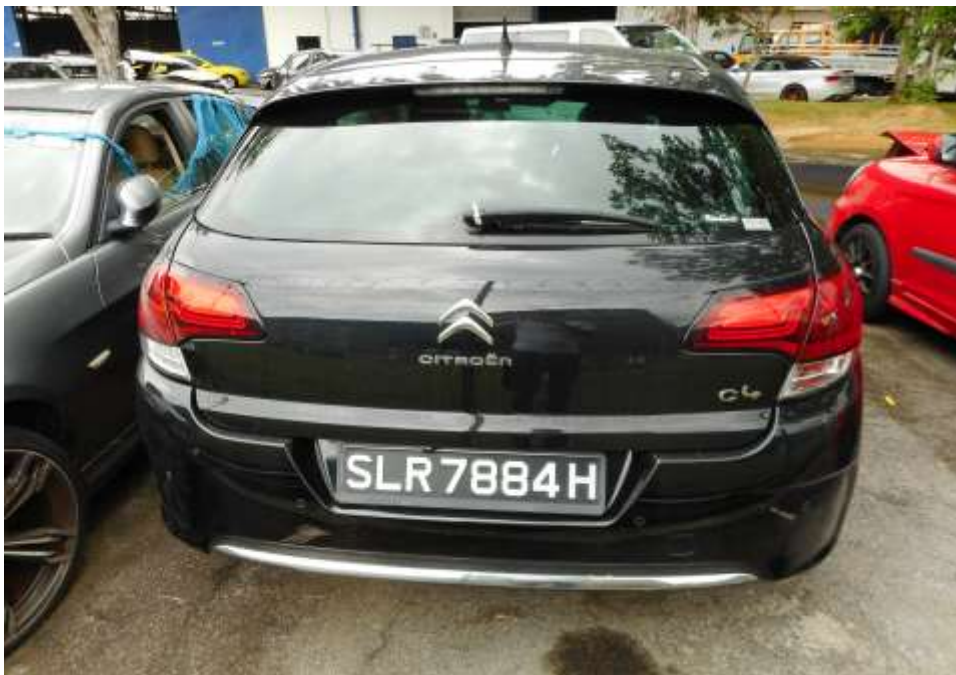
Photo 5 shows a general view of the Motor Car's rear body at the time of my inspection. The rear portion of the Motor Car was observed to have been unaffected by the accident.

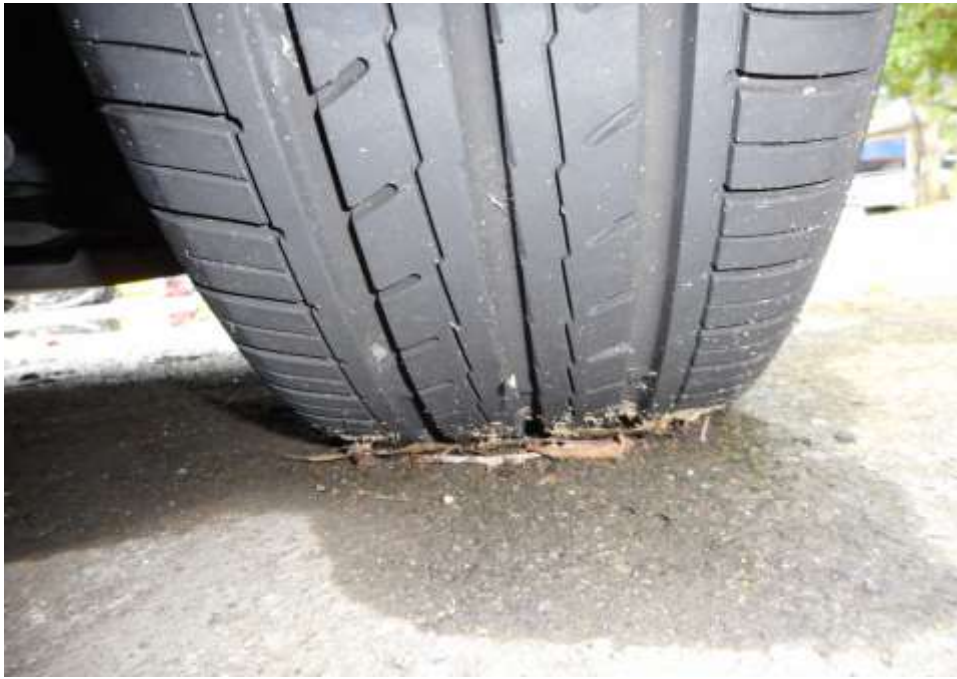
Photo 6 shows the condition of the front right tyre of the Motor Car, which was observed to be in serviceable condition with remaining tread depth of approximately 4.4mm. The tyre was sufficiently inflated for vehicular operation with no tear, cut or burst mark(s) on the outer and the inner sidewalls as well as across the tread. The 4 tyres of the Motor Car were wrapped around standard alloy wheel rims without any damage.

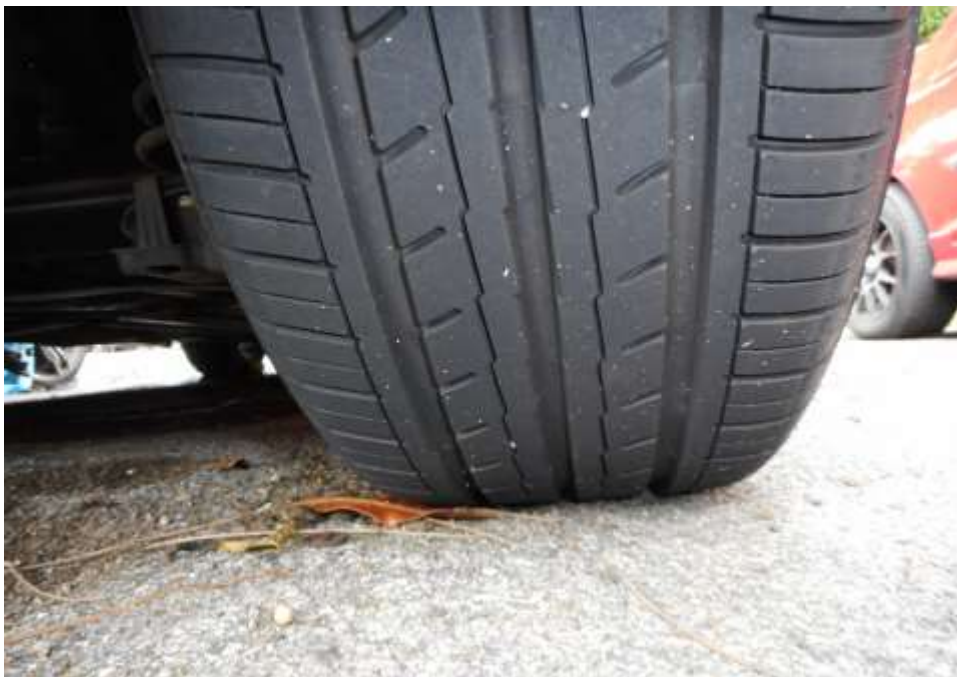
Photo 7 shows the condition of the rear right tyre of the Motor Car, which was observed to be in serviceable condition with remaining tread depth of approximately 7mm. The tyre was also observed to be sufficiently inflated for vehicular operation with no tear, cut or burst mark(s).

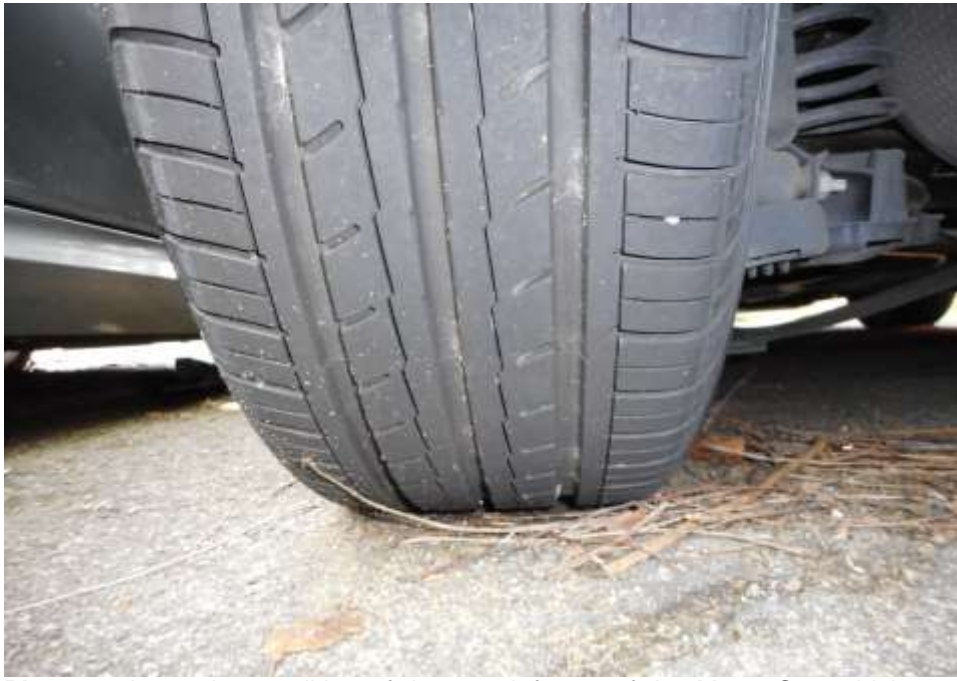
Photo 8 shows the condition of the rear left tyre of the Motor Car, which was observed to be in serviceable condition with remaining tread depth of approximately 6.5mm. The tyre, which was wrapped around alloy wheel rim, was also observed to be sufficiently inflated for vehicular operation. The 4 tyres of the Motor Car were wrapped around standard alloy wheel rims.

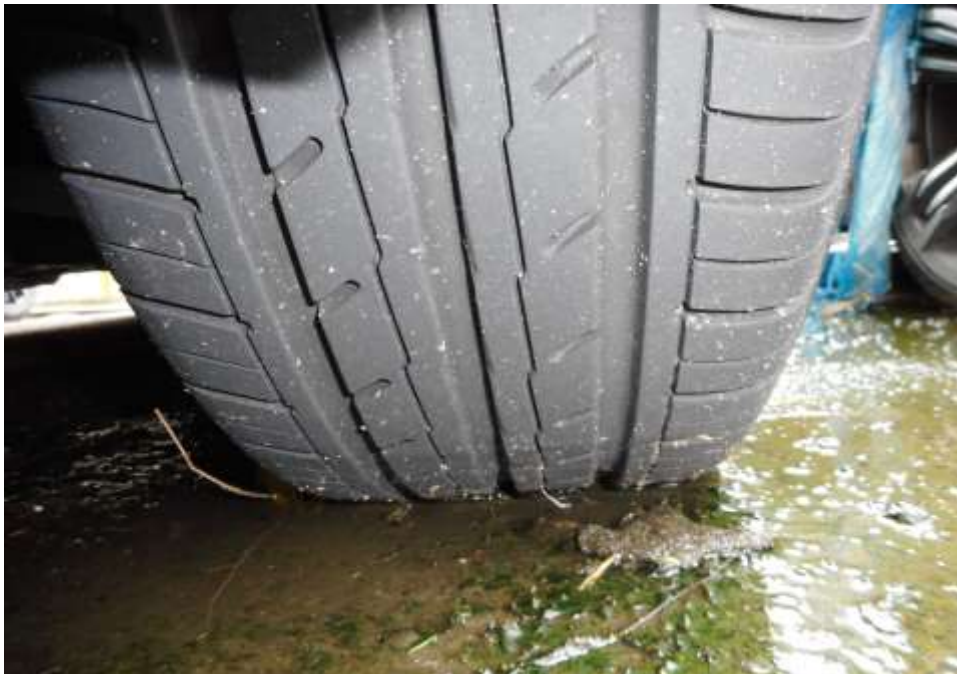
Photo 9 shows the condition of the rear right tyre of the Motor Car, which was observed to be in serviceable condition with remaining tread depth of approximately 6.7mm. There was also no tear, cut or burst mark(s) on the outer and the inner sidewalls as well as across the tread of the Motor Car's 4 tyres.

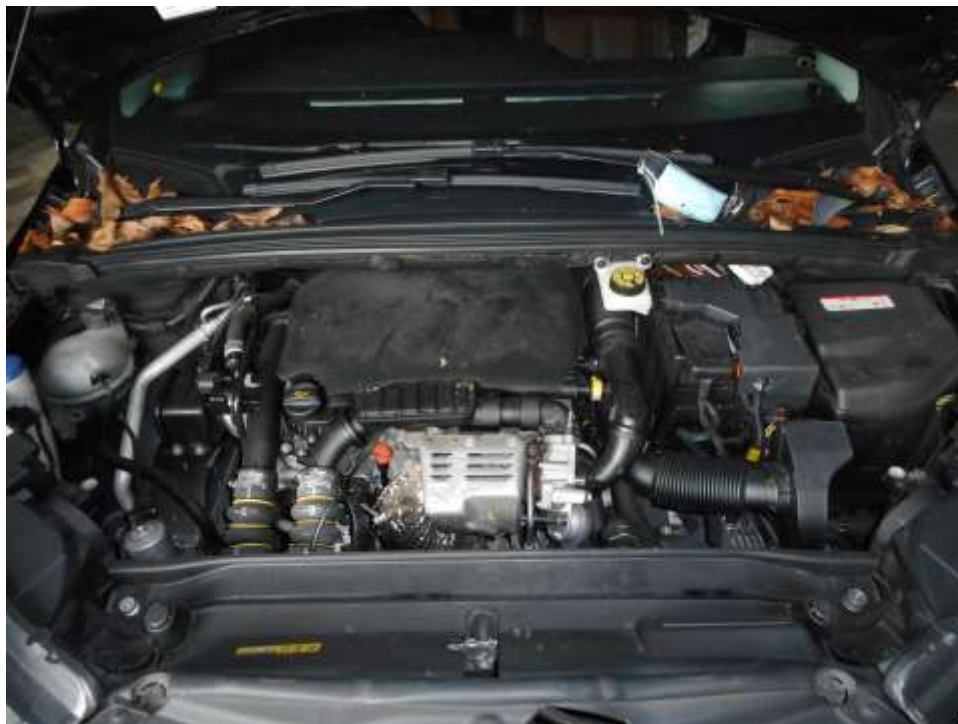
8. Upon examination of the engine compartment of the Motor Car, I had observed all the parts and components inside the engine compartment to be intact and unaffected by the accident. The brake fluid, engine oil and engine coolant were all found to be of sufficient level for operating purposes. Visually, there was also no contamination found to these fluids.
9. Further examination of the engine compartment revealed no sign(s) or indication(s) of fluid leakage and/or fluid stain within the engine compartment of the Motor Car.
10. My subsequent checks on the underside of the Motor Car also revealed no sign(s) or indication(s) of fluid leak and/or fluid stain(s). Visually, the various undercarriage components of the Motor Car were all observed to be intact and without any visible damage. See photo 10 – 14 below.

Photo 10 shows a general view of the Motor Car's engine compartment. The various parts and components inside the engine compartment were unaffected by the accident. There was also no sign(s) or indication(s) of fluid leakage and/or fluid stain within the engine compartment.

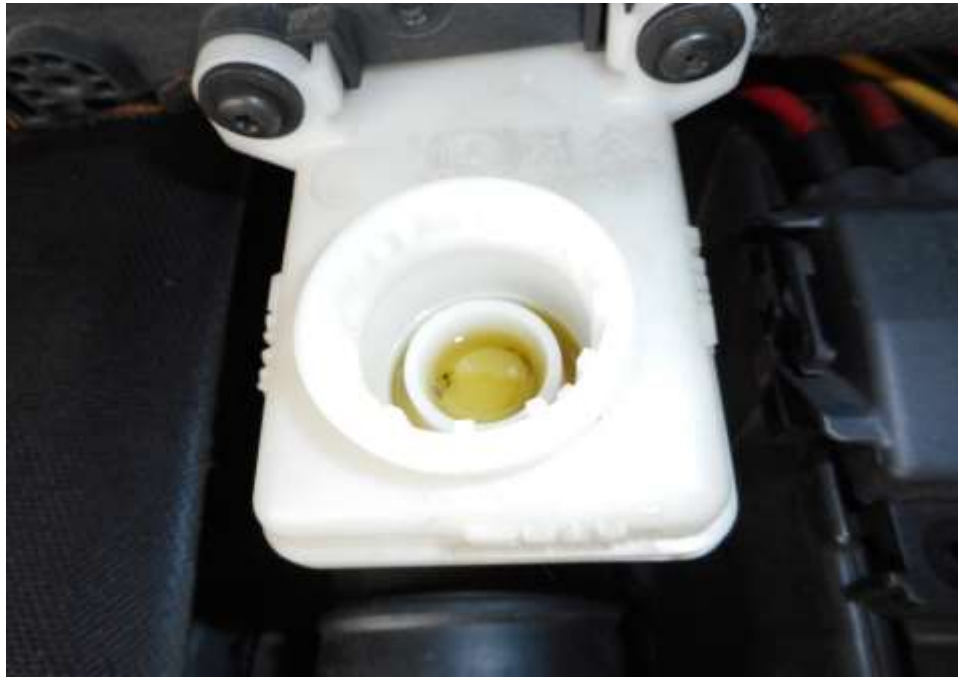
Photo 11 shows the brake fluid reservoir of the Motor Car at the time of my inspection. The brake fluid was observed to be of sufficient level and without any visible contamination.

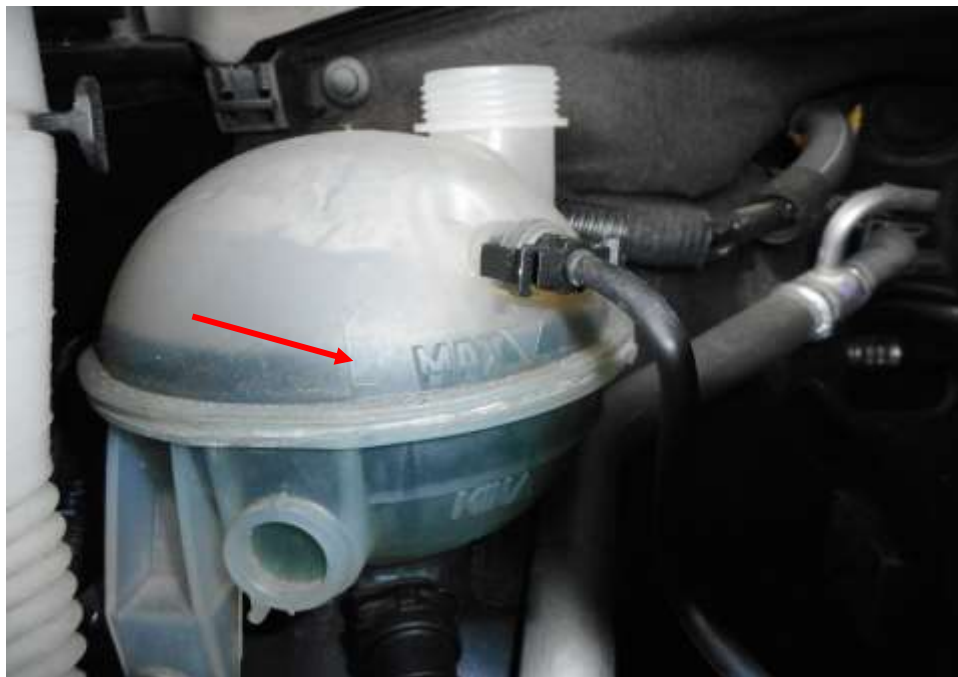
Photo 12 shows checks being carried out to the engine coolant of the Motor Car at the time of my inspection. The engine coolant was observed to be of sufficient level (arrowed) and without any visible contamination.

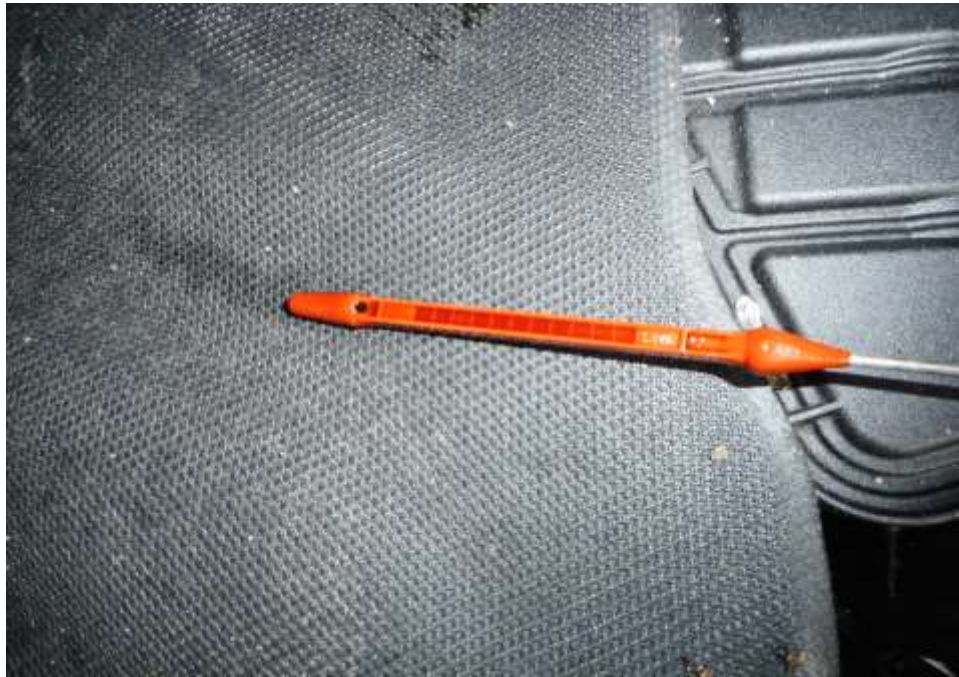
Photo 13 shows the engine oil dip stick of the Motor Car at the time of my inspection. The engine oil was observed to be of sufficient level and without any visible contamination.

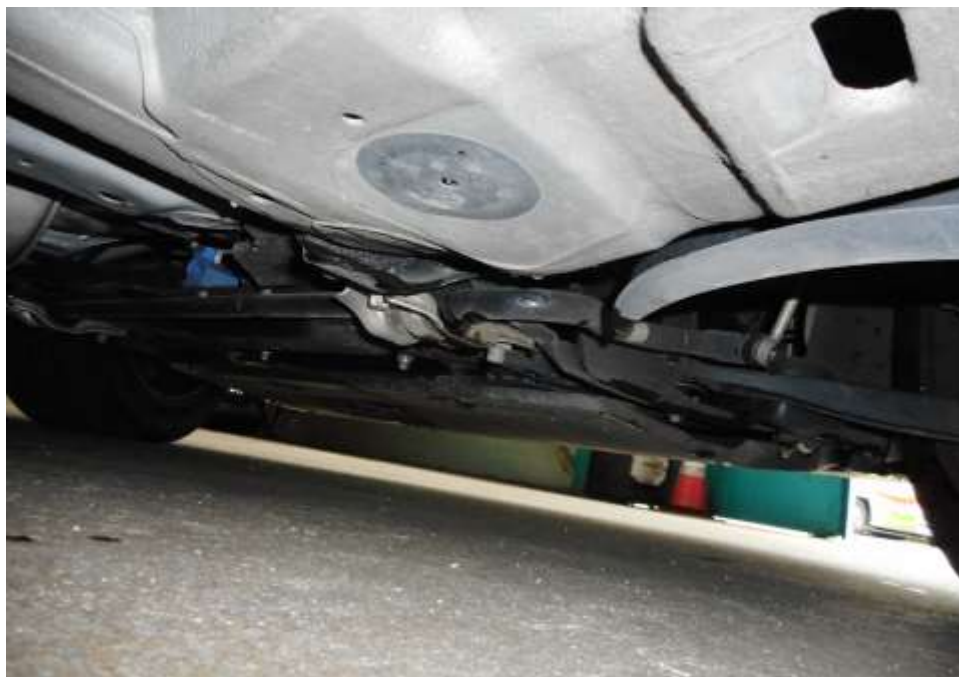
Photo 14 shows the undercarriage of the Motor Car, at the area where the engine housing and transmission housing are located. I did not find any sign(s) or indication(s) of fluid leak and/or fluid stain(s) on the underside of the Motor Car.

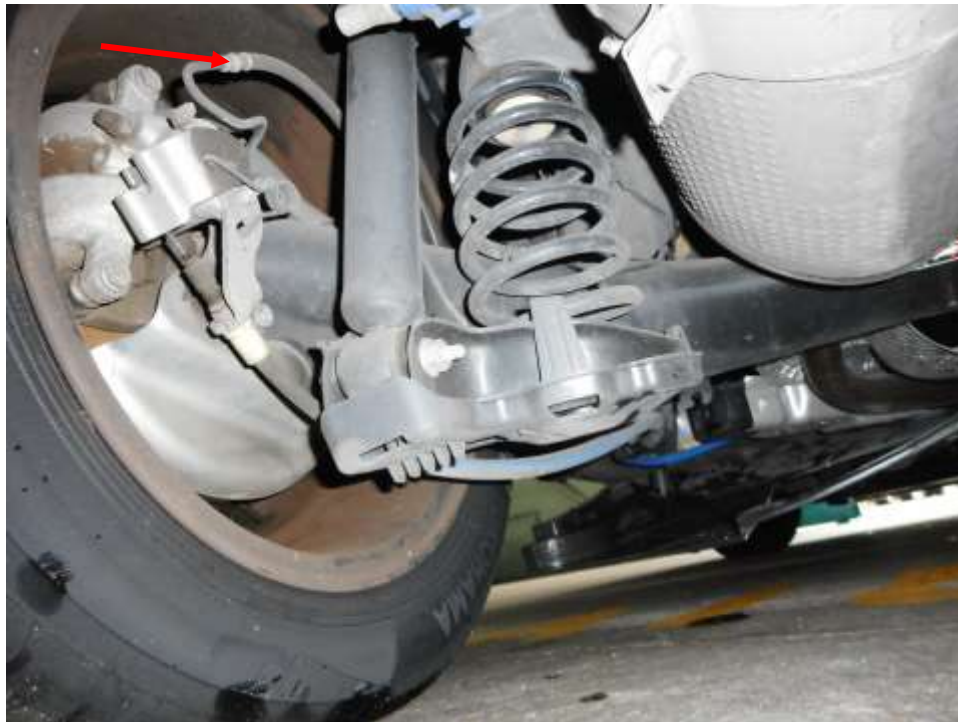
11. Static brake tests conducted on the Motor Car revealed no abnormality. The brake booster had responded well to the various tests conducted. There was also no abnormal movement of the brake pedal when it was depressed. In general, the static brake tests had suggested that there was no internal leakage of pressure/vacuum in the braking system of the Motor Car. The braking system of the Motor Car was likely to be in serviceable condition at the material time. This was taking into consideration that the brake fluid was of sufficient level, and also that there was no sign(s) of brake fluid leakage along the brake hoses and brake pipes.

Photo 15 shows the brake hose/pipe (arrowed) at the rear left wheel of the Motor Car. I did not observe any leakage of brake fluid at the time of my inspection of the Motor Car. Static tests of the Motor Car's braking system had indicated that there was no internal leakage of pressure/vacuum. The undercarriage components of the Motor Car were also all found to be intact and without any visible damage.

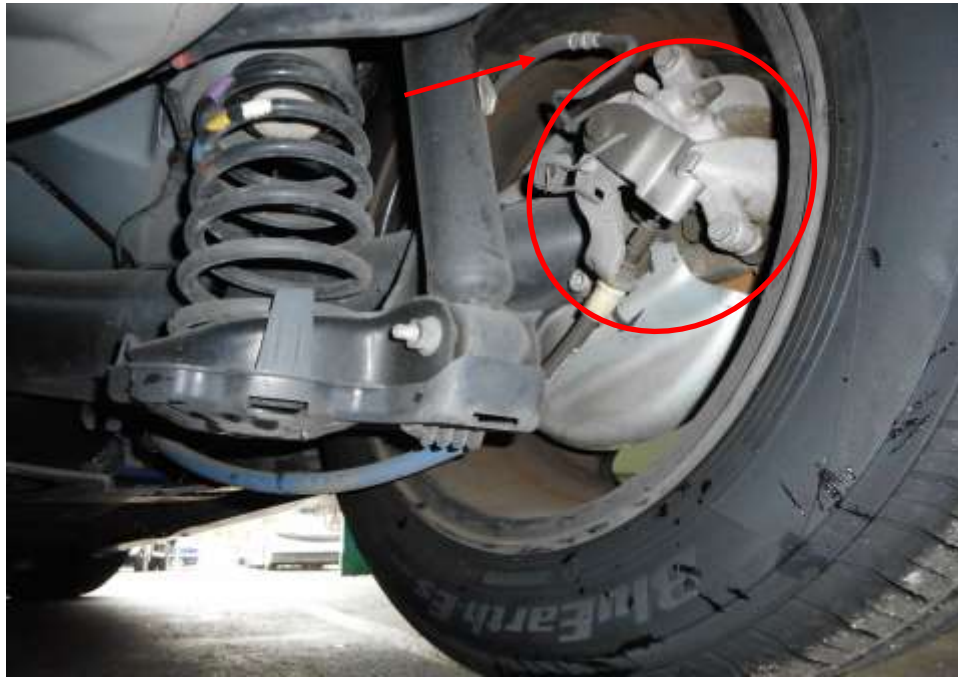
Photo 16 shows the brake hose/pipe (arrowed) at the rear right wheel of the Motor Car. No leakage of brake fluid was observed. Visual examination of the various components of the braking system like the brake caliper (circled), brake booster, brake pedal etc had revealed all to be intact and without visible damage.

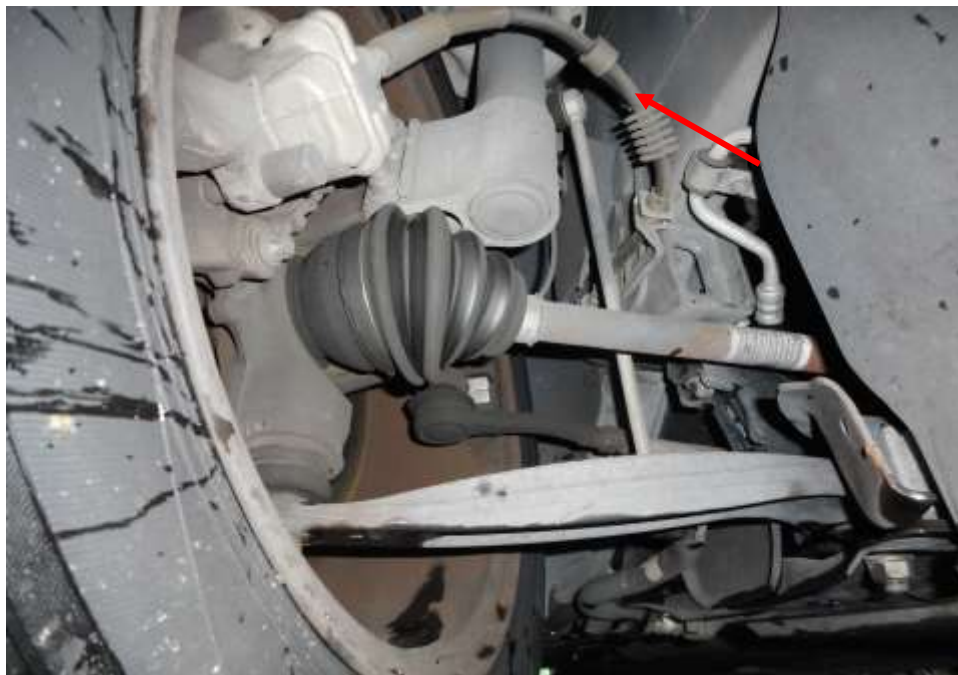
Photo 17 shows the brake hose/pipe (arrowed) at the front right wheel of the Motor Car. I did not observe any leakage of brake fluid at the time of my inspection of the Motor Car. Static tests of the Motor Car's braking system had indicated that there was no internal leakage of pressure/vacuum. The undercarriage components of the Motor Car were also all found to be intact and without any visible damage.

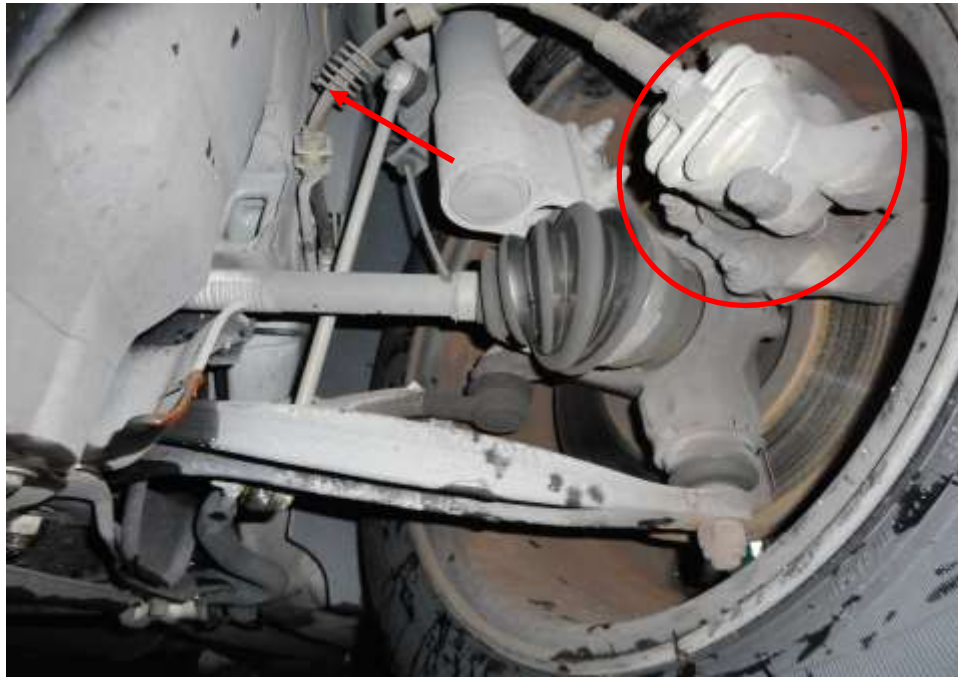
Photo 18 shows the brake hose/pipe (arrowed) at the front left wheel of the Motor Car. No leakage of brake fluid was observed. Visual examination of the various components of the braking system like the brake caliper (circled), brake booster, brake pedal etc had revealed all to be intact and without visible damage.

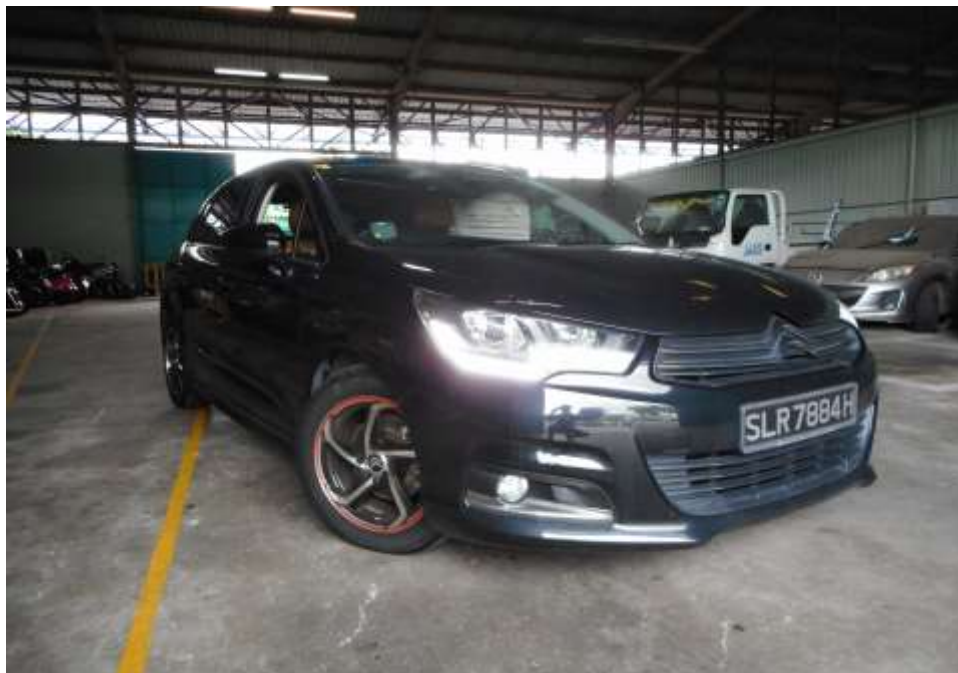
12. Static test on the steering system of the Motor Car also revealed no abnormality to the steering system. I did not experience any abnormal free play and/or other resistance when turning the steering wheel left and right to full lock positions. My visual examination of the various steering components which had included the steering rack and pinion, tie rods, tie rod ends and ball joints revealed that these components were all generally in good condition. See photo 15 - 21 below.

Photo 19 shows the front right wheel of the Motor Car turned to its full left. During my steering system test, I did not experience any abnormal free play and/or resistance when I had turned the steering wheel towards the left and right. This would suggest that the steering system of the Motor Car was likely to be in serviceable condition at the material time of accident.

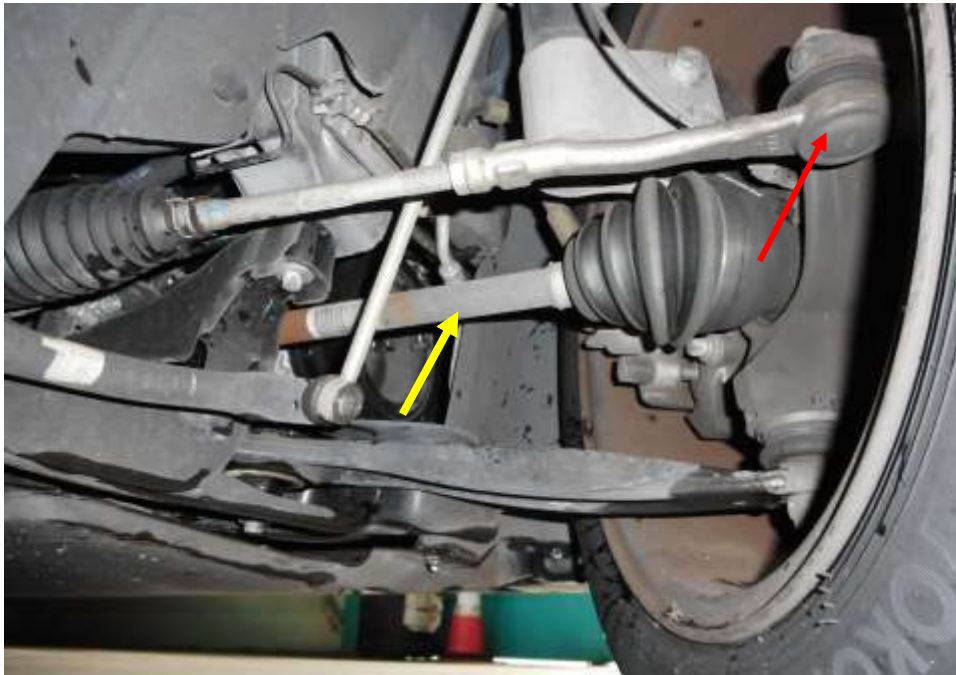
Photo 20 shows the various undercarriage components at the front right wheel of the Motor Car, in particular the steering tie rod (red arrow) and drive shaft (yellow arrow). The various steering components were all found to be intact, suggesting that the steering system of the Motor Car was likely to be in serviceable condition at the material time of accident. There was also no sign of fluid stain observed on the various undercarriage components at the front right wheel of the Motor Car.

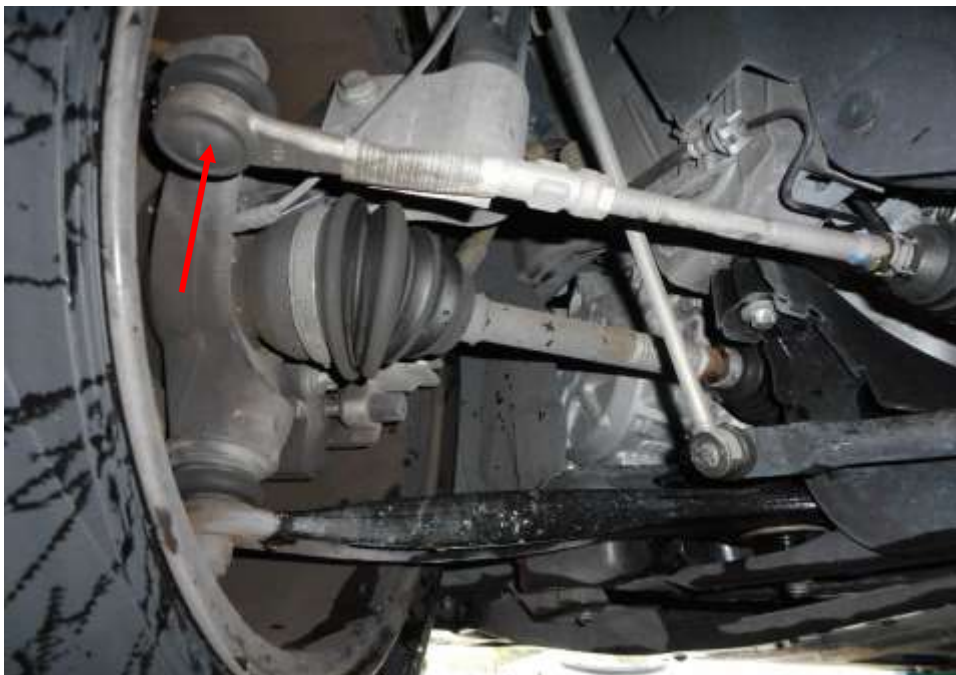
Photo 21 shows the various undercarriage components at the front left wheel of the Motor Car, which had included the steering tie rod (red arrow). The various undercarriage components of the Motor Car were all found to be intact without any visible damage.

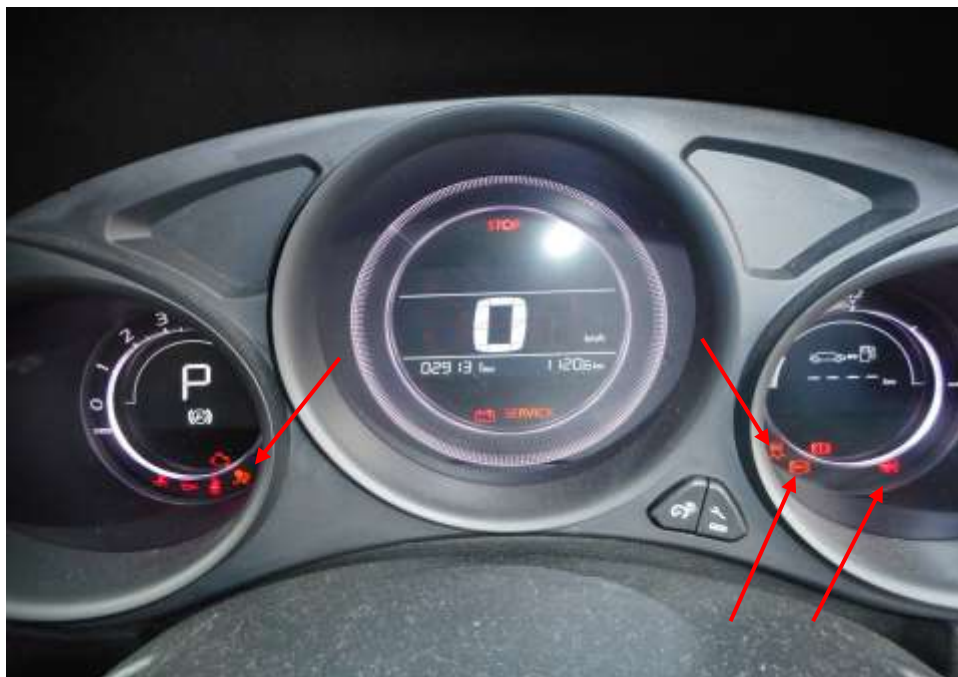
13. The Motor Car's automatic self-test of the functionality of its various electronic operating systems like the Anti-Lock Brake System (ABS), Electric Power Steering System (EPS), Traction Control (TC) and Supplemental Restraint System (SRS) during cranking of the engine had indicated that these systems were in working condition and without abnormality. This can be established from the warning lights disappearing from the instrument panel after the self-test. See photo 22 & 23 below.

Photo 22 shows the warning light for Anti-Lock Brake System (ABS), Electric Power Steering System (EPS), Traction Control (TC) and Supplemental Restraint System (SRS) appearing on the instrument panel of the Motor Car during the self-test of its various electronic operating systems when its engine was cranked.

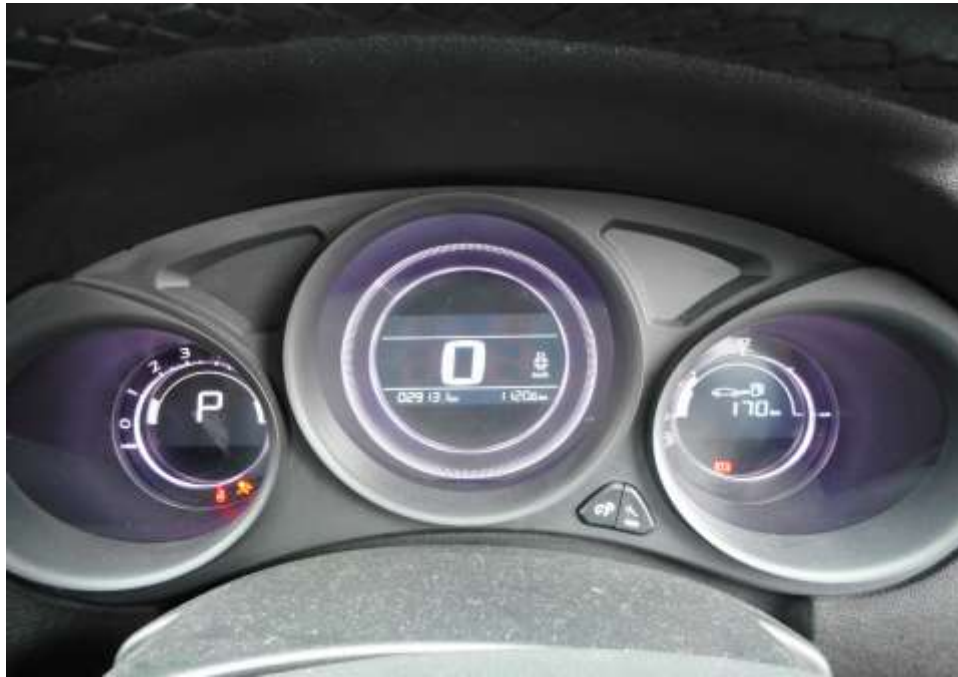
Photo 23 shows no warning lights illuminated on the instrument panel of the Motor Car after the engine was cranked. This would suggest that there was no abnormality to the various electronic operating systems of the Motor Car, like the ABS, EPS, TC and SRS etc.
