Your Ref: TP/IP/13597/2019  
Our Ref : CI/TPD19008262/N

**Fatal Accident Investigation Team**

**INSPECTION REPORT OF MOTORCYCLE FW 672T**

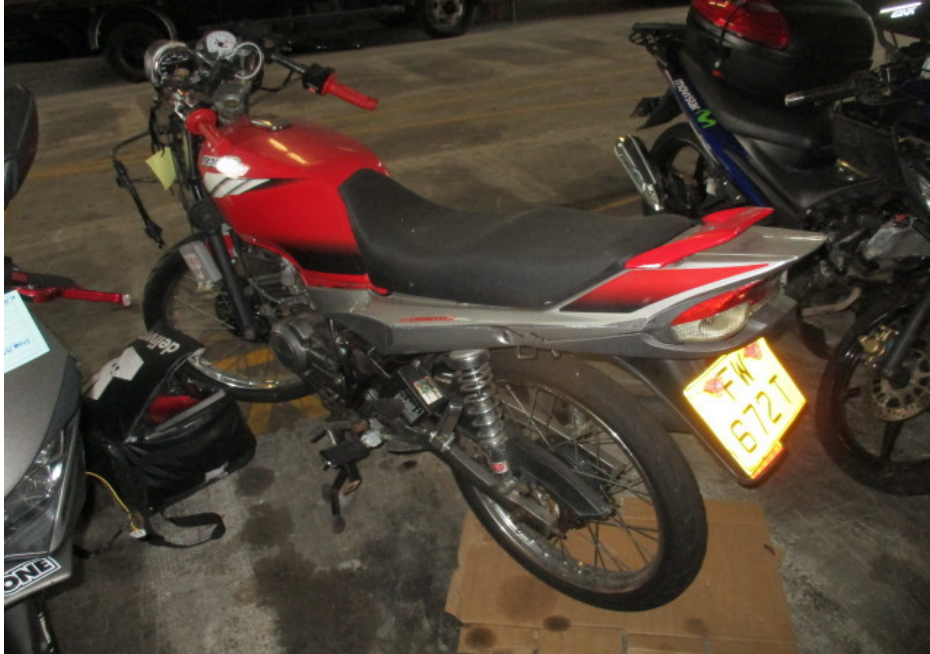
4. The mileage of the Motorcycle at the time of our inspection was 37, 589km.
5. The Motorcycle was observed to have sustained damages all around. The body parts that were found to have been damaged include its speedometer gauge, headlamp assembly, headlight, front mudguard, side mirrors, clutch lever, front brake lever, handlebars, petrol tank, right front footrest, exhaust muffler, exhaust muffler heat shield and rear side covers, amongst others.

**Photo 1** shows a general view of the left rear body of the Motorcycle at the time of our inspection. The Motorcycle was observed to have sustained damages all around. The mileage at the time of inspection was recorded to be 37, 589km.

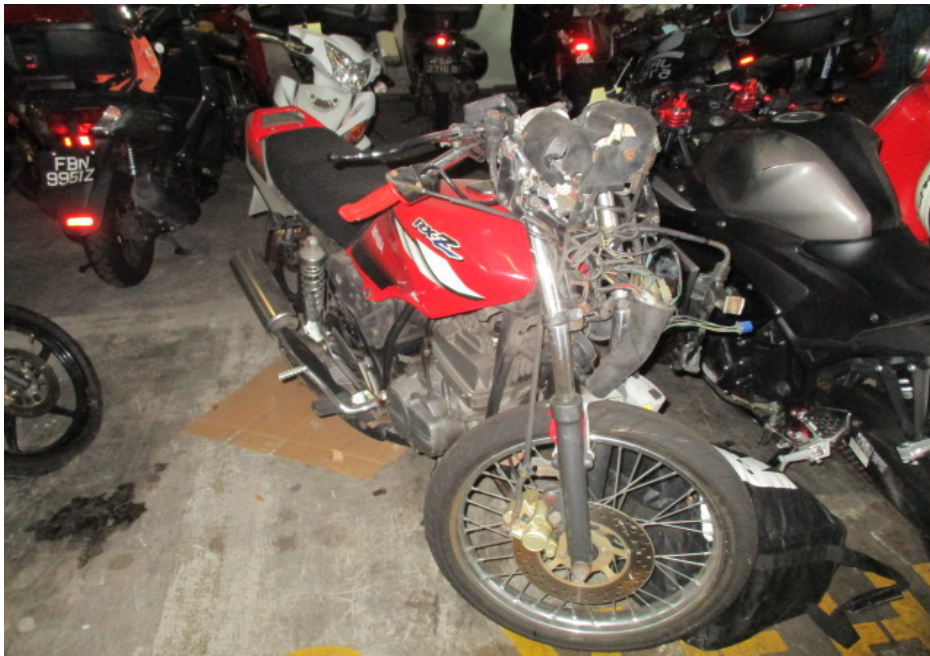
**Photo 2** shows a general view of the right front body of the Motorcycle at the time of our inspection. The Motorcycle was observed to have sustained damages all around. The body parts that were found to have been damaged include its speedometer gauge, headlamp assembly, headlight, front mudguard, side mirrors, clutch lever, front brake lever, handlebars, petrol tank, right front footrest, exhaust muffler, exhaust muffler heat shield and rear side covers, amongst others.

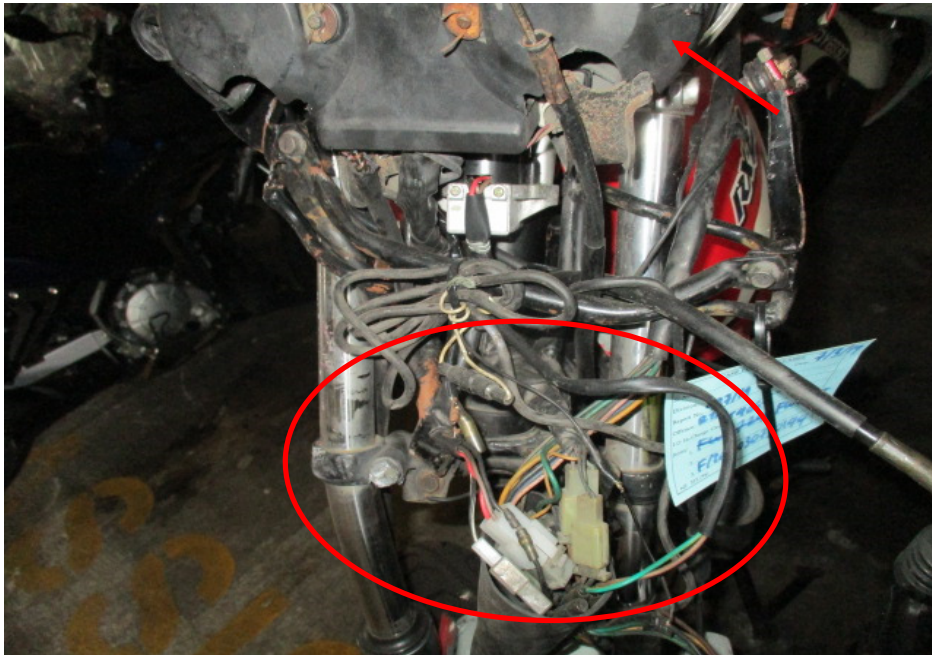
**Photo 3** shows a closer view of the headlamp assembly (circled) and speedometer gauge (arrowed) which were amongst the body parts at the front body of the Motorcycle that had sustained damage as a result of the accident.

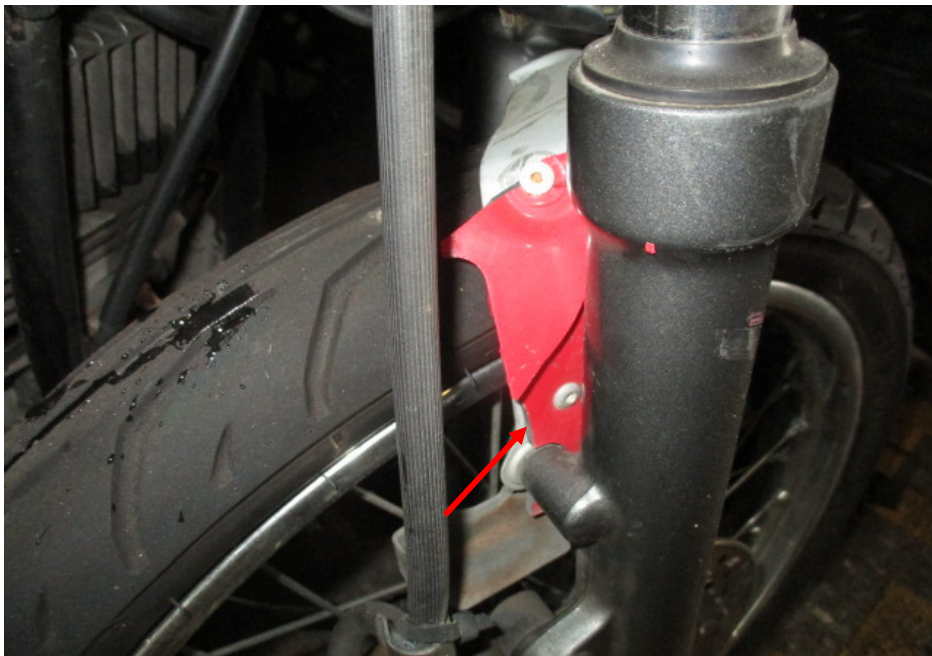
**Photo 4** shows a closer view of the front mudguard (arrowed) which was amongst the body parts at the front body of the Motorcycle that had sustained damage as a result of the accident.

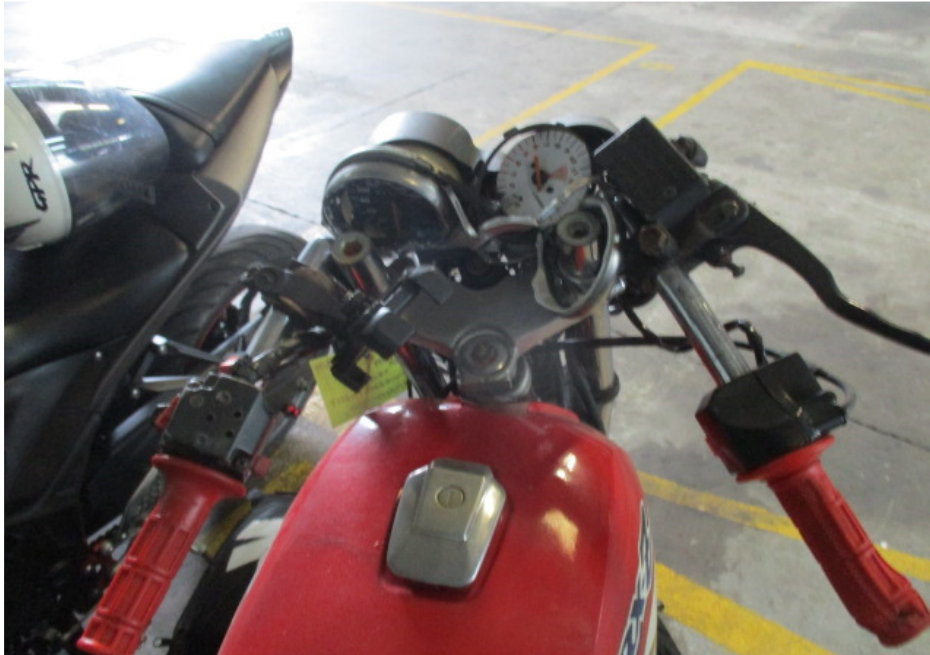
**Photo 5** shows a close up view of the side mirrors, clutch lever, front brake lever, handlebars and right handlebar end of the Motorcycle. These parts were amongst the body parts of the Motorcycle which were damaged as a result of the accident.

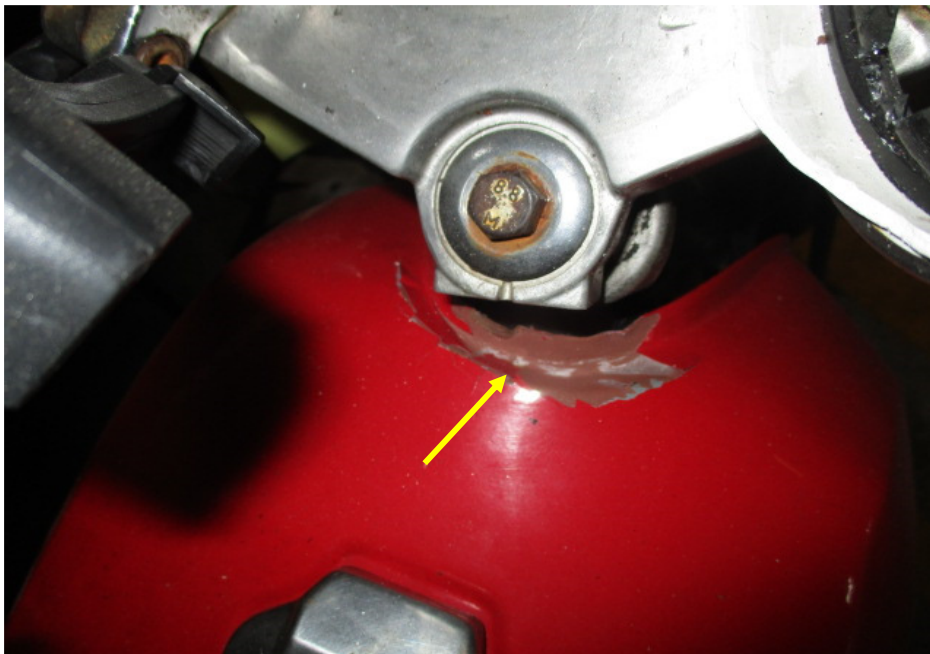
**Photo 6** shows a closer view of the petrol tank, which was amongst the body parts of the Motorcycle that had sustained damage as a result of the accident (arrowed).

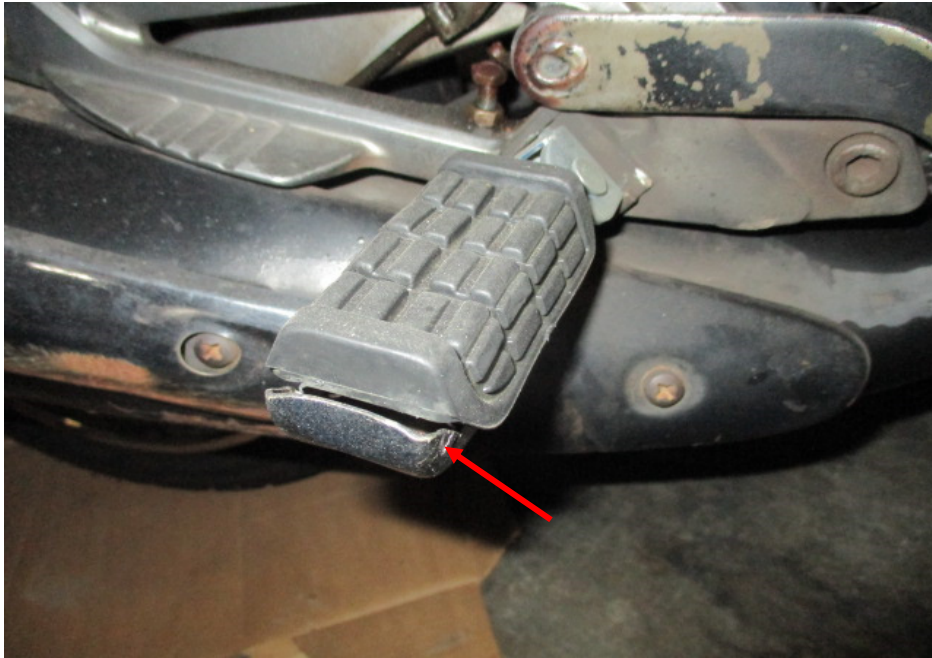
**Photo 7** shows a closer view of the right front footrest (arrowed) which was amongst the body parts of the Motorcycle that had sustained damage as a result of the accident.

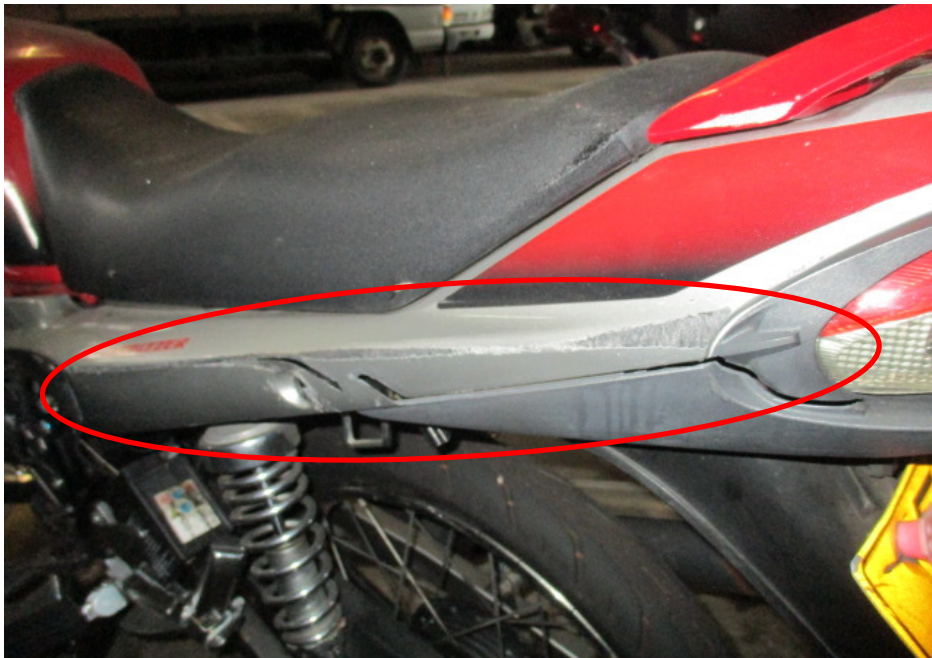
**Photo 8** shows the damaged left rear side cover (circled) which was amongst the body parts of the Motorcycle that had sustained damage as a result of the accident.

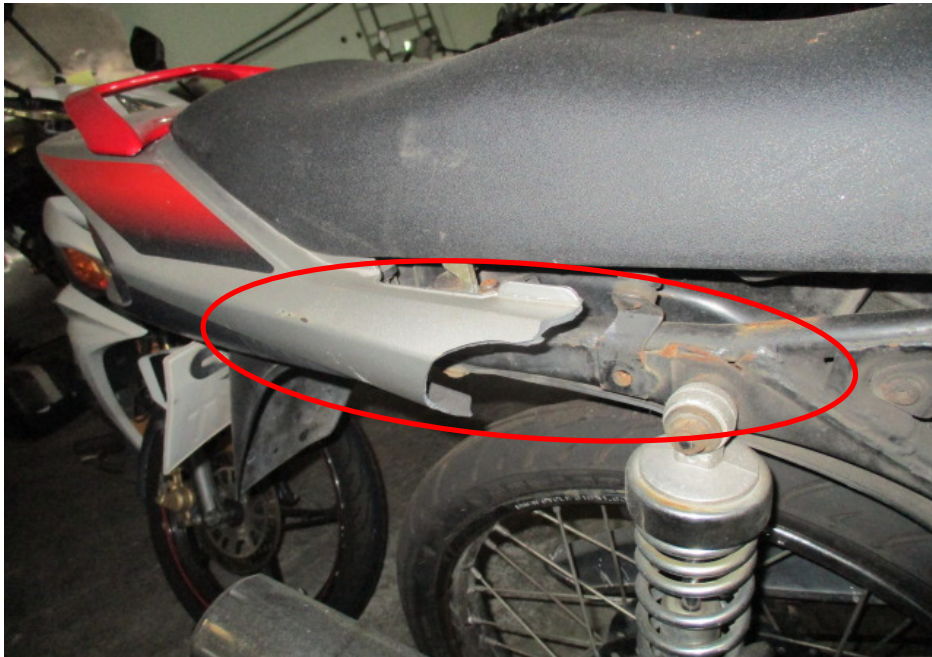
**Photo 9** shows the damaged right rear side cover (circled) which was amongst the body parts of the Motorcycle that had sustained damage as a result of the accident.

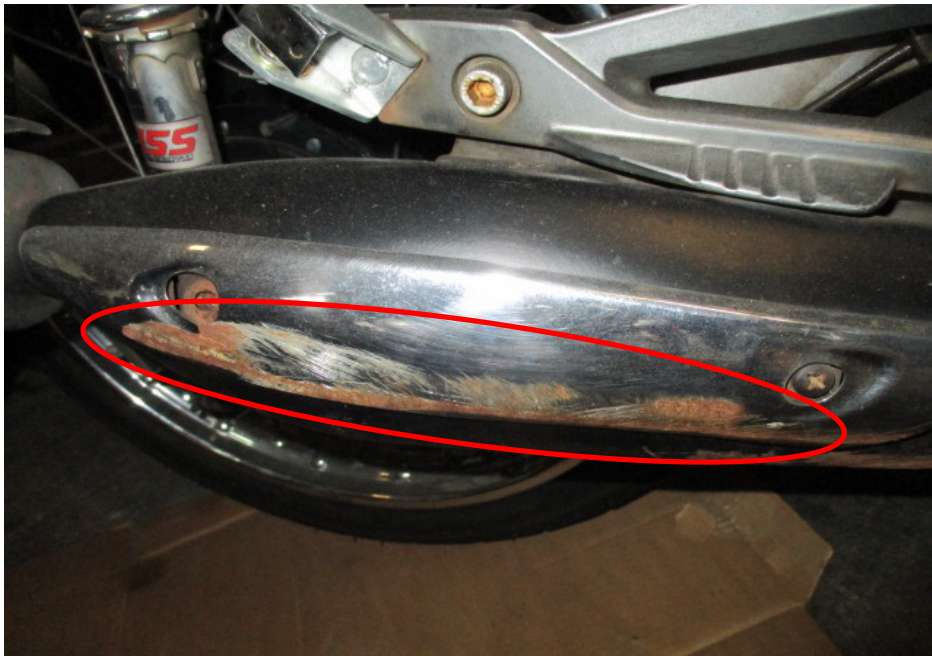
**Photo 10** shows the exhaust muffler heat shield (circled) which was amongst the body parts of the Motorcycle that had sustained damage as a result of the accident.

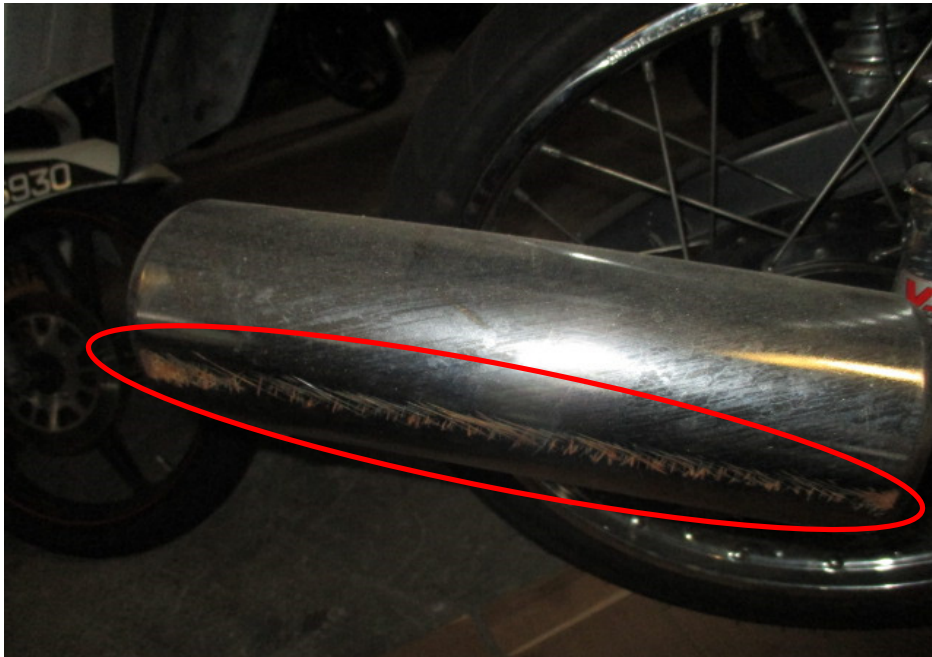
**Photo 11** shows the exhaust muffler (circled) which was amongst the body parts of the Motorcycle that had sustained damage as a result of the accident.

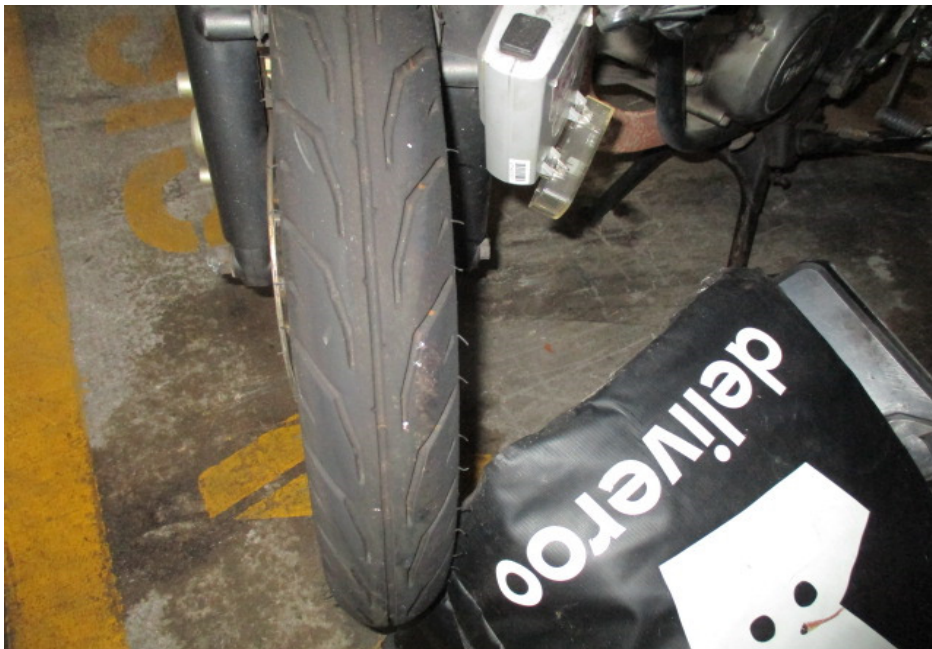
**Photo 12** shows the front tyre of the Motorcycle at the time of our inspection. The front tyre was observed to be in serviceable condition with remaining tread depth of approximately 4mm. The tyre was also observed to be sufficiently inflated for vehicular operation. We did not observe any tear, burst mark(s) and/or punctured hole(s) on the sidewalls as well as across the tread of the front tyre.

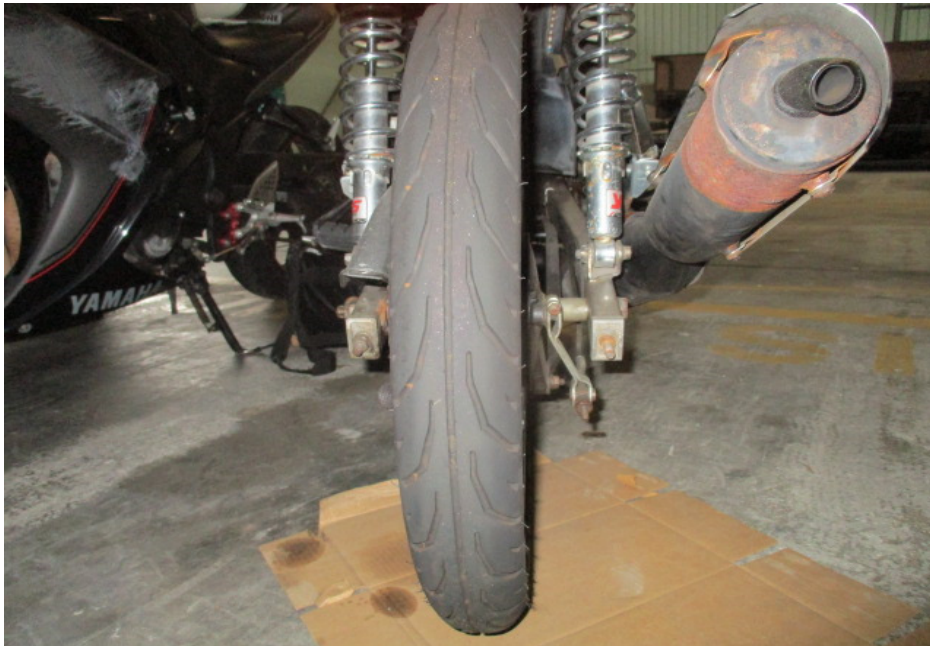
**Photo 13** shows the condition of the Motorcycle's rear tyre. The rear tyre was observed to be in serviceable condition with remaining tread depth of approximately 3mm. The tyre was also observed to be sufficiently inflated for vehicular operation. We did not observe any tear, burst mark(s) and/or punctured hole(s) on the sidewalls as well as across the tread of the rear tyre.

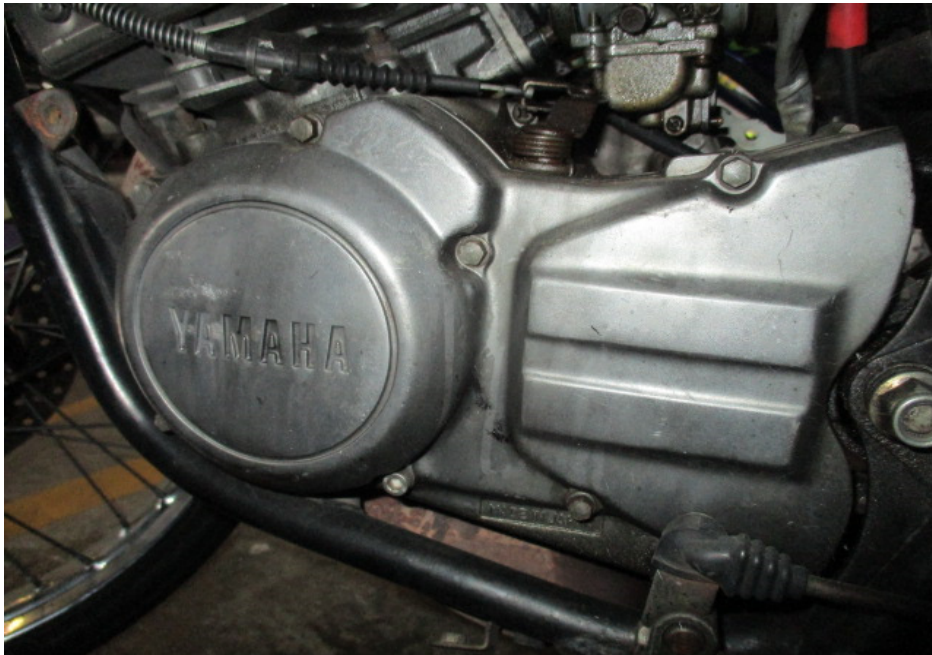
**Photo 14** shows the left side of the engine of the Motorcycle at the time of our inspection. The various engine related parts and components were found to be intact with no visible damage. There was also no sign(s) or indication(s) of fluid leak observed around the left engine area of the Motorcycle.

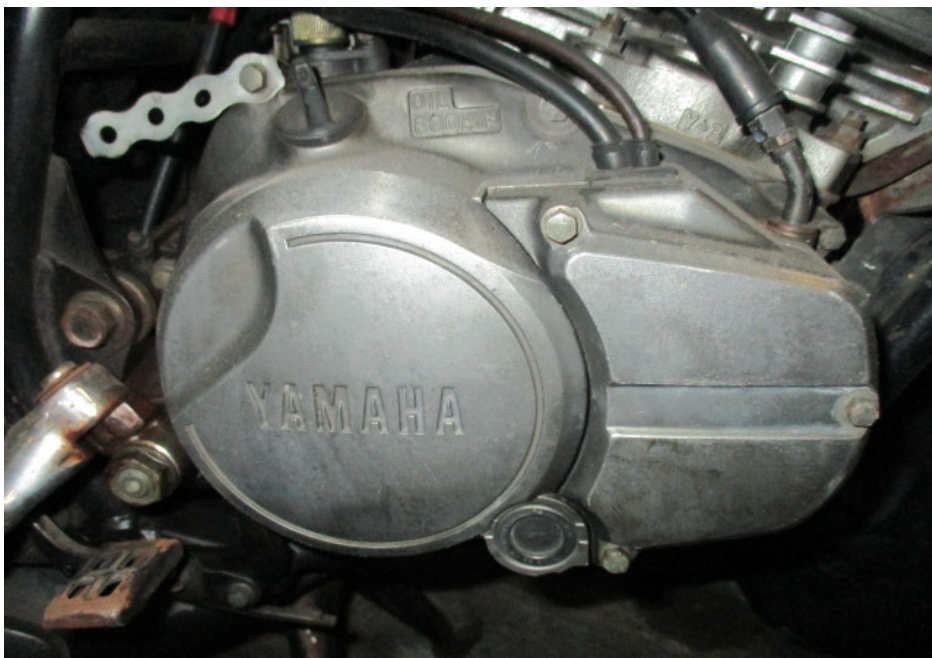
**Photo 15** shows the right side of the engine of the Motorcycle at the time of our inspection. The various engine related parts and components were found to be intact with no visible damage. There was also no sign(s) or indication(s) of fluid leak observed around the right engine area of the Motorcycle.

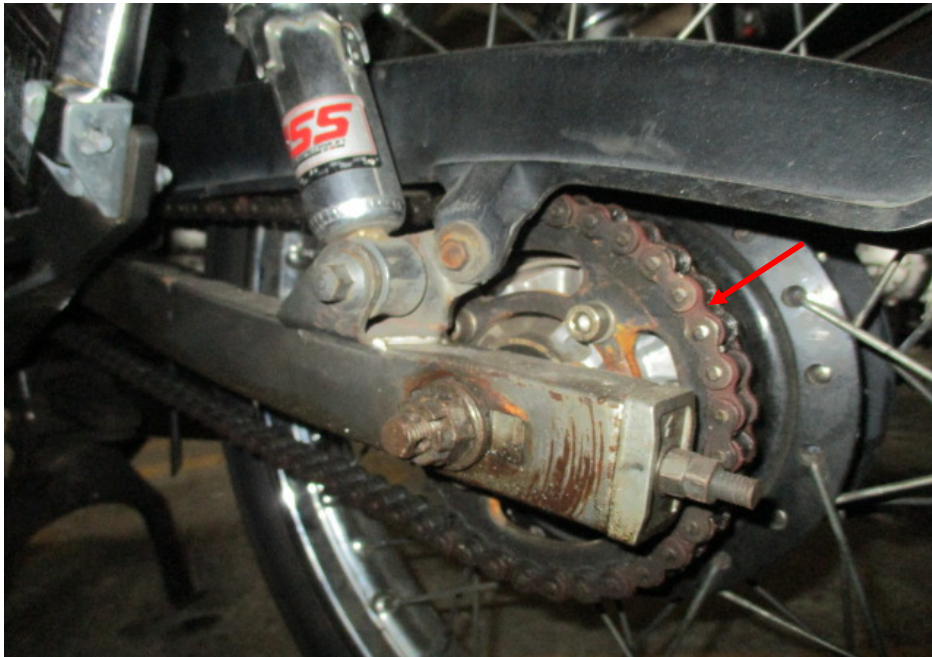
**Photo 16** shows the general view of the gear train (arrowed) of the Motorcycle, which was observed to be intact with no misalignment. It was also adequately lubricated for operating purposes.

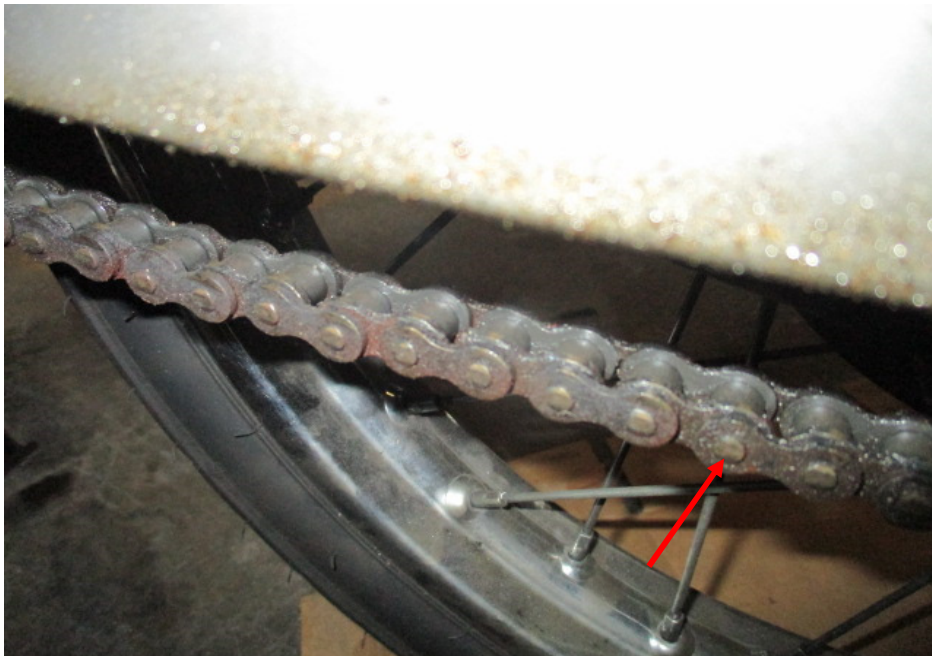
**Photo 17** shows a closer view of the gear train (arrowed) of the Motorcycle, which was observed to be intact with no misalignment. It was also adequately lubricated for operating purposes.

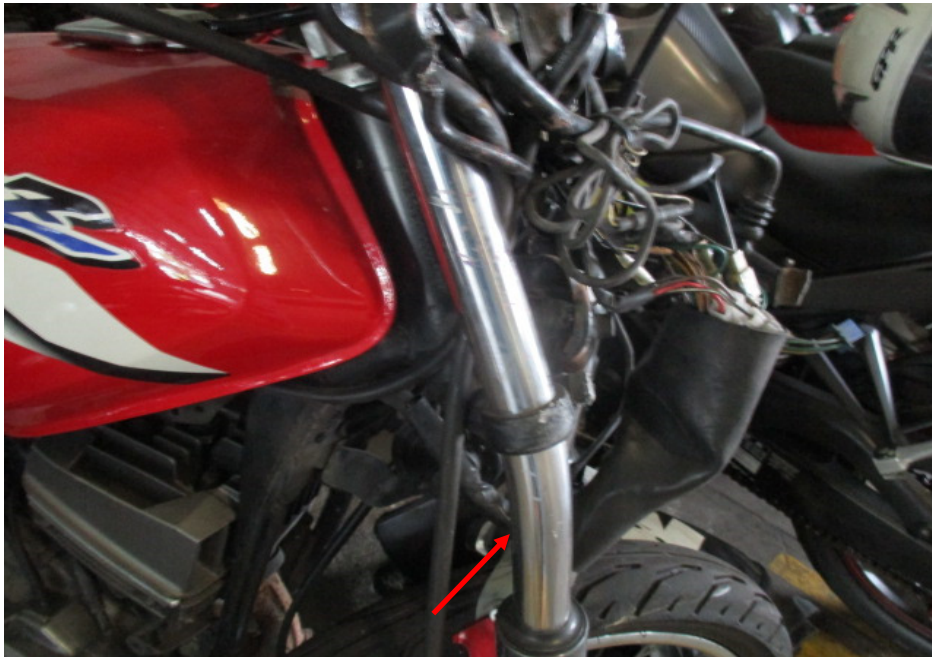
11. For this case, we were not able to conduct any test(s) on the steering system of the Motorcycle due to the damage of its front fork. The front fork was found to be bent inwards as a result of the accident.

14. For this case, we were not able to carry out any operational tests to the steering system and front braking system of the Motorcycle due to the damage of its front fork, which had rendered the Motorcycle immobile for the operational tests. We were not able to push the motorcycle manually forward and backward, simulating movement of the Motorcycle, for the operational tests.

**Photo 18** shows the front right fork of the Motorcycle. The front right fork (arrowed) was observed to be bent inwards as a result of the accident. We were hence not able to conduct any tests on the steering system of the Motorcycle.

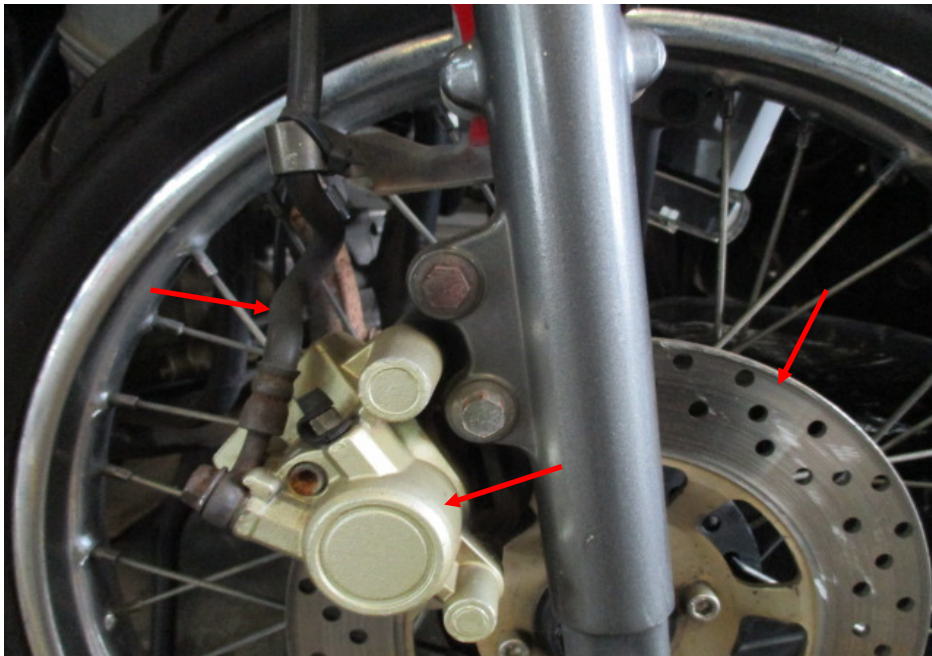
**Photo 19** shows a close up view of the front brake caliper, front brake disc and front brake hose (arrowed) of the Motorcycle, which are all part of the components in the hydraulic front brake system of the Motorcycle. Our visual checks of these various components had revealed all to be intact with no visible damage. No leakage of brake fluid was also observed.

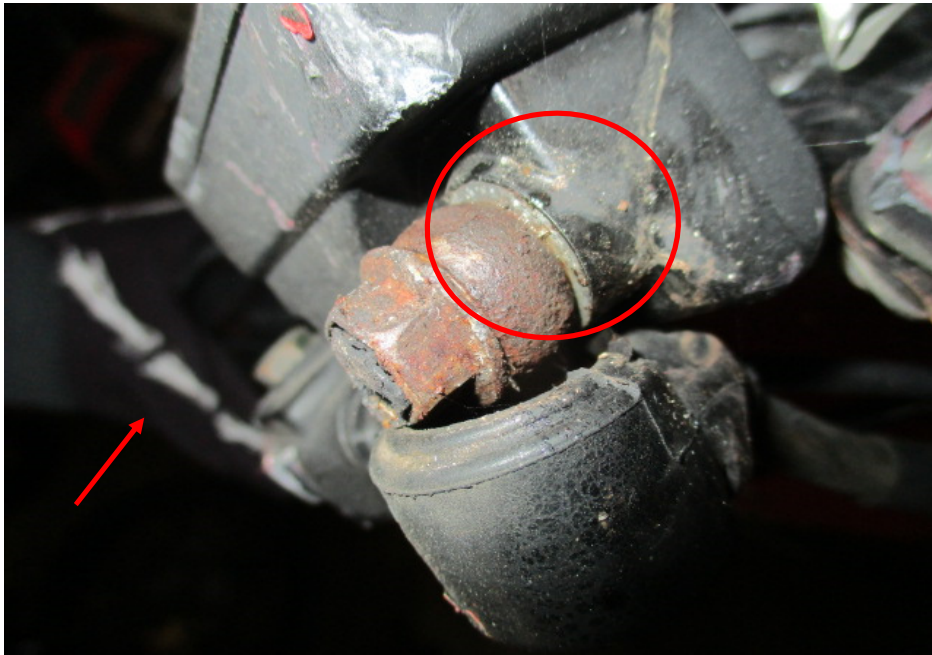
13. The brake fluid for the front brake was found to be of sufficient level and without any contamination. However a leakage of brake fluid from the front brake fluid reservoir was observed when the front brake lever was depressed. The leakage of brake fluid from the front brake fluid reservoir could have been due to the accident as the front brake fluid reservoir was found to be bent inwards causing a crack to the front brake fluid reservoir.

**Photo 20** shows the brake fluid reservoir for the front brake of the Motorcycle. A leakage of brake fluid from the front brake fluid reservoir was observed (circled) when the front brake lever was depressed (arrowed).

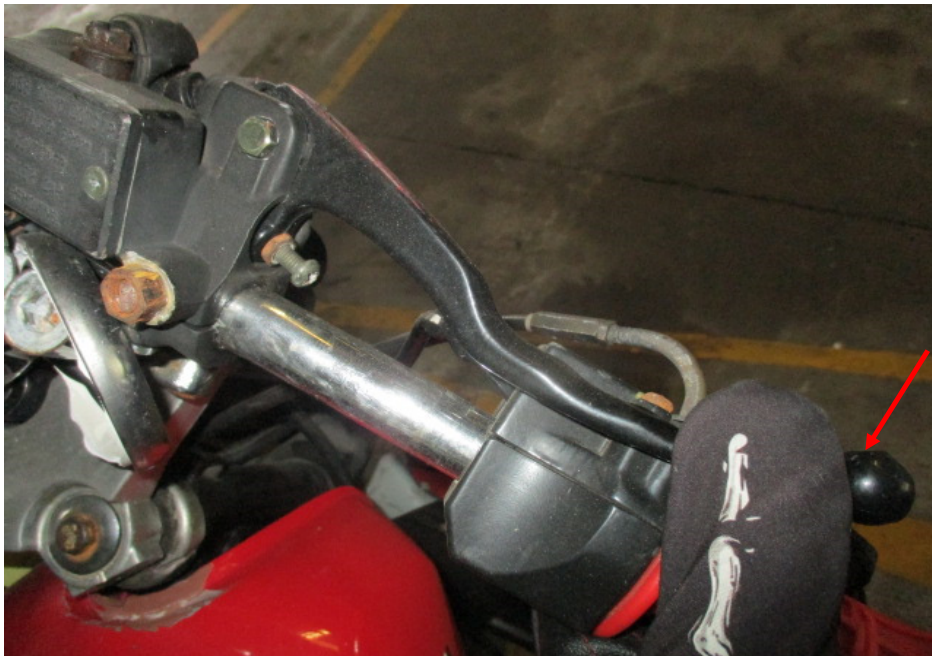
**Photo 21** shows the front brake lever being depressed. There was no resistance felt (spongy like feel) upon pressing the front brake lever (arrowed). This would indicate that there is leakage of pressure/vacuum in the brake system.

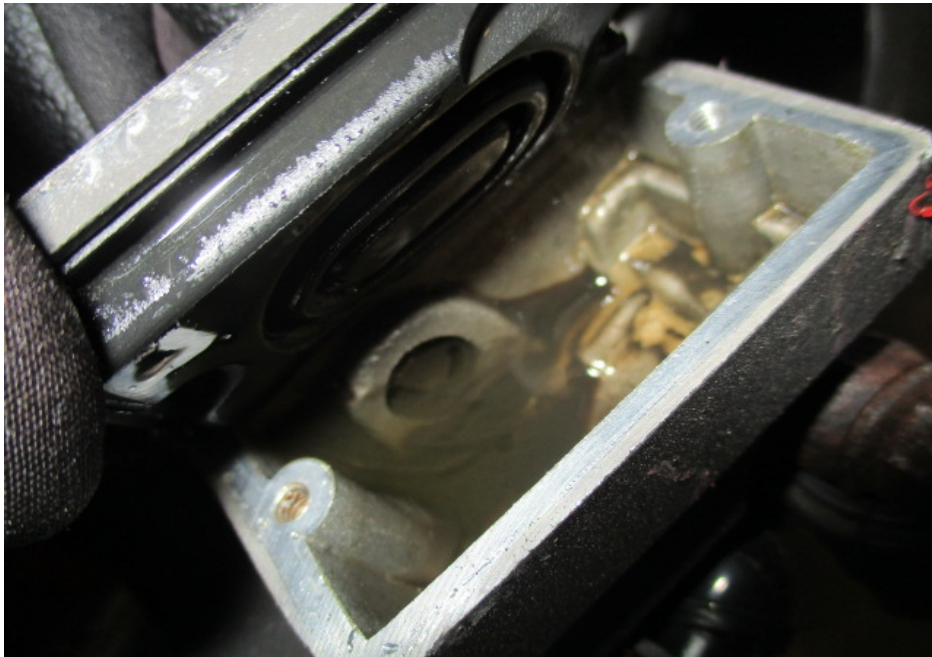
**Photo 22** shows the brake fluid reservoir for the front brake of the Motorcycle. The brake fluid was observed to be of sufficient level and without contamination for operational purposes.

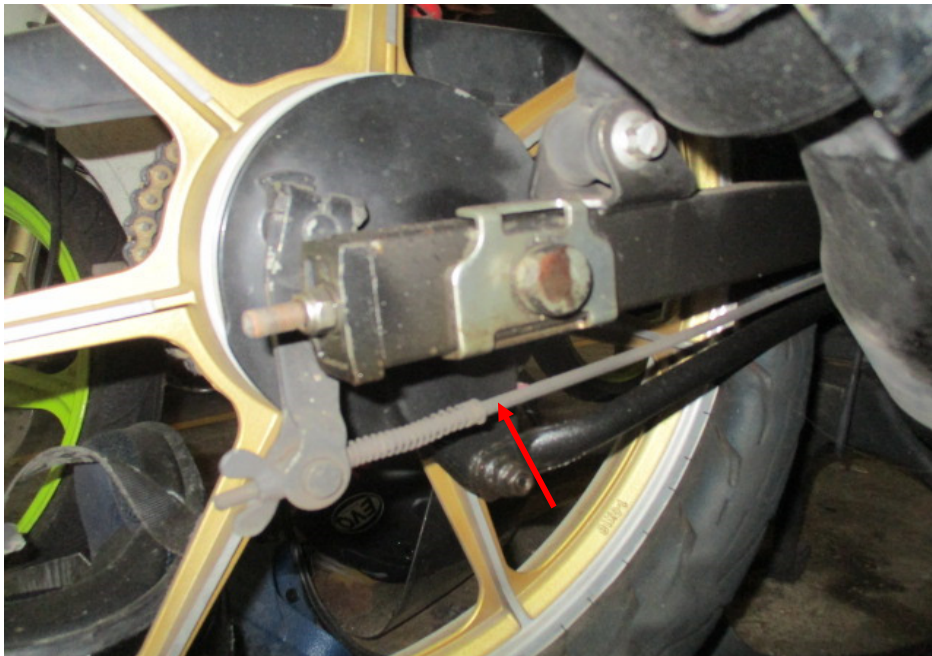
15. We subsequently carried out an operational test of the Motorcycle's rear braking system. This was done by firstly putting the Motorcycle on its main stand. We then proceeded to turn the rear wheel, allowing it to spin freely, simulating the Motorcycle in motion. We thereafter engaged the rear brake pedal of the Motorcycle. The rear wheel of the Motorcycle was able to stop rotating immediately upon depressing the brake pedal. At the end of the short operational test, we did not observe any abnormal behaviour of the Motorcycle's rear braking system. See photos 18 – 23 below.

**Photo 23** shows the rear wheel of the Motorcycle. The type of brake system for the rear wheel was of a mechanical type, controlled by the brake foot pedal of the Motorcycle. Our checks of the cable (arrowed), spring and drum which are all part of the components in the rear brake system of the Motorcycle reveal all to be intact and without damage.
