Your Ref: TP/IP/10941/2019
Our Ref : CI/TPD19008263/P

Fatal Investigation Accident Team

MECHANICAL INSPECTION REPORT OF MOTOR CAR SJM 5103S

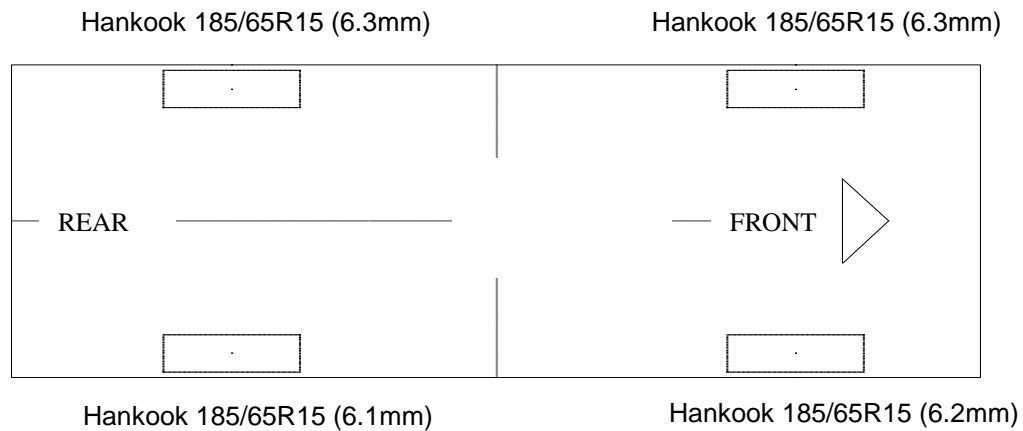
6. The condition of the Motor car's 4 tyres was observed to be in serviceable condition. I did not find any tear, cut or burst mark(s) on the outer and the inner sidewalls as well as across the tread of the 4 tyres. The 4 tyres were also observed to be sufficiently inflated for vehicular operation. The tyre brand, tyre size and remaining tread depth of the 4 tyres were recorded as follows:-

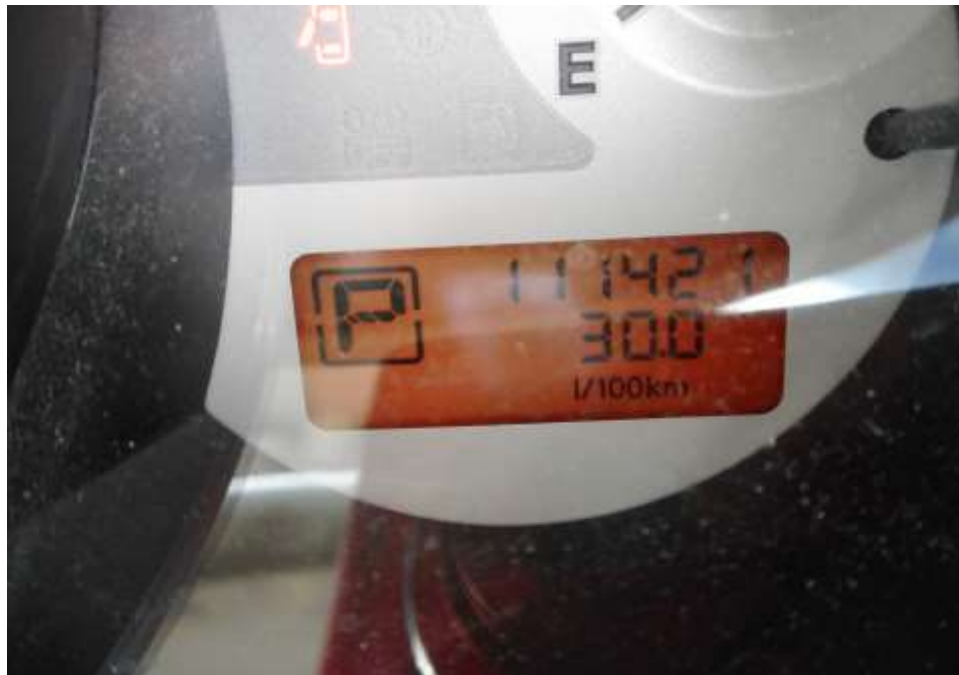
Photo 1 shows the mileage of the Motor Car at the time of my inspection. The mileage of the Motor Car at the time of my inspection was recorded to be 111,421km.

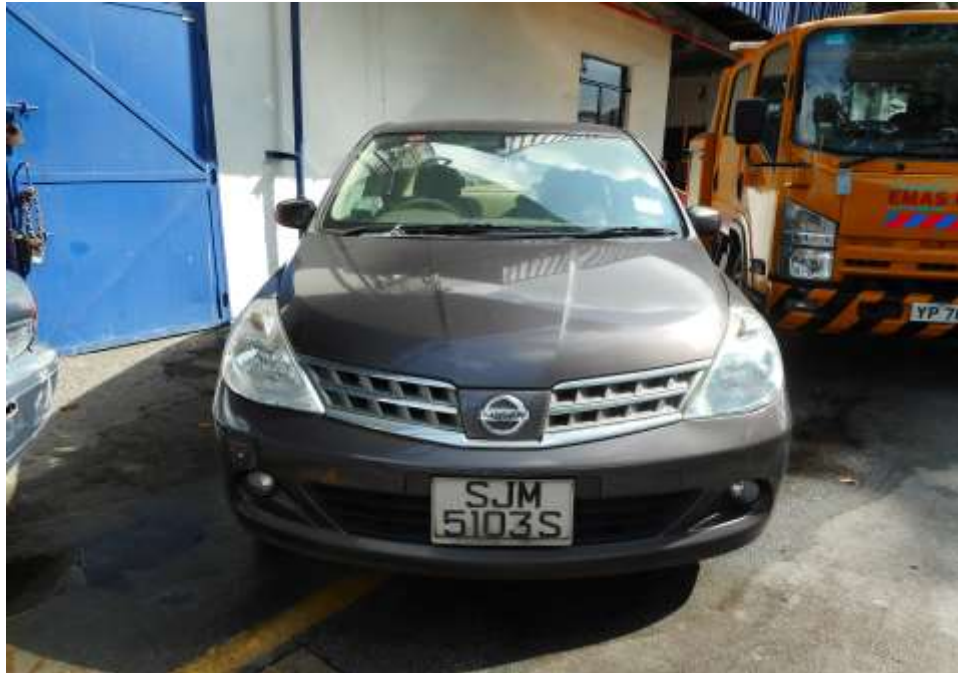
4. The mileage of the Motor car at the time of my inspection was 111,421km.
5. The Motor car was observed to have sustained relatively minor damage at its frontal portion. Its front bumper and its front number plate were amongst the body parts that were damaged as a result of the accident.

Photo 2 shows a general view of the front right body of the Motor Car at the time of my inspection. The Motor car was observed to have sustained relatively minor damage at its frontal portion. Its front bumper and its number plate were amongst the body parts that were damaged as a result of the accident.

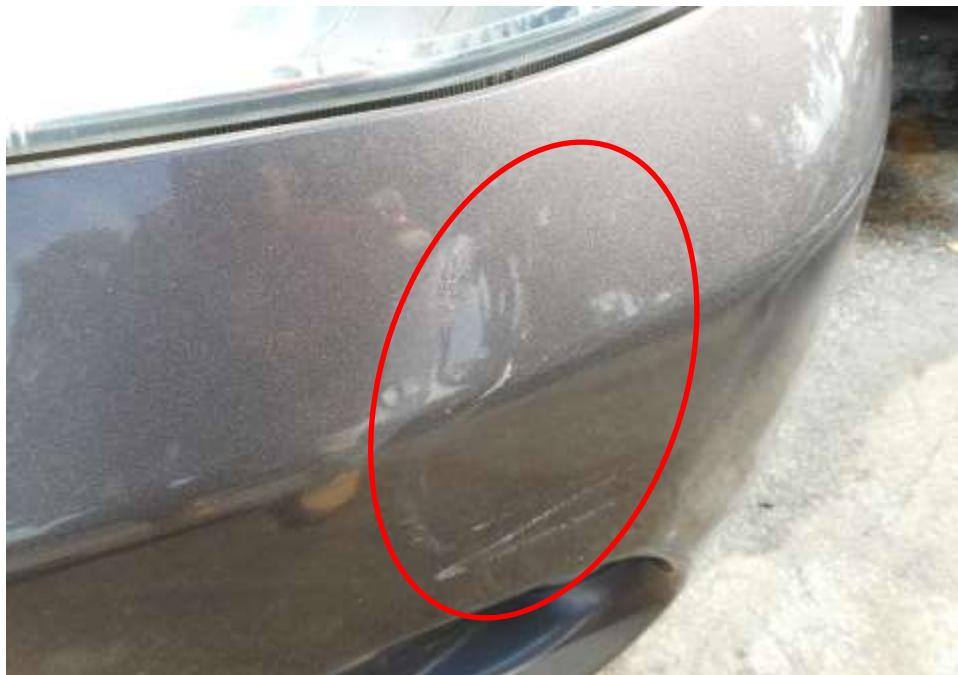
Photo 3 shows a close up view of the damaged front bumper (circled) of the Motor Car. It was damaged as a result of the accident. The mileage of the Motor Car at the time of my inspection was recorded to be 111,492km.

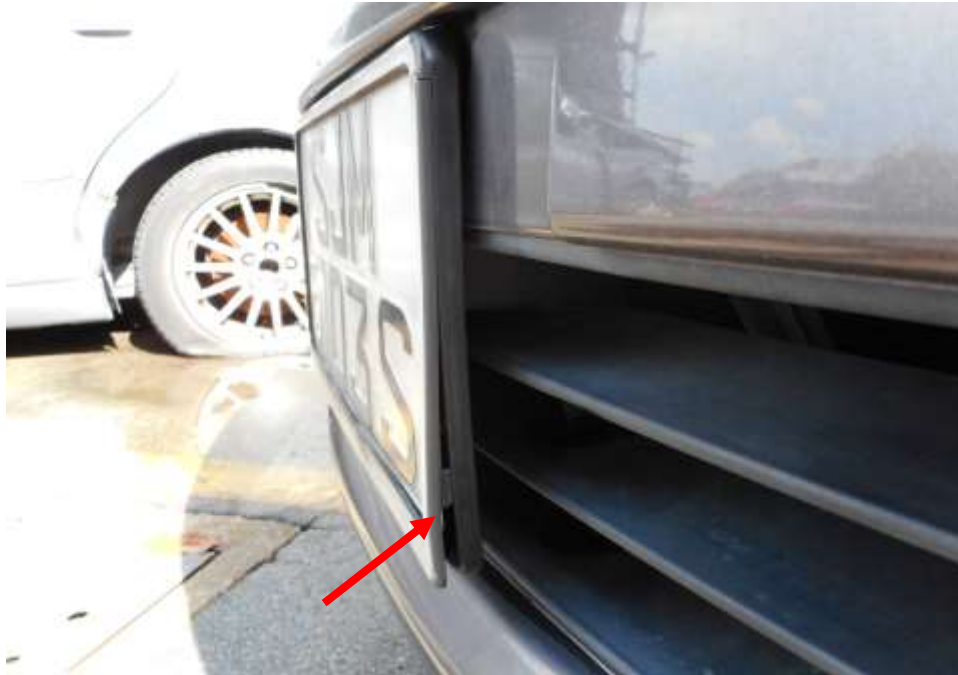
Photo 4 shows a close up view of the Motor car's front number plate. Its front number plate (arrowed) was damaged as a result of the accident.

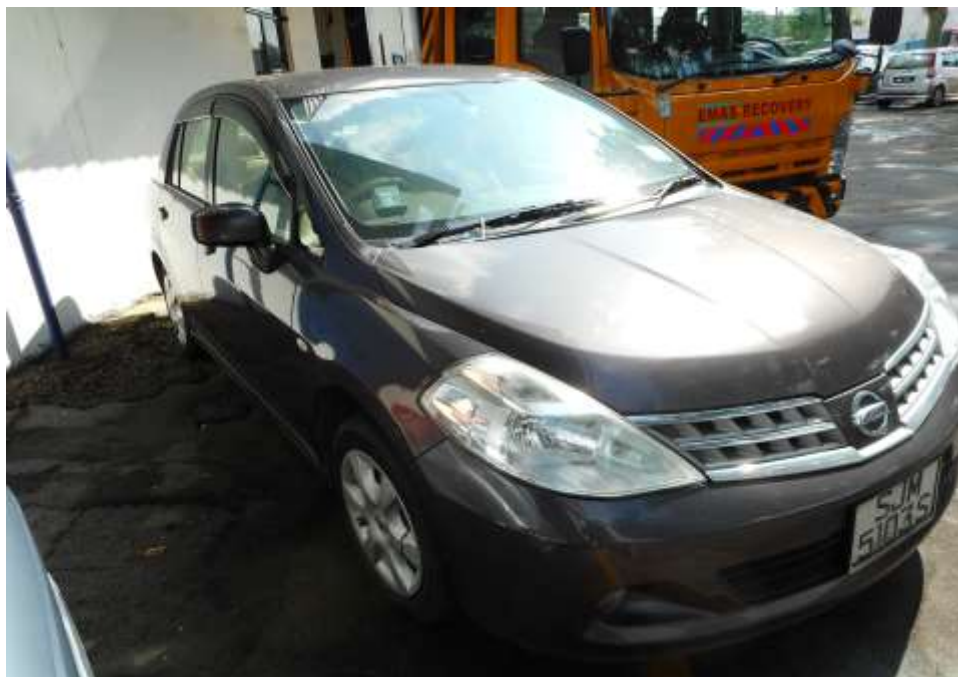
Photo 5 shows a general view of the Motor Car's right side body at the time of my inspection. The right portion of the Motor Car was observed to have been unaffected by the accident.

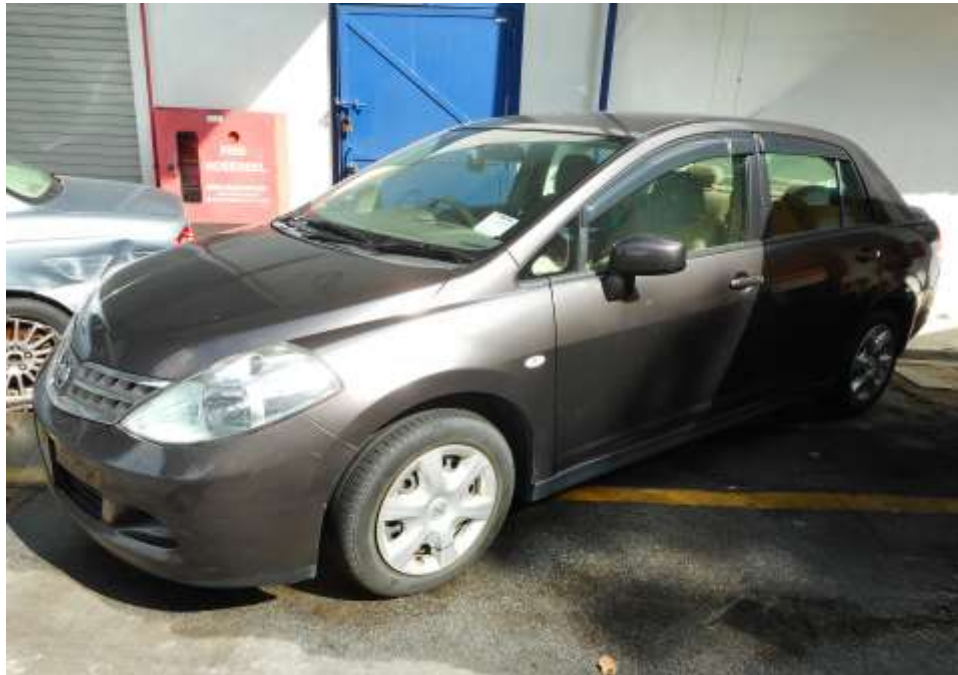
Photo 6 shows a general view of the Motor Car's left side body at the time of my inspection. The left portion of the Motor Car was observed to have been unaffected by the accident.

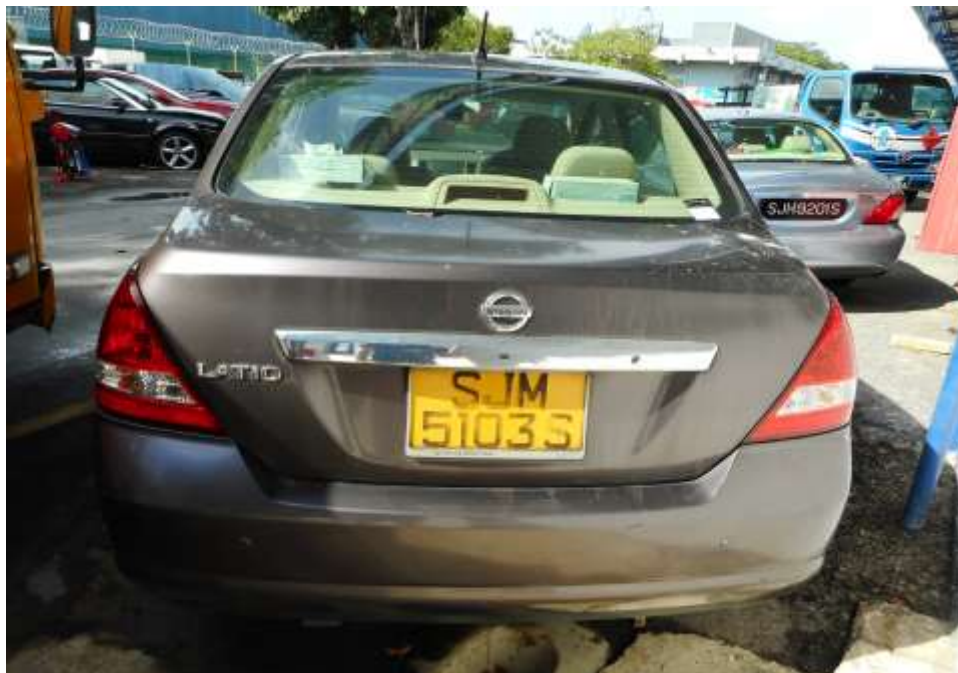
Photo 7 shows a general view of the Motor Car's rear body at the time of my inspection. The rear portion of the Motor Car was observed to have been unaffected by the accident.

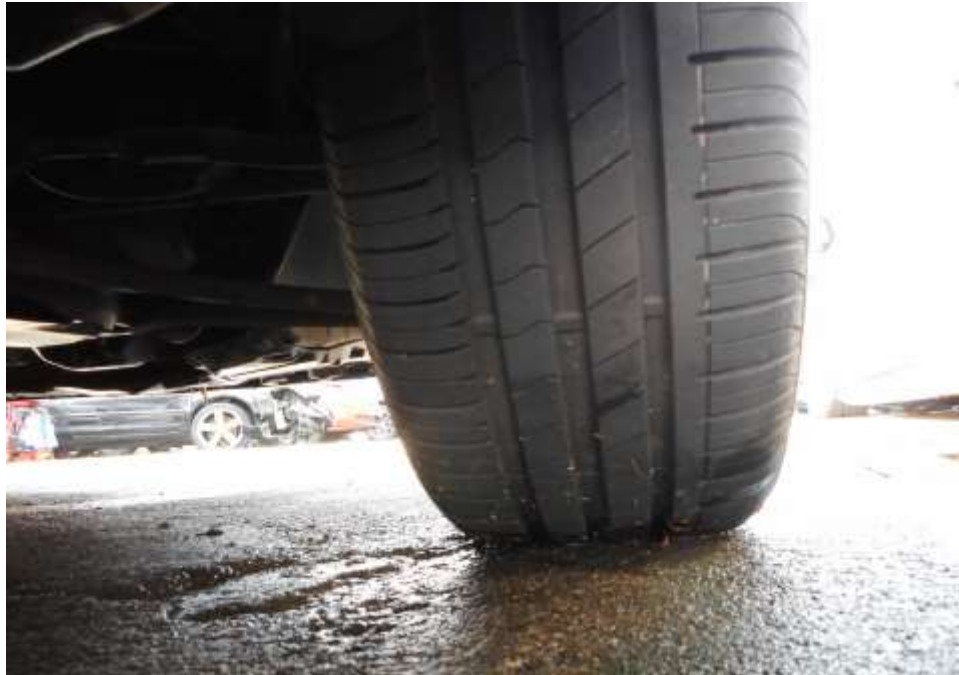
Photo 8 shows the condition of the front right tyre of the Motor Car, which was observed to be in serviceable condition with remaining tread depth of approximately 6.2mm. The tyre was sufficiently inflated for vehicular operation with no tear, cut or burst mark(s) on the outer and the inner sidewalls as well as across the tread. The 4 tyres of the Motor Car were wrapped around standard alloy wheel rims without any damage.

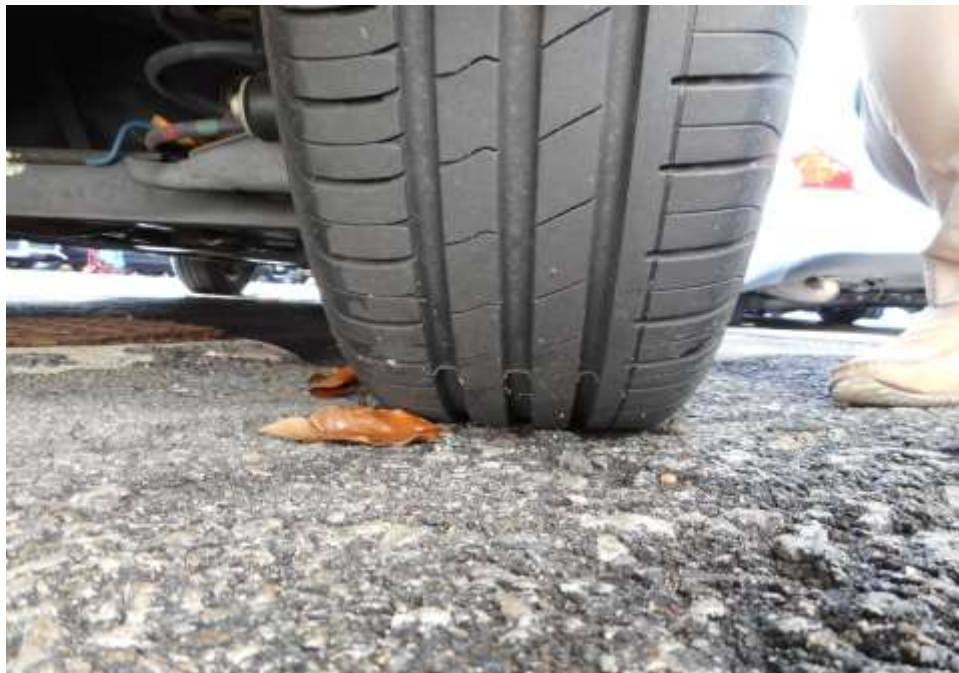
Photo 9 shows the condition of the rear right tyre of the Motor Car, which was observed to be in serviceable condition with remaining tread depth of approximately 6.1mm. The tyre was also observed to be sufficiently inflated for vehicular operation with no tear, cut or burst mark(s).

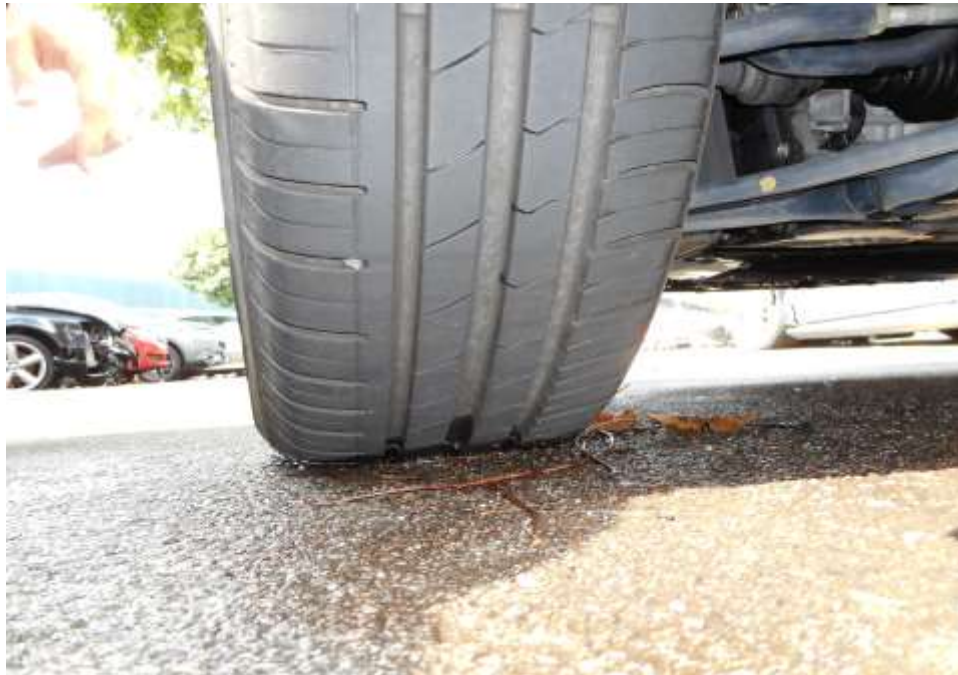
Photo 10 shows the condition of the front left tyre of the Motor Car, which was observed to be in serviceable condition with remaining tread depth of approximately 6.3mm. The tyre, which was wrapped around alloy wheel rim, was also observed to be sufficiently inflated for vehicular operation. The 4 tyres of the Motor Car were wrapped around standard alloy wheel rims that were without any significant damage apart for some relatively minor kerb grazing type of damage on the outer side of the wheel rims

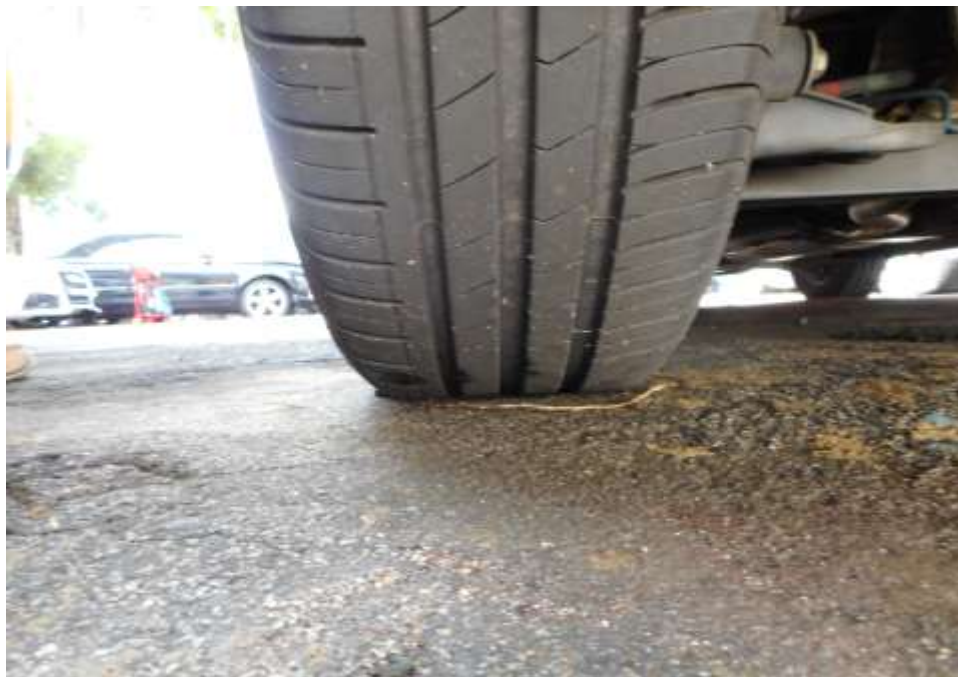
Photo 11 shows the condition of the rear right tyre of the Motor Car, which was observed to be in serviceable condition with remaining tread depth of approximately 6.3mm. There was also no tear, cut or burst mark(s) on the outer and the inner sidewalls as well as across the tread of the Motor Car's 4 tyres.

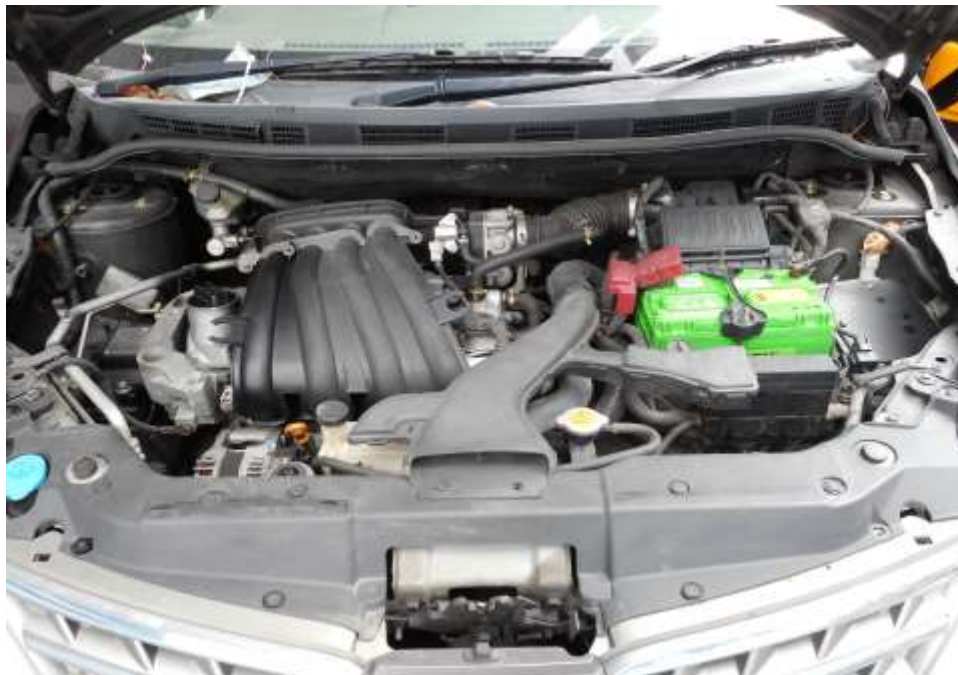
Photo 12 shows a general view of the Motor Car's engine compartment. The various parts and components inside the engine compartment were unaffected by the accident. There was also no sign(s) or indication(s) of fluid leakage and/or fluid stain within the engine compartment.

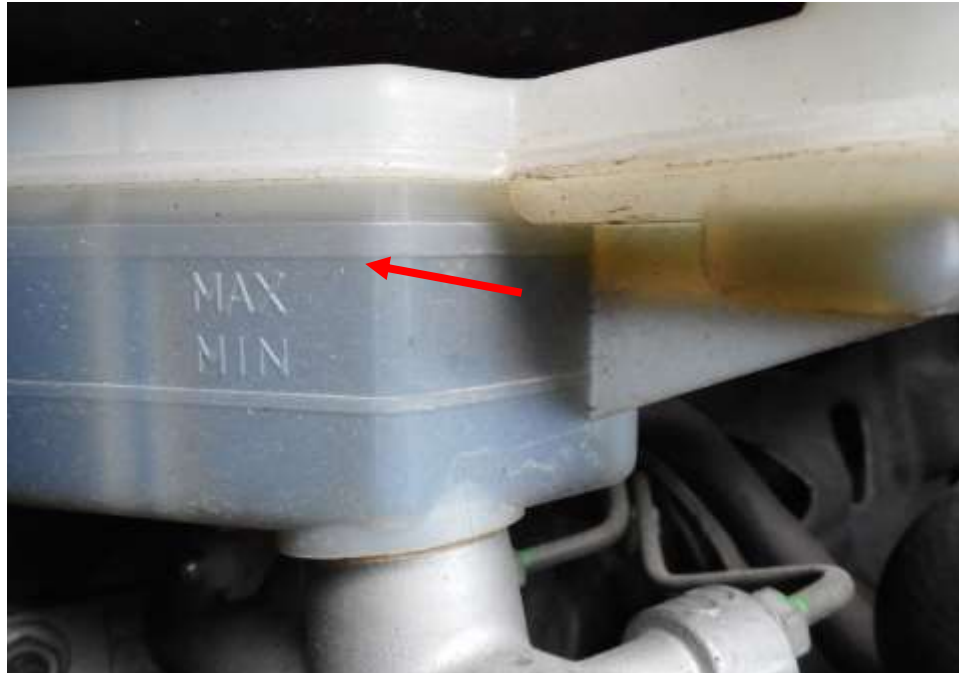
Photo 13 shows the brake fluid reservoir of the Motor Car at the time of my inspection. The brake fluid was observed to be of sufficient level (arrowed) and without any visible contamination.

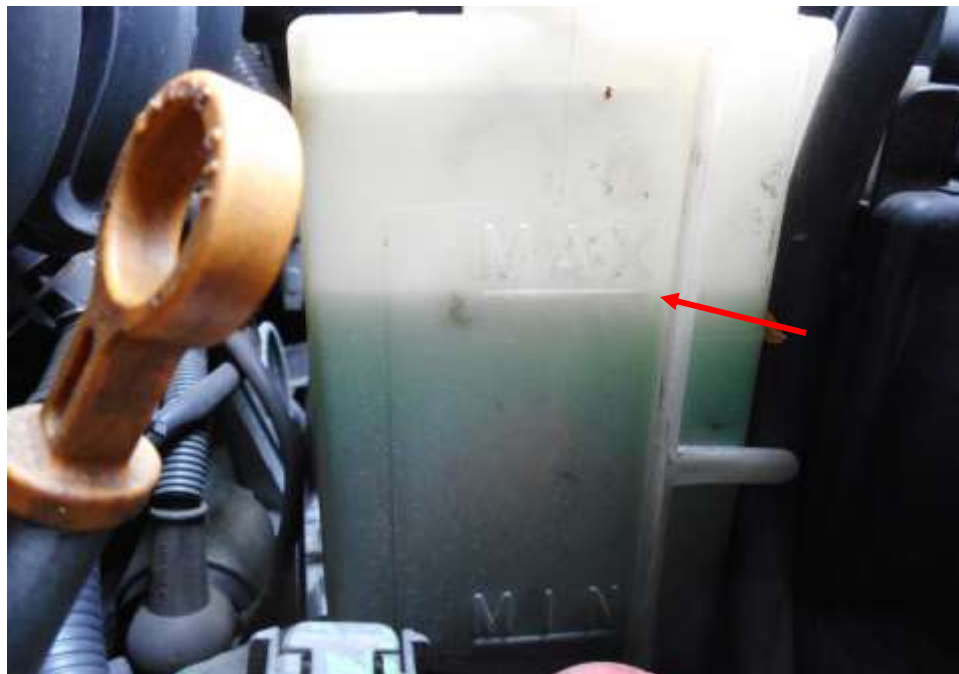
Photo 14 shows checks being carried out to the engine coolant of the Motor Car at the time of my inspection. The engine coolant was observed to be of sufficient level (arrowed) and without any visible contamination.

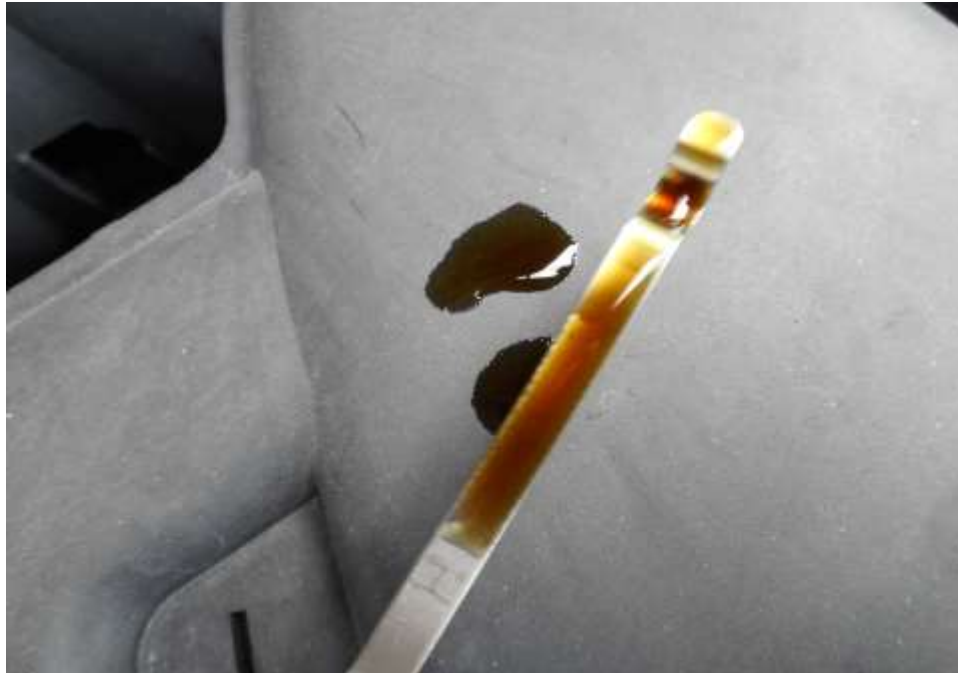
Photo 15 shows the engine oil dip stick of the Motor Car at the time of my inspection. The engine oil was observed to be of sufficient level and without any visible contamination.

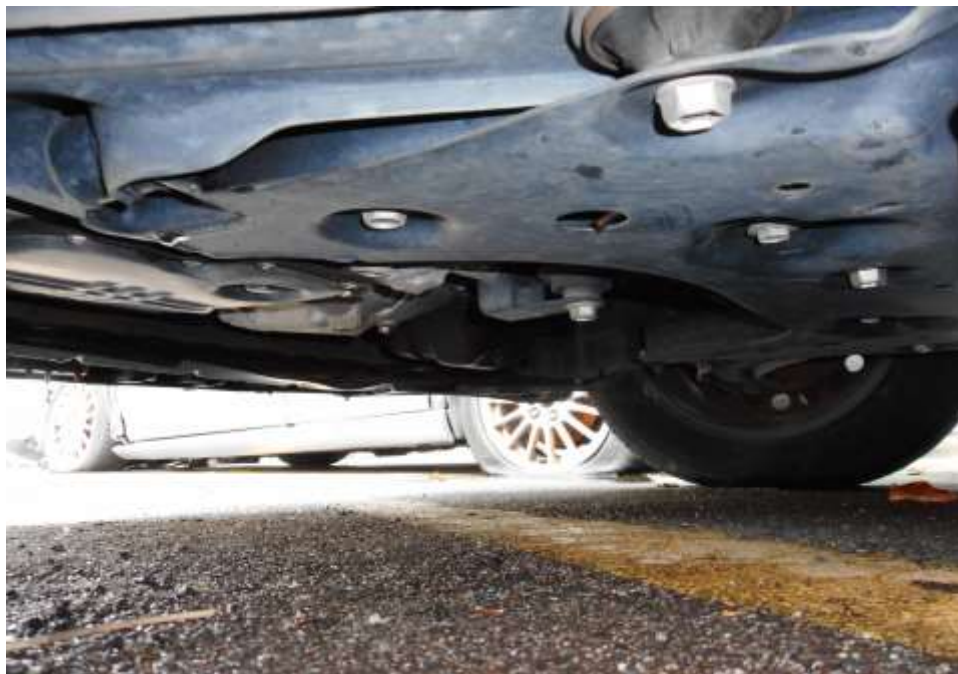
Photo 16 shows the undercarriage of the Motor Car, at the area where the engine housing and transmission housing are located. I did not find any sign(s) or indication(s) of fluid leak and/or fluid stain(s) on the underside of the Motor Car.

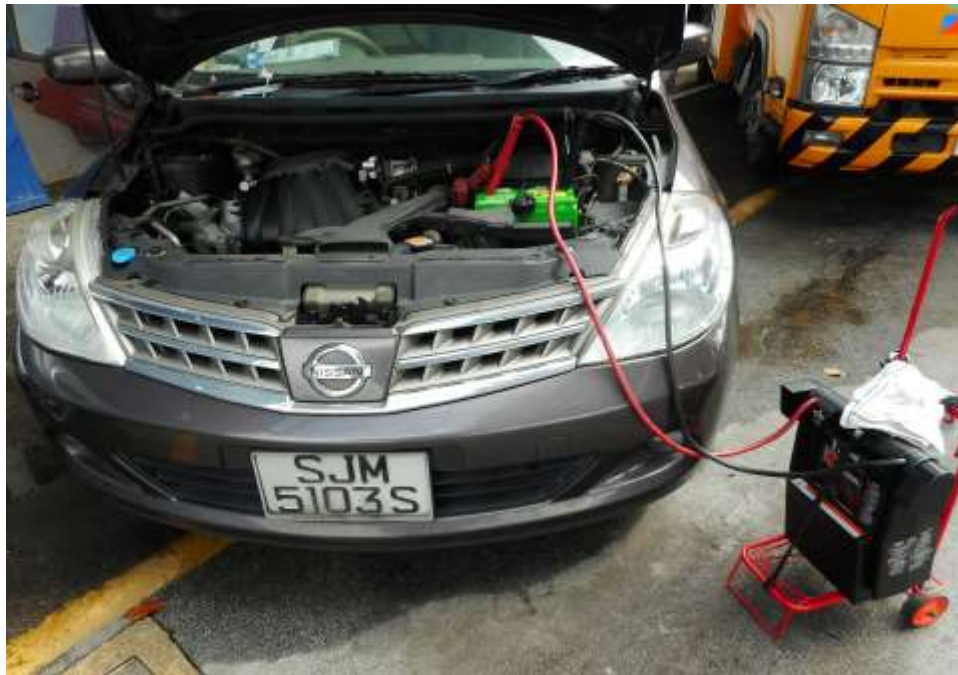
11. For this inspection, the Motor Car's engine could not be cranked despite multiple attempts on jumpstarting it with an external battery pack due to a fault in the ignition system; therefore we were unable to conduct any tests on both the braking and the steering system because its brake servo unit and the electronic power steering motor requires the vehicle's engine to be started to be tested.
12. My visual inspection of the various undamaged mechanical components of the braking system to the other parts like the, brake calipers, brake drum, brake hoses and the various steering components which had included the steering rack and pinion, tie rods, tie rod ends and ball joints are observed to be intact. See photo 17 - 21 below.

Photo 17 shows the jumpstarting process of the Motor Car with an external battery pack. The Motor Car was unable to be cranked due to a fault in the ignition system.

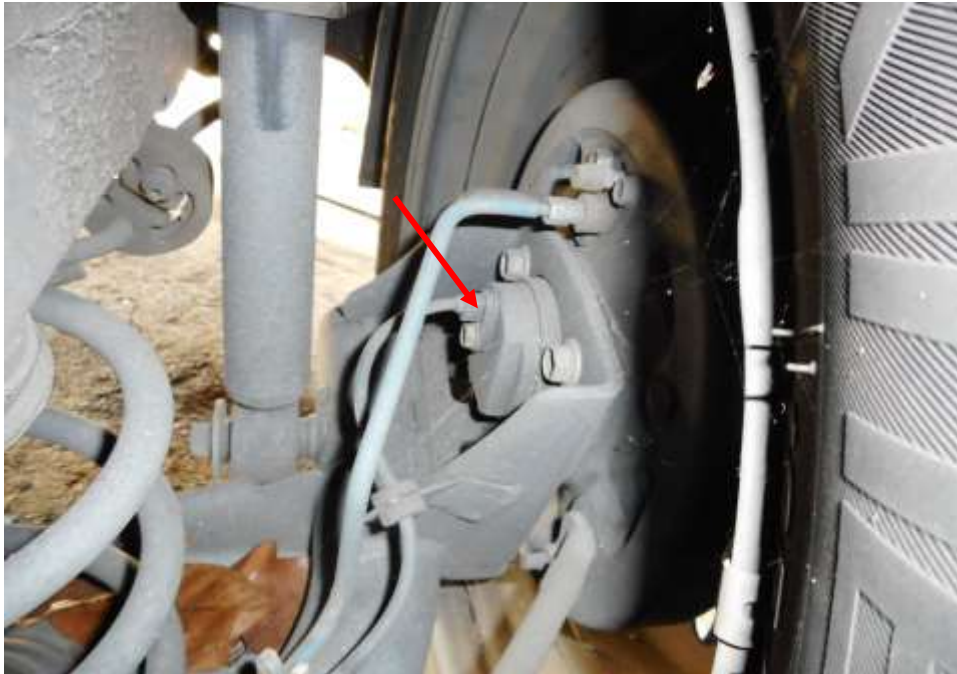
Photo 18 shows the brake hose/pipe (arrowed) at the rear left wheel of the Motor Car. I did not observe any leakage of brake fluid at the time of my inspection of the Motor Car. The undercarriage components of the Motor Car were also all found to be intact and without any visible damage.

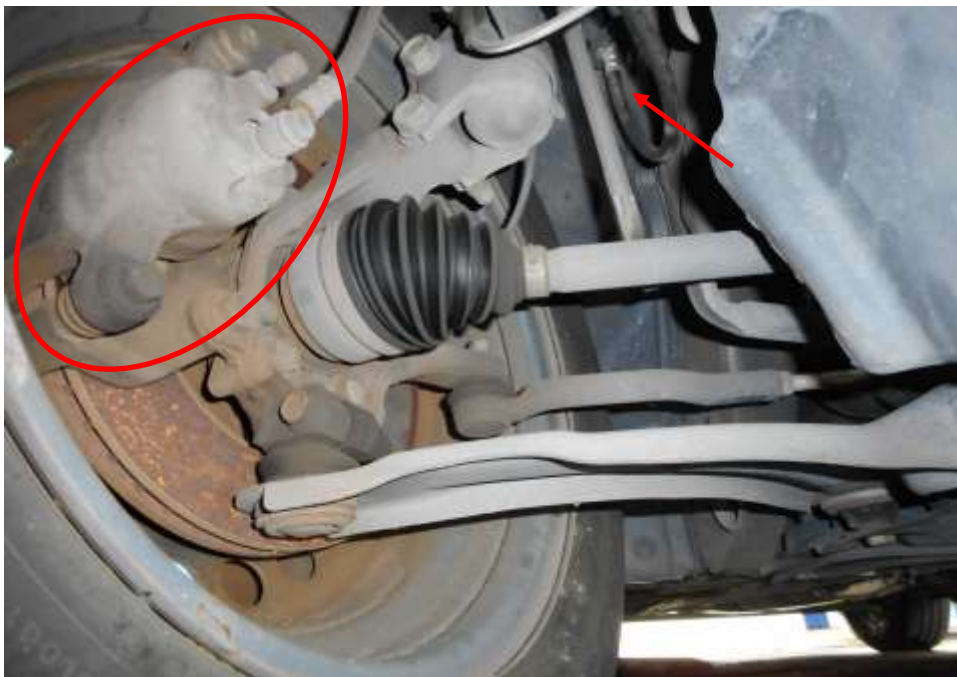
Photo 19 shows the brake hose/pipe (arrowed) at the front right wheel of the Motor Car. No leakage of brake fluid was observed. Visual examination of the various components of the braking system like the brake caliper (circled) revealed to be intact and without visible damage.

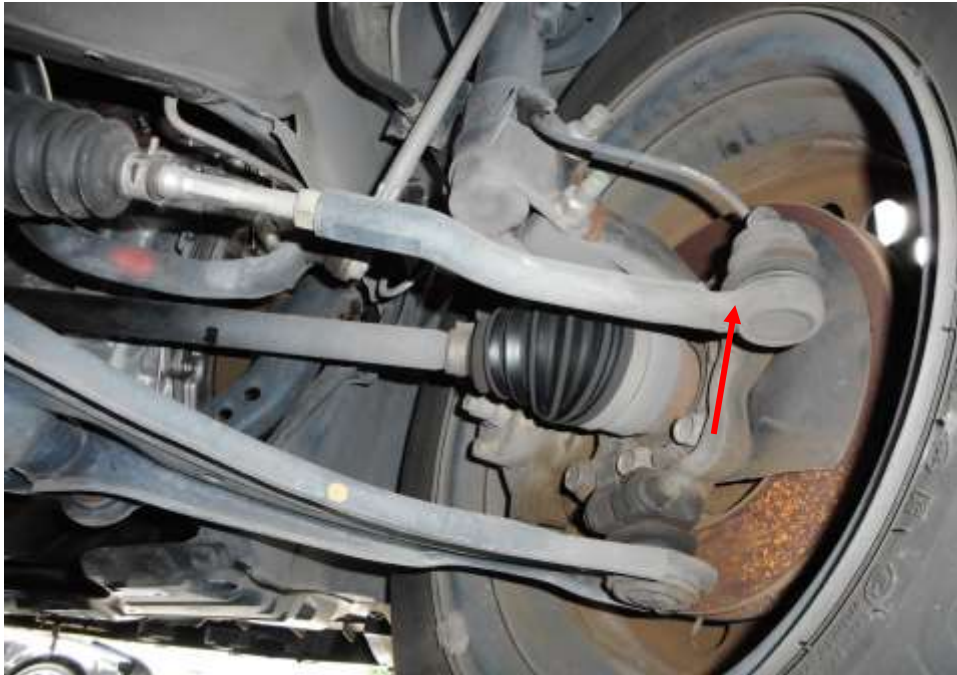
Photo 20 shows the various undercarriage components at the front right wheel of the Motor Car, in particular the steering tie rod (arrowed). The various steering components were all found to be intact; there was also no sign of fluid stain observed on the various undercarriage components at the front right wheel of the Motor Car.

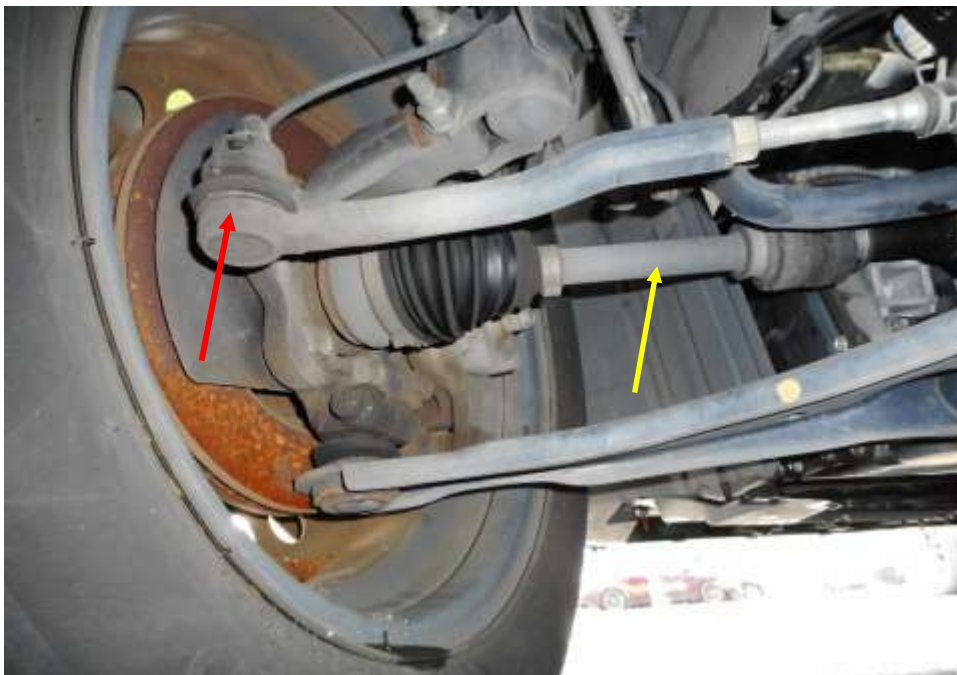
Photo 21 shows the various undercarriage components at the front left wheel of the Motor Car, which had included the steering tie rod (red arrow) and front left drive shaft (yellow arrow). The various undercarriage components of the Motor Car were all found to be intact without any visible damage.
