Your Ref: TP/IP/06699/2019
Our Ref : CI/TPD19008264/P

General Investigation Team A

MECHANICAL INSPECTION REPORT OF MOTOR CAR SLX 4768Z

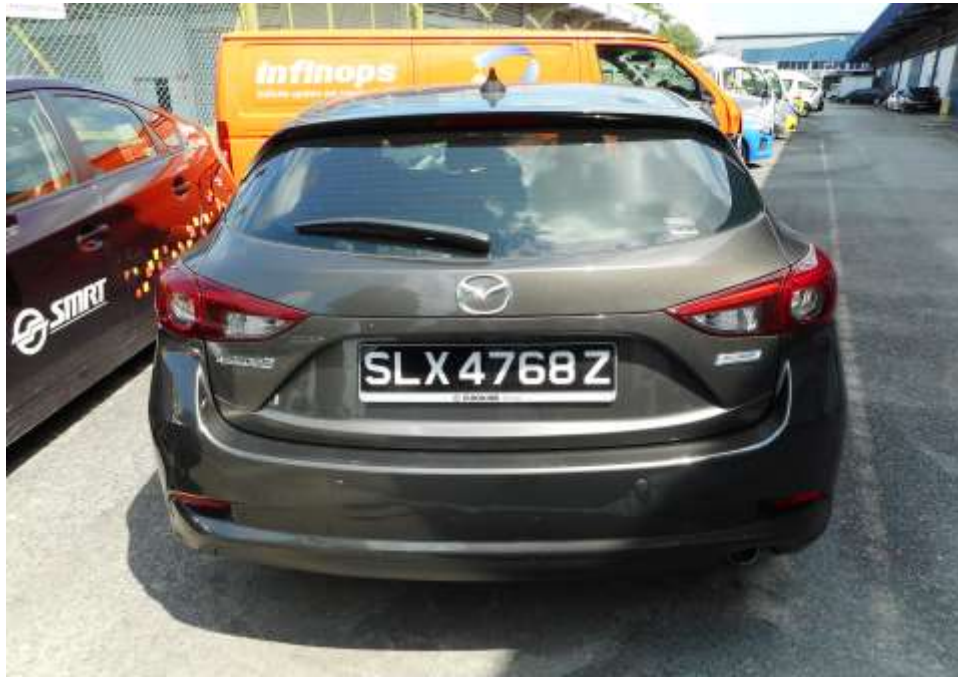
Photo 1 shows a general view of the rear portion of the Motor Car at the time of my inspection. The rear portion of the Motor Car was observed to have been unaffected by the accident. The mileage of the Motor Car at the time of my inspection was not recorded as its engine and ignition system was affected by the collision.

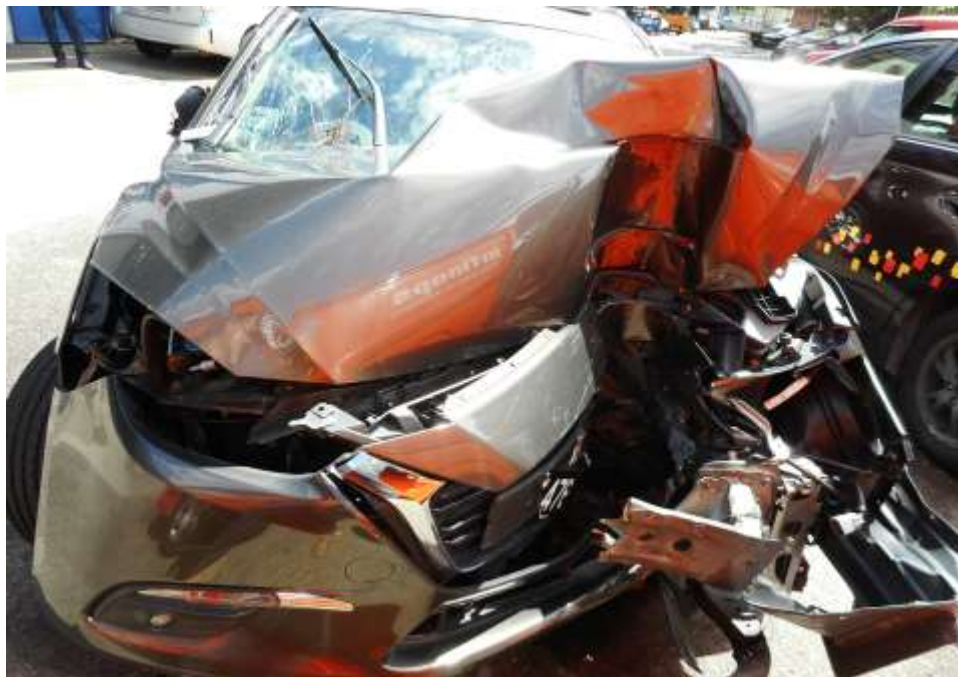
Photo 2 shows a general view of the front portion of the Motor Car at the time of my inspection. This had included its front windscreen, front bonnet, both front bonnet hinges, bonnet lock mechanism, front bumper, front number plate, left and right fenders, rear right body panel, engine system, radiator, both front left and right headlamp and its undercarriage components. were amongst the body parts that were observed to have been damaged as a result of the accident.

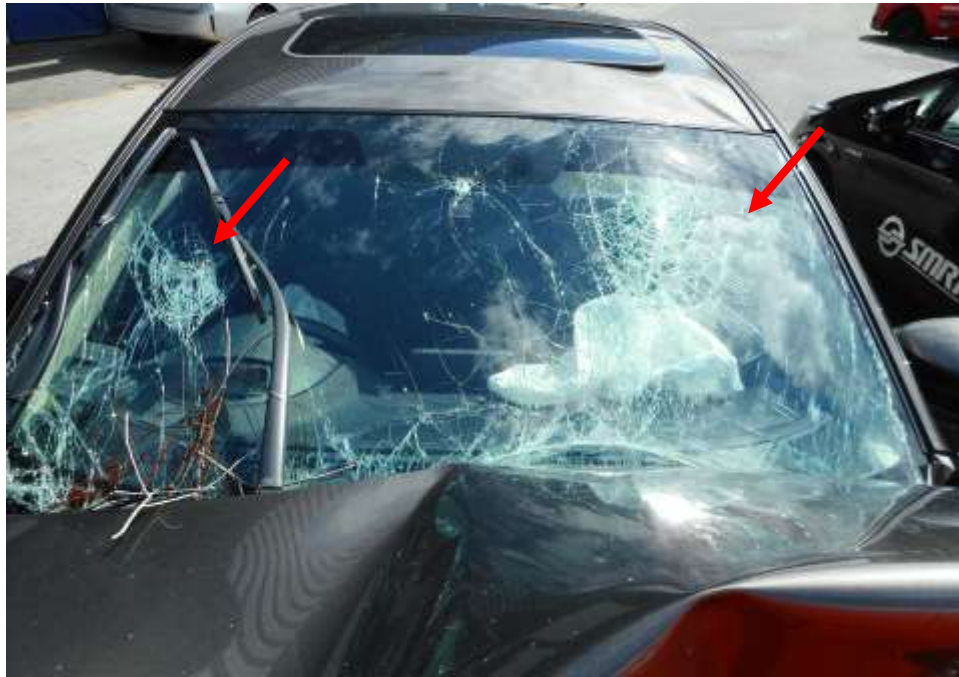
Photo 3 shows a close up view of the front windscreen of the Motor Car at the time of my inspection. The front windscreen (arrowed) of the Motor Car was observed to have been damaged as a result of the accident

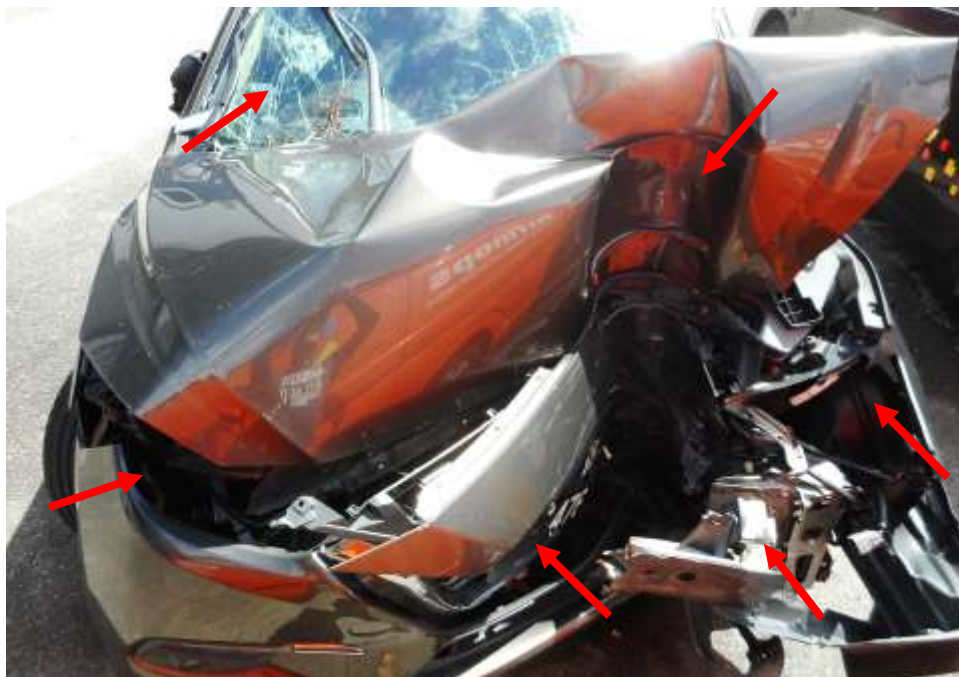
Photo 4 shows a general view of the front right portion of the Motor Car at the time of my inspection. its front windscreen, front bonnet, front bumper, front number plate, both front left and right headlamp (arrowed) were amongst the body parts that were observed to have been damaged as a result of the accident.

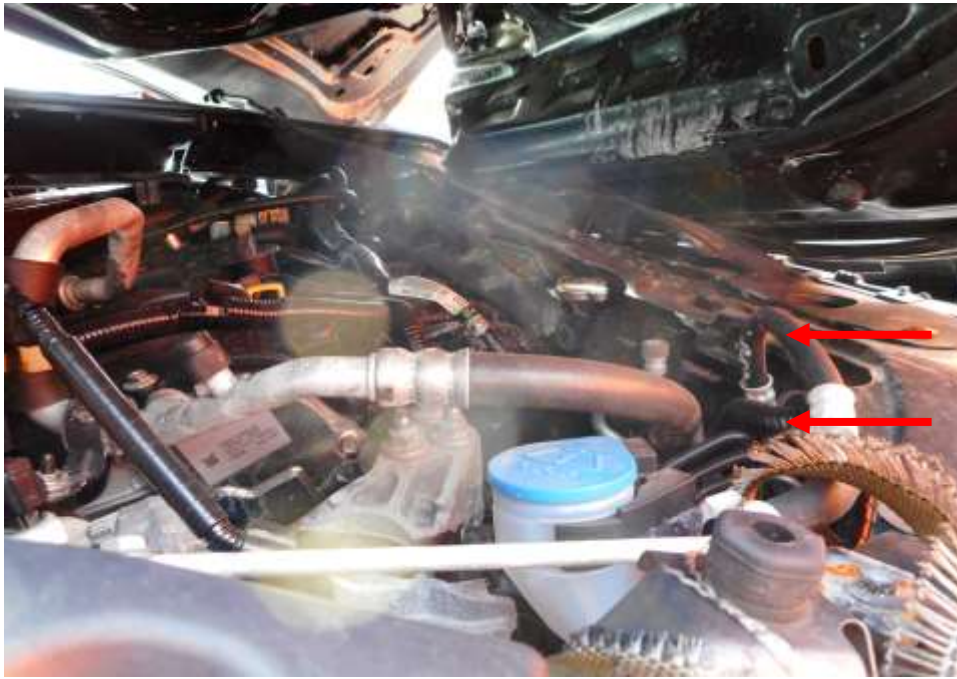
Photo 5 shows a close up view of the front portion of the Motor Car at the time of my inspection. The engine system (arrowed) of the Motor Car was observed to have been damaged due the induced impact as a result of the accident

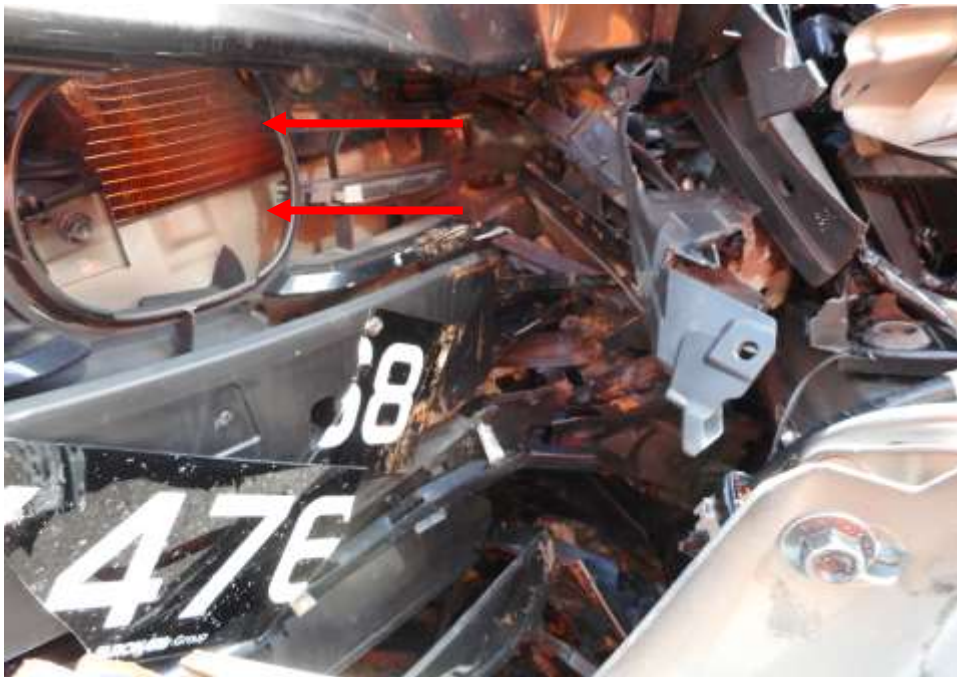
Photo 6 shows a close up view of the front portion of the Motor Car at the time of my inspection. The radiator (arrowed) of the Motor Car was observed to have been damaged by an induced impact as a result of the accident

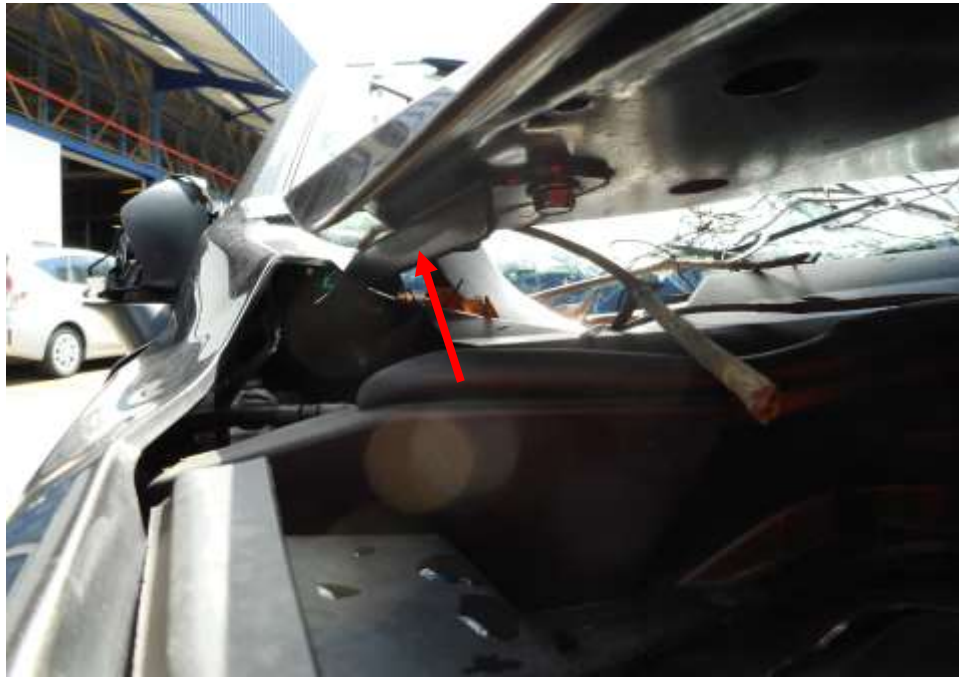
Photo 7 shows a close up view of the right bonnet hinge of the Motor Car at the time of my inspection. The right bonnet hinge of the Motor Car was observed to have been damaged as a result of the accident rendering the bonnet unable to be opened (arrowed)

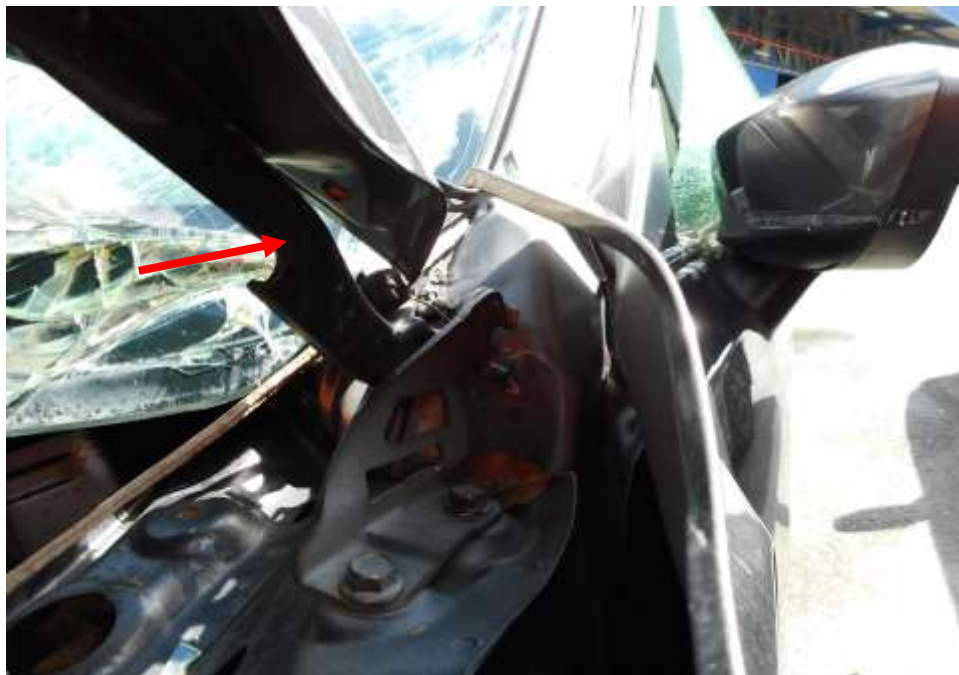
Photo 8 shows a close up view of the left bonnet hinge of the Motor Car at the time of my inspection. The left bonnet hinge of the Motor Car was observed to have been damaged as a result of the accident rendering the bonnet unable to be opened (arrowed)

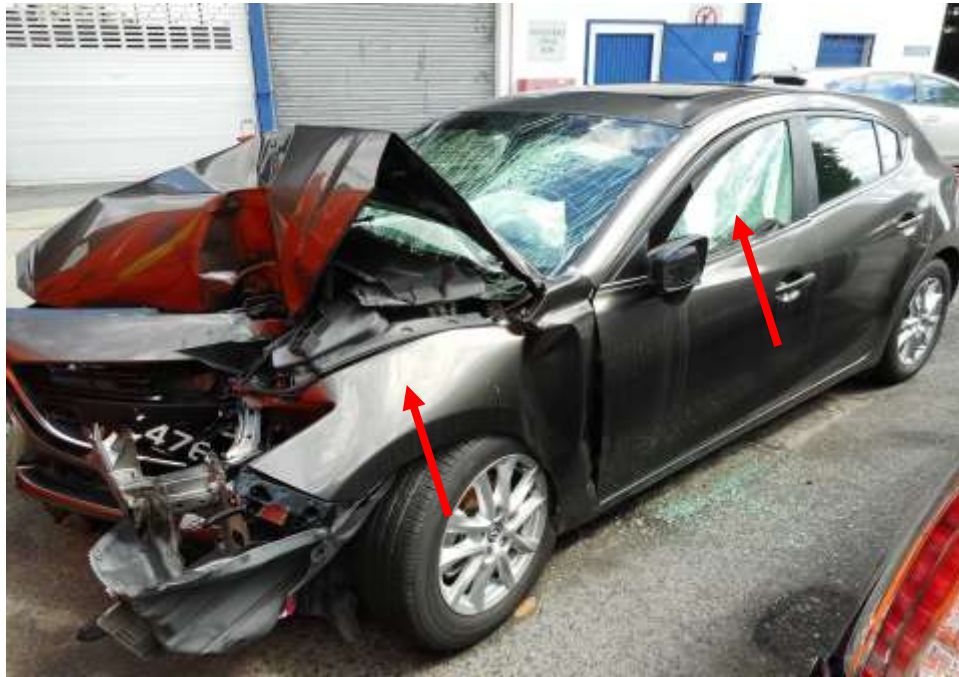
Photo 9 shows a general view of the front left portion of the Motor Car at the time of my inspection. The front left fender and the front left passenger windscreen panel (arrowed) of the Motor Car was observed to have been damaged as a result of the accident.

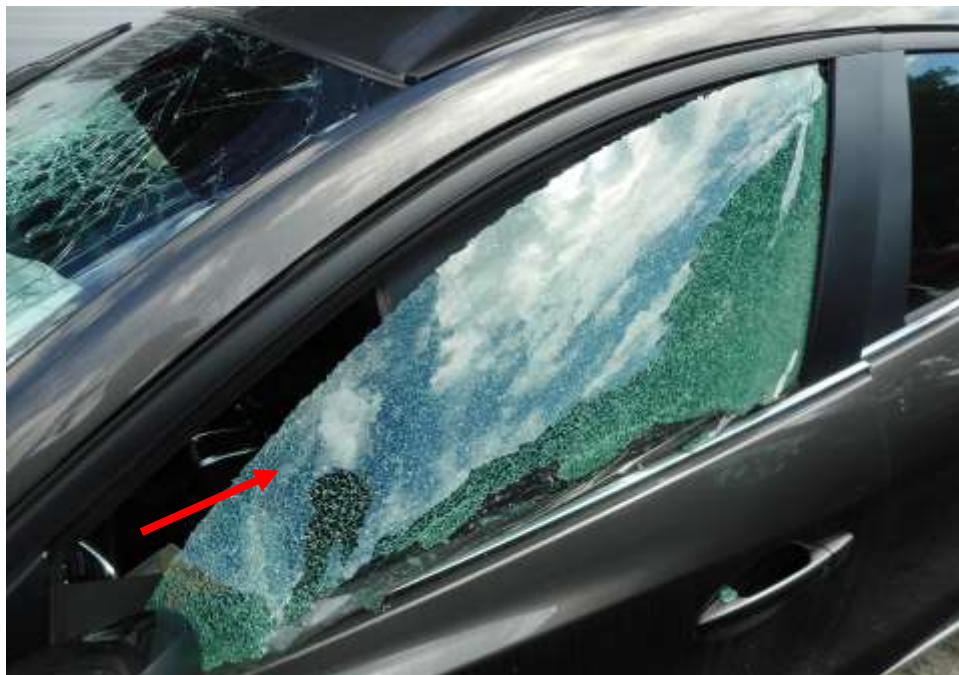
Photo 10 shows the close up view of the left panel portion of the Motor Car at the time of my inspection. The front left passenger windscreen (arrowed) of the Motor Car was observed to have been damaged as a result of the accident.

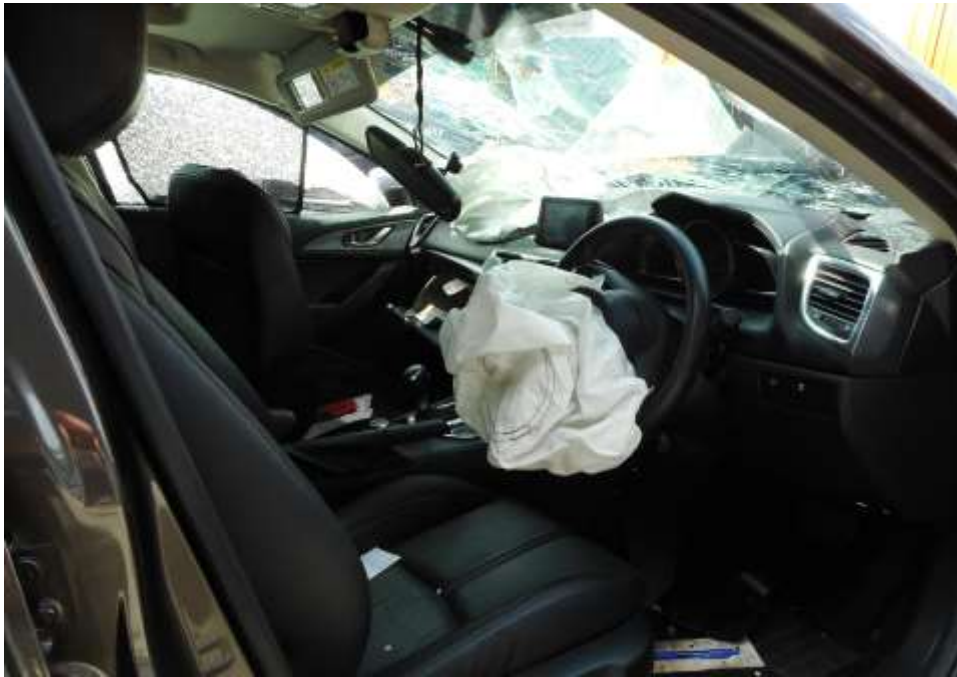
Photo 11 shows a general view of the Motor Car's interior compartment. Both the driver and front passenger air bags were also deployed as a result of the accident.

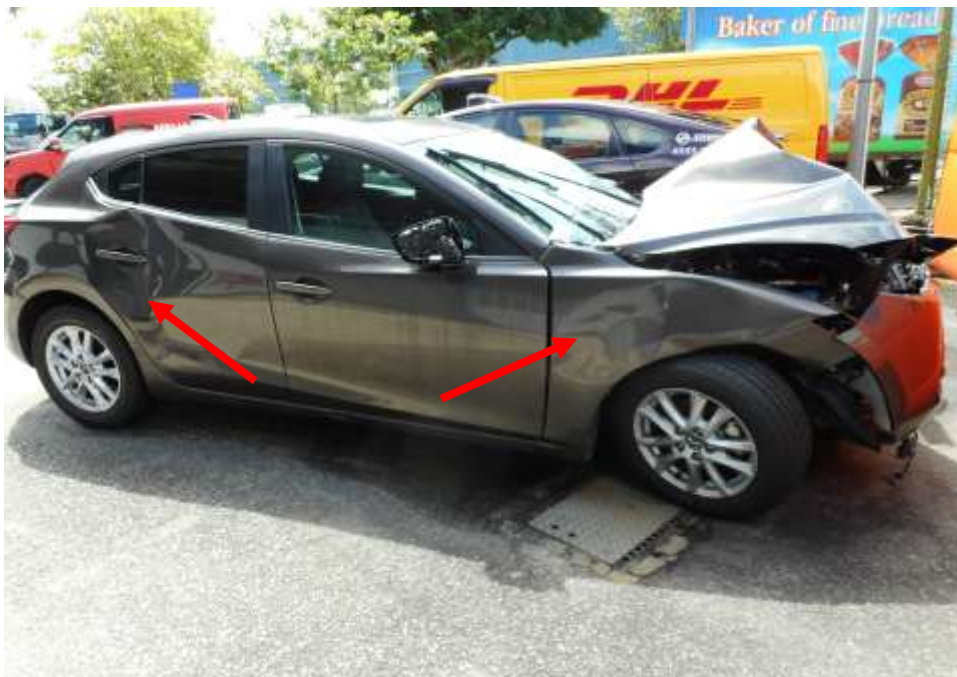
Photo 12 shows a general view of the left portion of the Motor Car at the time of my inspection. The left portion of the Motor Car was observed to have been affected by the accident. Its front fender and rear passenger door panel (arrowed) was damage as a result of the accident.

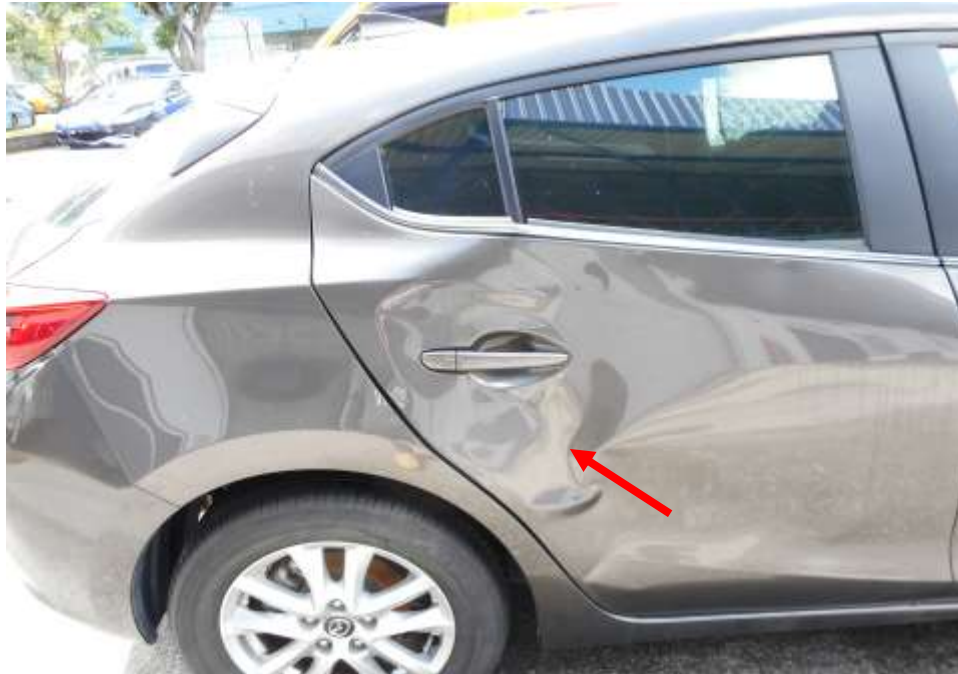
Photo 13 shows close up view of the left portion of the Motor Car at the time of my inspection. Its rear passenger door panel (arrowed) was damage as a result of the accident.

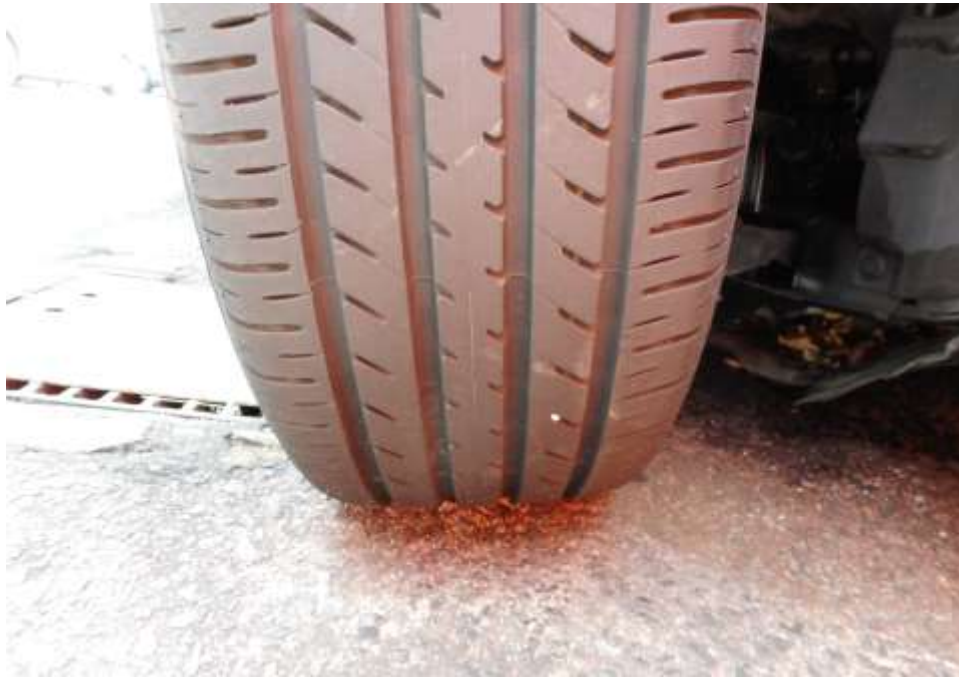
Photo 12 shows the condition of the front right tyre of the Motor Car, which was observed to be in serviceable condition with remaining tread depth of approximately 6.9mm. There was no tear, cut or burst mark(s) on the outer and the inner sidewalls as well as across the tread of this tyre.

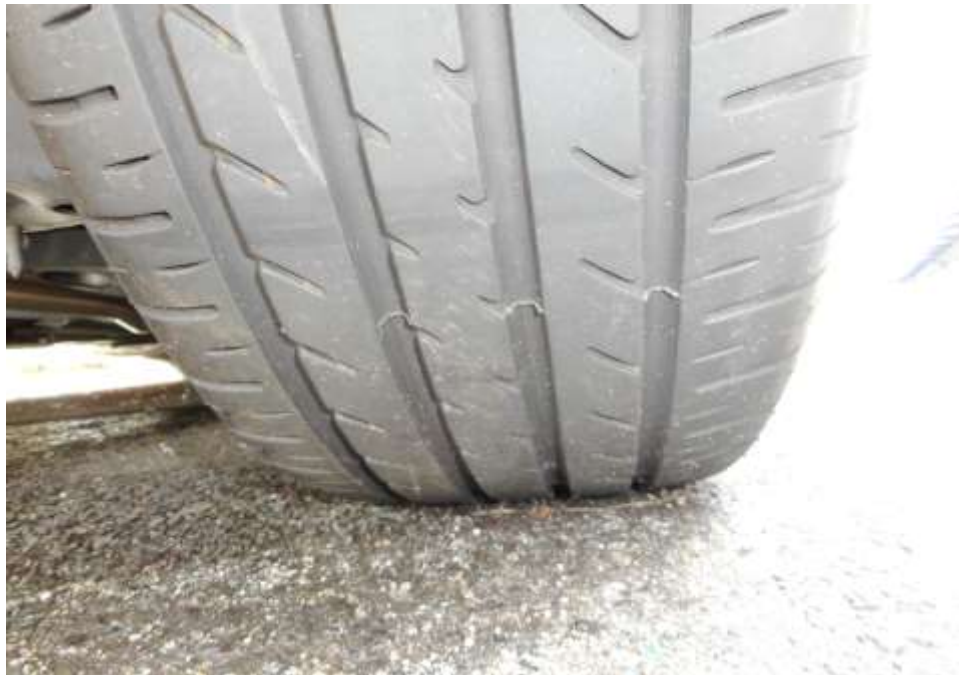
Photo 13 shows the condition of the rear right tyre of the Motor Car, which was observed to be in serviceable condition with remaining tread depth of approximately 5.1mm. There was no tear, cut or burst mark(s) on the outer and the inner sidewalls as well as across the tread of this tyre.

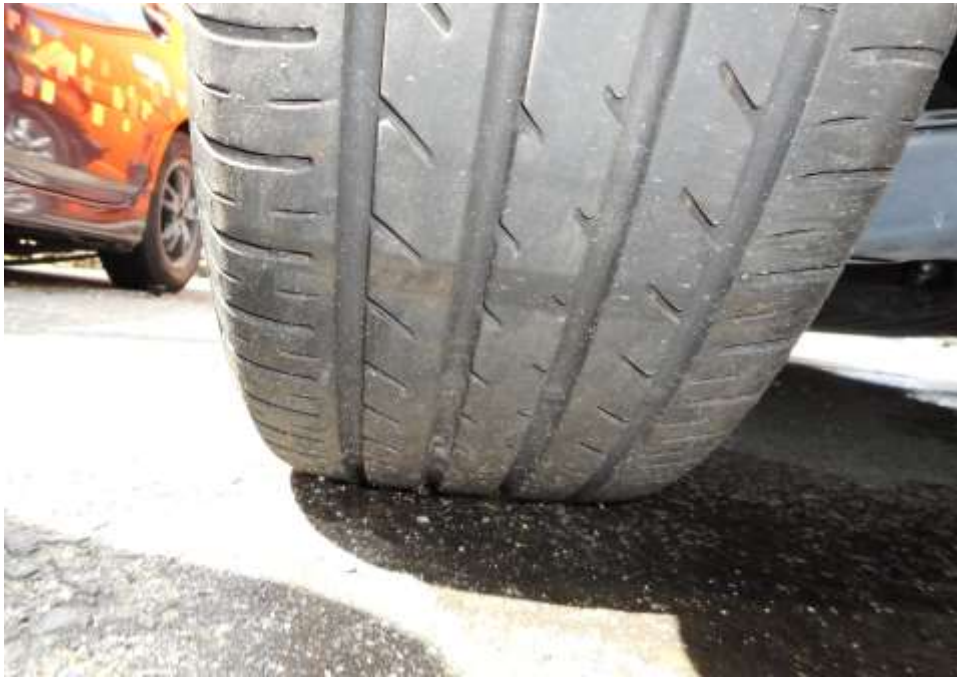
Photo 14 shows the condition of the rear left tyre of the Motor Car, which was observed to be in serviceable condition with remaining tread depth of approximately 5.7mm. There was no tear, cut or burst mark(s) on the outer and the inner sidewalls as well as across the tread of this tyre.

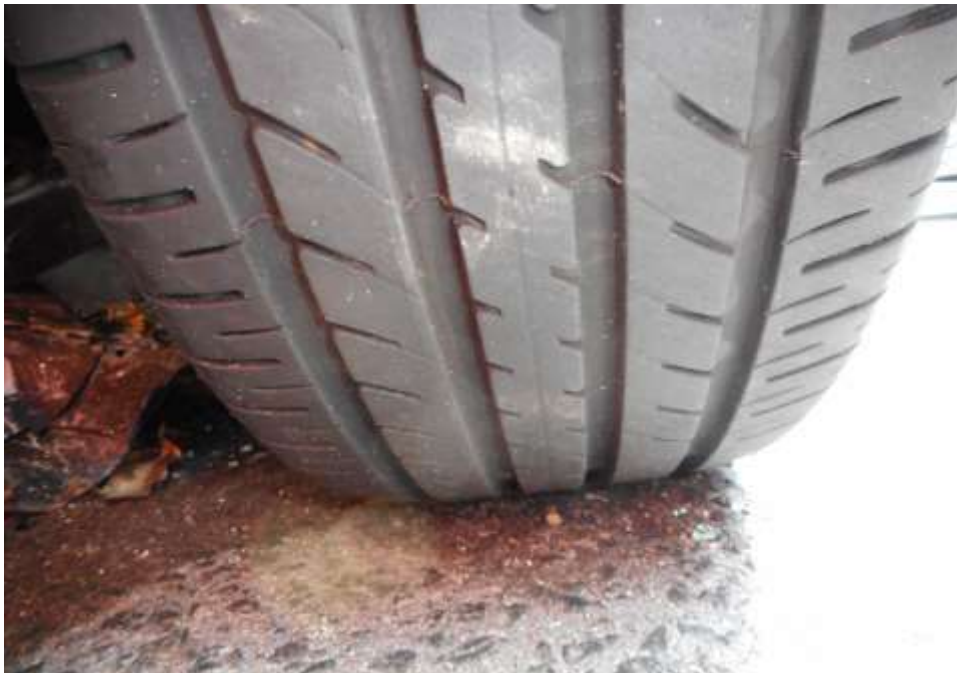
Photo 15 shows the condition of the front left tyre of the Motor Car, which was observed to be in serviceable condition with remaining tread depth of approximately 6.4mm. There was no tear, cut or burst mark(s) on the outer and the inner sidewalls as well as across the tread of this tyre.

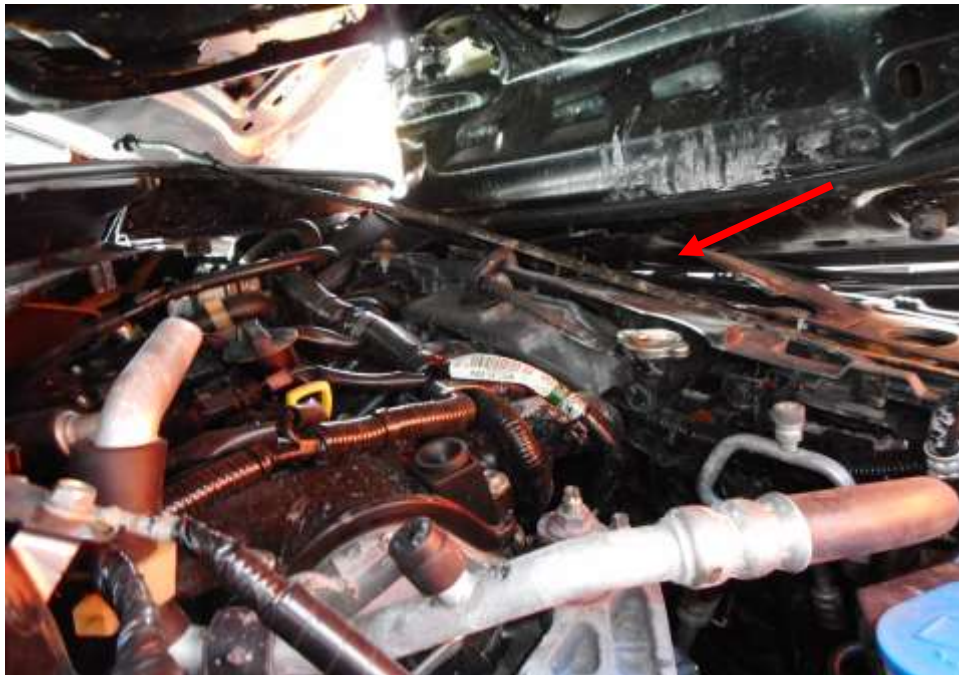
8. The impact from the collision had affected the engine compartment of the Motor Car. Parts towards the front of the engine compartment were observed to be damaged. The locking mechanism and the hinges of the Motor Car's front bonnet were also affected and I was unable to unlock and lift the front bonnet to carry out examination of the Motor Car's engine compartment. The various operating fluids like its engine coolant, brake fluid and transmission fluid etc were hence unable to be inspected. See photo 16 below.

Photo 16 shows the damage to the bonnet locking mechanism (arrowed) Motor Car's front bonnet, rendering it unable to be unlocked and lifted up to carry out examination of the Motor Car's engine compartment as a result of the accident.

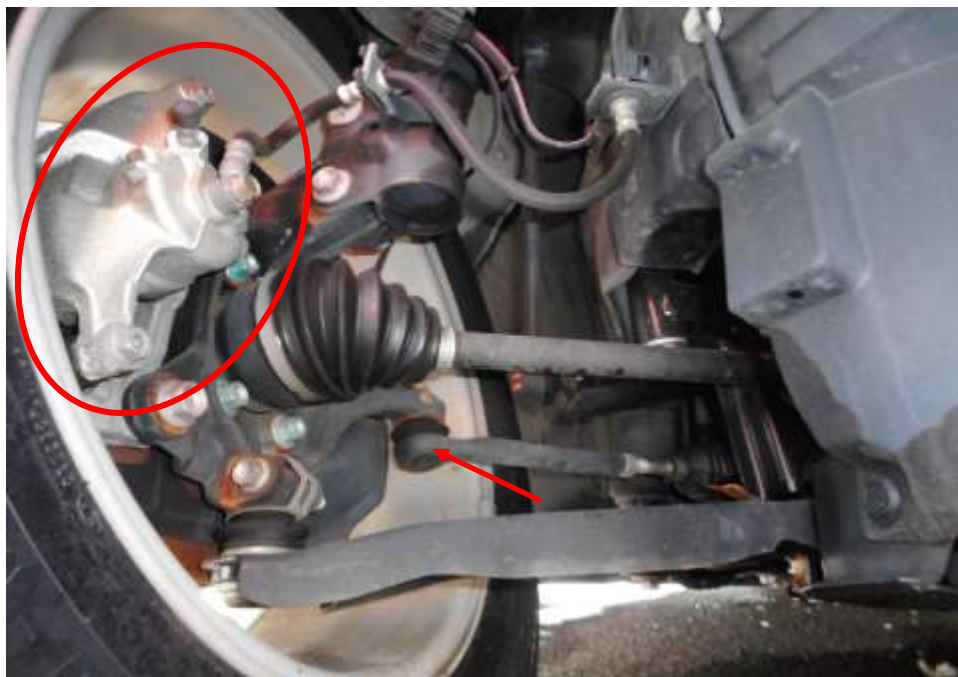
Photo 17 shows the undercarriage components at the front right wheel of the Motor Car. My checks on the underside of the Motor Car revealed damage to the various undercarriage components, the steering rack and pinion, tie rods, tie rod ends and ball joints (arrowed), the brake caliper and brake hoses (circled) revealed that these components were all generally intact.

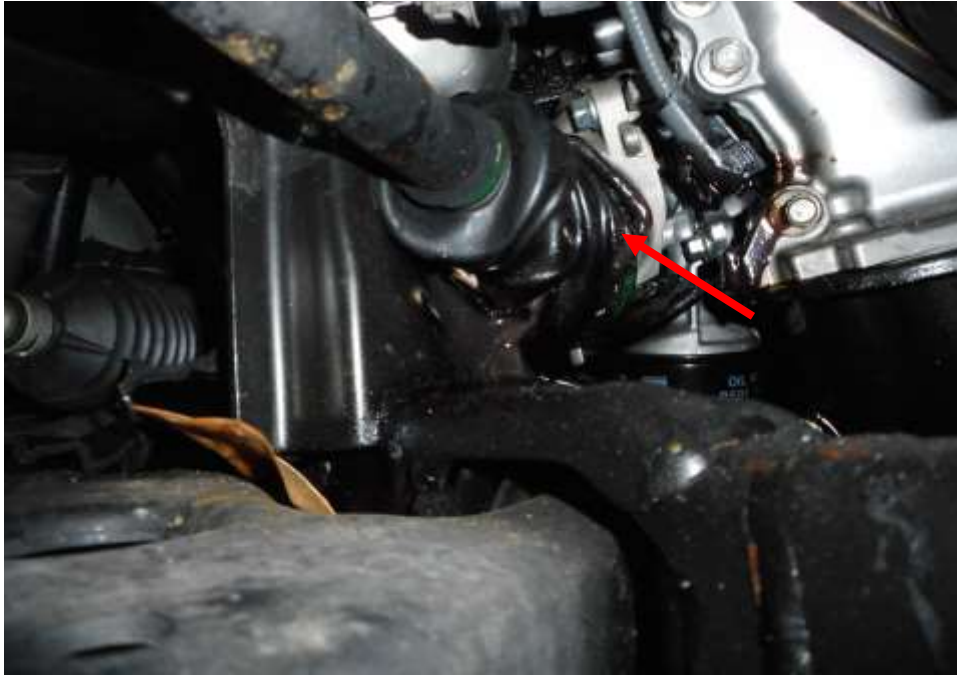
Photo 18 shows the undercarriage components at the front right wheel of the Motor Car. My checks on the underside of the Motor Car revealed damage to the various undercarriage components, the driveshaft inner rubber boot (arrowed) was found to be broken with fresh fluid leakage as a result of the accident. At the time of our inspection

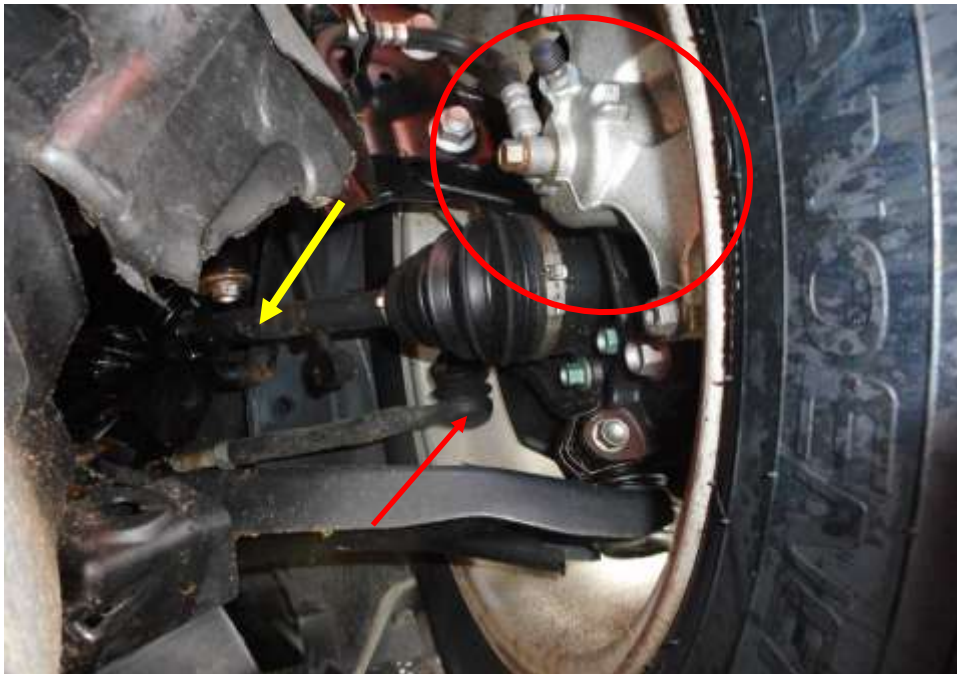
Photo 19 shows the various undercarriage components at the front left wheel of the Motor Car, which had included the steering tie rod (red arrow) and front left drive shaft (yellow arrow), its brake caliper and brake hoses (circled). The various undercarriage components of the Motor Car were all found to be intact without any visible damage.

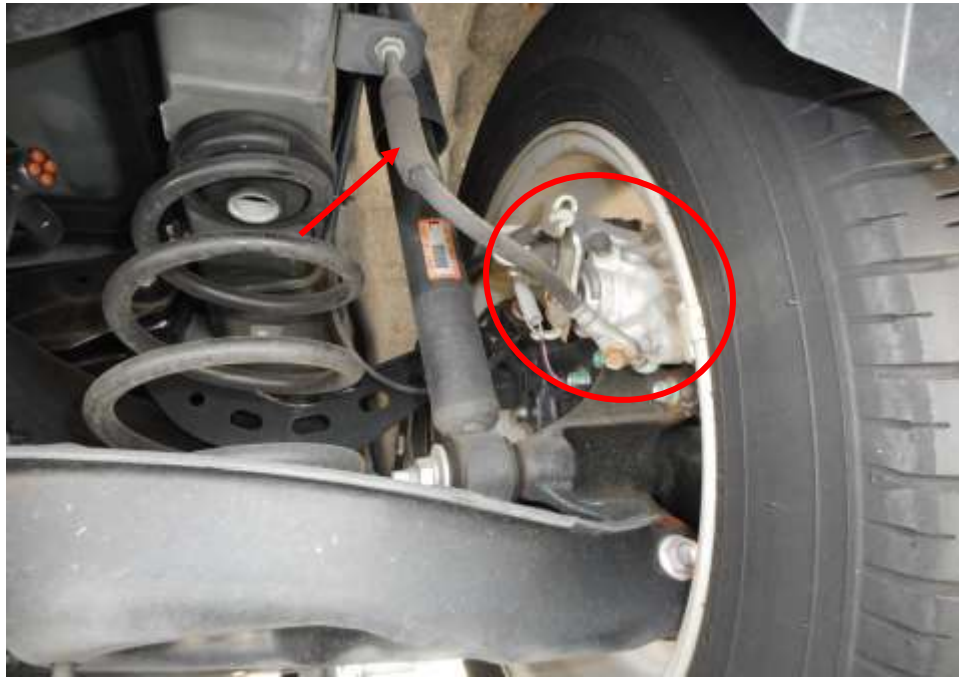
Photo 20 shows the various undercarriage components at the rear right wheel of the Motor Car, in particular the brake hose (arrowed) and brake caliper (circled). I did not observe any leakage of brake fluid at the 4 wheels of the Motor Car. My visual inspection of the various mechanical components of the Motor Car's braking system revealed all to be intact and without visible damage.

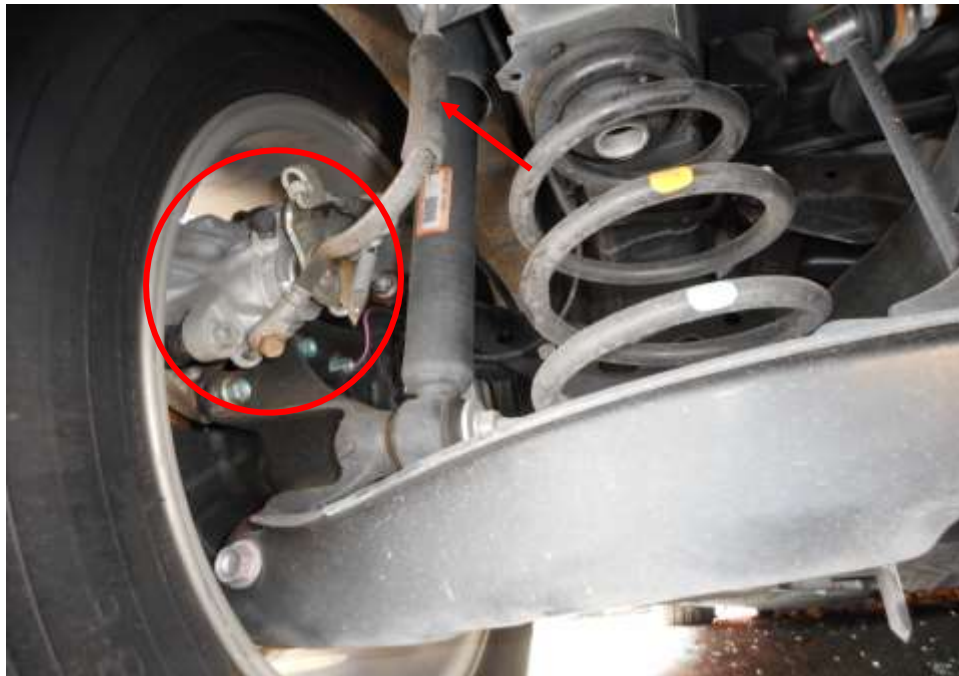
Photo 21 shows the various undercarriage components at the rear left wheel of the Motor Car, in particular the brake hose (arrowed) and brake caliper (circled). I did not observe any leakage of brake fluid at the 4 wheels of the Motor Car. My visual inspection of the various mechanical components of the Motor Car's braking system revealed all to be intact and without visible damage.
