Report No: 0164-19-TCA

## ACCIDENT VEHICLE SURVEY REPORT

**EVALUATION REPORT (PAPER SURVEY) OF ACCIDENT VEHICLE NO: SJH 8503C  
INSURED VEHICLE: SLF 8448R ACCIDENT DATE: 19/08/2018**

## ADJUSTMENT ON REPAIR COST FOR VEHICLE NO. SJH 8503C

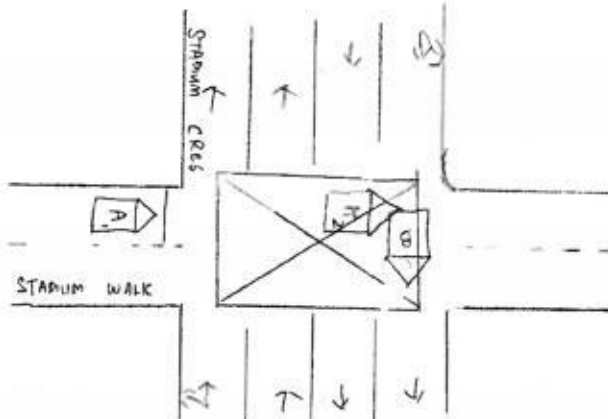
## SKETCH PLAN

The accident happened on 19/08/2018 at 4:45pm at Junction of Stadium walk / cres. Vehicle A stop at the stop line and proceed to move very slowly across the Junction. Suddenly, vehicle B dashes forward and the front of vehicle A crashes the rear of vehicle B.

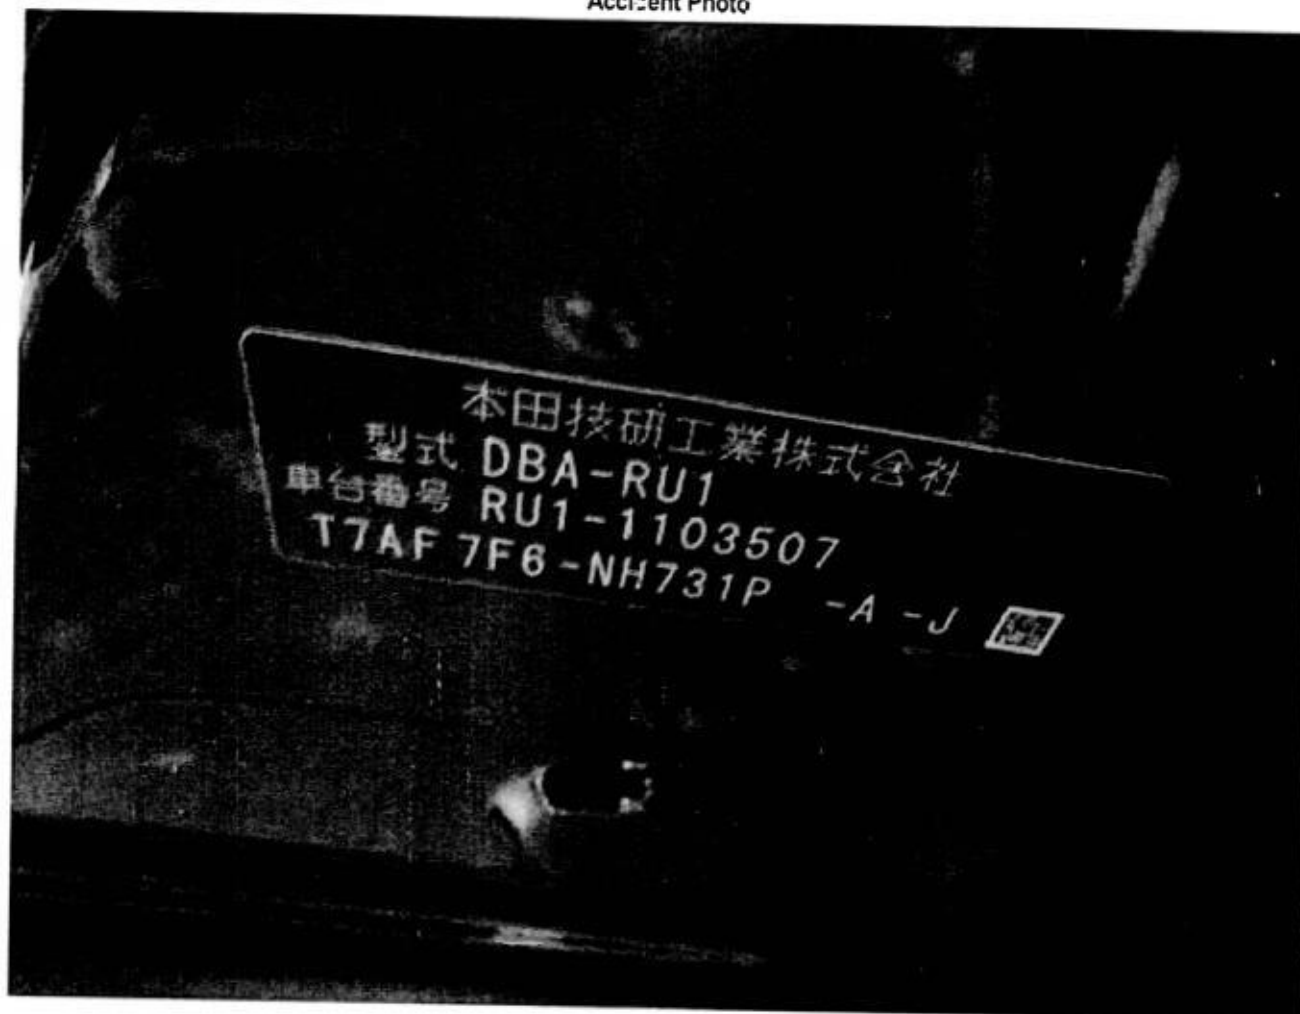
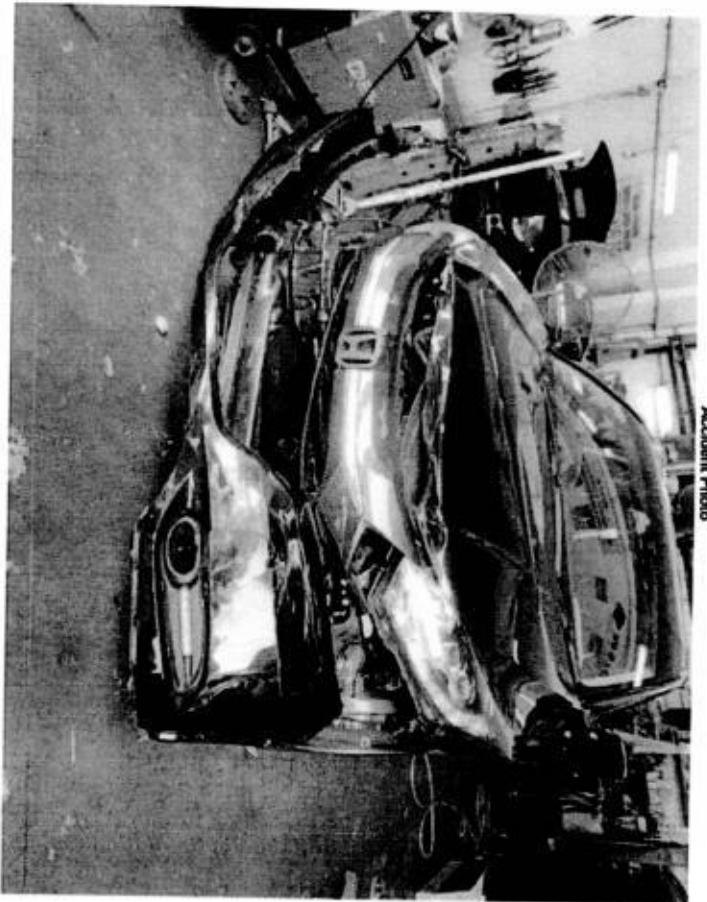
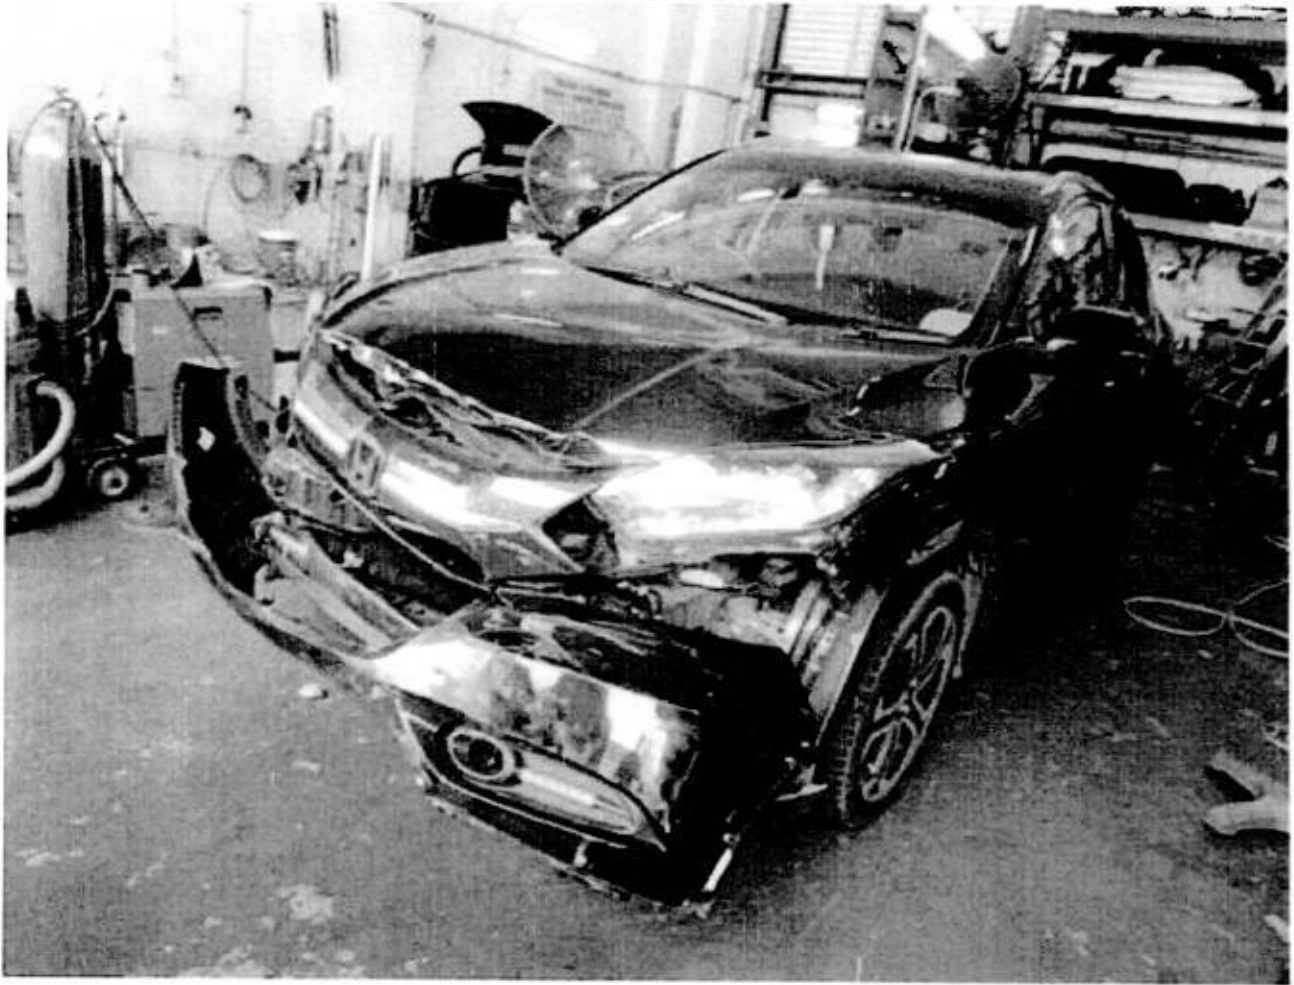
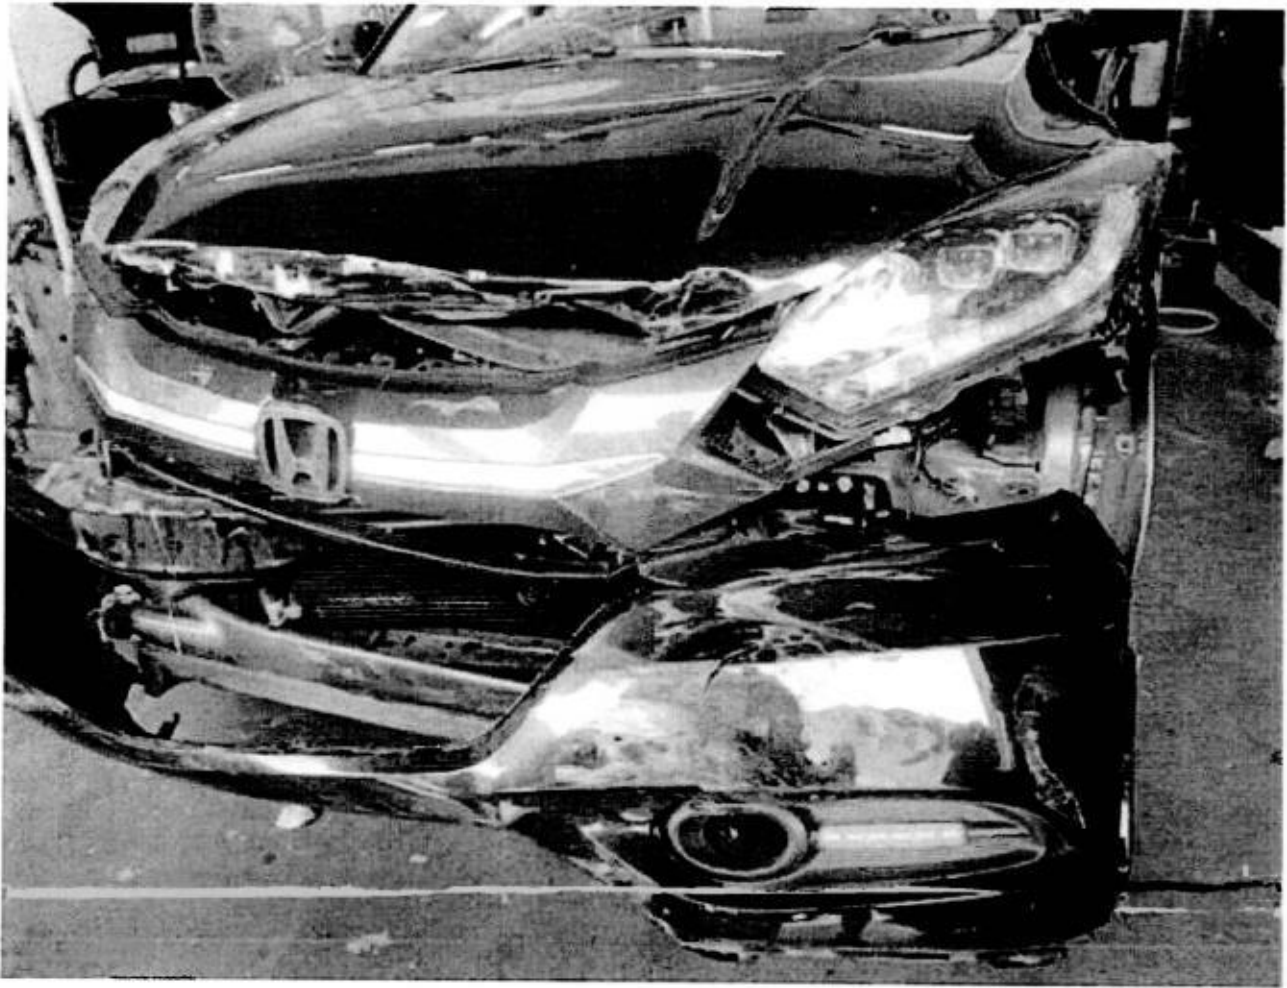
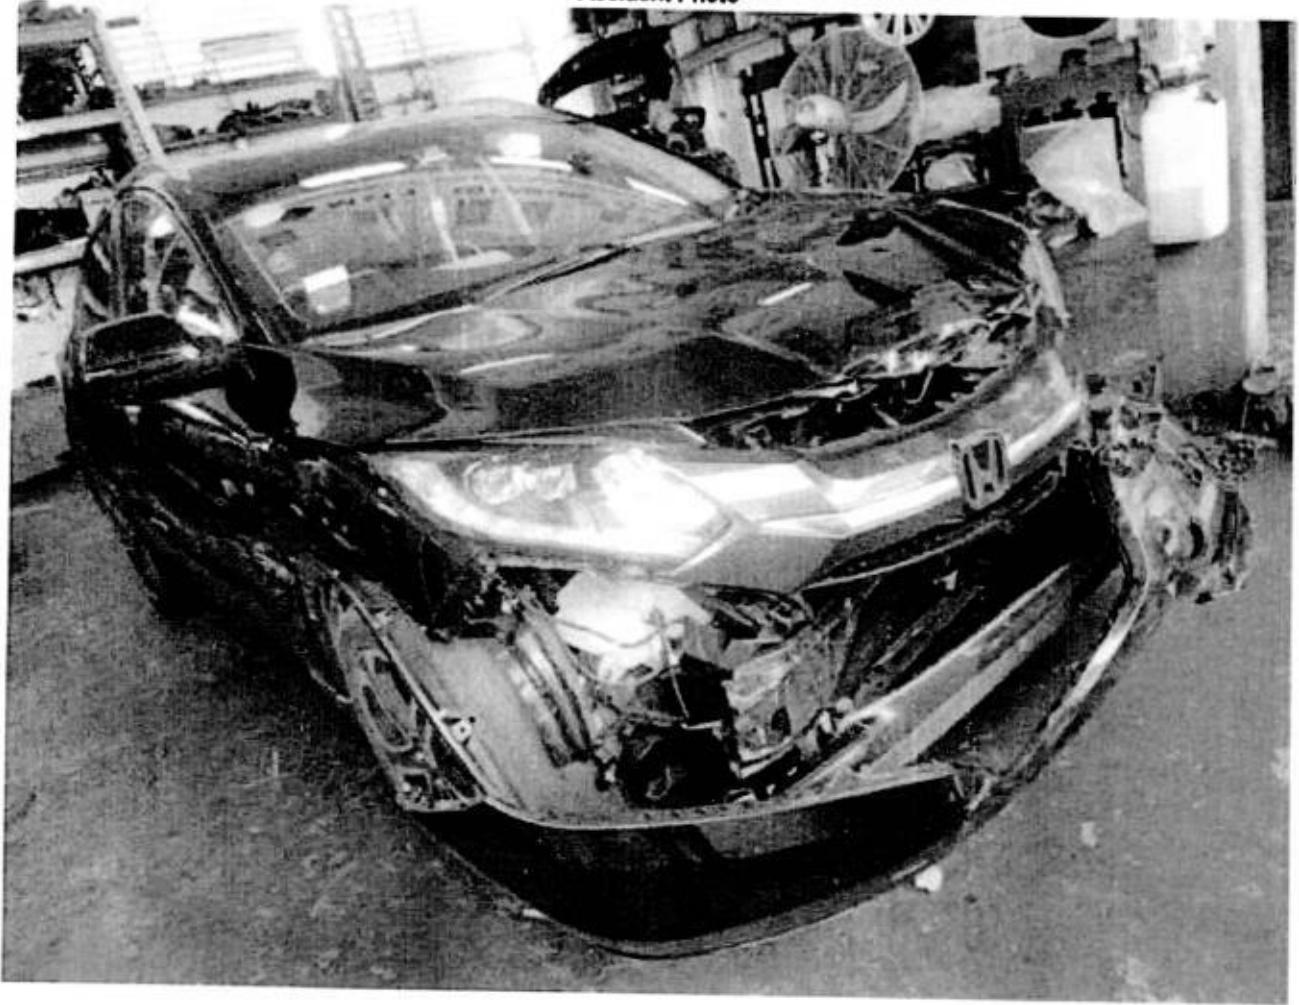
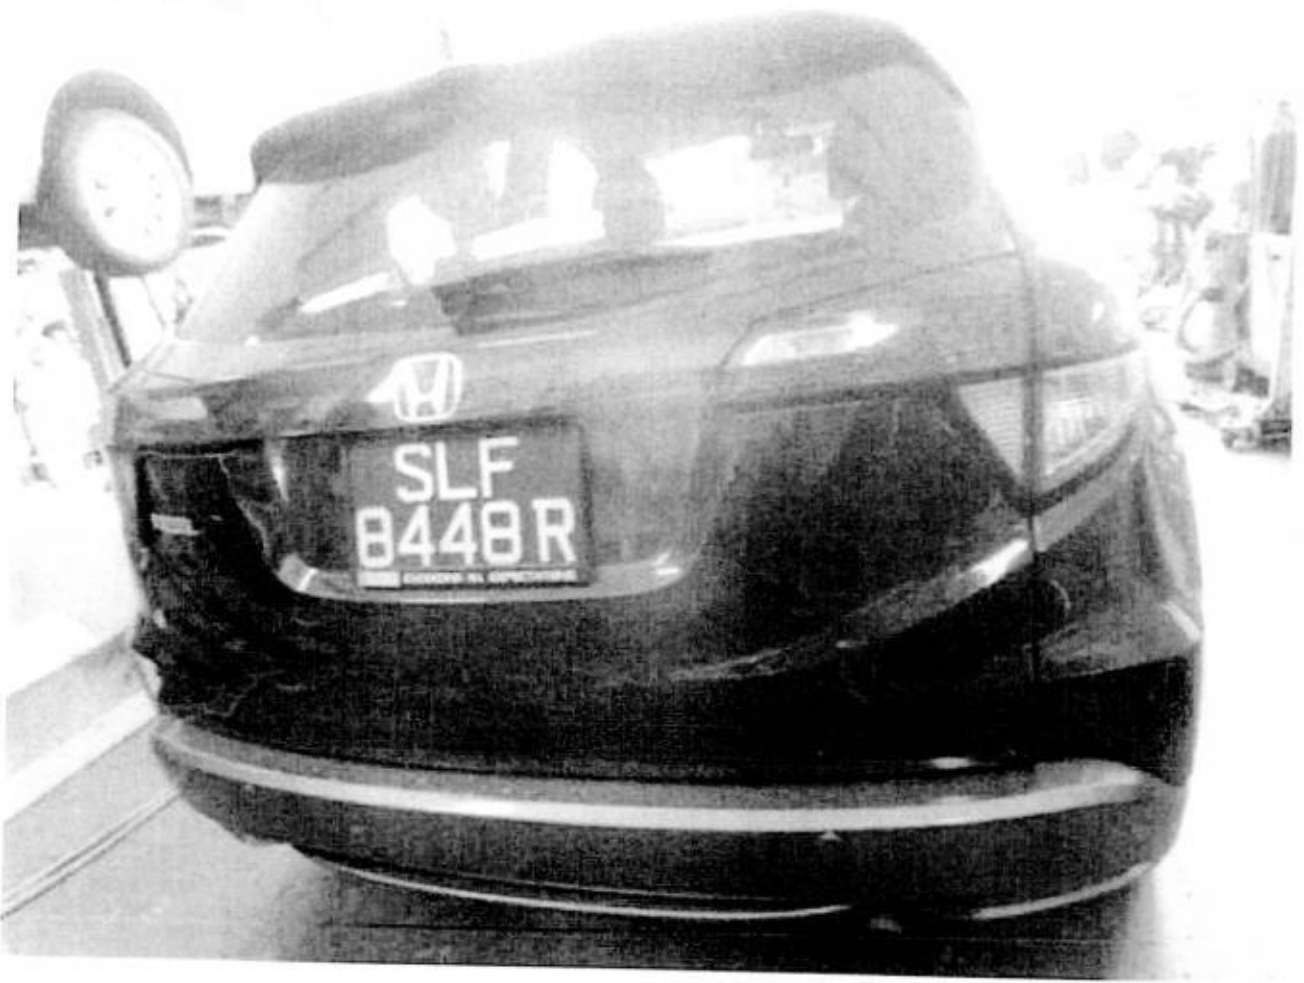
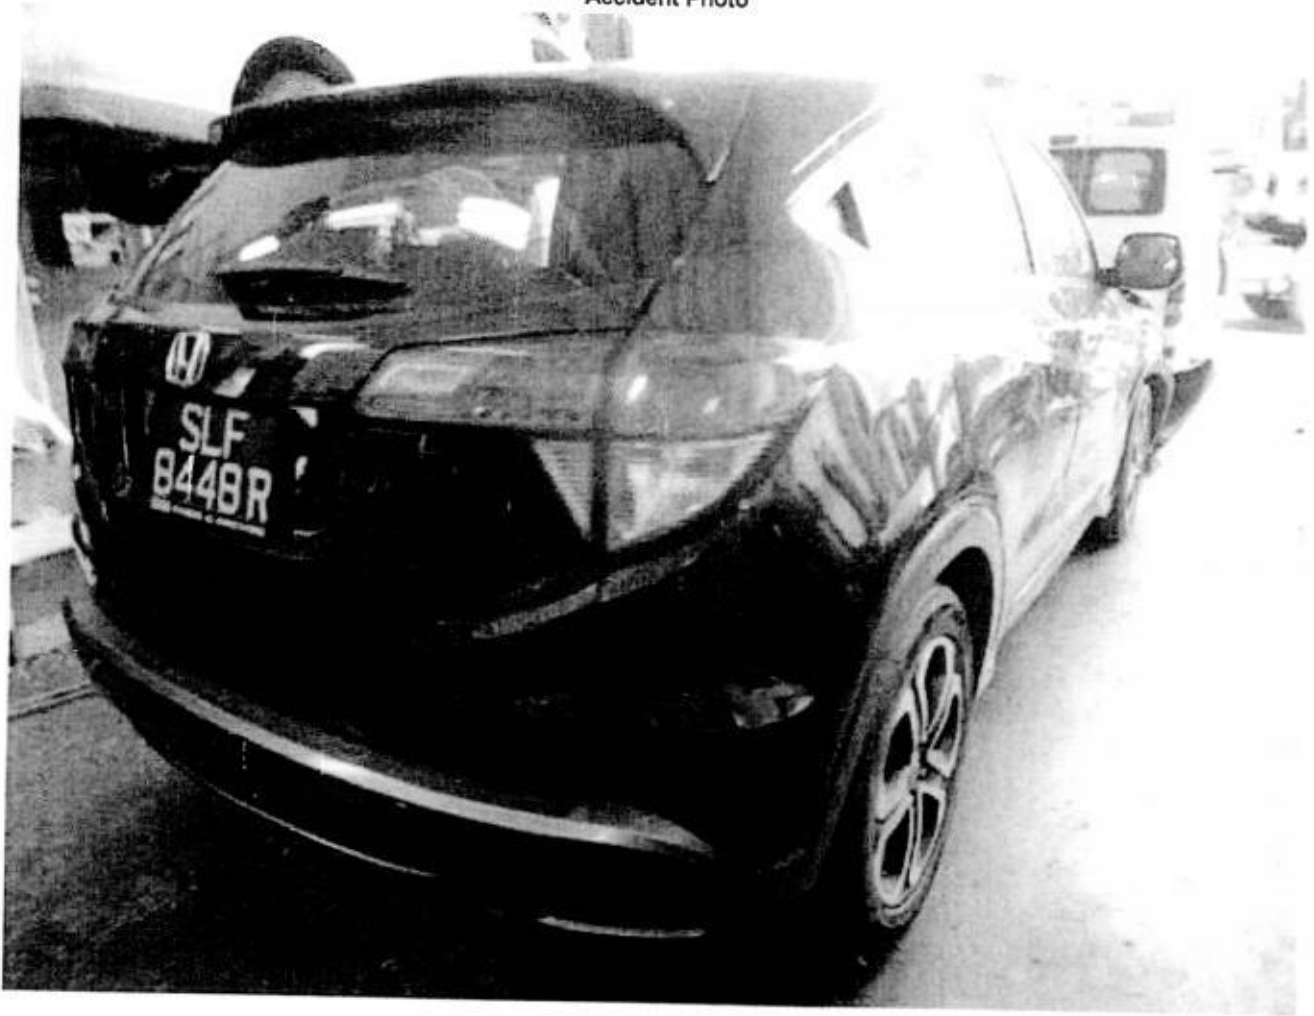
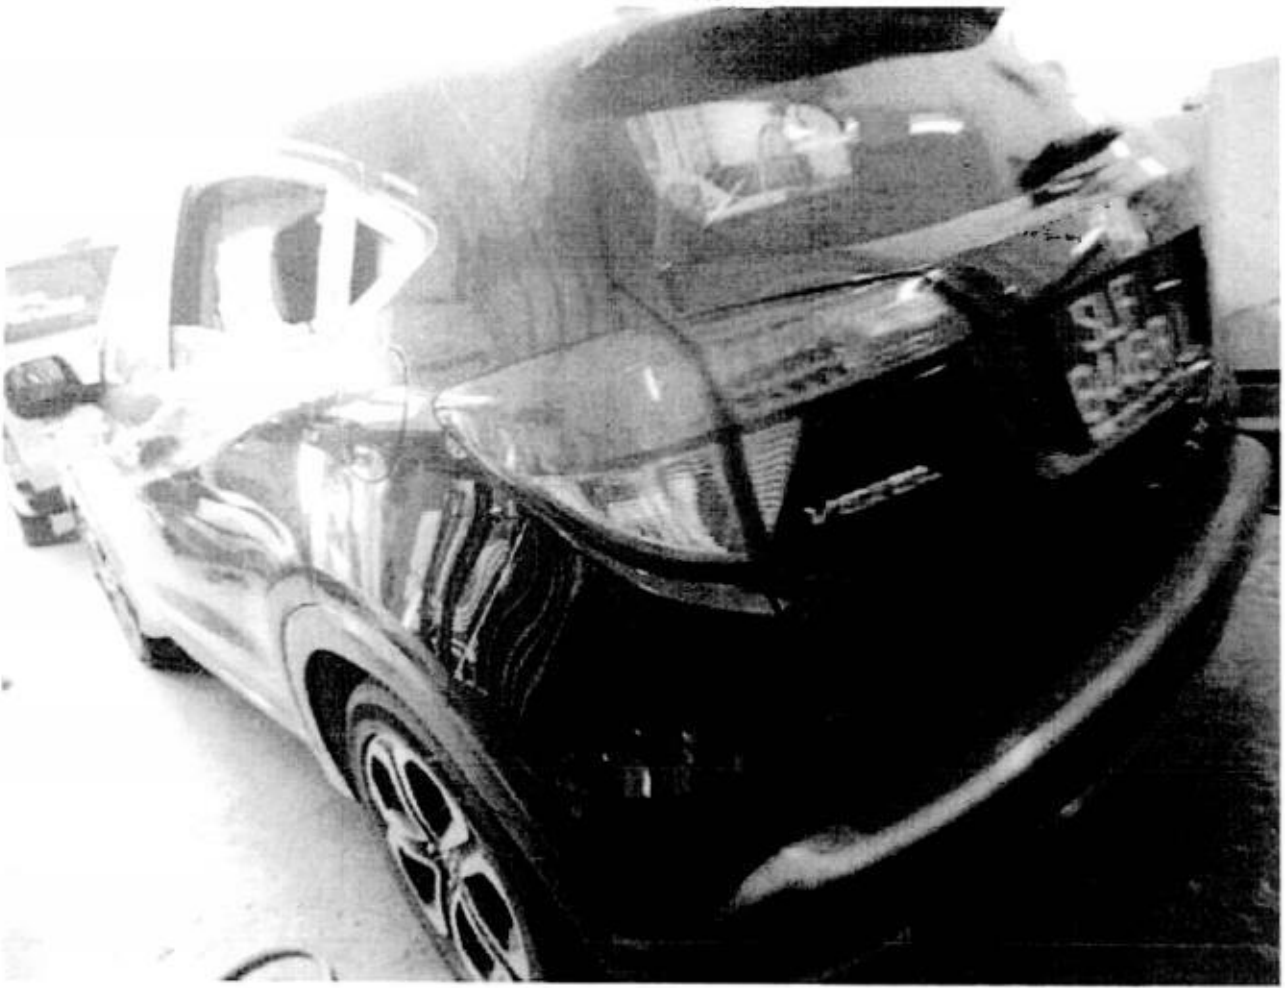
Accident Photo

Impact on the rear RH and LH portion.  
Please see details as described in the Annex for parts and labour.

Hence, the recommended cost of repairs based on Lump Sum repairs is : SS 13,100.00 and the recommended number of working days for the repairs is within 11 day(s).
