Your Ref: TP/IP/03945/2019
Our Ref : CI/TPD19008268/P

Fatal Accident Investigation Team

MECHANICAL INSPECTION REPORT OF MOTOR BUS PC 8218G

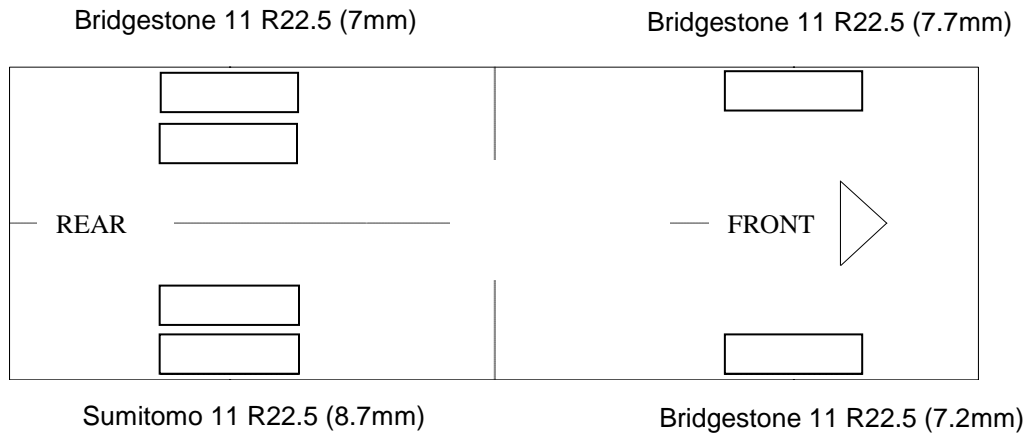
6. The 2 front tyres and 4 rear tyres of the Motor Bus were observed to be in serviceable condition and sufficiently inflated for vehicular operation. I did not find any tear, cut or burst mark(s) on the outer and the inner sidewalls as well as across the tread of the 6 tyres. The tyre brand, tyre size and remaining tread depth of the 6 tyres of the Motor Bus were recorded as follows:-

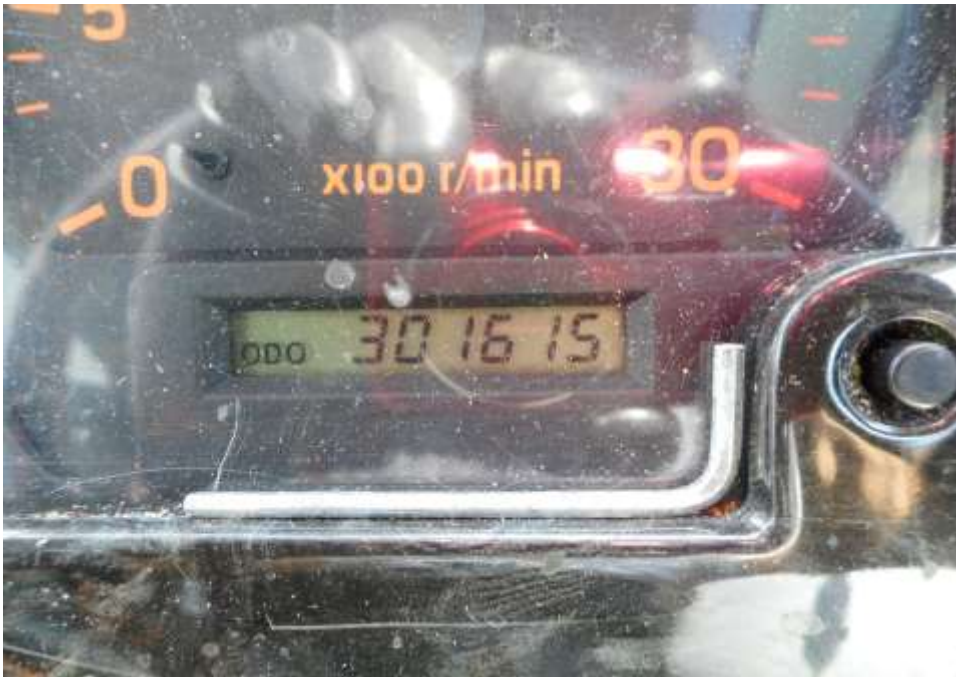
Photo 1 shows a general view of the instrument cluster of the Motor Bus at the time of my inspection. The mileage of the Motor Bus was 301,615km

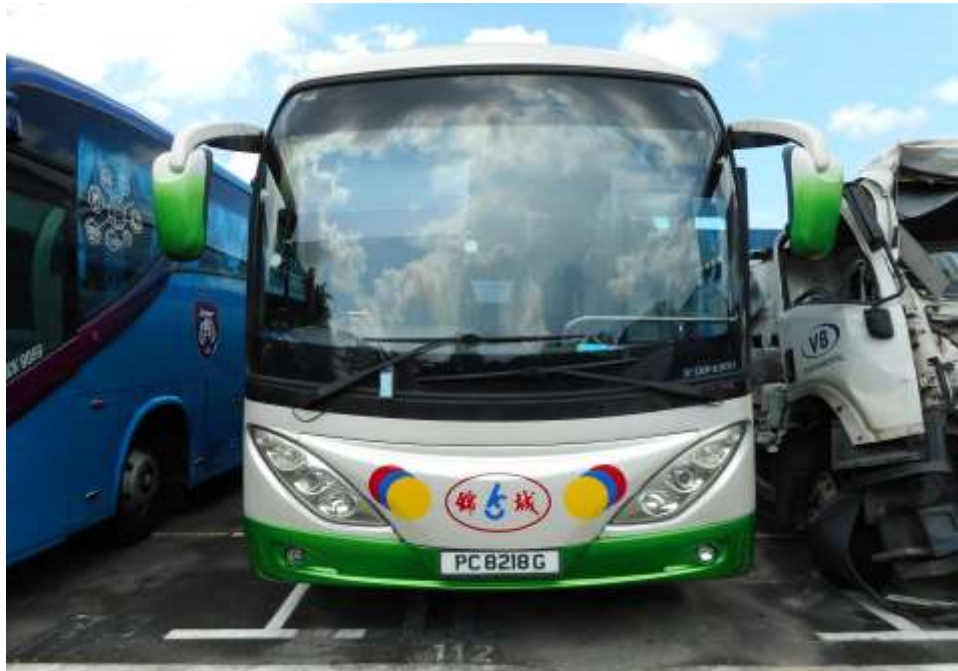
Photo 2 shows a general view of the front body of the Motor Bus at the time of my inspection. The Motor Bus was observed to be in good general condition.

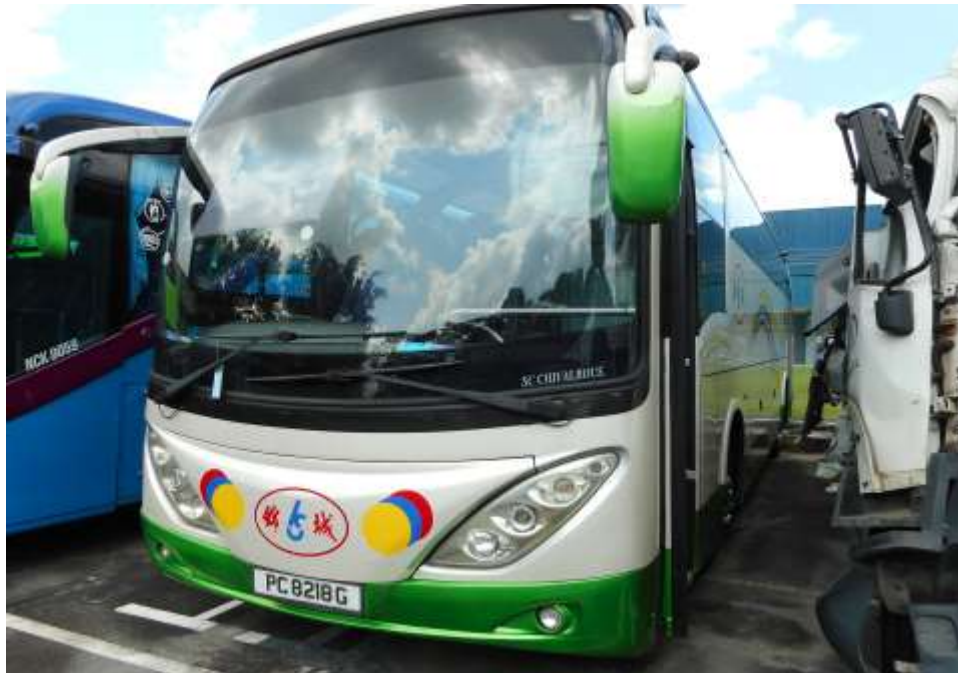
4. The mileage of the Motor Bus at the time of my inspection was 301,615km.
5. The Motor Bus was observed to have sustained minor damages at its left side portion. Its left side body panel was damage as a result of the accident at the time of my inspection.

Photo 3 shows a general view of the left body of the Motor Bus at the time of my inspection. The Motor Bus was observed to have sustained minor damage to its left portion; its left body panel was damaged as a result of the accident.

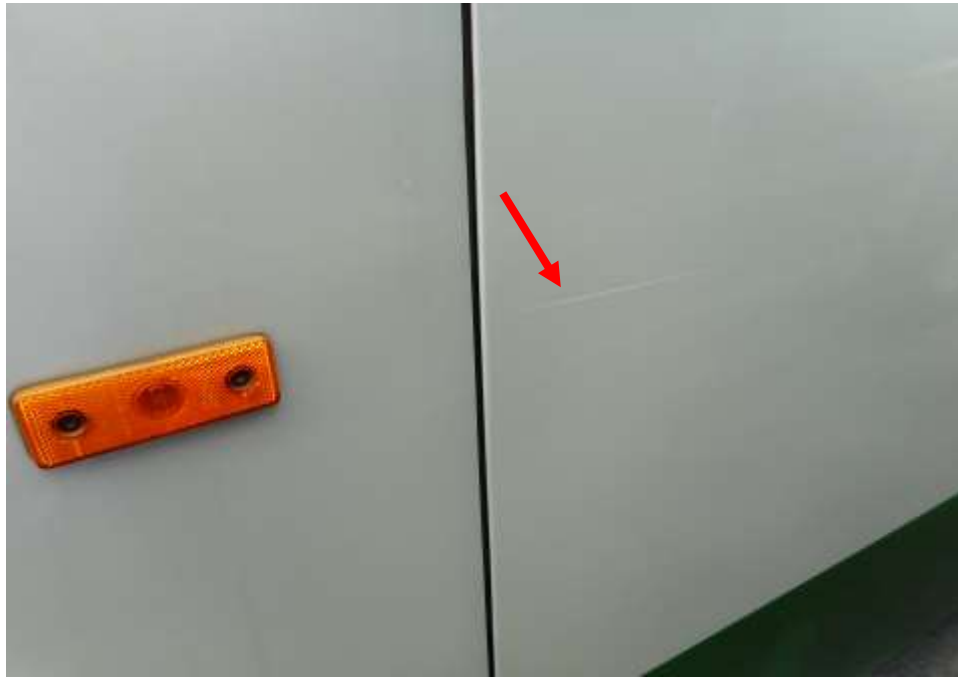
Photo 4 shows a close up view of the front body of the Motor Bus at the time of my inspection. The Motor Bus was observed to have sustained minor damage to its left portion; its left body panel (arrowed) was damaged as a result of the accident.

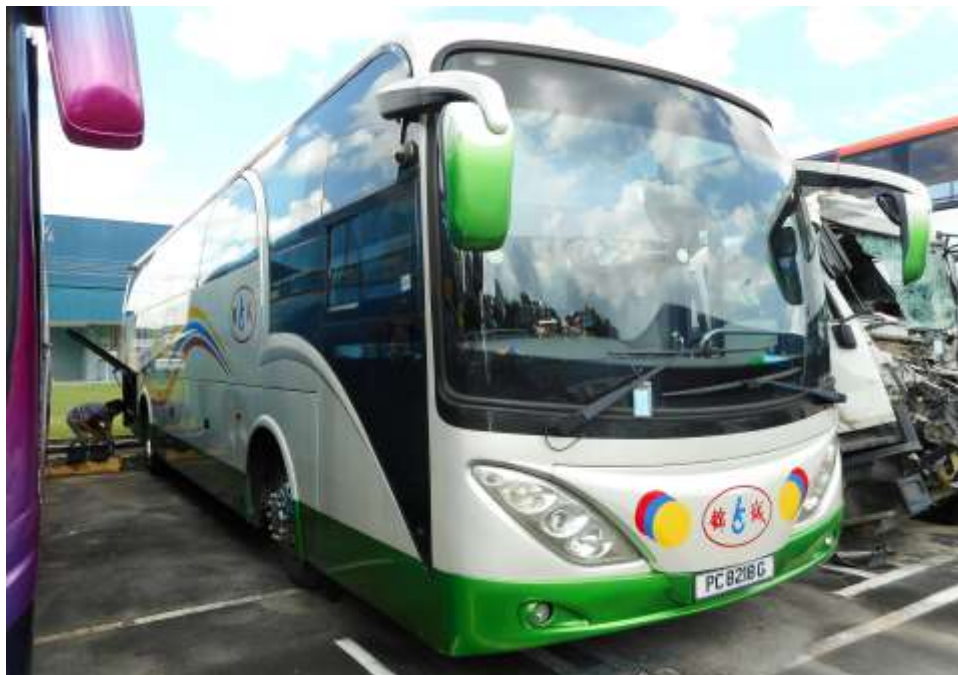
Photo 5 shows a general view of the right body of the Motor Bus at the time of my inspection. The Motor Bus was observed to be in good general condition.

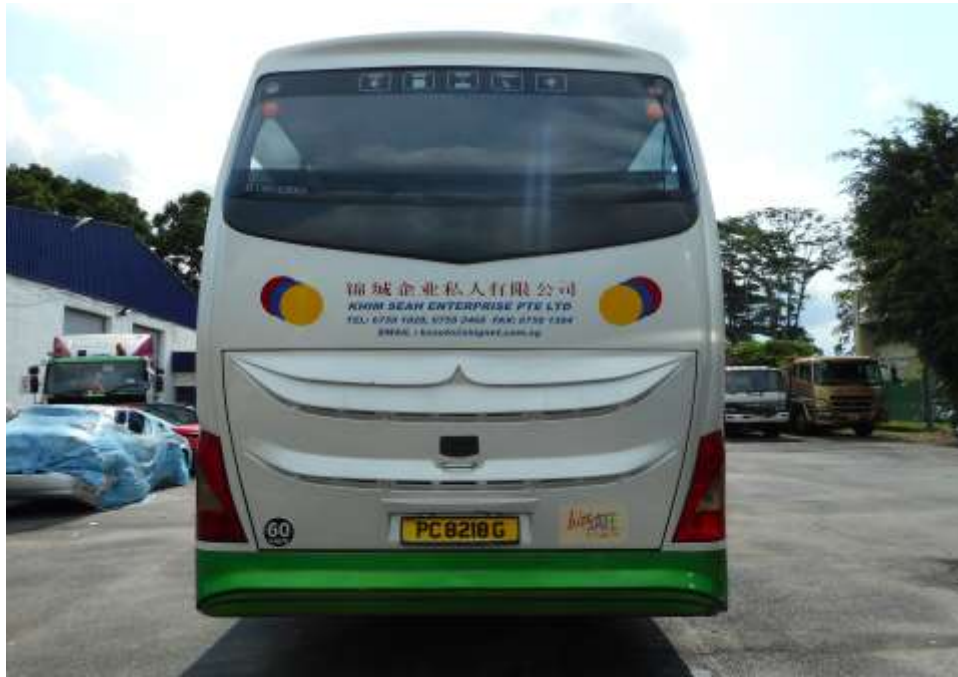
Photo 6 shows a general view of the Motor Bus's rear left body at the time of my inspection. There was no damage found to the rear portion of the Motor Bus.

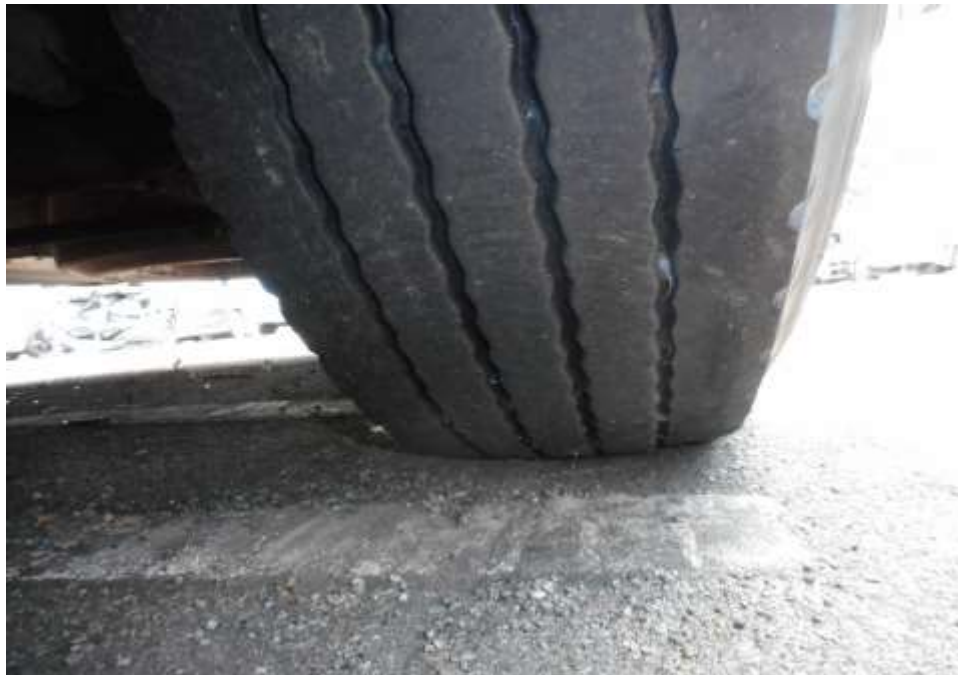
Photo 7 shows the condition of the front right tyre of the Motor Bus, which was observed to be in serviceable condition with remaining tread depth of approximately 7.2 mm. The tyre, which was wrapped around standard steel wheel rim, was also observed to be sufficiently inflated for vehicular operation. There was no tear, cut or burst mark(s) on the outer and the inner sidewalls as well as across the tread of the 6 tyres that were fitted on the Motor Bus.

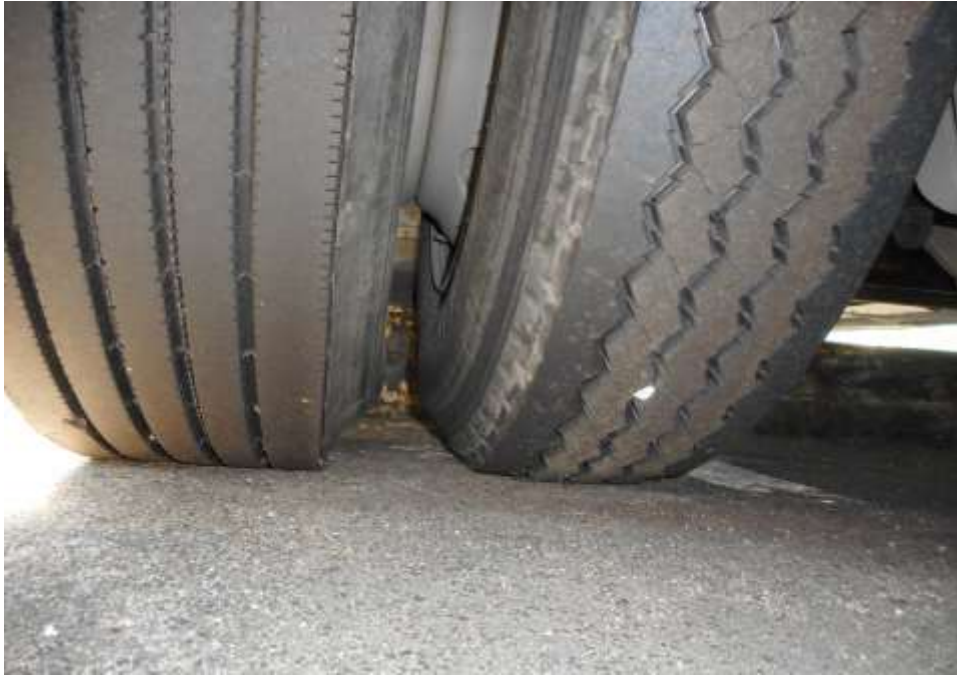
Photo 8 shows the condition of the rear right tyre of the Motor Bus, which was observed to be in serviceable condition with remaining tread depth of approximately 8.7mm. The tyre, which was wrapped around standard steel wheel rim, was also observed to be sufficiently inflated for vehicular operation.

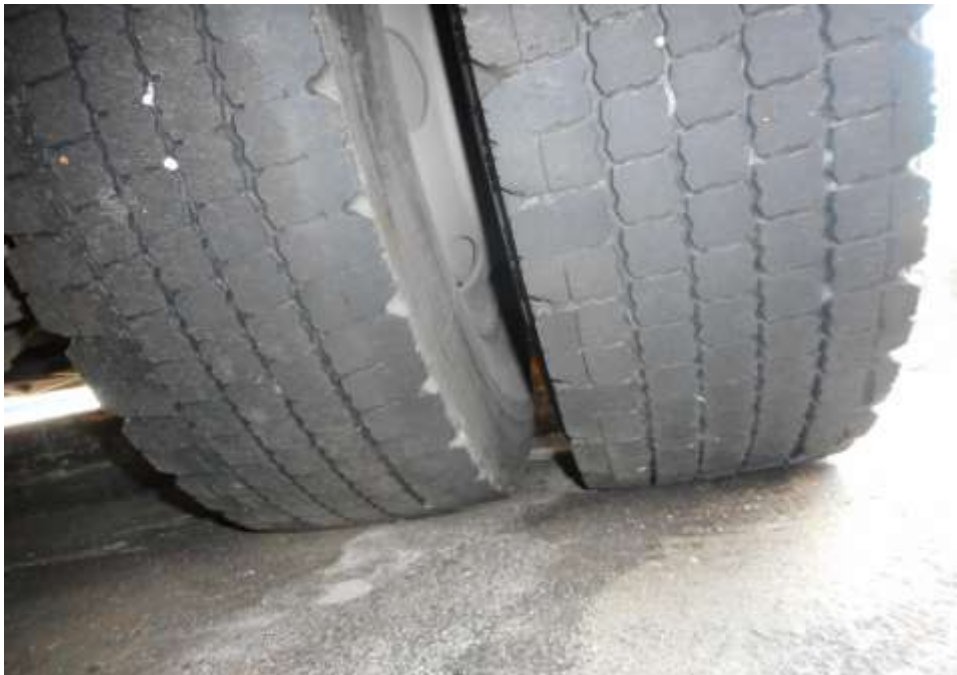
Photo 9 shows the condition of the rear left tyres of the Motor Bus, which was observed to be in serviceable condition with remaining tread depth of approximately 7mm. The tyres, which were wrapped around standard steel wheel rim, were also observed to be sufficiently inflated for vehicular operation. There was also no damage found on all 6 steel wheel rims of the Motor Bus.

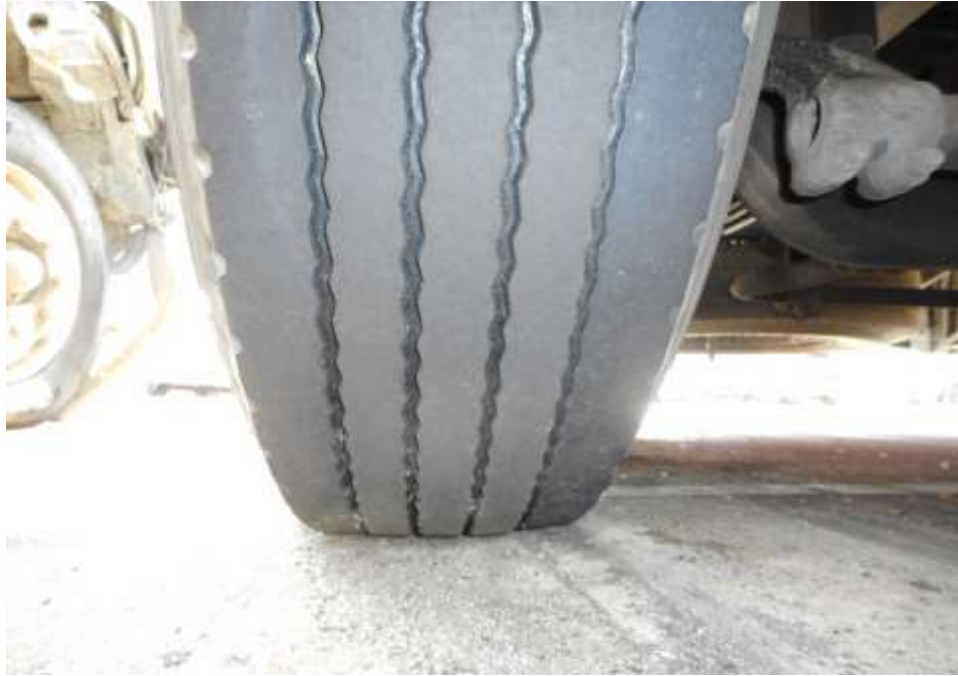
Photo 10 shows the condition of the front left tyres of the Motor Bus, which were observed to be in serviceable condition with remaining tread depth of approximately 7.7mm. There was also no tear, cut or burst mark(s) on the outer and the inner sidewalls as well as across the tread of the 6 tyres that were fitted on the Motor Bus.

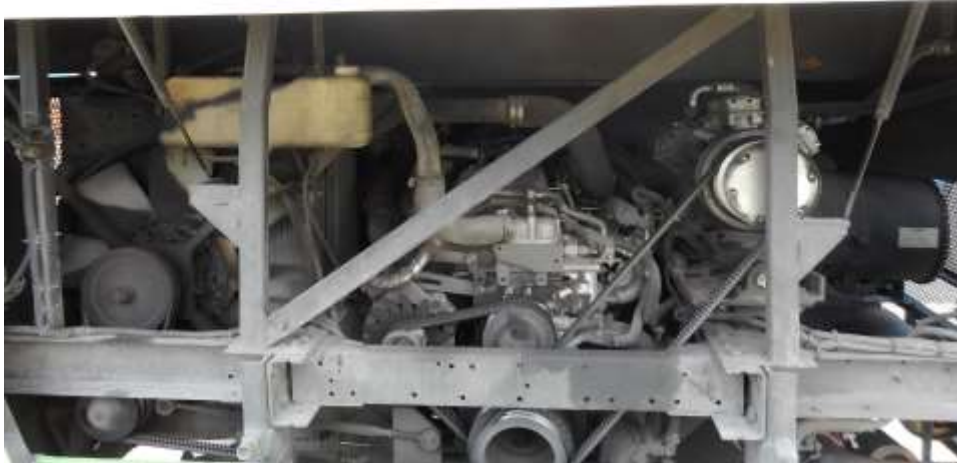
Photo 11 shows a general view of the Motor Bus's engine compartment, which was accessed by lifting the front cabin of the Motor Bus. The various parts and components inside the engine compartment were unaffected by the accident. There was also no sign(s) or indication(s) of fresh fluid leakage and/or fluid stain within the engine compartment (photograph shows the engine compartment as viewed from the right front side of the Motor Bus).

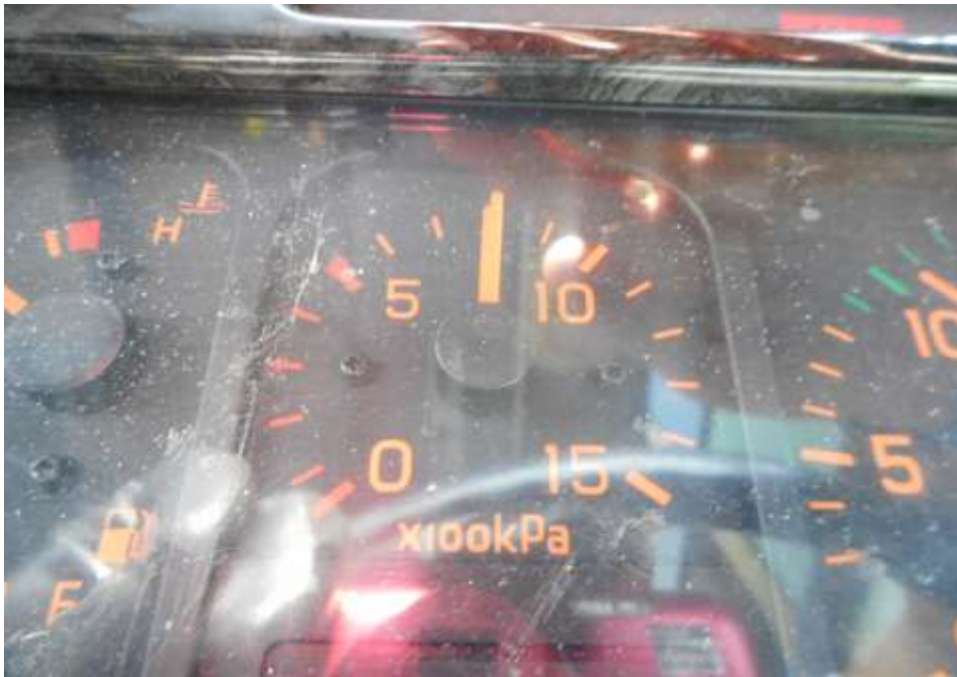
Photo 12 shows the air in the air brake cylinder of the Motor Bus at the time of my inspection. The air in the cylinder was observed to be of sufficient level & serviceable at the time of the accident.

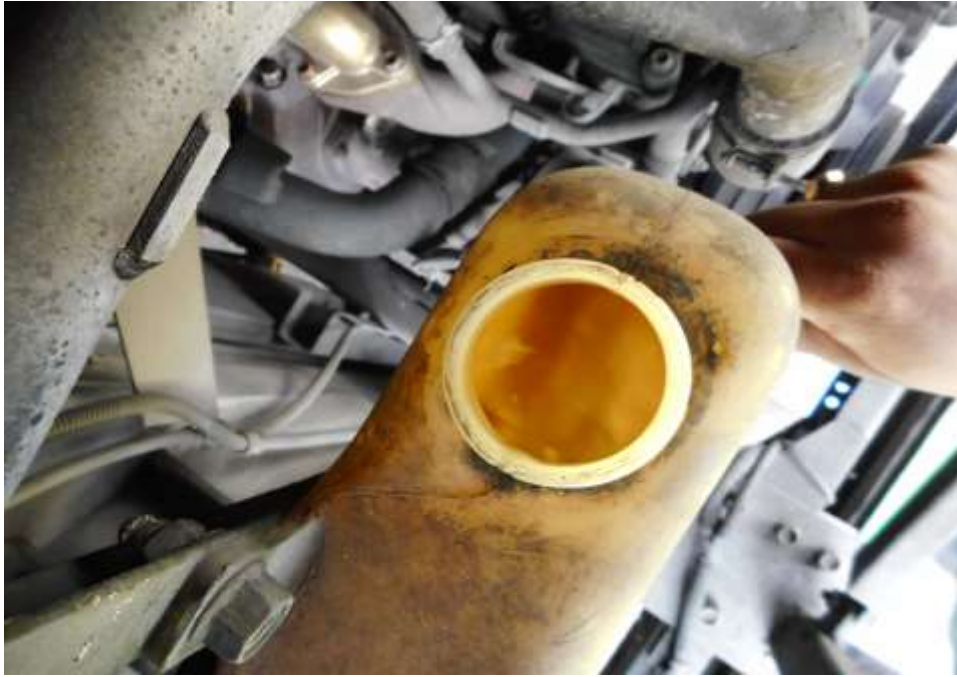
Photo 13 shows the engine coolant reservoir of the Motor Bus at the time of my inspection. The engine coolant was observed to be of sufficient level and without any visible contamination.

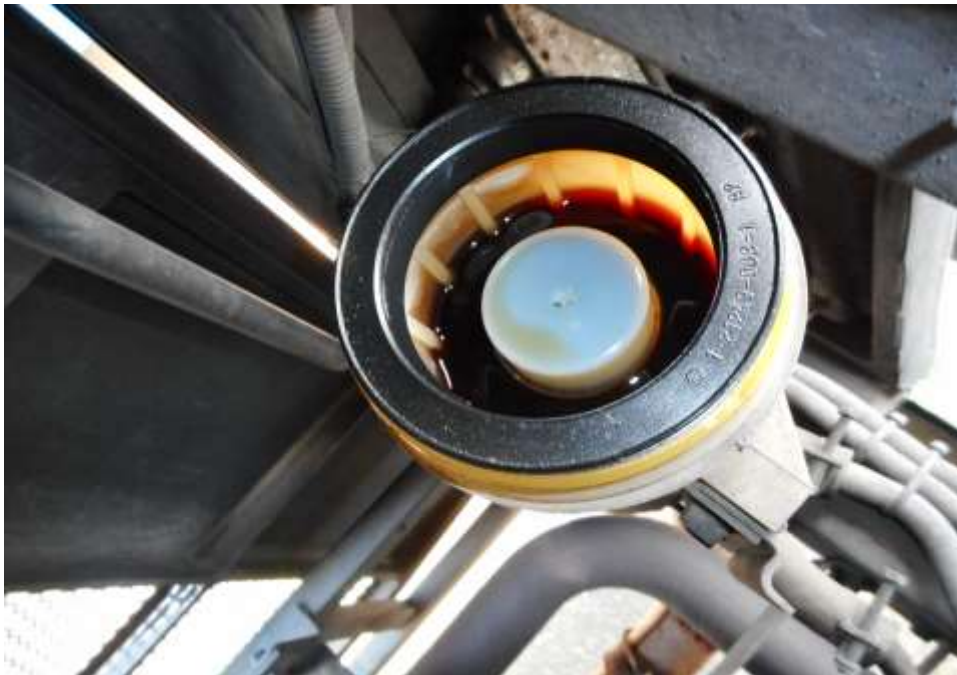
Photo 14 shows the power steering fluid reservoir of the Motor Bus at the time of my inspection. The power steering fluid was observed to be of sufficient level and without any visible contamination.

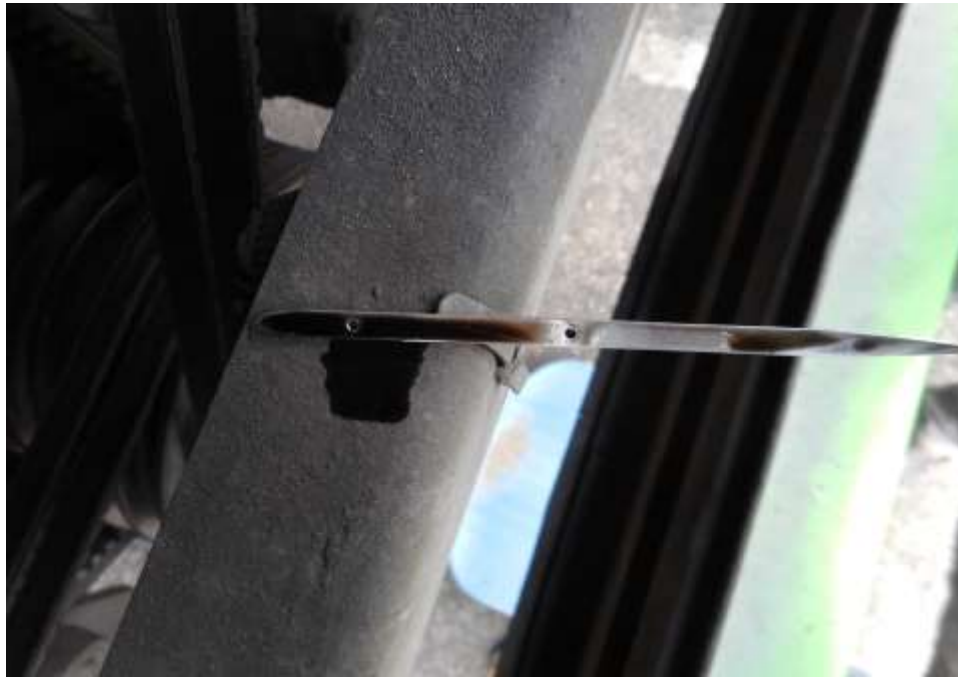
Photo 15 shows the engine oil dip stick system of the Motor Bus at the time of my inspection. The engine oil was observed to be of sufficient level and without any visible contamination.

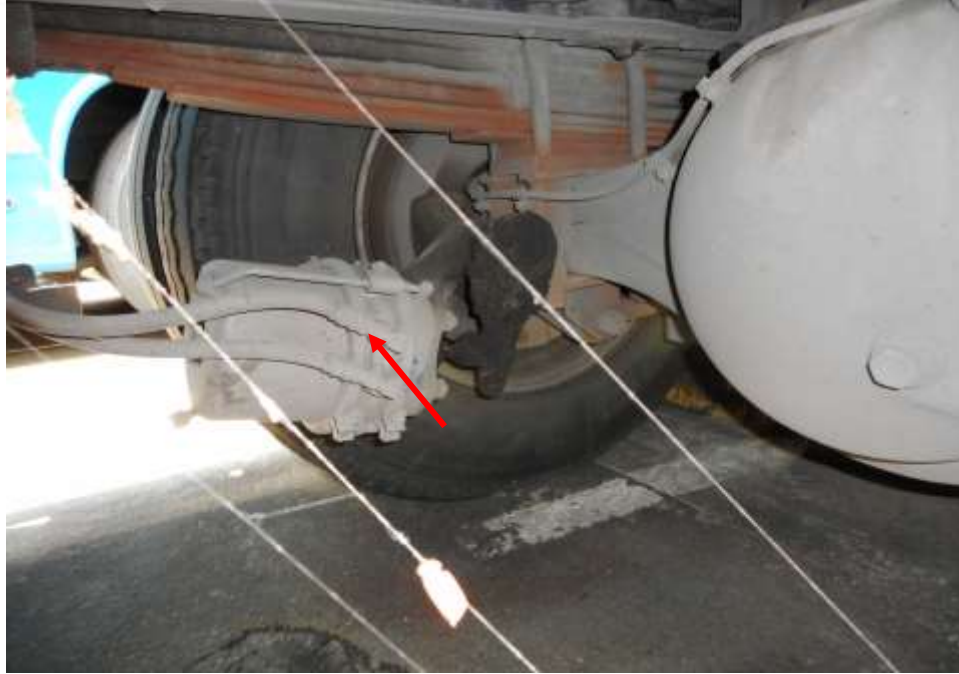
Photo 16 shows the brake pipe (arrowed) at the rear right wheel of the Motor Bus. I did not observe any leakage of brake fluid at the time of my inspection of the Motor Bus. My static tests of the Motor Bus's braking system, along with my visual examination of the various mechanical components in the braking system, had indicated that there was no internal leakage of pressure/vacuum. Hence the braking system of the Motor Bus was likely to be in serviceable condition at the material time of accident.

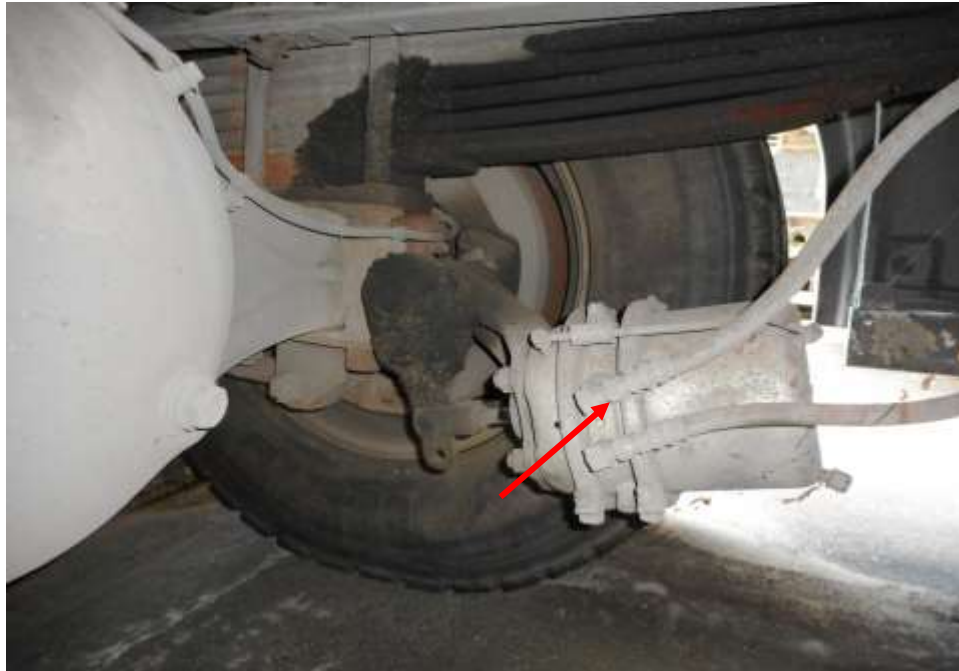
Photo 17 shows the brake pipe (arrowed) at the rear left wheel of the Motor Bus. I did not observe any leakage of brake fluid at the time of my inspection of the Motor Bus. My static tests of the Motor Bus's braking system, along with my visual examination of the various mechanical components in the braking system, had indicated that there was no internal leakage of pressure/vacuum. Hence the braking system of the Motor Bus was likely to be in serviceable condition at the material time of accident.

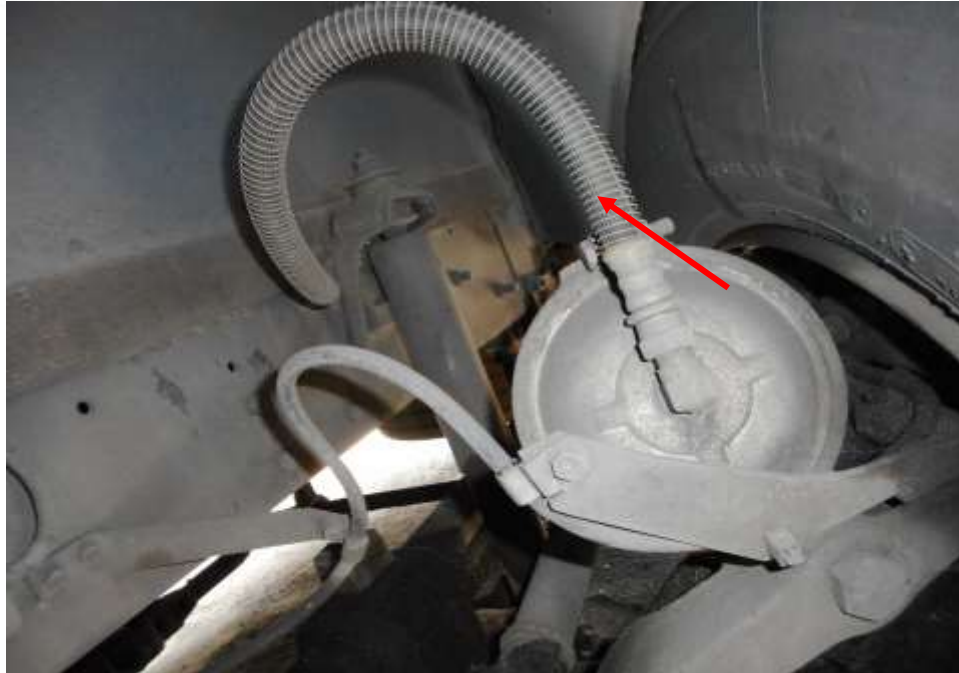
Photo 18 shows the brake pipe (arrowed) at the front right wheel of the Motor Bus. I did not observe any leakage of brake fluid at the time of my inspection of the Motor Bus. My static tests of the Motor Bus's braking system, along with my visual examination of the various mechanical components in the braking system, had indicated that there was no internal leakage of pressure/vacuum. Hence the braking system of the Motor Bus was likely to be in serviceable condition at the material time of accident.

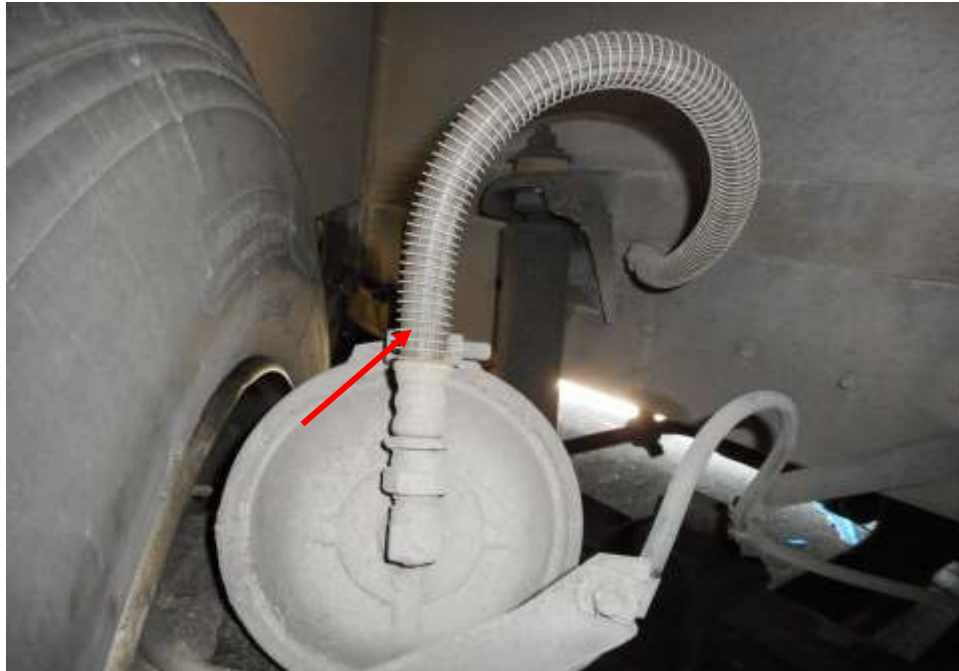
Photo 19 shows the brake pipe (arrowed) at the front left wheel of the Motor Bus. I did not observe any leakage of brake fluid at the time of my inspection of the Motor Bus. My static tests of the Motor Bus's braking system, along with my visual examination of the various mechanical components in the braking system had indicated that there was no internal leakage of pressure/vacuum. Hence the braking system of the Motor Bus was likely to be in serviceable condition at the material time of accident.

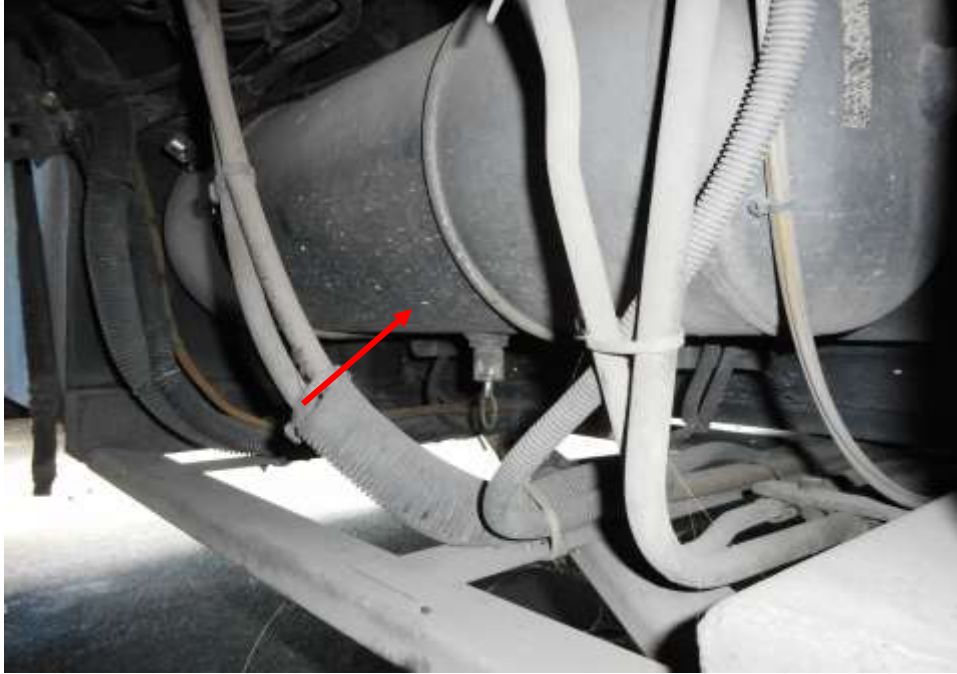
Photo 20 shows the air brake cylinder (arrowed) at the undercarriage of the Motor Bus. I did not observe any leakage of air brake fluid at the time of my inspection of the Motor Bus. My static tests of the Motor Bus's braking system, along with my visual examination of the various mechanical components in the braking system had indicated that there was no internal leakage of pressure/vacuum. Hence the braking system of the Motor Bus was likely to be in serviceable condition at the material time of accident.

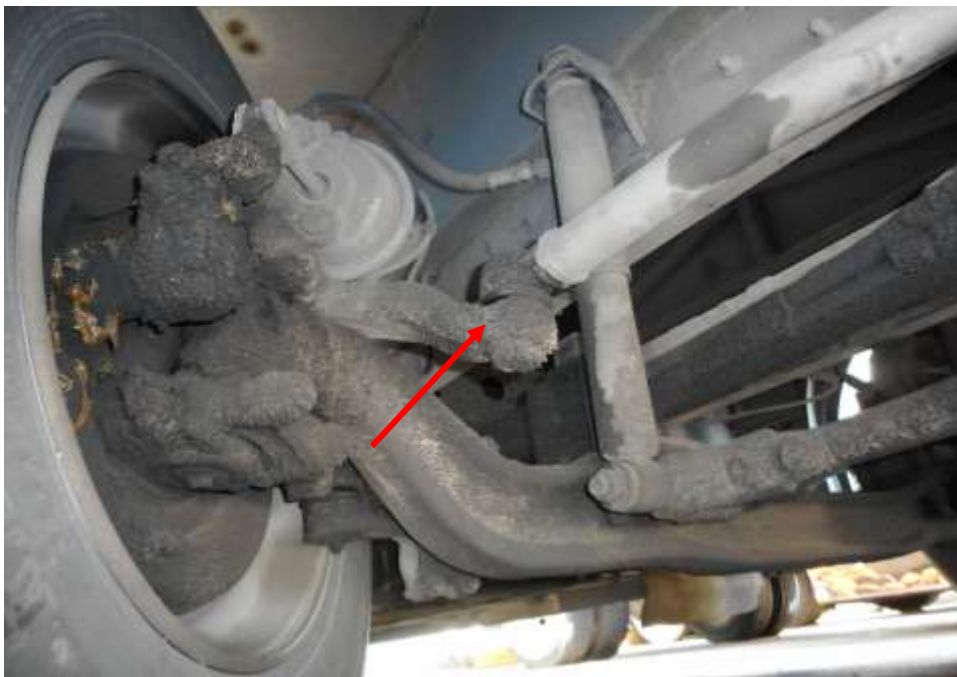
Photo 21 shows the various undercarriage components at the front right wheel of the Motor Bus, in particular the steering tie rod end (arrowed). The various steering components were all found to be intact, suggesting that the steering system of the Motor Bus was likely to be in serviceable condition at the material time of accident. There was also no sign of fluid stain(s) observed on the various undercarriage components.

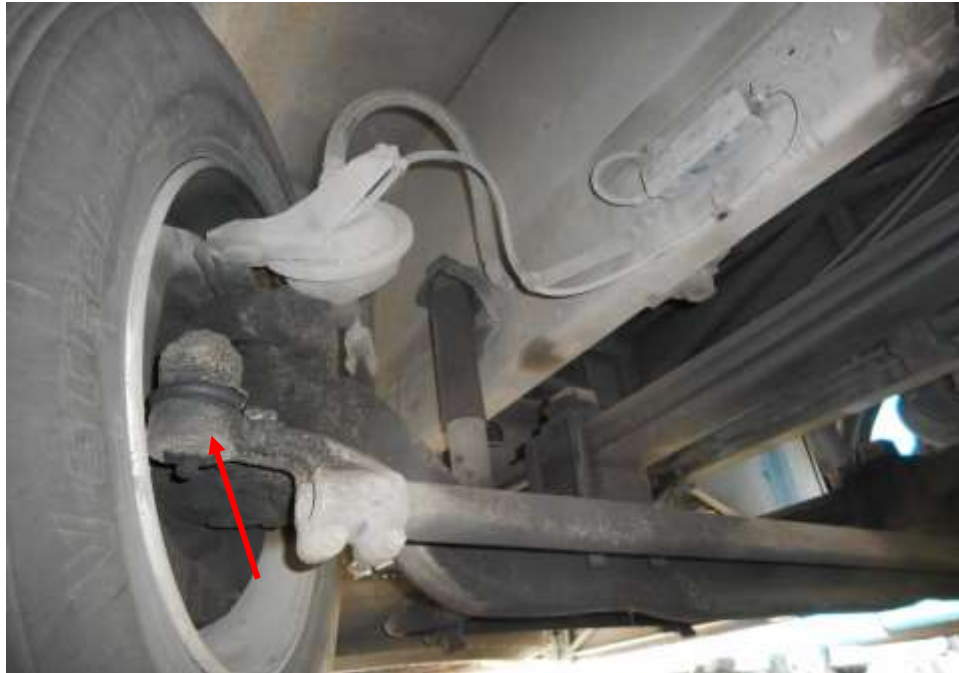
Photo 22 shows the various undercarriage components at the front left wheel of the Motor Bus, in particular the steering tie rod end (arrowed). The various undercarriage components of the Motor Bus were all found to be intact without any visible damage. There was also no sign of fluid stain(s) observed on the various undercarriage components.

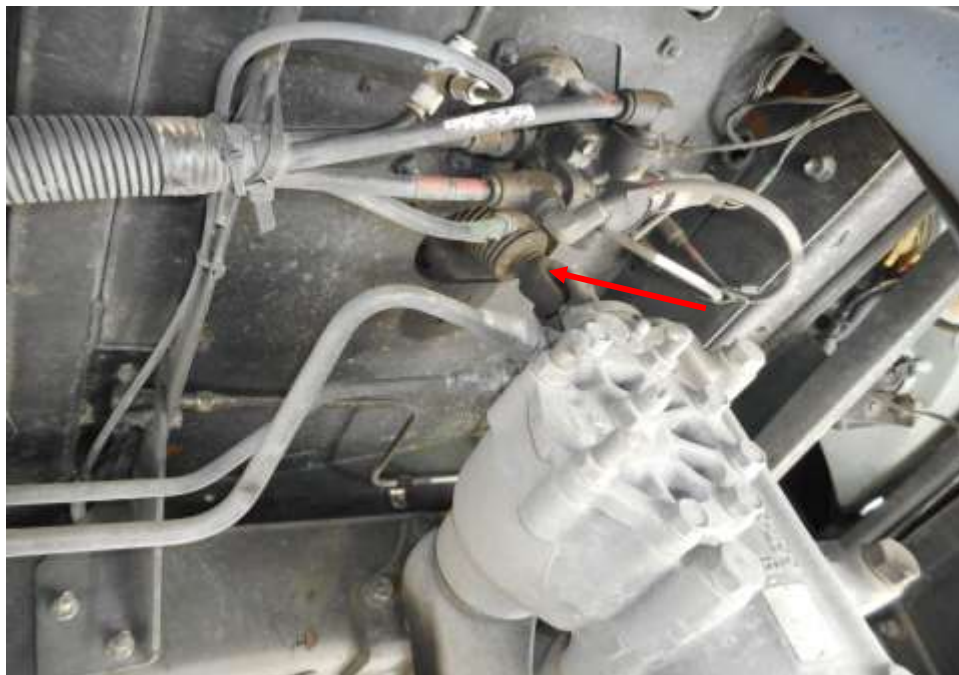
Photo 23 shows the steering box component (arrowed) at the undercarriage of the Motor Bus was found to be intact without any visible damage. There was also no sign of fluid stain(s) observed on the various undercarriage components.

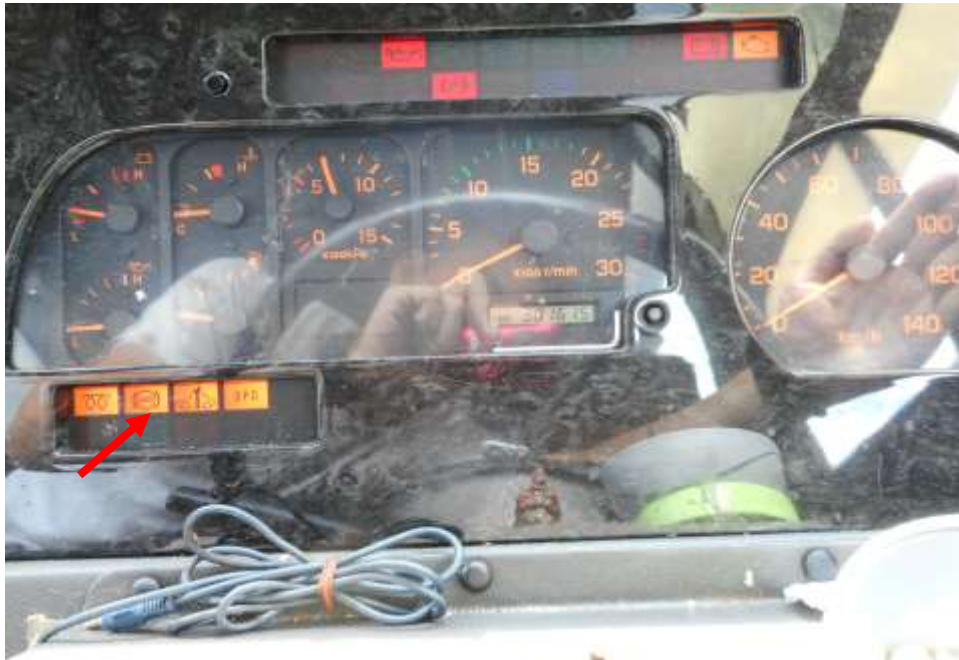
Photo 25 shows the warning light for Anti-Lock Brake System (ABS) appearing on the instrument panel of the Motor Bus during the self-test of its various electronic operating systems when its engine was cranked.

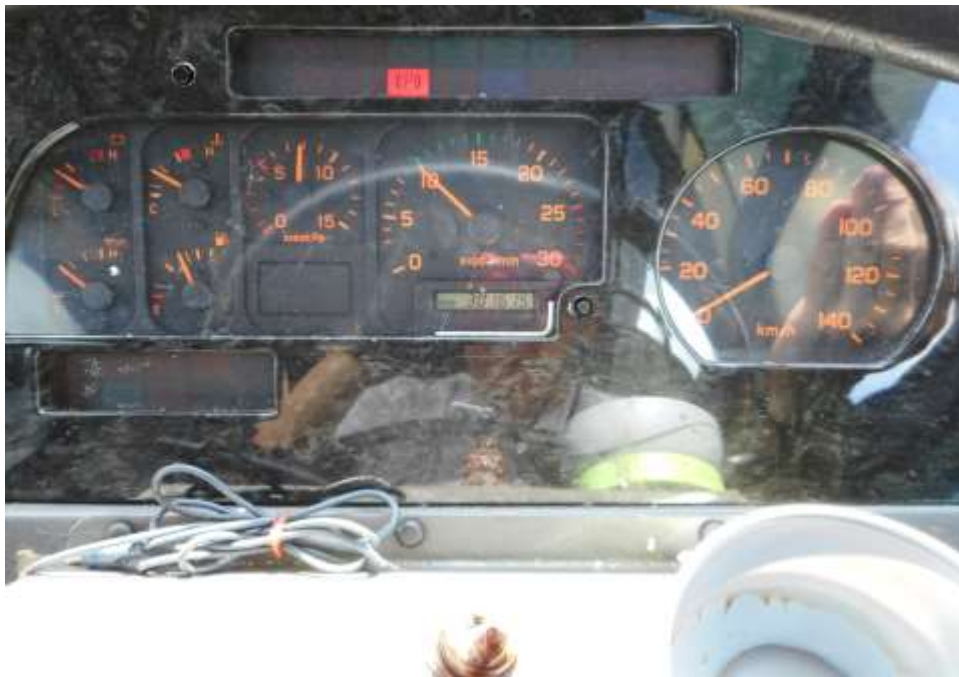
Photo 26 shows no warning lights illuminated on the instrument panel of the Motor Bus after the engine was cranked. This would suggest that there was no abnormality to the various electronic operating systems of the Motor Bus, like the ABS.
